Centennial Coal

Subsidence Management Status Report

Four Monthly Update

Clarence Colliery

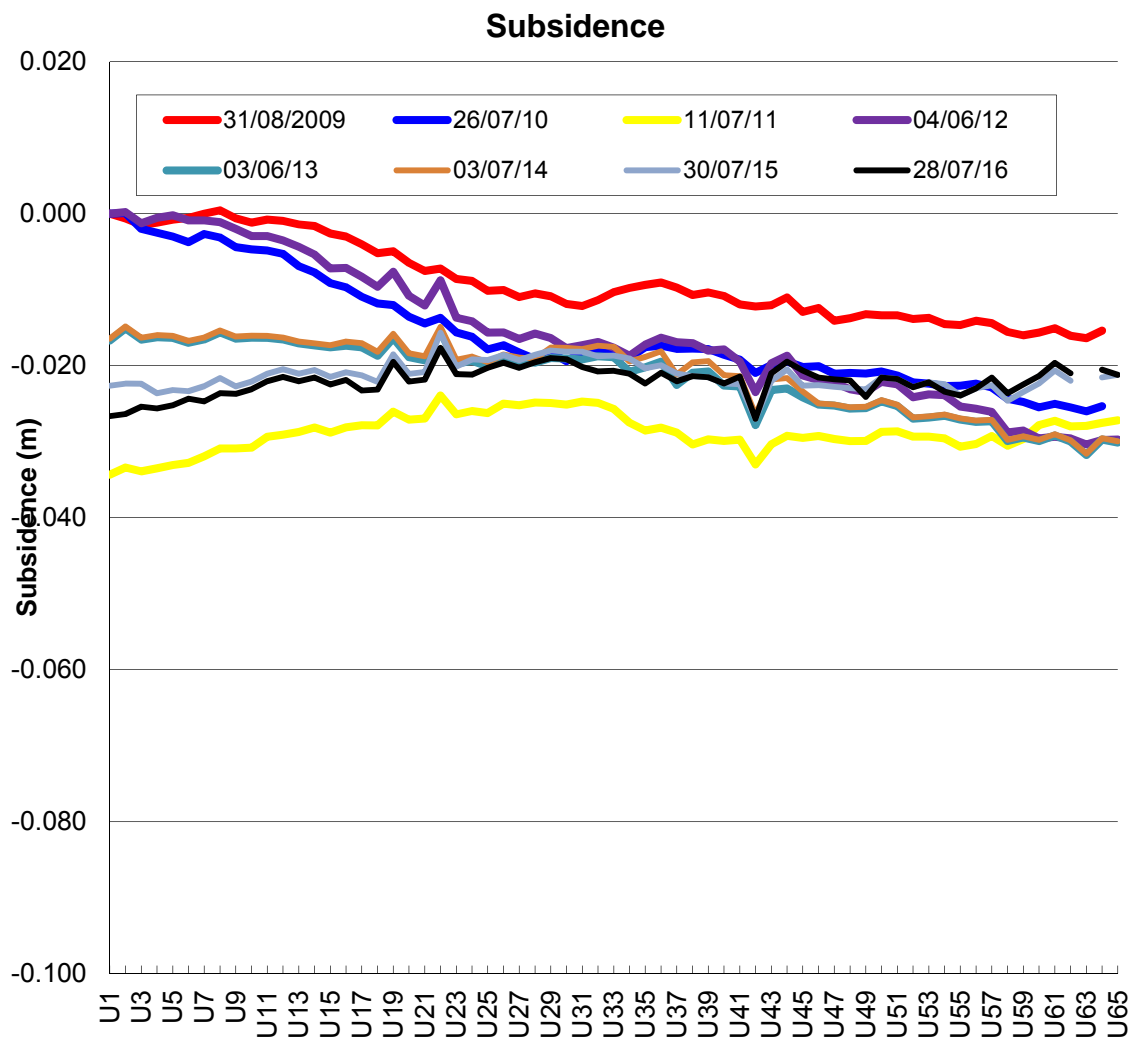
Figure 1. U Line Subsidence.

The U Line overlies the 400 Area and lies over and adjacent to the gateroads associated with the older longwall panels (and panel 408).

Maximum subsidence recorded during this survey was 27mm. The surveyed levels that were measured were all in line with the previous survey, indicating that there has been little to no movement.

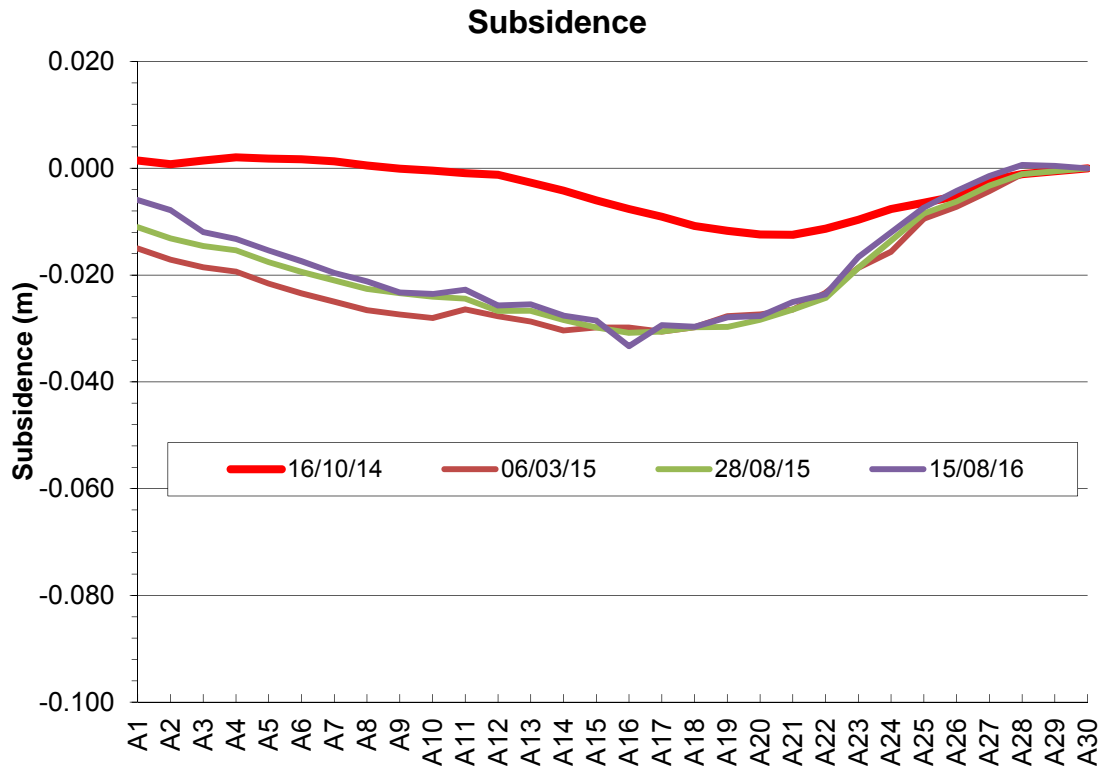
Figure 2. 900A Line Subsidence.

The 900A Line was resurveyed on 15th August 2016. This survey was the annual survey of the 902 and 904 panels. Results from the survey of the 900A line are presented in **Figure 2**.

Results from the survey are very similar to the previous survey with a maximum subsidence of 33mm recorded.

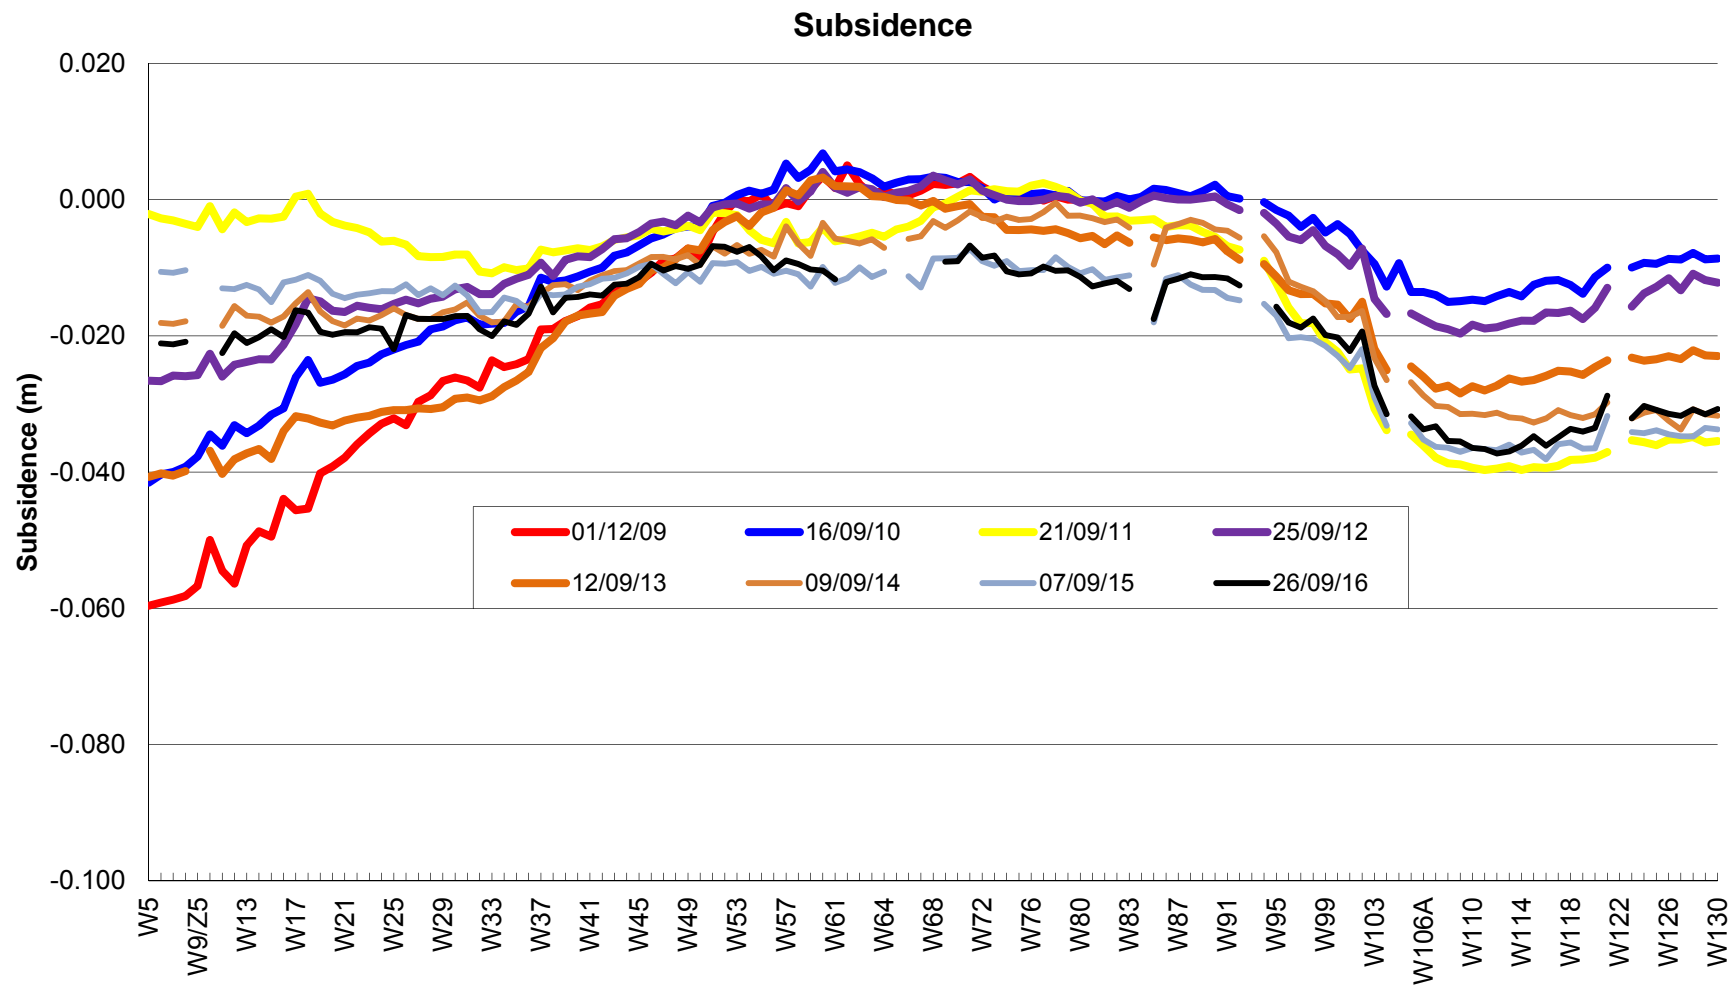
Figure 3. W Line Subsidence.

Irrespective, all results recorded along the W and Z Lines are well within Condition Green of the subsidence TARP and most certainly less than the maximum limit of 100mm.

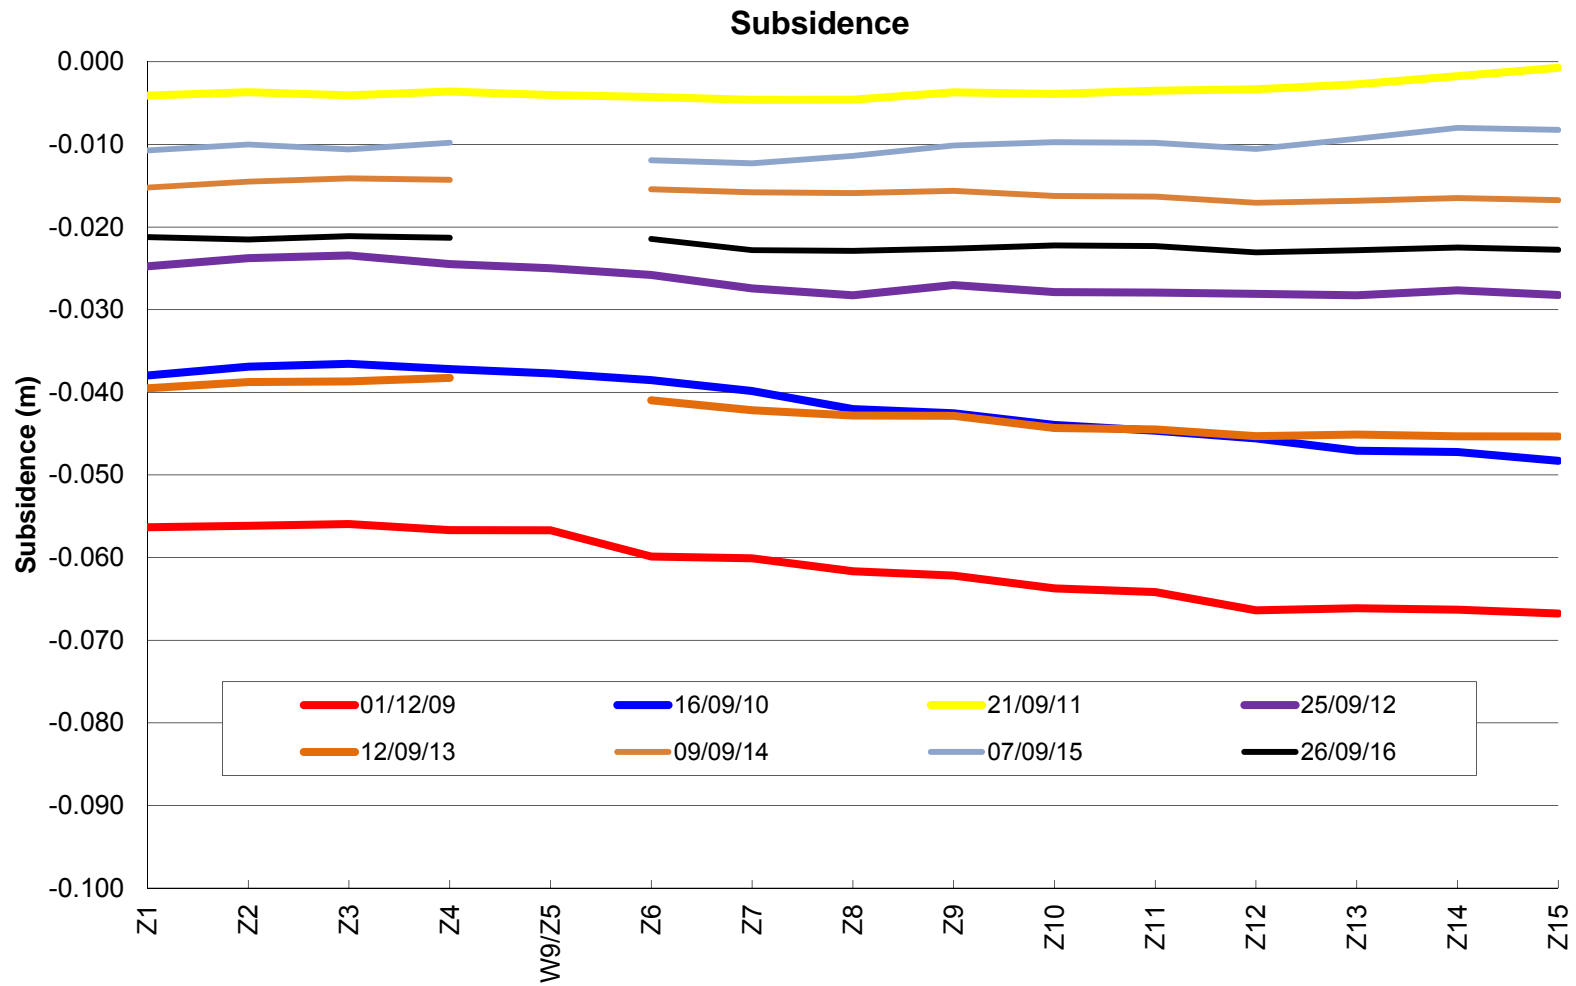
Figure 4. Z Line Subsidence.

The Z Line recorded a maximum subsidence of 22mm. The movement recorded along the Z Line has fluctuated over the years and this may be a result of survey technique (GPS) used to measure the lines and the very small numbers that are being measured.

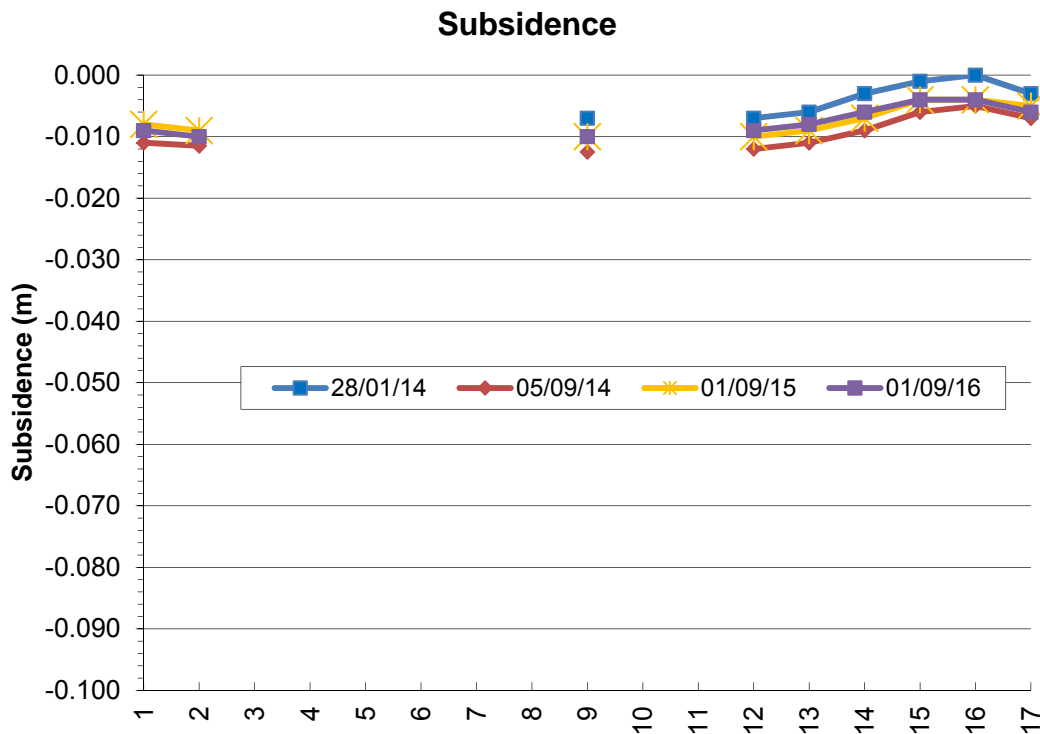
Figure 5. 700F Line Subsidence

As reported previously, a number of feno markers were severely damaged and/or lost during the 2013 bushfires. Losses were sustained from the creation of a firebreak/access track and/or direct fire. Regardless, a number of the pegs along this line can still be measured. The results from the 700F line are presented in **Figure 5**.

Maximum subsidence recorded from the survey was 10mm. This was recorded from Peg 9 and Peg 2 which are located over extracted pillars associated with the 716 Panel.

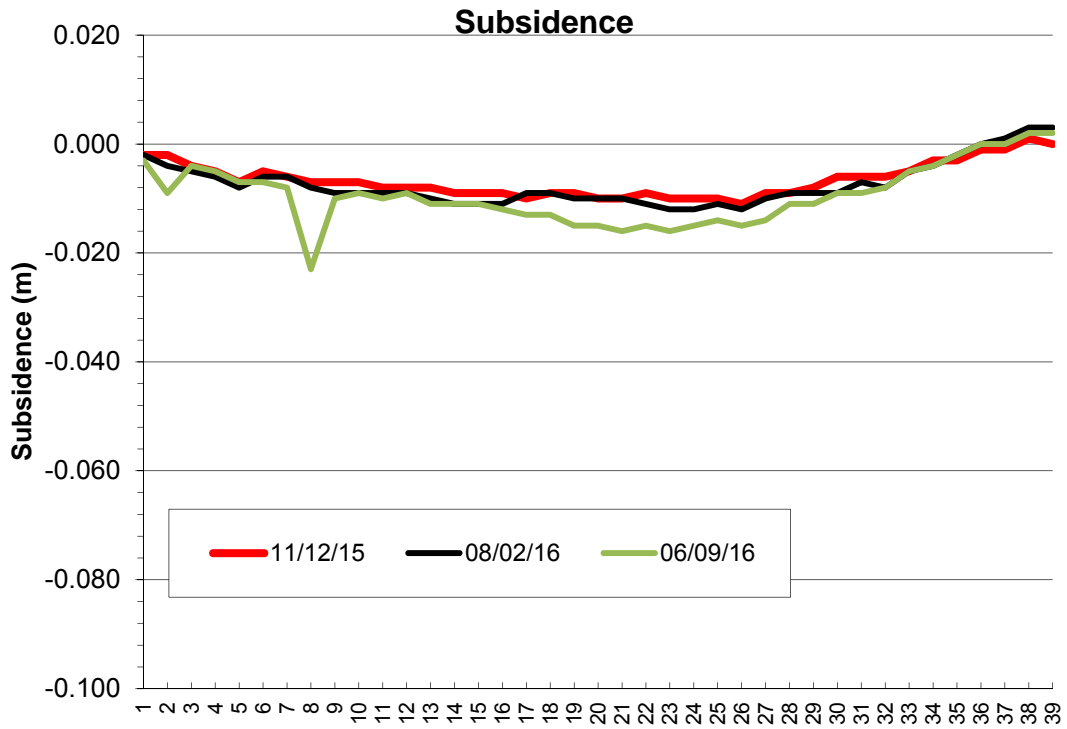
Figure 6. 903 Line Subsidence.

The 903 line was first surveyed in December 2015, and the most recent resurvey was conducted on 6th September 2016. Peg 8 recorded a maximum subsidence of 23 mm, with the remainder of the results in line with the previous surveys. Results from the survey are presented in **Figure 6**.

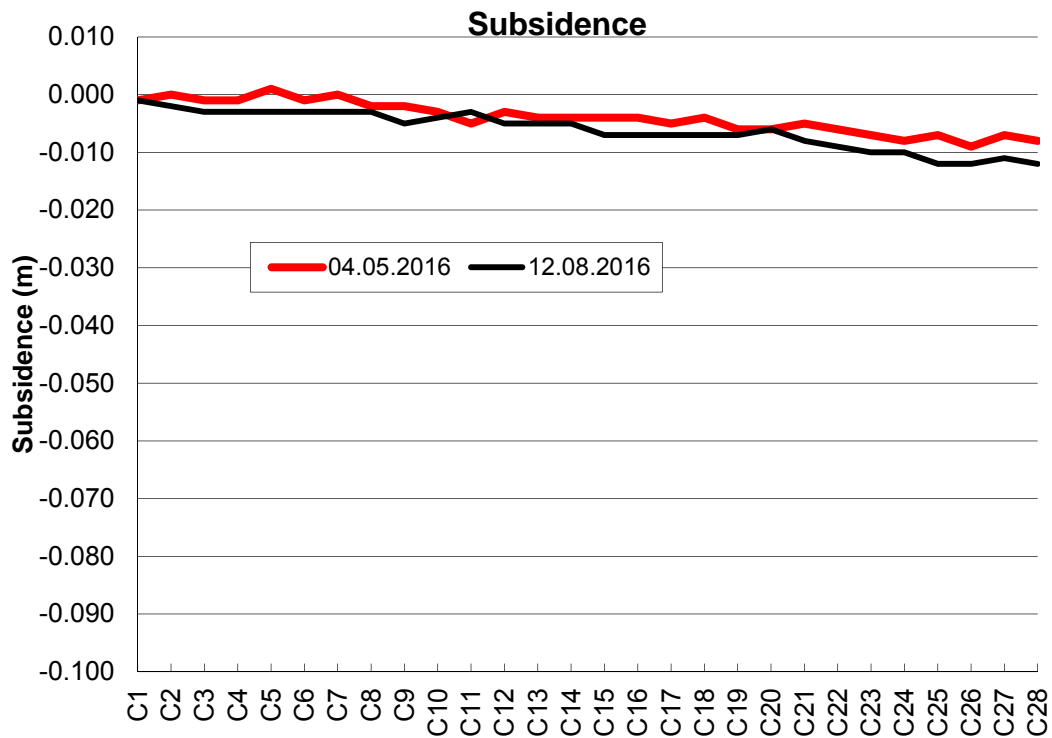
Figure 7. 800C Line Subsidence

The 800C line was resurveyed on 12th August 2016. Maximum subsidence was recorded to be 12mm. The 800C line is situated between the far inbye end of the 812 panel and the Blue Mountains National Park Boundary. This survey represents six months since the 812 Panel commenced extraction. Pegs 21 – 28 overlie the extracted panel and Peg 1 is the closest peg to the National Park (but still within the Newnes Plateau). The results from the 800C line survey are presented in **Figure 7**.

The results show that there has been no movement near the National Park Boundary.

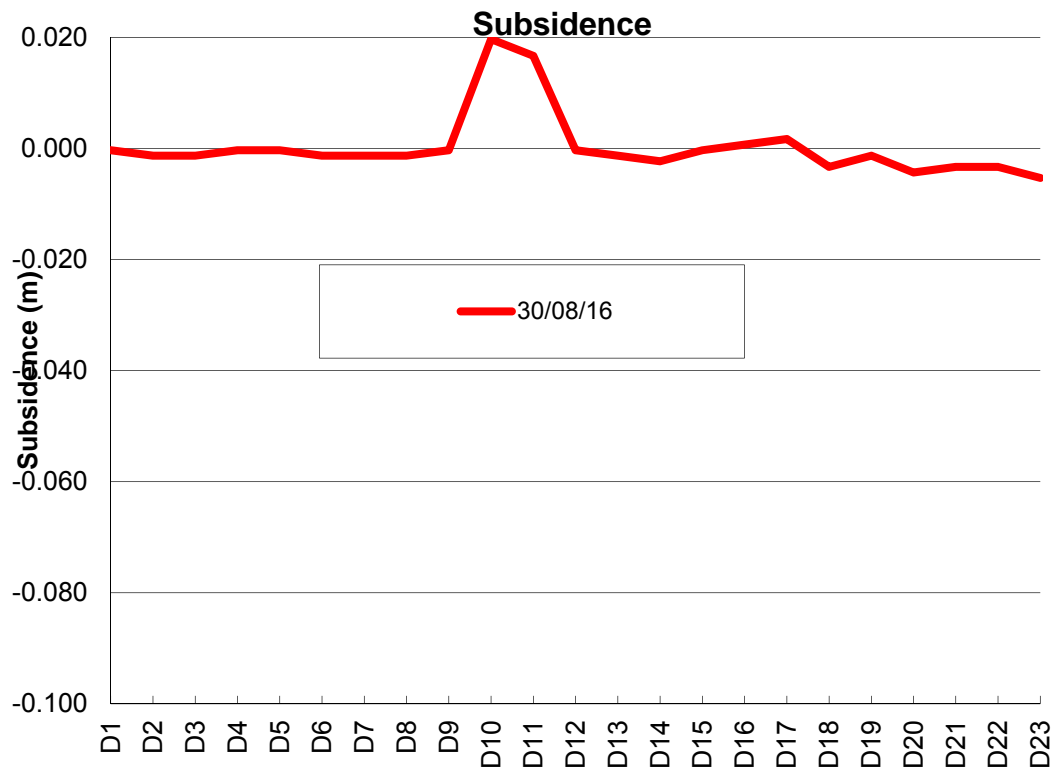
Figure 8. 800D Line Subsidence.

The 800D line was resurveyed on 30th August 2016. Maximum subsidence was recorded to be 5mm, with two pegs recording anomalous movement. The 800D line is situated between the far inbye end of the 814 panel and the Blue Mountains National Park Boundary. This survey represents 3 months since the 814 Panel commenced extraction. Pegs 21 – 23 overlie the extracted panel and Peg 1 is the closest peg to the National Park (but still within the Newnes Plateau), the remainder of the pegs (17-1) lie away from any workings. The results from the 800D line survey are presented in **Figure 8**.

The results show that there has been no movement near the National Park Boundary.

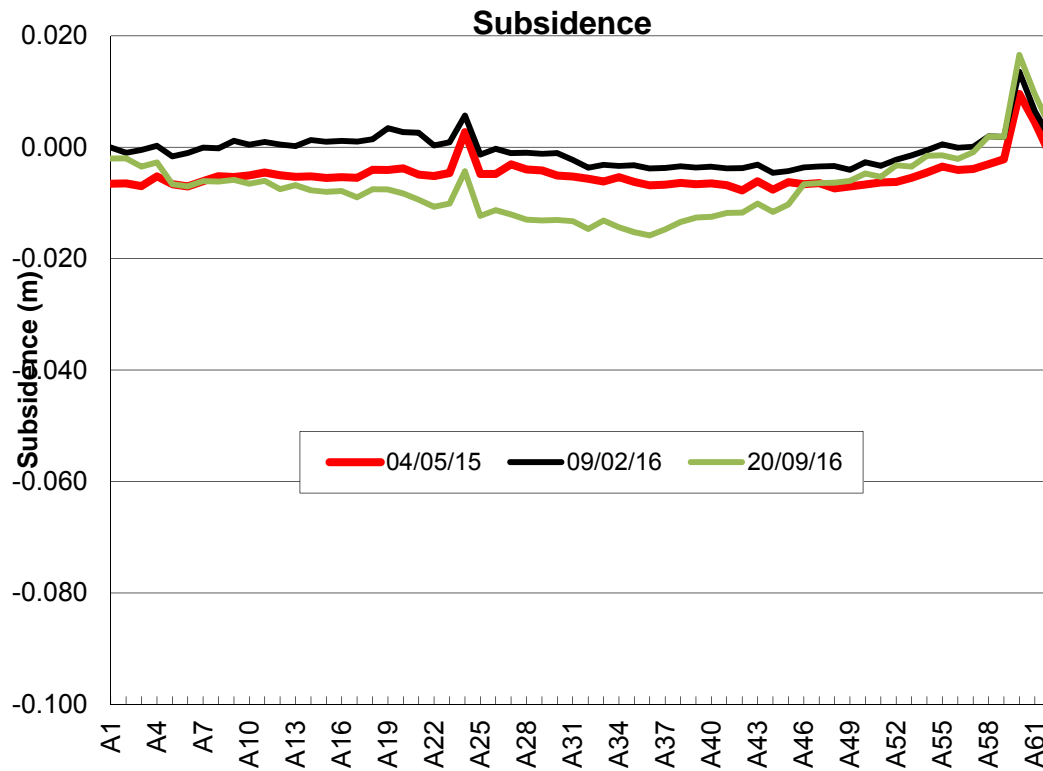
Figure 9. 800A Line Subsidence.

The 800A line was resurveyed on 20th September 2016. Maximum subsidence was recorded to be 16mm, recorded over the extracted 812 panel. The 800A line is extended mid panel between 808 panel, across 810, 812, 814, and into 816 panel. This survey represents 3 months since the 812 Panel commenced extraction. The results from the 800A line survey are presented in **Figure 9**.

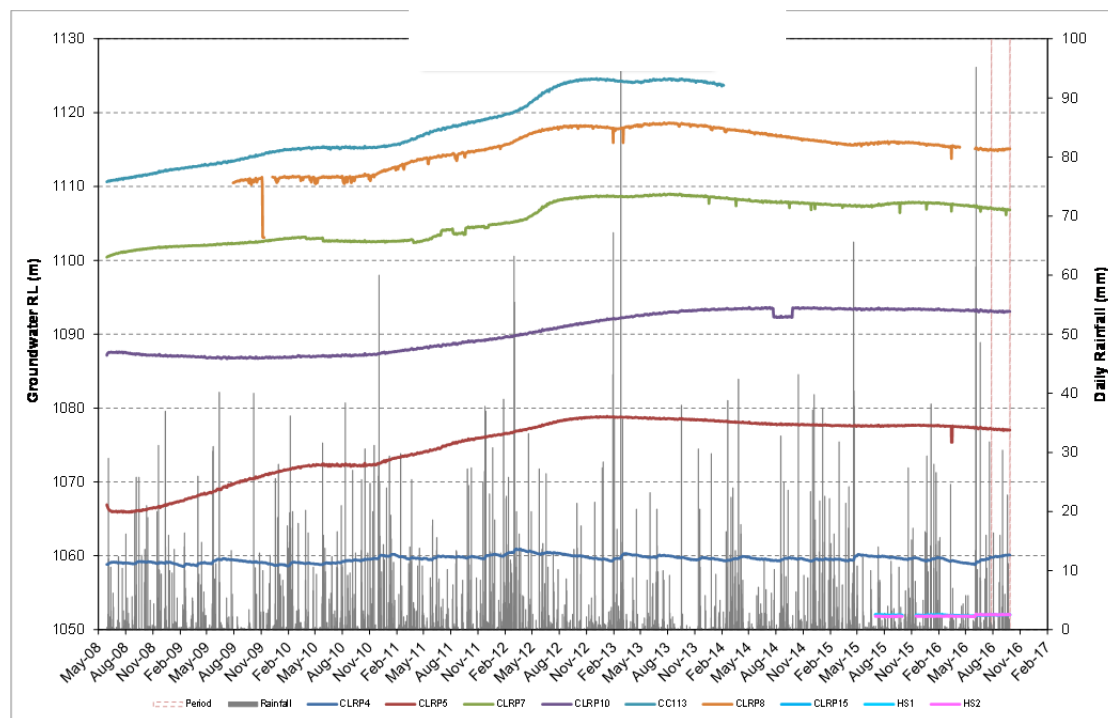
Figure 10. Open Hole Piezometer Results

First workings in panel 902 undermined CLRP5 during December 2013 – January 2014. During the current period, first workings occurred in the 900 area, around 1.5 km northwest and north.

There is no evidence of any mining-related impacts on any of these piezometers, based on the continuing uniform responses of the piezometers. The results from the open hole piezometers are presented in **Figure 10**.

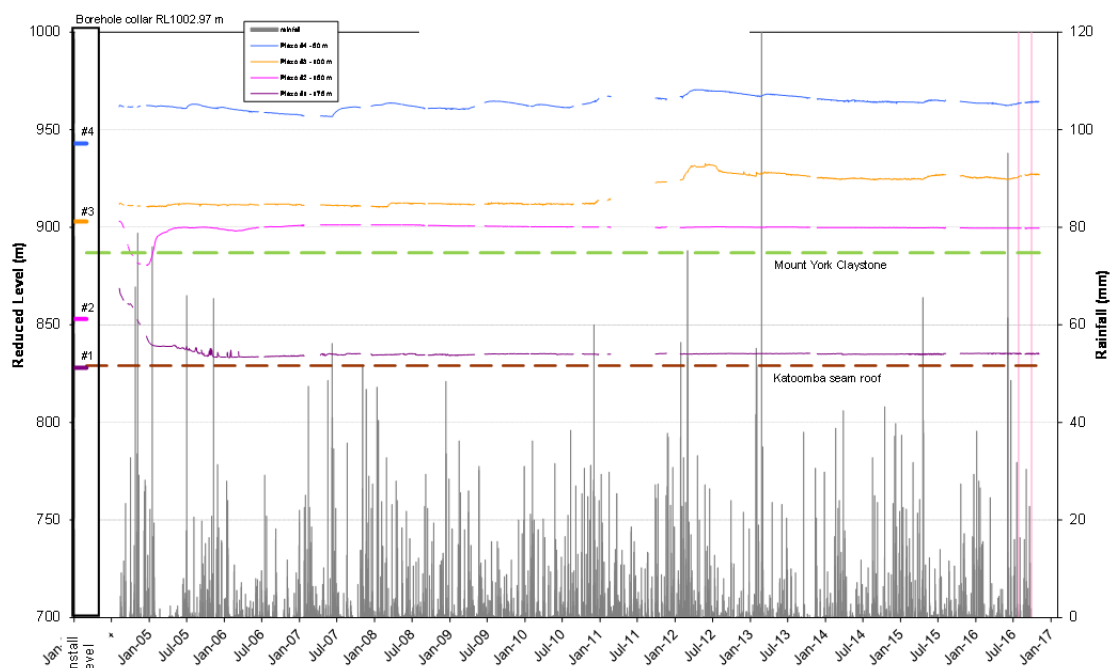
Figure 11. CLRP1 Results

Pillar removal was carried out in Panel 330 immediately to the north of this bore in late 2004. This resulted in a significant depressurisation of the Katoomba seam, as measured by piezometer number 1. In December 2013, first workings in panel 803 were developed over 1km to the east. There was no evidence of any permanent mining-related impacts in the three piezometers higher up in the bore (including the two in the Banks Wall Sandstone), although piezometer number 2 just above the roof of the seam did show minor partial depressurisation followed by near-complete recovery. Since that time there have been no further indications from the data recorded to the present of any mining-related impacts. Pillar extraction occurred in Panel 803 during July 2014, with no apparent impact. Pressures recorded in the two Banks Wall Sandstone piezometers remained above pre-mining levels. During the current period, mining occurred in the 800 area, 2 – 3 km east of the hole, with no discernible impact on groundwater pressures.

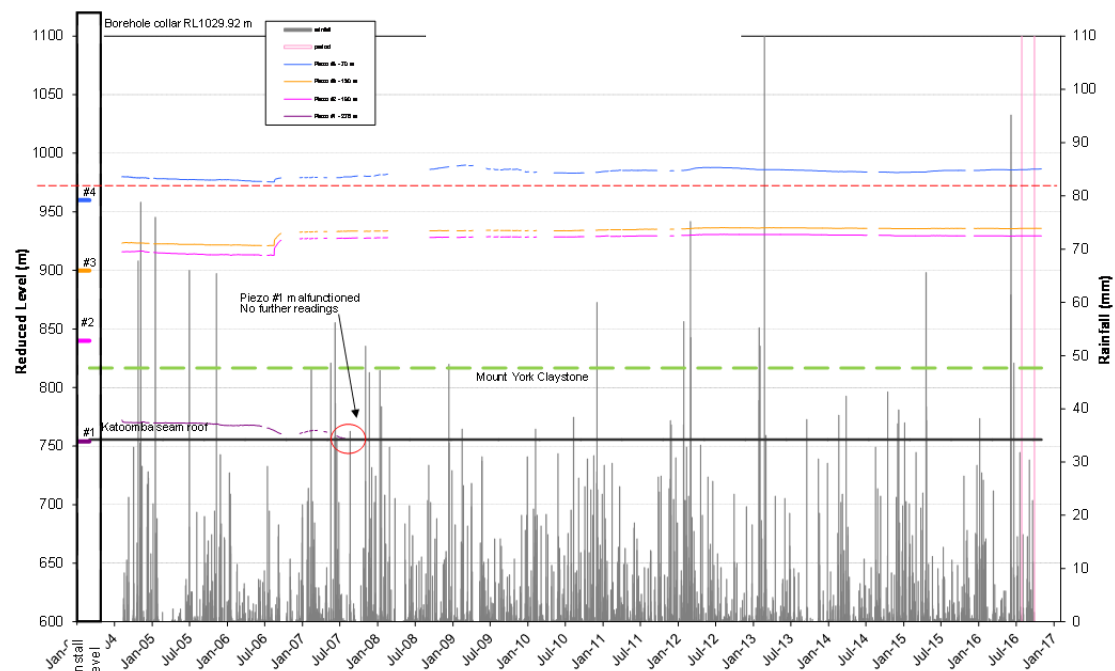
Figure 12. CLRP 2 Results

continued the slowly rising trend observed since March 2015. All pressures in the operating piezometers remain above pre-mining levels.

Total depressurisation occurred in piezometer number 1 in the coal seam in August 2007 after mining below the borehole, as would be expected. The other three piezometers showed no negative impact from mining at the time, and continue to show no impact from the mining. Results from CLRP 2 are presented in **Figure 12**.

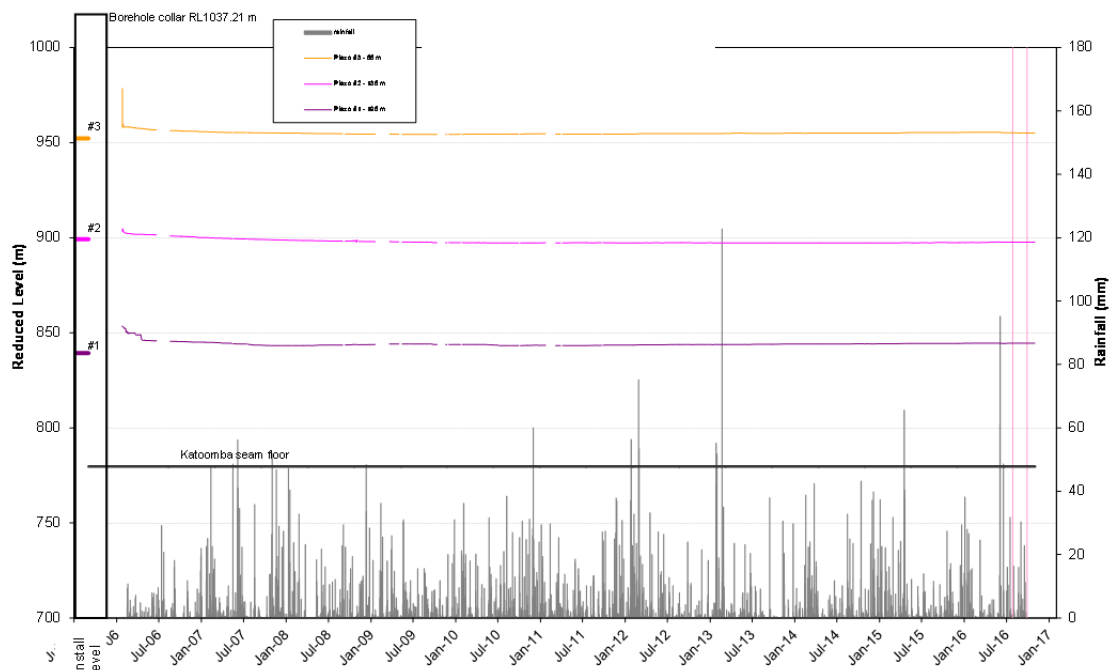
Figure 13. CLRP 3 Results

This borehole was undermined shortly after it was installed in 2006, with no mining-related impacts evident in the data up to the present. Results from CLRP3 are presented in **Figure 13**.

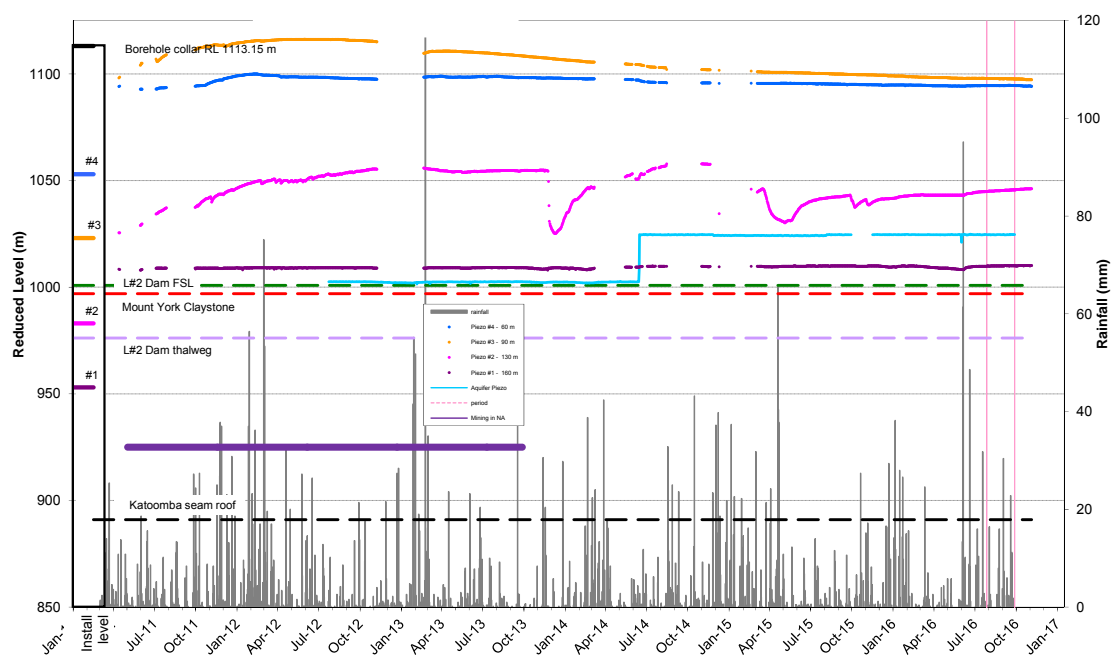
Figure 14. CLRP 15 Results

Available data from CLRP 15 indicate that pore pressure in the Burra-Moko Head Sandstone (piezometer number 1), though declining slowly, has remained above the Lithgow No 2 Dam FSL, so that groundwater flow in this unit was towards the dam storage. Piezometer number 1 is located lower in the section than piezometer number 2, thus closer to the mining horizon. The lack of any response in piezometer number 1 indicates that the variability in piezometer number 2 that was observed is highly unlikely to be due to mining.

First workings in 707 panel were about 250 m east of the borehole at the end of July 2012, and partial extraction was completed in August 2012. Pillar extraction in panel 716 approached to within approximately 750 m during August – September 2013. During the current period, mining occurred at around 3.5 – 4.5 km distance to the north, in the 900 area. The level trends and evidence of flow towards the reservoir indicate that there is no recognisable impact from mining

Results presented in **Figure 14** also include the data from the open hole piezometer situated next to the multi-level piezometer.

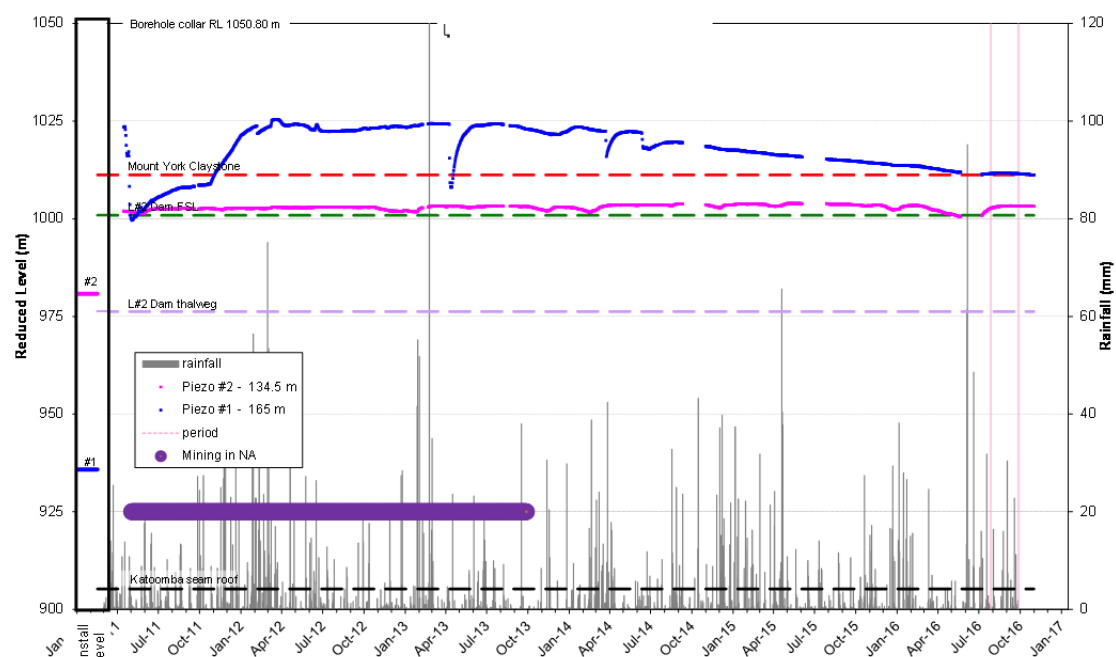
Figure 15. CLRP 16 Results

Piezometer number 1, located in the cover sequence approximately 35 m above the level of the mine workings, also shows a level pressure trend in recent periods, following a more complex trend. The head measured by piezometer number 1 remains well above the values seen in the overlying piezometer. The overall pressure trend does not appear to be natural. It is possible that there are instrumental effects in these data or that the instrument has failed. As borehole CLRP15 is closer to the

Pillar extraction in 716 panel was more than 1 km northeast of the borehole in August – September 2013. Pillar extraction in 700 Panel occurred over 1.8 km m the east during March 2014. Mining in the 900 area during the period was 4 – 5 km to the north. There is no evidence of mining impact in the groundwater record. Results from the piezometer are presented in **Figure 15**. The solid purple line indicates when mining within the Lithgow No.2 Dam Notification Area took place.

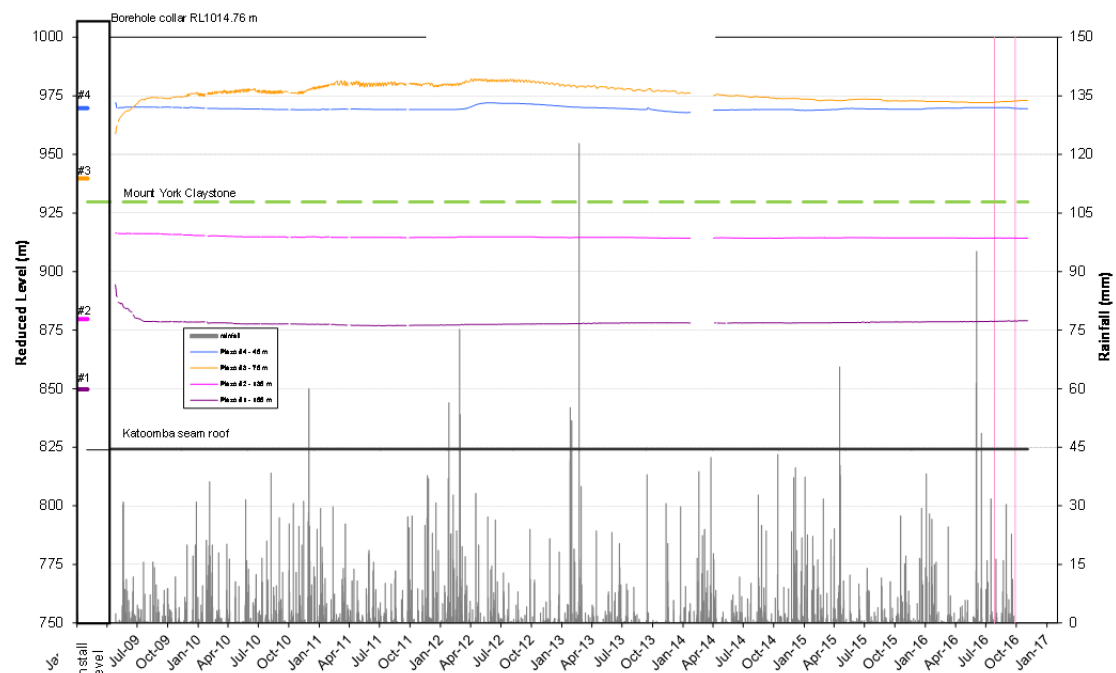
Figure 16. CC114 Results

Previously observed trends recorded from CC114 continued, with piezometers number 1 and number 2 showing a generally flat trend.

Piezometer number 4 has drifted between slightly positive and negative pore pressures throughout most of the data record, and currently shows negative values. Negative pressures indicate that the piezometer is dry. The dry condition has previously been ascribed to lower-than-average rainfall. However, it may also be in part due to the topographic location of this installation, analogous to CLRP3, situated

During the period, first workings and pillar extraction occurred in the 800 area, 2 – 3 km to the east. There is no indication of mining impact in the data. Results from CC114 are presented in **Figure 16**.

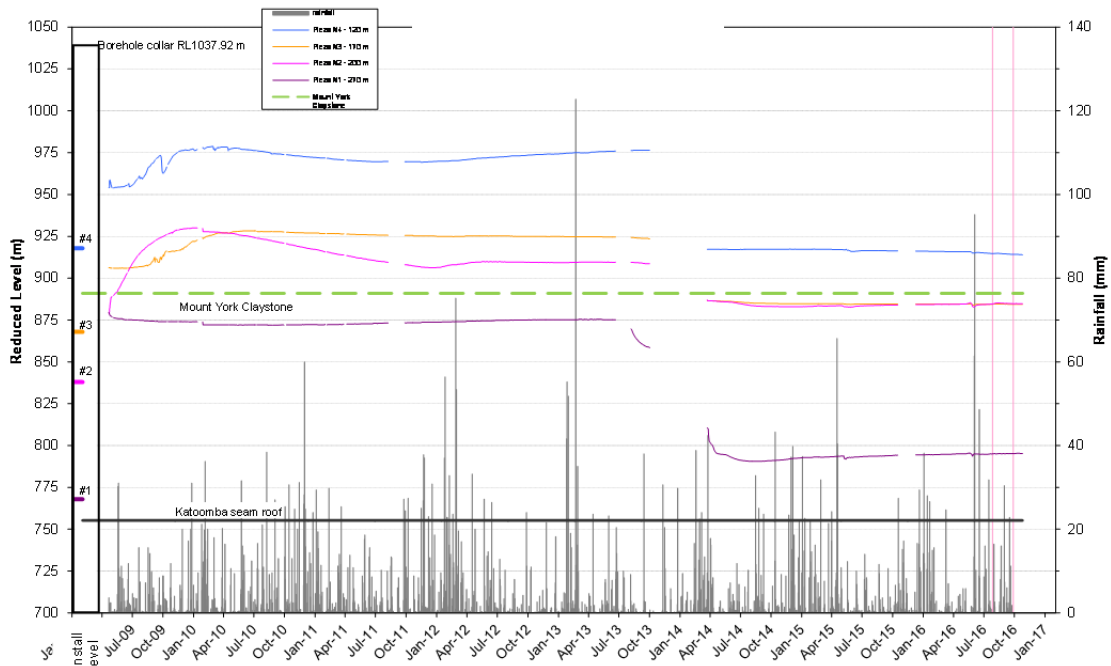
Figure 17. CC115 Results

Trends in the CC115 dataset after repair are broadly consistent with those seen previously, although at lower absolute levels than before. The difference in pressure heads are 30 – 50 m, which is highly unlikely to be a real groundwater phenomenon. The most likely reason is a calibration difference between the old and new data

In late May 2016, the borehole was directly undermined by pillar extraction in Panel 812. The very small but distinct drop and recovery in the piezometers are mining impacts. It is notable that pressure has totally or partially recovered in each piezometer. No instruments showed a drop to negative values, and the upper strata have not been affected by development of a permeability connection to the workings. The movements are mining-induced, and according to expectations. They have not had a significant or permanent impact on the groundwater system. Piezometer number 1, which lies closest to the mining horizon, has shown slowly rising pressure trends for the past year, indicating that there has been no permeability connection created between the mining horizon and this installation level. During the current period, mining in the 800 area consisted of partial pillar extraction up to 1.5 km west of the borehole.

loggers. It is noted that the loggers were replaced following the 2013 bushfire. This should be reviewed by the data logger installers.

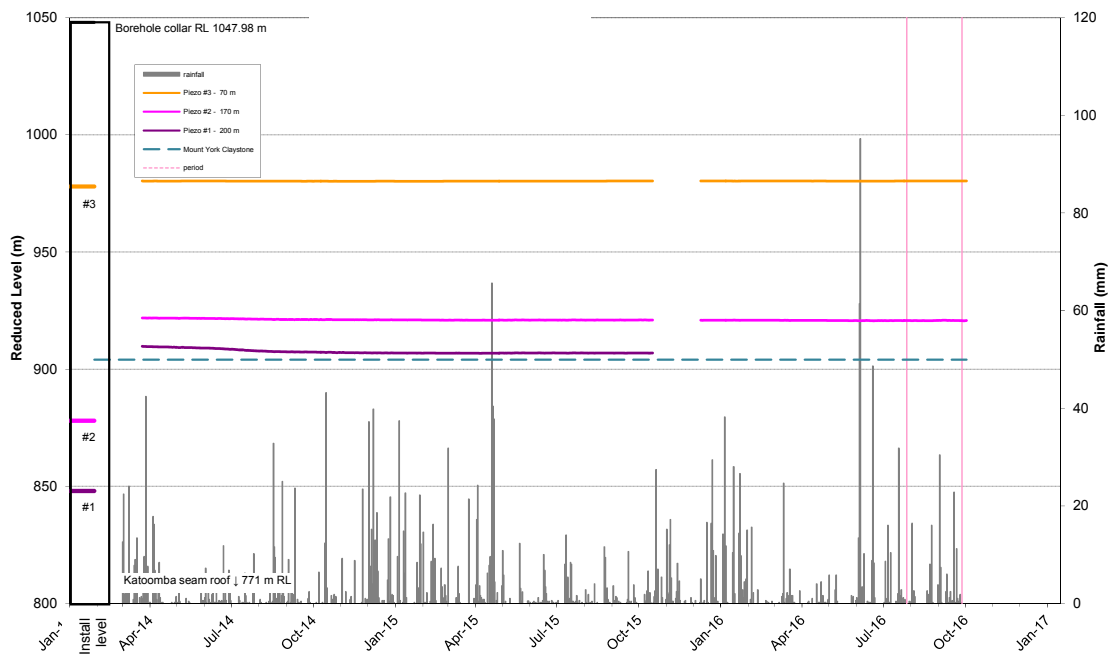
Figure 18. CLR17 Piezometric Height

Mining in the 800 area was 0.2 – 1 km north, east and west of the piezometer. Pillar extraction proceeded past the site in September 2016, with no apparent affect. The very slow decline in the lower piezometers probably reflects stabilisation of the piezometers after installation. The steady, level trends in the uppermost piezometer indicate that there has been no dewatering in the near-surface aquifer. There is no evidence of mining impact in the groundwater record. Monitoring results for piezometric height at CLRP17 is presented in **Figure 18**.

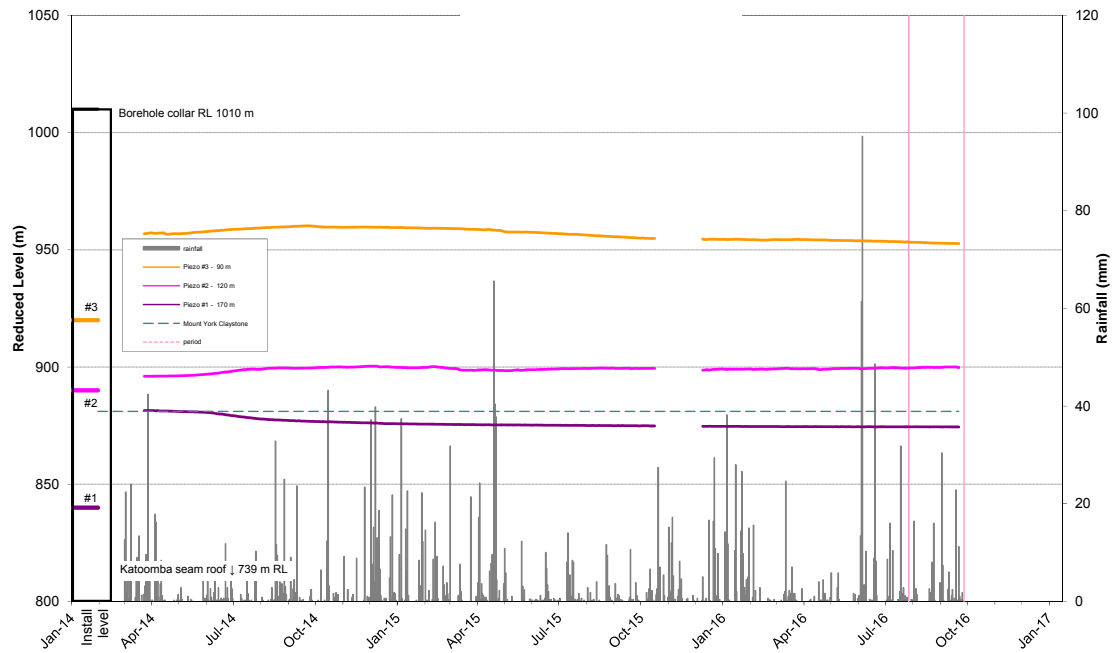
Figure 19. CLRP19 Piezometric Height

In Piezometer number 1, installed approximately 100 m above the working horizon but below the Mount York Claystone, the pressure trend was initially level, with a head that lay near the top of the Mount York Claystone (the regional aquiclude). The coincidence suggests that this is a confined aquifer with no significant leakiness or formation damage in the cap rock, which is controlling pressure in the underlying aquifer. As this piezometer is installed in a low permeability unit, pressures can take some time to dissipate, possibly explaining that the slow decline may have been due to gradual stabilisation of the borehole after installation.

Pillar extraction took place immediately below the piezometer site during March 2016. Current mining is partial pillar extraction 1 – 2.5 km from the borehole, to the east, south, and west. The data show no impact from mining. The slow decline in piezometer number 1 is most likely due to slow stabilisation after installation, and does not appear to be an impact caused by mining.

Monitoring results for piezometric height at CLRP19 is presented in **Figure 19**.

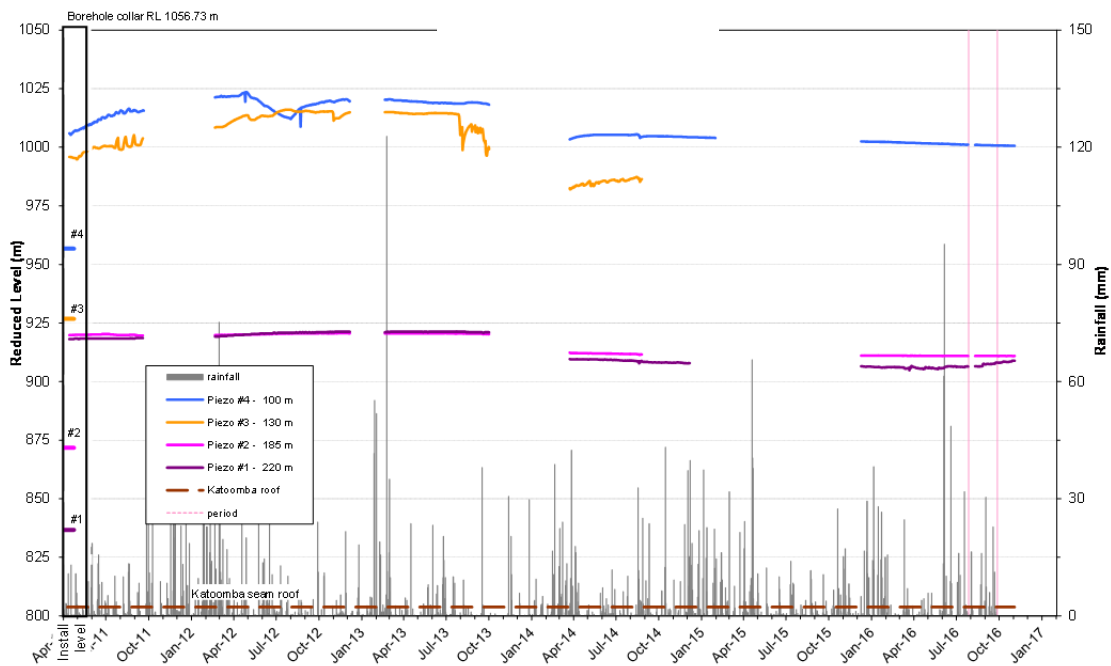
Figure 20. CLRP14 Piezometric Height

The lowest piezometers show similar stable pressure trends. The similarity of pressure previously observed in piezometers number 1 and number 2 suggested that the instruments were in hydrogeological continuity. Since early 2014 these pressures started to diverge. Data from recent periods show the trends converging again.

The uppermost piezometer number 4 shows a nearly level trend. Piezometer number 4 commenced producing more stable data, although, for a few days after 19 August 2014, the pressure head varied by up to 1 m daily. The cause of this anomalous behaviour is unclear, but it is transient, unprecedented, and likely to be non-significant.

Pillar extraction in the 800 area has occurred previously under the piezometers; first workings were 1 – 2 km east. The available data record shows no mining impact. The data record shows no mining impact. Results are presented in **Figure 20**.

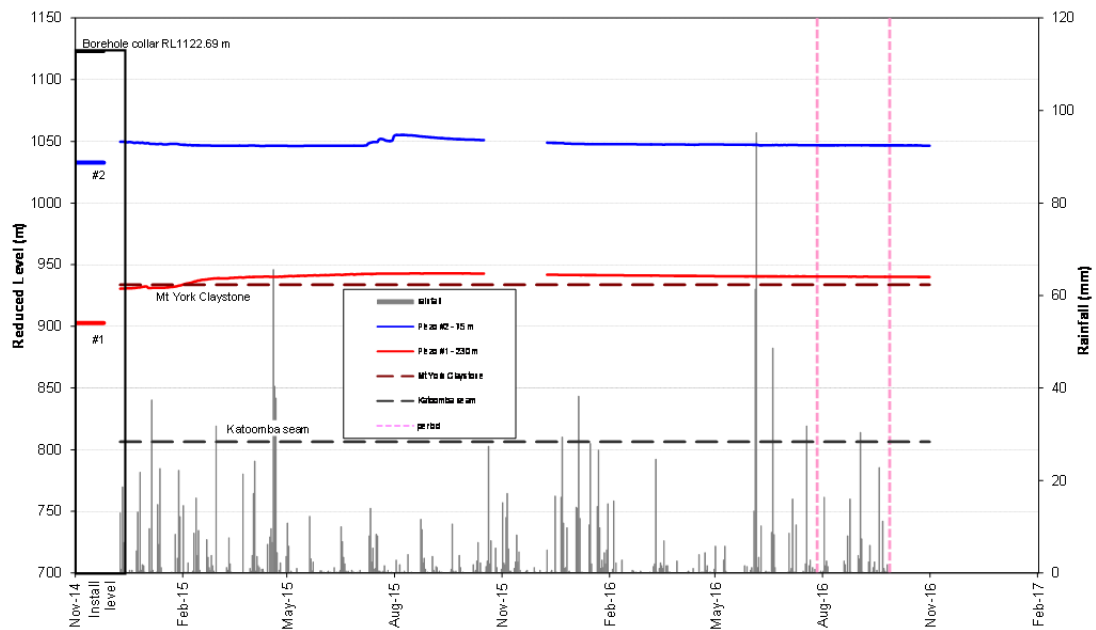
Figure 21. CLRP22 Piezometric Height

Trends observed previously from CLRP 22 continue in the available data. Piezometer number 1, installed approximately 100 m above the working horizon but below the Mount York Claystone, has stabilised after a very slowly rising pressure trend, with pressure that lies near the top of the Mount York Claystone (the regional aquiclude). The coincidence suggests that this is a confined aquifer with no significant leakiness or formation damage in the cap rock, which is controlling pressure in the underlying aquifer.

The nearest mining during the period was 1.5 – 3 km southwest of the installation. Old workings lie more than 400 m to the east. There is no indication in the current data of any mining impact. The data record shows no mining impact. Results are presented in **Figure 21**.
