Ivanhoe North

Centennial Coal

Annual Environmental Management Report

2013

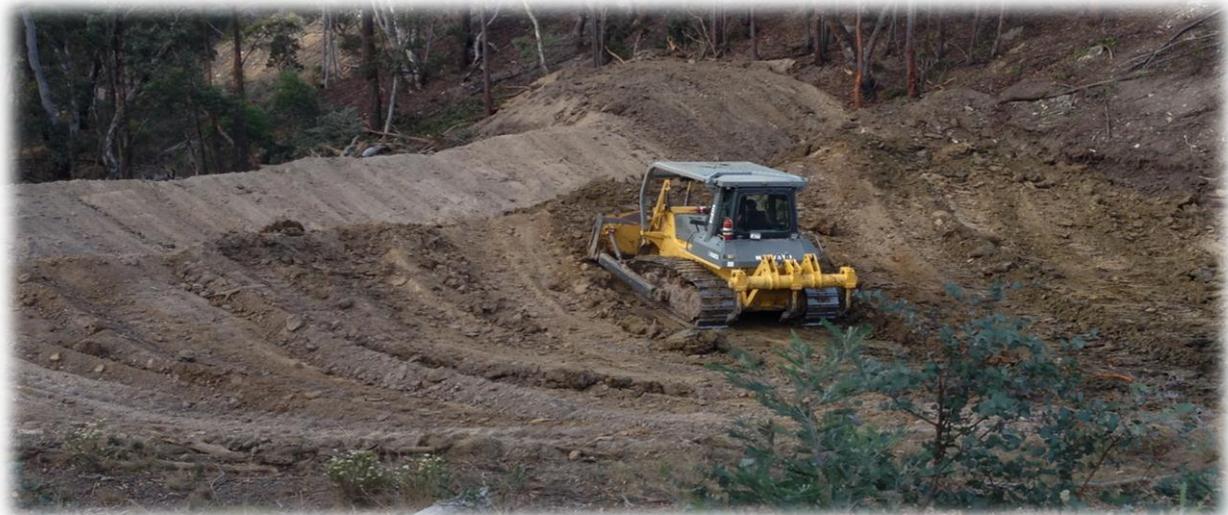
Figure 2. Preliminary Sediment Dam 1B: resizing work during the reporting Period

During the reporting period preliminary sediment dam upstream of SD3 was installed to safeguard comply with Blue Book Type D/F Basin Standards (3.5ML total capacity) and incorporates a small diversion and gentle spill way directing the water away from existing erosion areas and into established grass lands before the water enters in to Lilley’s Dam.

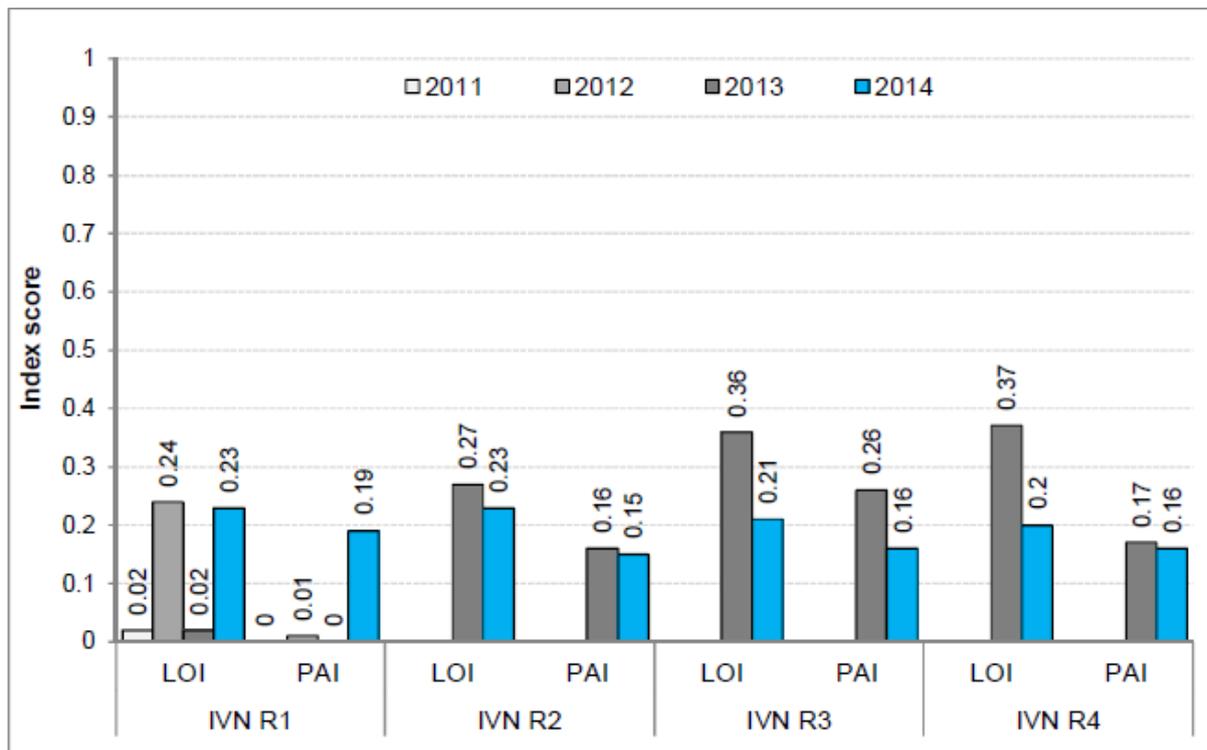
Figure 5. Landscape Function Indices (2011-2014) – Ivanhoe North Rehabilitation Sites

- IVN R1 showed a marked increase in LOI/PAI scores from last year, promoted by the strong growth in woody vegetation (see further below); and
- In contrast, the LOI/PAI scores at IVN R2, IVN R3 and IVN R4 have all decreased from last year. This is explained by the increasing severity and of rill erosion in these areas, breaking through the contour banks and reducing the capacity of the ‘troughs’ to trap and retain resources which can leak through the breaks in the banks created by the rills. This has led to shorter and narrower patches being recorded during the LFA procedure and subsequently a decrease in index scores.

For all sites the soil stability index was satisfactory (i.e. index comprised within 40-45% **Table 11**) and the infiltration and nutrient cycling indices were poor (i.e. indices <20%). The poor performance in terms of infiltration and nutrient cycling is largely explained by the lack or very low levels of ground cover (basal cover and litter) and of woody vegetation across the rehabilitated landform.

The stability indices at IVN R2, IVN R3 and IVN R4 have all increased since last year, while their infiltration indices have decreased and nutrient cycling indices have remained relatively unchanged. It is anticipated that infiltration and nutrient cycling properties of the soils at Ivanhoe North should improve after woody vegetation has established and developed.

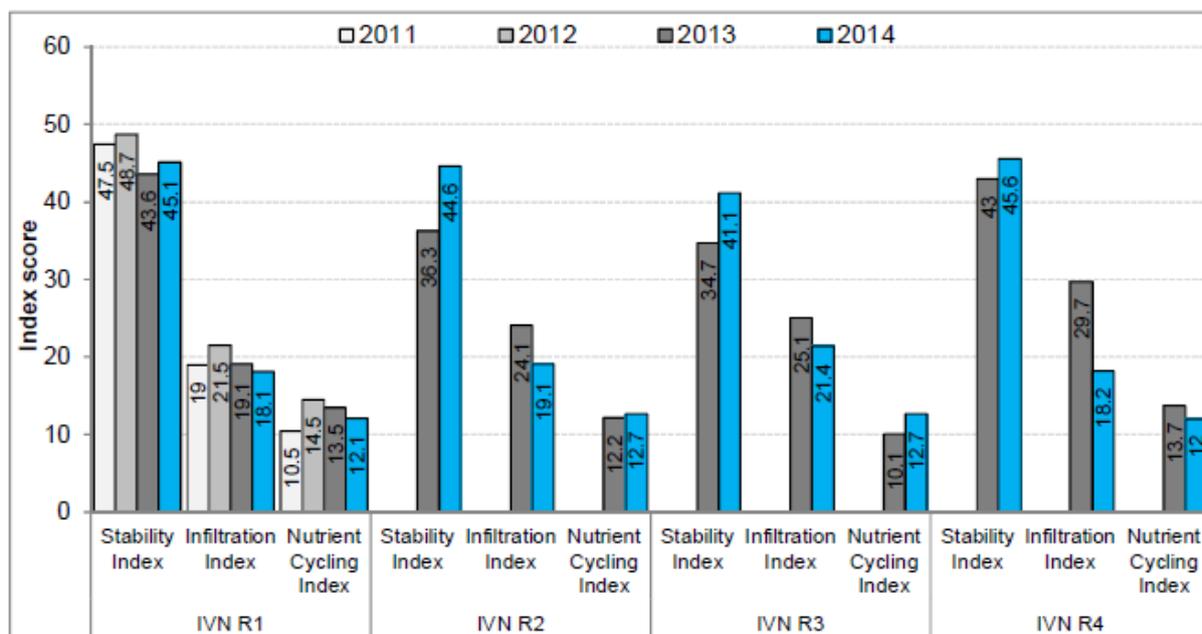
Figure 7. Soil Surface Condition Indices (2011-2014) – Ivanhoe North Rehabilitation Sites

Active rill erosion occurs throughout the site on the rehabilitated slopes, and has worsened and is more severe than what was observed in 2013. The failure of ground cover and woody vegetation to establish during the last year means that there are no root structures in the soil profile providing much needed soil stabilisation.
