ANNUAL ENVIRONMENTAL MANAGEMENT REPORT

Awaba Colliery

January 2014 to December 2014

Name of mine AWABA COLLIERY

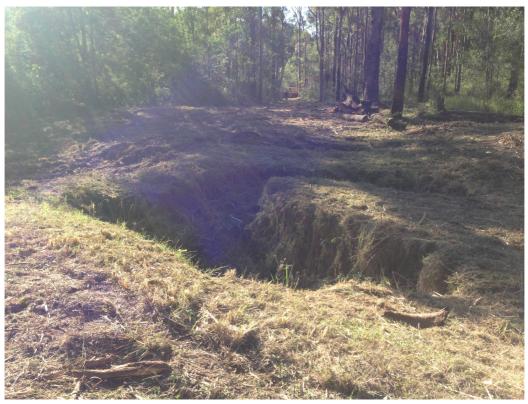
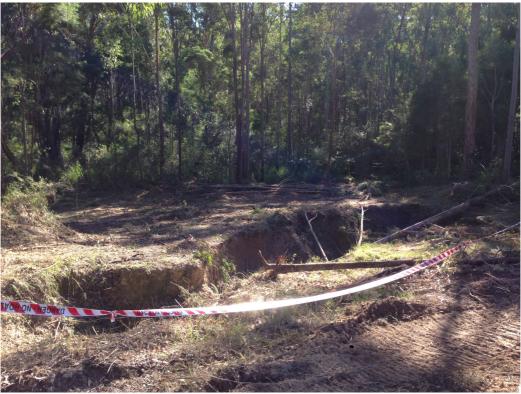
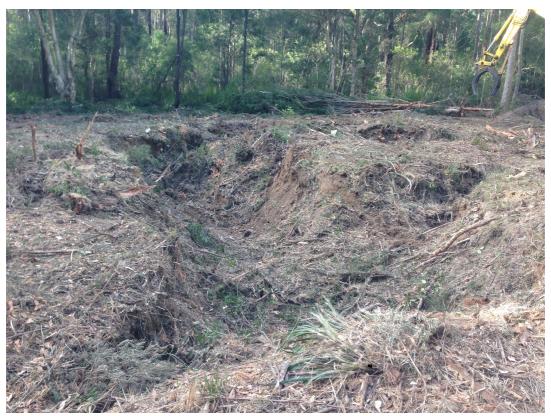
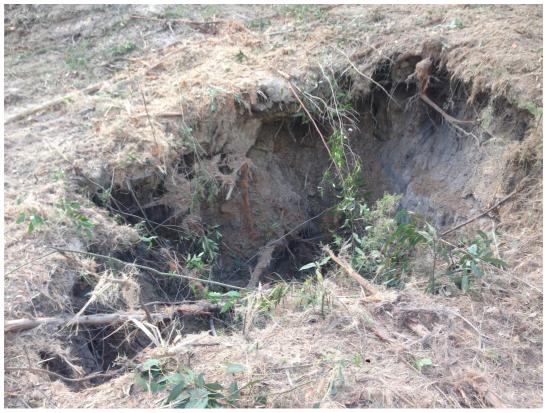
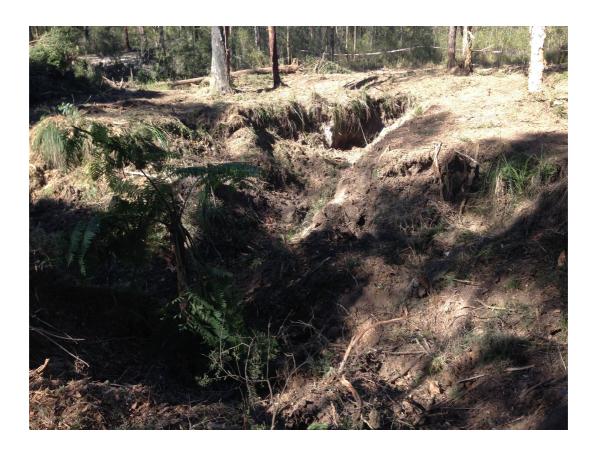
5.2.1 Sinkhole Photos

SMP Approval Condition No.	Requirement Summary	Comment / Description
		Environmental impacts in Stage 3 have been confined to the one sinkhole as described above. It is most likely linked to a significant rainfall event in June 2011.
22 (c) – Stage 1 23 (c) – Stage 2 18 (c) – 3 North 24 (c) – Stage 3 18 (c) – East B	Trends in Monitoring Results	In general - the trend in monitoring results shows that the majority of subsidence occurs during and shortly after mining extraction.
		In the following months the rate of subsidence decreases toward a stable environment.
		However after approximately 6 years of relative stability – there has been greater than predicted subsidence in Main South Stage 1 and Stage 2.
		During the year — after the initial sudden increase in subsidence - results began to trend toward decreasing movement. In recent months surveys have consistently shown relatively stable results.

- It was determined that the whole area between holes 2, 3, 4, 5 & 6 was lower than the rd crossing causing the flow of water to go down the sink holes into the mine workings. By raising the height of the whole area from holes 2, 3, 4, 5 & 6 cutting diversion drains either side of the whole area and lowering the level of Hawkmount rd with a rock lined causeway we achieved natural water flow around the whole area letting the water escape around the holes as opposed to passing over the holes.

Sinkhole rehabilitation is planned to continue in 2015. Rehabilitation monitoring and any additional maintenance and weed management will occur on previously rehabilitated sinkholes as required.
