Annual Environmental Management Report

Myuna Colliery

January 2013 to December 2013

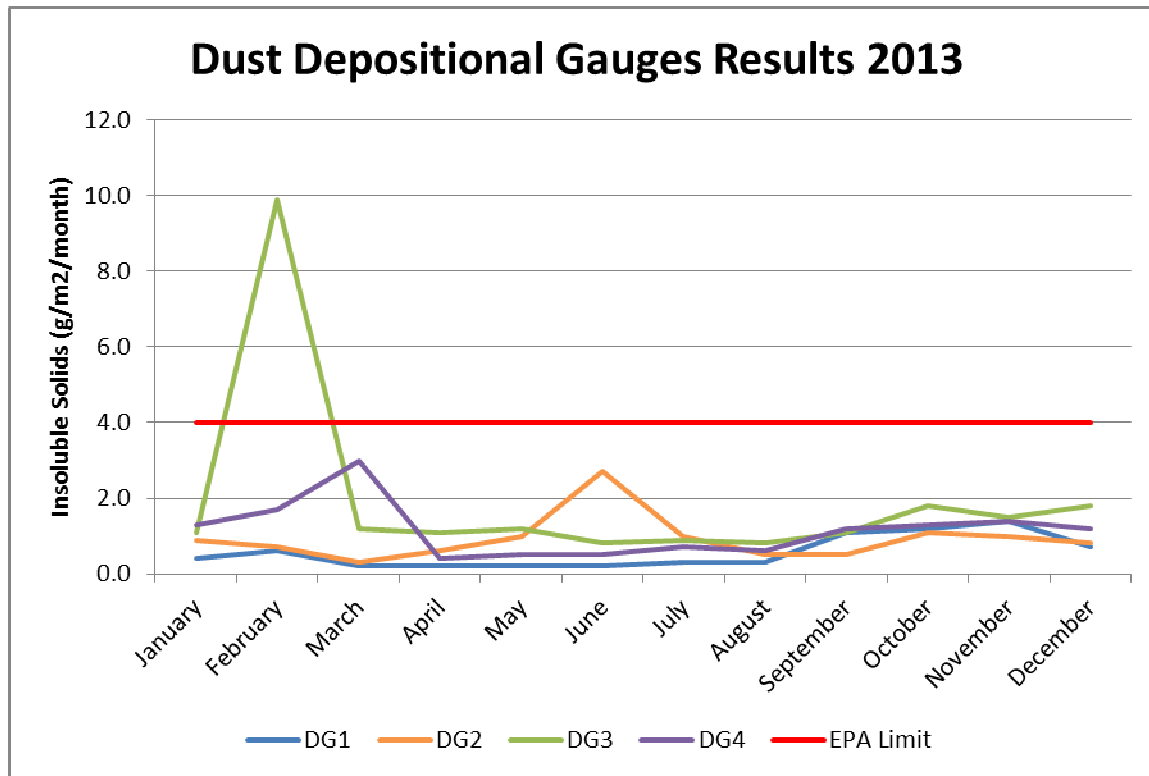
Figure 1: 2013 Dust Deposition Gauge Results

One above average monthly reading was recorded at DG3 which was sent for microanalysis and were the result of increased plant matter and mineral quartz/clay matter.

The annual average for each dust gauge is below the DECCW guideline (4g/m²/month). Figure 1 also shows the monthly results from the Dust Depositional Gauges.

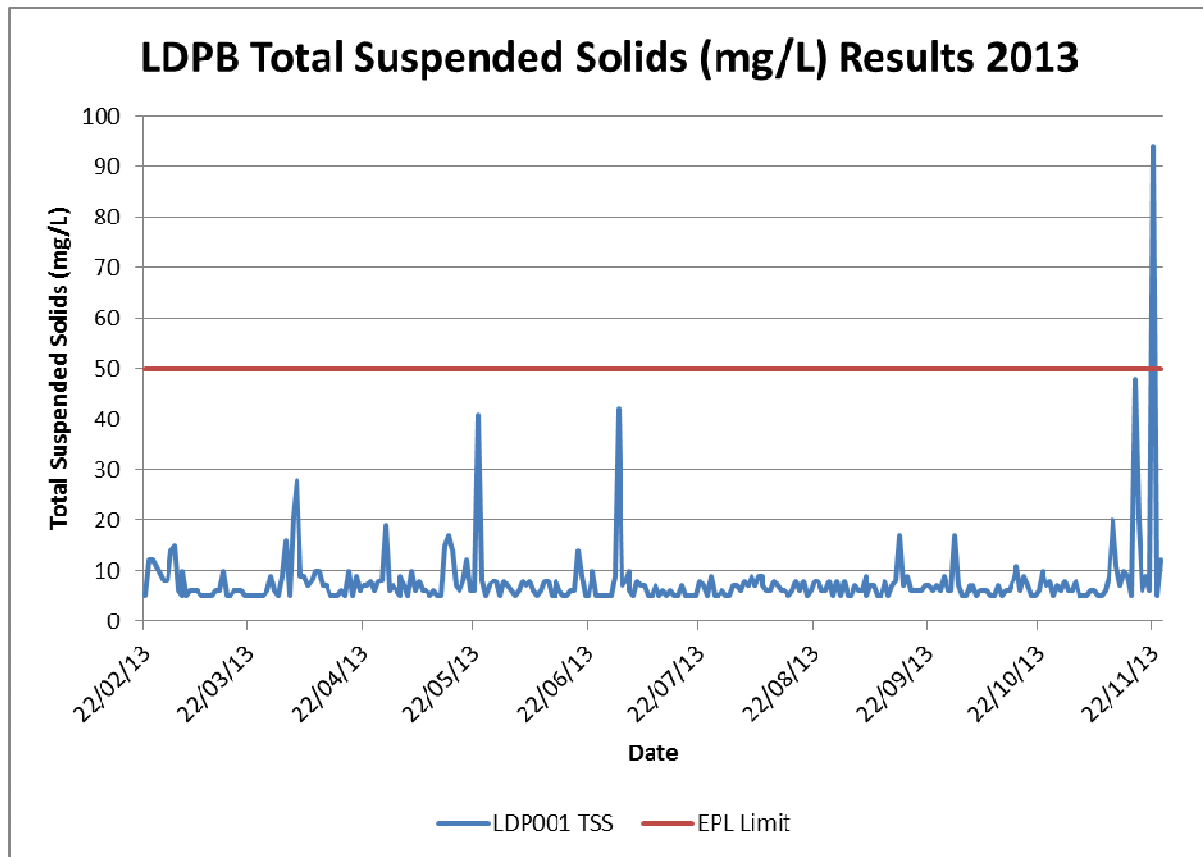
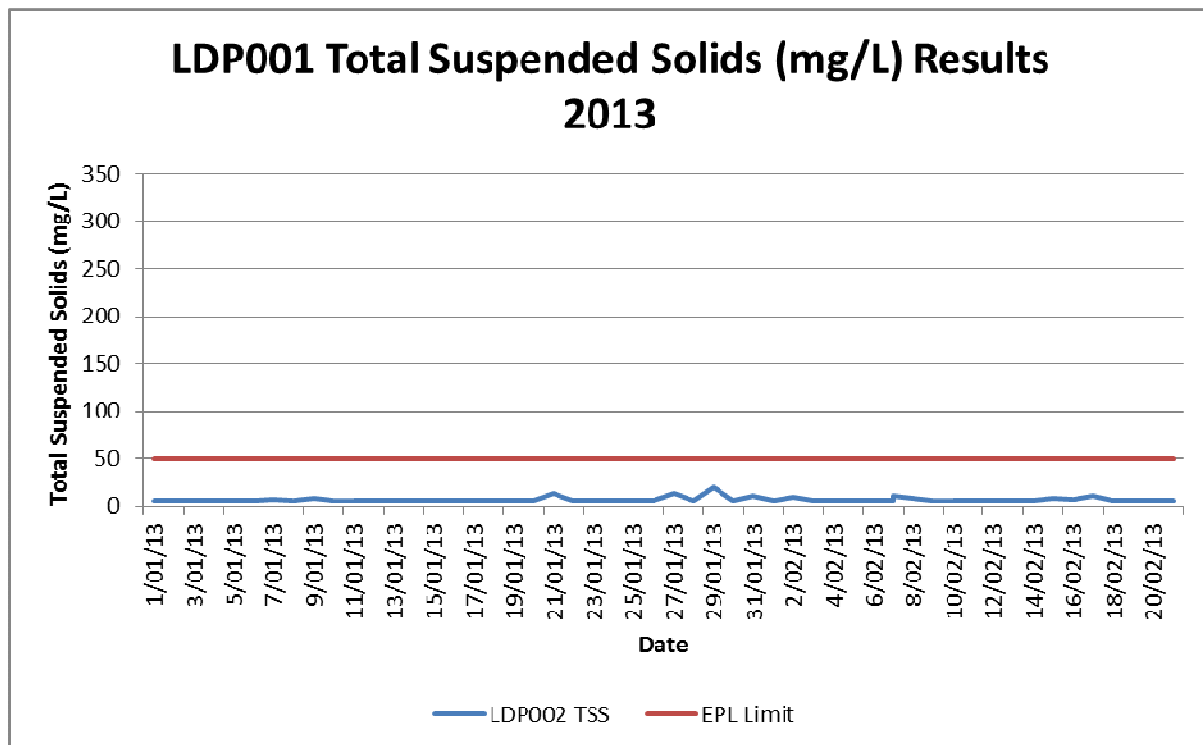
The Figures 3 & 4 show the TSS results for LDPB and LDP1 during the reporting year.

There was one non-conformance with regards to high TSS reported in the Annual Return (Appendix 2) for 2013.

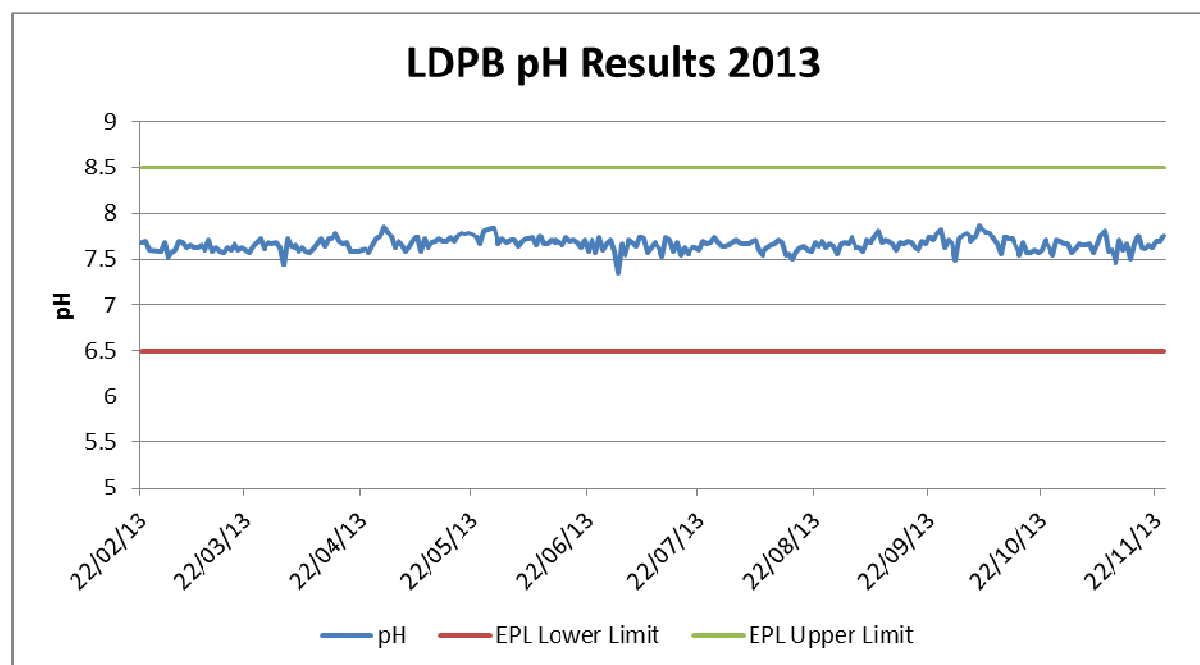
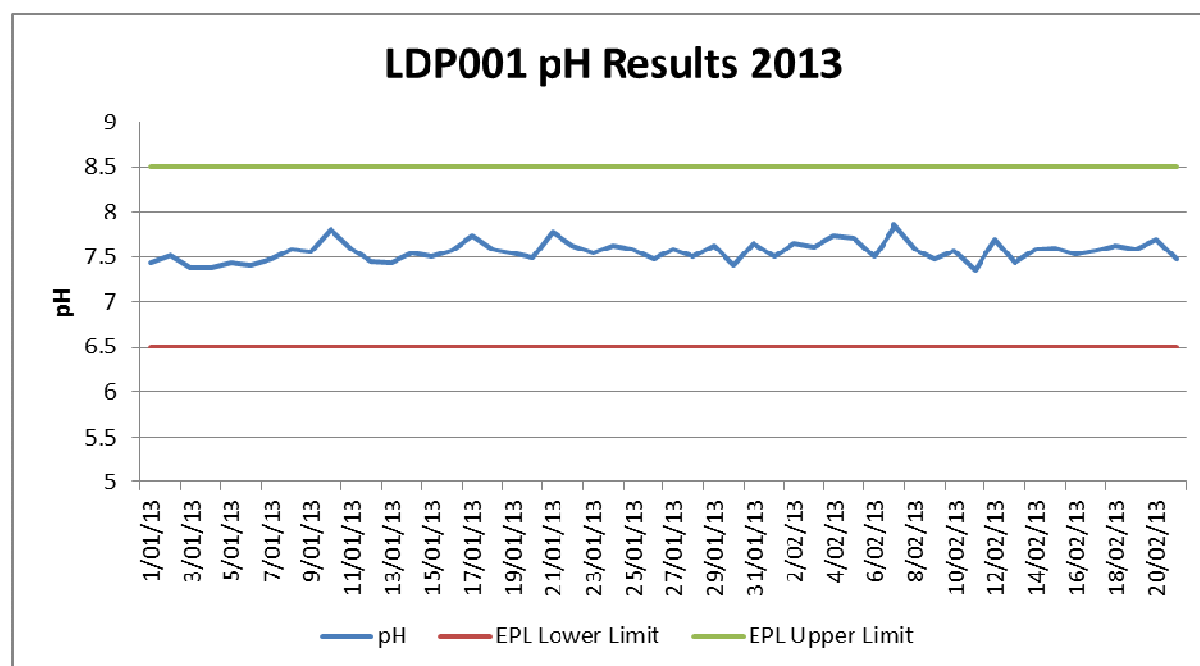
Figures 5 & 6 shows the results of pH monitoring at LDPB and LDP1 during the reporting period. There were no pH exceedences in 2013.

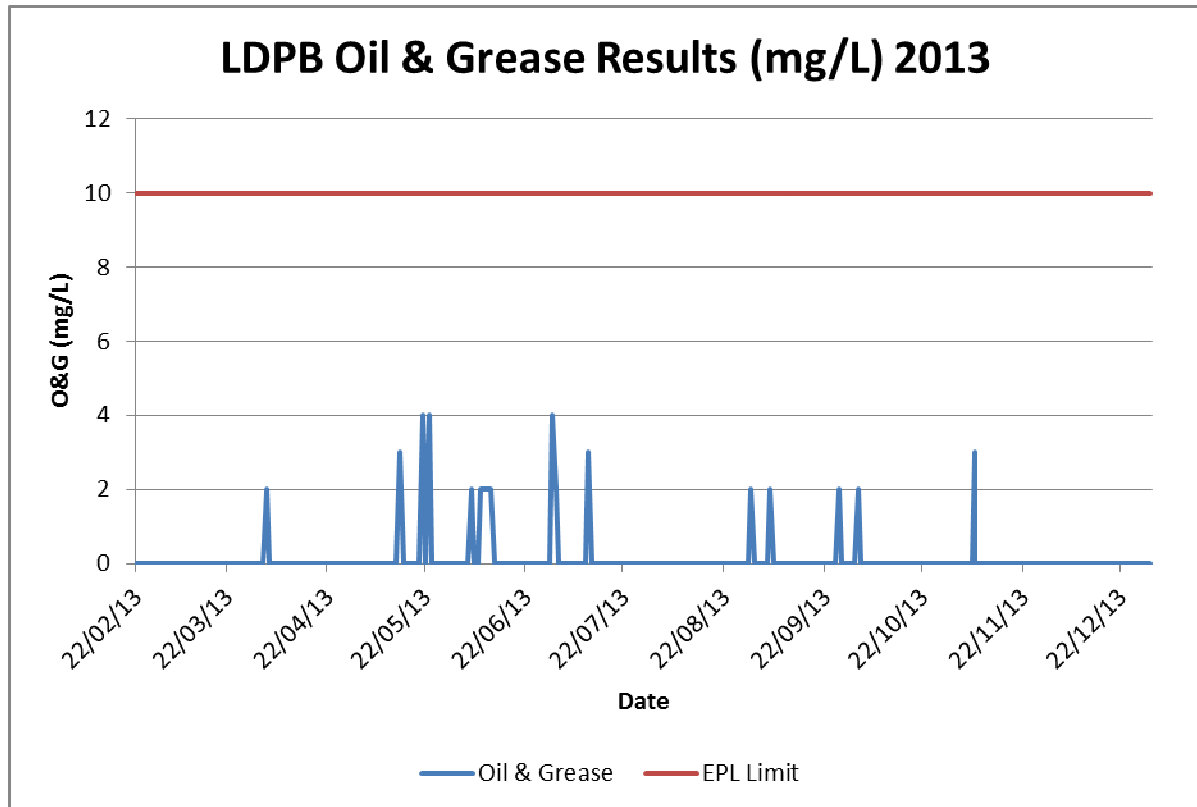
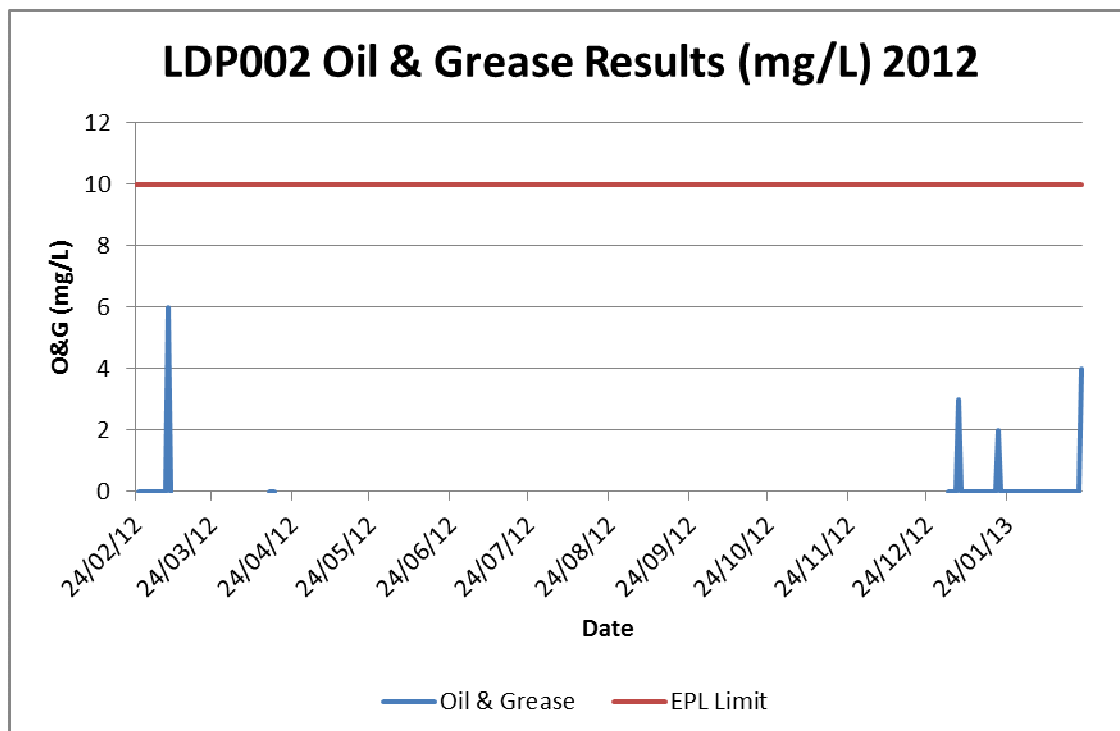
Figures 7 & 8 show the results of Oil & Grease (O&G) monitoring at LDPB and LDP001 during the reporting period. There were no O&G exceedences in 2013.
