Consent Conditions Extract - Mandalong

Mandalong Compliance Audit Of Consent Conditions

Mandalong - Groundwater Monitoring Review 2013 (G1455J)

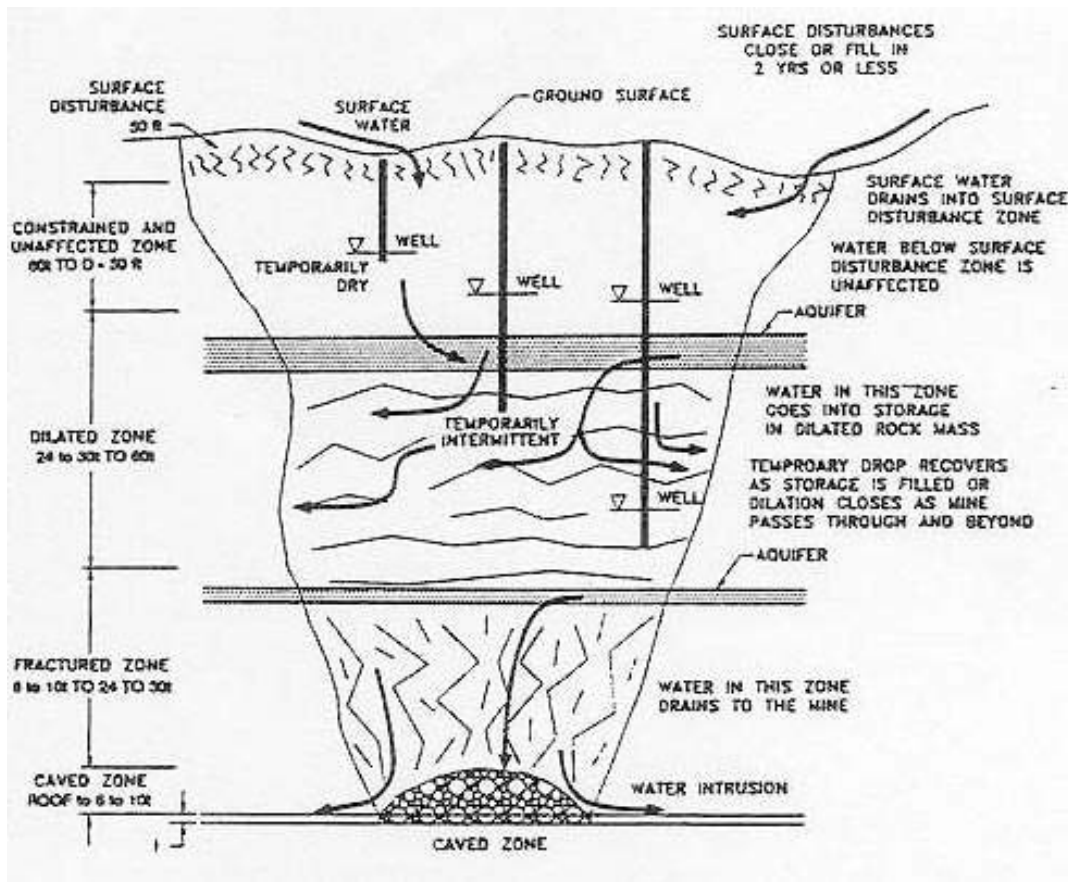
Figure 2: Schematic Subsidence - Groundwater Inflow Model

- **Caved Zone:** This is the zone of complete disruption of broken and rubble-sized strata extending to 2 to 10 times (2 t to 10 t) the seam thickness in height above the caving roof.

- **Fractured Zone:** This zone occurs above the caved zone to a height of 24 t to 30 t. The strata does not fall and detach but cracks and settles, resulting in fractures extending through individual beds, opening of bedding planes and shearing and dislocation of beds. The caved and fractured zones have increased vertical and horizontal transmissivity and storativity and both attributes decrease exponentially with height above the seam roof.

- **Dilated Zone:** This zone is often referred to as the “Aquiclude Zone”. In this zone, the strata sag allowing bed separations, but not allowing connecting fracturing and drainage into the mine. It occurs at a height of 30 t to 60 t or greater. The water level of aquifers located in this zone may be lowered in response to the relatively rapid increases in void space laterally, that is, due to an increase in storage volume, but the water level generally recovers given sufficient time, as the voids are filled.

- **Surface Fracture Zone:** The surface fractures generally relate to panel and trough edges and extend to a depth of about 15 m. If transmitted into soils, the soil properties may allow little or no crack development due to the plastic and non-brittle nature of many soils. If in rock, the natural pre-existing fracturing will be dilated, having little effect on continuity. The cracks are transmissive zones and the increased void space may result in a temporary lowering of shallow groundwater levels as the voids fill. The cracks will not provide pathways for deeper migration of groundwater unless extending into the “fracture zone”. This may happen where the “dilated zone” is absent due to shallow mining, that is, shallow overburden thickness. Surface cracks also generally fill quickly with sediment or close due to spalling.

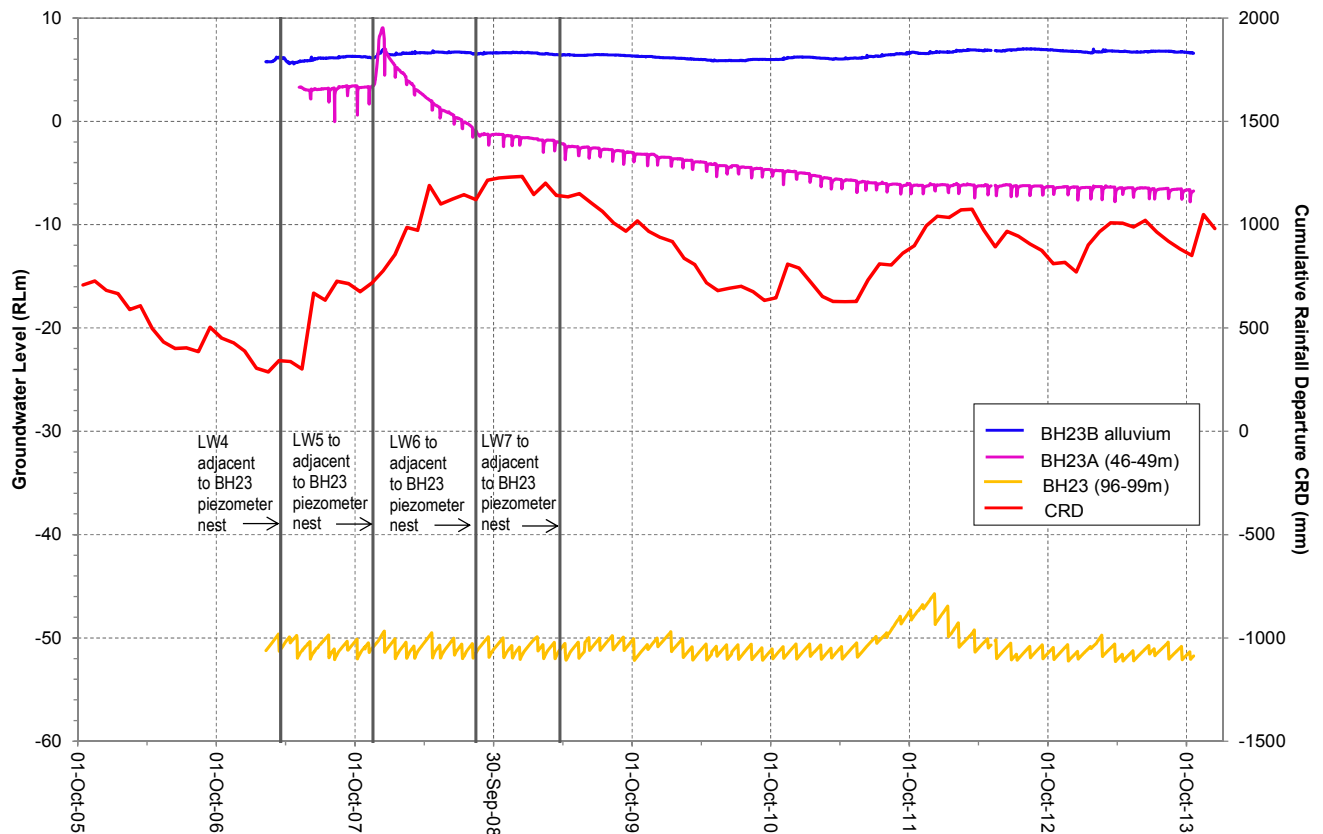
Figure A12: Nested Monitoring – Data-logger Hydrographs of Bores BH23, 23A, 23B

BH23 is set between 96 mbgl and 99 mbgl, and as such is much closer to the mine workings than BH23A. However, unexpectedly, groundwater levels in BH23 did not show the declining trend observed between 2007 and 2012 in BH23A. The reason for this is unknown, but does suggest limited drawdown in this unit related to mining.

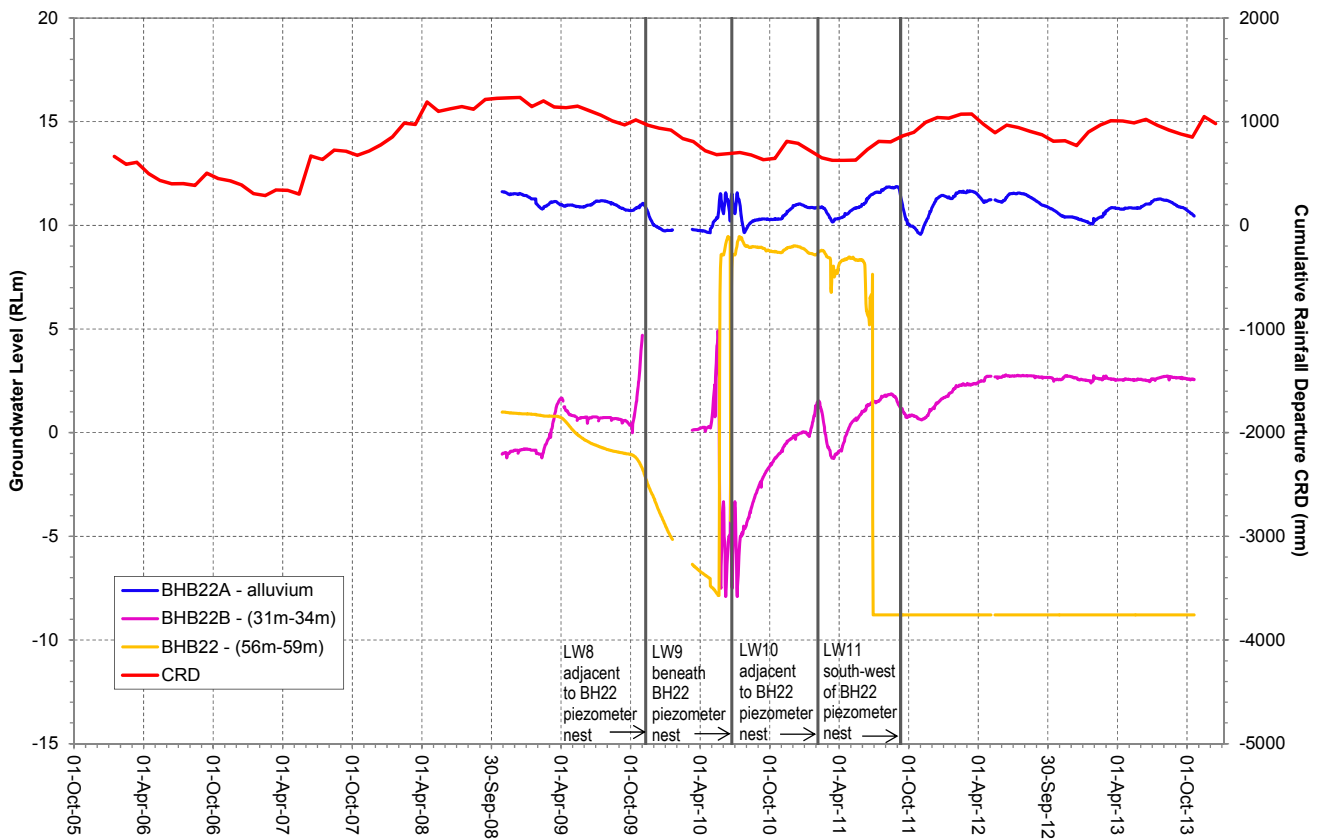
Figure A20: Nested Monitoring – Data-logger Hydrographs of Bores BH22 (A, B, C)

The water level in BH22 declined sharply to below the water level sensor in June 2011 (Figure A20), which is four months after the passage of LW10 adjacent to site BH22. These effects did not coincide with the passing of mining activities, but may be related to completion of fracturing that started earlier. The water level did not recover since.

Generally, as longwall panels LW8 to LW11 approached the piezometer, it would appear that there was compression of the overburden resulting in a temporary rise in water level in BH22A and BH22B followed by a decline as the overburden subsequently dilated as the longwalls passed. The passage of LW11 south-west of BH22A and BH22B in September 2011 caused a water level decline of 1 m in the intermediate layer and about 1.8 m in the alluvium; however, water levels in both strata recovered in late 2011/early 2012. The water level within the alluvium (BH22A) retained a close correlation with the CRD since. The water level changes appear to be dilating strata beneath the alluvium following mining.

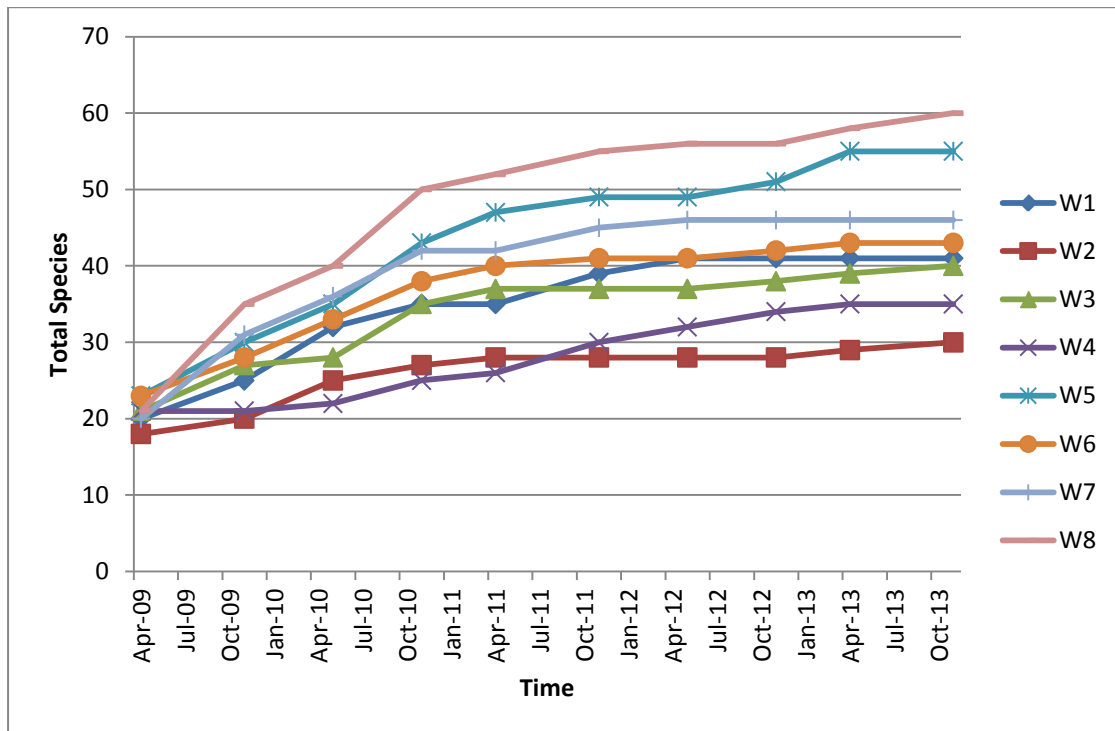
Figure 4 Cumulative species for each wetland transect over time

The total number of species recorded has close to, or more than, doubled for each wetland since the start of monitoring and is an indication of the size of the seedbank. Further analysis (data not shown) revealed that at any one monitoring occasion for any wetland, less than two thirds of the total possible species were present.

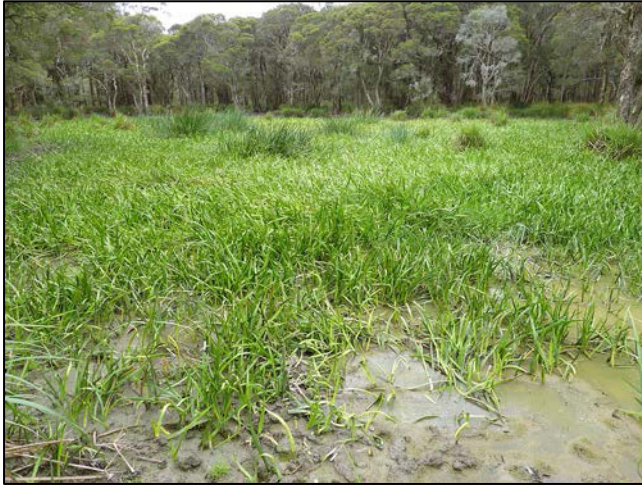
Figure 15 Wetland 6 Maundia triglochinooides patch November 2012

The dense patch of the threatened *Maundia triglochinoidea* reported in November 2012 (**Figure 15**) was substantially reduced in April 2013 (**Figure 16**) and further reduced in November 2013 (**Figure 17**). It is not known what causes this change but the abundance of this species has also reduced since April 2009 in wetlands 1, 2 and 4.

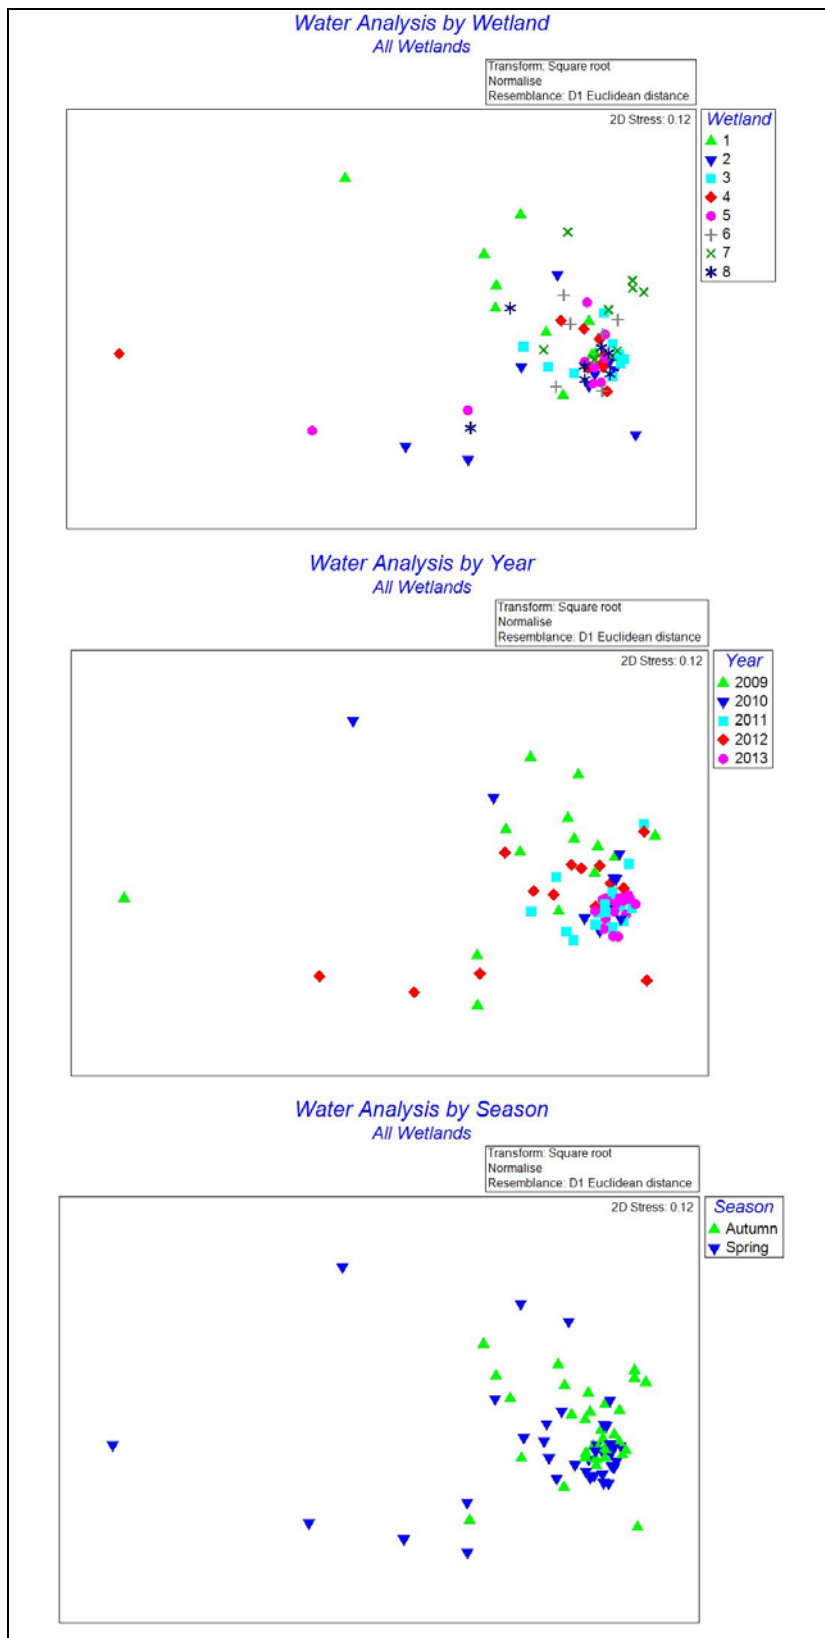
Figure 31 MDS similarity plots of water analysis by wetland, year and season

Similarity analysis using all water analytes was conducted to determine whether any patterns existed between wetlands, year or season. MDS plots in **Figure 31** show no groupings. From this analysis it can be concluded that there is no effect of wetland, or season on the measured water variables. Up until 2012 there was no effect of year on the variables. However, in 2013 data for all wetlands in both April and November were very similar as can be seen by the close grouping of the 2013 symbols.

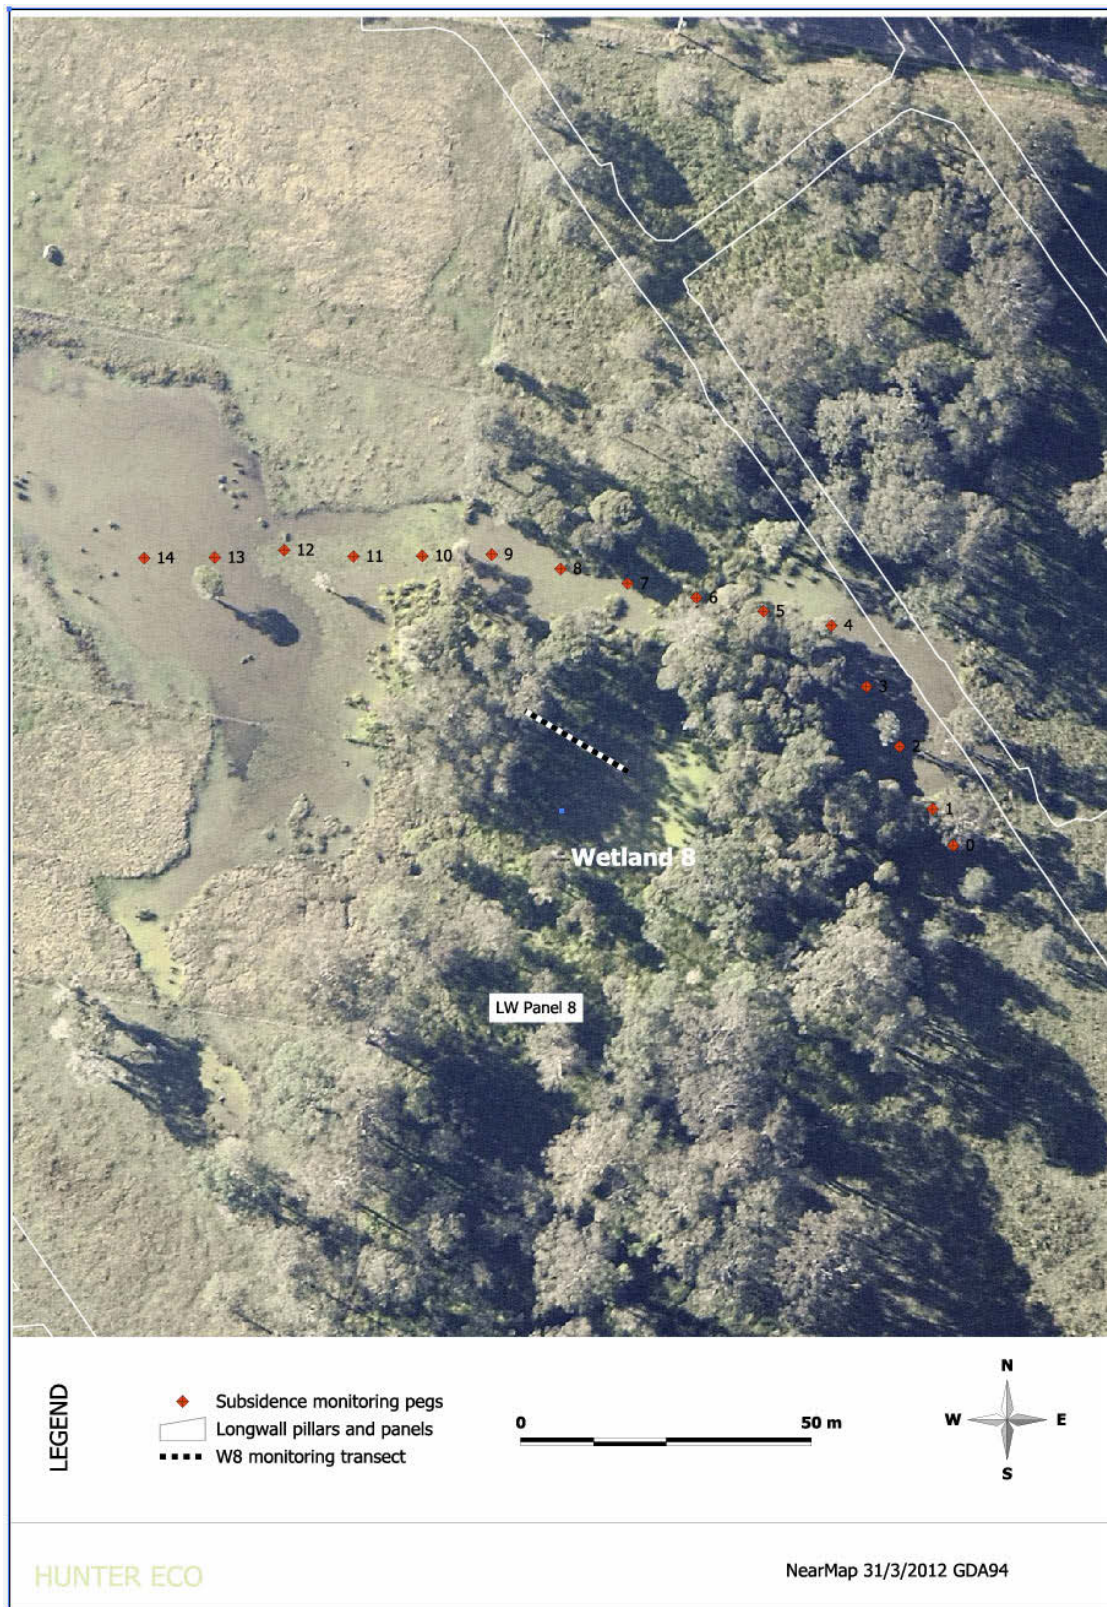
Figure 34 Wetland 8 subsidence monitoring line and wetland monitoring transect

Survey data collected on 7 July 2013 shows that subsidence has stabilised around 2011 levels i.e. about one metre of subsidence. There are no detectable subsidence impacts on the monitored wetland and subsidence is now expected to have stabilised after four years.
