# MAIN TAILINGS DAM ANNUAL TYPE 2 INSPECTION, NEWSTAN COAL MINE

## CENTENNIAL COAL

OUR REF: 2122823B-GEO-REP-17088 REVA\_FINAL.DOCX

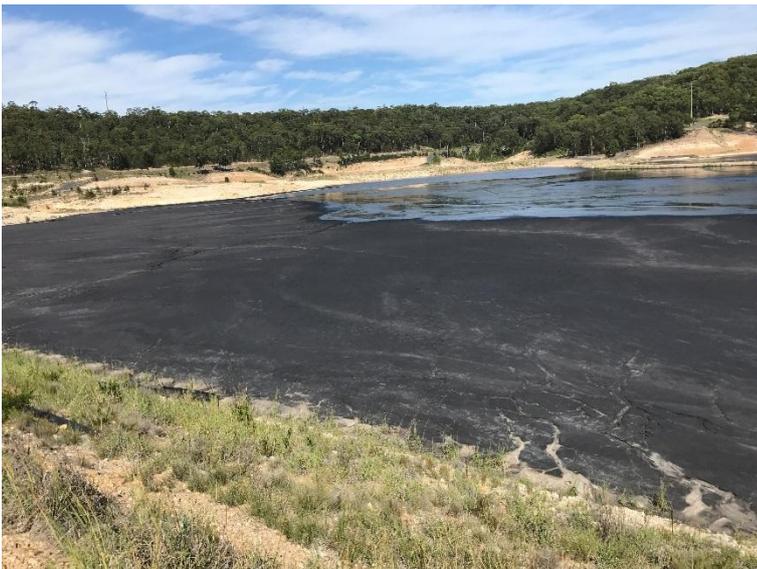
The storage level was at RL 35 m, approximately 8.5 m below the crest level. A wide tailings beach was present along the entire length of the upstream batter. No water was pooled against the batter. A shallow decant pond was present at the west end of the storage area.

No evidence of mine subsidence features, such as development of sinkholes or loss of stored surface water, was noted in the undermined area of the storage, or has been noted in routine inspections of the dam storage since October 2011 (the date of the most recent sinkhole).

Photo 3.1 Dam Storage Area

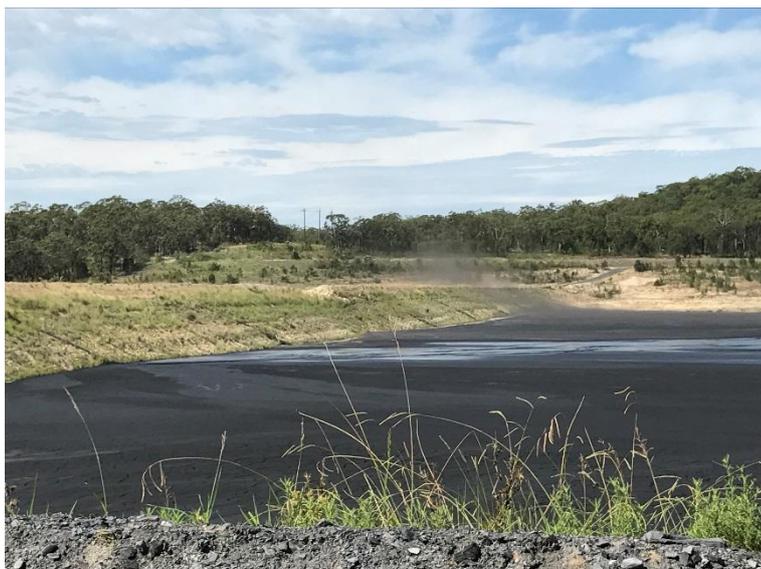
The tailings discharge point is moved along the upstream batter as required to maintain the tailings beach. No evidence of cracks or slips was noted. Minor erosion runnels due to surface runoff had developed along runoff flow paths. The batter appeared in a stable condition.

Photo 3.2 Upstream Batter

The growth of small trees and shrubs should be monitored and should be removed during regular weed spraying. If extensive networks of tree roots are allowed to grow in to the dam wall they could provide preferential pathways for seepage and internal erosion. Grass growth should be encouraged as it provides erosion protection.

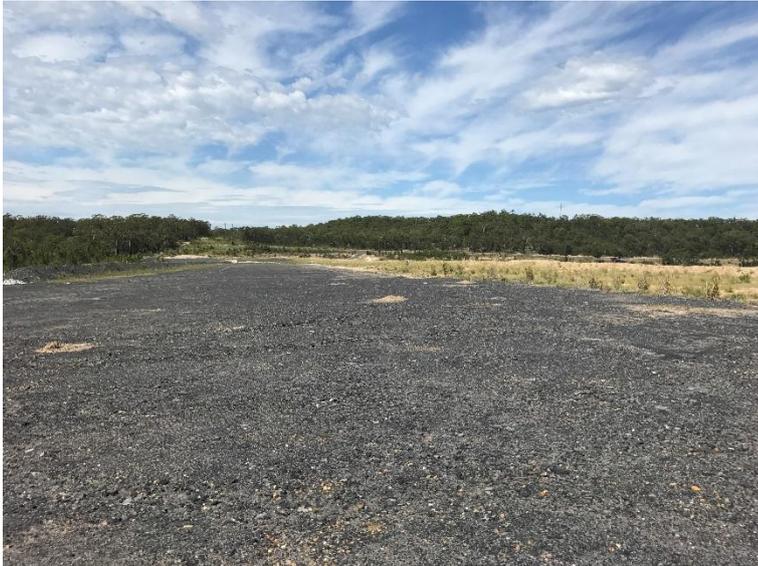
The surface comprised coal chitter, which appeared to be generally well compacted. No cracking or slumping was evident. Some minor surface depressions were present which contained pooled water. The depressions were generally related to depressions at the base of windrows. The pooled water did not appear to have any impact on the integrity of the dam.

Photo 3.3 Dam Crest

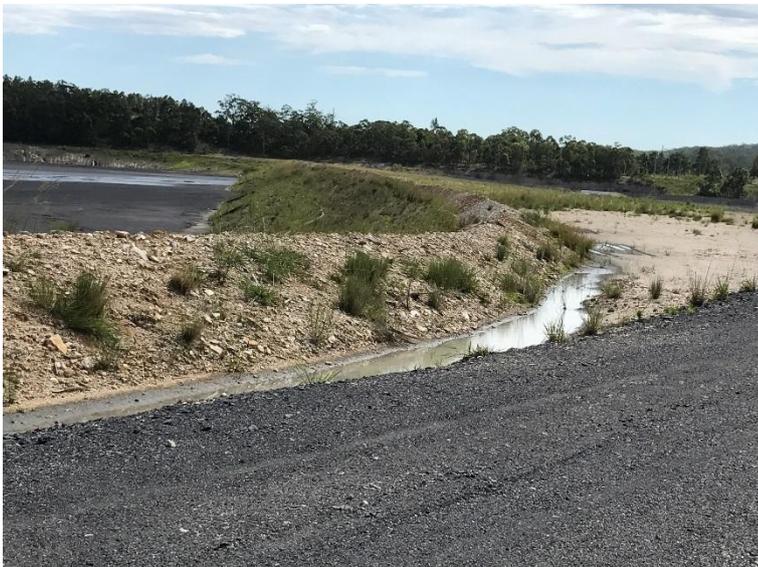
Photo 3.4 Pooled water at the base of the upstream batter windrow

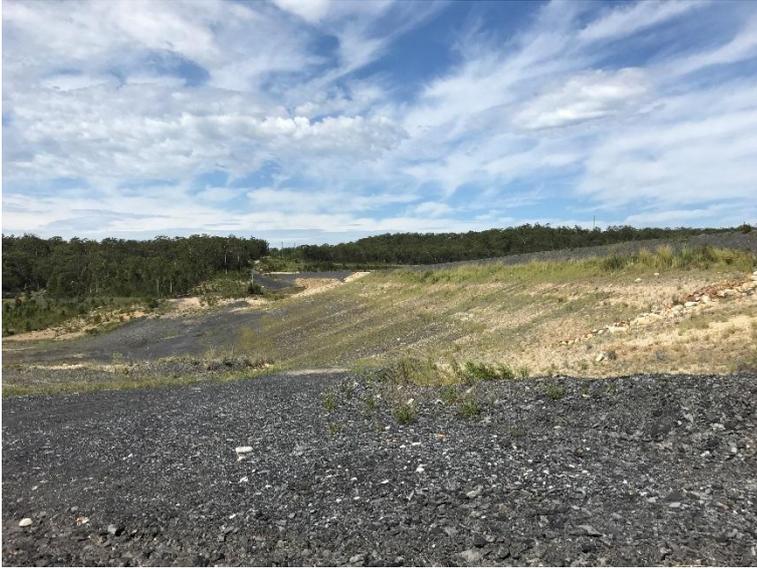
Coarse reject was exposed on the downstream batter, which contained numerous grass mounds and some small shrubs which had taken root. The batter appeared to be in good condition with no evidence of cracks or settlement. Some minor gully erosion was noted. The growth of shrubs should be monitored and should be removed during regular weed spraying.

No seepage was observed along the downstream batter. Commonly damp patches develop at the southern ends of the batter. None were observed during the inspection. These patches develop regularly along the downstream face following periods of heavy rainfall. They are not thought to be the result of seepage through the dam wall as they were present when the storage level was much lower and a wide tailings beach is present along the upstream batter. It is thought that they may be the result of crest and batter infiltration during periods of prolonged and/or heavy rainfall moving along bands of compacted earthfill where permeability variations and anisotropy are encountered.

A line of grass generally grows along the centre of the downstream batter at approximately RL 31.5 m. The embankment material along this section is usually damp. Some seepage was present along the toe of the southern end of the downstream batter. This water is the result of surface water infiltrating through the upper layers of the downstream batter and seeping down to the toe of the dam, as seepage has been occurring here prior to the tailings level reaching the same level. It is also considered unlikely that the seepage is reporting here from the storage area due to the large tailings beach along the upstream batter. Some water was pooled in the downstream area of the dam. The water was not near the dam toe.

Photo 3.5 Downstream Batter

Areas prone to development of damp patches should be monitored following rainfall. Any variations or increased seepage should be reported to a qualified dams engineer for inspection.

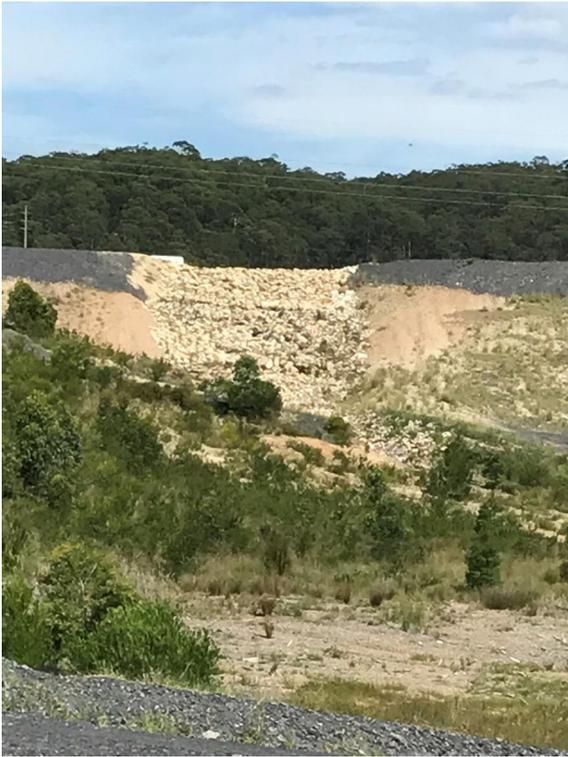
At the time of the inspection the spillway was at RL 42 m and was lined with sandstone riprap on the downstream side and across the dam crest to the top of the upstream batter. The rip rap generally appeared in good condition. Some additional rip rap had been placed around the top of the downstream batter to reduce gully erosion forming around the crest in this area.

Photo 3.6 Spillway

Some small shrubs have taken root in the rip rap on the downstream side. These should be removed during regular weed spraying so that they do not grow large enough to cause any obstructions.

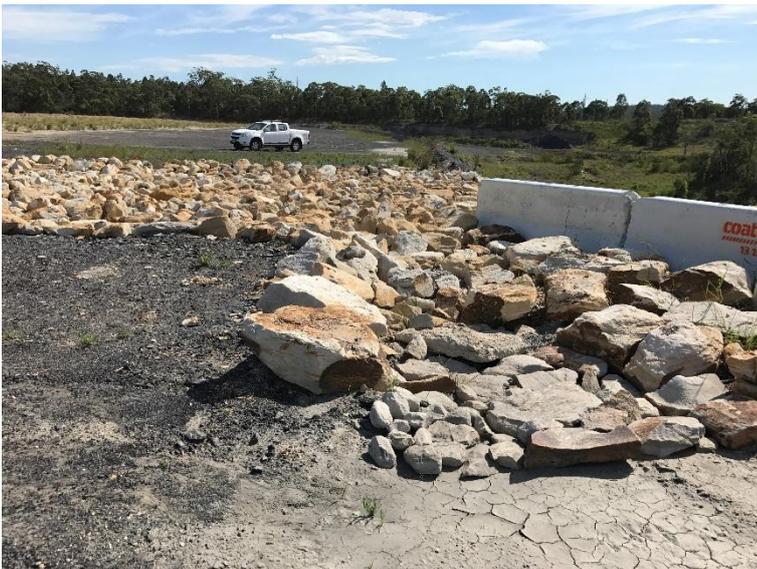
Photo 3.7 Additional rip rap at the top of the downstream batter

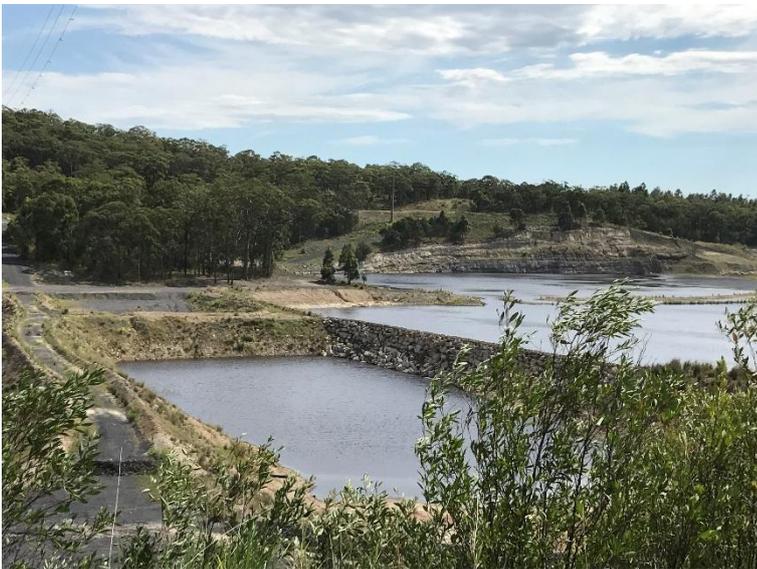
Previously following times of heavy rainfall NCS were often not able to decant from the Main Tailings dam to the underground workings as the water levels in the Fassifern seam would often be too high. Decant water was then stored on the dam until it could be pumped out via pipelines to other storage facilities on the site.

To manage water onsite, NCS has constructed a wastewater treatment plant, which is now operational. The treatment plant allows NCS to remove, treat and discharge excess water from the dam within the required 7-day time frame for a 'High A' consequence dam.

Photo 3.8 Decant Area
