# Centennial Coal

***CENTENNIAL MANDALONG PTY  
LTD***  
***Mandalong Mine***  
***ANNUAL REVIEW***

**March 2018**

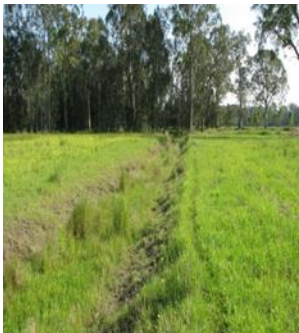
Remnant Ponding Remediation							
Location	Description	Remediation	Remediation Comments	Ponding Predicted	Subsidence Completed	Status	Property Ref. Lot & DP
Longwall 1 (P1)	Open grassland	Proposed new dam and area levelled as per PSMP	Continuing negotiations with landowner.	No	Yes	Negotiations with landowner ongoing	Ref. 6 2//557230
Longwall 2 (P2)	Open grassland	Drained	Constructed open drain and connected to nearby water course.

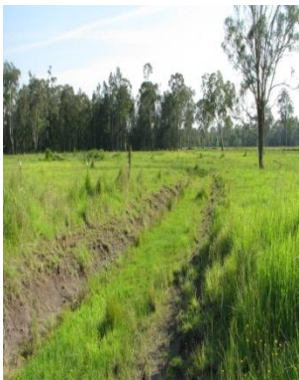
Yes	Yes	Completed	Ref. 7, 8 1//557230 3//557230
Longwall 3 (P3)	Open grassland	Drained	Constructed open drain and connected to nearby water course.

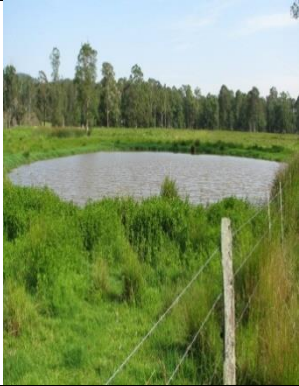
Remnant Ponding Remediation							
Location	Description	Remediation	Remediation Comments	Ponding Predicted	Subsidence Completed	Status	Property Ref. Lot & DP
Longwall 4 (P4)	Open grassland	Allowed to remain as a source of water for stock.

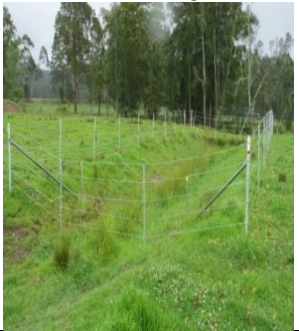
Yes	Yes	Completed	Ref. 7, 59 1//557230 580//73322 7
Longwall 5 (P5)	Open grassland	Drained	Constructed open drain and connected to nearby water course. Fenced to restrict stock access causing erosion.
