# Independent Environmental Audit (IEA) Lidsdale Siding

for Ivanhoe Coal Pty Limited

Lidsdale Coal Loading Facility, Wallerawang, New South Wales 2845

15 December 2015  
mcwenvironmental@bigpond.com.au

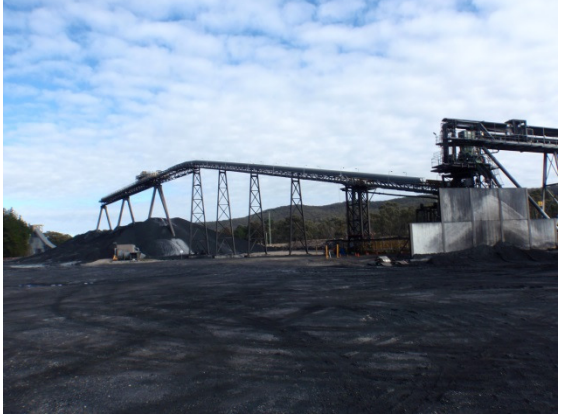
Photo #	Comment	Photo
4-1.	The overland conveyor (right) and new stockpile conveyor (CV01).

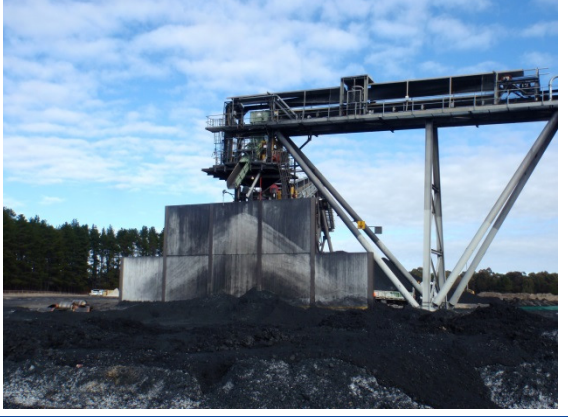
4-2.	The overland conveyor showing the chute and wall where previous operations using front end loaders would collect coal.

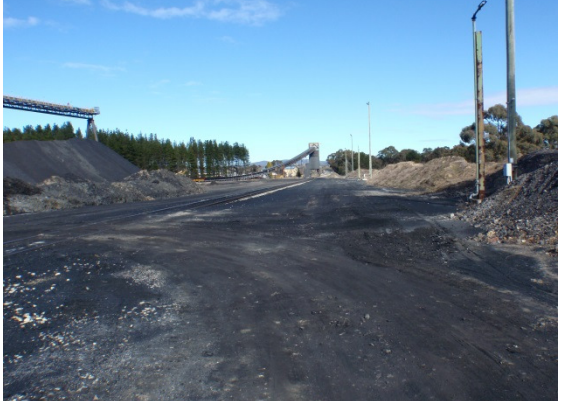
4-3.	Coaly material was evident on the ground on the northern side of the rail siding.

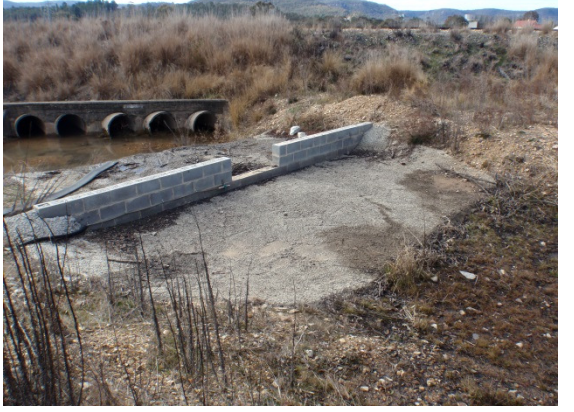
Photo #	Comment	Photo
4-7.	<p><u>LDP004 at the Triangle Pond</u></p> <p>Settled and treated water is discharged under licence into Pipers Flat Creek via a stormwater drainage channel, approximately 200 m south-west of the Coxs River confluence.</p>

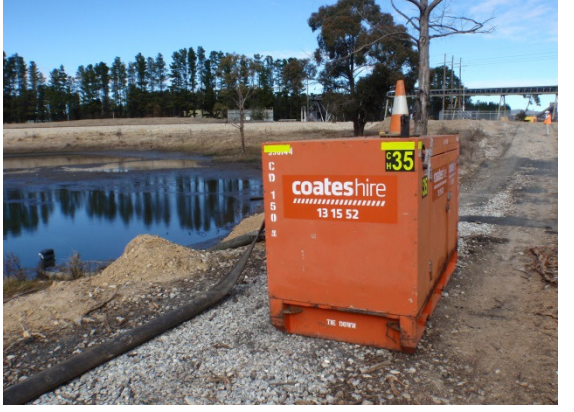
4-8.	<p><u>Triangle Pond</u></p> <p>Water is pumped from the Triangle Pond through LDP004 to maintain the freeboard of the pond. Water quality is analysed prior to discharge.</p> <p>At the time of the site inspection on 31 July 2015 a hired pump was observed and the pond was essentially empty. The base of the pond was evident in places.</p>

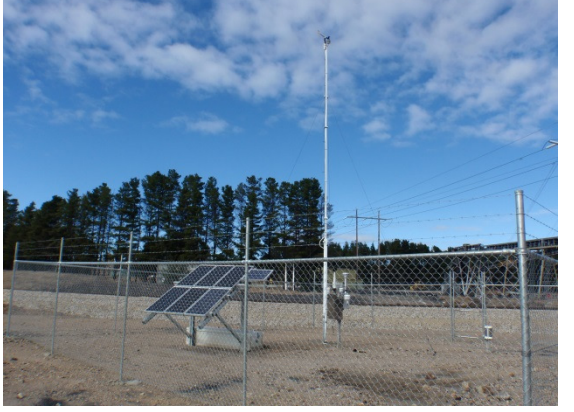
4-9.	<p>The Lidsdale Siding Weather Station (LSWS) was located to the east of the overland conveyor and adjacent to the mainline spur.</p>

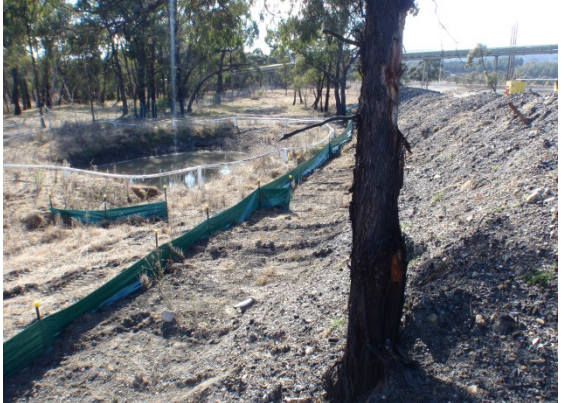
4-10.	<p>Stockpiles of earth were located between the northern boundary fence and the siding. Lidsdale management reported the stockpiles were due to be sampled to determine if the material will be suitable for use in the formation of levees adjacent to Pipe Flat Creek and inside the boundary fence, a requirement of the Flood Study.</p> <p>The formation of levees as required by the Flood Study remains outstanding.</p>

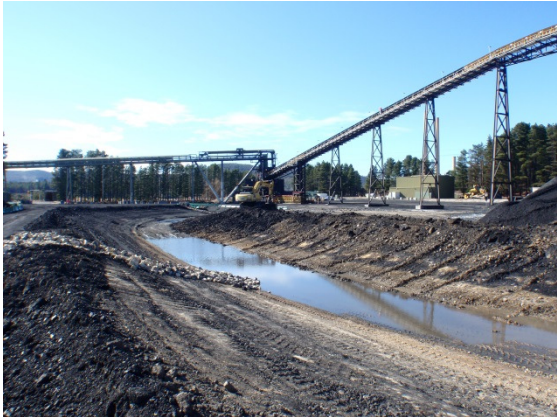
Photo #	Comment	Photo
4-11.	Construction of a new drainage line to the Dirty Water Dam was observed at the time of the site inspection on 31 July 2015.

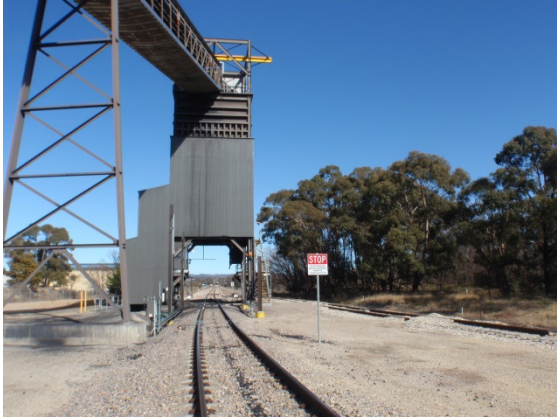
4-12.	The new TLO bin with 'Stop' sign. Trains reverse through the TLO bin at a speed of between 0.5 km/hr – 1 km/hr up a slight incline to prevent the 'knuckling' of wagons.

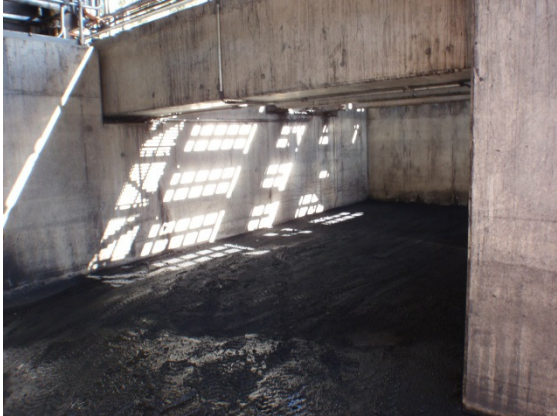
4-13.	The spill pit captures spills from the loading process. The pit is a concrete structure and is emptied by a 'Bobcat' as required.

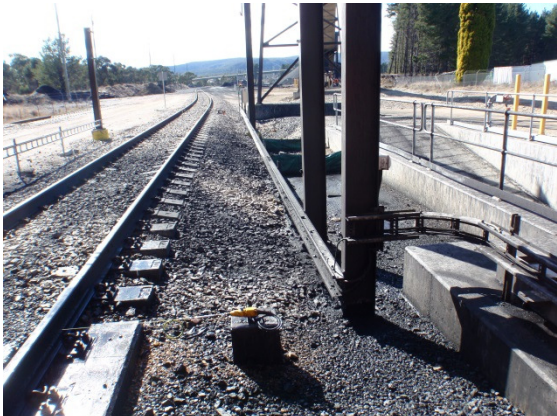
4-14.	<p>Water was observed to be dripping intermittently from the overhead conveyor (CV01) to the train loading bin. Pooled water had collected at the eastern base of the train loading bin and there was the potential for coal fines to flow into a clean water catchment drain adjacent to the train loading bin if the flow of water increased.</p> <p><b>REC-2015-01</b> - Repair the leak from CV01 at the TLO bin. Ensure that coal fines are prevented from entering the clean water catchment drain adjacent to the TLO bin by either regular cleaning or construction of infrastructure (e.g. concrete pad for containment).</p>

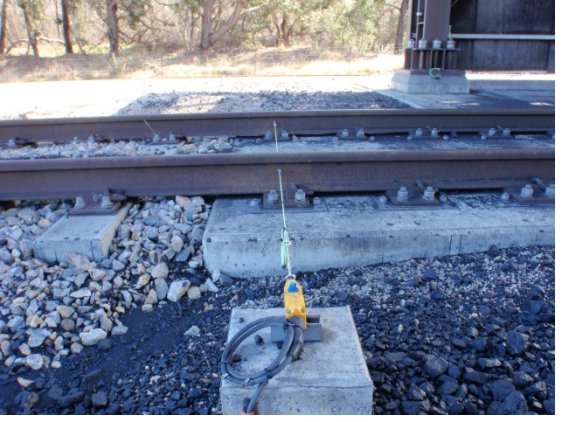
Photo #	Comment	Photo
4-15.	Coal spill sensors were observed on the track either side of the TLO bin.

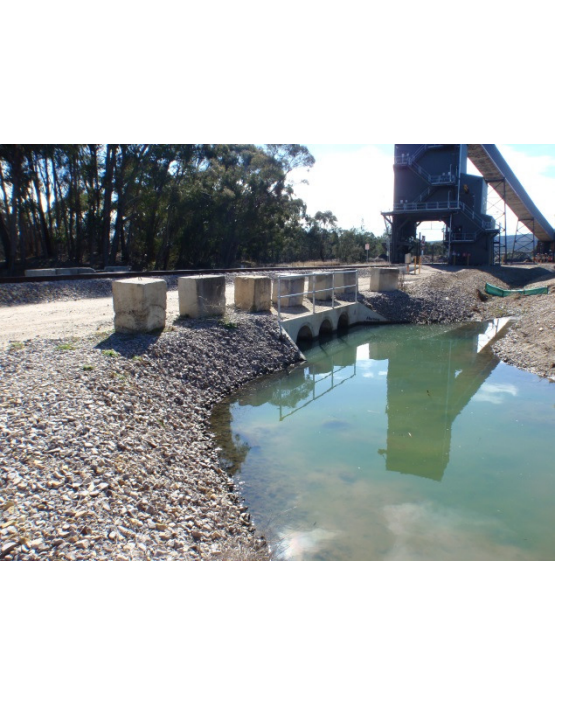
4-16.	<p>A culvert had been constructed under the new train line. The drainage channel flows onto the site from neighbouring properties to the south, under the new train line and existing siding where it exits the site to the north flowing into Pipers Flat Creek.</p> <p>The Flood Study prepared by AURECON (2014, p.17) notes that <i>“duplication of the existing rail siding is proposed to the south-east of the existing siding. At the time of assessment, topographic data was not available for the proposed alignment and as such, developed case modelling has not been undertaken”</i>. AURECON considered that <i>“provided that locations and sizes of culverts are similar to those beneath the existing alignment and existing rail levels are maintained, flood impacts of the proposed duplication would be minimal”</i>.</p> <p><b>REC-2015-02</b> – Confirm that the increased height of the new rail line would not restrict flows and lead to possible redirection of flows onto the site in the event of the culvert being overtopped.</p>

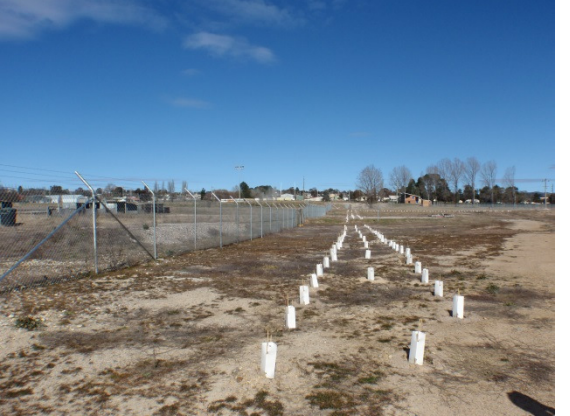
4-17.	<p>Evidence of rehabilitation was observed at the western end of the site. Tree saplings had been planted along the south-western boundary.</p> <p>Tree planting appeared to be in accordance with the Biodiversity Management Plan (RPS, 2013) in that it was conducted by a suitably experienced bushland regeneration contractor (NewEra Pty Ltd). Areas with scarce vegetation had been seeded with native grass and/or native shrubs and trees (NewEra, 2015-A&amp;B).</p>

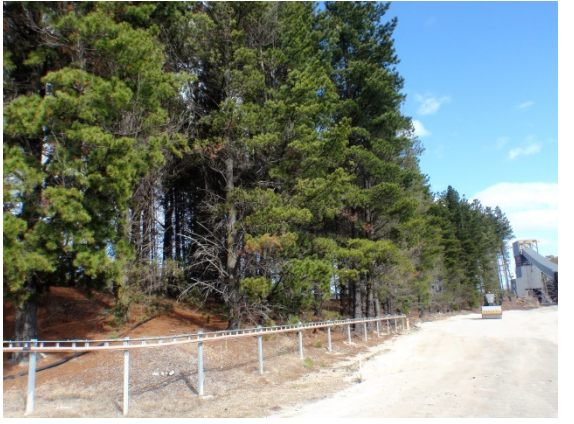
Photo #	Comment	Photo
4-18.	Mature tree screening was noted adjacent to the coal stockpile and conveyor CV01.

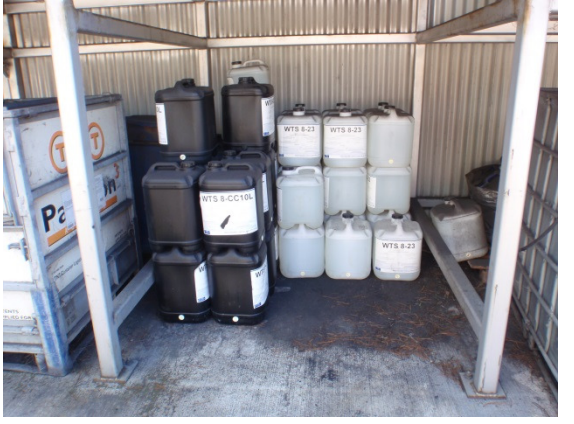
4-19.	Water management chemicals were observed to be stored on sealed ground and undercover adjacent to the former workshop building.

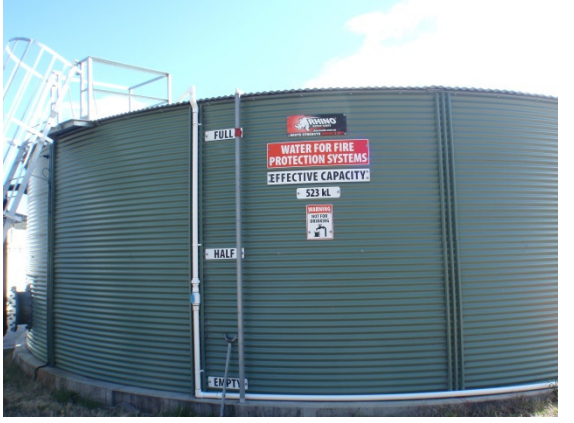
4-20.	A new firewater tank with a capacity of 523 kilolitres (KL) was observed on-site. The tank is topped up via a combination of bore water and the town municipal supply.

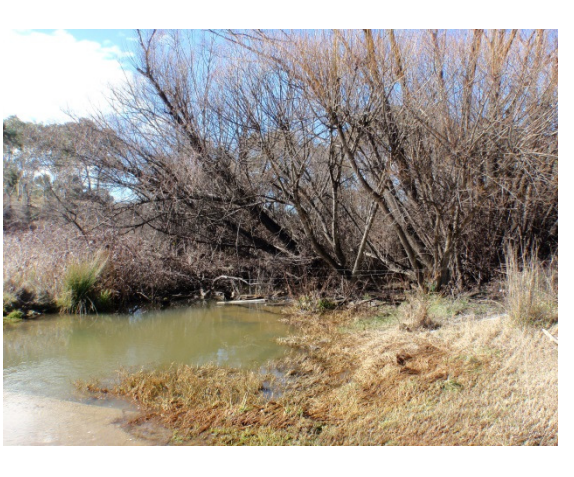
4-21.	<p>Invasive willow trees were observed from Brays Lane in Pipers Flat Creek.</p> <p>The willow trees are due to be removed from the channel, in particular to the north-west in the bend near to the 'Railway Culvert'. The removal of invasive species will be undertaken over a five year period with the advice of and/or in collaboration with the Hawkesbury-Nepean Catchment Management Authority (HNCMA). A letter from Centennial to DP&amp;E concerning the Flood Study (including Willow tree removal) dated 1 May 2014 noted that proposed mitigation controls would be implemented by April 2016.</p> <p>The removal of the willow trees is a</p>

Photo #	Comment	Photo
	commitment that remains outstanding.

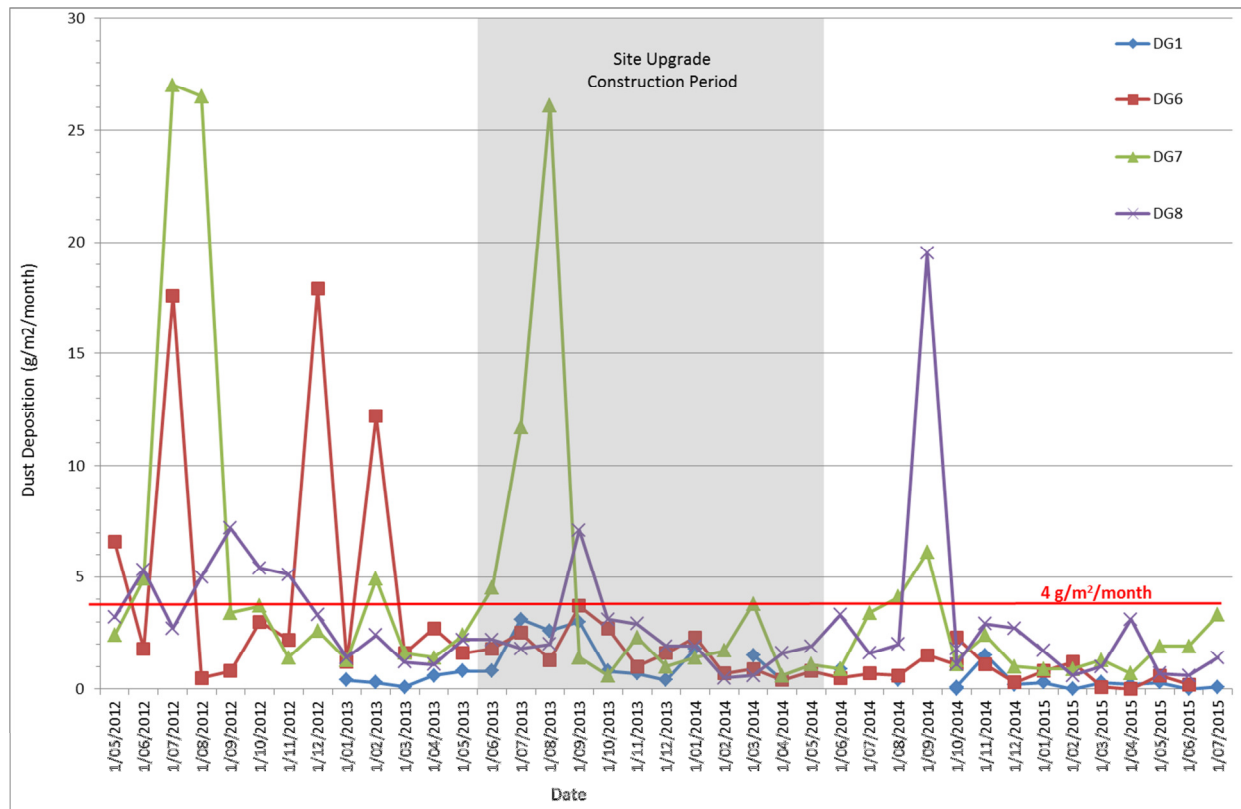
Figure 4-1 - Dust Deposition Rates between 2013 and 2015 (DG1, DG6, DG7 and DG8)

The specialist auditor considers these samples to be indicative of dust samples associated with construction works; with insect and plant debris likely to be contributing to at least 30% of the total dust deposition rates at DG7.

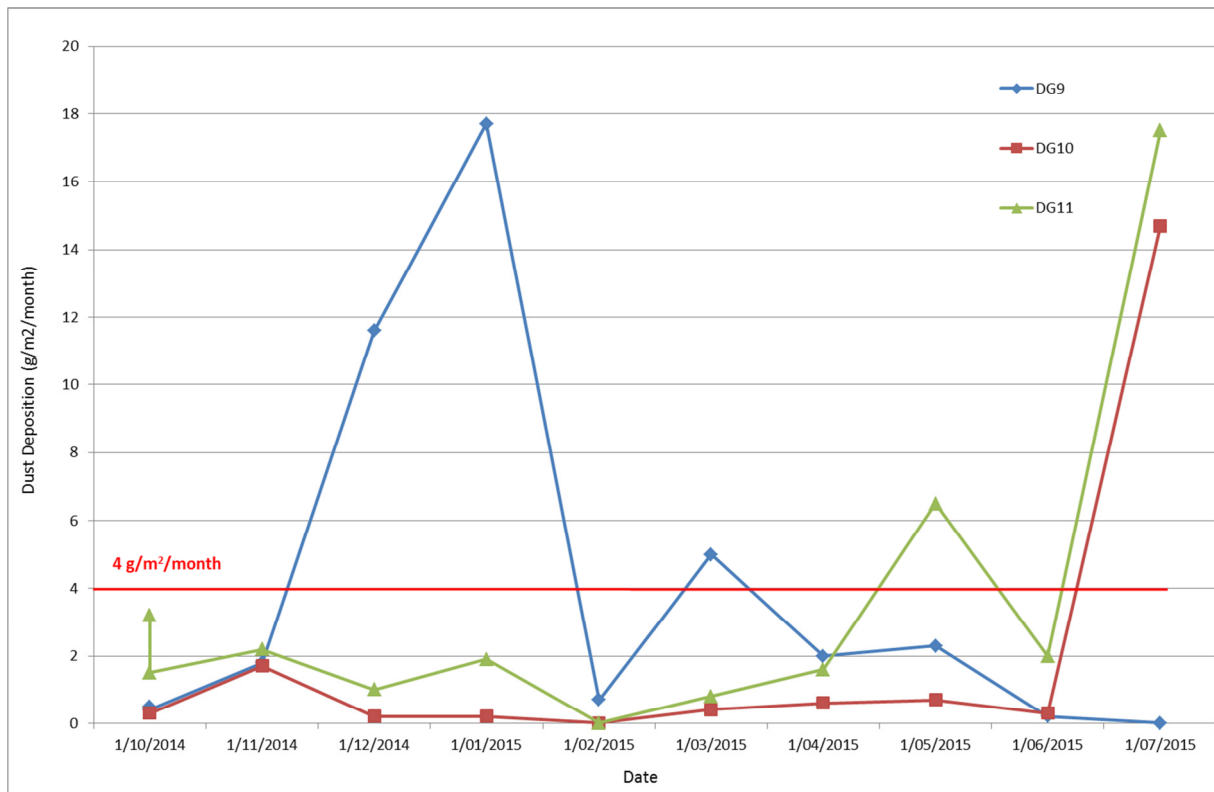
Figure 4-2 - Dust Deposition Rates between 2014 and 2015 (DG9, DG10, DG11)

Whilst the average measurements of DG9, DG10 and DG11, presented in in **Figure 4-2** appear to be close to the 4 g/m<sup>2</sup>/month, none of the new stations have been operating for 12 months, consequently it cannot yet be established if the measurements exceed the relevant guidelines.

The measurements of the three new dust deposition locations (DG9, DG10 and DG11) are presented in **Figure 4-2**. Due to the short operating time, compliance against guidelines for the DG9 and DG10 cannot be established. It is also noted that DG11 is an internal dust deposition gauge, installed to be representative of background concentrations, consequently is not considered for compliance purposes as it is not listed as a monitoring point under Condition P1.1 of EPL 5129.

- **REC-2015-03** – Real time measurements coupled with additional composition analysis may be required to establish the likely source should consistent elevated results at DG9, DG10 and DG11 show a 12 month rolling average above the guideline.
- **REC-2015-04** – Review monitoring data and consider relocating DG11 to a location more representative of background conditions at the site. Current results at DG11 are above results close to the source areas (e.g. the stockpile), where higher measurements would be expected.

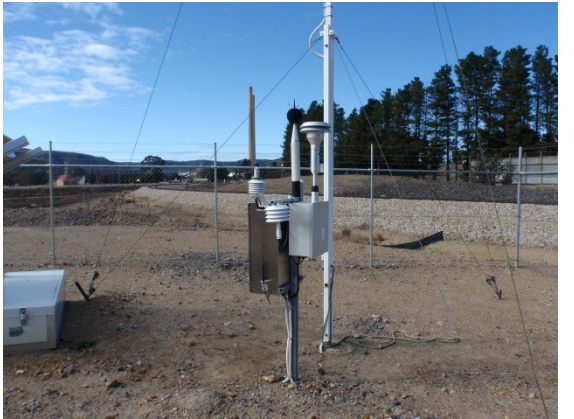
Photo #	Comment	Photo
4-22.	<p>The LSWS with High Volume Air Sampler (HVAS) to measure real-time continuous PM<sub>10</sub>.</p>

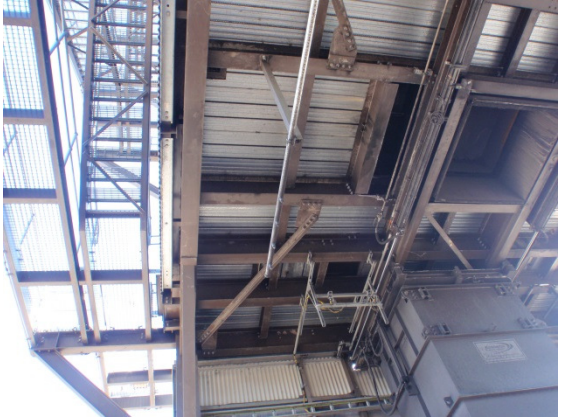
4-23.	<p>Water sprays were observed in the loading area. Lidsdale management reported that sprays are not routinely used during loading operations.</p> <p>Section 7.1.1 (p.12) of the Air Quality Management Plan<sup>7</sup> states that “At the request of the DP&amp;I and in support of the Project’s Environmental Impact Statement (EIS), a study was performed to quantify the effects of methods used to control dust lift off from coal wagons leaving the site. The results of this study indicated that coal dust is likely to be emitted when the Washed Coal product has a moisture content of approximately 5%(w/w) or less, and that emissions of dust from loaded rail wagons during transport are low and are in line with emissions calculated as part of the EIS.</p> <p><i>Given the moisture content of the Washed Coal product is typically 8% (w/w), the study concludes that significant emissions of dust will not be generated during coal handling, loading or storage of coal on the site”.</i></p>

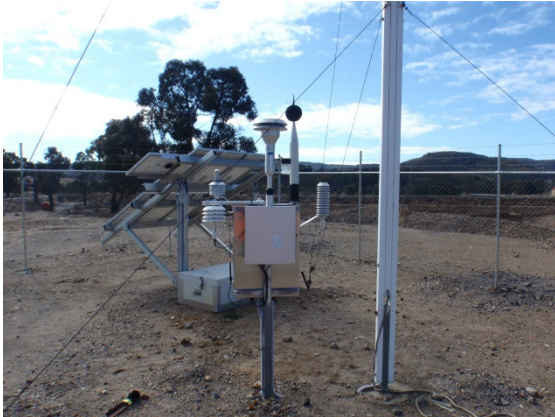
Photo #	Comment	Photo
4-25.	The LSWS with near-field noise monitoring for determining operational sound power levels of acoustically significant plant and equipment.
