Ivanhoe North

Centennial Coal

Annual Environmental Management Report

2013

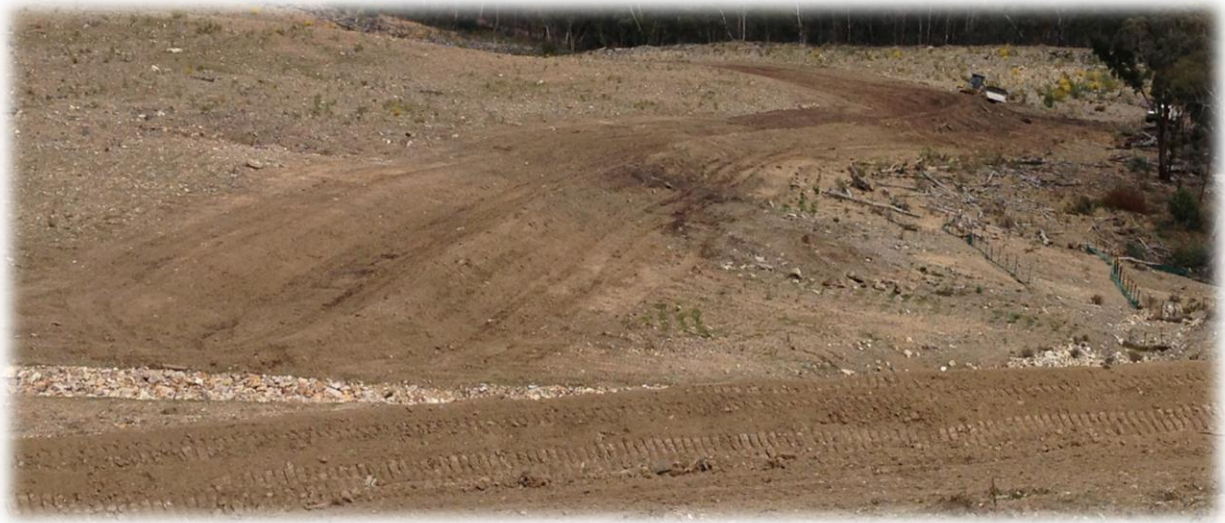
Figure 1. Contour bank structure installation during the reporting period

- Mid-slope contour banks aiming to increase infiltration and trap sediment by catching surface runoff and slowing the flow;
- A series of small sediment traps within the new contour system pools runoff water and settles coarse sediment;

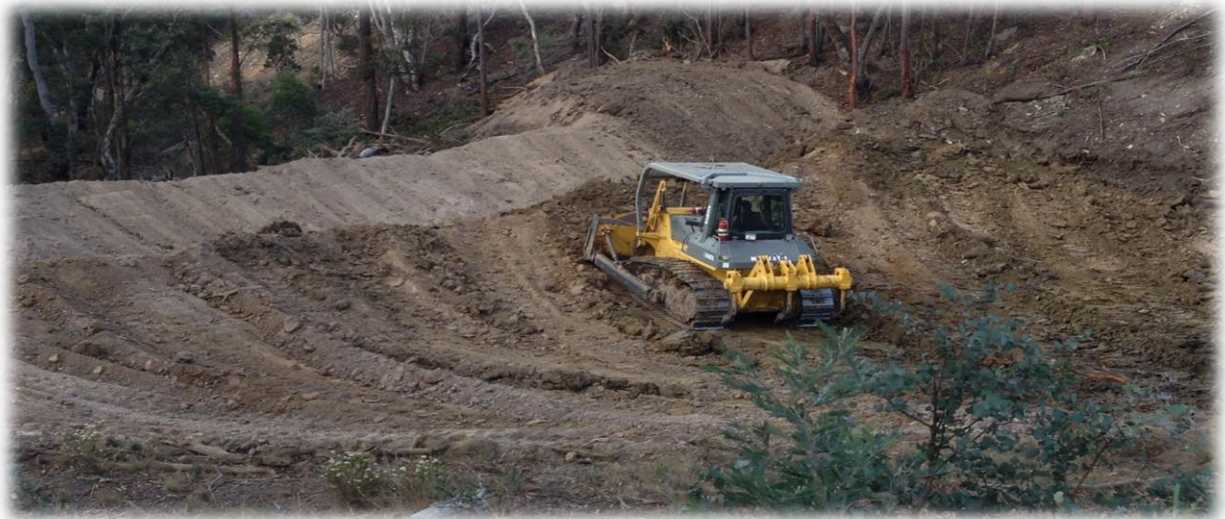
Figure 2. Preliminary Sediment Dam 1B: resizing work during the reporting Period

- The preliminary sediment dam upstream of Lilley's Dam SD1, was resized to comply with Blue Book Type D/F Basin Standards (3.5ML total capacity) and incorporates a small diversion and gentle spill way directing the water away from existing erosion areas and into established grass lands before the water enters in to Lilley's Dam.

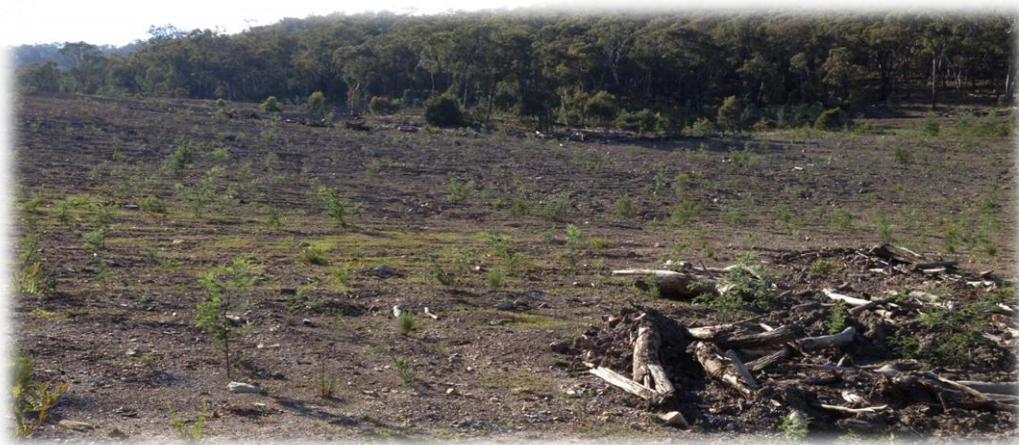
The major rehabilitation activities associated with the INRP are outlined in the RMCP. Rehabilitation results in areas of the southern blocks were below expectations and the investigation findings are outlined in **Section 5.4.2**.

Figure 4. Rehabilitation Area in Southern Blocks

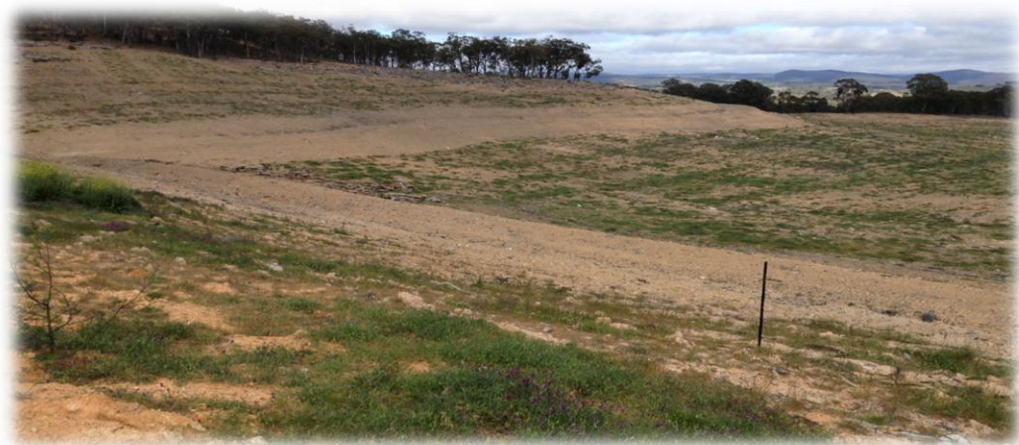
Figure 5. Rehabilitation in Northern Block

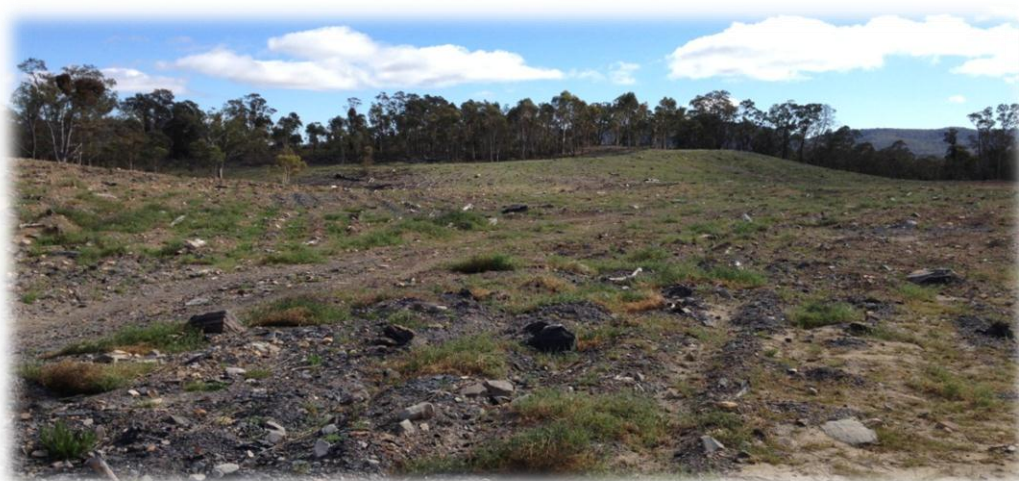
Figure 6. Rehabilitation in Central Block
