# Centennial Coal

***CENTENNIAL MANDALONG PTY  
LTD***  
***Mandalong Mine***  
***ANNUAL REVIEW***

**March 2016**

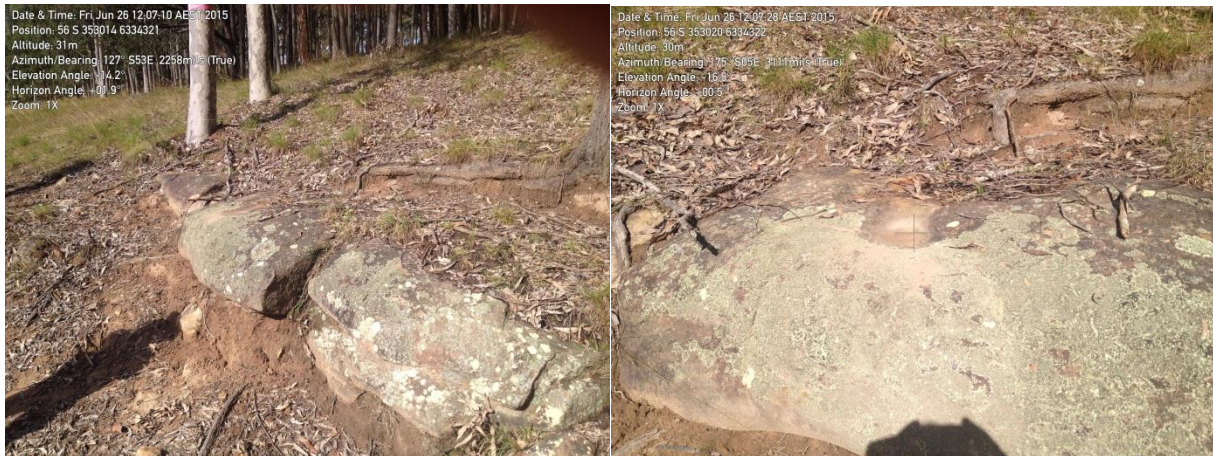
**Figure 8: Post Mining Photographs of Grinding Grooves at RPS Mand Nth 9 Site**

RPS Mand Nth 9 (Grinding Grooves) were considered more susceptible to damage than the other recorded sites. The grinding grooves located in the RPS (2012) survey are located over the three heading Maingate 14. The impact of any increased subsidence over the long-term stable maingate pillars is expected to be minimal. The site was included in the subsidence monitoring program. Subsidence over Maingate 14 was within predicted levels (0.15m) and there was no observed impact to the grinding groove site as shown in Figure 8.

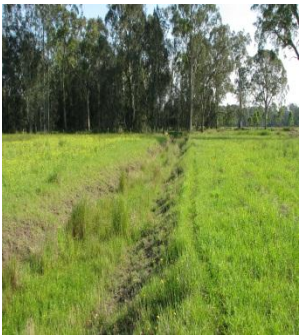
Location	Description	Remediation	Remediation Comments	Ponding Predicted	Subsidence Completed	Remediation Status
Longwall 1 (P1)	Open grassland	Proposed new dam and area levelled as per PSMP	Continuing negotiations with landowner.	No	Yes	Negotiations with landowner ongoing
Longwall 2 (P2)	Open grassland	Drained	Constructed open drain and connected to nearby water course.

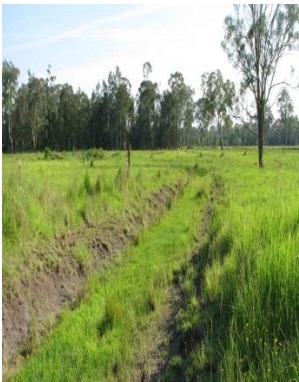
Yes	Yes	Completed
Longwall 3 (P3)	Open grassland	Drained	Constructed open drain and connected to nearby water course.

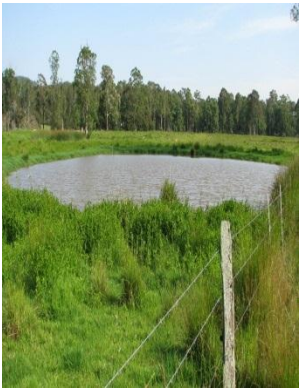
Location	Description	Remediation	Remediation Comments	Ponding Predicted	Subsidence Completed	Remediation Status
Longwall 4 (P4)	Open grassland	Allowed to remain as a source of water for stock.

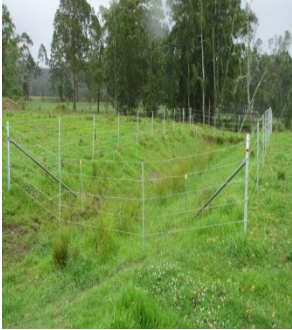
Yes	Yes	Completed
Longwall 5 (P5)	Open grassland	Drained	Constructed open drain and connected to nearby water course.

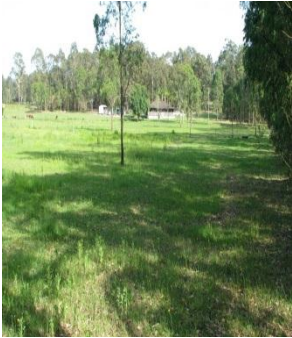
No	Yes	Completed
Longwall 6 (P6)	Open grassland	Drained	Installed sub-surface drainage and drainage to Stockton Creek.

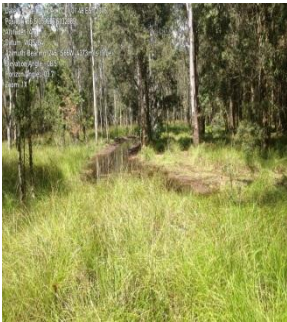
Location	Description	Remediation	Remediation Comments	Ponding Predicted	Subsidence Completed	Remediation Status
Longwall 16 (P16)	Redgum Rough-barked Apple Forest and Coastal Foothill Spotted Gum-Ironbark Forest.	Increase in existing ponded area remediated to pre-mining condition.  Minimal impact on flora.

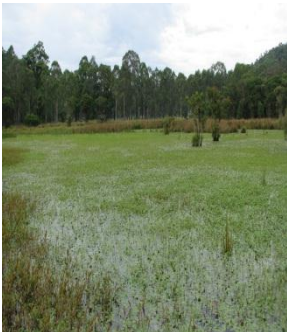
Yes	Yes	Completed
Longwall 16 (P16A)	Open grassland	Fill to restore drainage.	Increase in depth and extent of existing ponding slightly greater than predicted.	Yes	Yes	Survey completed.
Longwall 17 (P17)	Freshwater Wetland Complex EEC and Redgum Rough-barked Apple Forest EEC	Increase in extent of wetland as predicted.  No remediation required.	Currently monitoring area and waiting on subsidence to be completed on LW19..  Marginal increase in extent and depth of wetland has occurred as predicted. No predicted long-term impact on wetland.  Wetland 4 & 5 in Wetland Management Plan
