CENTENNIAL COAL CLARENCE COLLIERY ANNUAL REVIEW

January 2018 to December 2018

March 2019

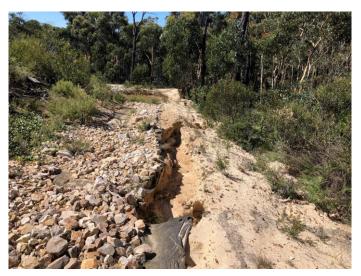
Photo 3 Failed batter of diversion drain causing sedimentation into adjacent bushland (REA IV)

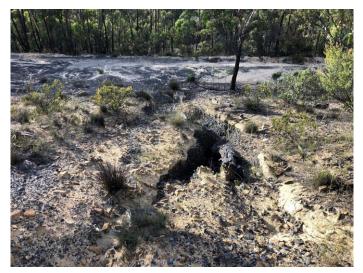
Photo 4 Gullying and poor capping depth (REA III)
