***CENTENNIAL COAL
CLARENCE COLLIERY
ANNUAL REVIEW***

March 2016

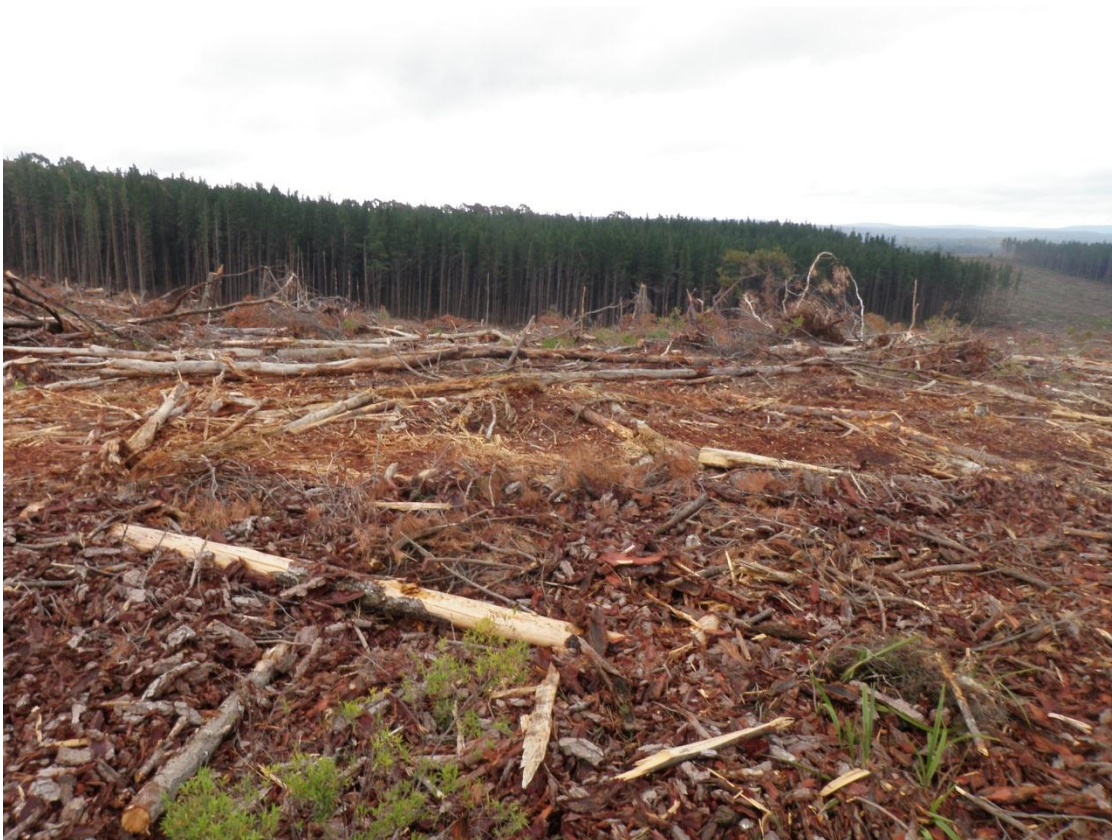
Photo 1. Cleared Pine Plantation

Photo 1 shows the cleared pine plantation area where a large proportion of the subsidence line used to be located. **Photos 2** and **3** show bushfire damaged pegs.

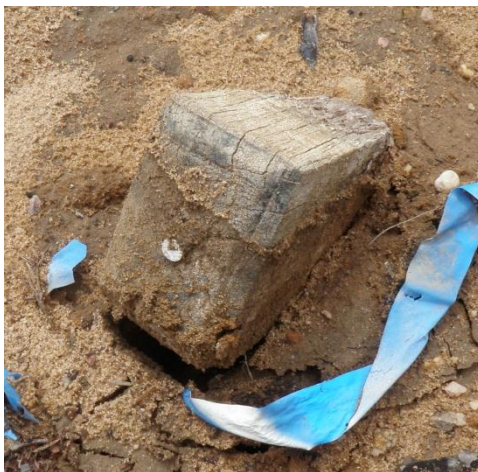
Photo 4. Peg D73

Photos 4 – 5 show deterioration and/or other impacts to pegs along the 609 D Line.

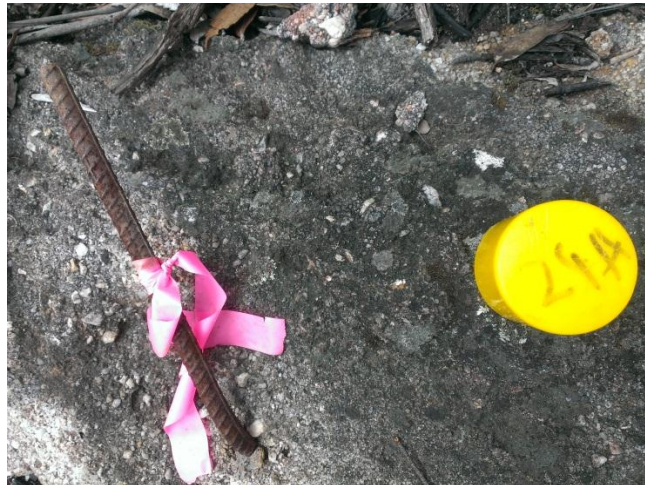
Photo 7. Peg A24

As discussed previously, the 900A line overlies the 904 and the 902 Panel. The three monthly post extraction subsidence survey for 902 Panel recorded a maximum of 28mm of movement and the annual survey carried out on 28th August 2015 recorded a maximum subsidence of 27mm. The annual survey for the extraction of 904 Panel recorded a maximum subsidence of 31mm. Unfortunately, two pegs were damaged throughout the reporting period. Peg A23 was vandalised, but can still be measured. **Photo 6** shows the damage sustained to this peg. Peg A24 was a rock marker and it has been damaged beyond repair. **Photo 7** shows the damage sustained to this marker.
