CENTENNIAL COAL AWABA COLLIERY ANNUAL REVIEW

March 2018

Newstan & Awaba Subsidence Rehabilitation Report

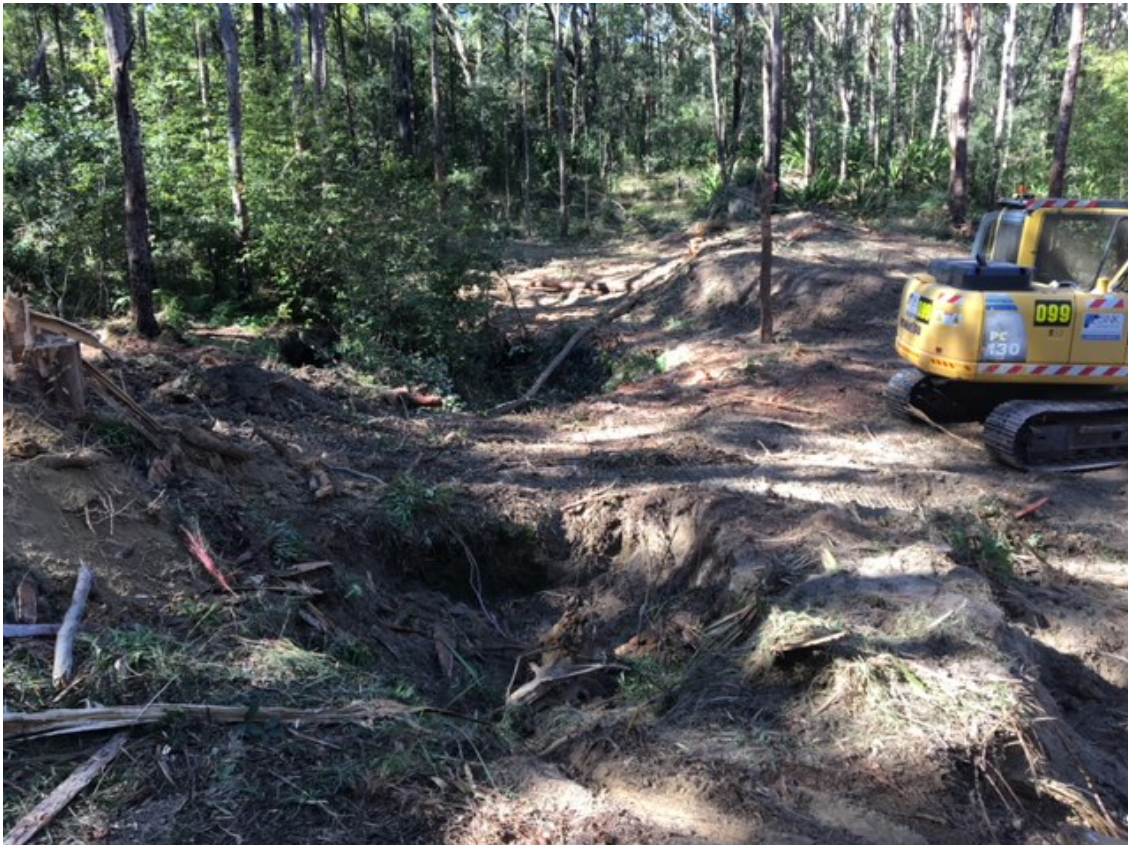
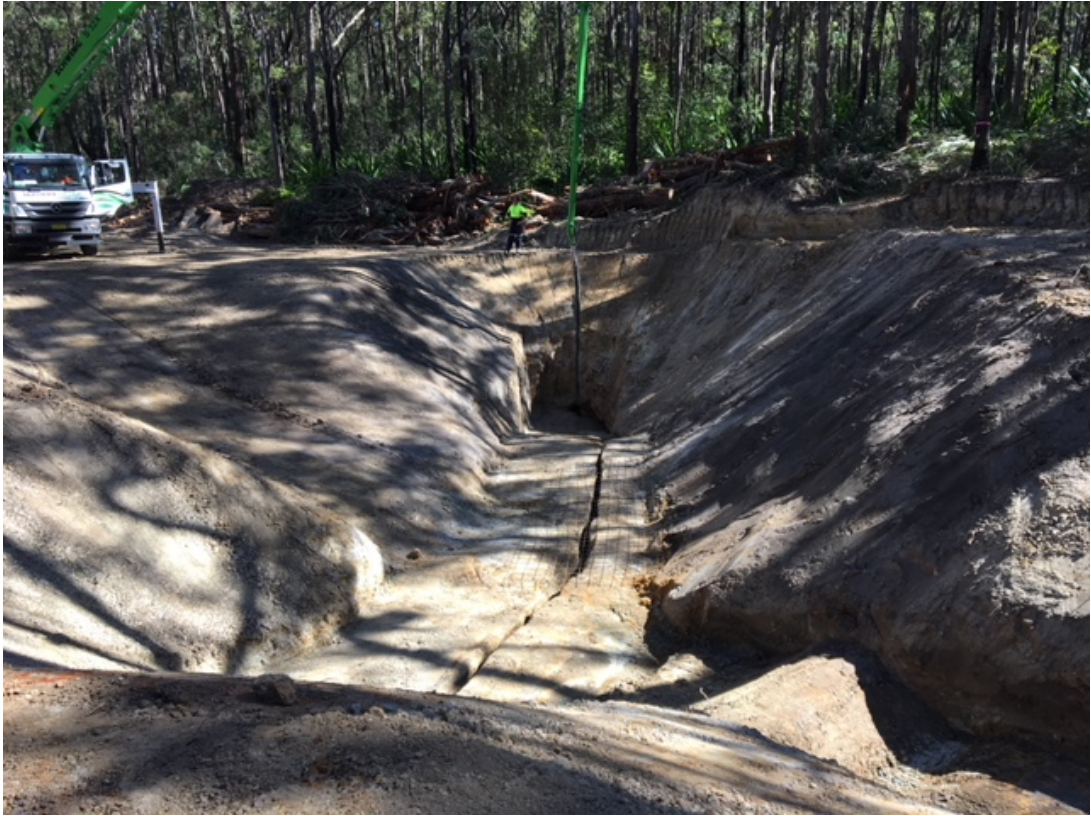
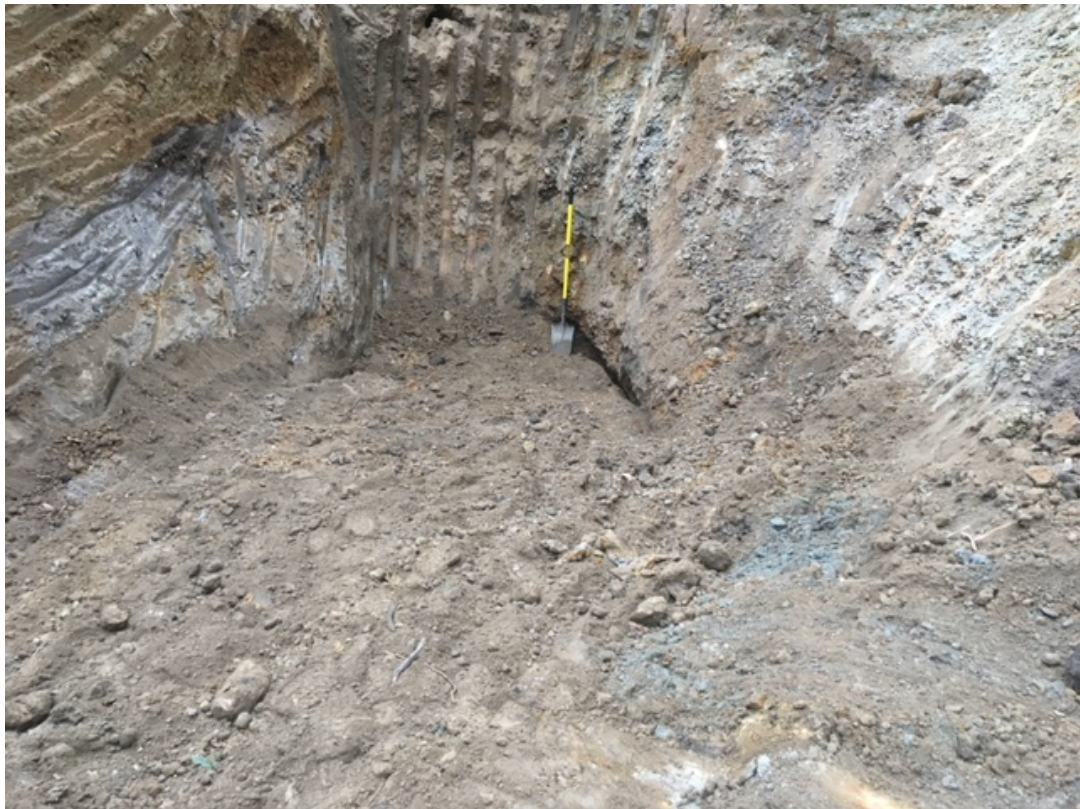
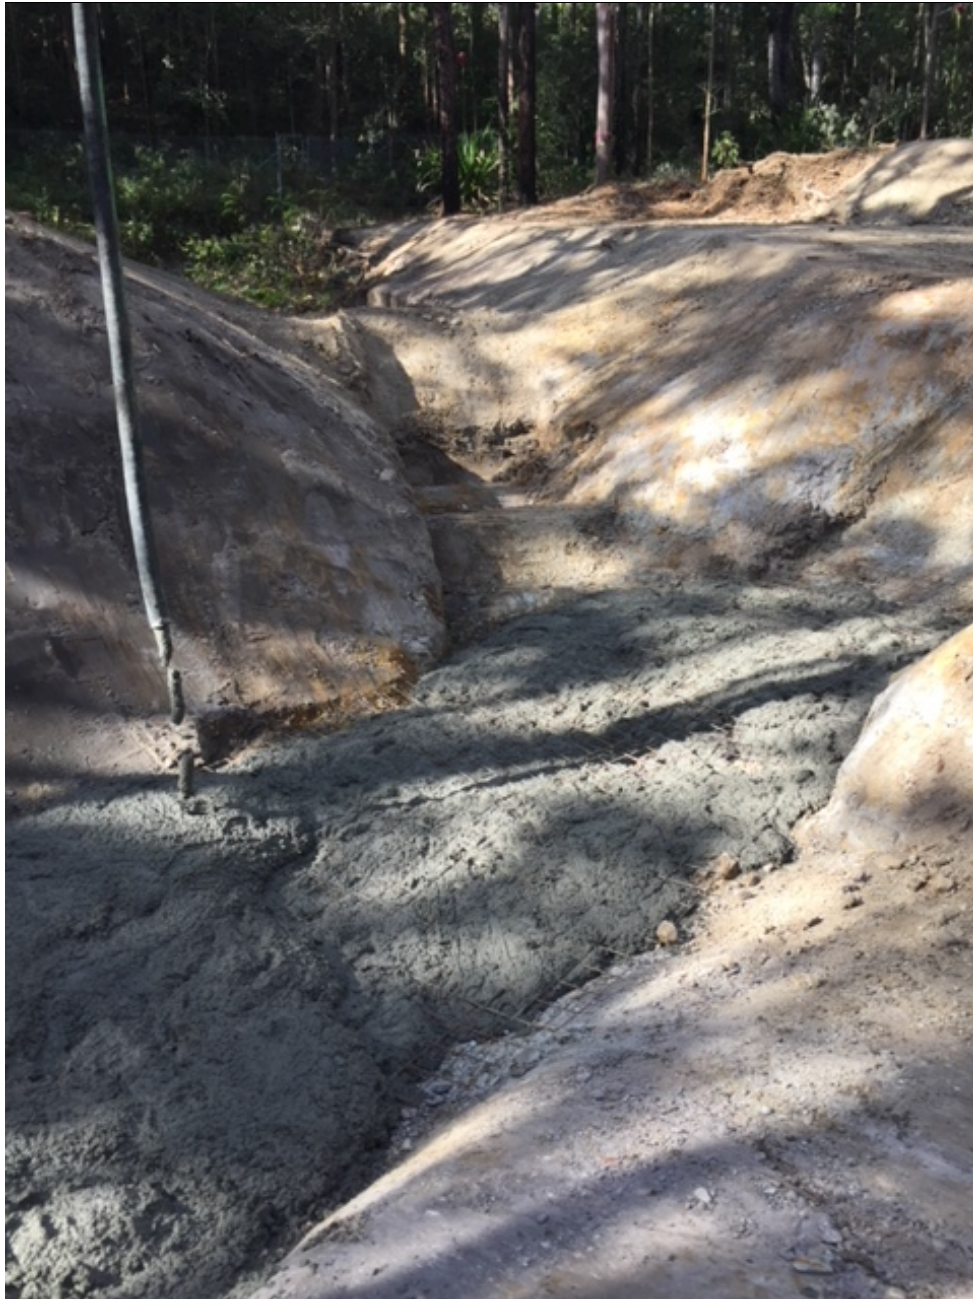
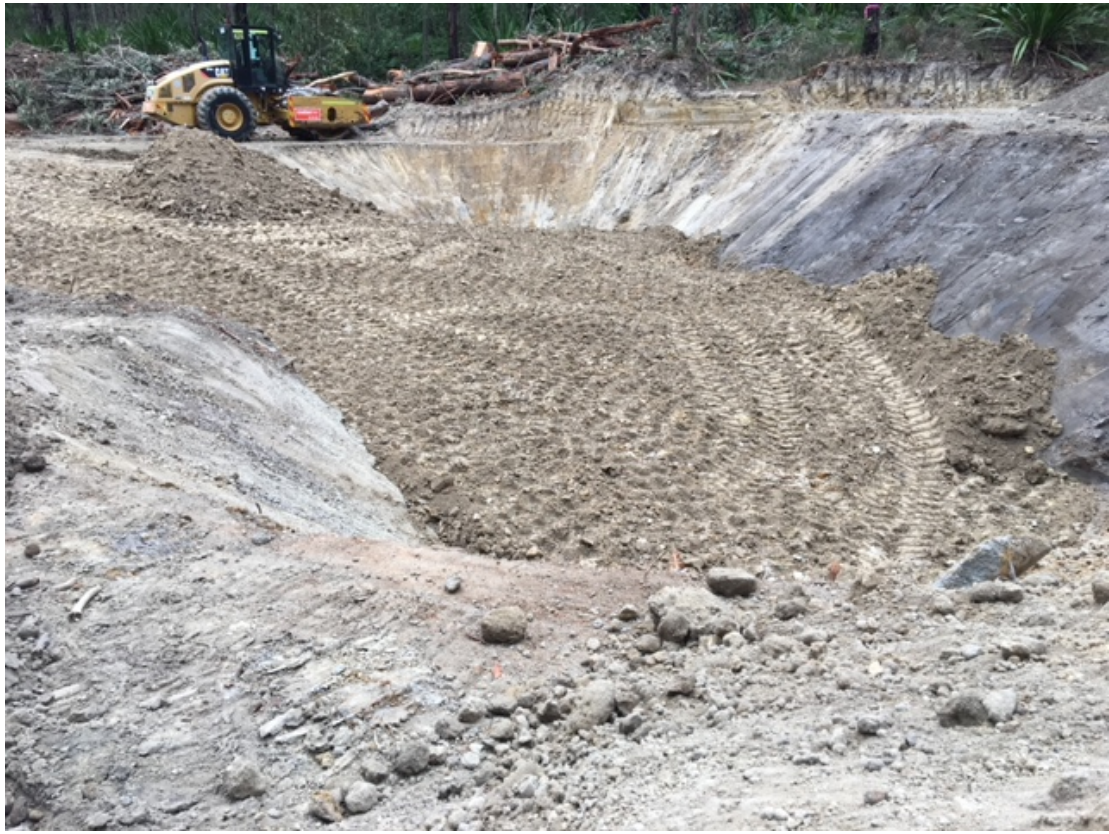
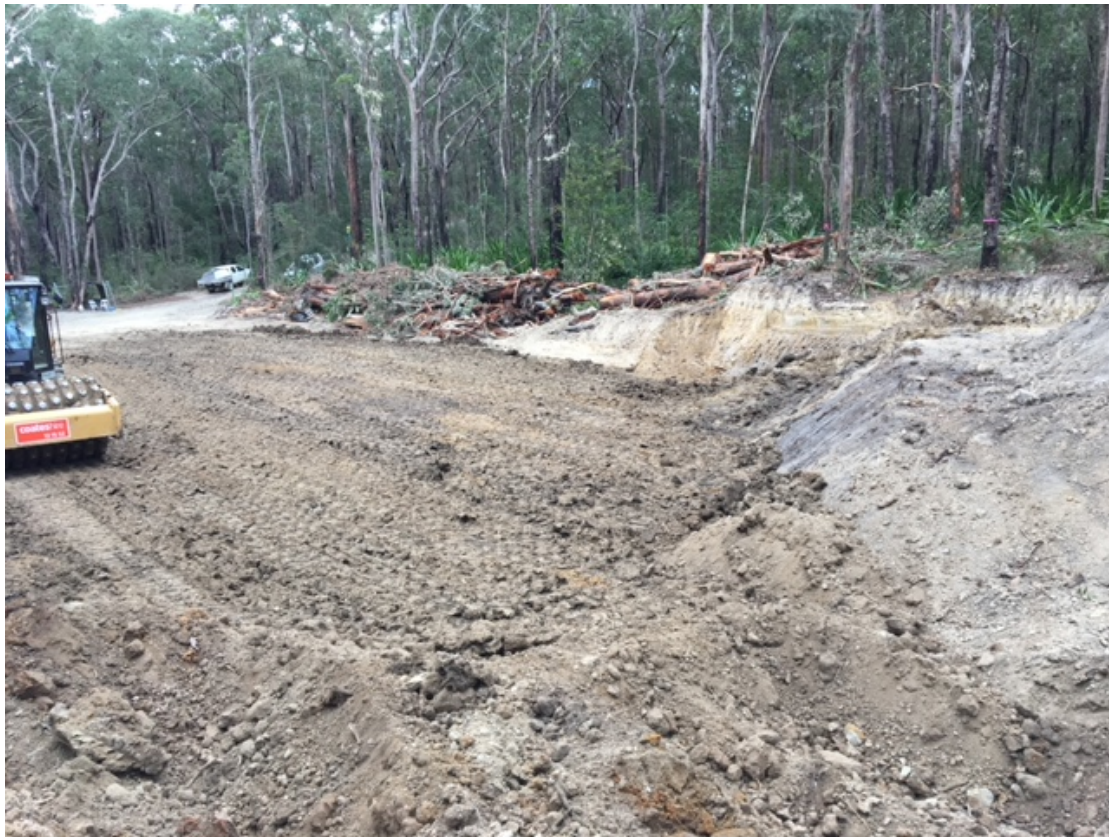
The below pictures provide before and after photos of the sinkhole.

Rehabilitation of the MR7-18 and MR7-20 sinkholes commenced in August 2017 and were done in conjunction with one another due to their close proximity. The sinkholes were cordoned off to restrict access, and sediment and erosion controls installed. Land clearing was restricted to the predetermined access route, subsidence area and the creek diversions. The base of the hole was filled with boulders and concrete followed by a layer of coarse rock, a layer of coarse sand, a layer of fine sand, a layer of clay and covered with soil excavated from the sink hole.

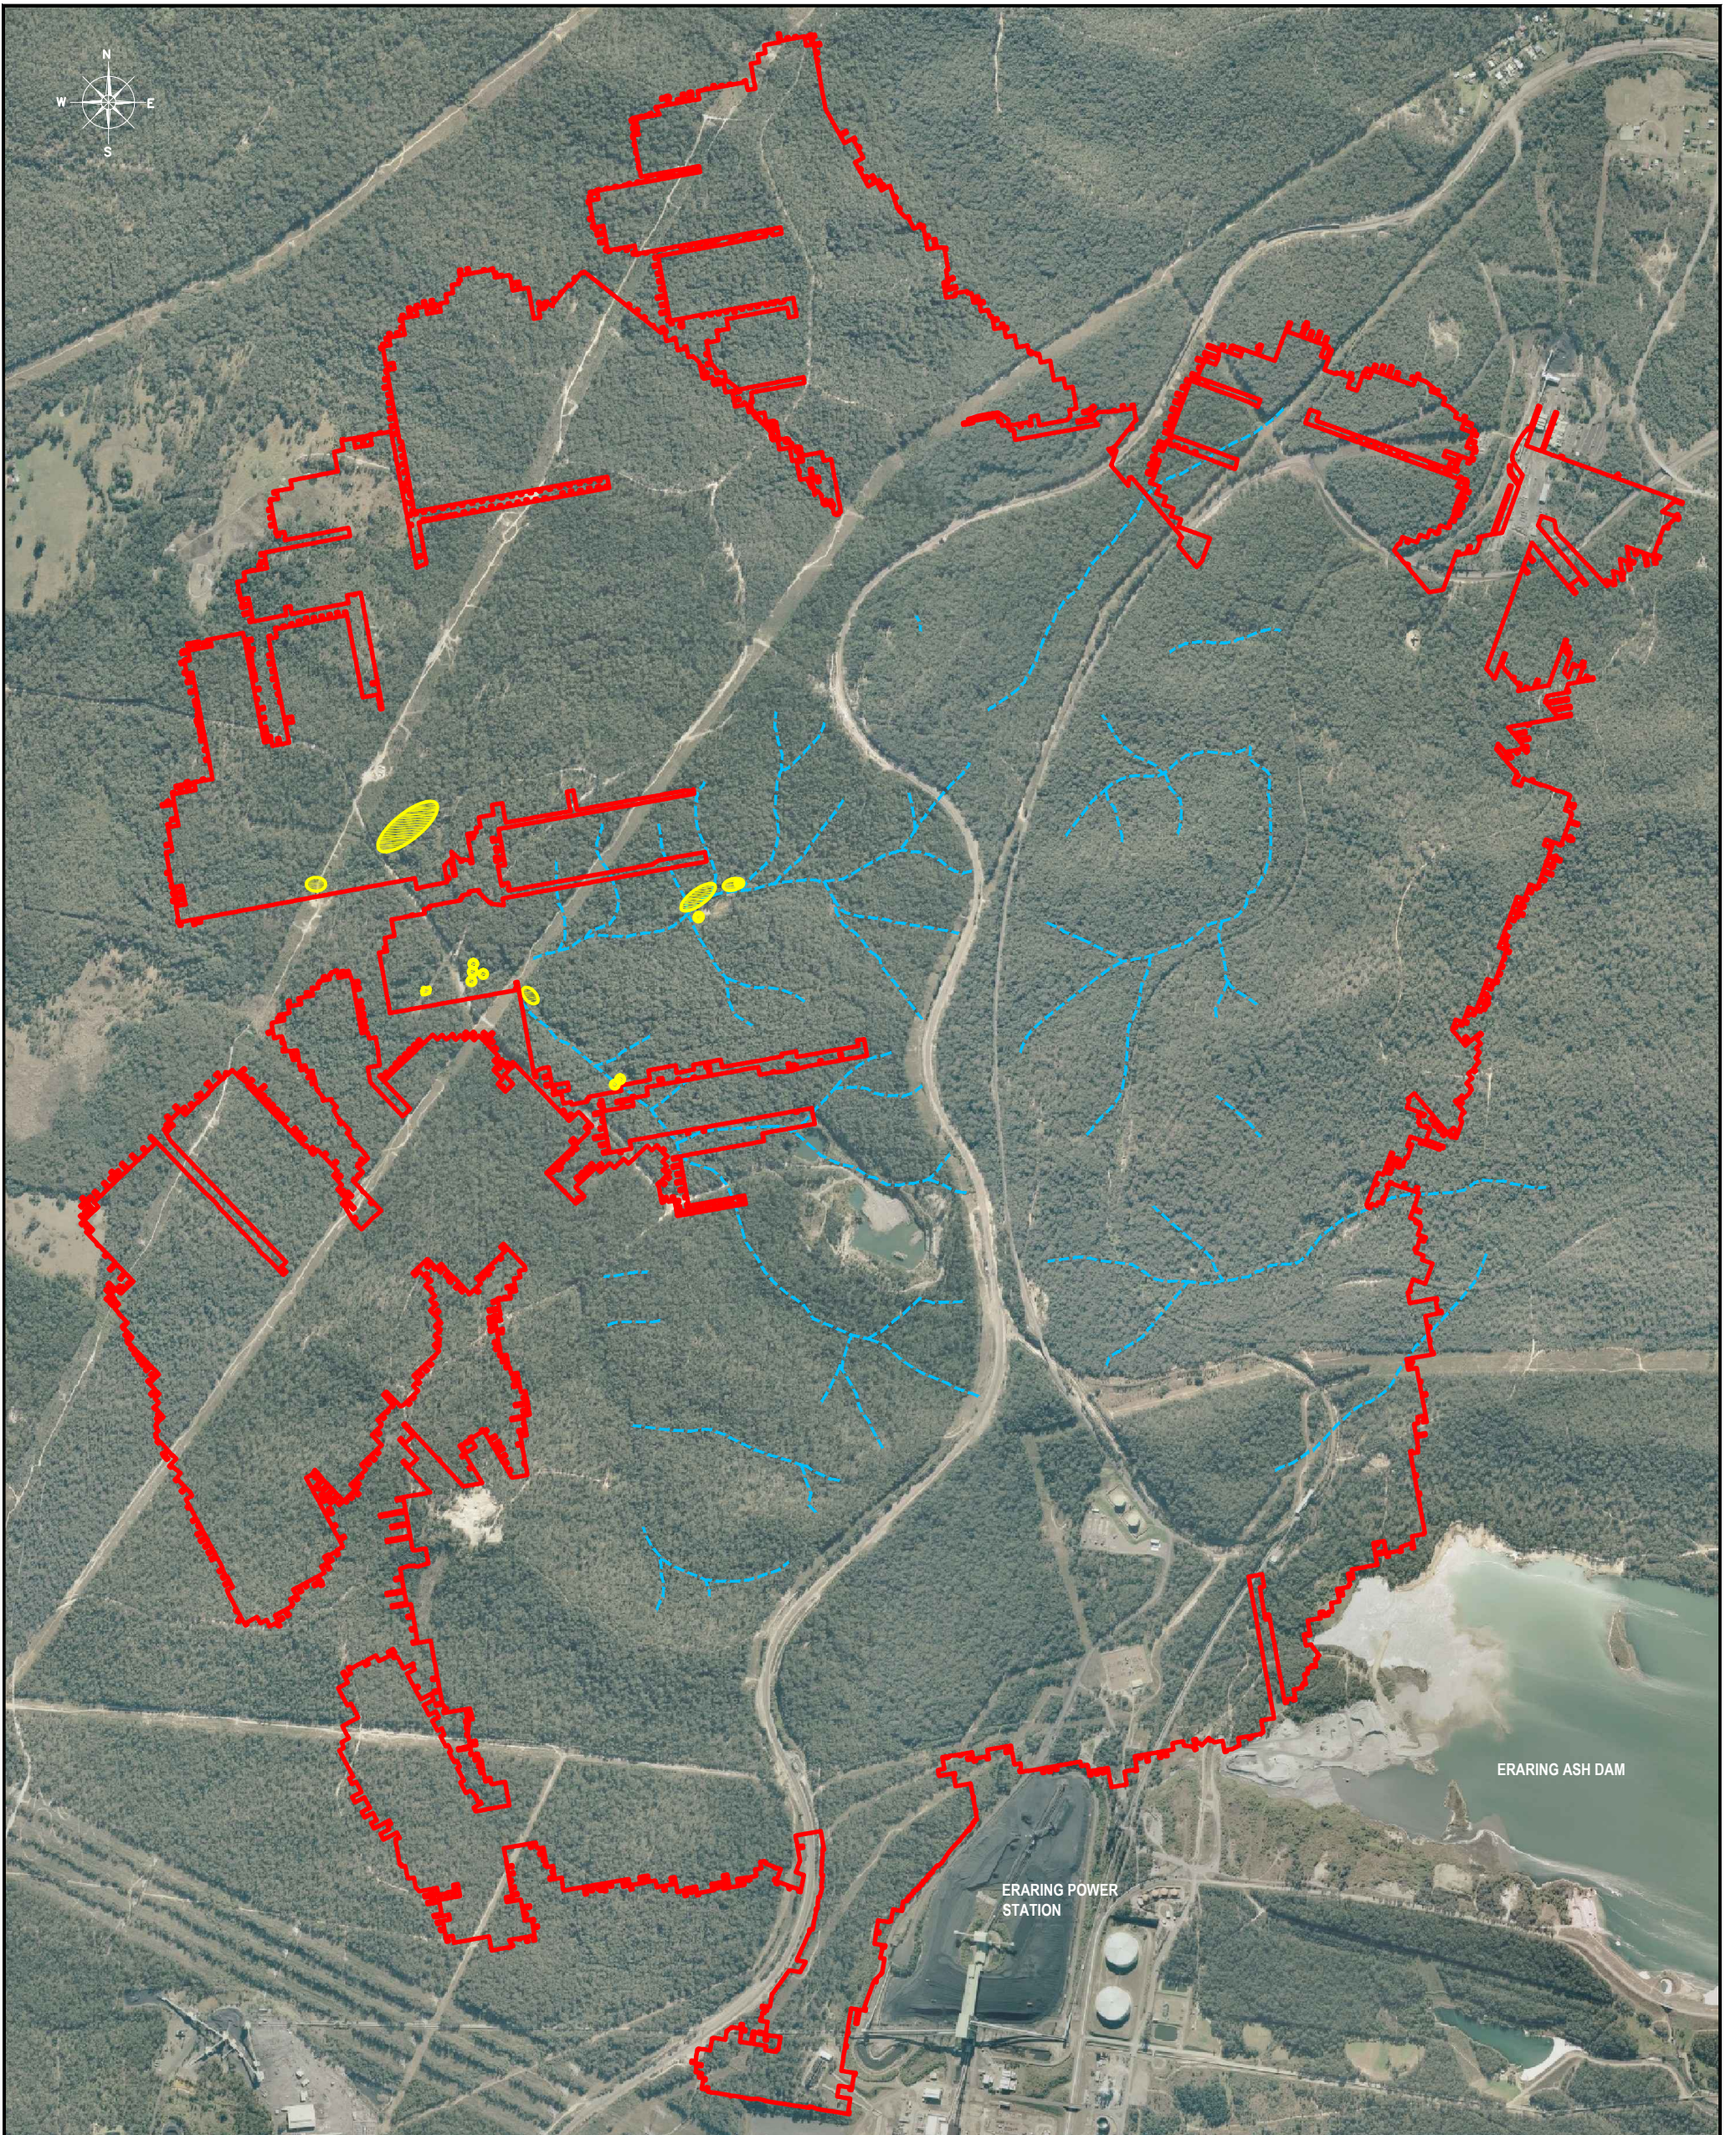
Awaba Colliery has experienced a number of sinkhole events caused by subsidence associated with the underground mines. The locations of identified sinkholes, creeks/drainage lines and the existing Awaba Colliery underground workings have been shown in **Figure 2**.

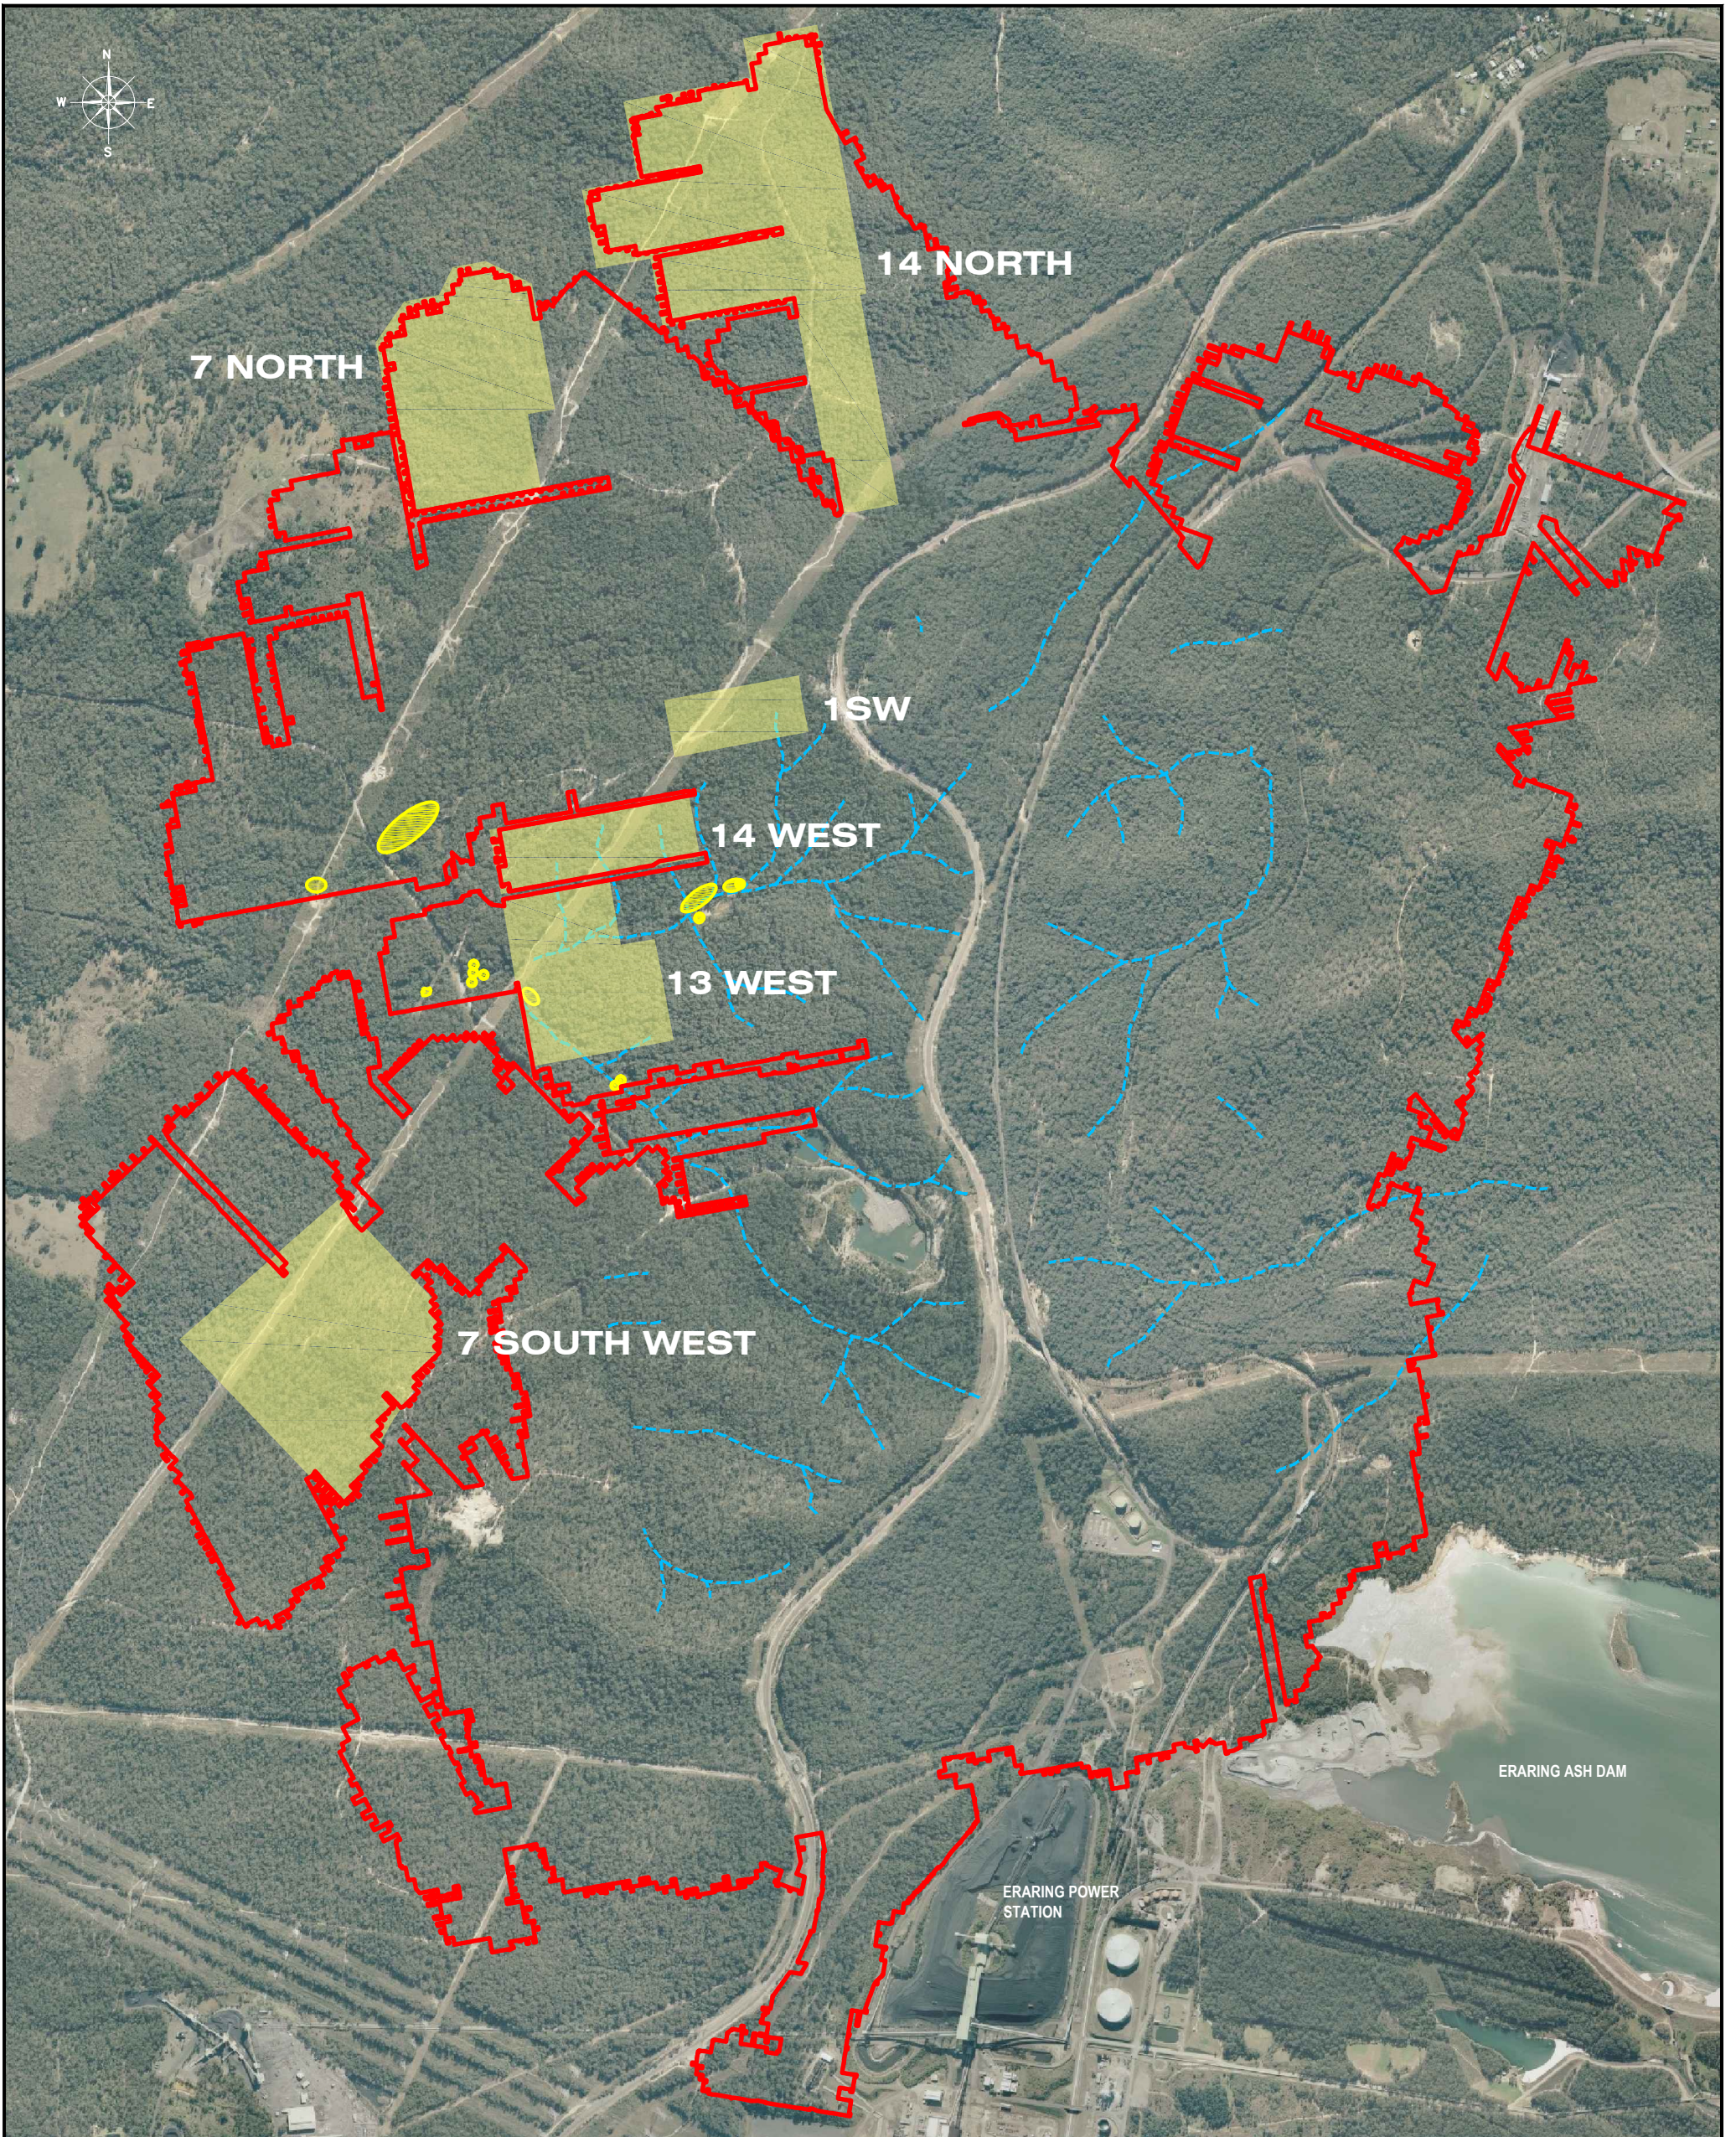
The adopted model is that the pillar floor foundations are unstable and will collapse once the panel is wide enough so that full loading is applied (refer to **Figure 4**). Due to the presence of low strength floor horizons, the bearing strength of the pillar foundation is significantly less than the strength of the coal component. The bearing strength is a function of the width of the pillar compared to the thickness of the low strength layer, so that wider pillars have higher bearing strength. The massive Teralba Conglomerate roof means that it can bridge across narrow panels and transfer more of the vertical stress to the abutments. As the panel increases in width, a condition develops where the conglomerate cannot span – the conglomerate then collapses and loads the pillars directly and the foundations fail; at the same time loads are reduced on the abutments. An implication of this model is that until the conglomerate beam fails there may be no indication of floor heave or other evidence of low strength floors (Seedsman, 2010).

The pillars involved had been formed on 20m centres and at depths from 25m to 80m such that the pillars themselves have had a very high factor of safety. There have also been reports of wind rush events in association with the failures. It is important to note that such events did not always develop with pillars of these dimensions – there are many areas of Awaba still standing with pillars formed on 20m centres (Seedsman, 2010).
