CENTENNIAL COAL NEWSTAN COLLIERY ANNUAL REVIEW

March 2017

Name of Operation	Newstan Colliery
Name of Operator	Centennial Newstan Pty Ltd
Development Consent/ Project Approval #	DA 73_11_98 and SSD-5145
Mining Lease #	Consolidated Coal Leases 727, 746, 763 and 764. Mining Leases 1380, 1452, 1480, 1586, and 1587. Mining Purposes Leases 304, 305, 327, 328. Private Lands Lease 497.
Name of Holder of Mining Lease	Centennial Newstan Pty Ltd
Water License #	
Name of Holder of Water License	Centennial Newstan Pty Ltd
MOP/RMP Start Date	August 2015
MOP/RMP End Date	August 2018
Annual Review Start Date	January 2016
Annual Review End Date	December 2016
<p>I, Mick Cairney, certify that this audit report is a true and accurate record of the compliance status of Newstan Colliery for the period January 2016 to December 2016 and that I am authorized to make this statement on behalf of Centennial Newstan Pty Ltd.</p> <p><i>Note:</i></p> <p>a) The Annual Review is an 'environmental audit' for the purposes of s122B(2) of the Environmental Planning and Assessment Act 1979. Section 122E provides that a person must not include false or misleading information (or provide information for inclusion) in a

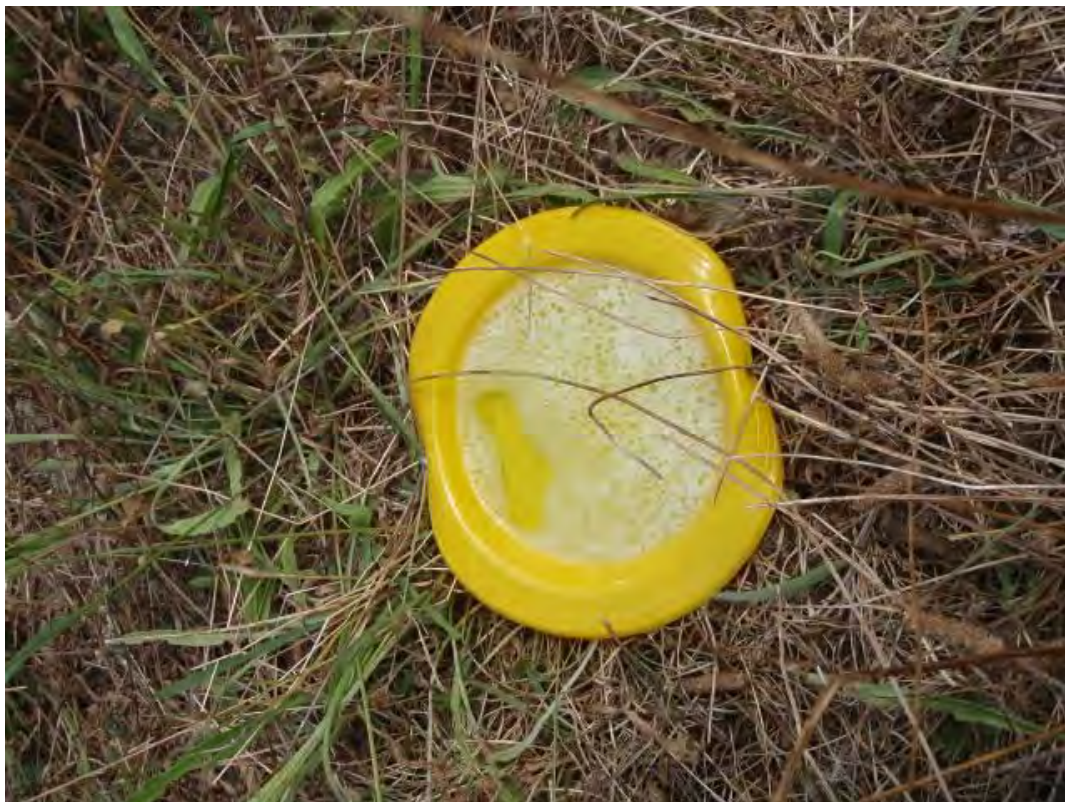
Flying invertebrates are attracted to the colour of yellow and as such were sampled using yellow pans (plastic plates with a diameter of 230 mm and a depth of 25 mm) containing a soap solution (Oliver et al., 1999; Dahms, 1997) (refer to **Plate 1**). Each pan was pegged to the ground using two skewers, as to prevent disturbance by other mobile fauna in the area.

Each site had a transect consisting of three yellow pans set 5 m apart, which were sampled on Wednesday and Friday mornings. A sieve was used to collect all insects, and as a result, invertebrates <0.5 mm were not included in the sampling process. The filtered material was placed in sampling jars containing methylated spirits and labelled appropriately. All pans and sieves were inspected thoroughly after each filtering process and washed out to ensure all invertebrates were removed.

Plate 1: Yellow Invertebrate Tray

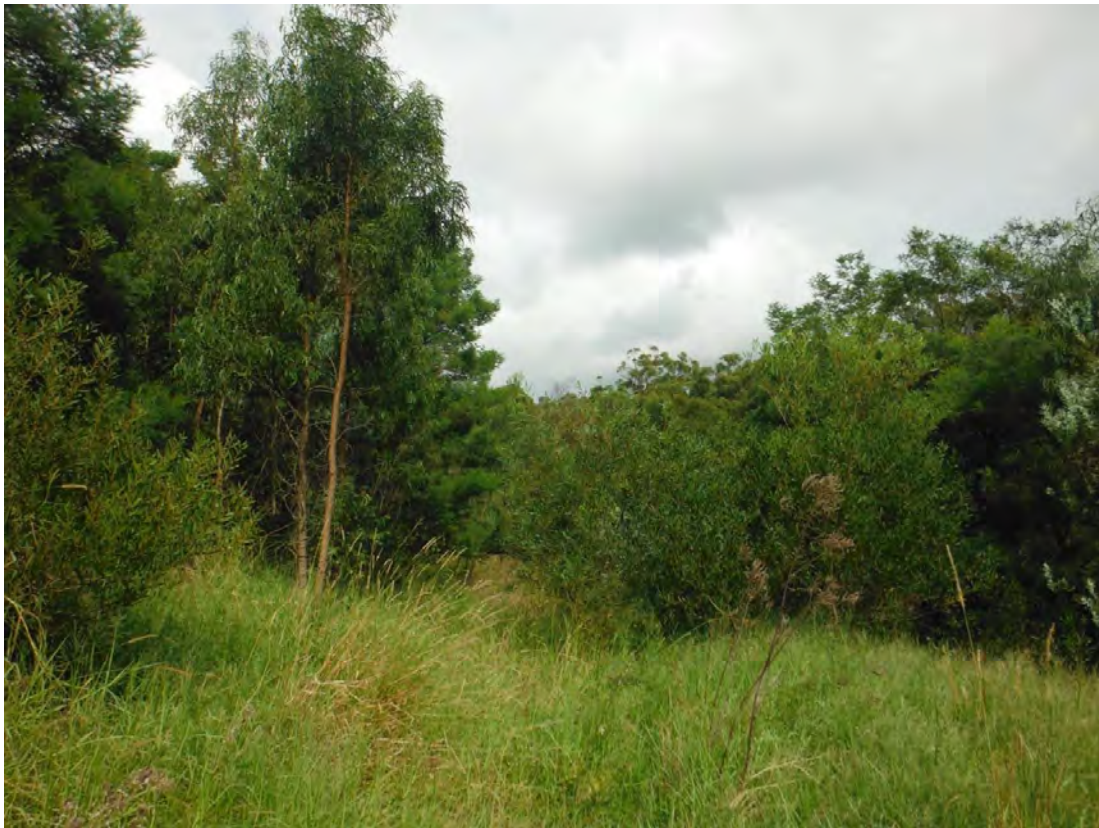
Rehabilitation Site A is situated in the mine rehabilitation area that has been subject to vegetation rehabilitation through direct seeding. It is the most western site of the three rehabilitation sites. Rehabilitation Site A is displayed in **Plate 3**.

Plate 3: Regenerating Acacias and non-native grasses at Rehabilitation A

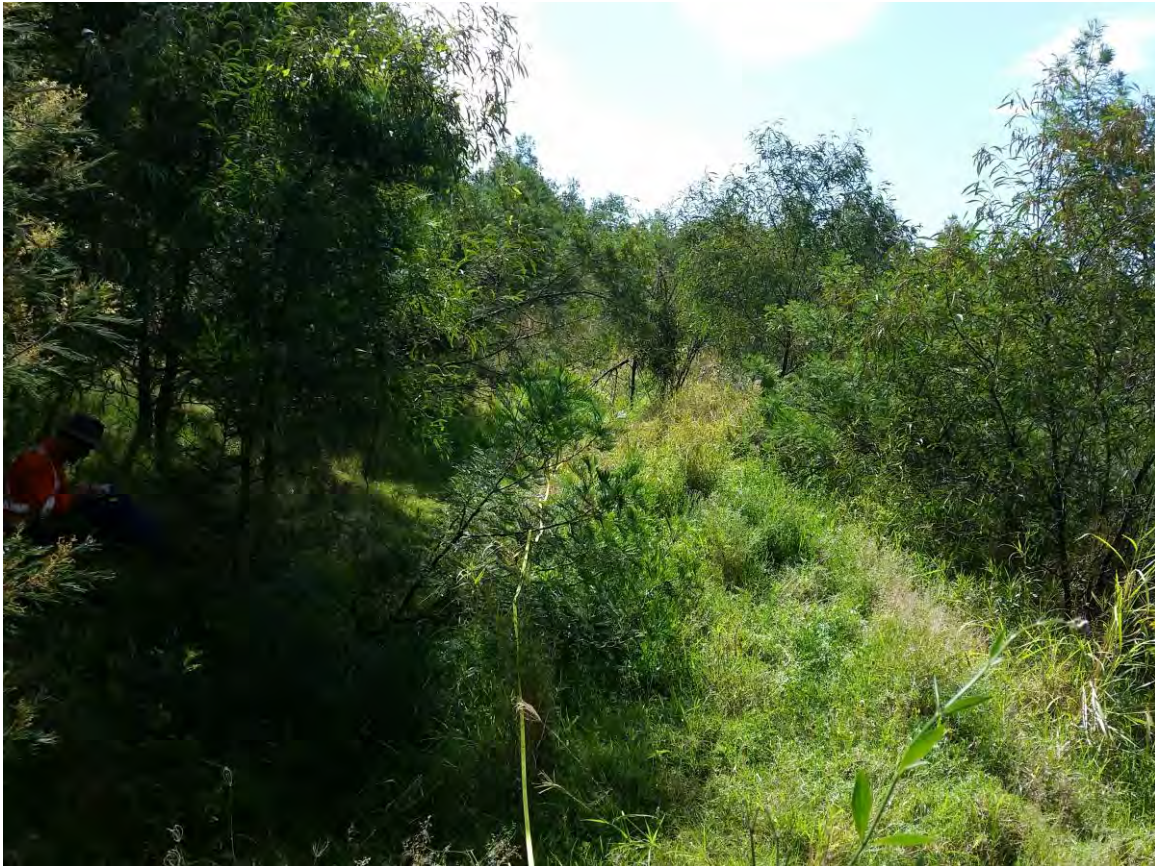
Rehabilitation Site B is situated in the mining rehabilitation area that has been subject to vegetation rehabilitation through direct seeding. It is situated between Rehabilitation Site A and Rehabilitation Site C. **Plate 4** displays Rehabilitation Site B.

Plate 4: Regenerating Acacias and non-native grasses at Rehabilitation B

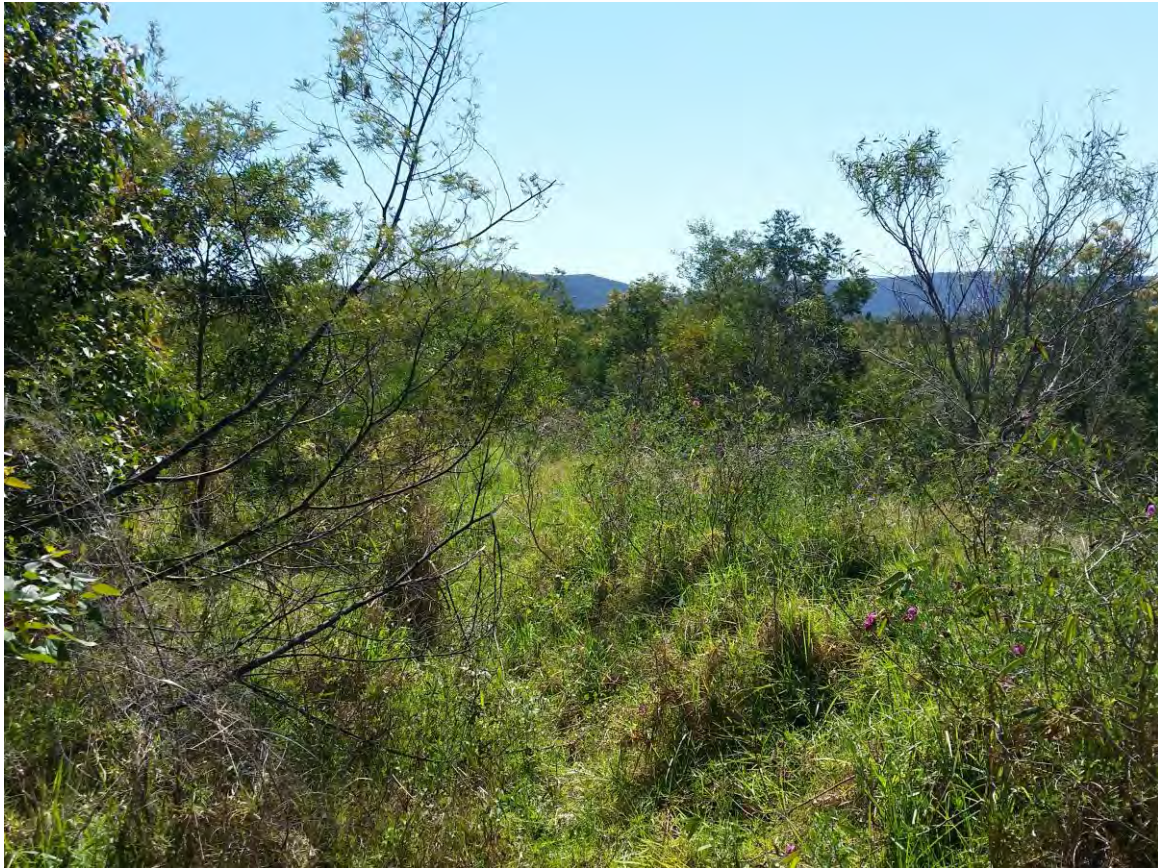
Rehabilitation Site C is situated in the mining rehabilitation area that has been subject to vegetation rehabilitation through direct seeding. It is situated to the east of Rehabilitation Site B. **Plate 5** displays Rehabilitation Site C.

Plate 5: Regenerating Acacias and non-native grasses at Rehabilitation C

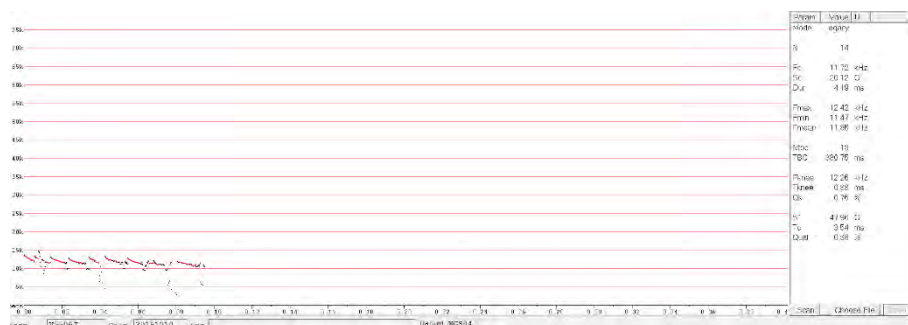
Figure 4-1: *Austronomus australis* definite call

A sample of the calls actually identified from the site for each species is given below.

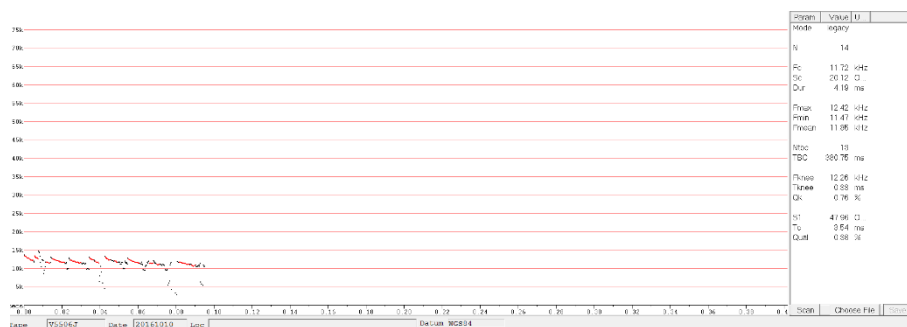
Figure 4-1: *Austronomus australis* definite call

A sample of the calls actually identified from the site for each species is given below.

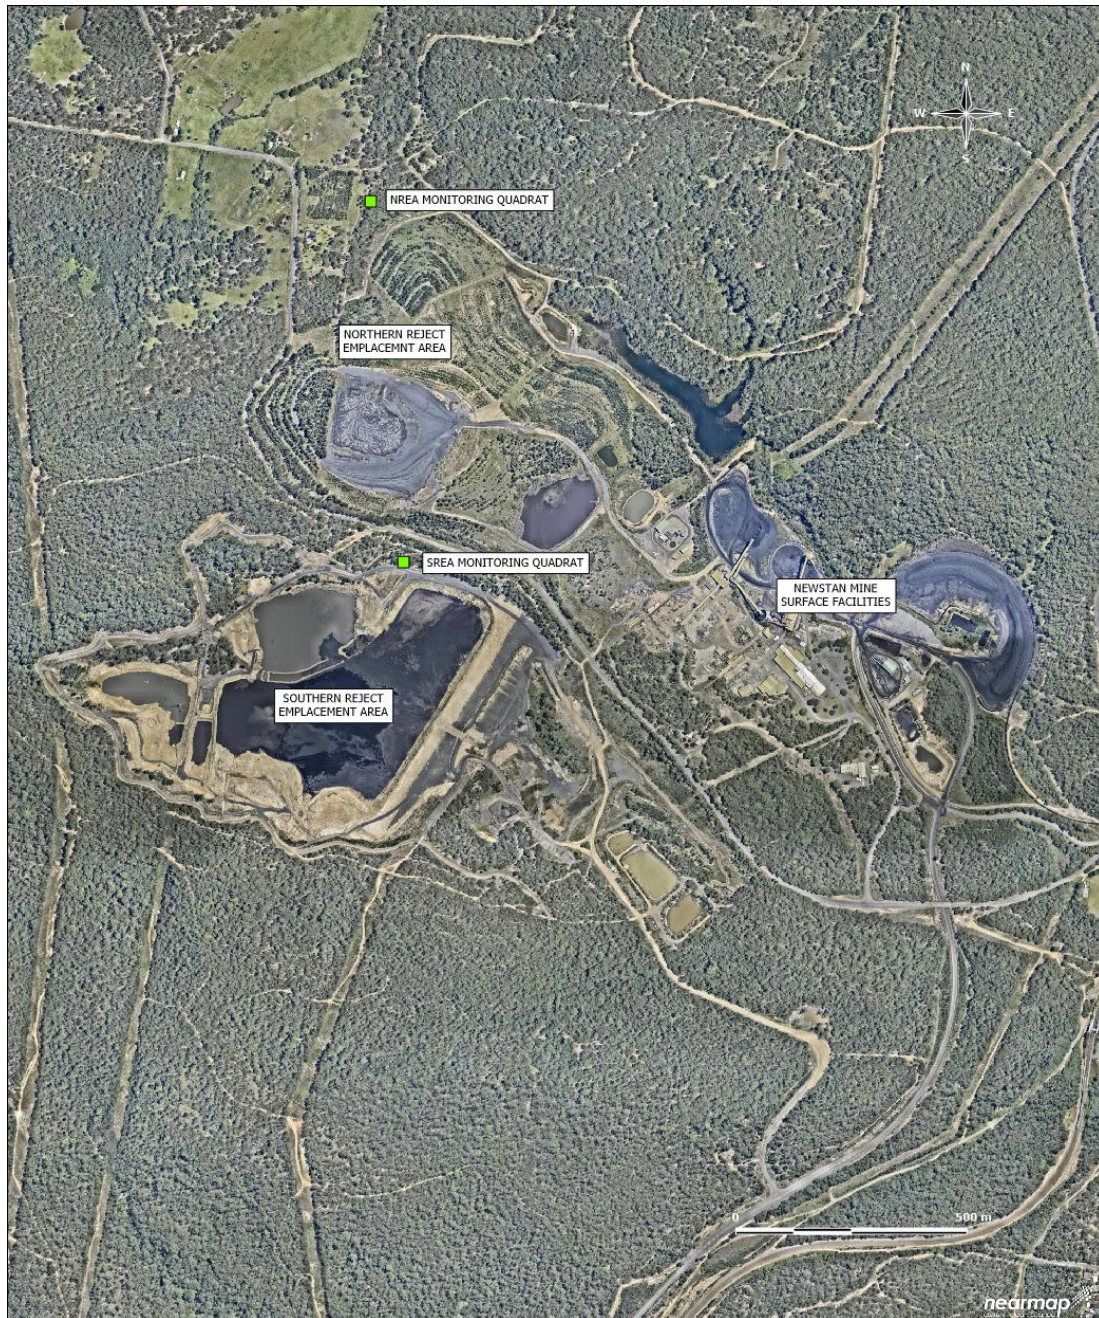
Results were reported as the number of clumps recorded within each of the 10 m square permanent quadrats.

Figure 1 The monitoring locations in the reject emplacement areas

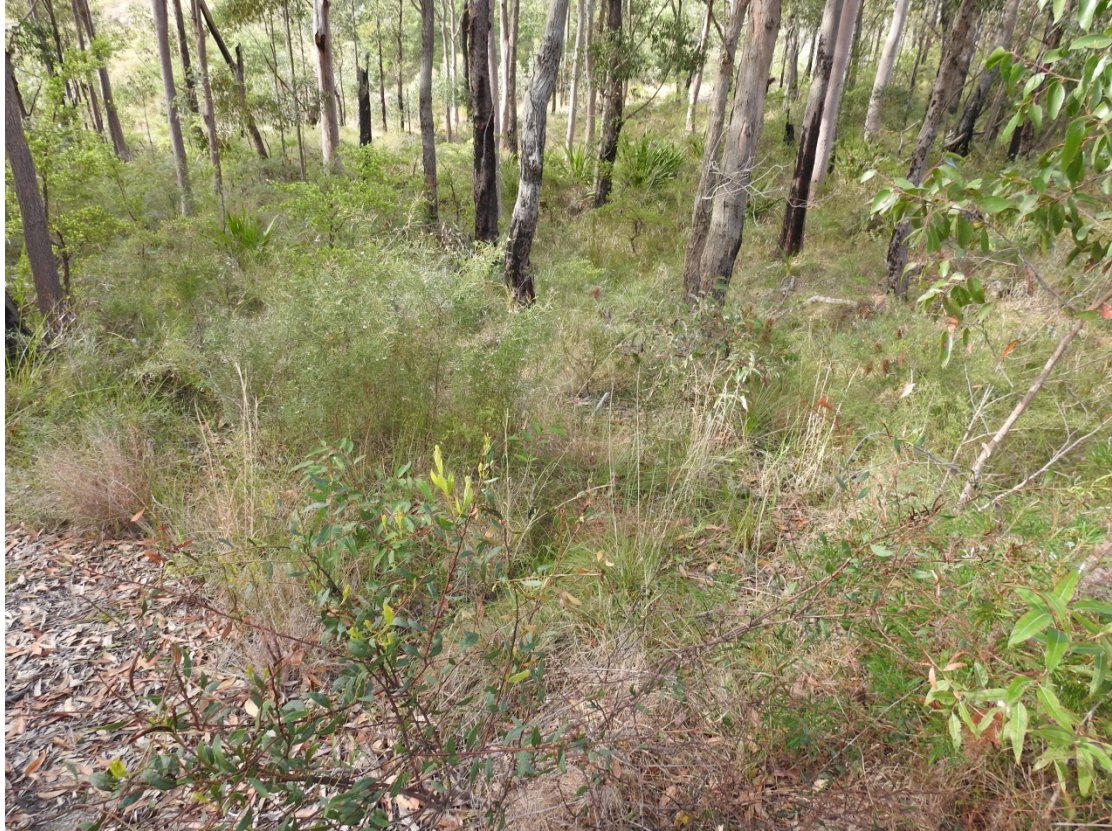
NREA monitoring quadrat

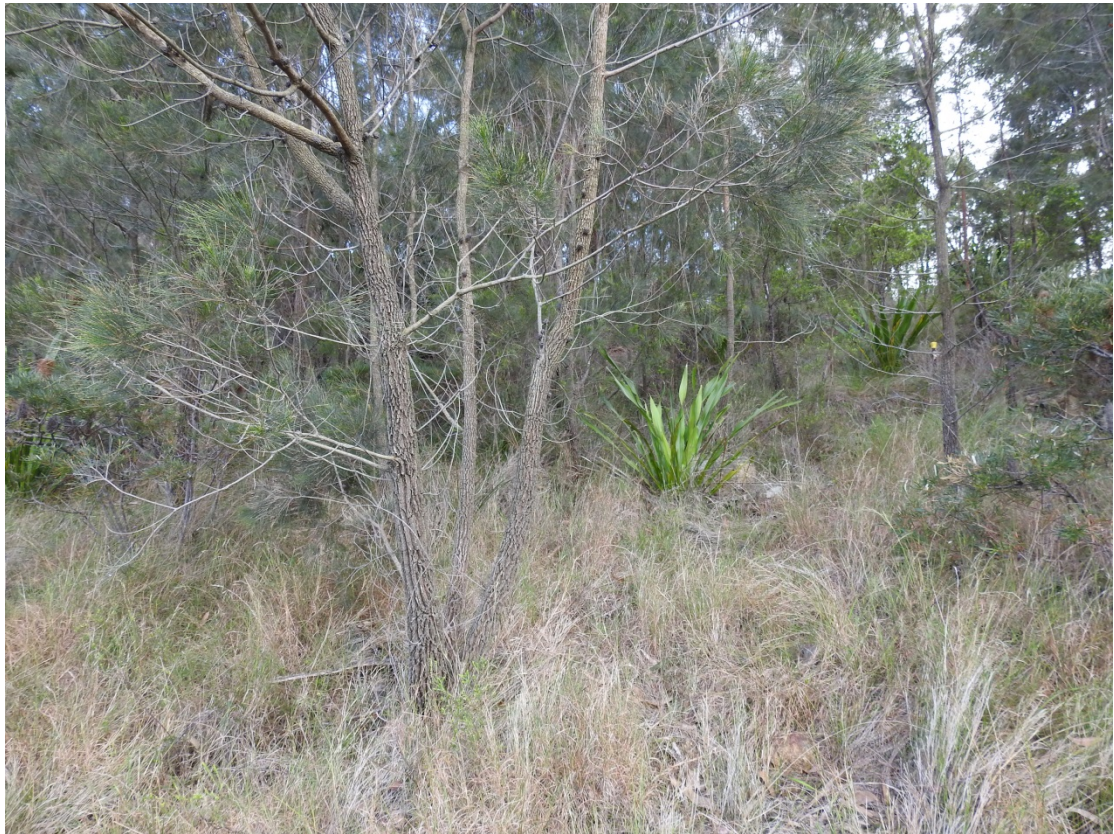
SREA monitoring quadrat

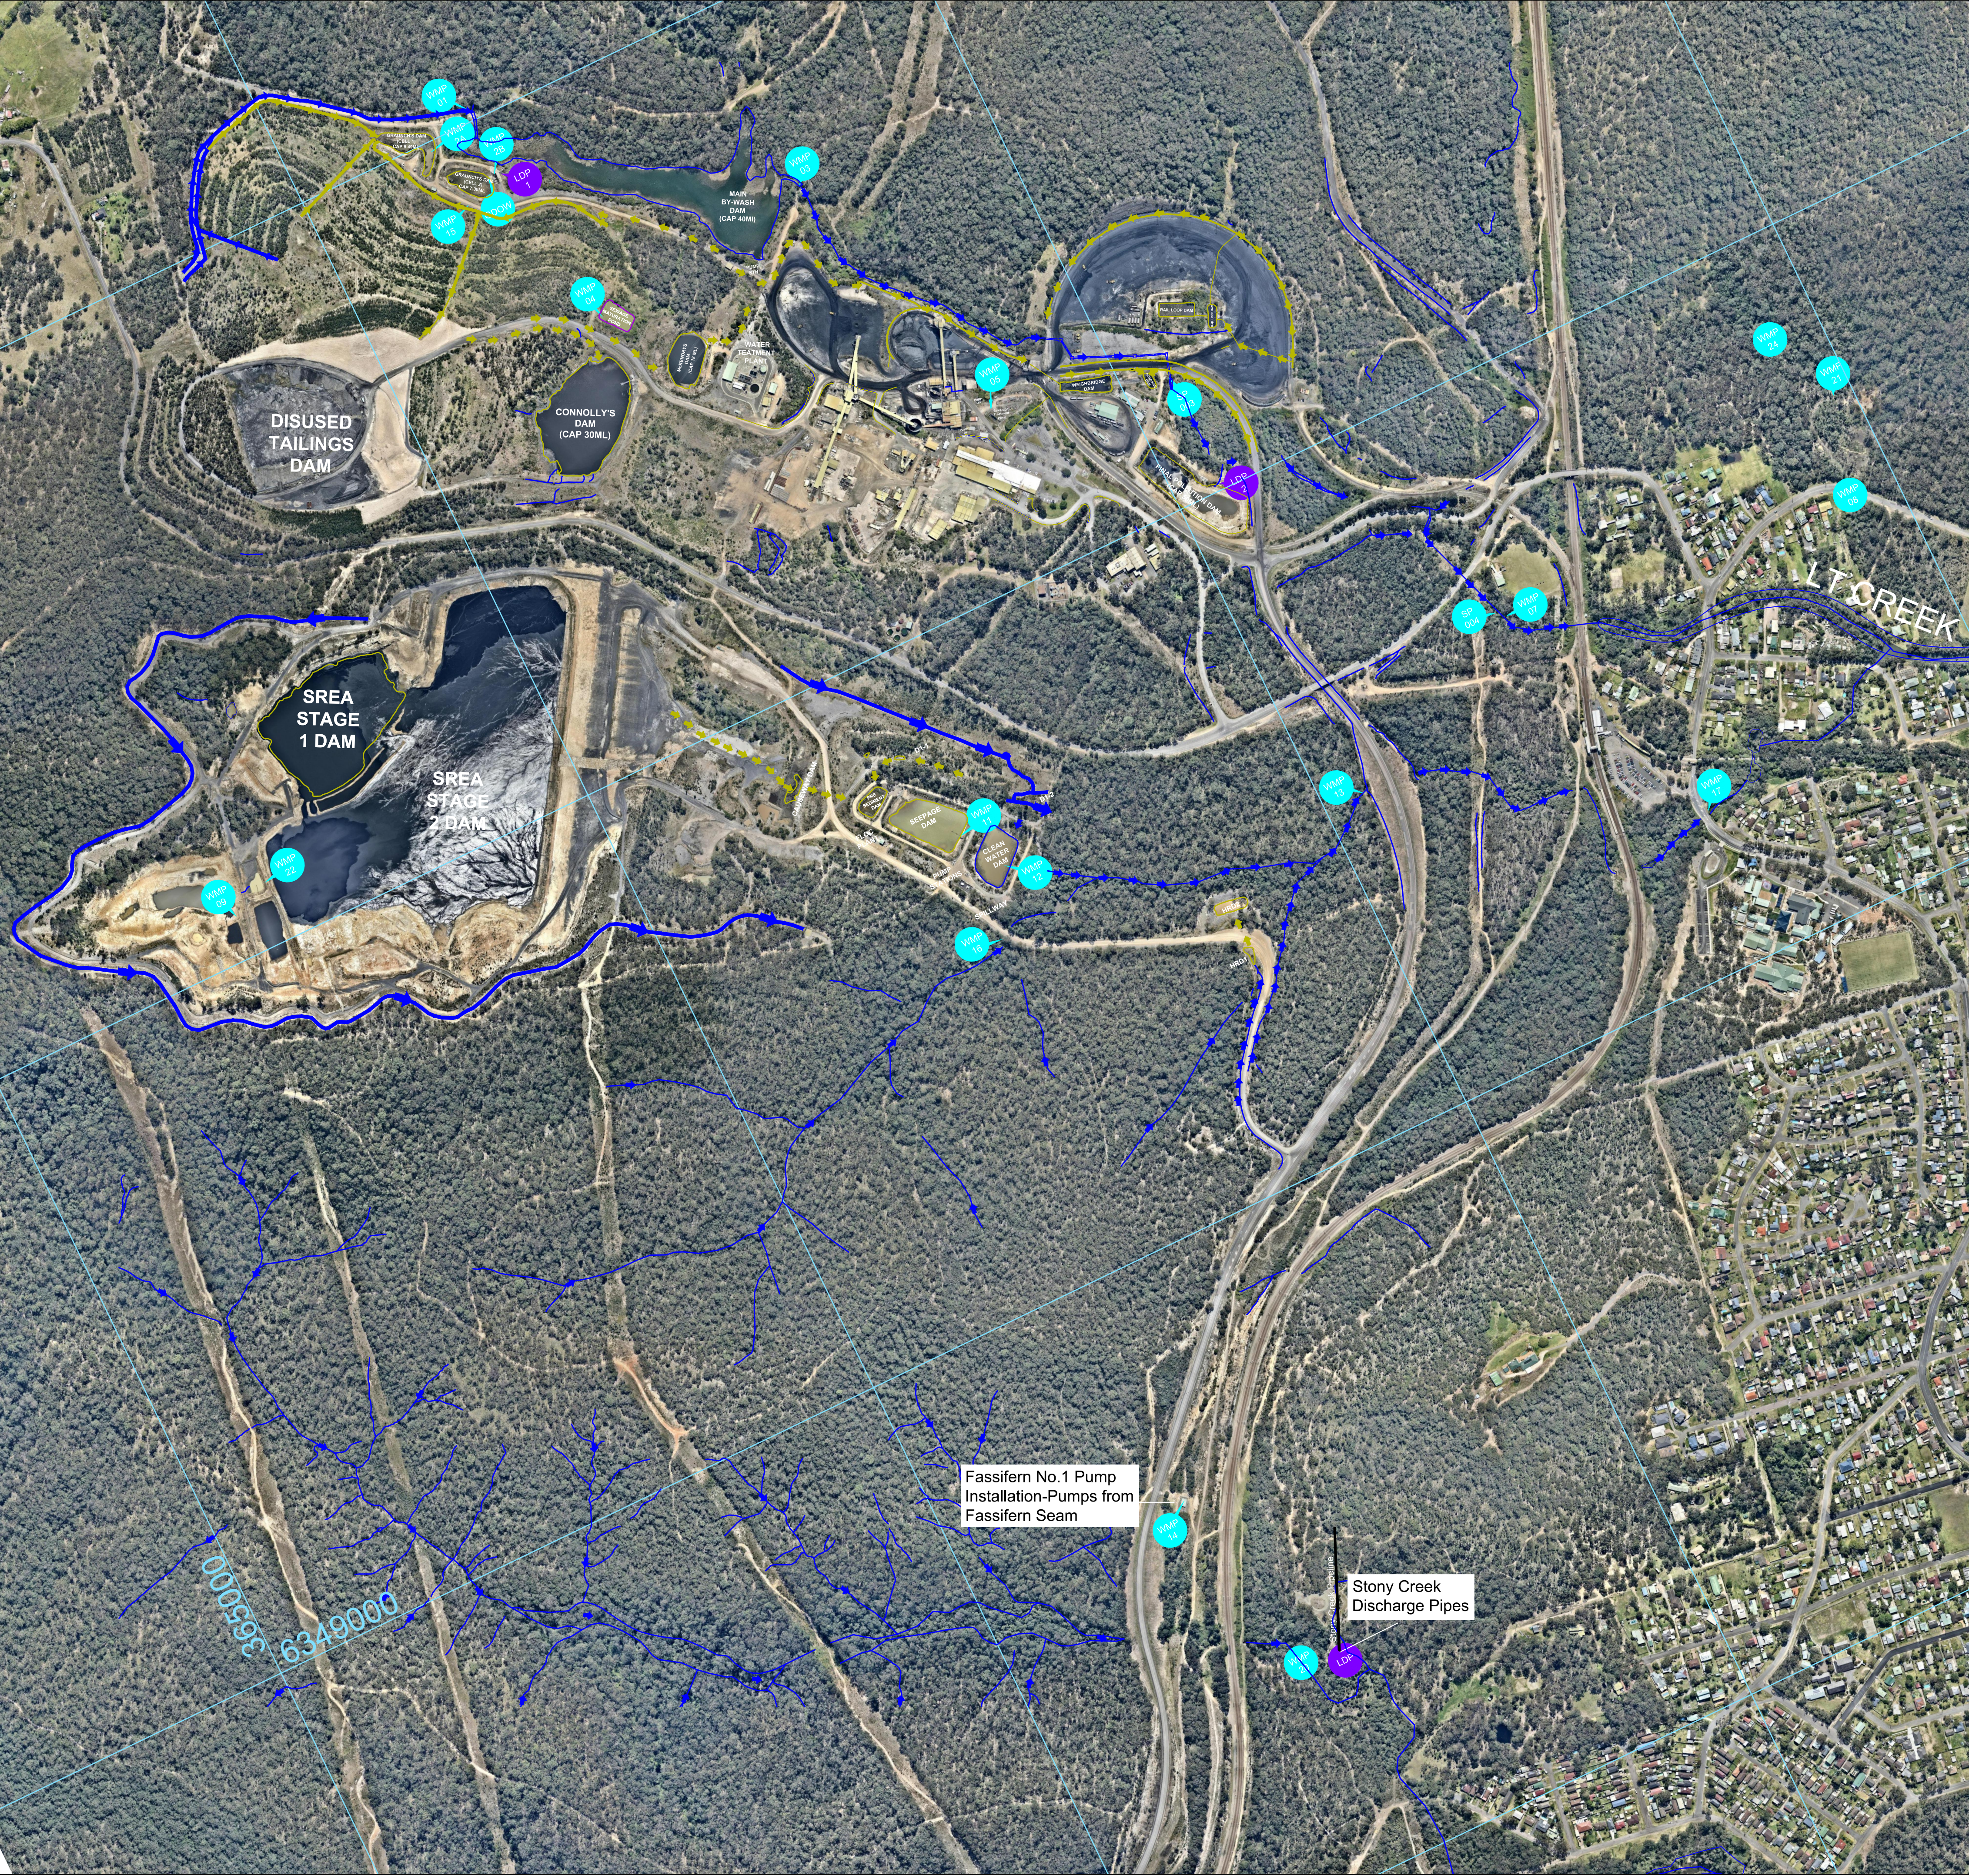
SURFACE WATER MONITORING POINTS			
Name	Easting	Northing	Description
WMP01	366287	6351020	Upstream of LDP001
WMP2A	366211	6350984	Grauch's Dam Cell 1
WMP2B	366282	6350913	Grauch's Dam Cell 2
GDOW	366271	6350911	Grauch's Dam Overflow Weir
LDP001	366292	6350908	EPL Point 1 - Also known as WMP02
WMP03	366691	6350695	EPL Point 19 - Bywash Dam Weir - Downstream of LDP001
WMP04	366335	6350646	Sewage Maturation Pond
WMP05	366806	6350261	Waste Water Treatment Plant
LDP002	367072	6350010	EPL Point 2 - Also known as WMP06
WMP07	367377	6349639	LT Creek downstream of Colliery U/S of Railway, D/S of Miller Rd
WMP08	367927	6349578	Seepage from the GNS into tributary of LT Creek sampled South of Macquarie St
WMP09	365438	6350067	Upstream of the SREA
WMP11	366483	6349698	SREA Seepage Dam
WMP12	366526	6349628	SREA Clean Water Dam (proposed LDP003)
WMP13	367063	6349491	EPL Point 6 - Southern branch LT Creek U/S of Eraring Haul Road

WMP14	366282	6350913	Pump line from Fassifern Seam No.1 Bore
WMP15	366225	6350887	NREA seepage pipe
WMP16	366470	6349529	EPL Point 5 - SREA LT Creek Side catchment
WMP17	367525	6349240	Southern Branch LT Creek below Railway Station
LDP	366466	6348315	EPL Point 17 - Stony Creek Pipeline - Also Known as WMP19
WMP20	366404	6348341	EPL Point 18 - Located in a tributary of Stony Creek, upstream of WMP19
WMP21	367970	6349726	Located within the Wetland system, upstream of WMP8
WMP22	365501	6350094	The decant from Stage 2-4 dam into the Fassi seam
WMP24	367920	6349844	Seepage from the GNS into tributary of LT Creek sampled North of Macquarie St
SP003	367071	6350187	EPL Point 3 - Upstream LDP002
SP004	367366	6349650	EPL Point 4 - Downstream LDP002
