**SPRINGVALE COAL PTY LTD
WESTERN COAL SERVICES
2016 ANNUAL REVIEW**

March 2017

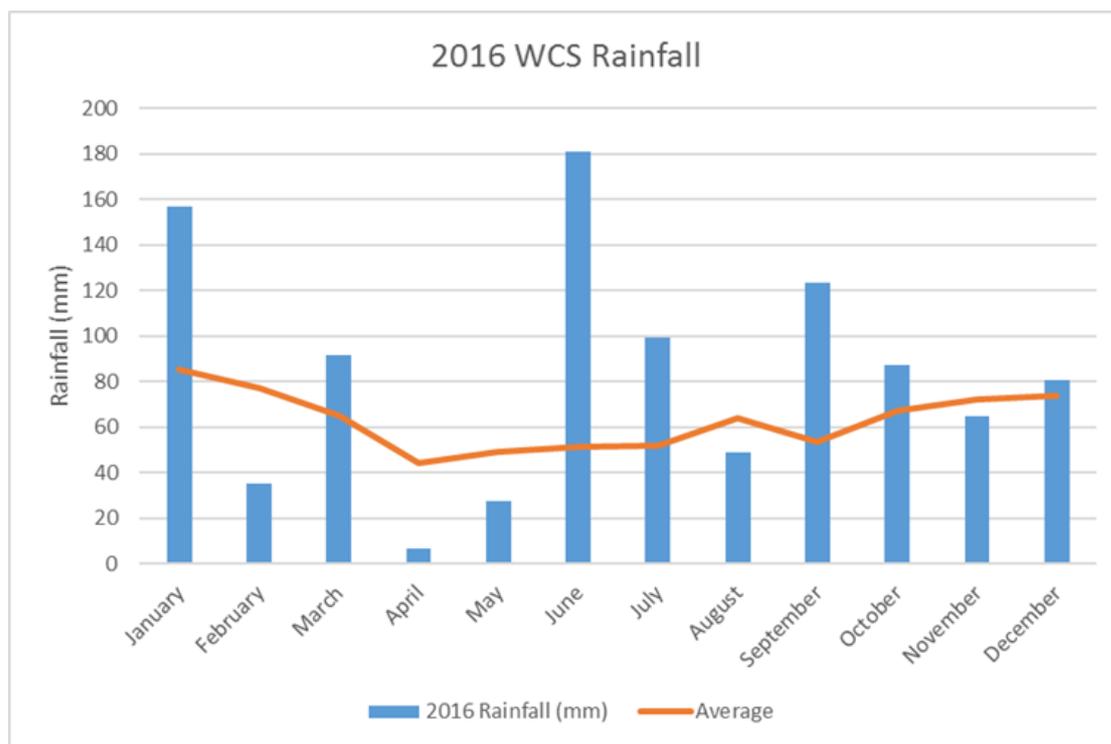
Figure 1 - WCS 2016 Rainfall summary

The monthly rainfall for WCS for the 2016 reporting period is summarised in Table 5 and Figure 1 below.

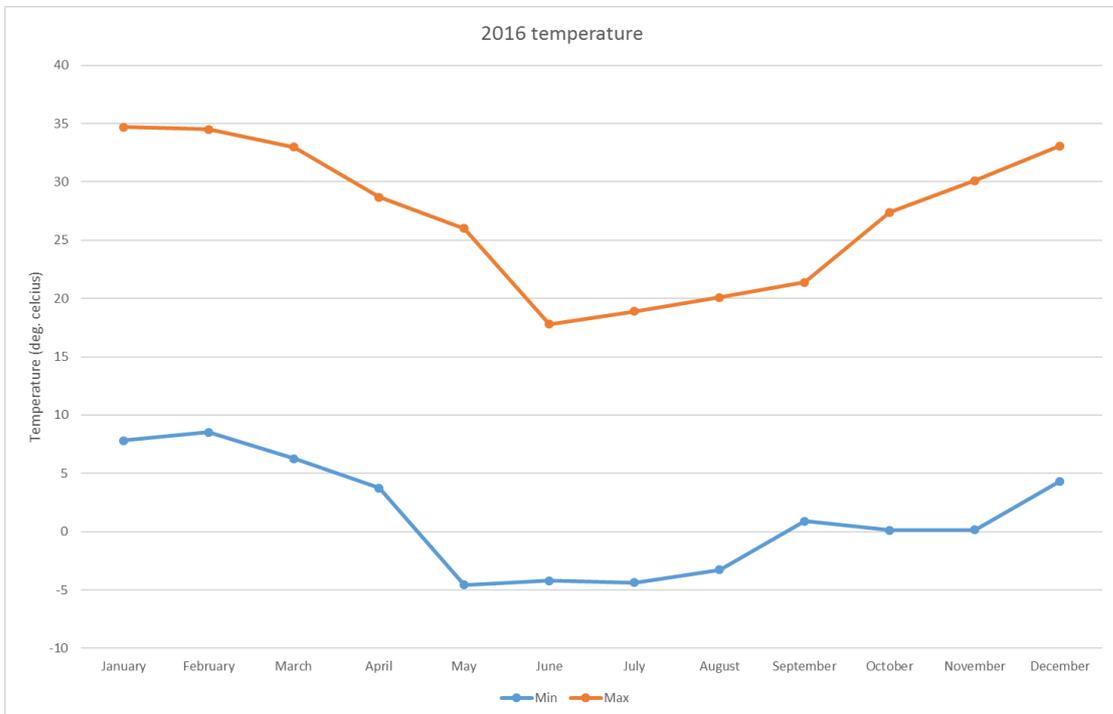
Figure 2 - WCS 2016 Monthly Temperature Summary

Month	Min	Max
January	7.82	34.7
February	8.51	34.5
March	6.27	33.0
April	3.75	28.7
May	-4.55	26.0
June	-4.22	17.8
July	-4.38	18.9
August	-3.27	20.1
September	0.90	21.4
October	0.11	27.4
November	0.17	30.1
December	4.34	33.1

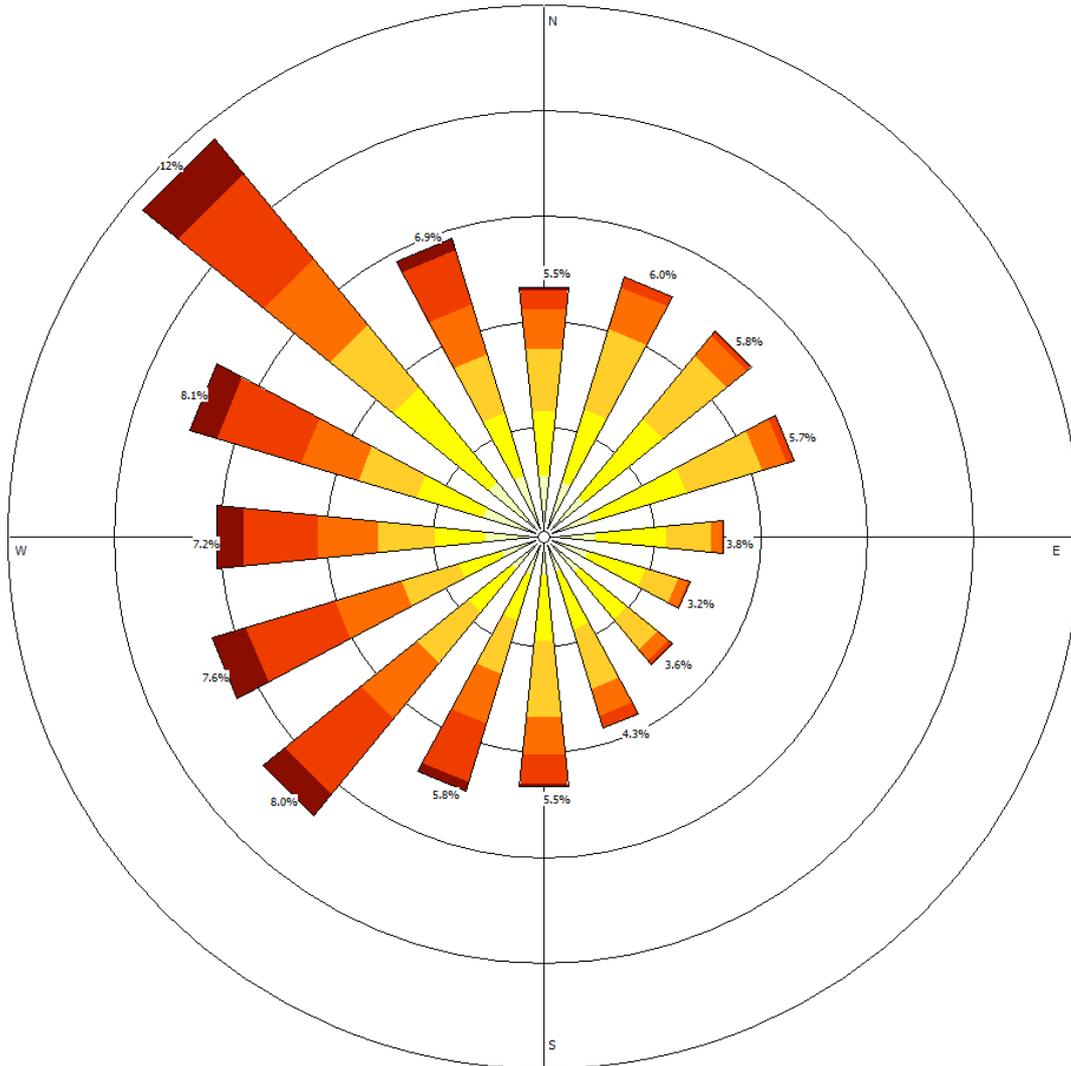
Figure 3 - WCS 2016 Wind Rose

The wind rose for the 2016 reporting period is shown in Figure 3 below. The predominant wind direction is from the north-west, occurring for 12% of the year. The strongest winds

occur from the south-west to the north-west. The predominant wind speed is 2-5 km/h occurring 25.4% of the year.

%	
4.4	> 25 km/h
15.2	15 < 25 km/h
15.6	10 < 15 km/h
22.8	5 < 10 km/h
25.4	2 < 5 km/h
15.3	0.5 < 2 km/h
1.4	< 0.5 km/h

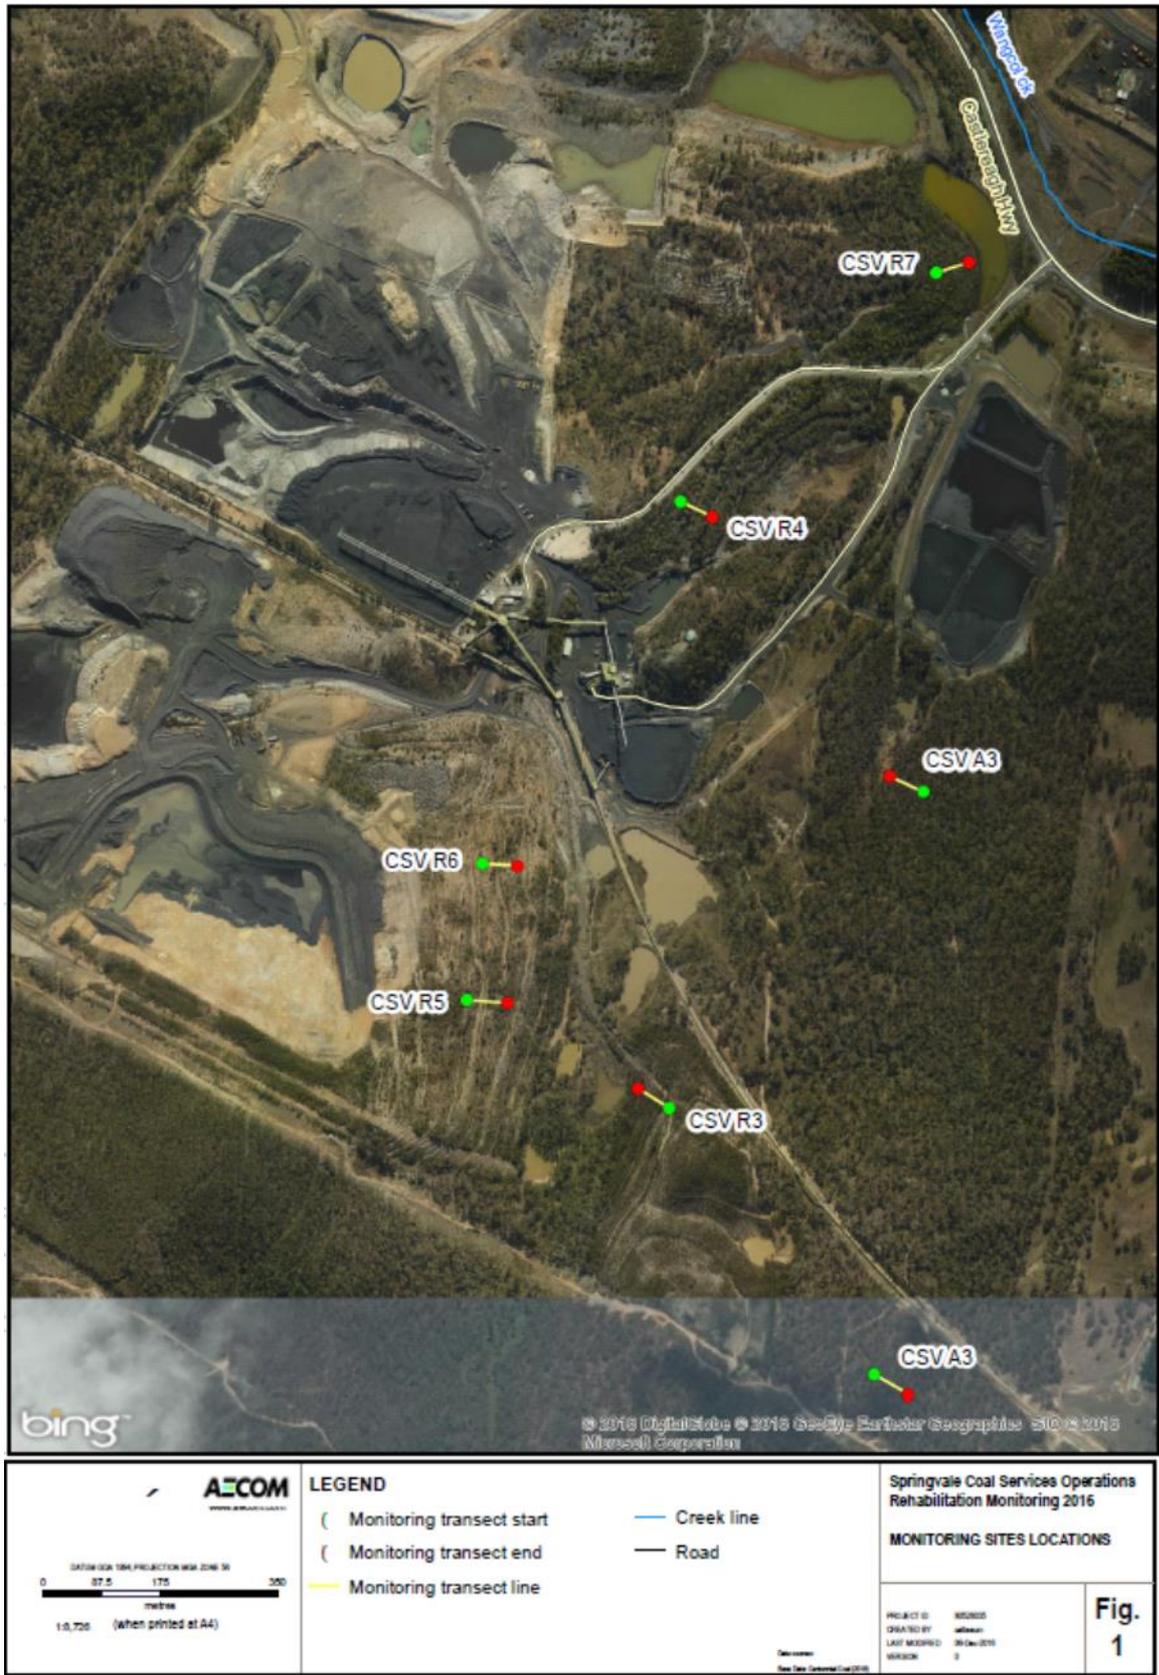
Figure 4 - WCS Rehabilitation Monitoring Sites

The 2016 field monitoring was undertaken on the 23rd and 24th November 2016.

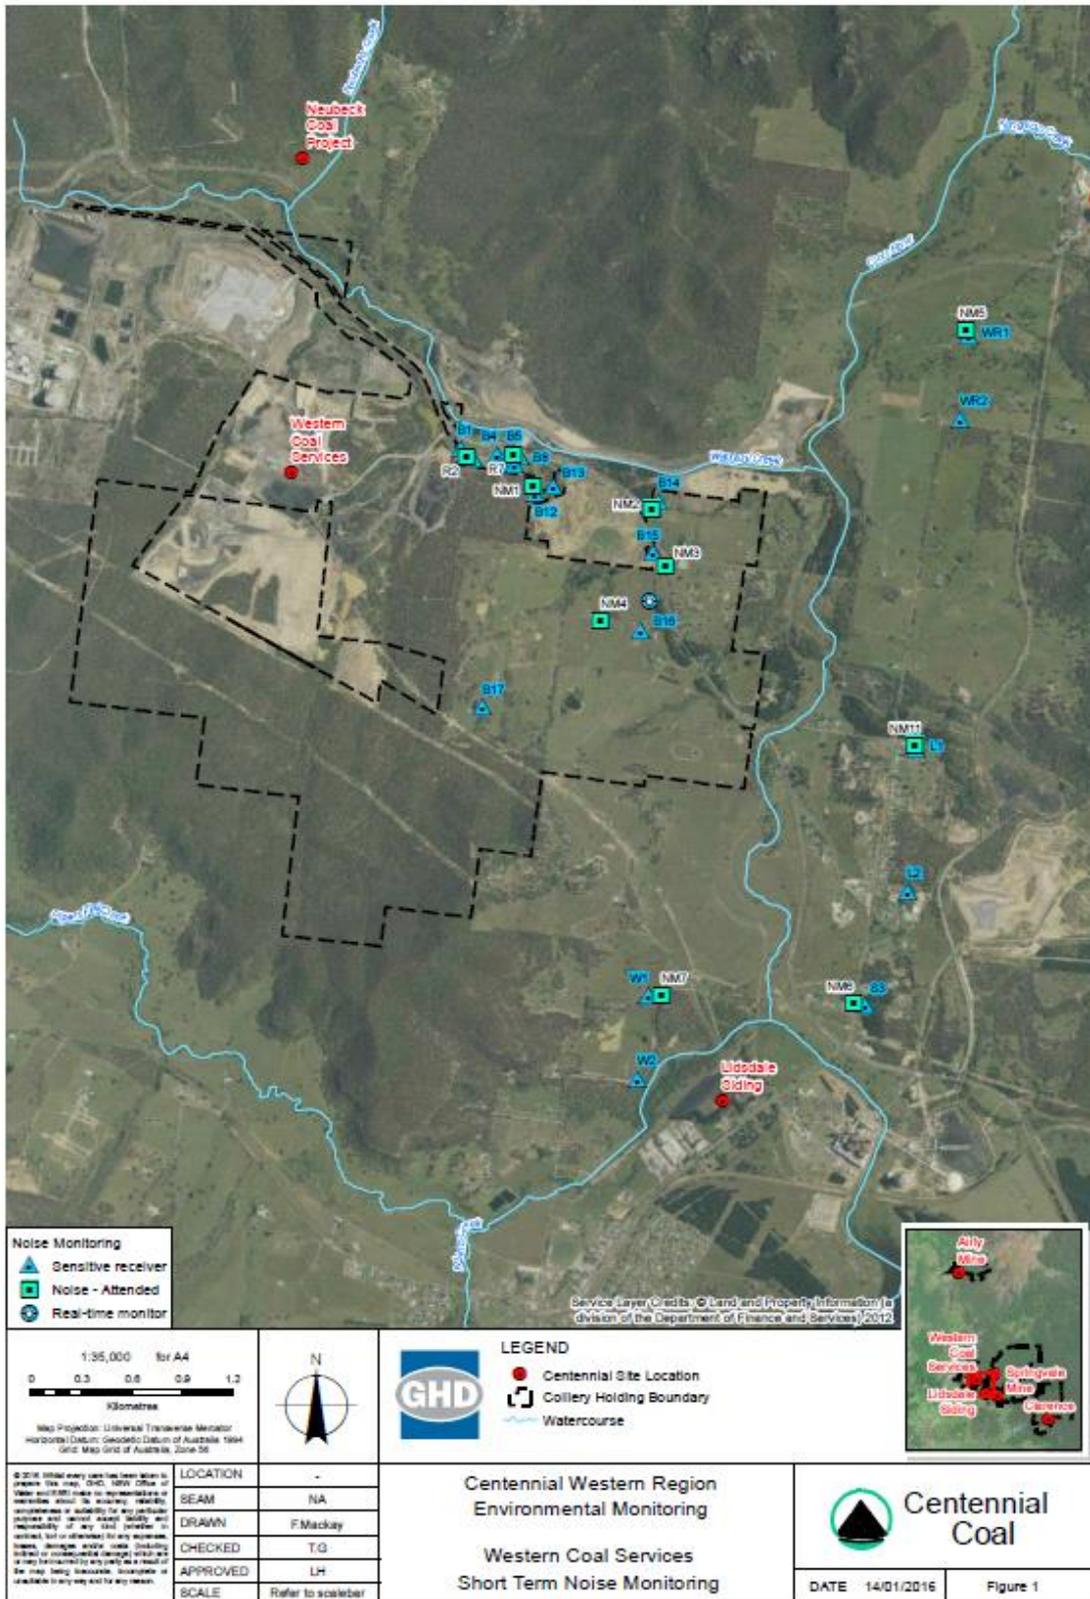
Figure 5 - WCS Attended Noise Monitoring Sites

Attended noise monitoring is undertaken at locations as prescribed in the CCWRNMP as illustrated in Figure 5 below.

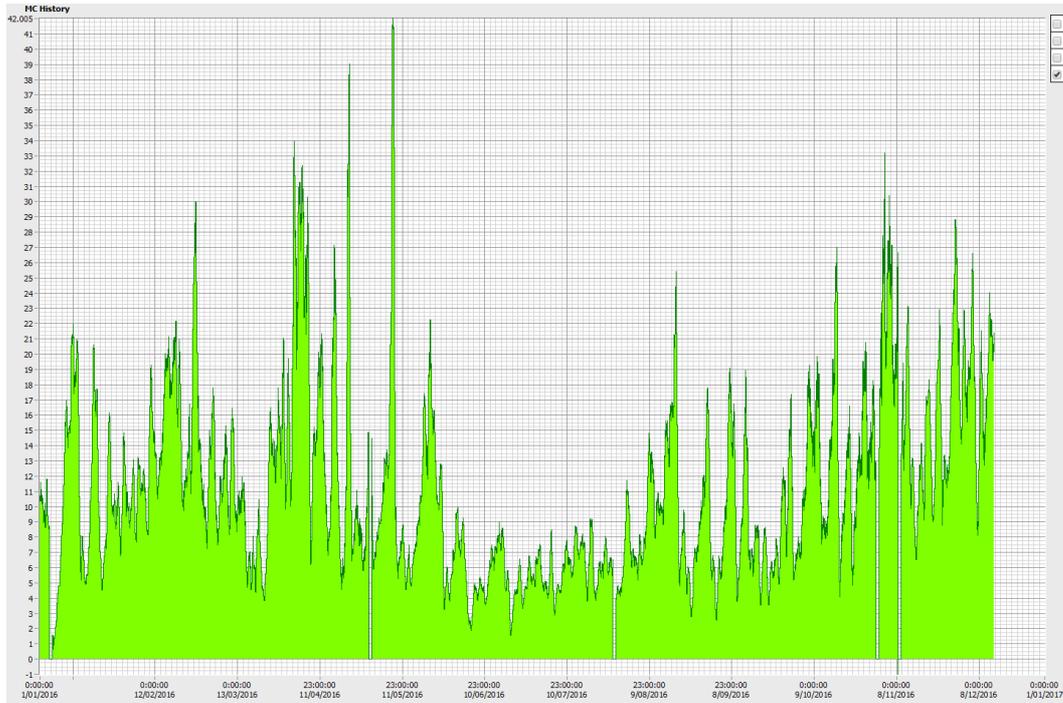
Figure 6 – WCS 2016 24 hour PM10 average concentration for 2016

The 24 hour PM10 average concentration for 2016 is presented in 6 below.

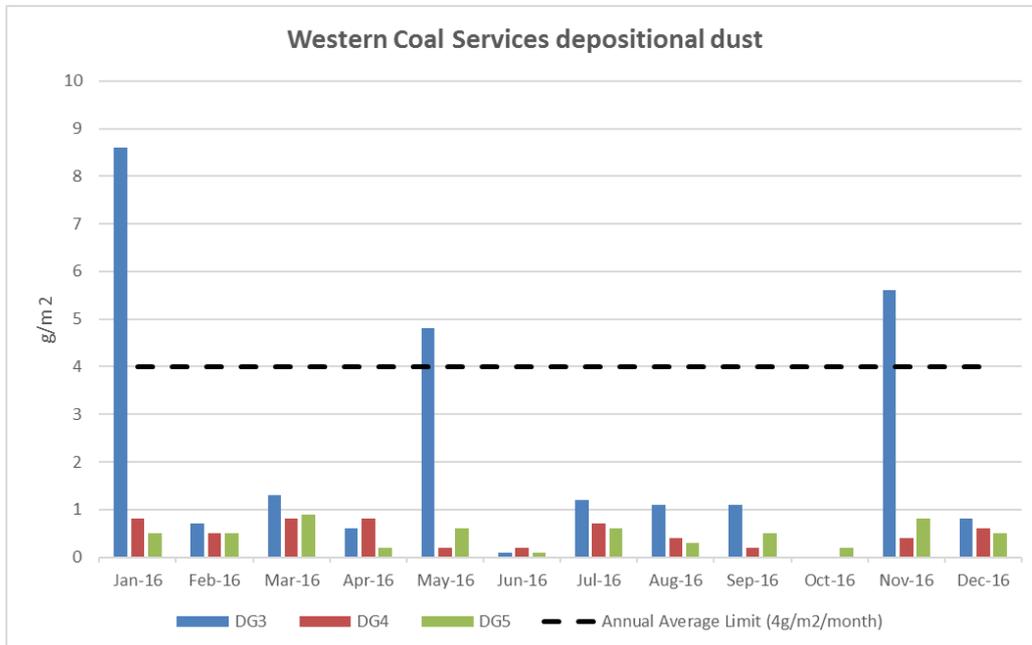
Figure 7 – WCS 2016 depositional dust summary

Depositional dust is monitored at three locations (DG3, DG4, DG5) as shown in the WCS Environmental Monitoring Locations (Water and Air Quality) Map attached in appendix 1 with monthly depositional dust results are presented in Figure 7 below.

DG4 and DG5 were consistently below 1 g/m²/month. DG3 showed several higher months (January, May and November). This gauge is located away from the main operational area and higher results are not attributed to WCS activities.

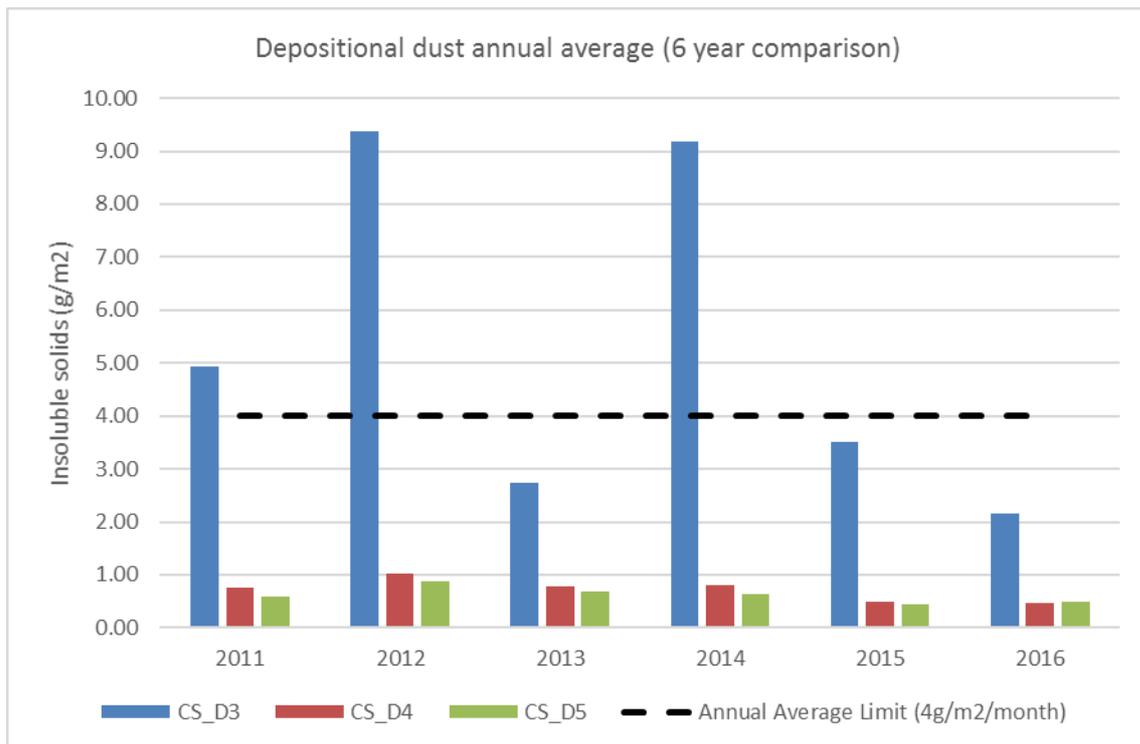
Figure 8 – WCS 6 year comparison of the annual average of depositional dust

The six year comparison of the annual average of depositional dust for WCS is illustrated in Figure 8 below.

Since 2015, CS_D3 has remained under the annual average limit of 4g/m²/month. Since 2011, CS_D4 and CS_D5 have remained under the annual average limit of 4g/m²/month.

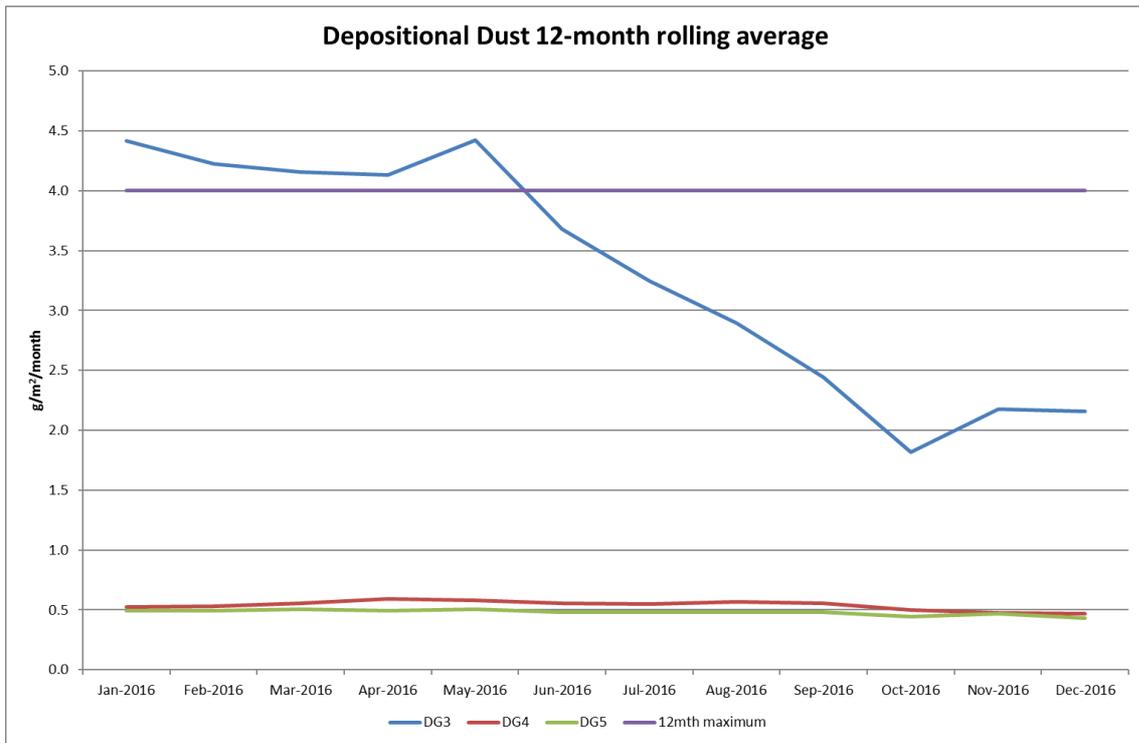
Figure 9 – WCS Depositional dust 12-month rolling average

The 12-month rolling average for depositional dust is illustrated in Figure 9 below.

The exceedance from January 2016 to May 2016 is due to a spike in depositional dust from June to October 2015. This was due to the development of storage units that are situated near the monitoring location for DG3.

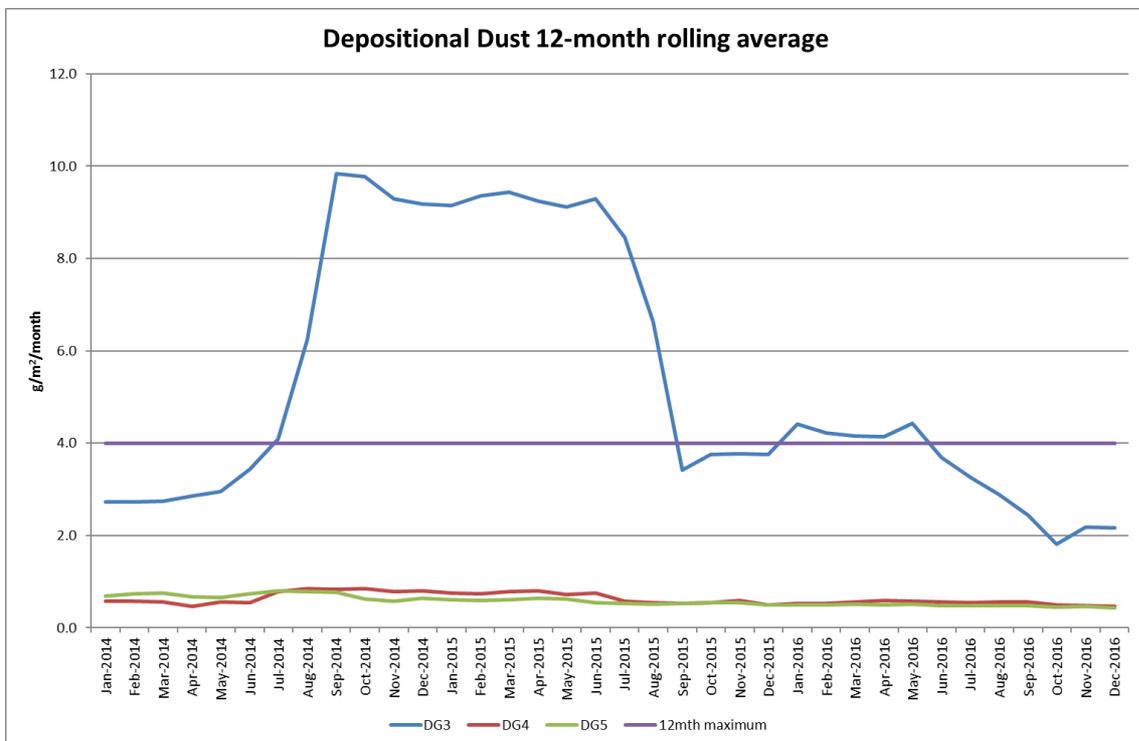
Figure 10 – WCS January 2013-December 2016 depositional dust 12-month rolling average

The rolling average for depositional dust uses 12 months of data from January 2013 to generate the graph commencing January 2014 as shown in Figure 10 below.

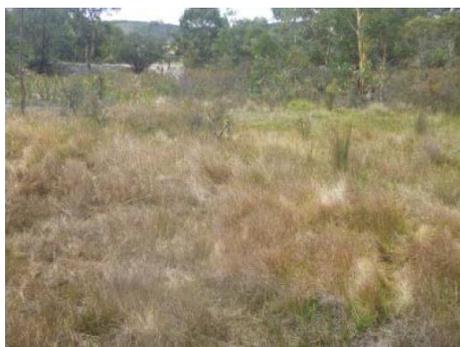
Figure 11 – AHIMS #45-1-2723 (facing east)

The archaeological survey identified no new Aboriginal objects. One previously registered Aboriginal object (AHIMS #45-1-2723) was groundtruthed during the survey. It is located approximately 80m south of the proposed works footprint at the southern boundary of the project area and is not proposed for impact with all works to avoid the object via notification of onsite personnel of its location to avoid the area. WCS will implement all recommendations as identified in the survey report and additionally install temporary barricade fencing to prevent access to AHIMS #45-1-2723 during construction activity. The site is pictured in Figure 11 below.

- WCS heritage management is proposed to be included and managed in accordance with the Centennial Coal Western Region Historic Heritage Management Plan (HHMP) in 2017. The HHMP was approved in July 2016, to be resubmitted including WCS by 28 April 2017.
- WCS will implement all recommendations as identified in the Due Diligence Archaeological Survey for water diversion works survey report and additionally install temporary barricade fencing to prevent access to AHIMS #45-1-2723 during construction activity.

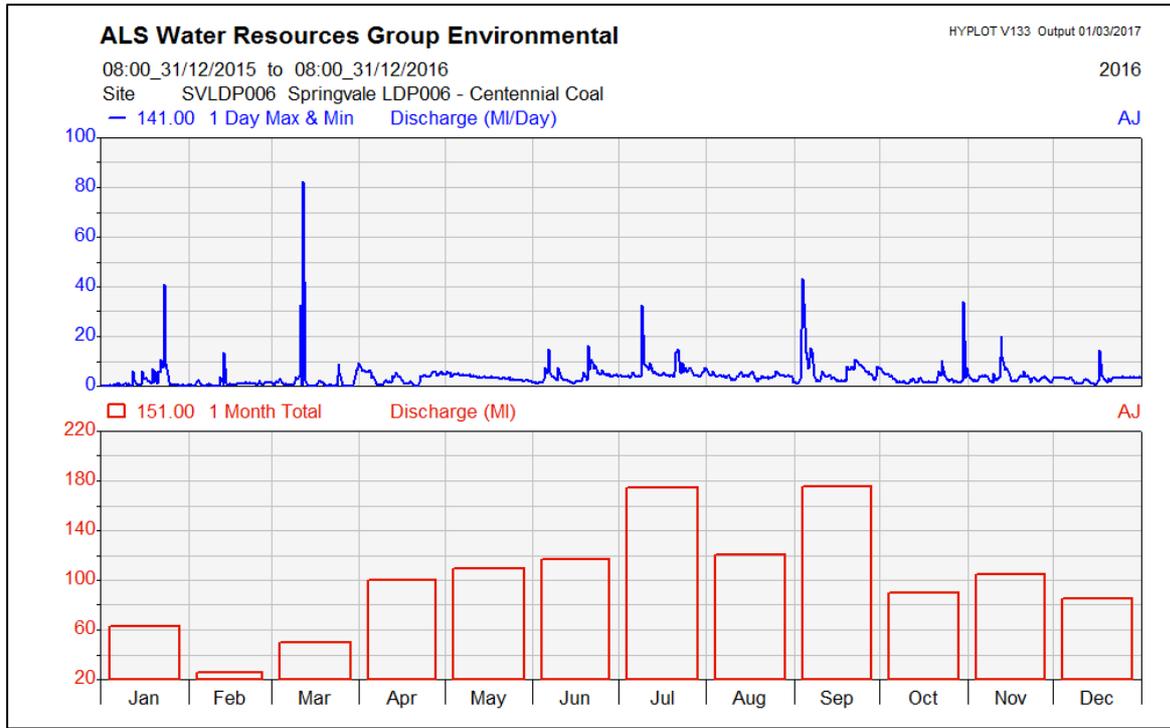
Figure 12 – WCS 2016 LDP006 discharges

Unit of measure	Frequency	No. of measurements made	Lowest result	Mean result	High result
Megalitres per day	Daily during any discharge	366	0.028	3.32	25.70

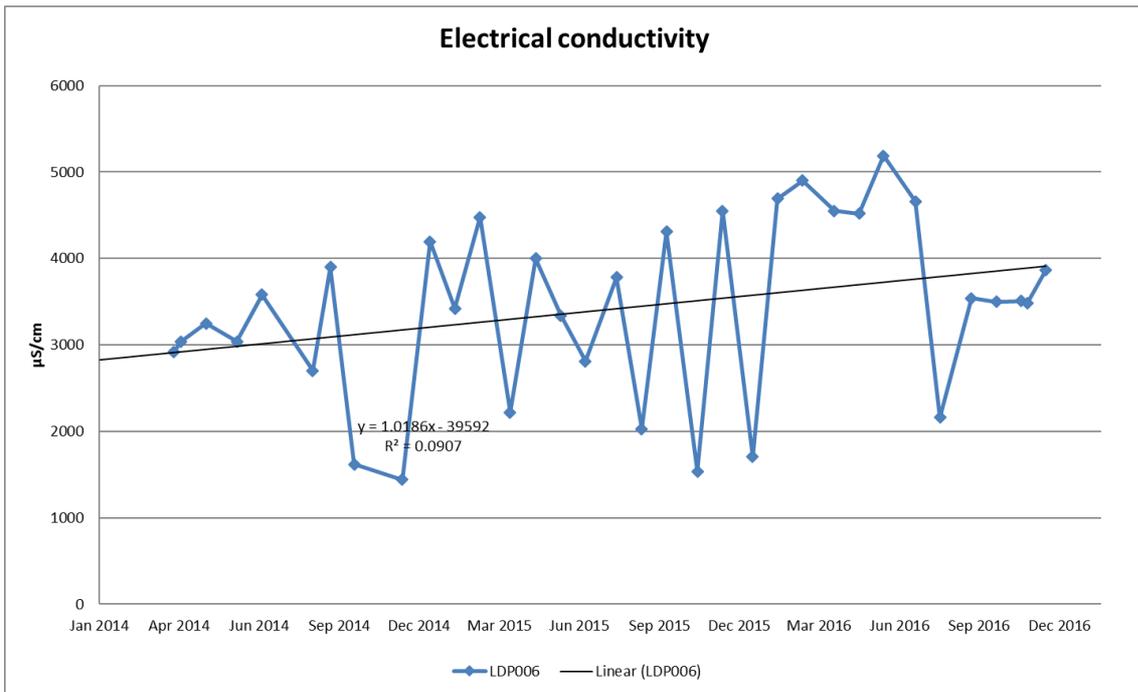
Figure 13 – WCS LDP006 Electrical Conductivity 2014-2016

Surface water pH, total suspended solids, electrical conductivity, oil and grease, turbidity, filterable iron, and filterable manganese are monitored at LDP006. Results are presented graphically for LDP006 to show a comparison with historic data trends in the following pages. LDP006 displays an increasing trend of electrical conductivity over the last three years as illustrated in Figure 13 below.

Analysis of the 2016 data saw a decreasing linear trend but with greater variability. The increase in EC has been attributed to increasing conductivity in groundwater entering Cooks Dam and investigations are currently underway to better understand the source of the conductivity.

The variability identified generally correlates to rainfall events which dilute Cooks Dam water with low conductivity surface water runoff at LDP006. The source of the low conductivity water is surface runoff from the Lamberts Gully catchment.

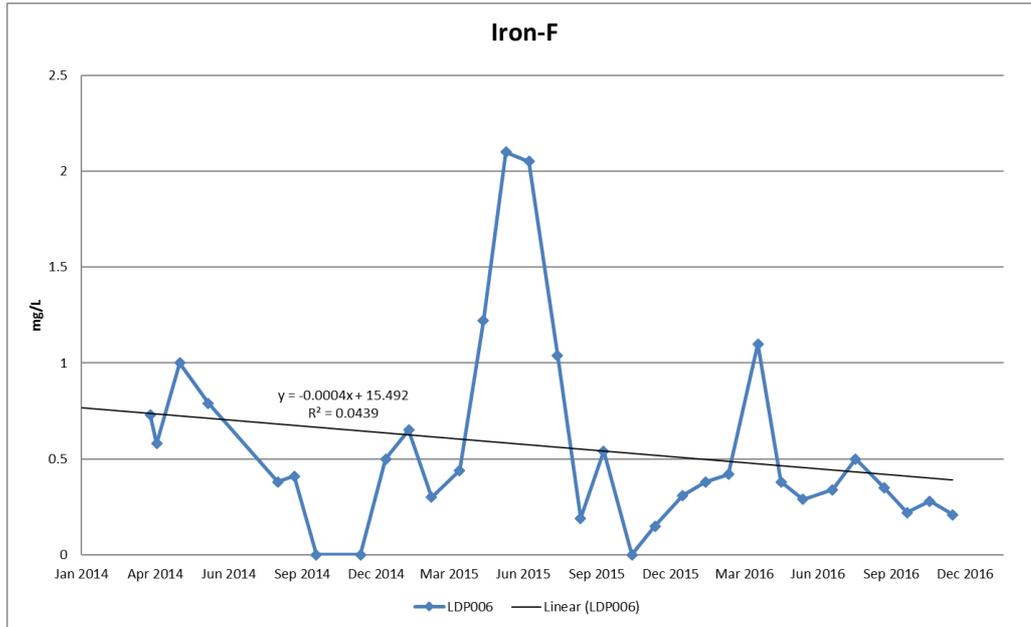
Figure 14 – WCS LDP006 Filterable Iron 2014-2016

Filterable iron results across the three years 2014-2016 are highly variable with a maximum of 2.1 mg/L and minimum below the limit or reporting <0.05 mg/L. Linear regression analysis shows a downward trend as illustrated in Figure 14 below.

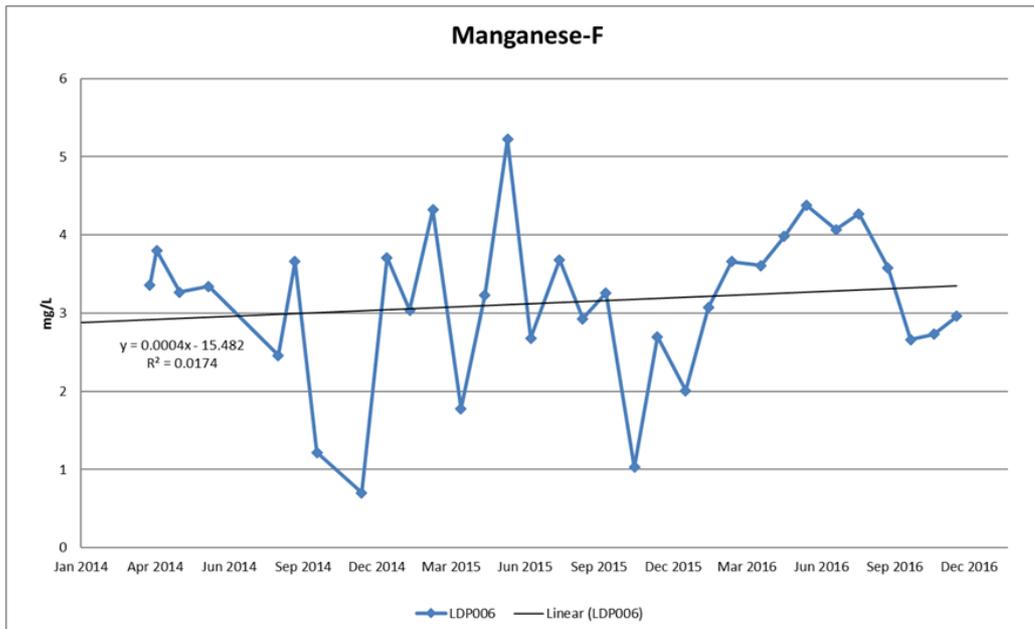
Figure 15 – WCS LDP006 Filterable Manganese 2014-2016

Filterable manganese results across the three years 2014-2016 are highly variable with a maximum of 5.22 mg/L and minimum of 0.70 mg/L. Linear regression analysis shows a slight trend upwards as illustrated in Figure 15 below.

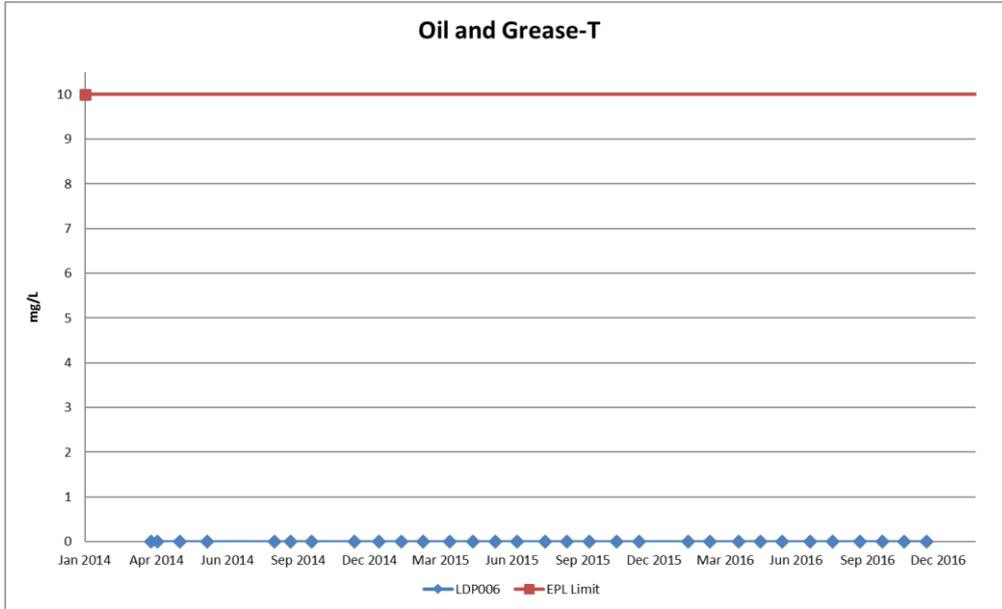
Figure 16 – WCS LDP006 Oil and Grease 2014-2016

Oil and grease results are consistently below the laboratory limit of reporting of 5 mg/L as illustrated in Figure 16 below.

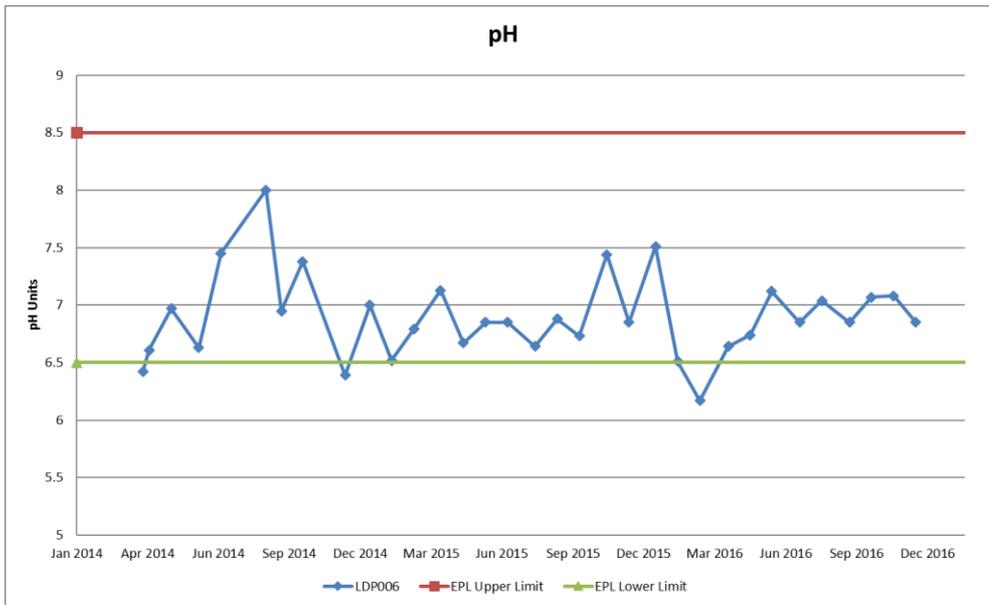
Figure 17 – WCS LDP006 pH 2014-2016

During 2016, pH was compliant with EPL limits with the exception of a low result of 6.17 recorded on 02/03/2016 as illustrated in Figure 17 below.

It has been observed that pH decreases when groundwater from historic underground workings, discharged via Cooks Dam, is the predominant discharge.

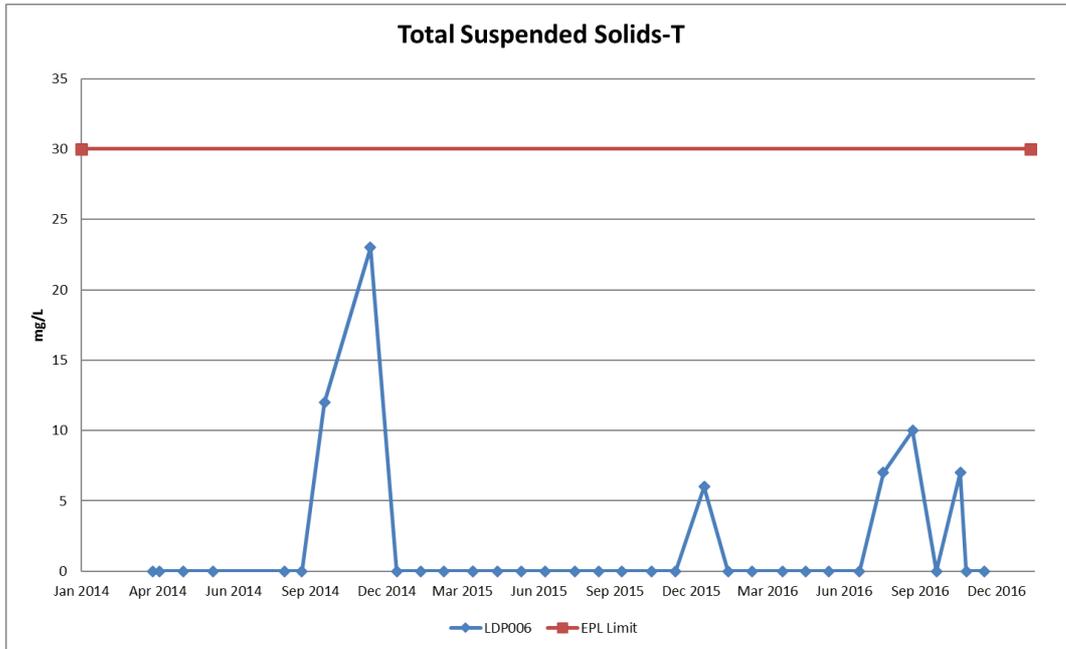
Figure 18 – WCS LDP006 Total Suspended Solids 2014-2016

Total suspended solids and turbidity display no discernable trend from and were compliant with the EPL concentration limit as illustrated in Figures 18 and 19 below.

All spikes in the TSS and turbidity readings across the three years of data are associated with rainfall events, which increase surface water flows in the Lamberts Gully catchment.

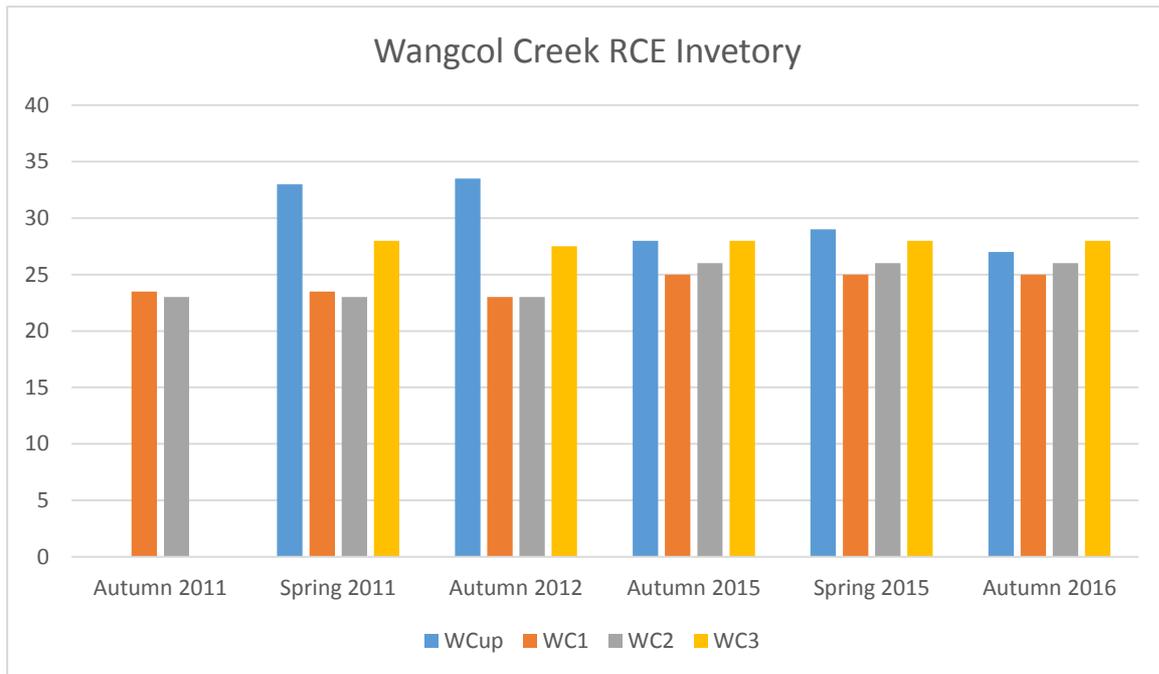
Figure 20– WCS River Health Monitoring Wangcol Creek RCE Inventory results

Riparian, Channel and Environment (RCE) Inventory results are consistent across the last six years of monitoring. Higher RCE Scores indicate better riparian and channel aquatic habitat condition.

Survey Date	Wangcol Creek Upstream	Wangcol Creek 1	Wangcol Creek 2	Wangcol Creek 3
Autumn 2016	27	25	26	28
Spring 2015	29	25	26	28
Autumn 2015	28	25	26	28
Autumn 2012	33.5	23	23	27.5
Spring 2011	33	23.5	23	28
Autumn 2011		23.5	23
