# Centennial Coal

Angus Place

## ***2013 ANNUAL ENVIRONMENTAL MANAGEMENT REPORT***

**Angus Place**

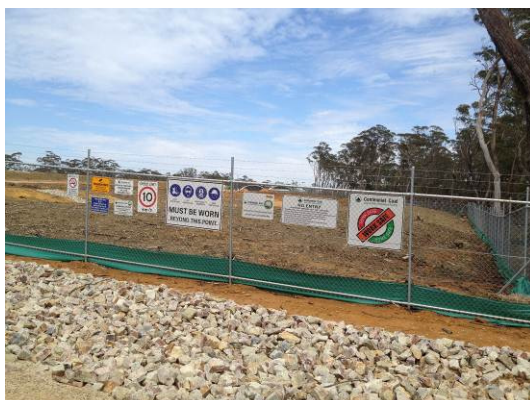
**Figure 2: Entrance into the Ventilation Facility site**

Construction associated with Ventilation Facility Project commenced in June 2013

Construction activities will continue in 2014 at the ventilation facility site.

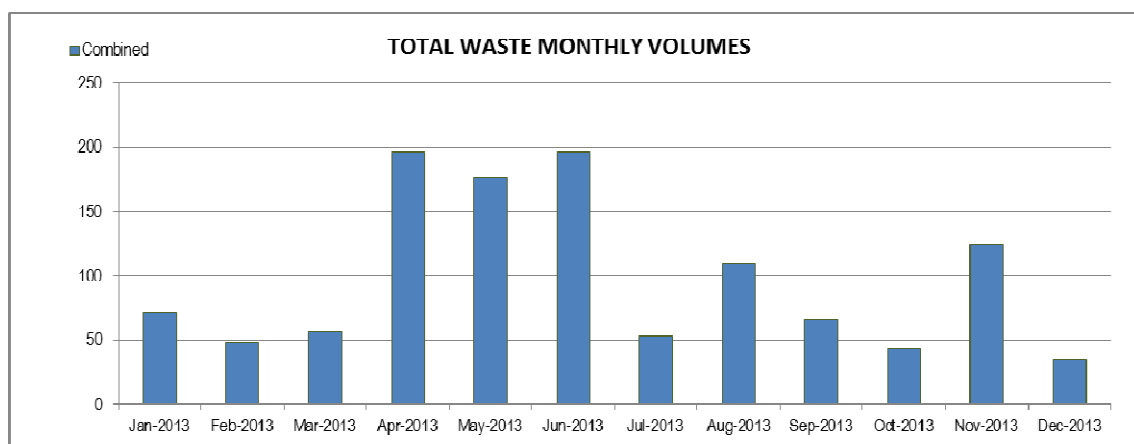
In 2011 Angus Place changed licensed waste removal contractors. Since the introduction of the colour coding waste system the colliery has demonstrated an increase in recycling rates. An overview of Angus Place waste management is shown in the following figures.

Figure 4: Total Waste volumes during 2013

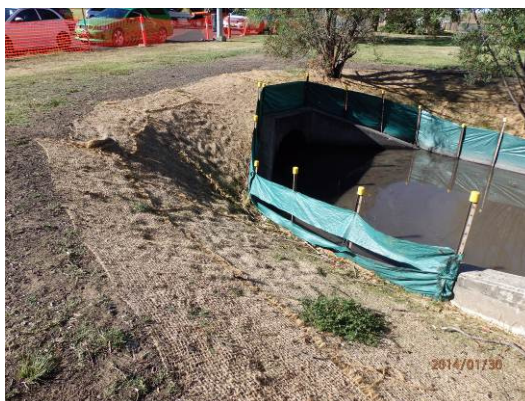
**Figure 6: Carpark Culvert improvement area**

- Tyne up bare areas
- Spreading topsoil over the tyned area
- Reshape culvert to improve water runoff
- Applying a mixture of seed and fertiliser to the areas tread with topsoil

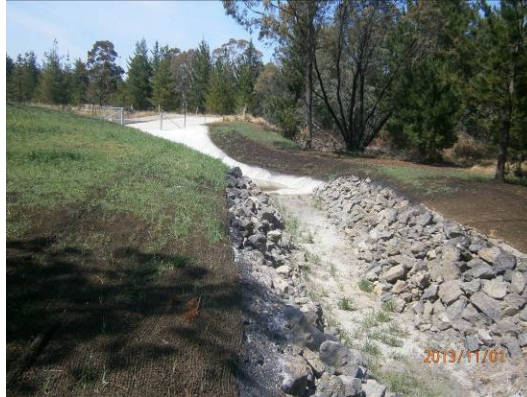
**Figure 7: LDP003 new weir**

factors including the surrounding soil, operation of the dam at nominal capacity, preceding months of low rainfall conditions and controlled release wall. The wall was temporarily repaired within 3 hours of the incident and EPA attended the site and found that Angus Place had acted in compliance with EPL licence conditions. Images of the new weir constructed are shown below.

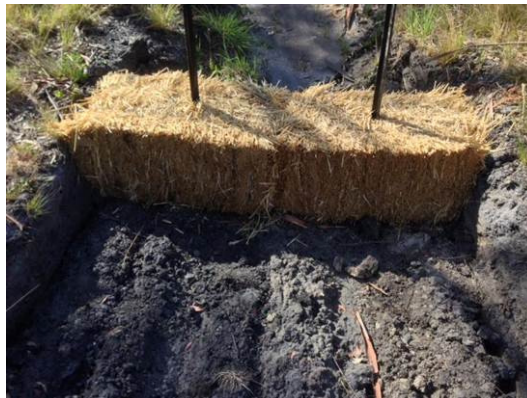
**Figure 8: Hay bales in drainage lines**

In 2013 the colliery continued to focus on water management improvements at the site. Targeted soil and sediment control works were conducted around the approved stockpile area. These included the installation of sediment fences, lining draining channels with terra-ferma and gabion rock, installing hay pales and channelling water flow into the final sedimentation dam at LDP003. Examples of the work conducted are shown in the following figures.

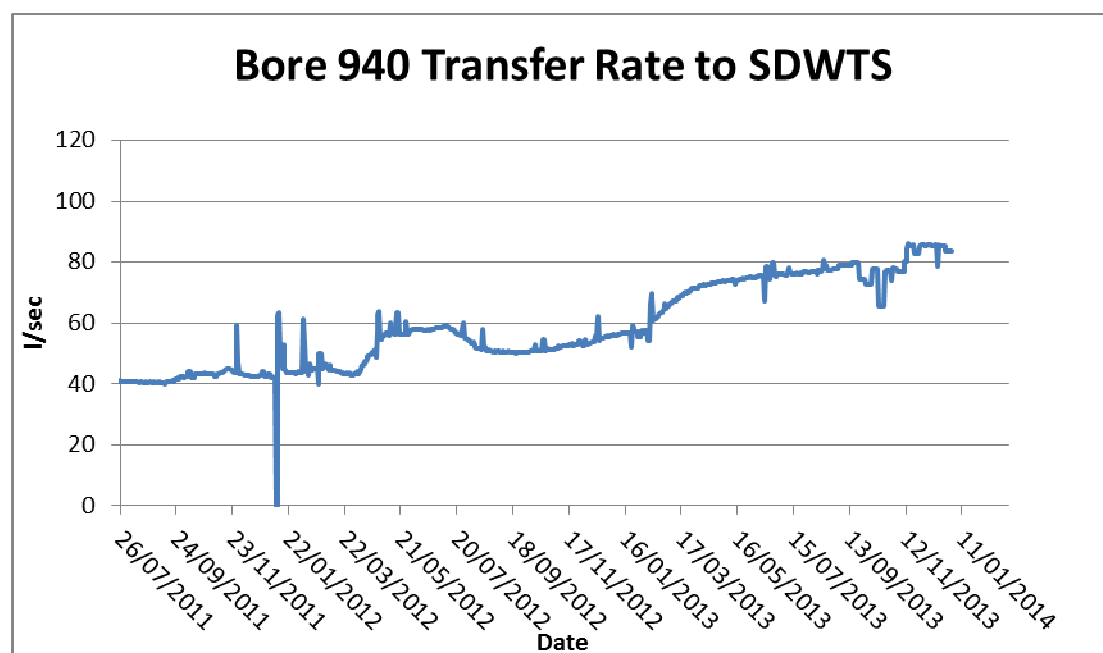
**Figure 12: Historic Bore 940 transfer rate to SDWTS**

Raw data is presented in the following graph as required under the water licence.

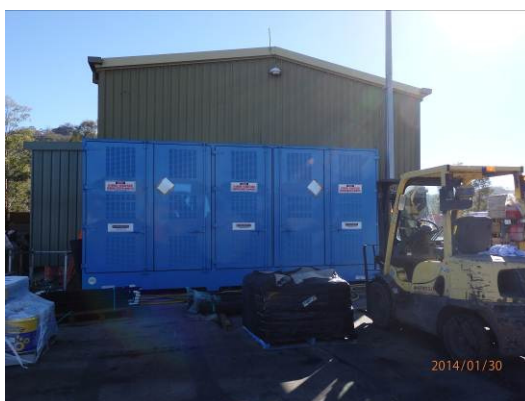
### **Figure 13: Bulki-Box Purchased for storage of dangerous goods**

In 2013 a Bulki Box Relocatable Outdoor Dangerous goods store was purchased for storage of chemicals on site. This will be installed and commissioned in 2014.

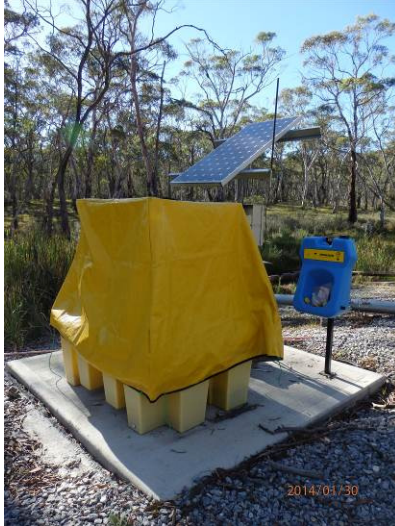
**Figure 14: Eyewash station installed at LDP001**

Also during the reporting period a safety eye wash station was established at LDP001 and water treatment chemicals stored outside the pit top area and used intermittently only were relocated to the pit top to prevent accidental misuse or vandalism. Hazardous substances which were required regularly in smaller quantities have also been ordered.

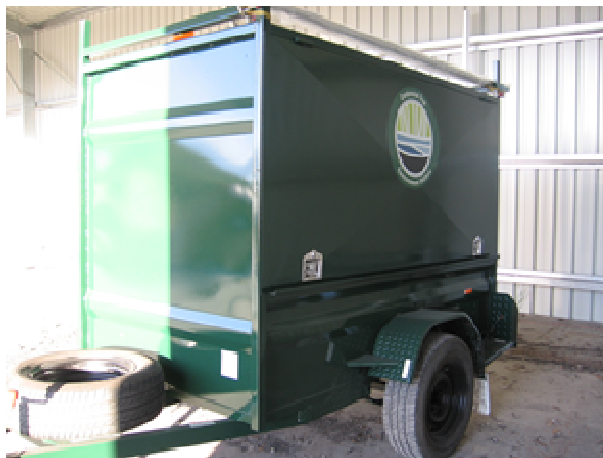
A spill response trailer was also purchased during 2013.

**Figure 15: Angus Place Spill Response Trailer**

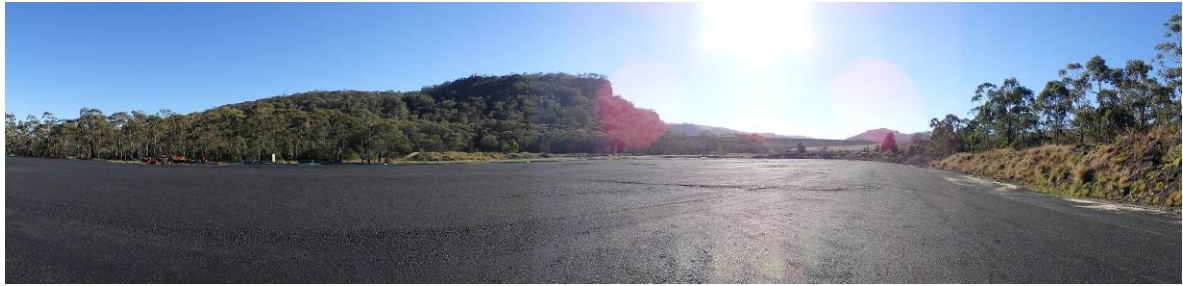
**Figure 17: Earth Bund and Vegetation established in vicinity of Kerosene Vale Stockpile Storage site**

In 2013, a stockpile design for Kerosene Vale was developed. The Kerosene Vale stockpile area has an established earth bund and vegetation area around the site to minimise dust control. This is shown in the figure below. In 2014 this area will be hydromulched to improve erosion from wind and water.

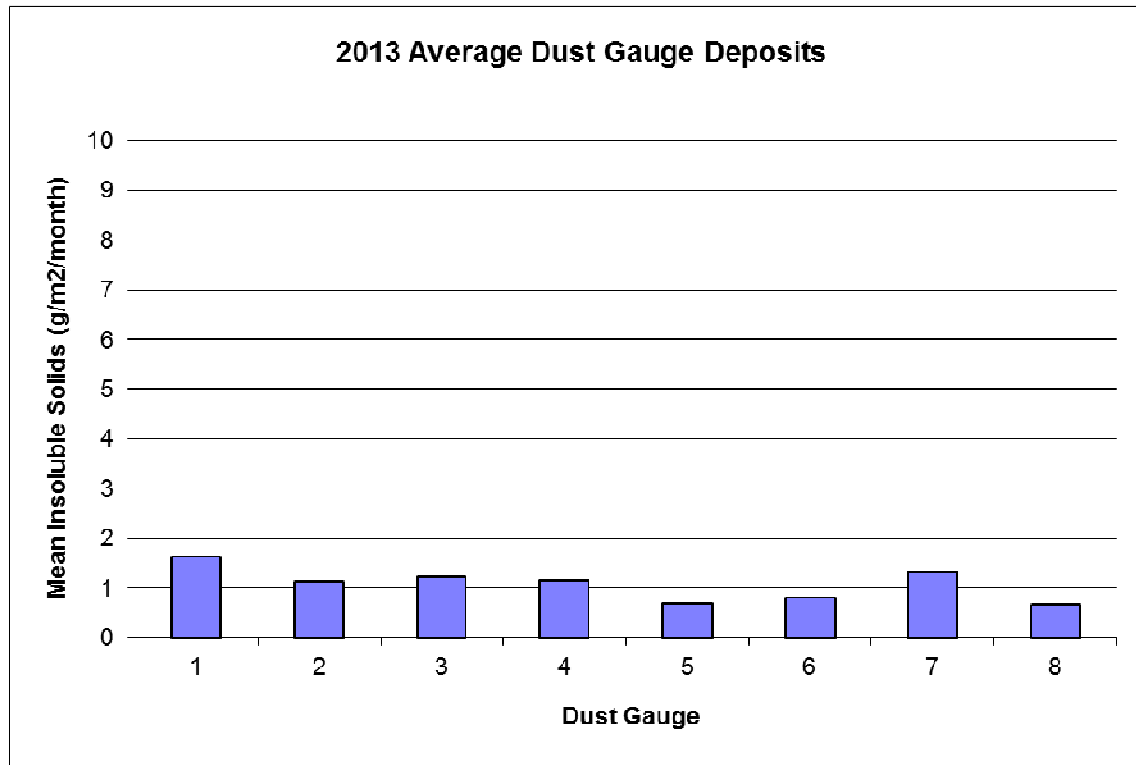
Figure 20: Average Monthly Total Deposited Solid Matter for All Gauges

Depositional dust monitoring occurs at eight sites within the vicinity of the surface operations (Plan 3211, Appendix 2). During the reporting period, dust management systems operated effectively. This is evidenced by all eight gauges demonstrating compliance against the long term impact assessment criteria of 4 g/m<sup>2</sup>/month with an annual averaging period. This is stipulated in the Angus Place Colliery Project Approval 06\_0021 and EPL 467.

The exceedances of the criteria were not caused by dust emissions at Angus Place.

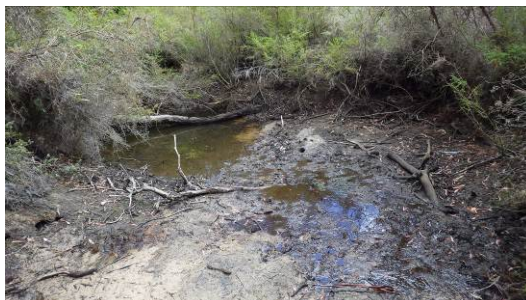
**Figure 21: Kangaroo Creek Waterhole November 2013**

The waterhole is maintained by a spring in the rock bar. Importantly, the spring was unaltered by the passage of longwall 950 and has been regularly monitored and inspected. An image taken during an inspection is shown below.

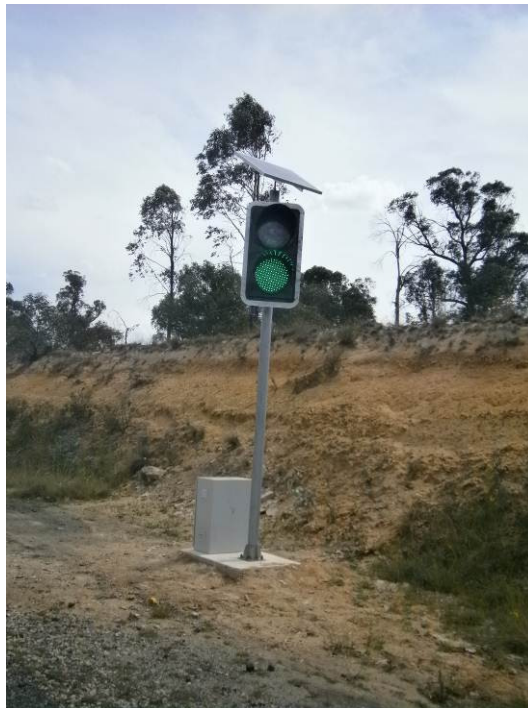
**Figure 31: Traffic Management system installed on Wallerawang Haul Road**

During 2013 Angus Place installed in the vicinity of the CHP (where trucks are loaded from Angus Place Colliery), a solar powered traffic control system to assist in the distribution of coal trucks along the Wallerawang Haul Road. This system currently operates on a timer. Further upgrades to the system are currently underway and will continue into 2014.

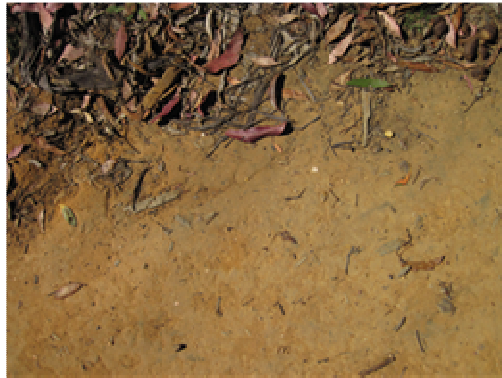
**Figure 37: Longwall 960 Crack self-healed**

As noted in the 2011 AEMR minor hairline cracking was identified during photographic monitoring on July 28<sup>th</sup> 2011 on Kangaroo Creek Road during the extraction of Longwall 960. The natural process of sedimentation has filled the cracks. There has been no evidence of new cracking within the surveyed area. To this end, no action was required to be undertaken by Angus Place to mitigate the effects of minor subsidence.

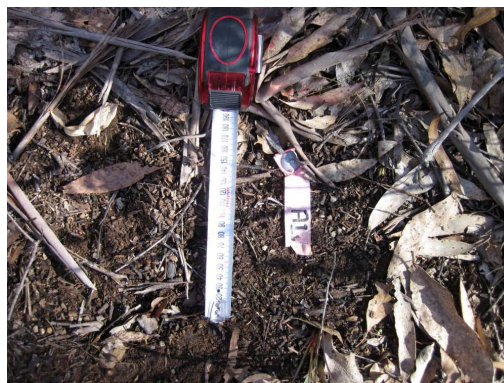
**Figure 23: Surveying the changes at Crack A1**

Weather conditions continue to move soil and surrounding debris. Angus Place will continue to monitor this area for changes. Angus Place will continue to monitor this area for changes.

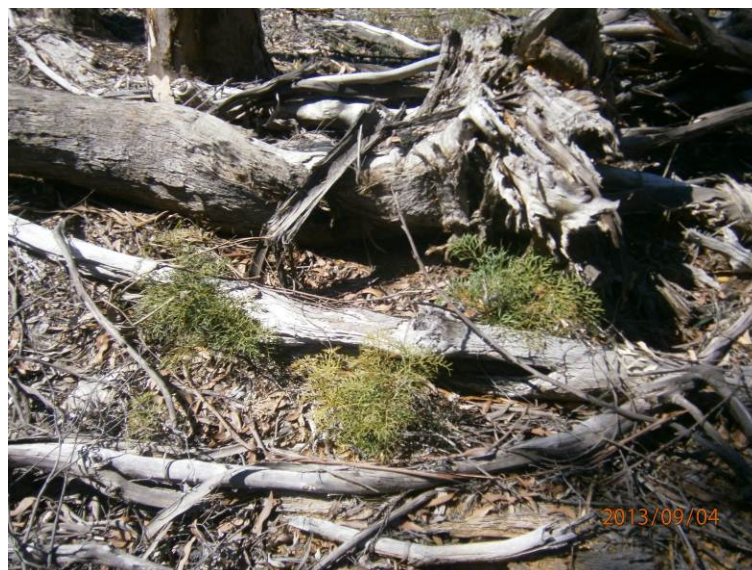
**Figure 40: AP1108 Regrowth at exploration site**

Inspections indicate minimal disturbance at the borehole locations. Strategically placing windrowed trees in the entry of the sites prevented vehicle access to the area after the exploration program was completed.

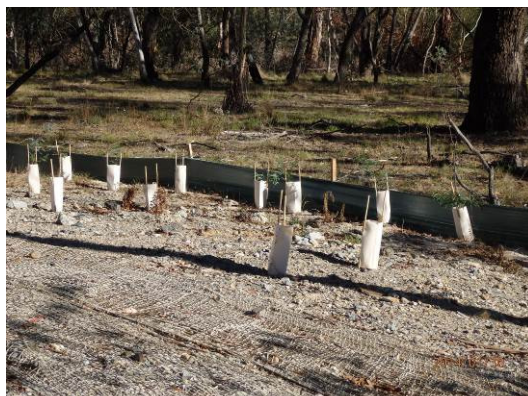
**Figure 41: Rehabilitation near LDP001**

An example of the work conducted is shown below in Figure41

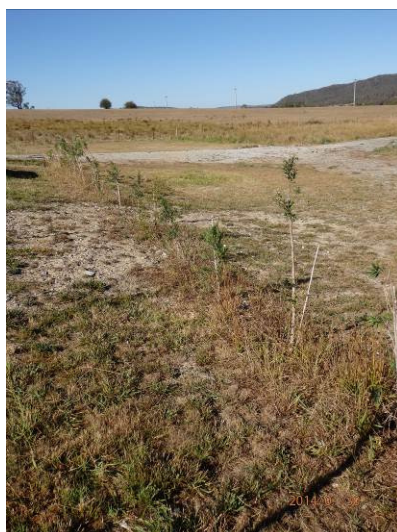
Tree screening works were also undertaken at the fenceline behind the new carpark near the Wolgan Road ponds to improve visual amenity of the area.

**Figure 42: Wolgan Road Tree screening**
