**SPRINGVALE WATER
TREATMENT PROJECT**

ANNUAL REVIEW

March 2018

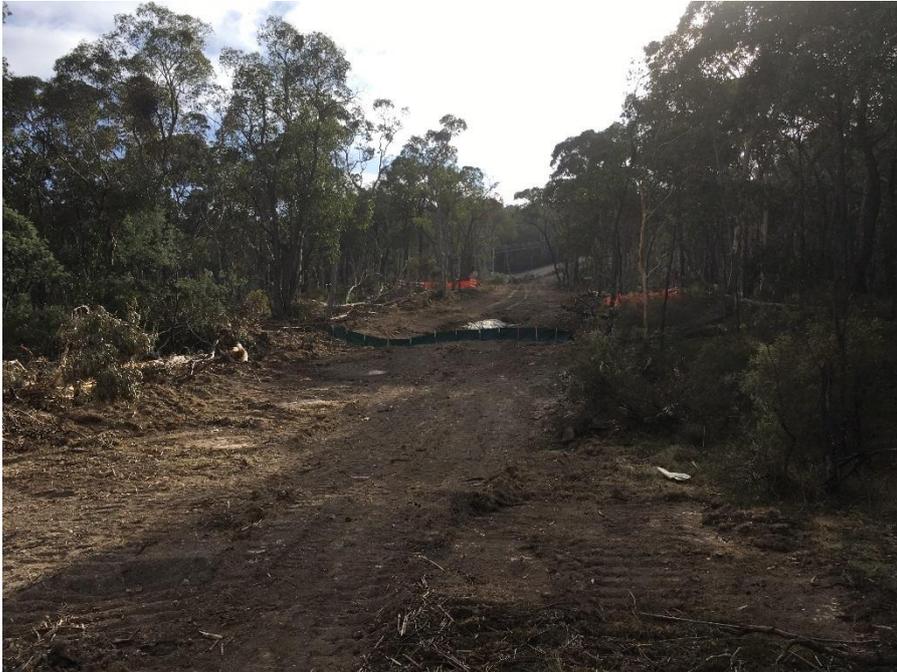
Photo 1 : The cleared 10 m corridor inside the project application area through the Red Stringybark - Brittle Gum - Inland Scribbly Gum dry open forest of the tablelands, South Eastern Highlands Bioregion PCT east of the WTP site

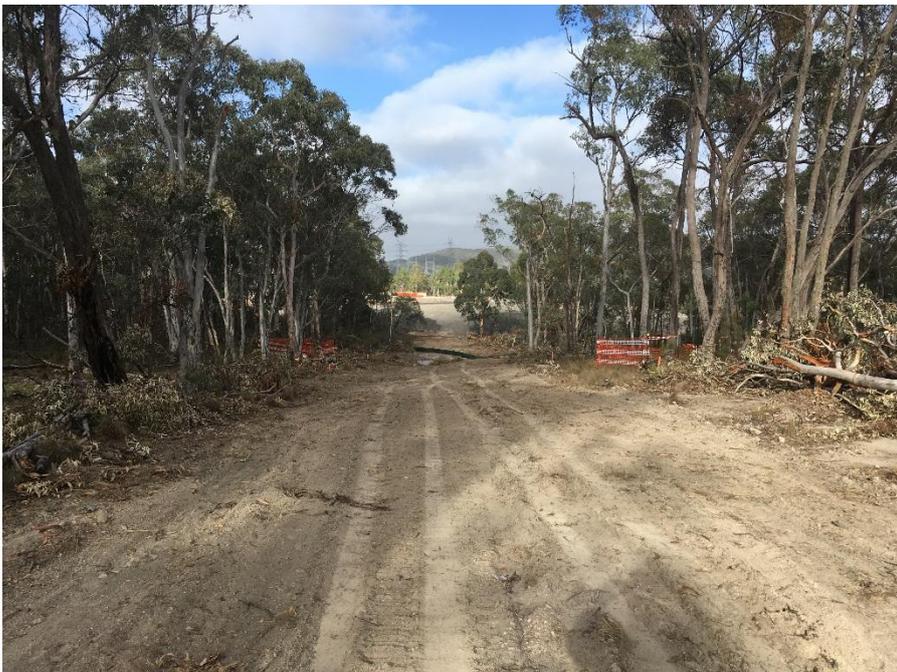
Photo 2 : The project application area east of the WTP site after clearing showing *Eucalyptus cannonii* trees protected with exclusion zones made from high visibility fencing

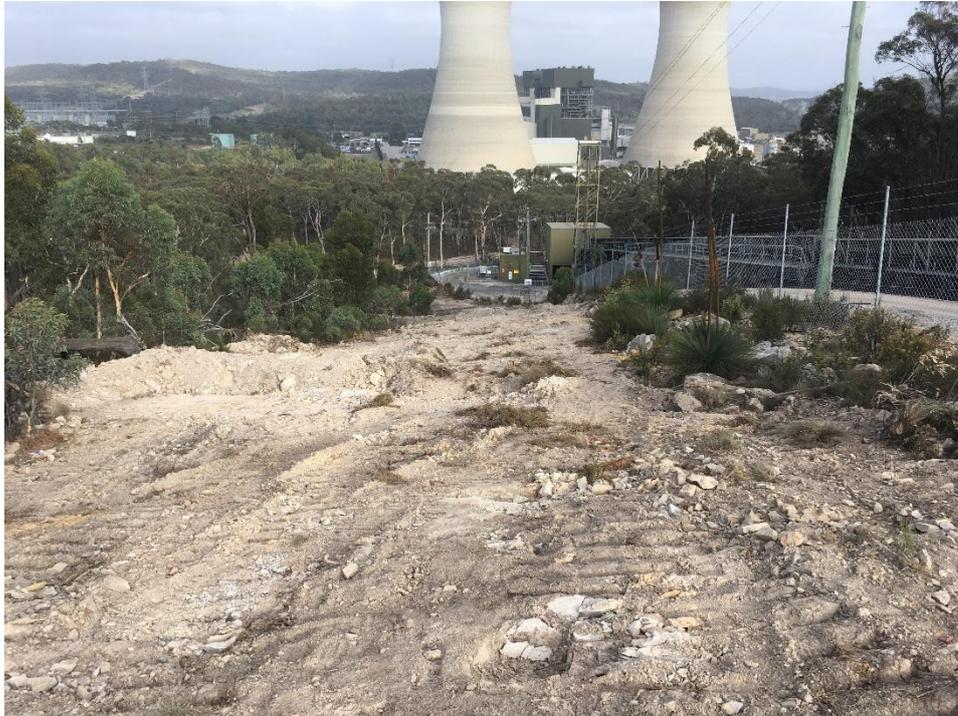
Photo 3 : The project application area at the top of the hill adjacent to the conveyor looking west showing the cleared area and some retained vegetation near the fence

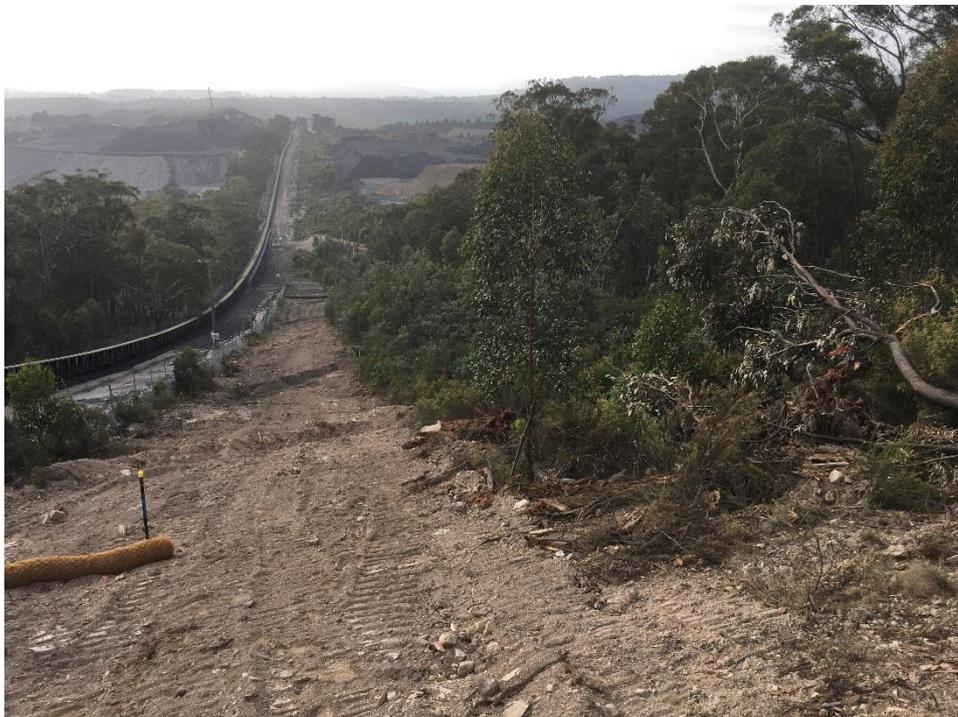
Photo 4 : The project application area mid slope near the SCS land looking east showing the minimised clearing area with retained vegetation including juvenile *Eucalyptus cannonii* trees directly adjacent

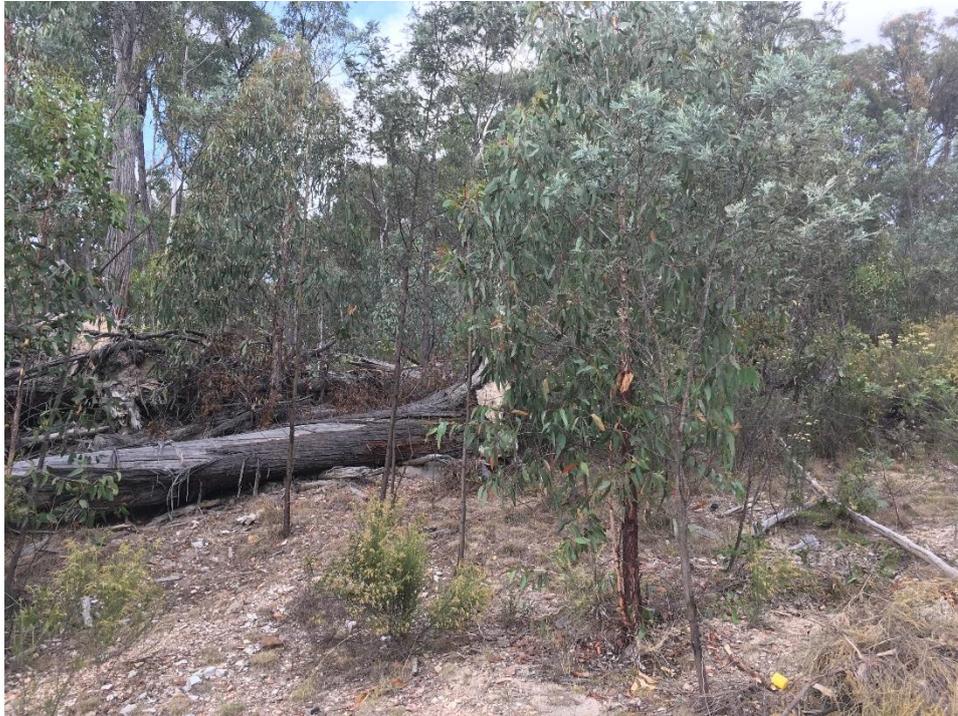
Photo 5 : Juvenile *Eucalyptus cannonii* trees that were retained in the project application area during clearing by minimising the width of the clearing footprint and careful location of the clearing footprint close to the fence to avoid these trees

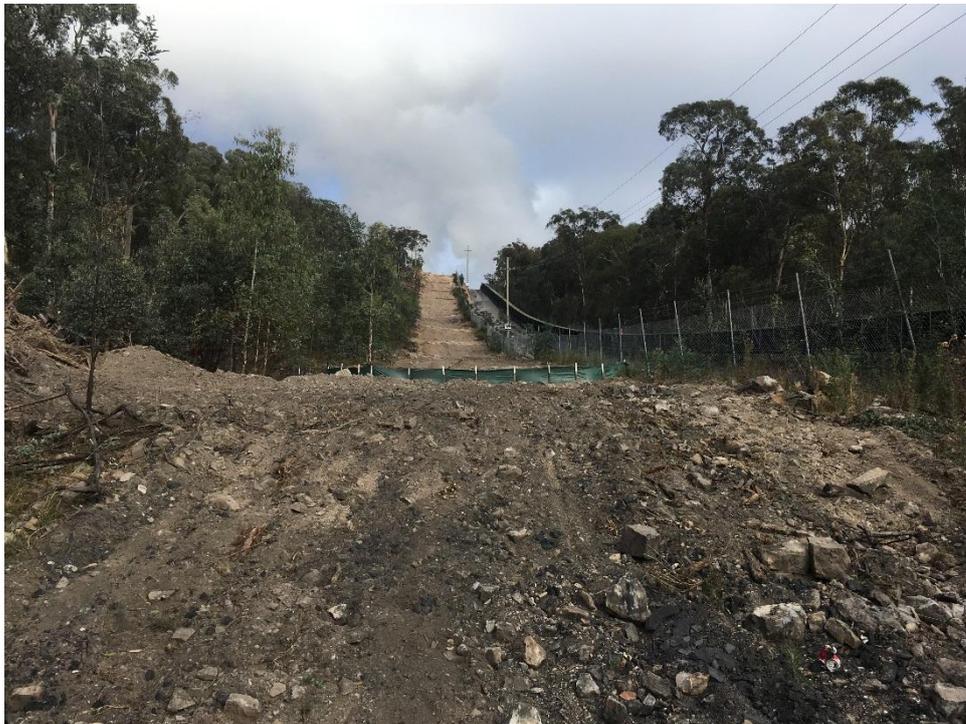
Photo 6 : The cleared are along the fence line showing retained juvenile *Eucalyptus cannonii* trees on the southern edge

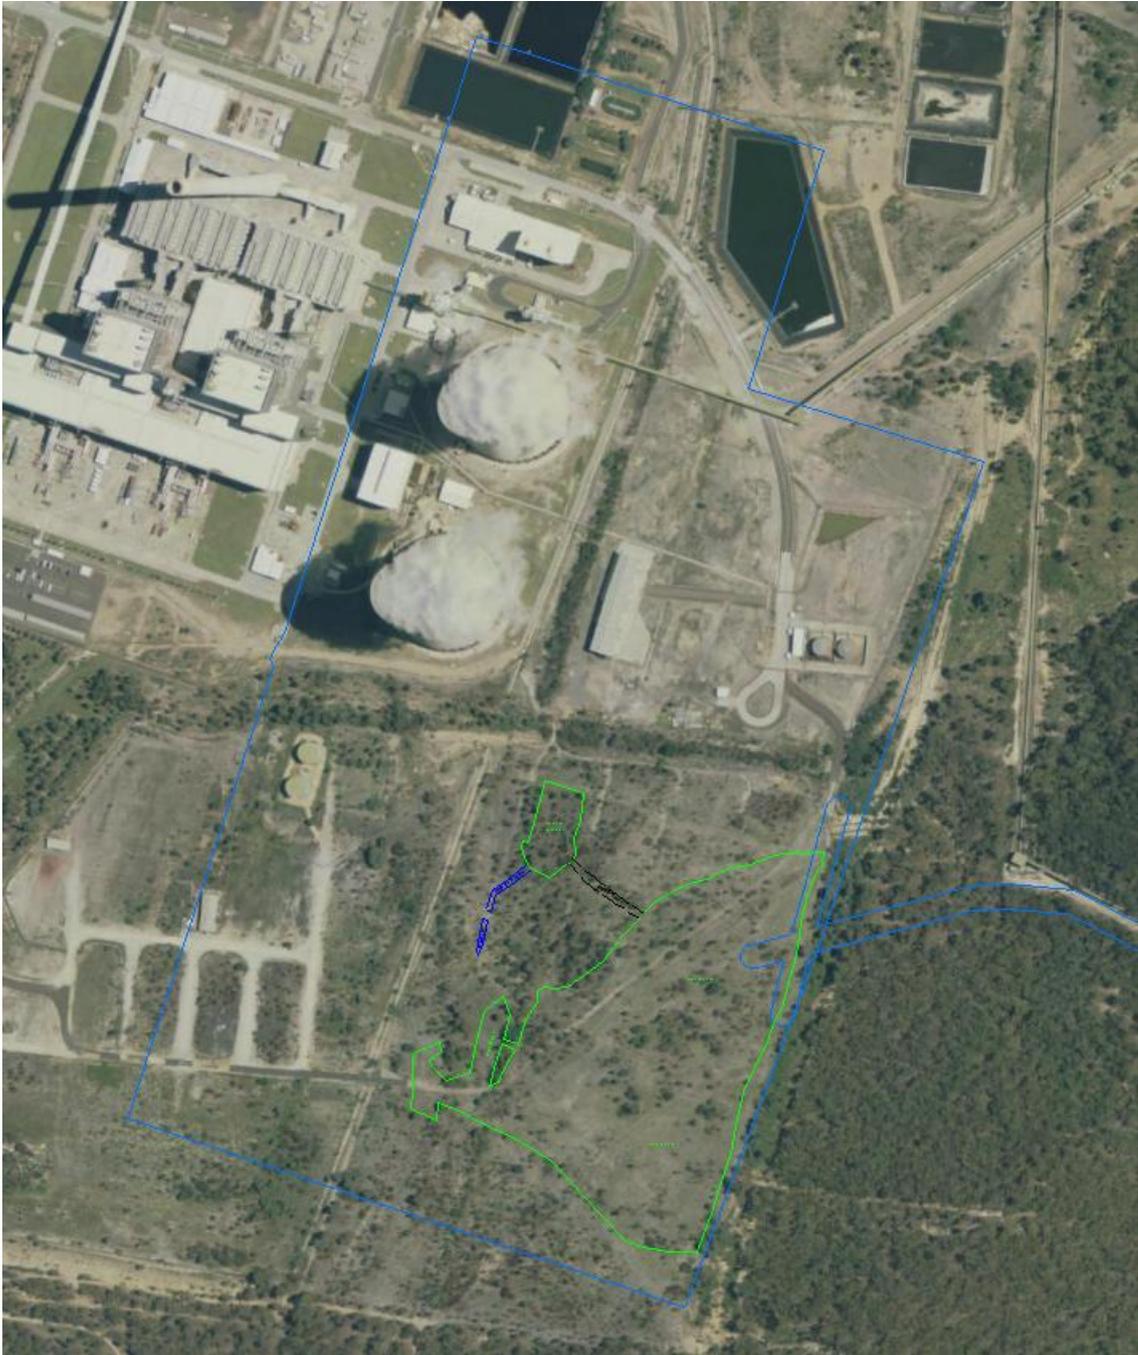
Figure 1.1 : Post-clearing survey of vegetation clearing boundaries undertaken on Friday 15 December 2017 showing area of clearing (green polygons) located within the project application area (Blue polygons)

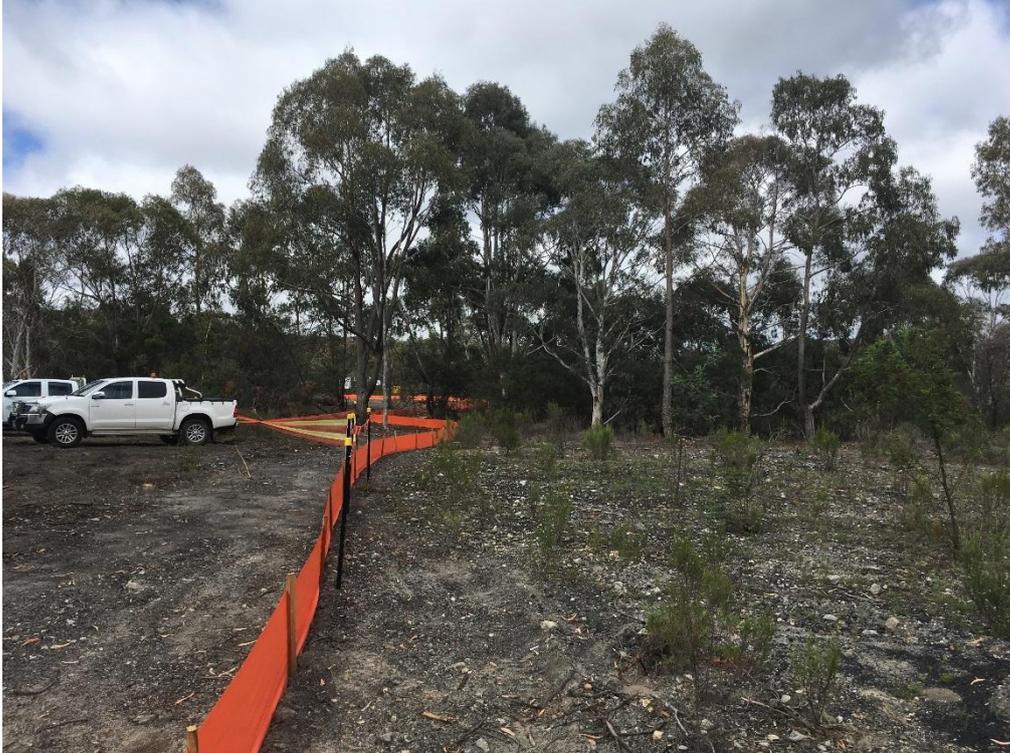
Photo 3: Sediment fencing and exclusion zones have been erected to prevent damage to adjacent vegetation

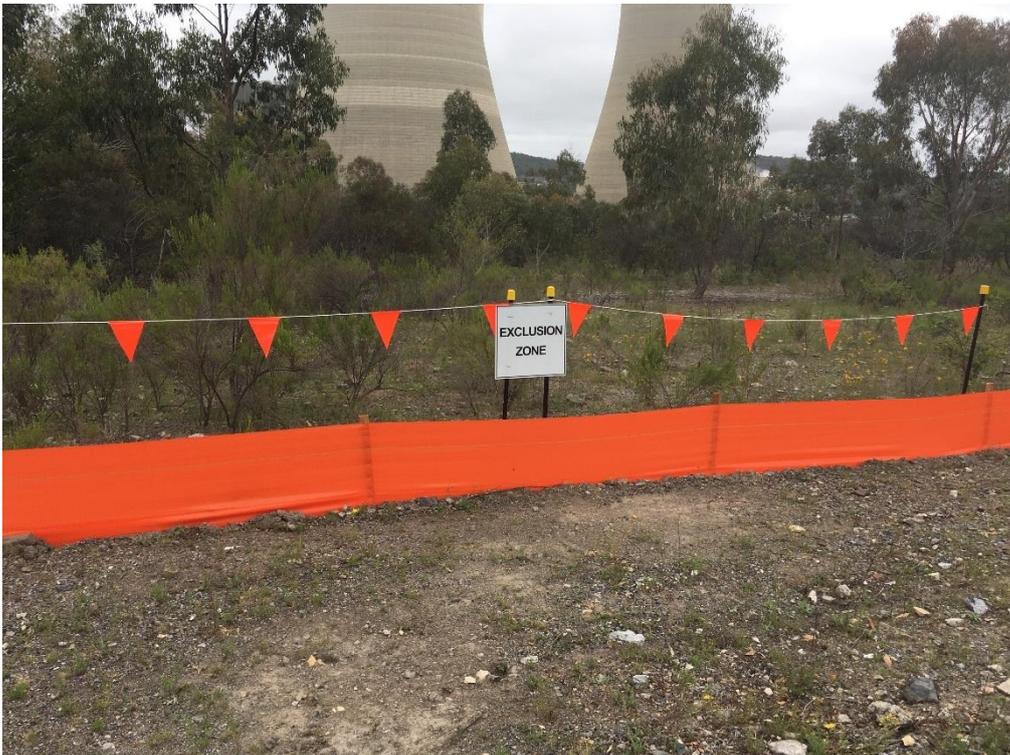
Photo 4: Another example of the exclusion zones and sediment fencing

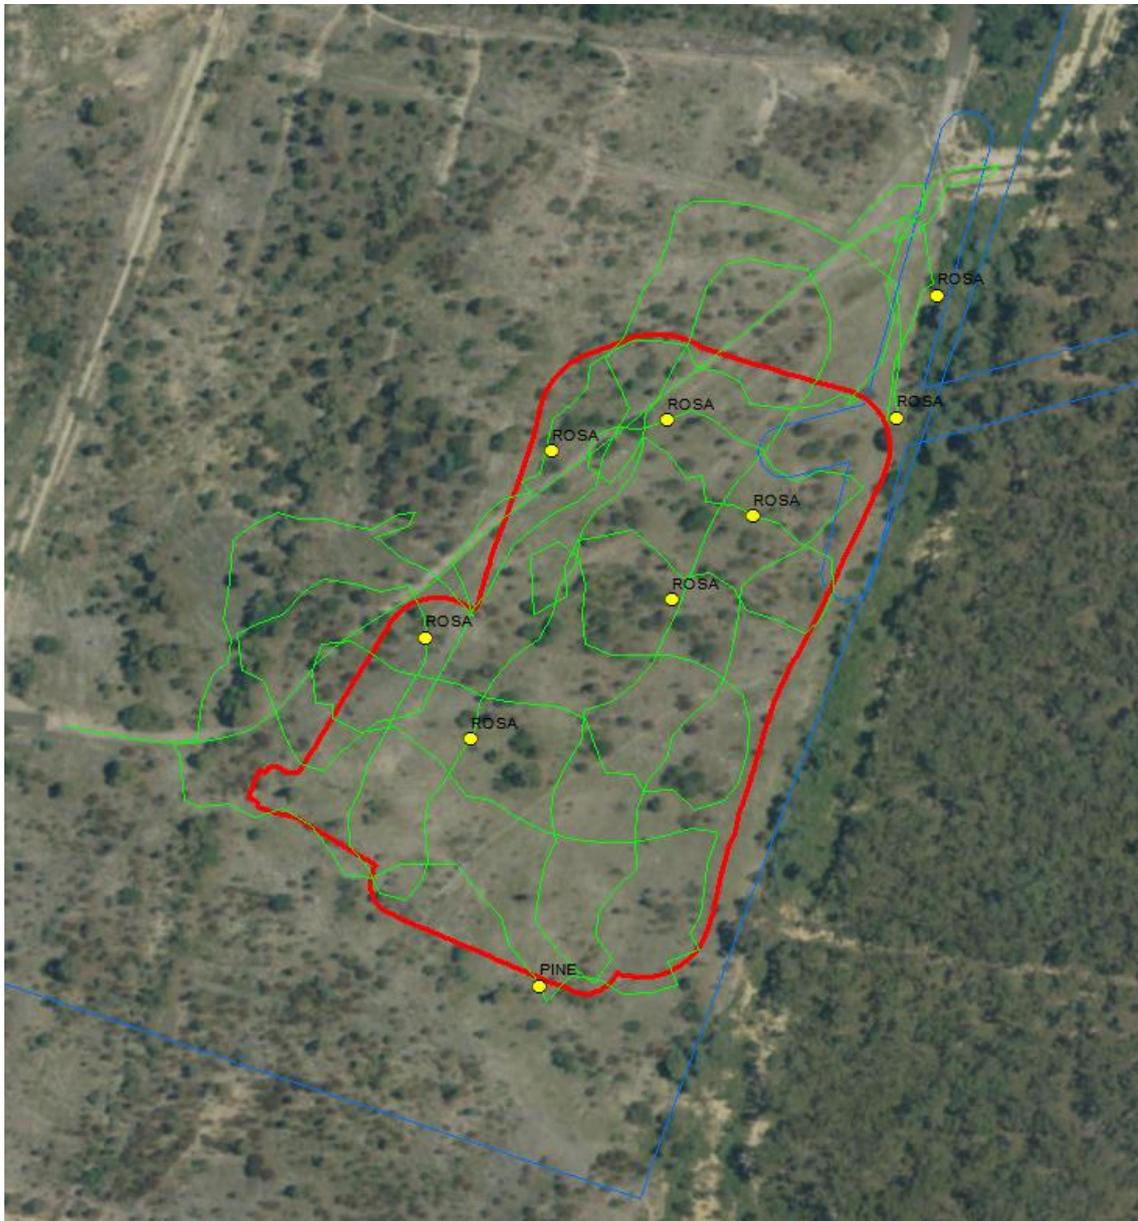
Figure 1.1 : Survey undertaken on 30 October 2017 showing area covered (green line) and location of high threat weed species *Rosa rubiginosa* and *Pinus* sp. (yellow dots). Other weeds including *Hypericum perforatum* and juvenile *Rubus fruticosus* sp. aggregate are scattered throughout the area. The red polygon shows the WTP footprint.

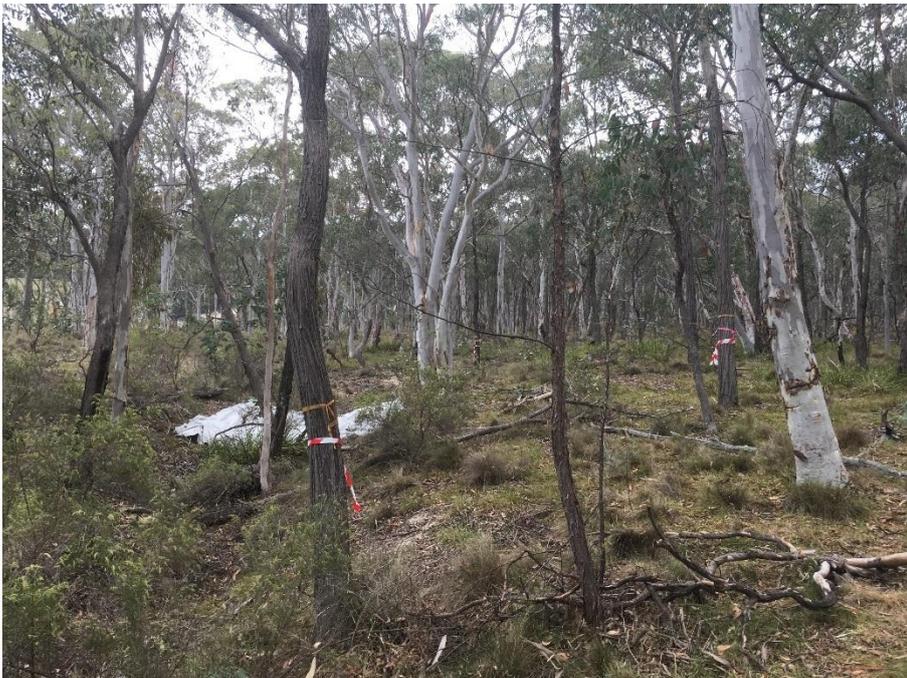
Photo 2 : The project application area east of the WTP site showing *Eucalyptus cannonii* (potential hybrids) identified with tape for retention

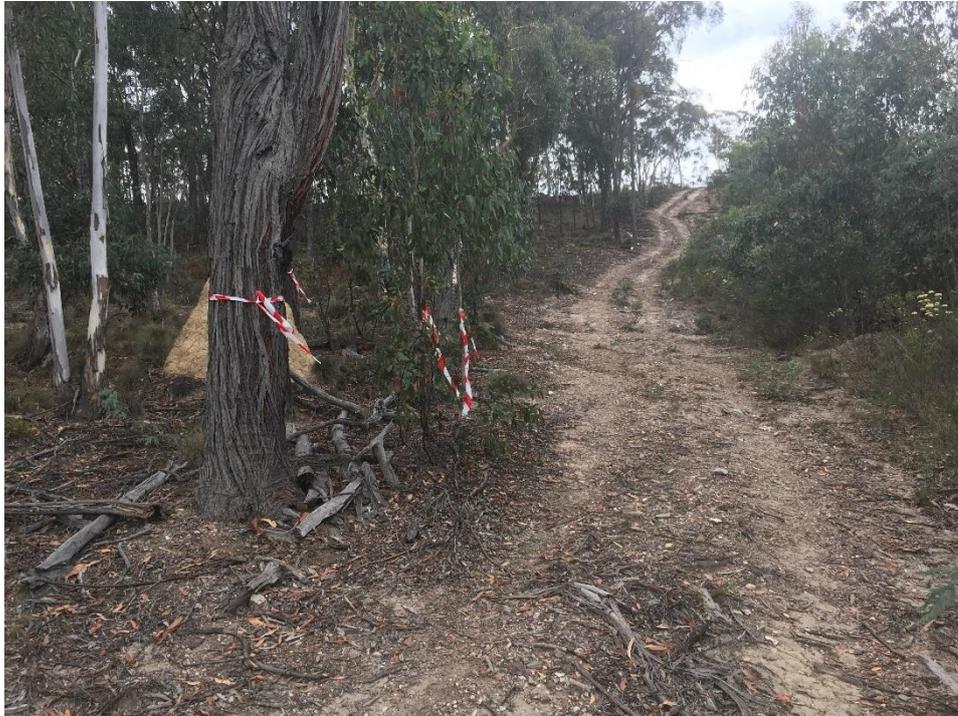
Photo 5 : The access track adjacent to the project application area showing mature *Eucalyptus cannonii* trees identified with tape to prevent accidental damage

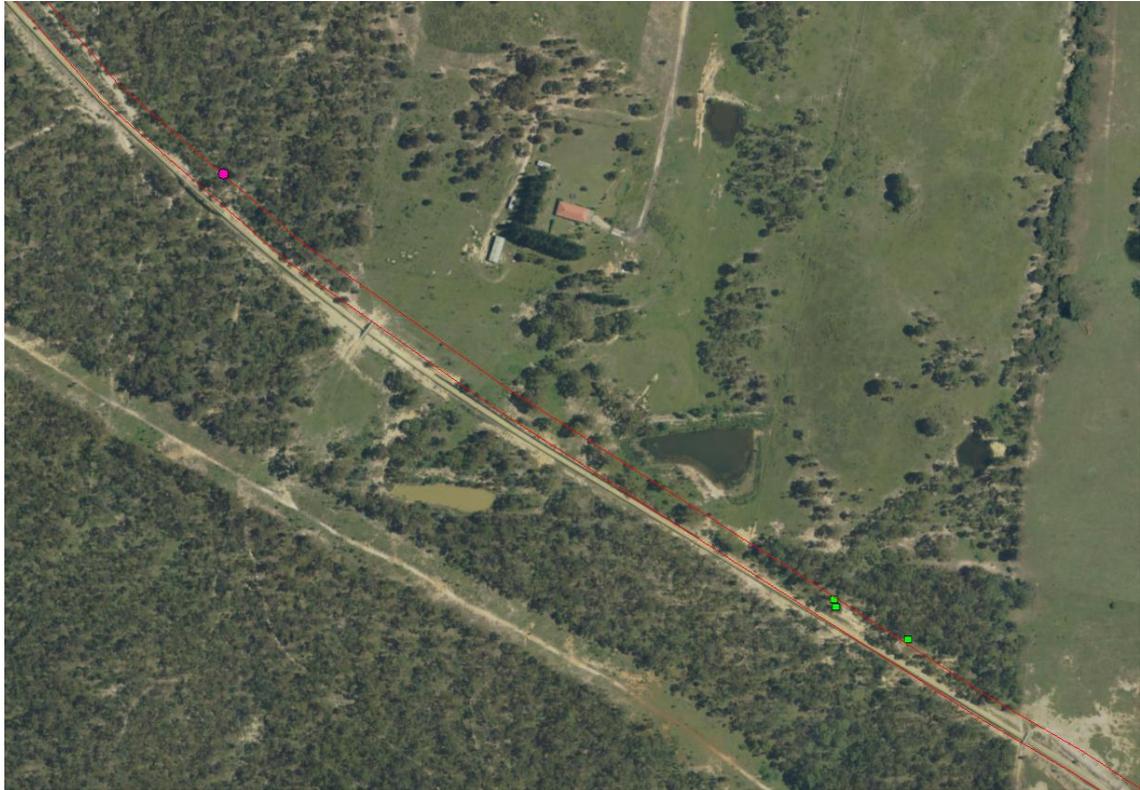
Figure 1 : Location of the three *Eucalyptus cannonii* trees (pink dot) and hollow-bearing trees (green squares) in the project application area along OL2

The maximum number of *Eucalyptus cannonii* trees that can be removed is three individuals as this is what was assessed in the EIS and outlined in the development consent. Exceeding this limit will constitute a breach of the conditions of development consent. Two *Eucalyptus cannonii* trees have been removed to date due to construction activities in the west of the project application area near the MPPS site so works are still within the approval limits. One more *Eucalyptus cannonii* tree could be removed but the three identified trees are at the edge of the project application area along OL2 and should be able to be avoided during vegetation

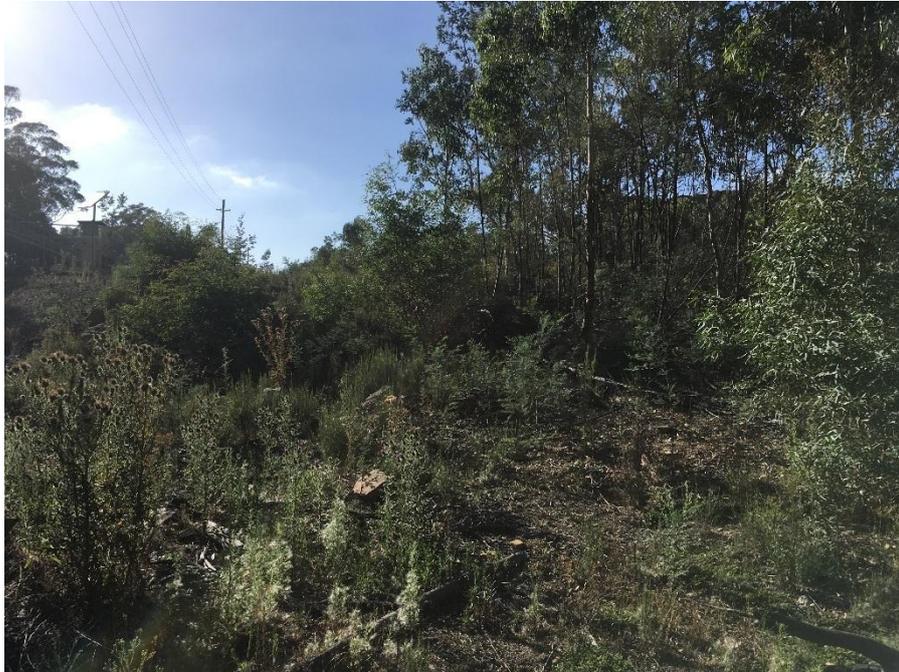
The area of *Ribbon Gum - Snow Gum grassy forest on damp flats, eastern South Eastern Highlands Bioregion* present adjacent to OL3 in the drainage line is in poor condition and is suffering from extensive weed invasion. This area contains some scattered young trees but is generally dominated by herbaceous weeds (see Photo 1). The conditions in this area are as identified in the EIS.

Photo 1 : The disturbed area of Ribbon Gum - Snow Gum grassy forest on damp flats, eastern South Eastern Highlands Bioregion in the project application area in the creek line at the western end of the SCS site

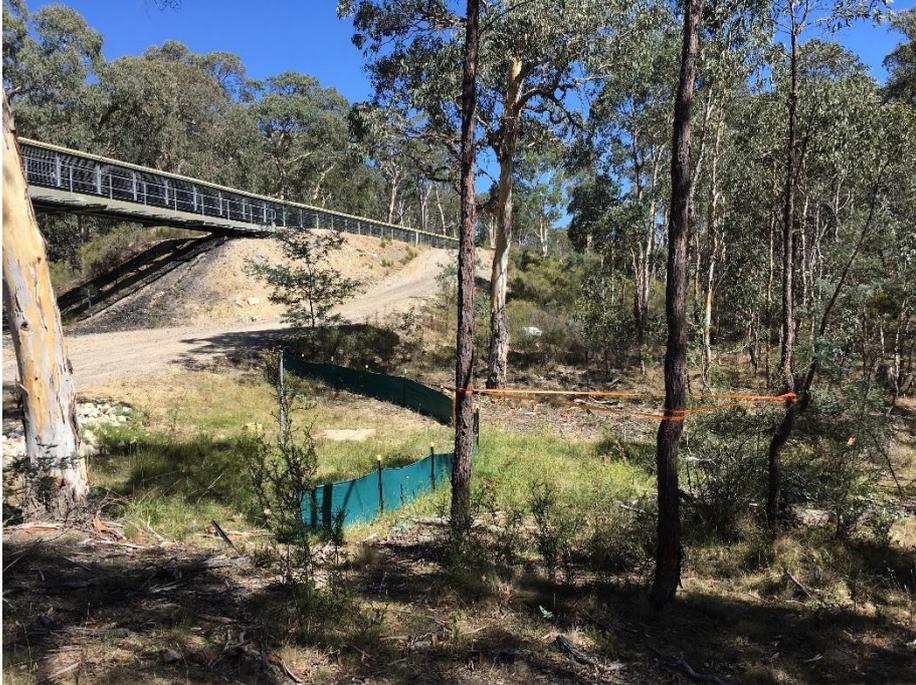
Photo 7 : Three threatened *Eucalyptus cannonii* trees at the edge of the project application area along OL2 identified by orange flagging tape

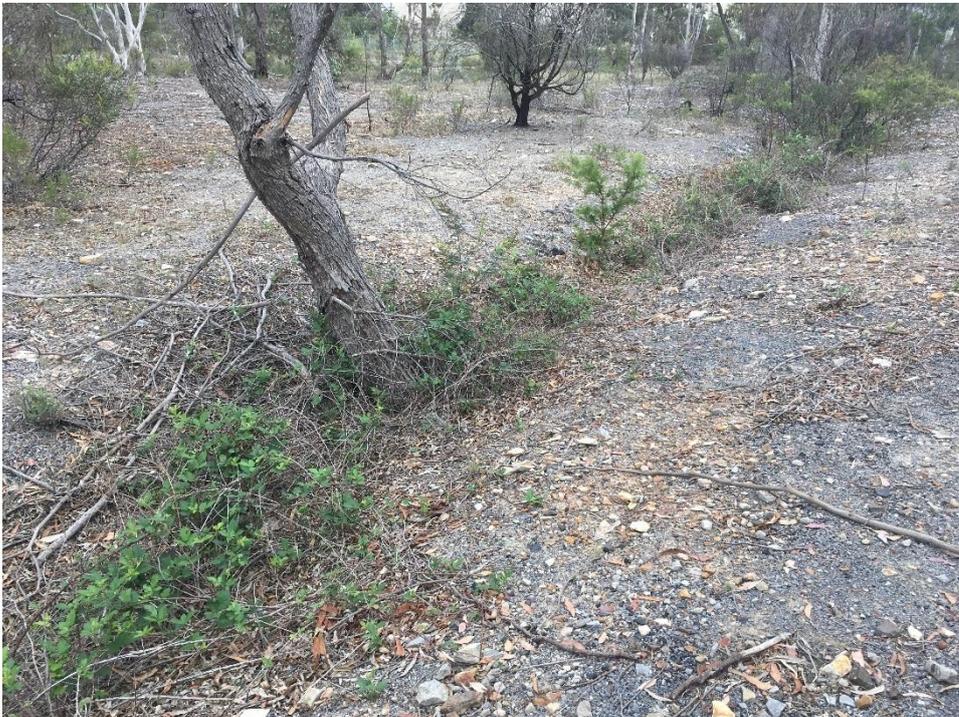
Photo 4: *Rubus fruticosus* sp. aggregate present in the drainage line

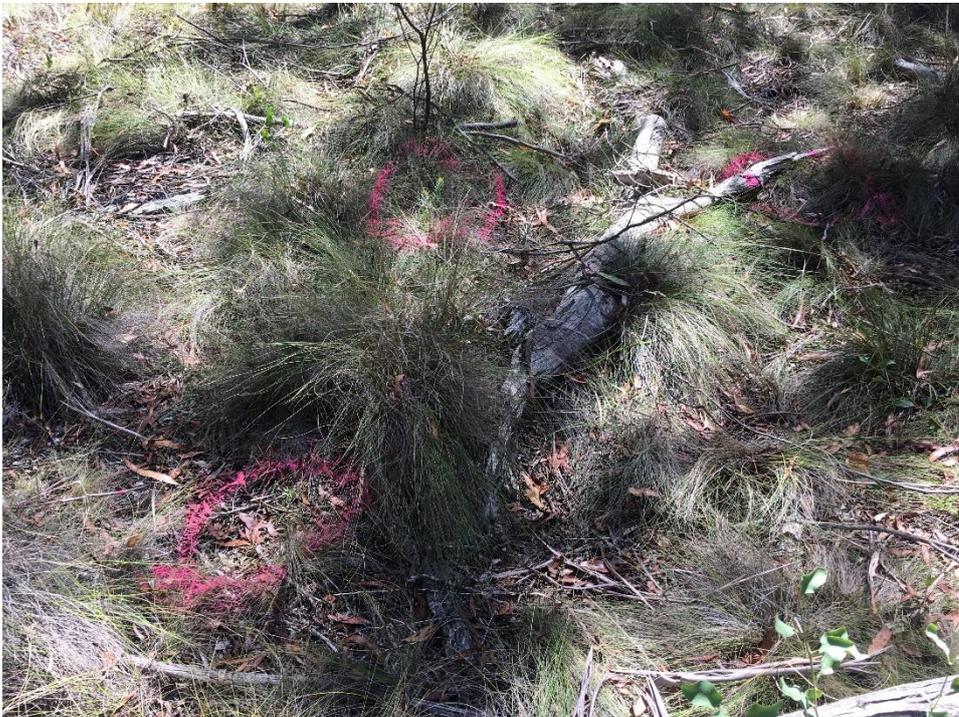
Photo 6 : The smaller *Persoonia hindii* plants marked with spray paint for easy identification during clearing
