***Longwall 411 to 418
Subsidence Management Status
Report***

Springvale Colliery

July 2017

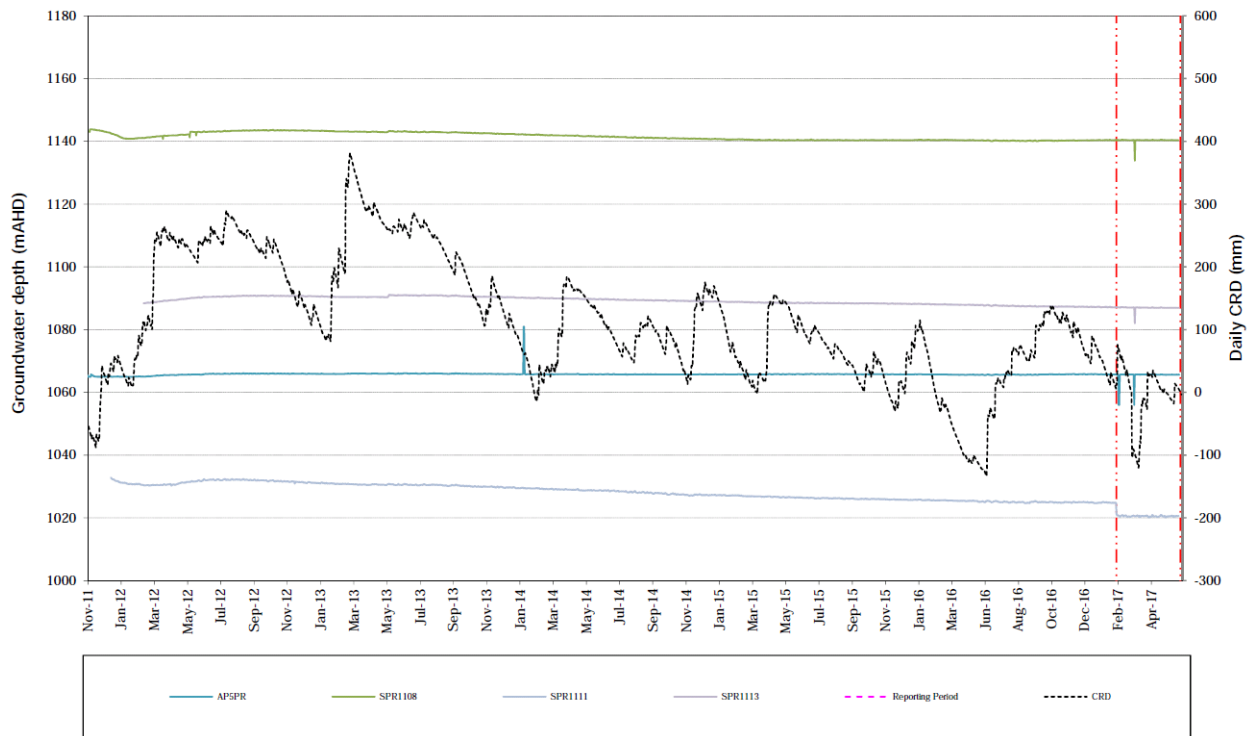
Figure 15 Reference Aquifer Piezometers

Reference site SPR1111 experienced a large (3.5 m) drop between the 1st and 2nd of February, 2017. A trigger notification was issued to Springvale under the LW420-422 Swamp Monitoring Program and is currently being investigated.

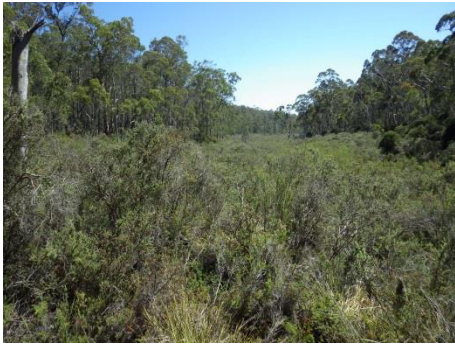
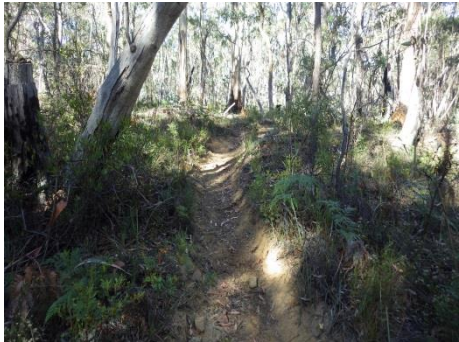
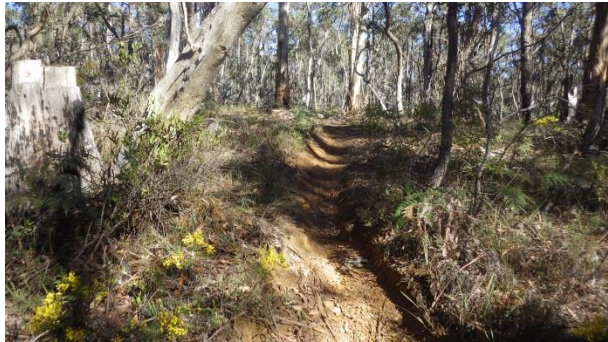
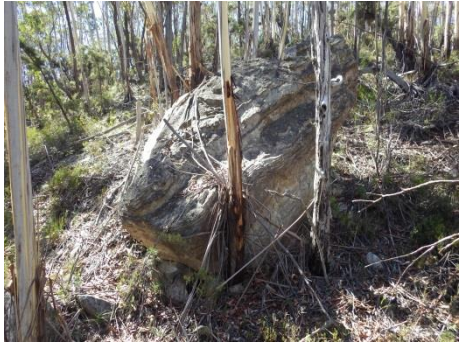
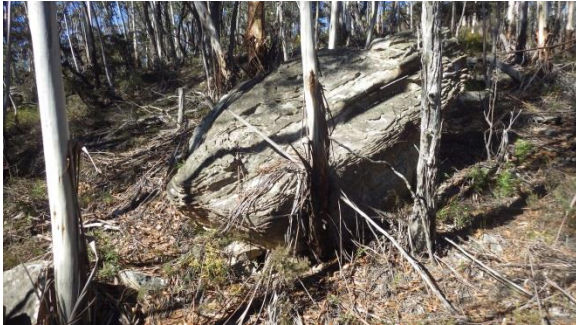
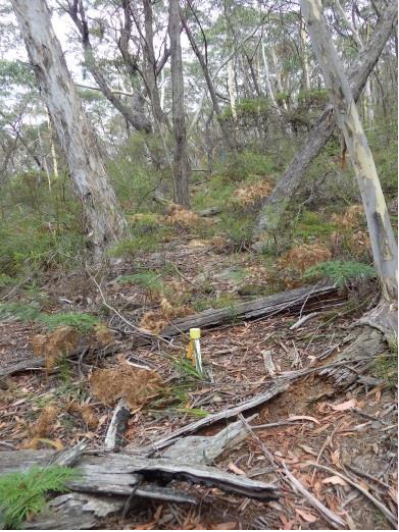
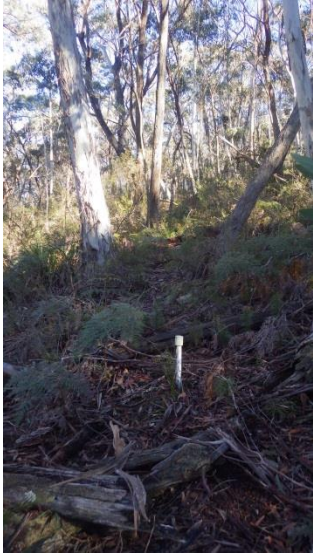
Photos are considered consistent with previous photographic records.

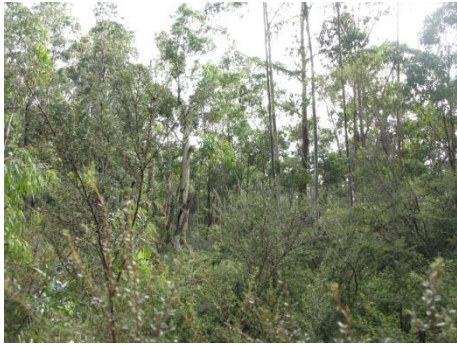
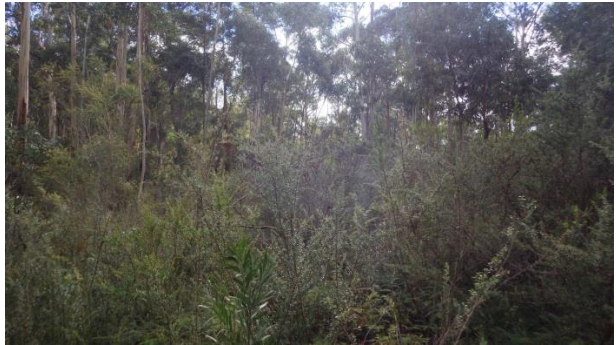
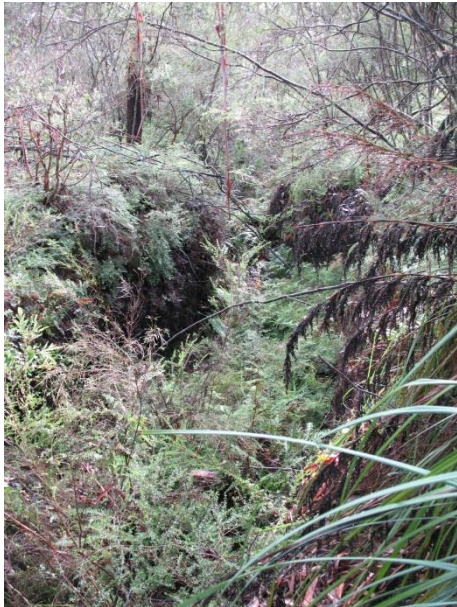
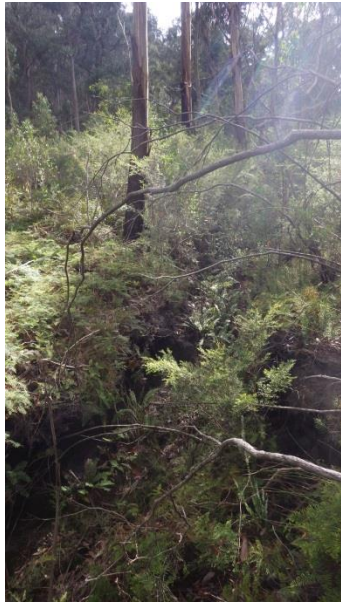
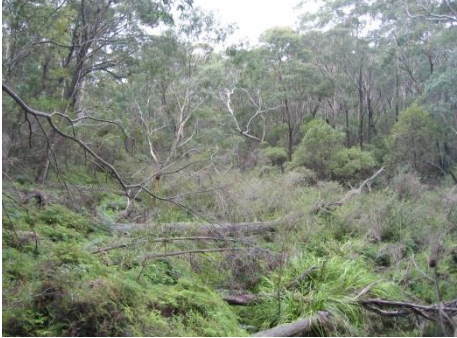
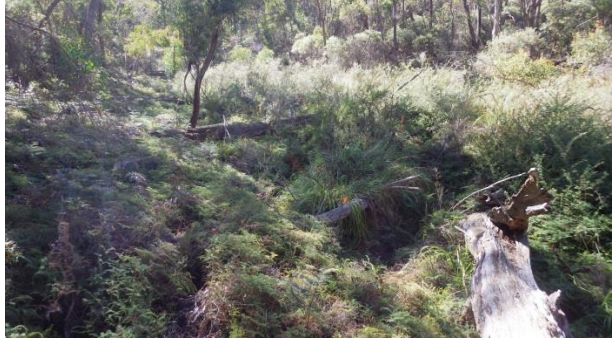
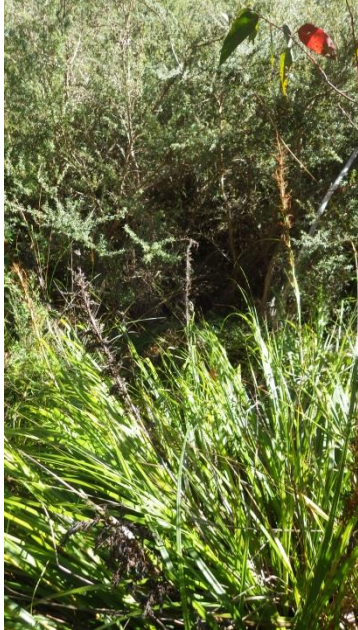
Table 27. Comparison of Sunnyside East Swamp Photographic Monitoring

Photos are considered consistent with previous photographic records.
