Centennial Coal

***Application to Allow Longwall
Mining Under Temperate Highland
Peat Swamps on Sandstone on the
Newnes Plateau***

Springvale Colliery

Information Request Regarding Application to Allow Longwall Mining Under Temperate Highland Peat Swamps on Sandstone on the Newnes Plateau (EPBC Approval 2011/5949)

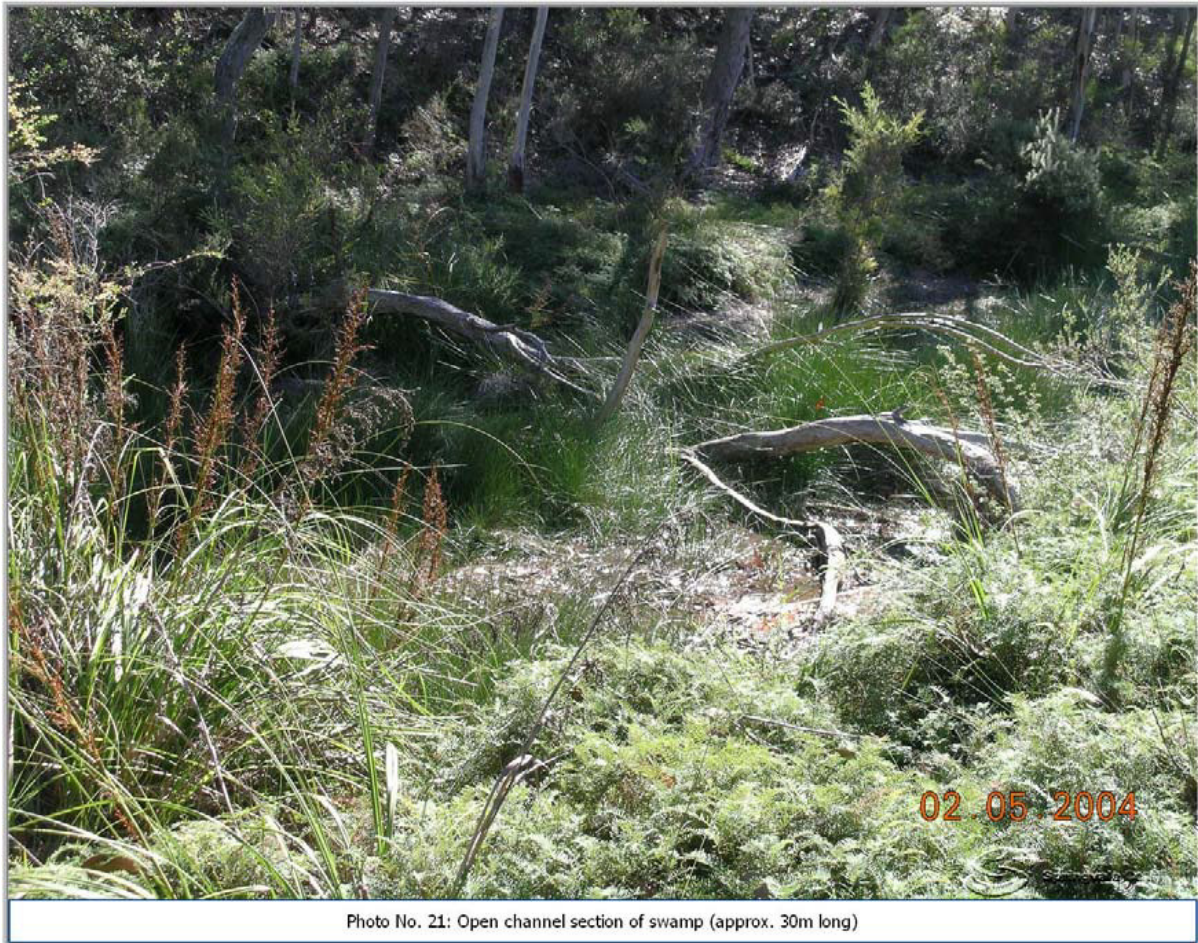
Figure 8.2 – Photo of East Wolgan Swamp taken 2 May 2005 from Location 21 (upstream of cavity location), showing mine water discharge and swamp vegetation. Note the sedges / rushes along the edges of the flow path of mine water discharge and limited vegetation with the flow path of mine water discharge. NB These photos were taken on 2 May 2005, but were incorrectly labelled 2 May 2004.

Figure 8.2 is a photo of East Wolgan Swamp taken on 2 May 2005 (but incorrectly dated 2 May 2004) from Location 21 (upstream of cavity location), showing mine water discharge and swamp vegetation. Note the sedges / rushes along the edges of the flow path of mine water discharge and limited vegetation with the flow path of mine water discharge

- Years of mine water discharge changed swamp hydrology from periodically waterlogged (baseline state) to permanently waterlogged
- Discharge Volumes <6MI/day (av.4MI/day) prior to baseline survey date
- Discharge Volumes up to 12MI/day (av.10MI/day) after baseline survey date
- Sedges and Rushes flourished adjacent to mine water discharge flow path
- Vegetation not present in mine water discharge flow path

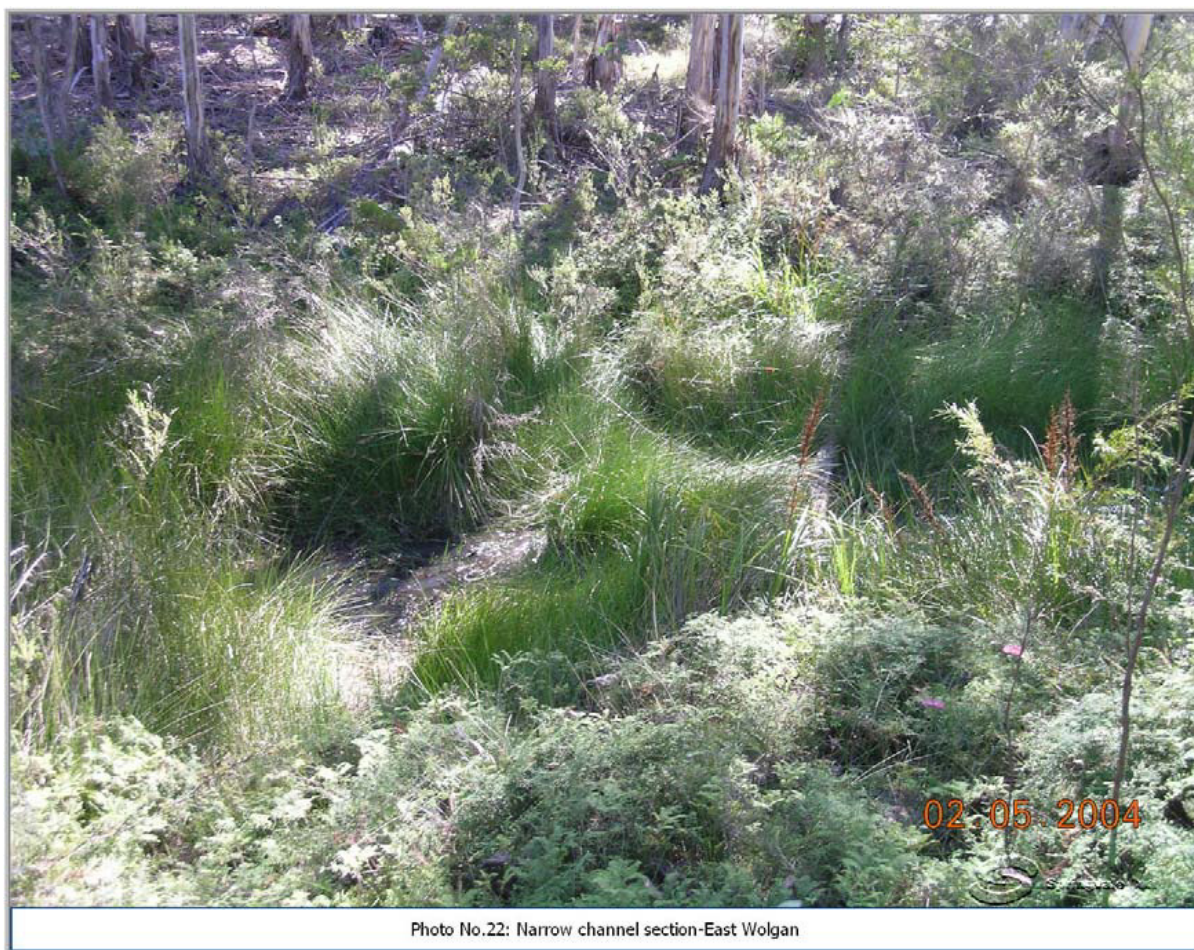
Figure 8.3 – Photo of East Wolgan Swamp taken 2 May 2005 from Location 22 (upstream of cavity location), showing mine water discharge and swamp vegetation. Note the sedges / rushes along the edges of the flow path of mine water discharge and limited vegetation with the flow path of mine water discharge. NB These photos were taken on 2 May 2005, but were incorrectly labelled 2 May 2004.

Figure 8.3 is a photo of East Wolgan Swamp taken on 2 May 2005 (but incorrectly dated 2 May 2004) from Location 22 (upstream of cavity location), showing mine water discharge and swamp vegetation. Note the sedges / rushes along the edges of the flow path of mine water discharge and limited vegetation with the flow path of mine water discharge

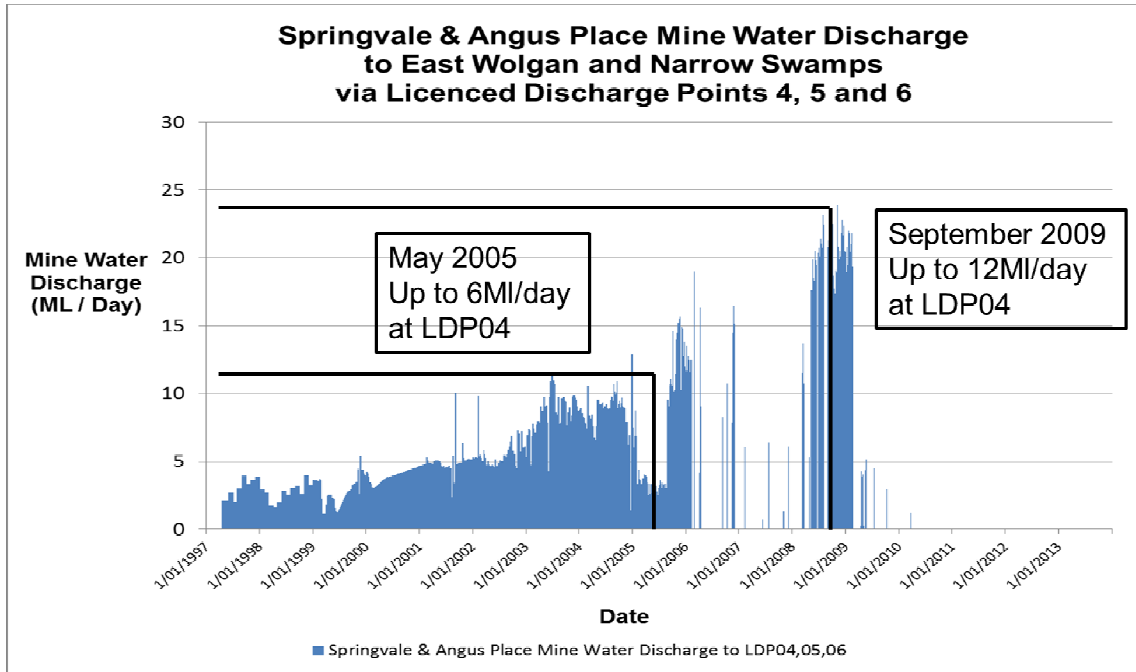
Figure 8.4 – Graph of Timescaled Volumetric Flow Rates of Mine Water Discharge from Licenced Discharge Points 4,5 and 6 to East Wolgan Swamp and Narrow Swamp . The volume discharged at LDP04 at East Wolgan Swamp is half of the total volume recorded on the graph. Note the discharge rates of up to 6ML/day up to May 2005 (timing of pre-mining baseline photographic survey) and the much greater emergency discharge rates of up to 12ML/day which occurred after this date.

Figure 8.4 is a graph of Timescaled Volumetric Flow Rates of Mine Water Discharge from Licenced Discharge Points 4,5 and 6 to East Wolgan Swamp and Narrow Swamp . The volume discharged at LDP04 at East Wolgan Swamp is half of the total volume recorded on the graph. Note the discharge rates of up to 6MI/day up to May 2005 (timing of pre-mining baseline photographic survey) and the much greater emergency discharge rates of up to 12MI/day which occurred after this date.

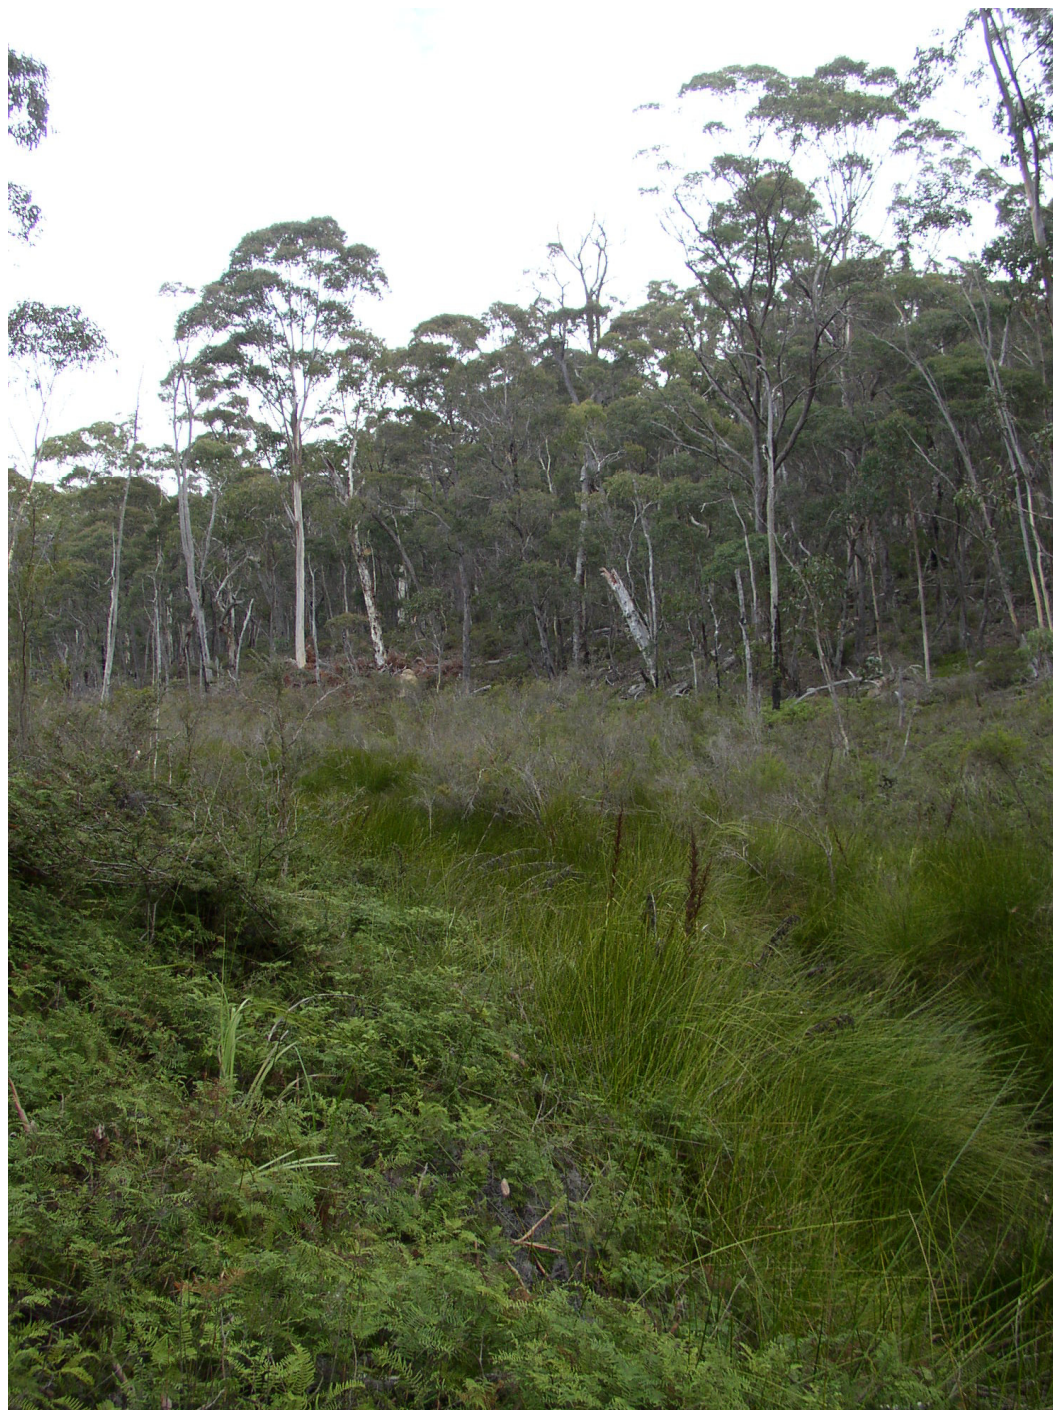
Figure 8.5 Photo of EW01 Flora Monitoring Quadrat dated 9 June 2005 (Winter). At this time:

- There had been continuous MWD at 2-5MI/day for several years
- Standing Water Level was at Ground Level in mine water discharge flow path
- Sedges Flourishing adjacent to mine water discharge flow path

Figures 8.5 to 8.8 are a series of photos of EW01 Flora Monitoring Quadrat dated between 9 June 2005 and 29 November 2006. Included with the figures is text relating to mine water discharge, standing water level and vegetation condition. Below is a summary of trends which can be observed from Figures 8.5 to 8.8.

- There was continuous mine water discharge at up to 8MI/day until 5 Feb 2006
- There was emergency mine water discharge of up to 9MI/day on only 13 days between 27 February and 10 November 2006.
- The standing water level at both swamp piezometers WE1 and WE2 fell from ground level to base of bores WE1 (2.5m bgl) and WE2 (1.2m bgl) by the end of July 2006.
- There was a trend of swamp drying within mine water discharge flow path
- Condition of sedges (and other species) adjacent to mine water discharge flow path was healthy during mine water discharge and deteriorated badly following cessation of continuous mine water discharge.

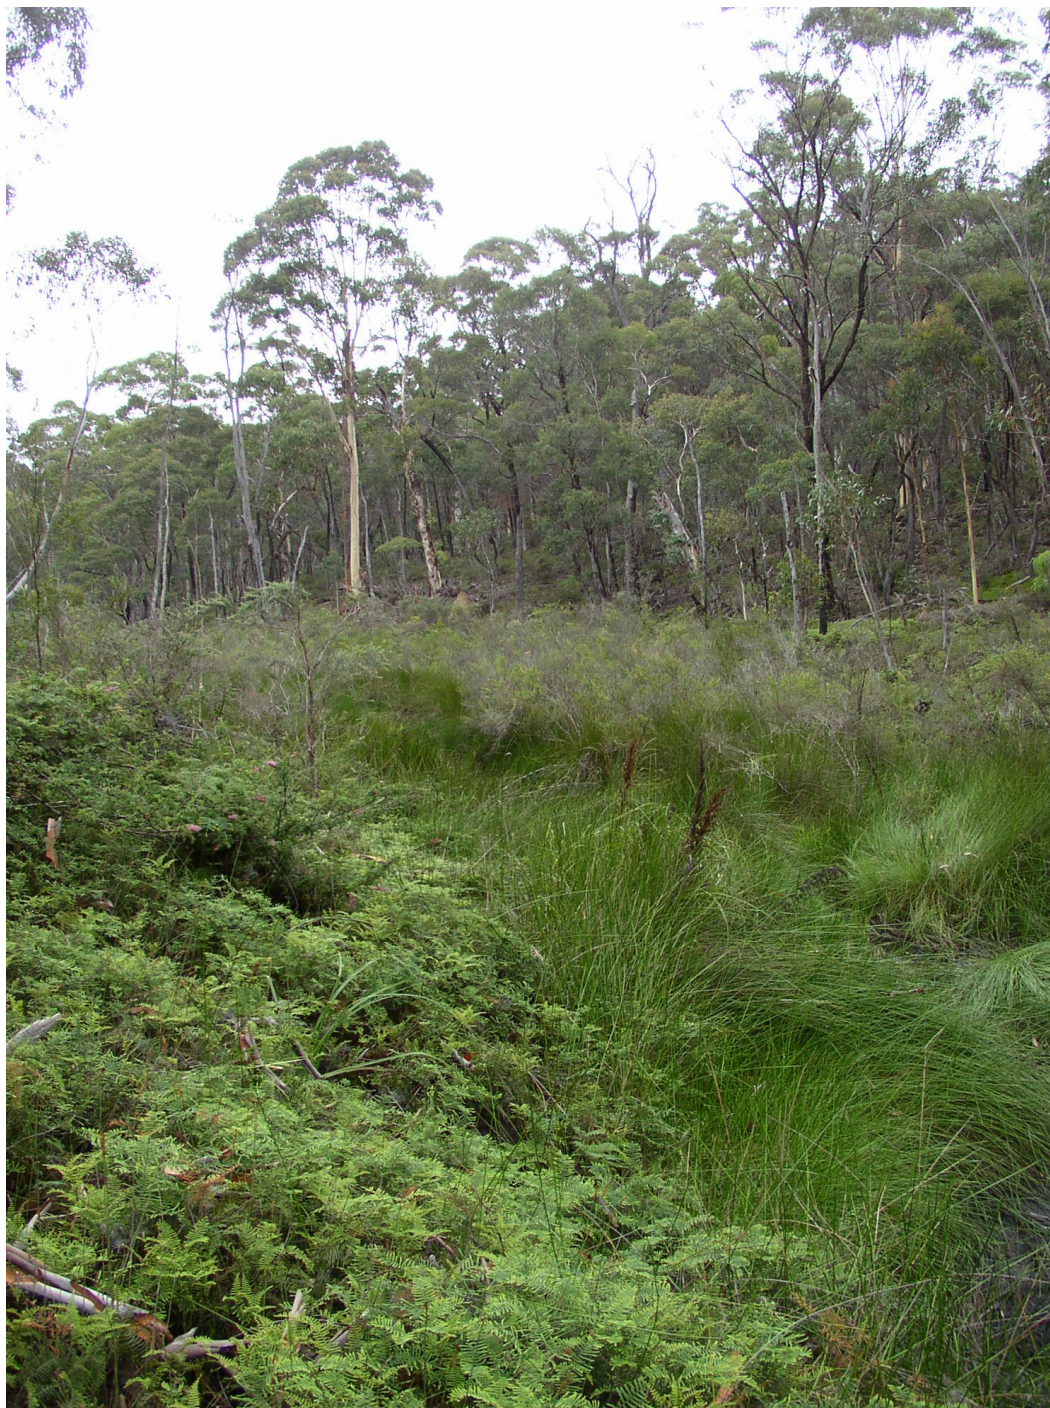
Figure 8.6 Photo of EW01 Flora Monitoring Quadrat dated 3 March 2006 (Autumn). At this time:

- There had been continuous mine water discharge at up to 8ML/day to 5 Feb 2006
- There had been emergency mine water discharge at up to 7ML/day 27 Feb - 1 Mar 2006
- Standing Water Level was at Ground Level in mine water discharge flow path
- Sedges Flourishing adjacent to mine water discharge flow path

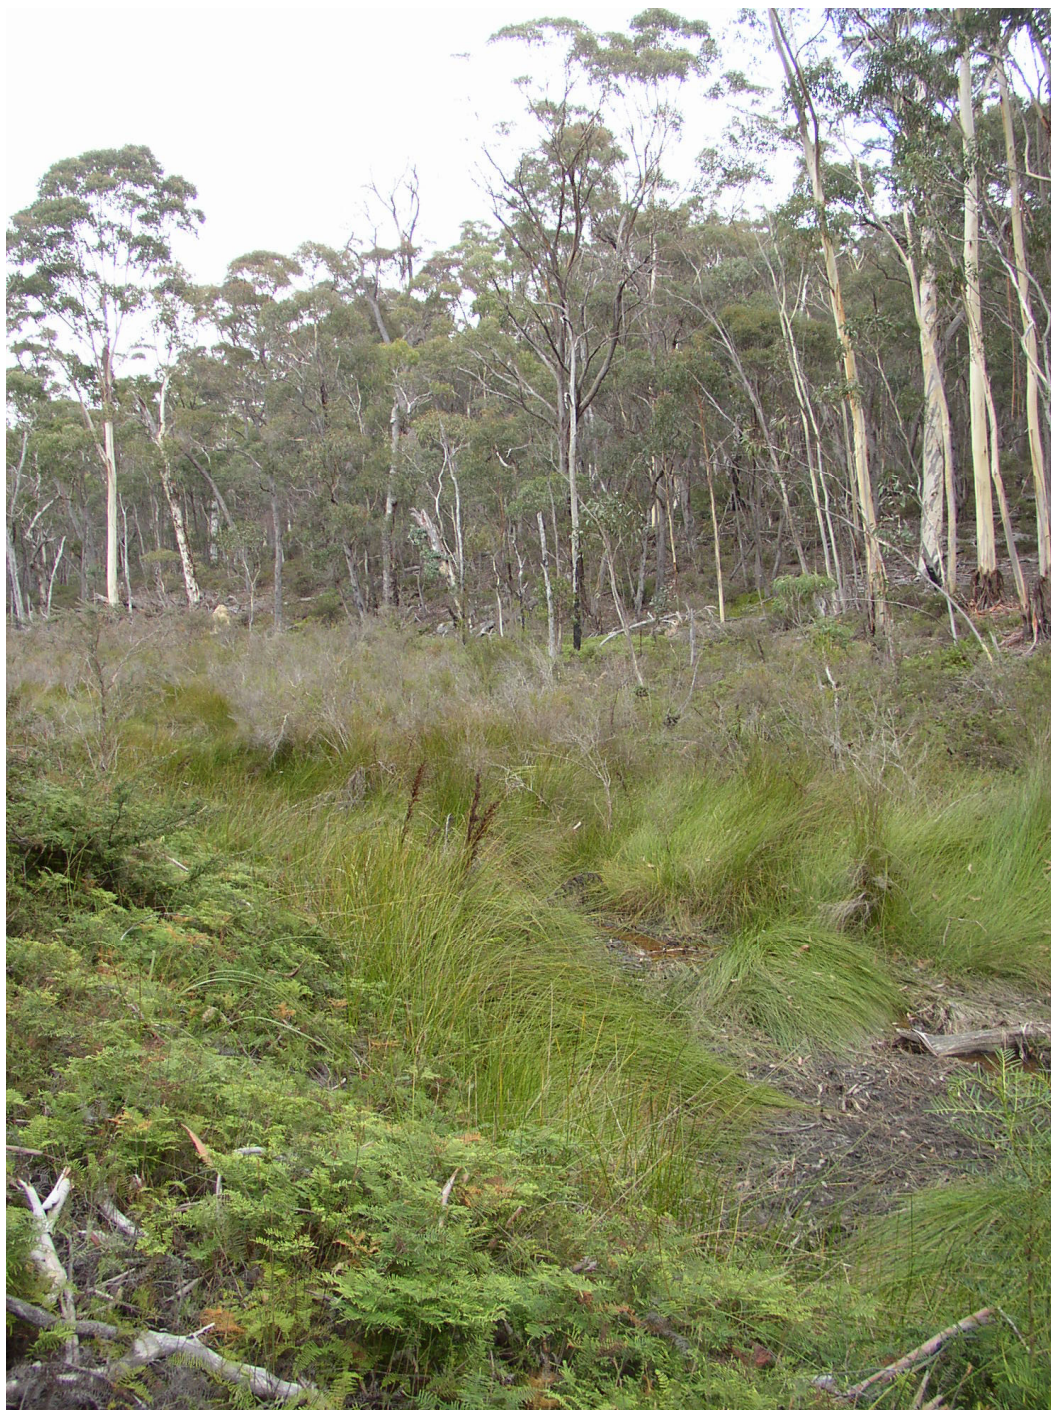
Figure 8.7 Photo of EW01 Flora Monitoring Quadrat dated 12 May 2006 (Winter). At this time:

- There had been minor emergency mine water discharge (9 days) at up to 9MI/day from 3 March to 12 May 2006
- Standing Water Level was falling (0.1m to 1.1m Below Ground Level)
- Swamp was drying within mine water discharge flow path
- Condition of sedges adjacent to mine water discharge flow path was deteriorating

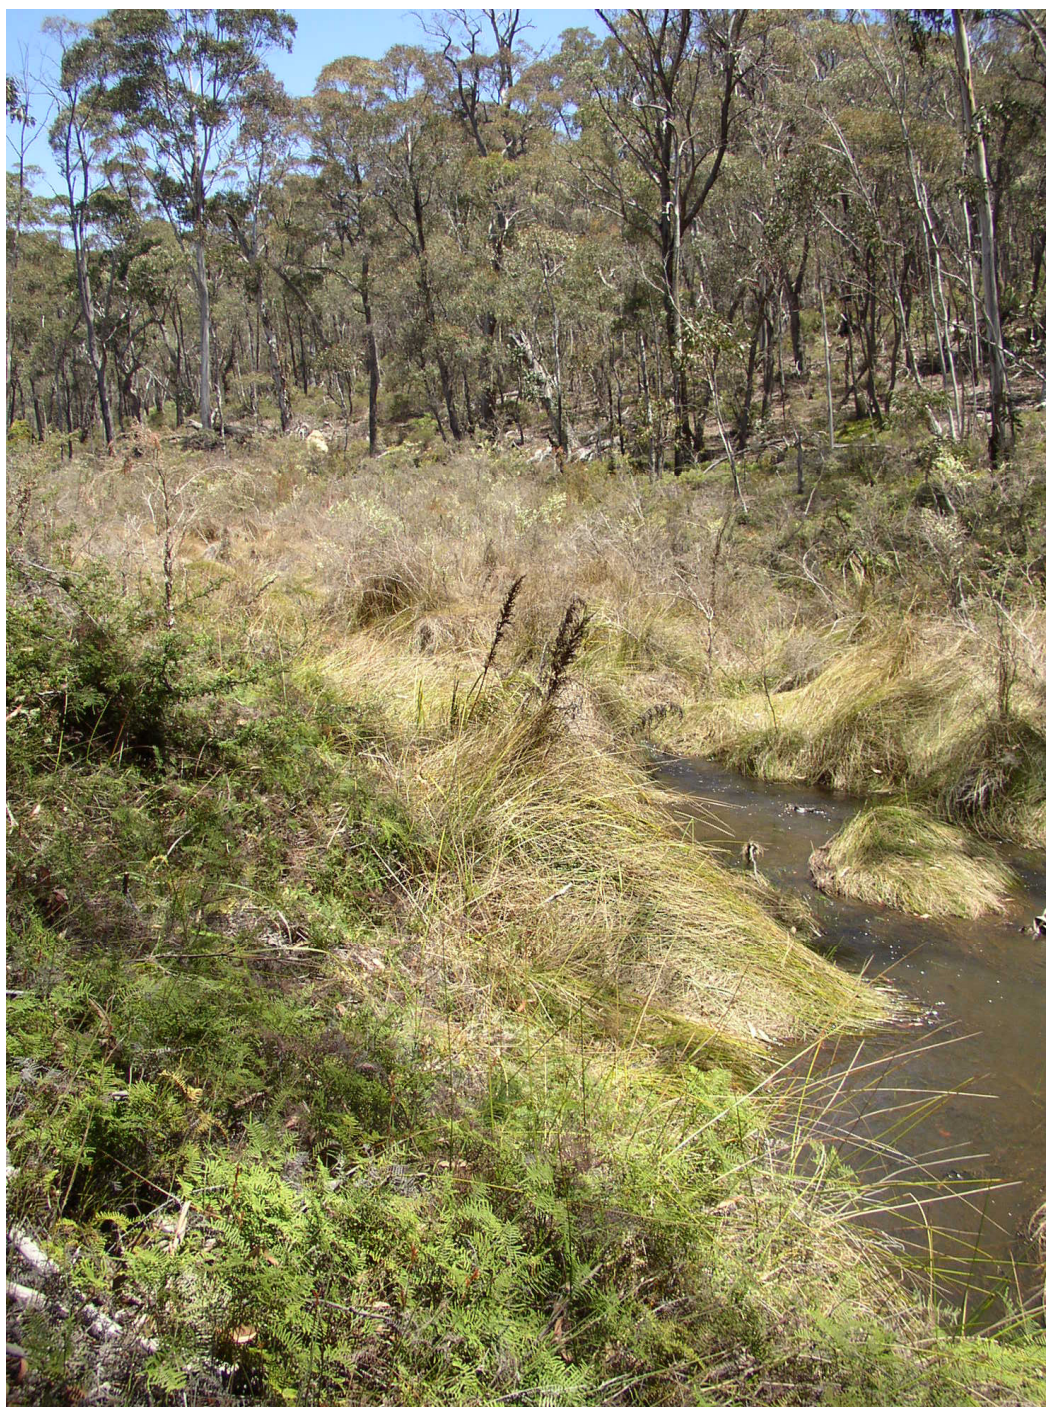
Figure 8.8 Photo of EW01 Flora Monitoring Quadrat dated 29 November 2006 (Spring). At this time:

- There had been minor emergency mine water discharge (4 of 182 days) at up to 9Ml/day from 12 May to 10 November 2006
- Standing Water Level Fell to base of Bores WE1 (2.5m bgl) and WE2 (1.2m bgl) for 4 months
- Trend of Swamp Drying within MWD flow path NB there is emergency mine water discharge in this photo (recorded 10-30 November 2006)
- Condition of sedges adjacent to mine water discharge flow path was deteriorating further

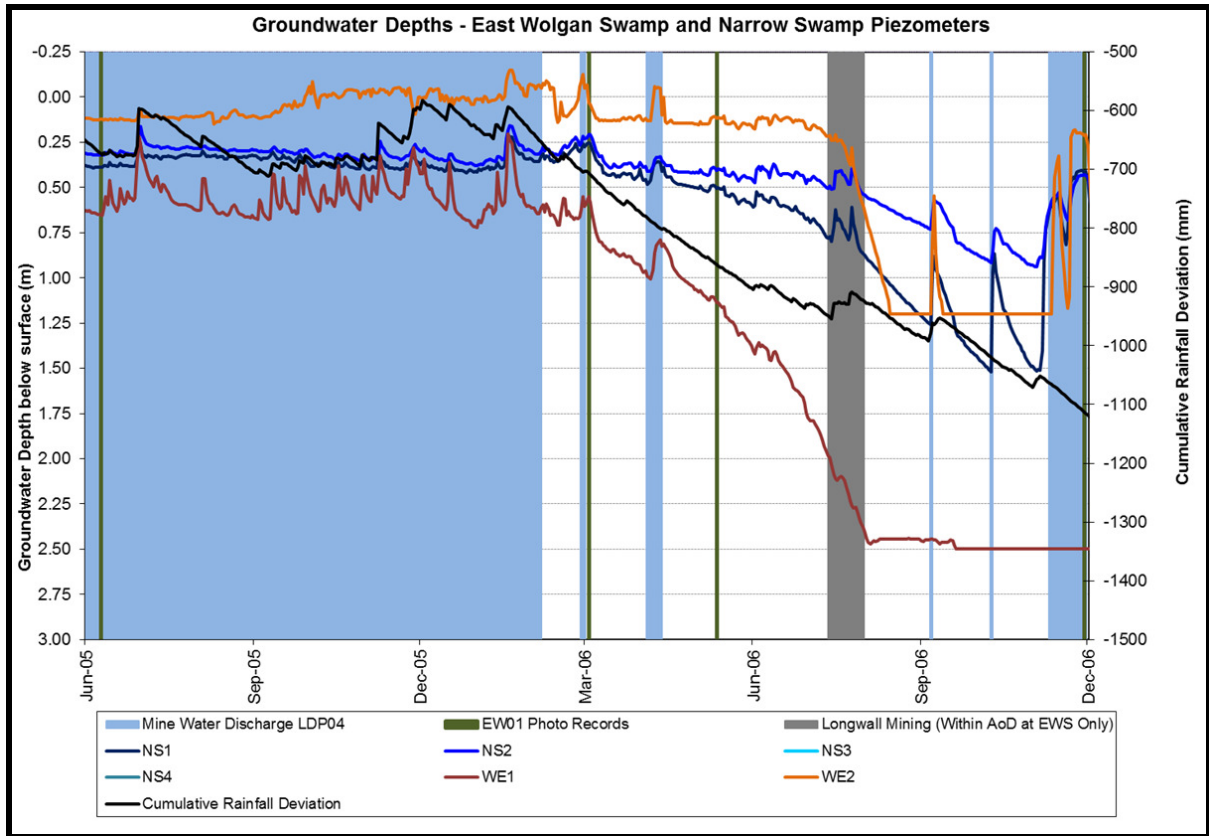
Figure 8.12 – Hydrographs of East Wolgan Swamp and Narrow Swamp Piezometers showing standing water levels near EW01 vegetation monitoring quadrat during the photo monitoring intervals shown on Figures 8.5 to 8.8 above. There is a clear trend of falling standing water levels during this period in both Narrow Swamp and East Wolgan Swamp, which illustrates the change of swamp hydrology back to pre-mine water discharge periodically waterlogged conditions. Note the similar behaviour of piezometers in Narrow Swamp and East Wolgan Swamp, with rates of decline in standing water levels increasing after 25 July 2006. The timing of increased rate of decline in standing water levels coincides with Longwall 411 mining within the Angle of Draw of piezometer WE2 (not WE1), but also coincides with the ongoing decline in Cumulative Rainfall Deviation (CRD) due to very low rainfall levels throughout the calendar year of 2006. Note that the rates of decline are generally greater in the East Wolgan Swamp piezometers than the Narrow Swamp piezometers, but the trend is the same.

Figure 8.12 shows hydrographs of East Wolgan Swamp and Narrow Swamp piezometers with standing water levels near EW01 vegetation monitoring quadrat during the photo monitoring intervals shown on Figures 8.5 to 8.8 above. There is a clear trend of falling standing water levels during this period in both Narrow Swamp and East Wolgan Swamp, which illustrates the change of swamp hydrology back to pre-mine water discharge periodically waterlogged conditions. Note the similar behaviour of piezometers in Narrow Swamp and East Wolgan Swamp, with rates of decline in standing water levels increasing after 25 July 2006. The timing of increased rate of decline in standing water levels coincides with Longwall 411 mining within the Angle of Draw of piezometer WE2 (not WE1), but also coincides with the ongoing decline in Cumulative Rainfall Deviation (CRD) due to very low rainfall levels throughout the calendar year of 2006. Note that the rates of decline are generally greater in the East Wolgan Swamp piezometers than the Narrow Swamp piezometers, but the trend is the same.

There is a clear trend of falling standing water levels during the period between March 2006 and November 2006, which illustrates the change of swamp hydrology back to pre-mine water discharge periodically waterlogged conditions.

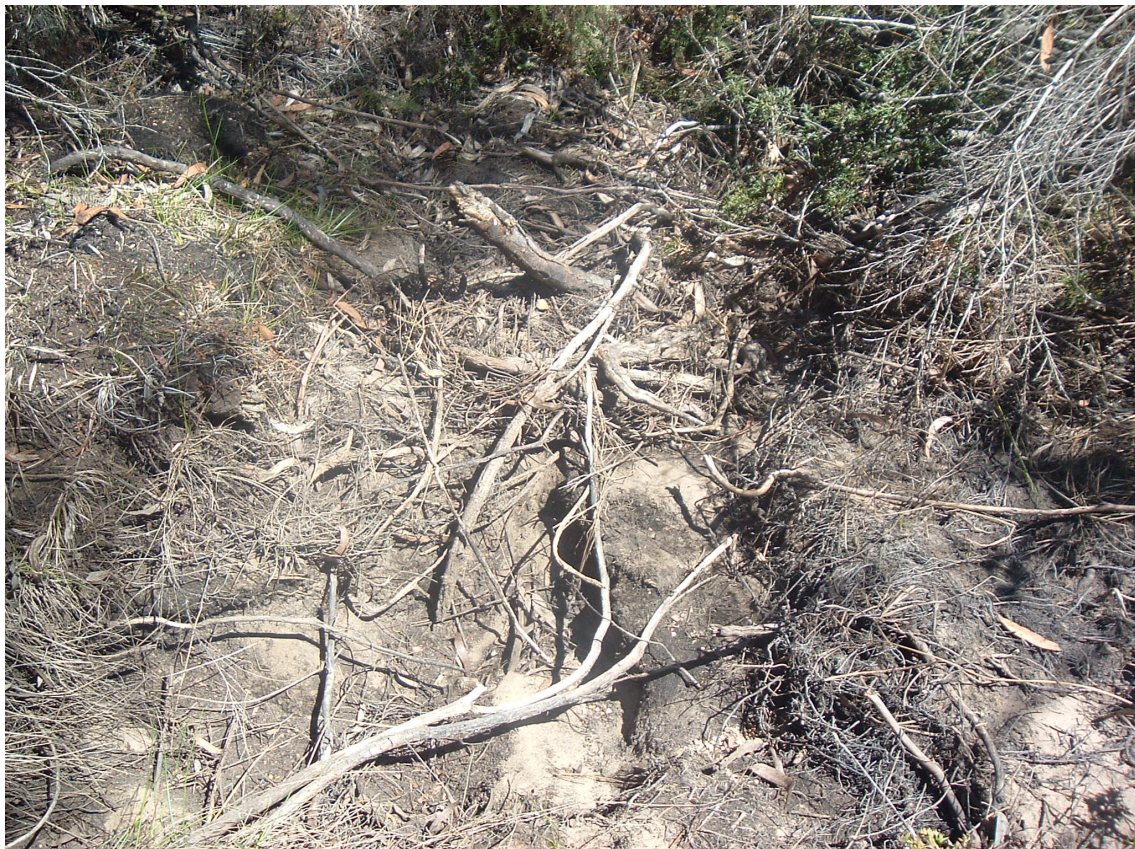
Figure 8.15 Northern Slump Site 12 May 2006 (Around Time Undermined) showing existing erosion

Figures 8.15 to 8.18 are a series of photos at the Northern (Downstream) Slumping and Cavity Location between May 2006 and June 2008, which indicate the presence of an existing erosional feature at this location at the time of mining.

Figures 8.15 to 8.18 are a series of photos showing the Northern (Downstream) Slumping and Cavity Location between 12 May 2006 and 16 June 2008.

- Photos from around the time of mining indicate existing slumping / erosion at the Northern slumping and cavity location
- Possible pre-existing open fault plane underlying peat at Northern slumping and cavity location
- Subsidence caused localised re-activation of fault and mine water discharge caused swamp sediment transport and slumping

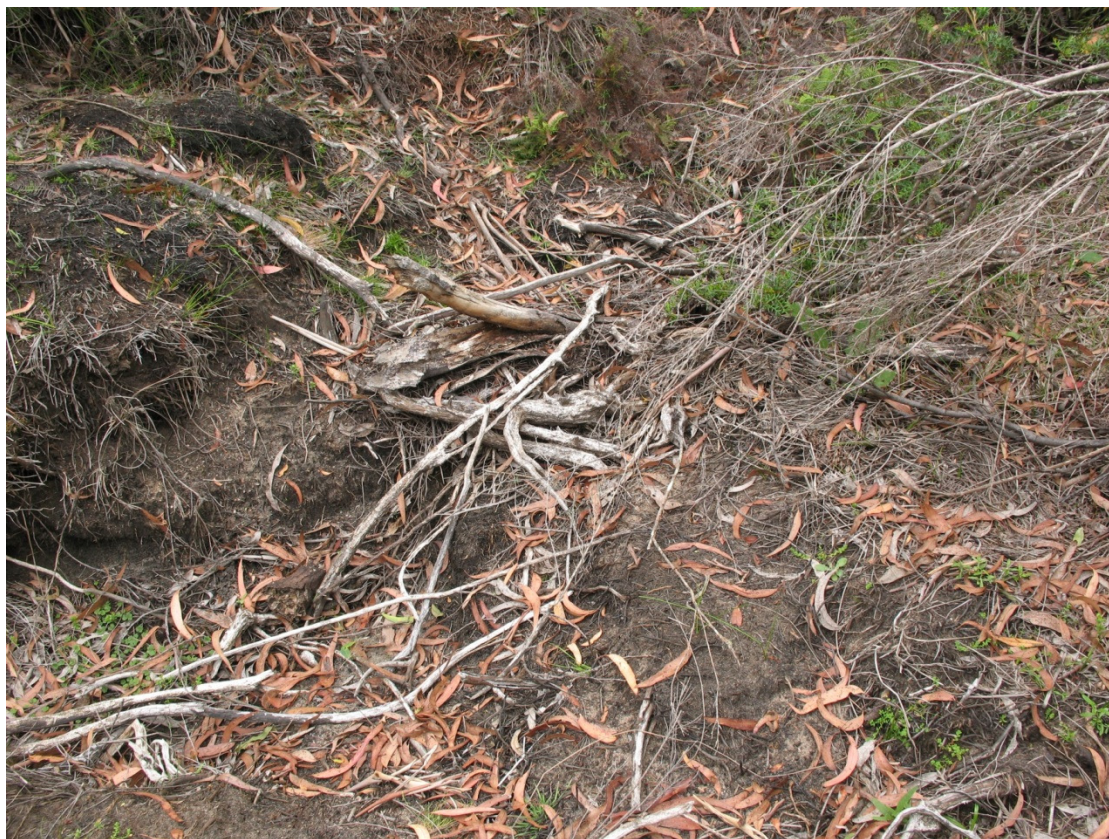
Figure 8.16 Northern Slump Site 17 January 2008 – Before Major Emergency Discharges

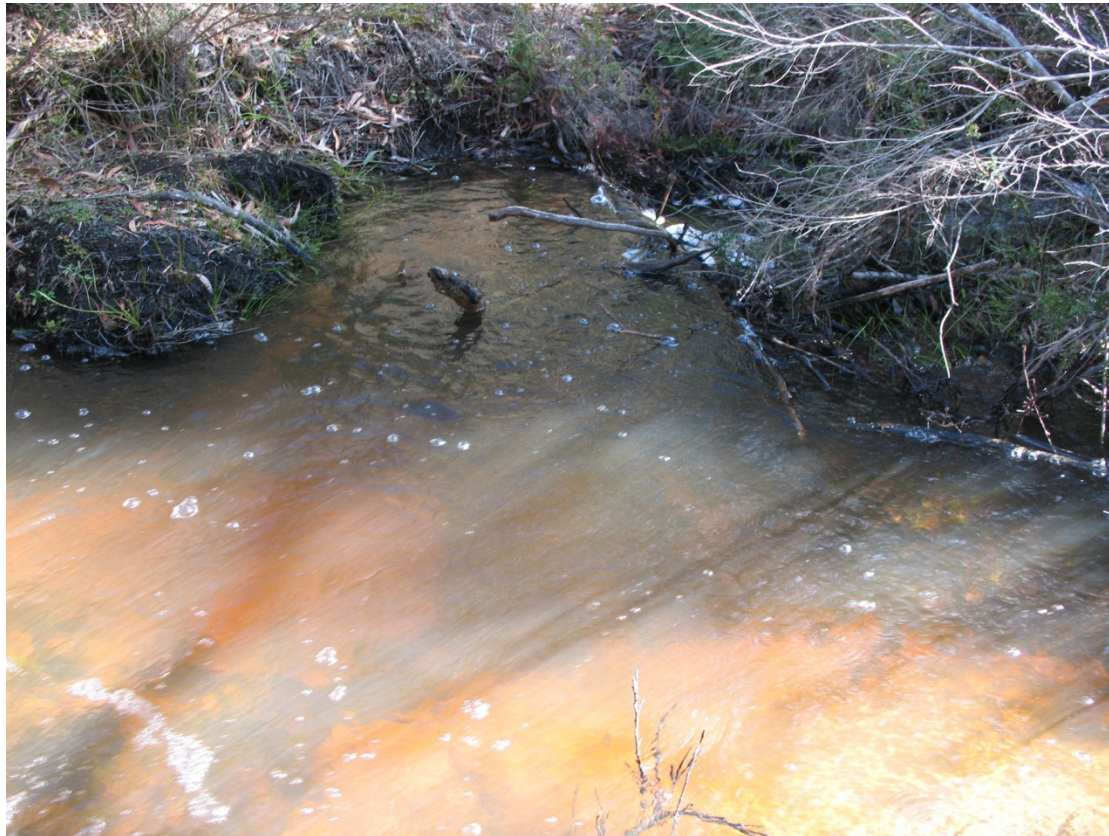
Figure 8.17 Northern Slump Site 23 May 2008 – During Major Emergency Discharges

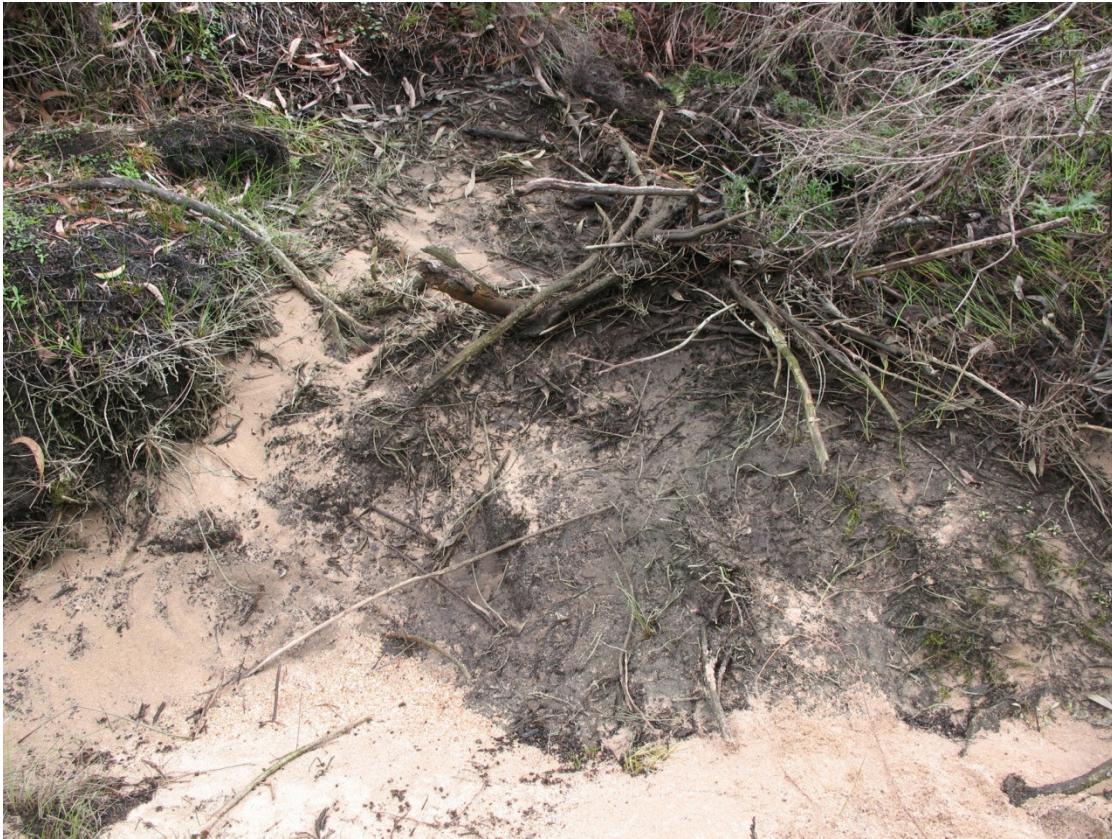
Figure 8.18 Northern Slump Site 16 June 2008 – Between Major Emergency Discharges
