Centennial Coal

***Application to Allow Longwall
Mining Under Temperate Highland
Peat Swamps on Sandstone on the
Newnes Plateau***

Springvale Colliery

Information Request Regarding Application to Allow Longwall Mining Under Temperate Highland Peat Swamps on Sandstone on the Newnes Plateau (EPBC Approval 2011/5949)

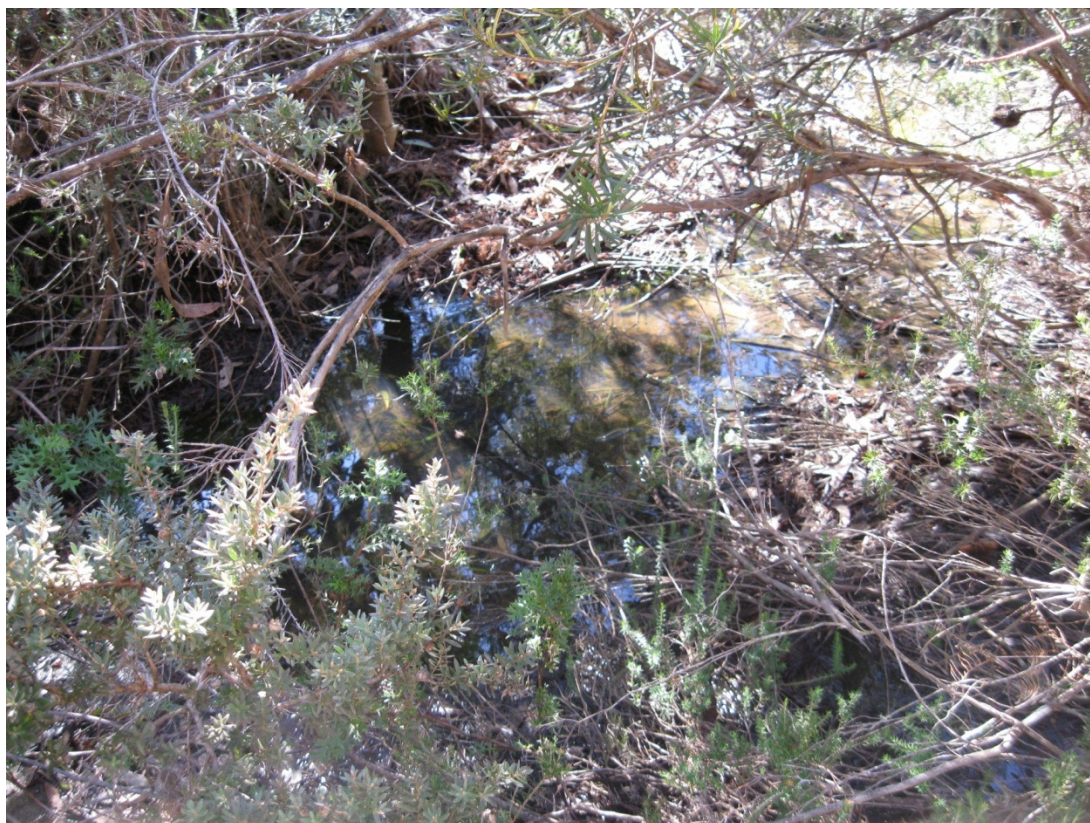
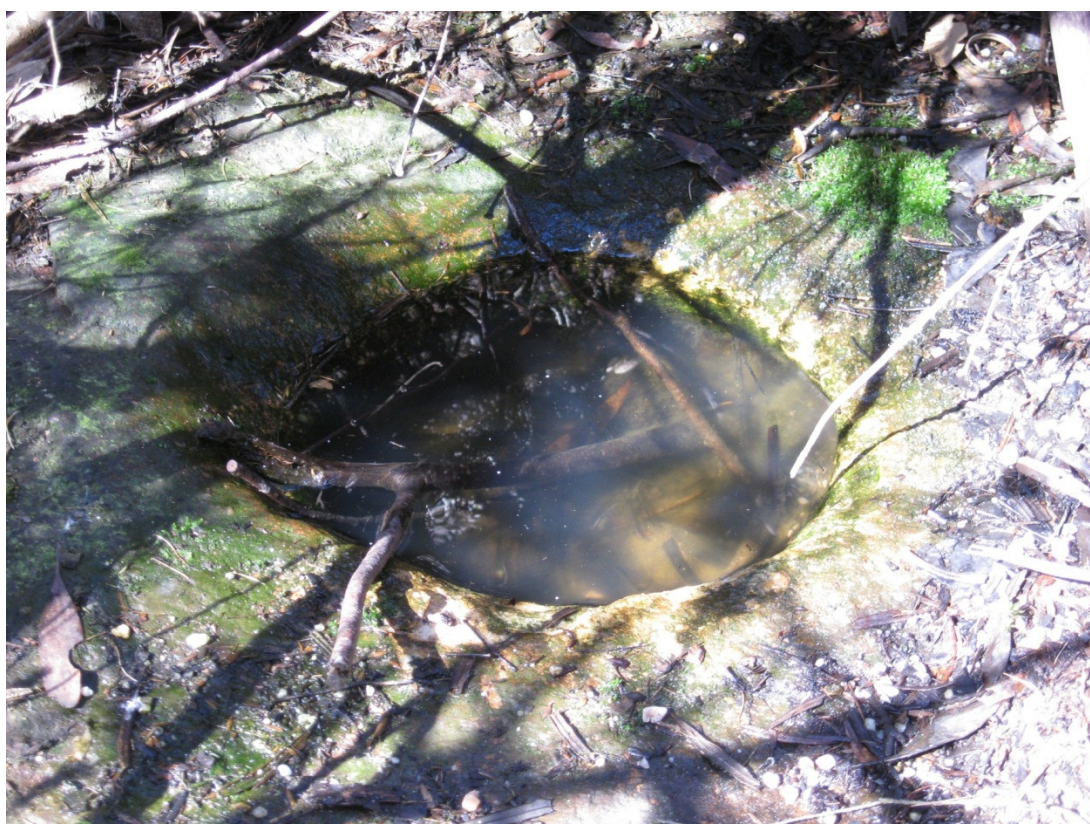
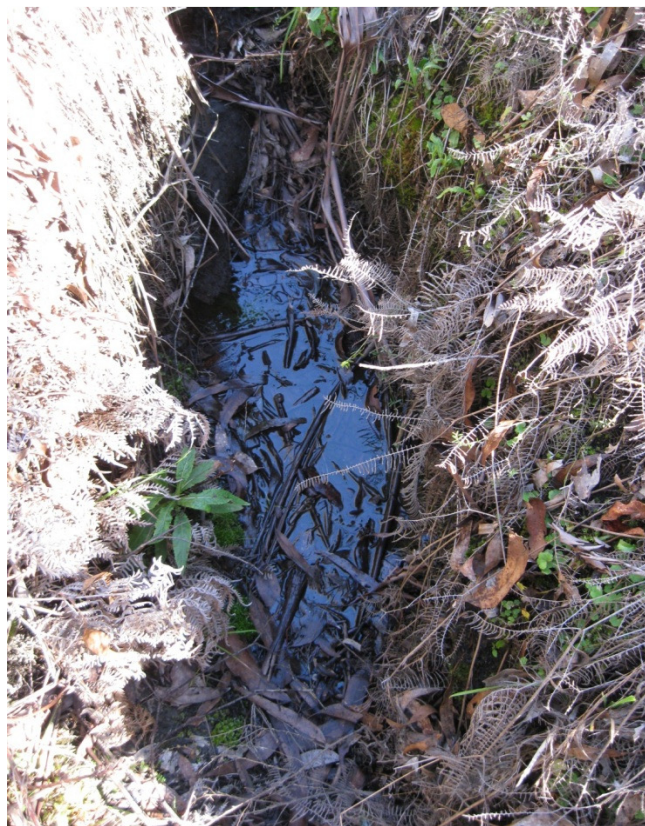
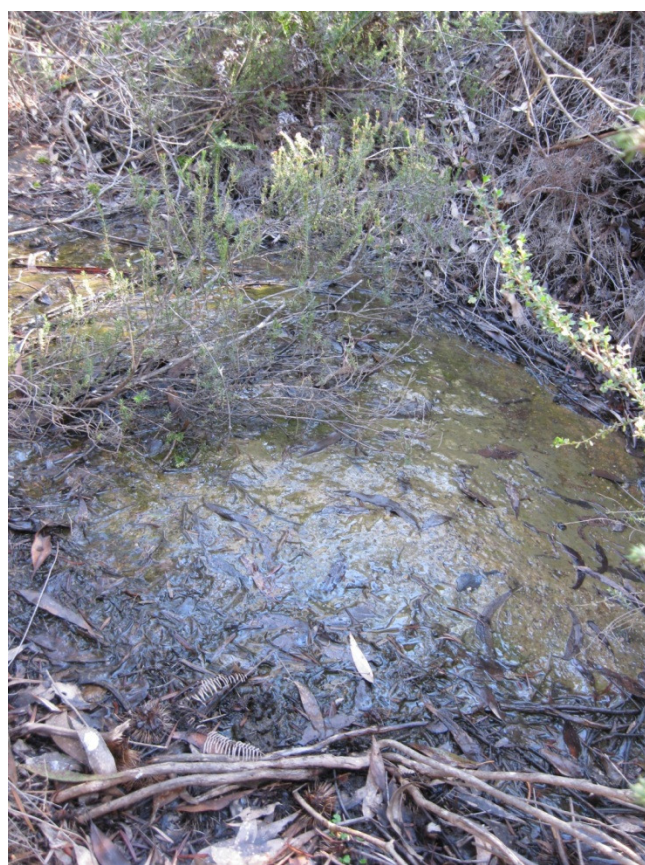
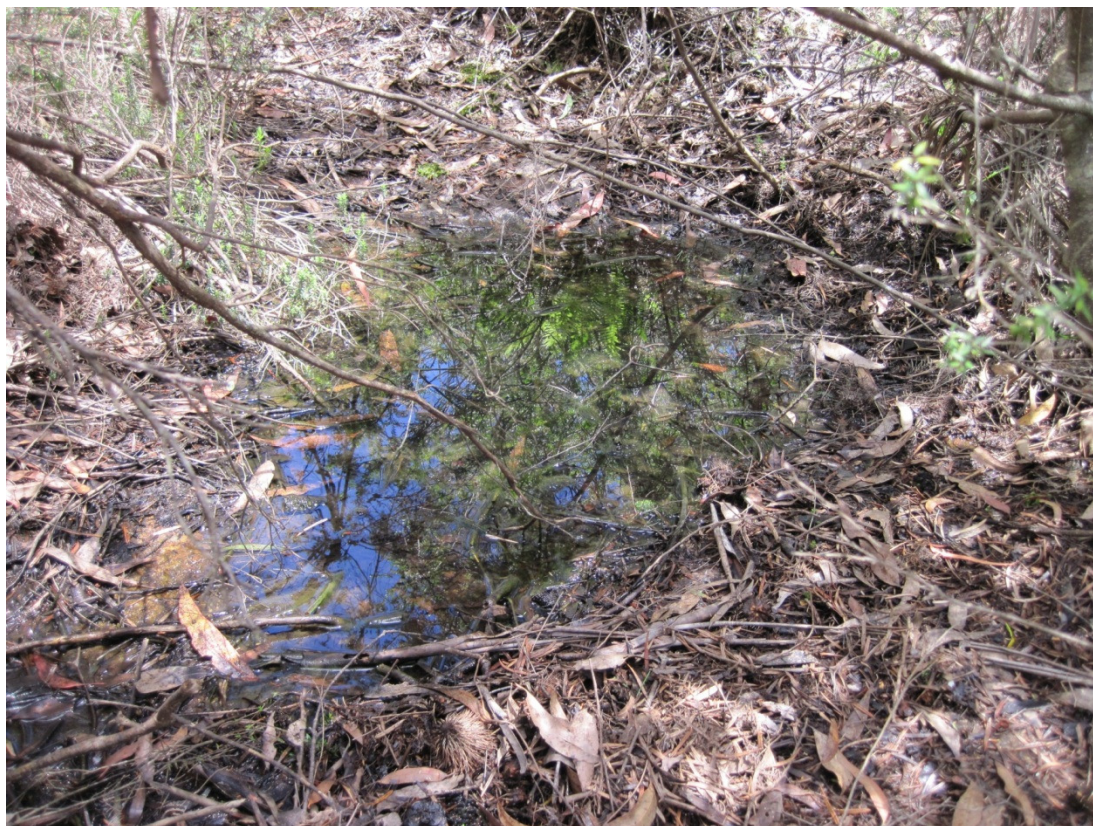
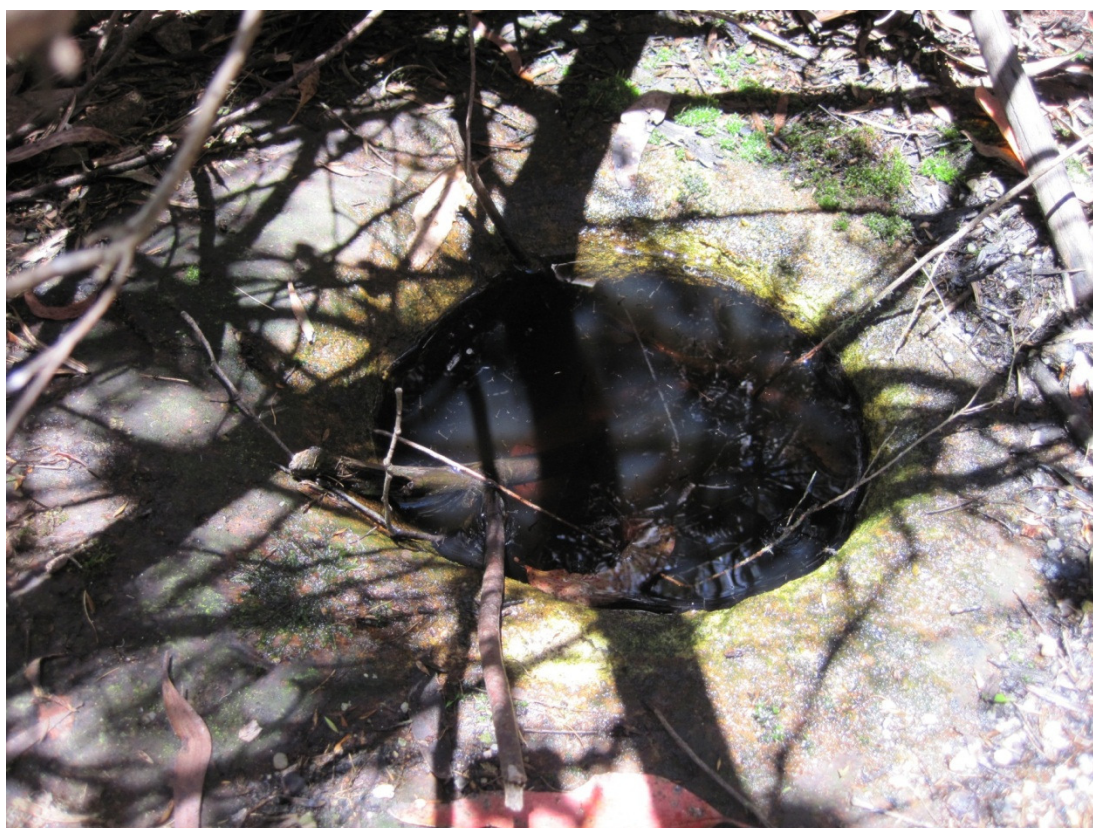
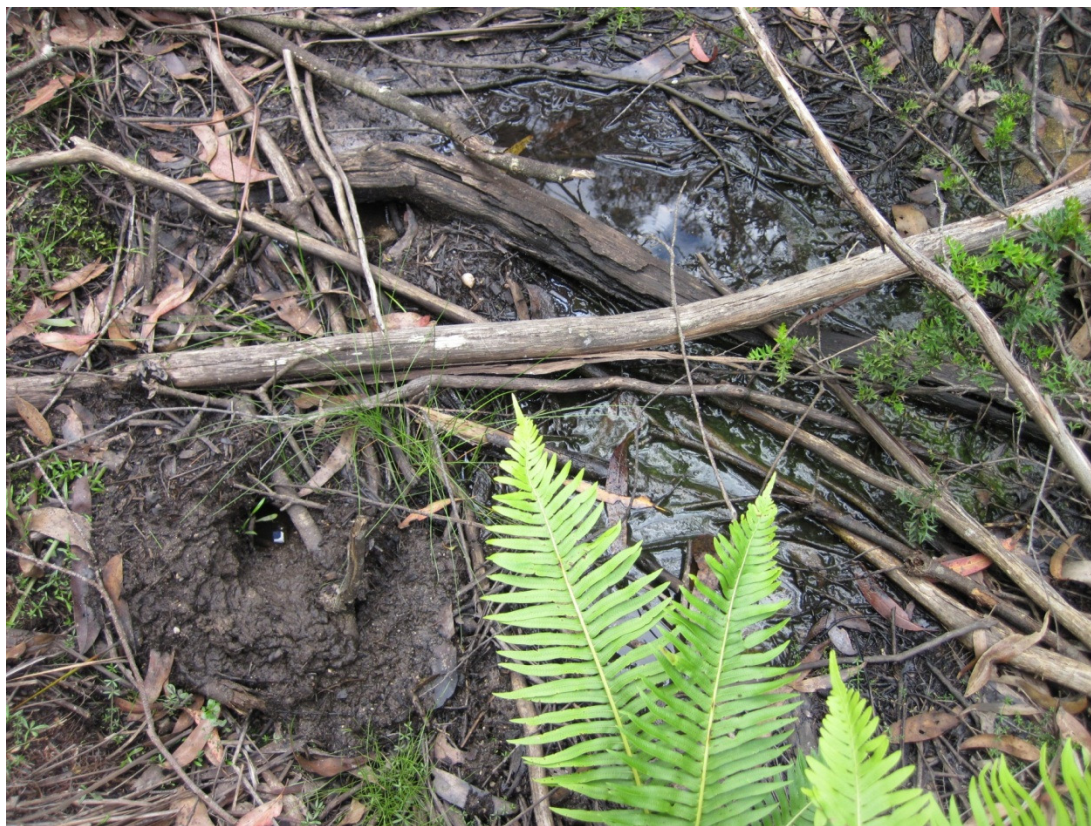
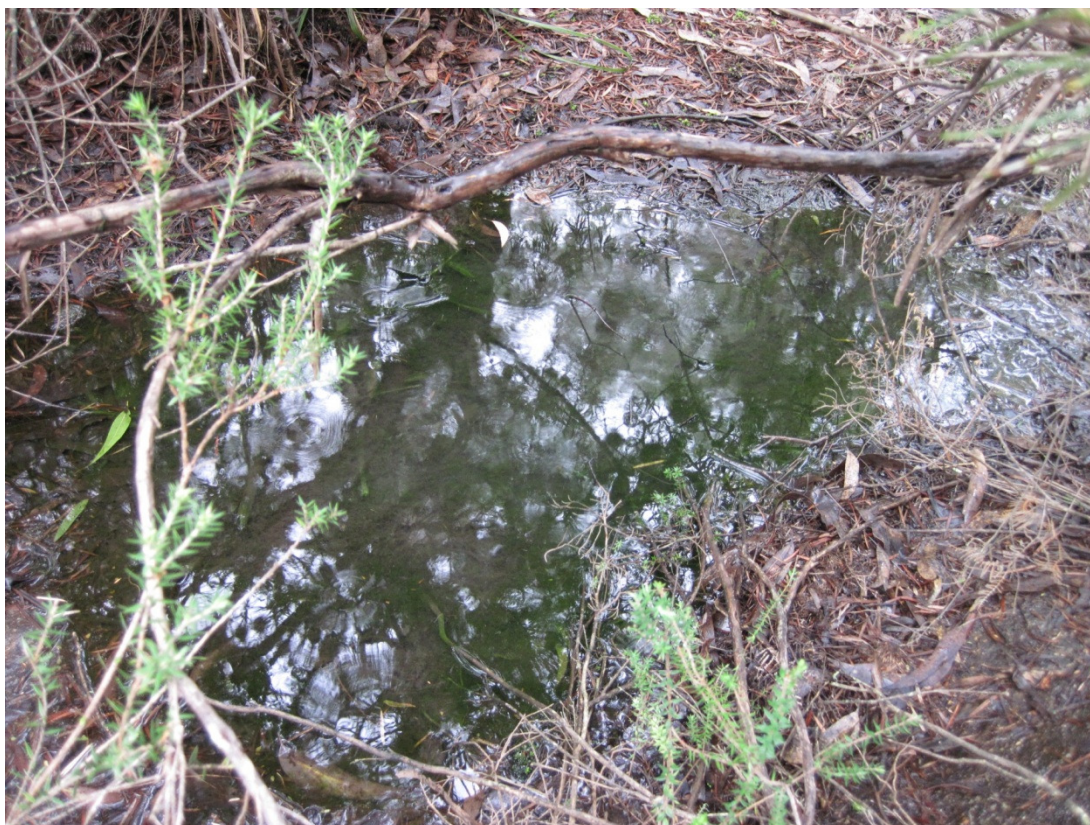
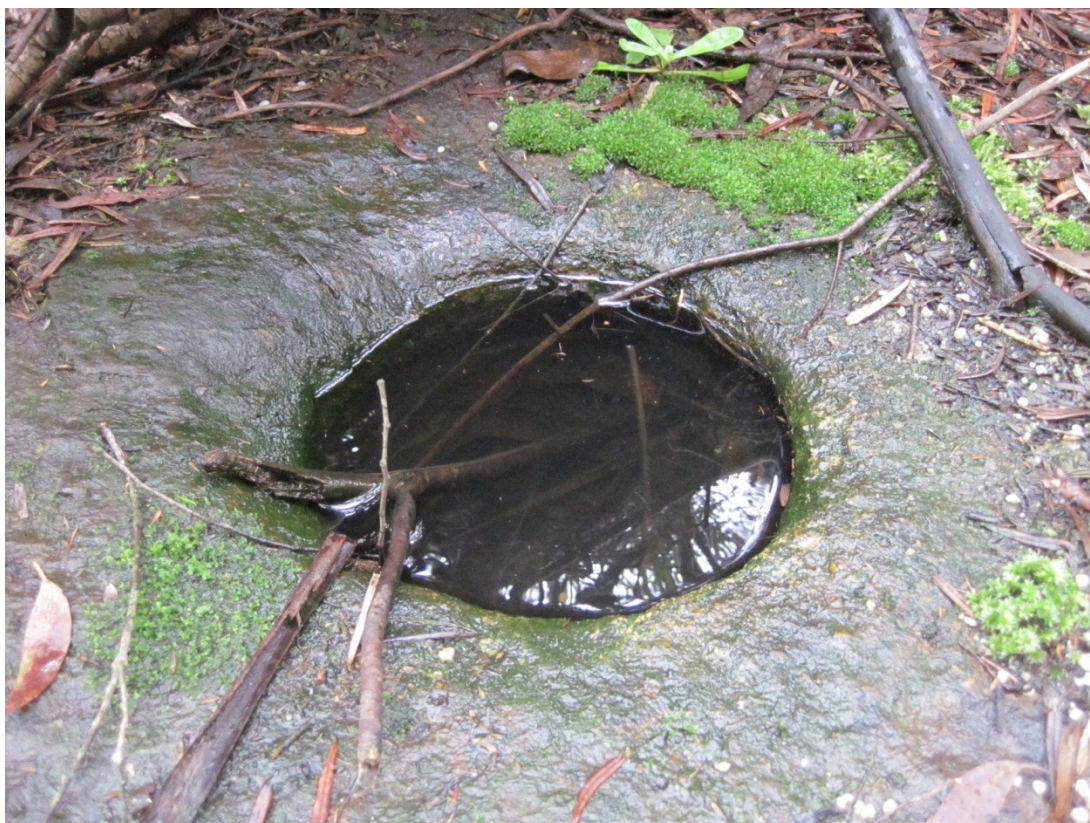
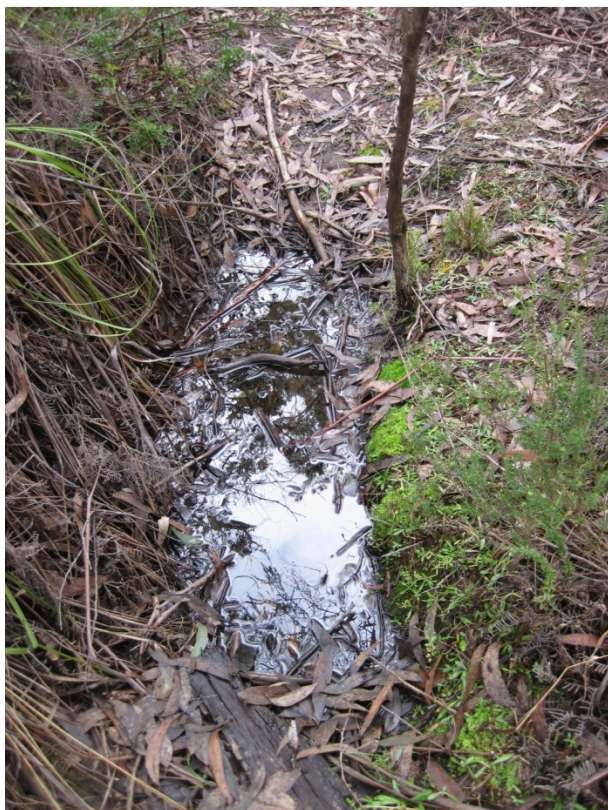
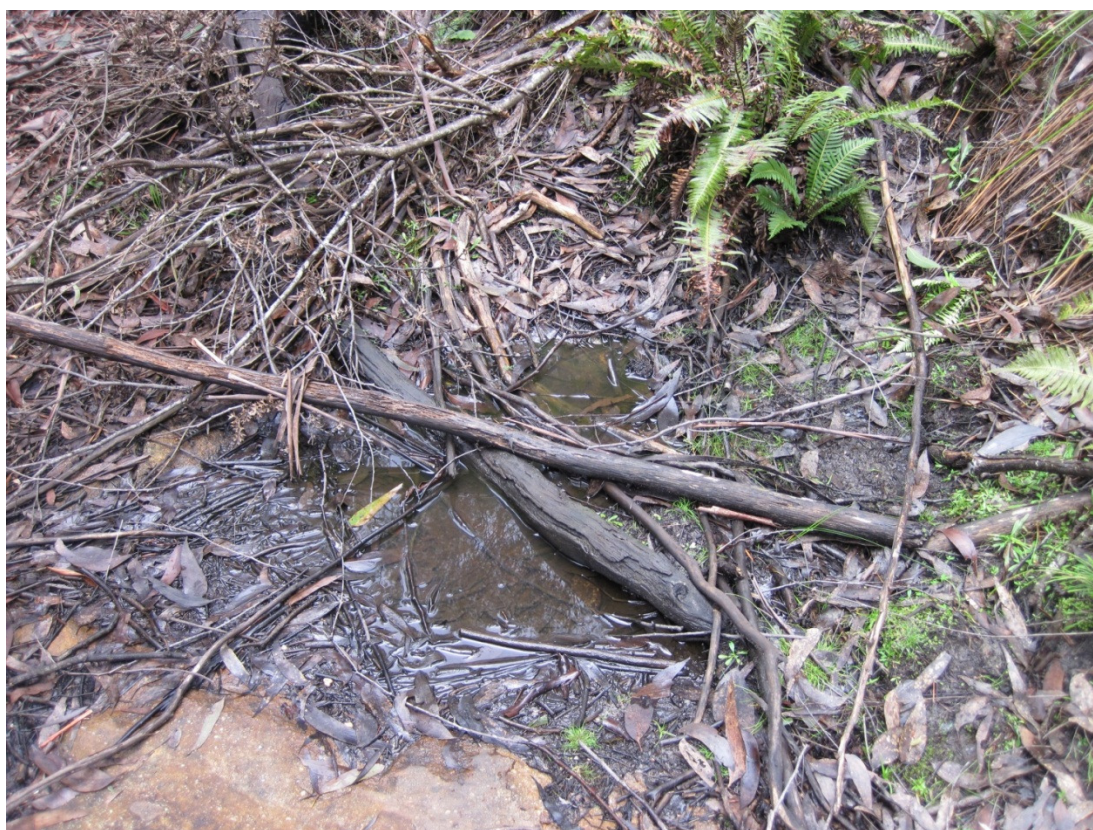
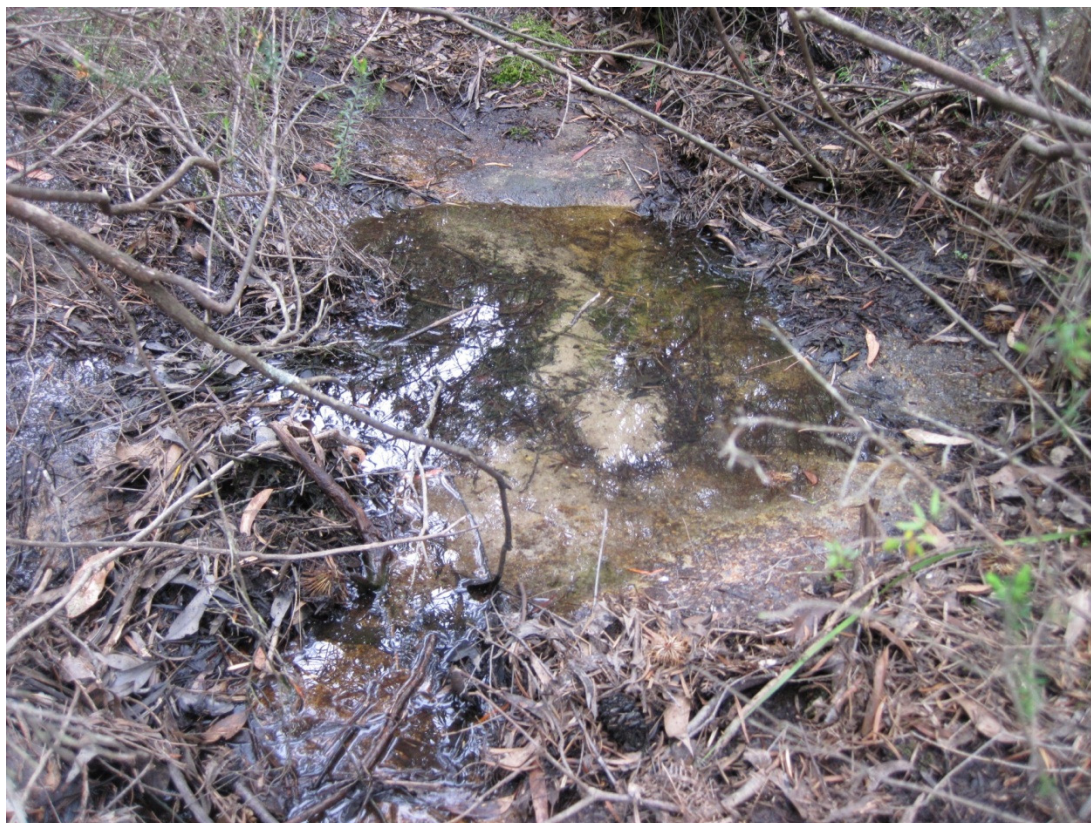
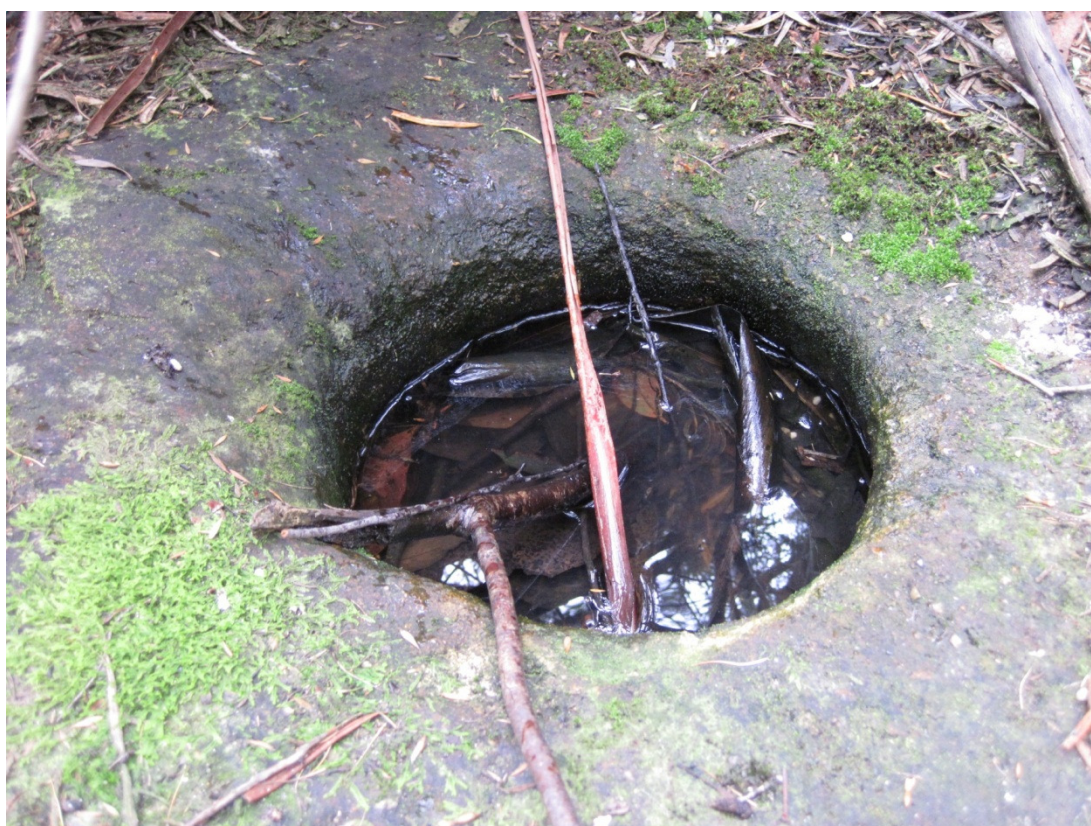
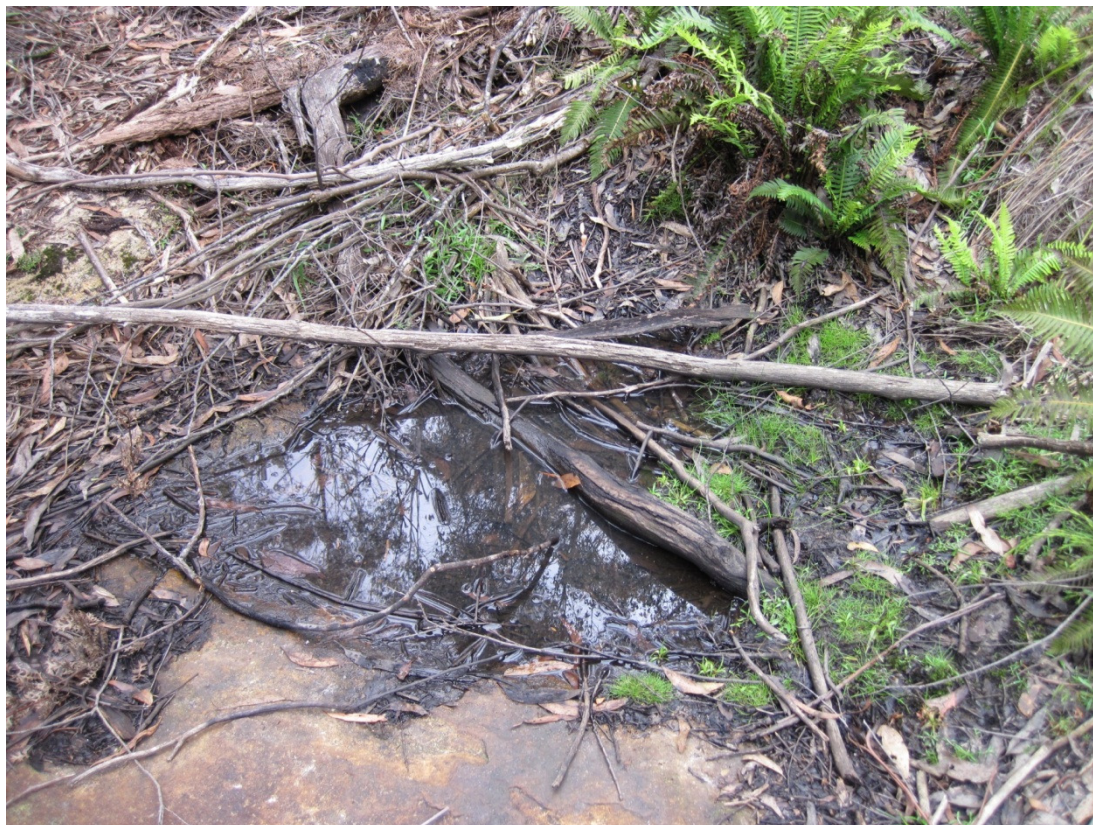
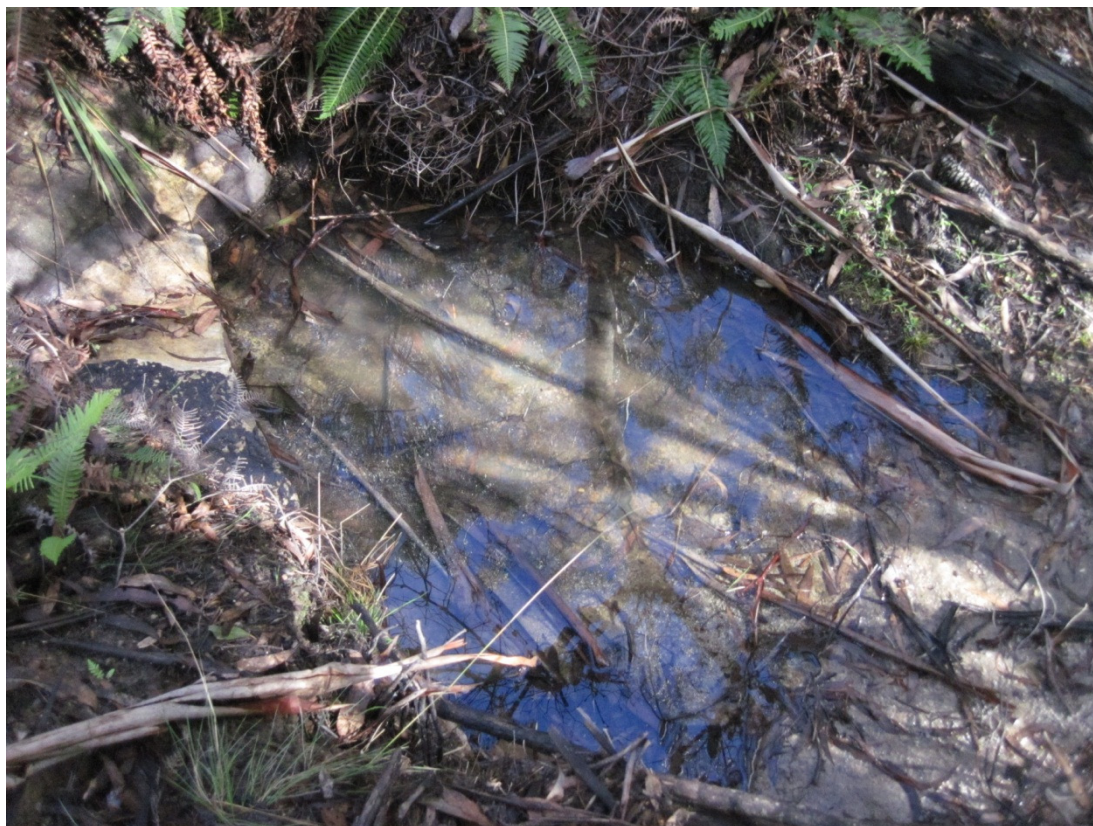
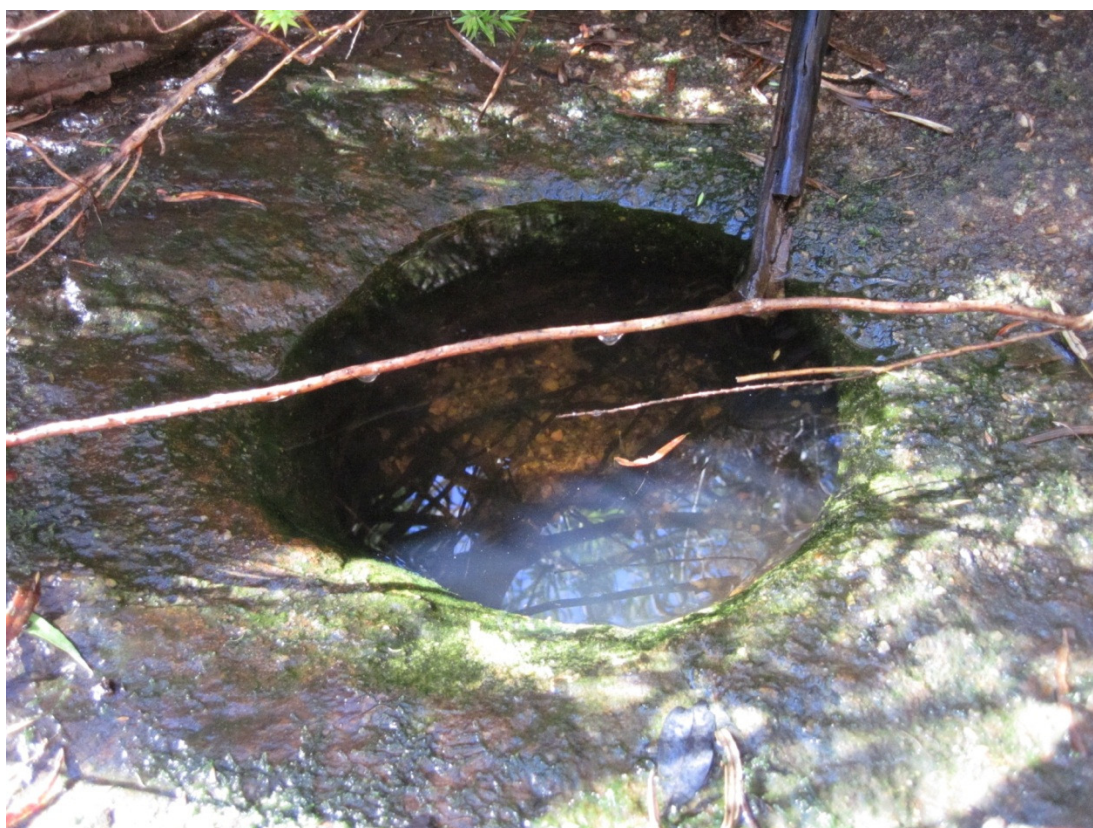
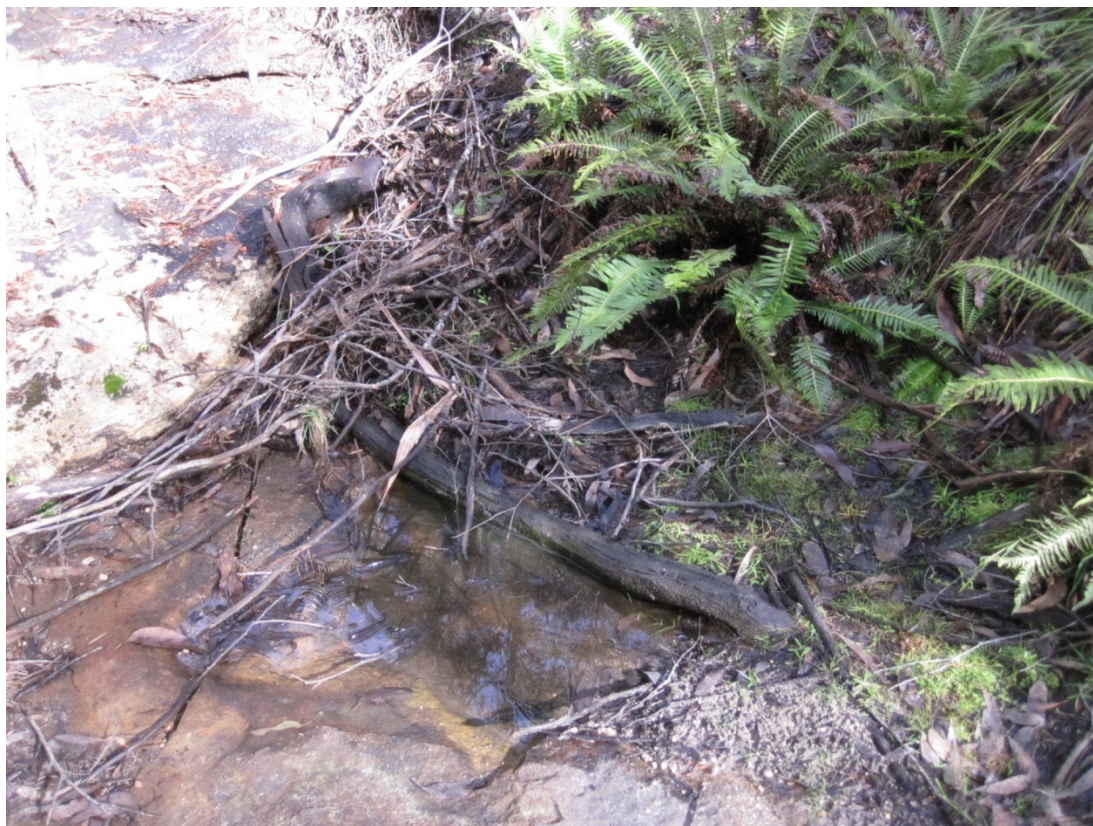
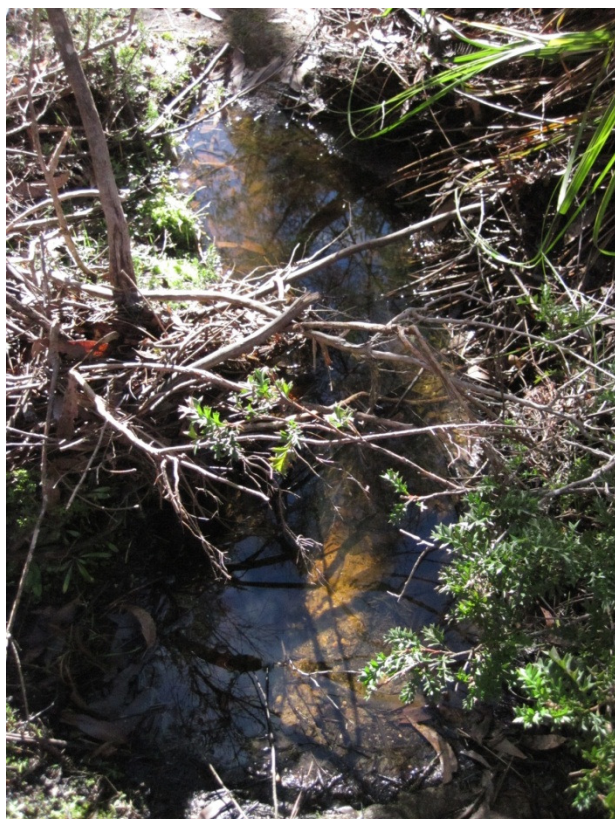
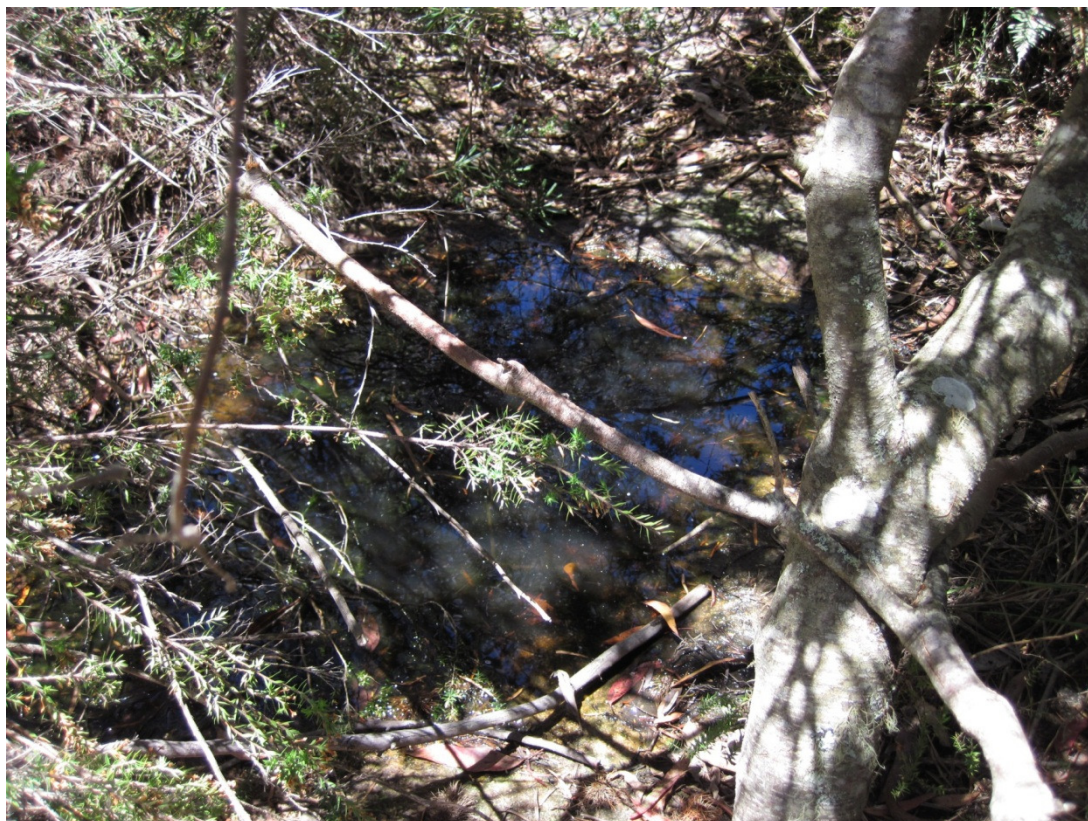
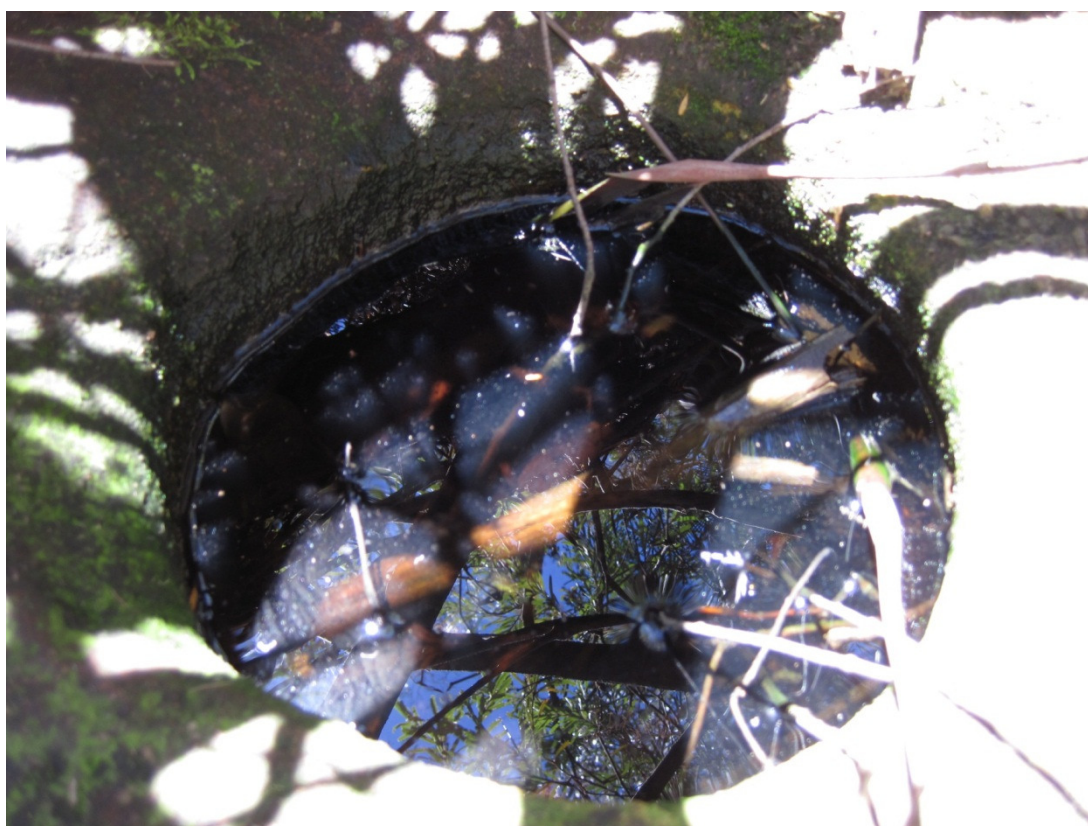
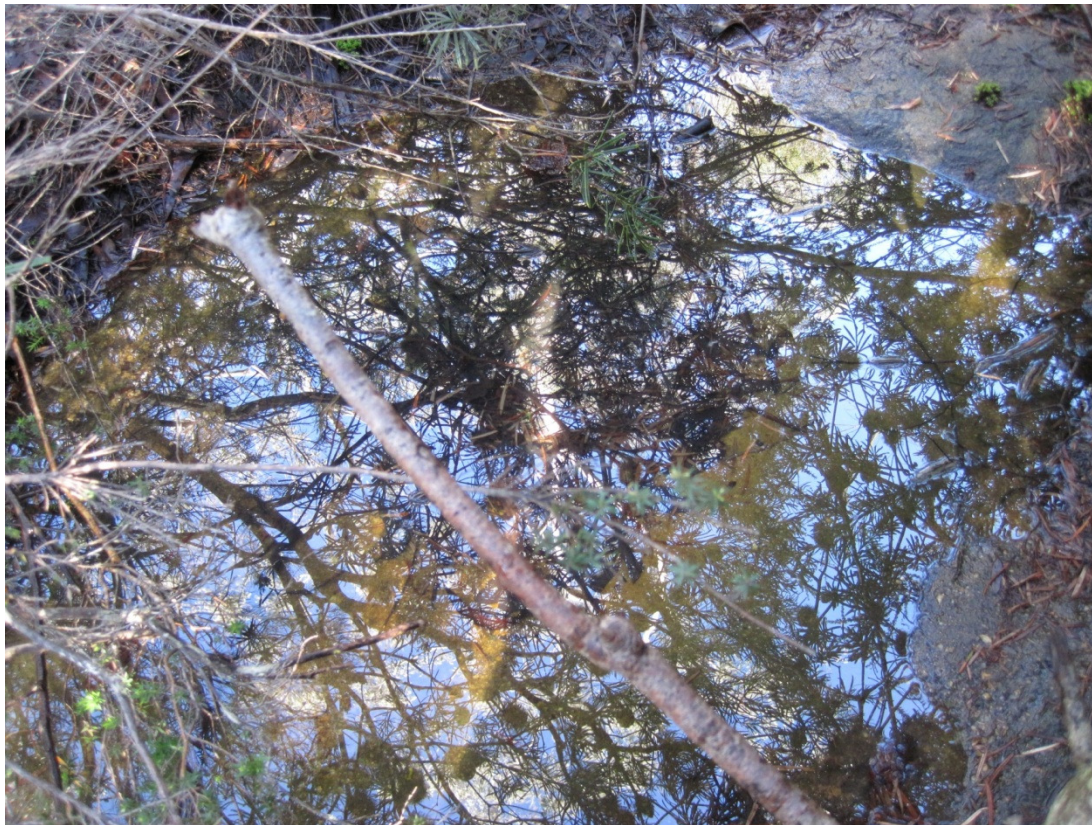
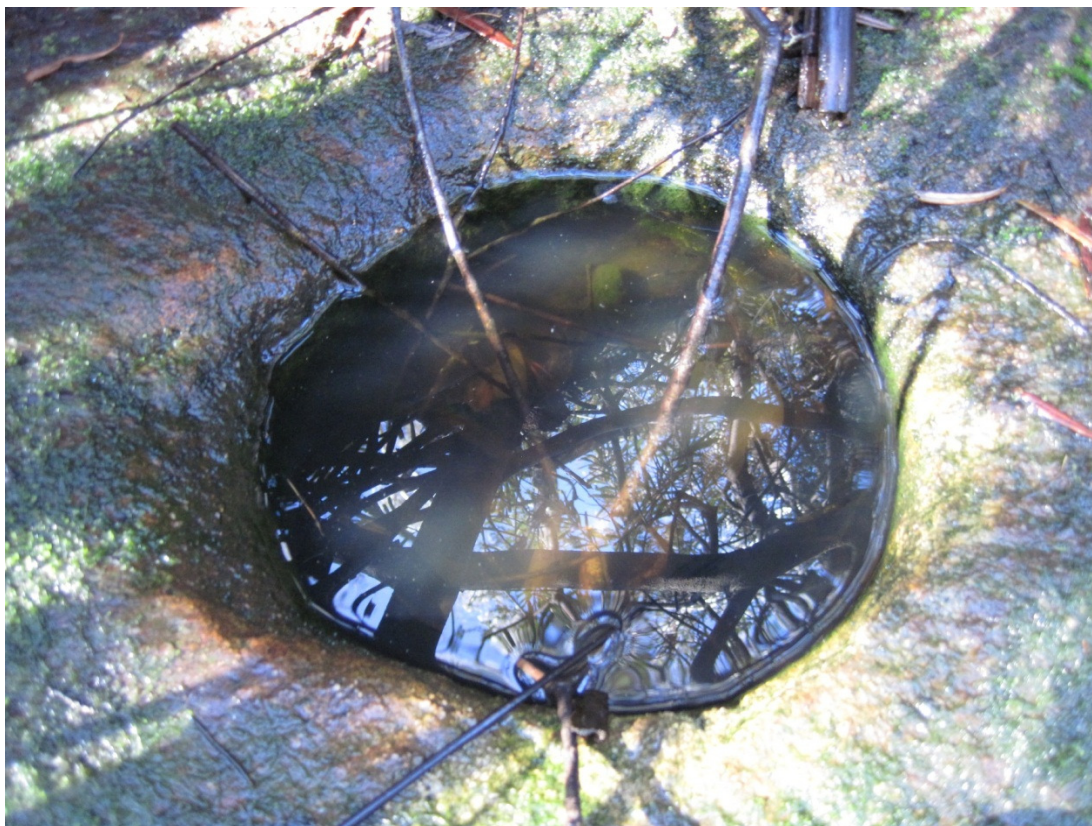
Figures 8.19 to 8.25 are a series of photos taken at locations downstream of the cavity since August 2010, which consistently show the presence of surface water downstream of the cavity since August 2010.

There were monthly records available during the period since August 2010. Photos presented in this report were sampled at six monthly intervals in June and December with consistent presence of surface water downstream of the cavity since August 2010.

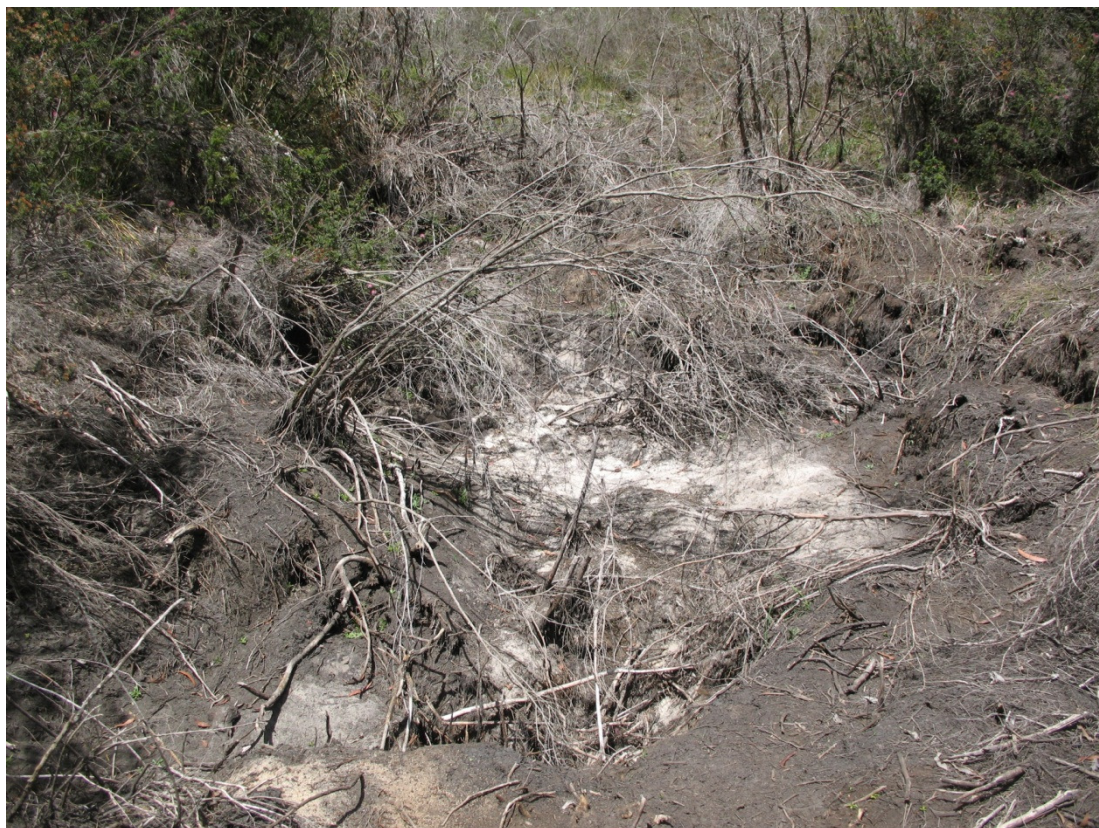
Figure 8.26 EWS Northern Slump 16 November 2009 – Major Emergency MWD Ceased May 2009

Figure 8.26 to 8.28 are photos taken at the Northern (downstream) slumping location, which show a trend of stabilising slumping and vegetation regrowth over time (after the cessation of mine water discharge) between November 2009 and December 2011.

- Slumping stabilised following cessation of mine water discharge in April 2010
- Vegetation regrowth progressively being established between April 2010 and January 2012
- Major rainfall events in February / March 2012 caused extensive erosion of Northern slump area (and other areas in East Wolgan Swamp)
- Major rainfall events in February / March 2012 caused a significant setback to swamp regeneration
- Remediation is required as soon as possible to prevent further erosion / degradation

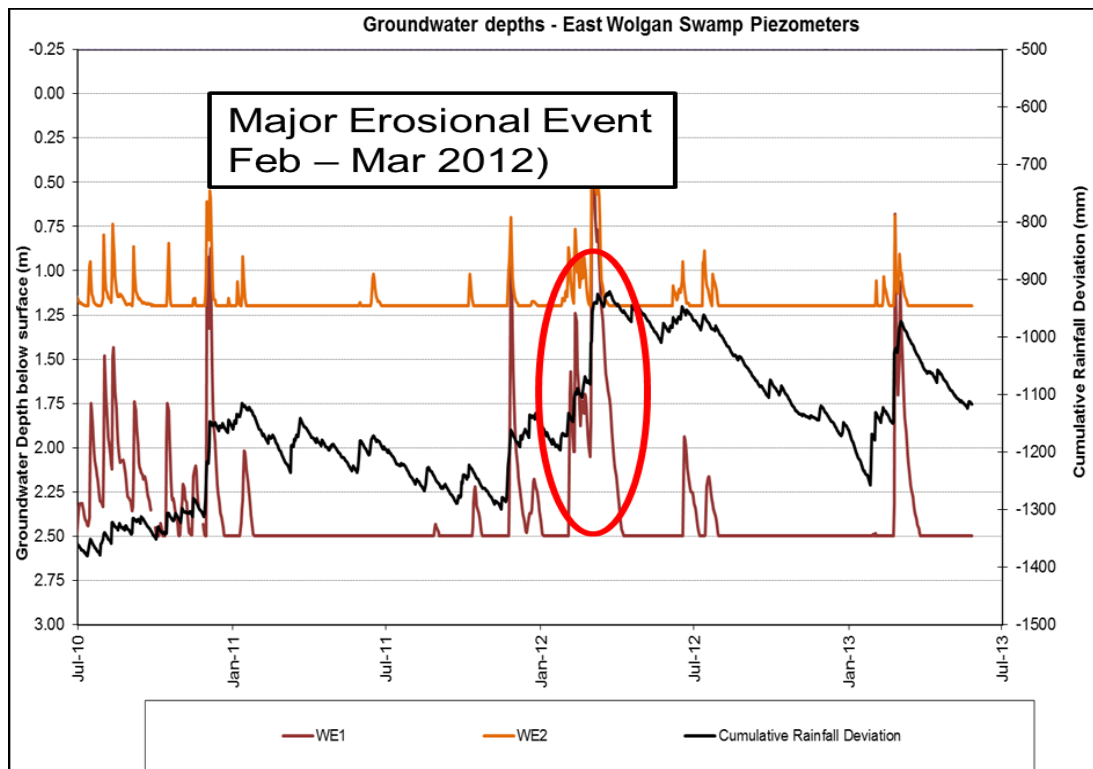
Figure 8.29 Erosion Due to Major Rainfall Event in February /March 2012

Figure 8.29 is a hydrograph of East Wolgan Swamp piezometers and cumulative rainfall deviation. It can be seen that there were major rainfall events in February and March 2012. During this period, the rainfall was 266mm greater than long term average (up to 75mm / day). There was evidence of water flow depth up to 0.5m

and major erosion along the length of East Wolgan Swamp from photographic monitoring.
