Angus Place

***Longwalls 900W and 910
Integrated SMP/Extraction Plan
2016 Annual Report***

Angus Place Colliery

June 2017

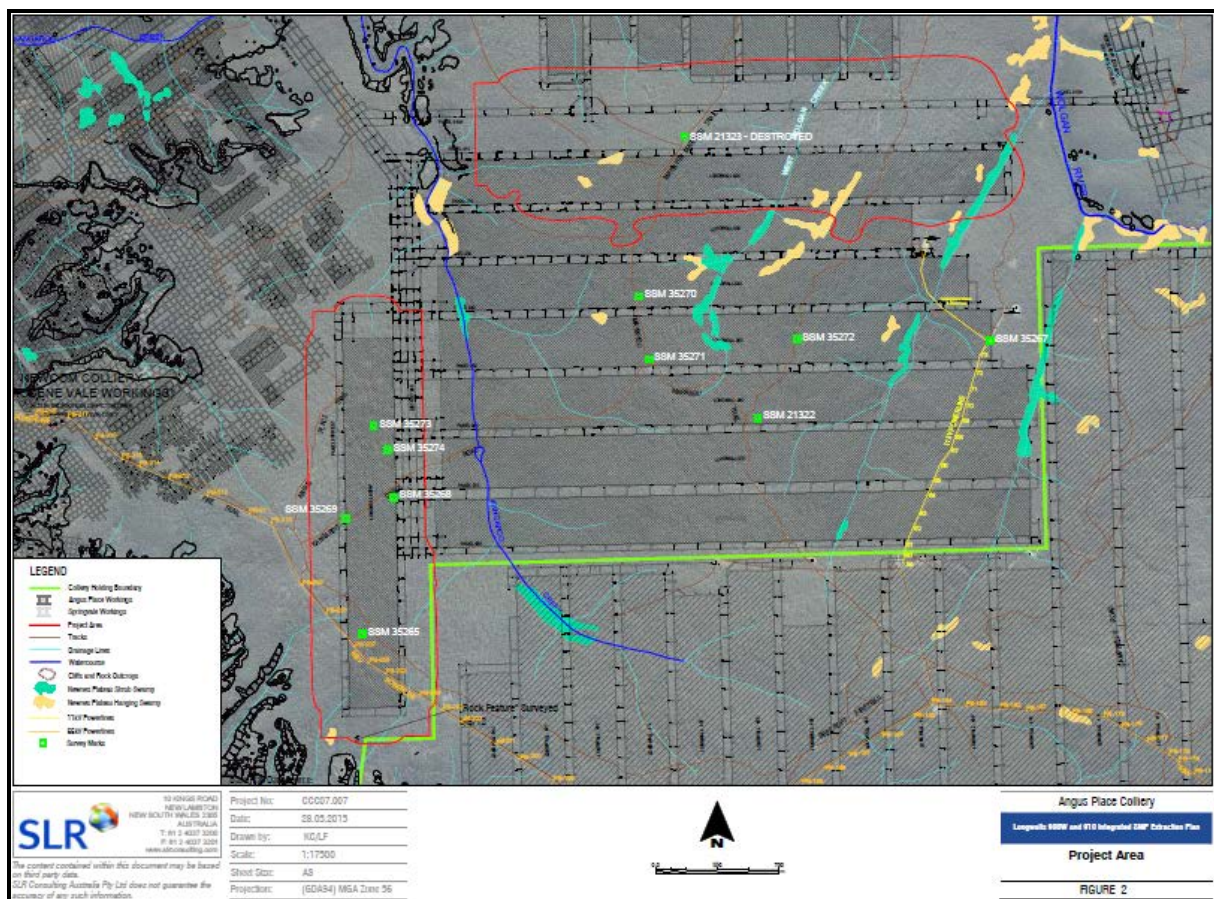
Figure 2. 900W and 910 Integrated SMP/Extraction Plan Project Area

The reporting program is specific to the Integrated SMP/Extraction Plan for 900W and 910 which is a portion of the Angus Place Colliery Holding. The Project Area was calculated by combining the areas bound by the following limits:

- A 26.5° angle of draw line from the limit of proposed extraction; and
- The predicted limit of vertical subsidence, taken as the 20 mm subsidence contour resulting from the extraction of the Longwalls 900W and 910.

The Project Area is shown in **Figure 2** below.

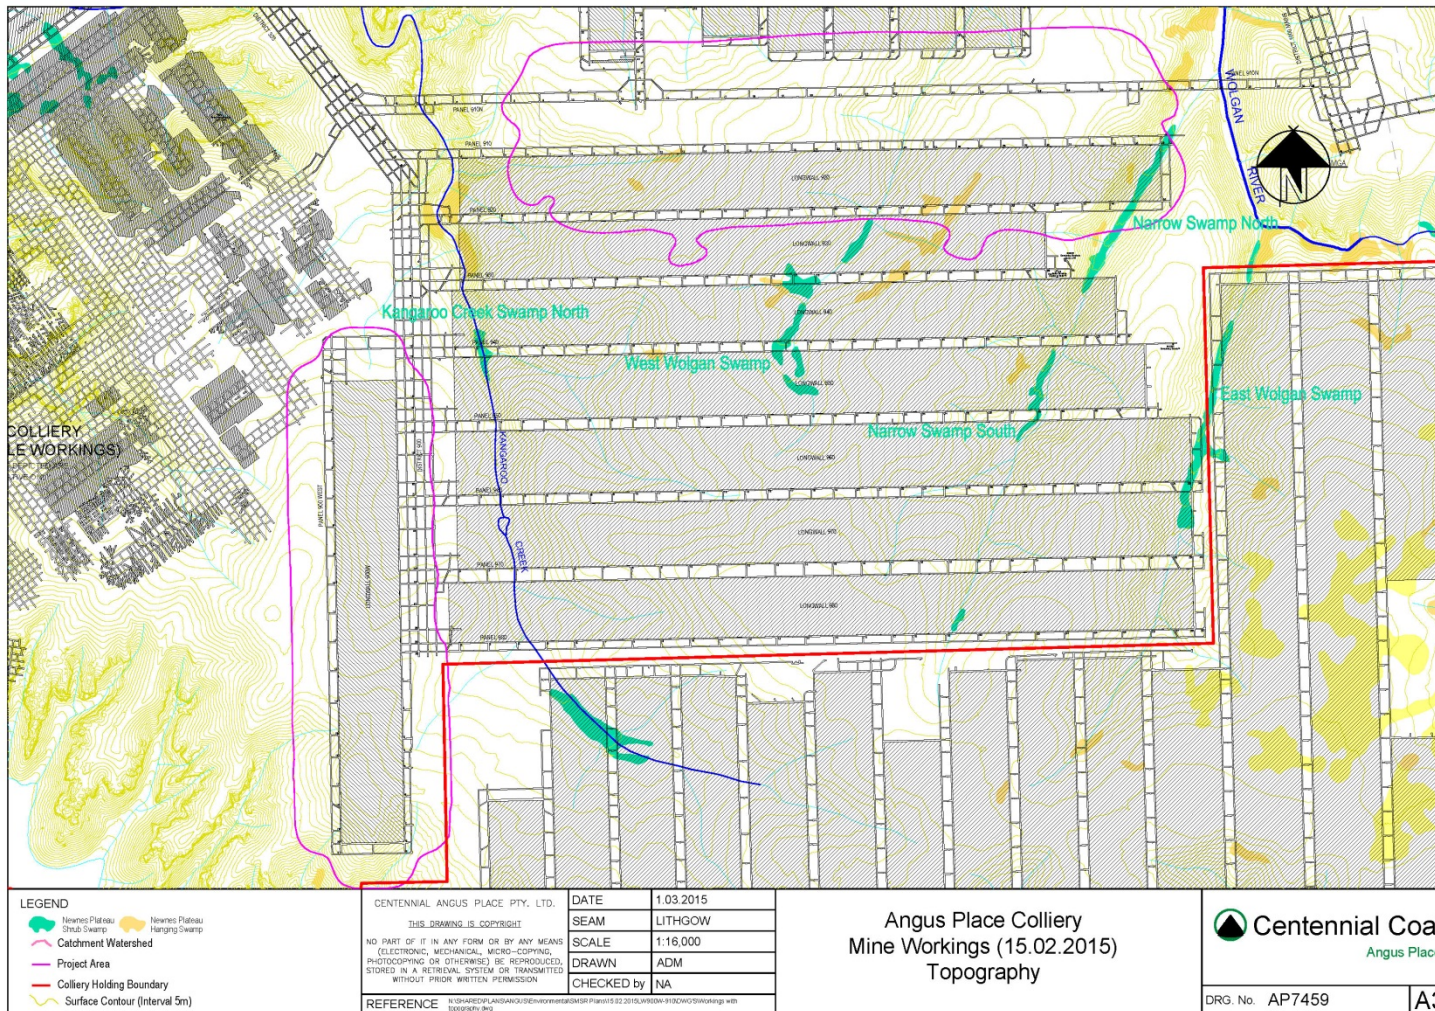
Figure 3. End Face Position of Longwall 900W

The extraction of Longwall 900W commenced on 30 April 2014. Longwall 900W completed extraction on 15 February 2015, a total distance of 2084.5m.

Secondary extraction of Longwall 910 has not commenced. The end face position of 900W is shown in **Figure 3**.

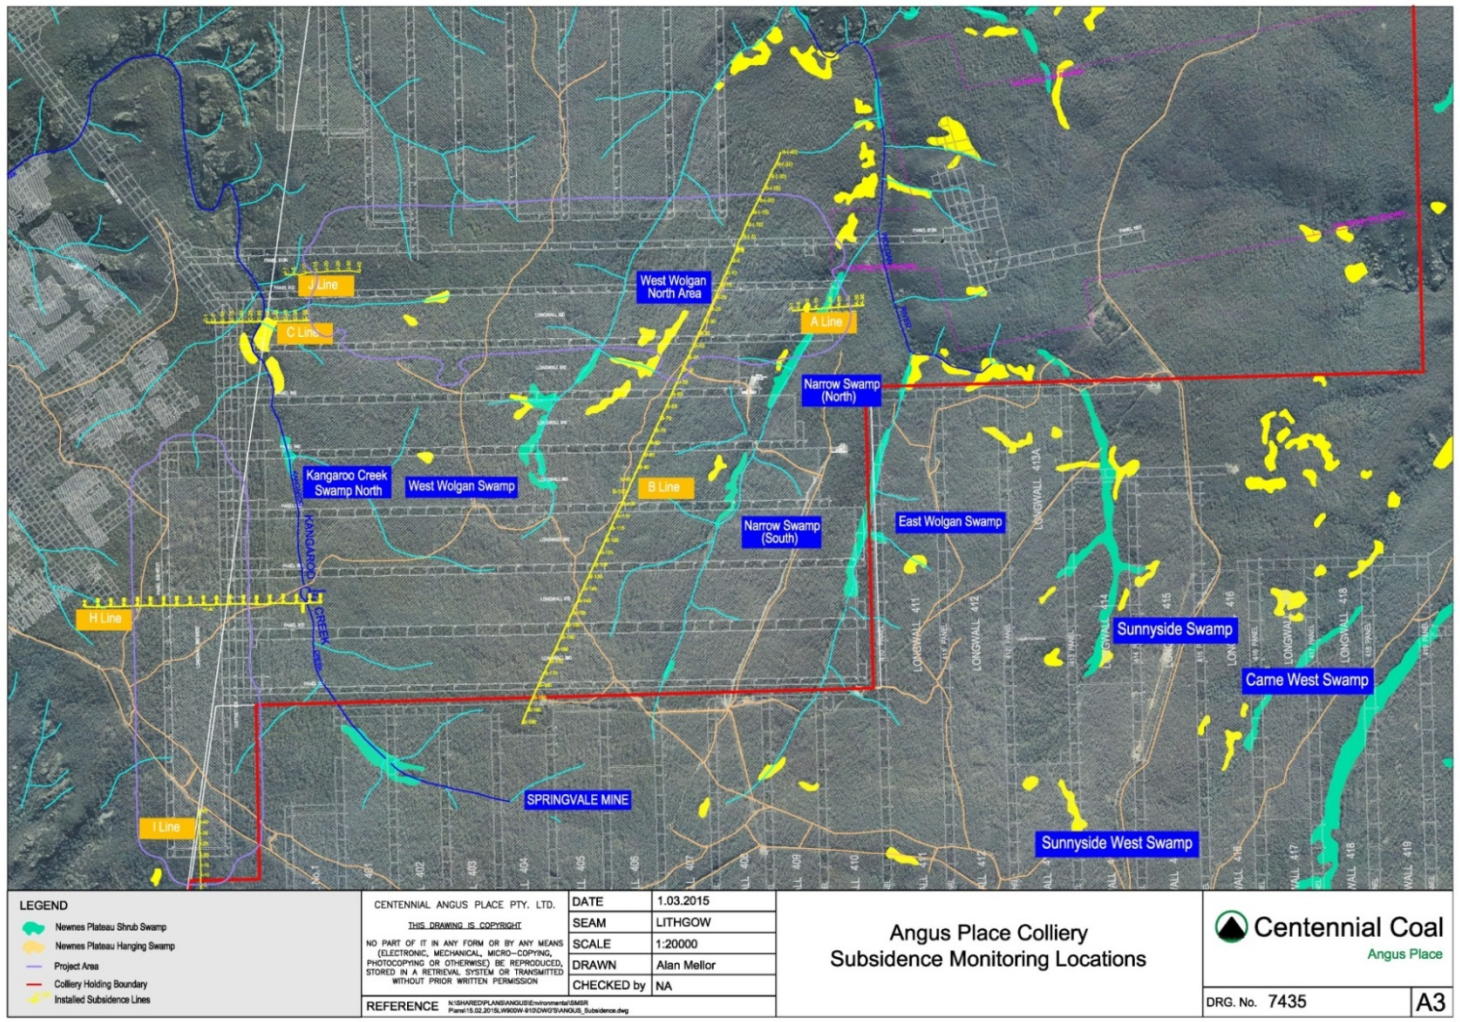
Figure 4. Subsidence Monitoring Lines

The location of subsidence monitoring lines relevant to the Project Area is presented in **Figure 4**.

Subsidence Line H was installed to monitor subsidence, strain, tilt and angle of draw associated with the extraction of Longwalls 970 and 900W.

Subsidence Line I was installed at the southern end of Longwall 900W to monitor subsidence, strain, tilt and angle of draw.

In their report of 25 February 2016, Ditton Geotechnical Services Pty Ltd (DgS) suggested the development of subsidence above LW 900W was practically complete (<92% the predicted maximum had developed after 10 months since panel completion) and the rate of subsidence at the time (2 mm/week) was unlikely to cause further impact at the surface. DgS concluded that subsidence monitoring lines H and I were no longer required and could be removed. Angus Place was granted approval from the Department of Industry, Resources and Energy on 20 April 2016 to remove subsidence monitoring lines H and I. These lines have not yet been removed.

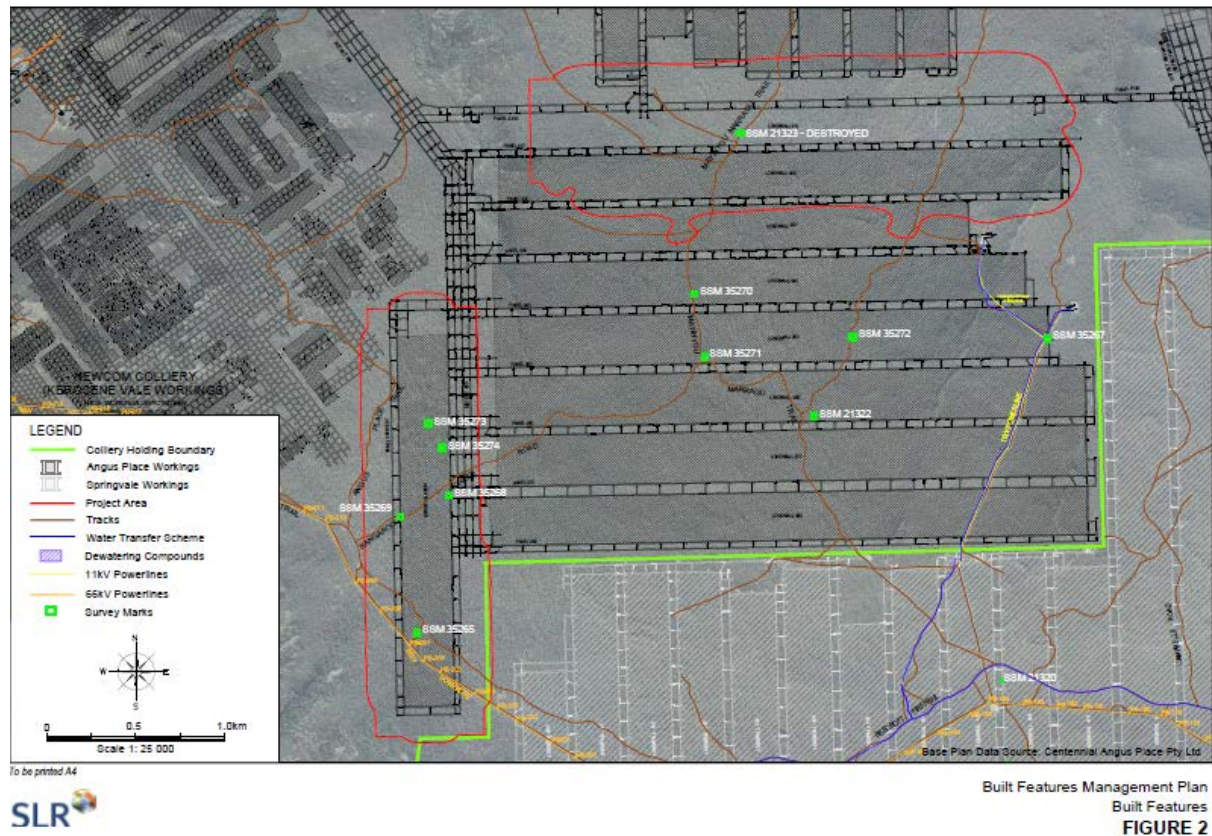
Figure 5. Built Features within 900W and 910 Project Area

The built features within the Project Area are shown in **Figure 5**.

There is a 66kV suspended powerline located above the commencing (southern) end of Longwall 900W at Angus Place. This powerline runs in a general northwest - southeast direction over the longwall panel and is owned by Endeavour Energy. The powerline is suspended using timber power poles that are approximately 15m high. There are five poles (204 – 208) located within the Project Area which are separated by distances ranging from 77m - 266m. The Endeavour Energy 66kV powerline was monitored pre and post-mining for evidence of any subsidence related impacts.

There are six permanent state survey control marks associated with the Project Area. Five state survey marks are associated with Longwall 900W, these being SSM35265, SSM35268, SSM35269, SSM35273 and SSM35274. The sixth mark, being SSM21323, is located above Longwall 910; however this mark has been destroyed. The locations of these survey marks are shown in **Figure 5**.

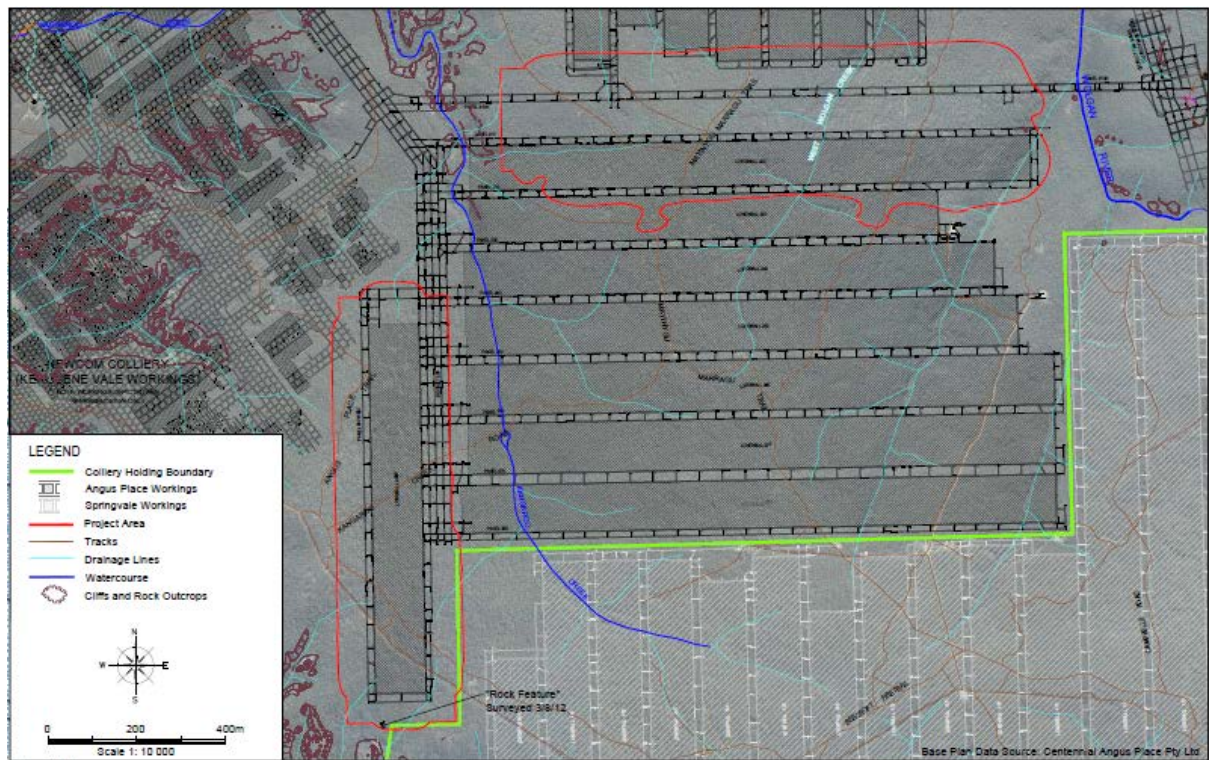
Figure 9. Natural Features within 900W and 910 Project Area

There are no significant clifflines (i.e. greater than 20m in height) or rock features (between 5m and 20m in height) located within the 26.5° angle of draw line from the limit of extraction within Longwalls 900W and 910. The nearest rock feature is located approximately 175m south of the commencing end of Longwall 900W. This feature is located approximately 17m within the 20mm subsidence contour and is subsequently located within the Project Area. The nearest cliffline is located approximately 275m west of the finishing end of Longwall 910. The location of all clifflines and rock features in proximity to the Project Area are shown on **Figure 9**.

There is one ephemeral drainage line located above Longwall 910 known as West Wolgan Creek, and there are two first order tributaries of Kangaroo Creek located above Longwall 900W. The locations of drainage lines associated with the Project Area are shown on **Figure 9**.

Rock features, clifflines, West Wolgan Creek, tributaries of Kangaroo Creek and drainage lines within and in close proximity to the Project Area were monitored pre and post mining for evidence of any subsidence related impacts such as cracking, ponding or erosion and sedimentation.

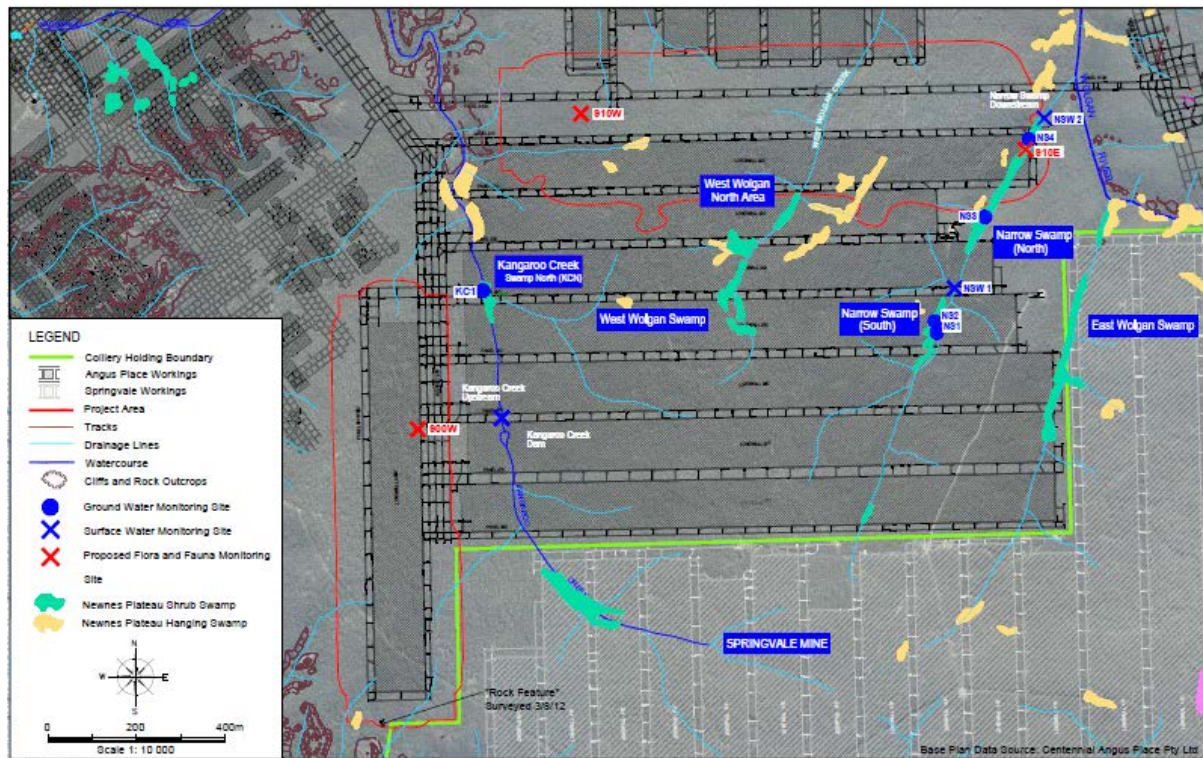
Figure 10. Environmental Monitoring Program within 900W and 910 Project Area

The Environmental Monitoring Program for 900W and 910 focuses on the Project Area. Monitoring requirements have been defined by the secondary extraction of these longwalls and will continue at the frequency rate for 12 months post mining. If environmental impacts are within the predictions, frequency of monitoring will be reduced.

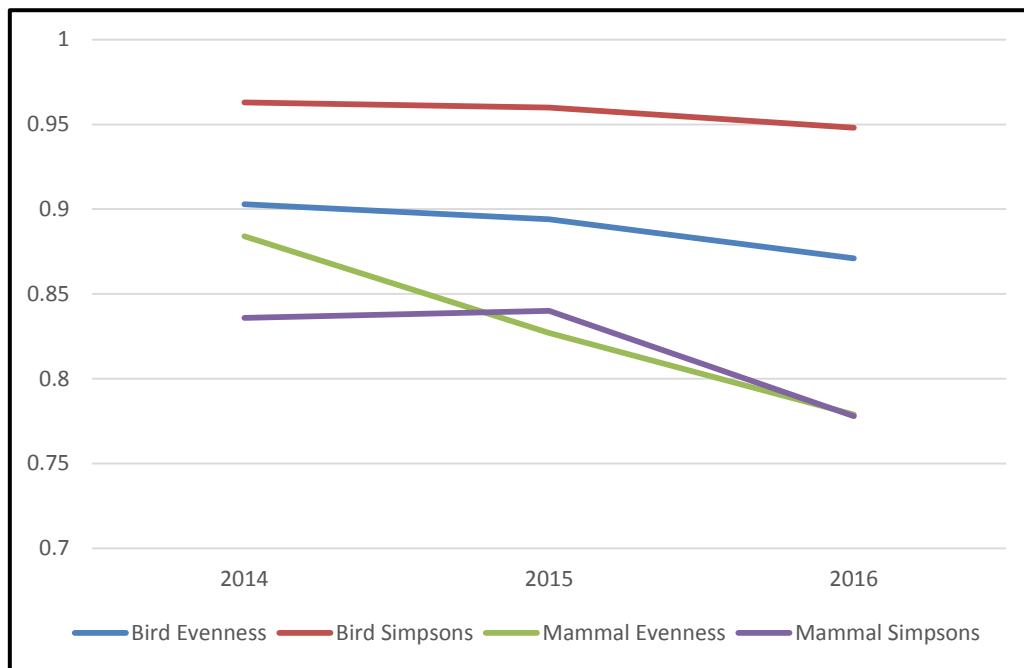
Figure 11. Numbers recorded and Species Richness in spring 2014 to 2016

Thirty-eight bird, 19 native mammal, two introduced mammal and two amphibian species were located within the 900/910 Area. **Appendix 5** contains the monitoring reports for the period. It is possible to calculate the biodiversity indices for the entire 900/910 area as well as for each individual site. The mean values for the swamp and forest environments are also given. **Figure 11 and 12** show there is no significant differences between the values for birds or mammals from the three years (non-parametric Kruskal-Wallis One Way Analysis of Variance on Ranks).

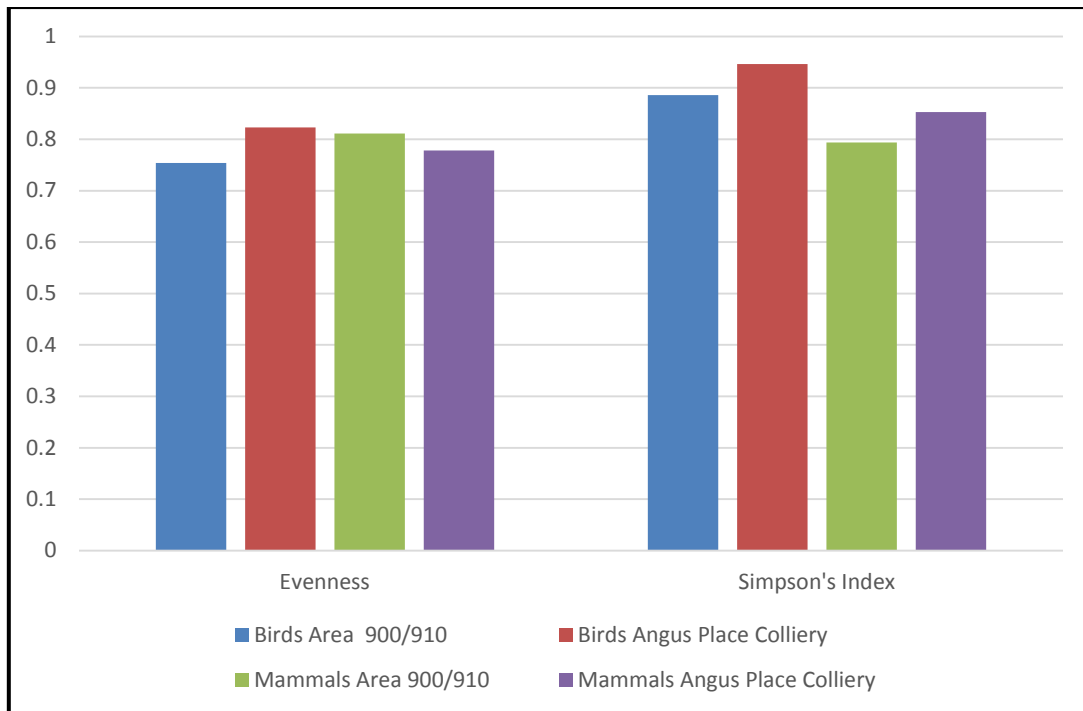
Figure 12. Mean Biodiversity Indices within Angus Place Colliery and Area 900/910

There are no significant differences between the biodiversity values for the swamp and forest sites for either the birds or the native mammals (non-parametric Mann-Whitney Rank Sum Test).

The results from the survey of the Angus Place Colliery 900/910 area in Spring 2016 show that the assemblages found are typical of that found throughout Newnes Plateau and are similar to that obtained in the remainder of Angus Place Colliery. There were sufficient numbers and diversities of native mammals and birds to be able to calculate a set of diversity indices that will form part of the baseline monitoring database. At this stage there are no significant differences between the habitat characteristics and fauna assemblages found within the Control and Treatment sites, indicating no discernible impacts from mining.
