# Centennial Coal

## ***Annual Environmental Management Report***

**1<sup>st</sup> January 2012 to 31<sup>st</sup> December 2012**

**Clarence Colliery**

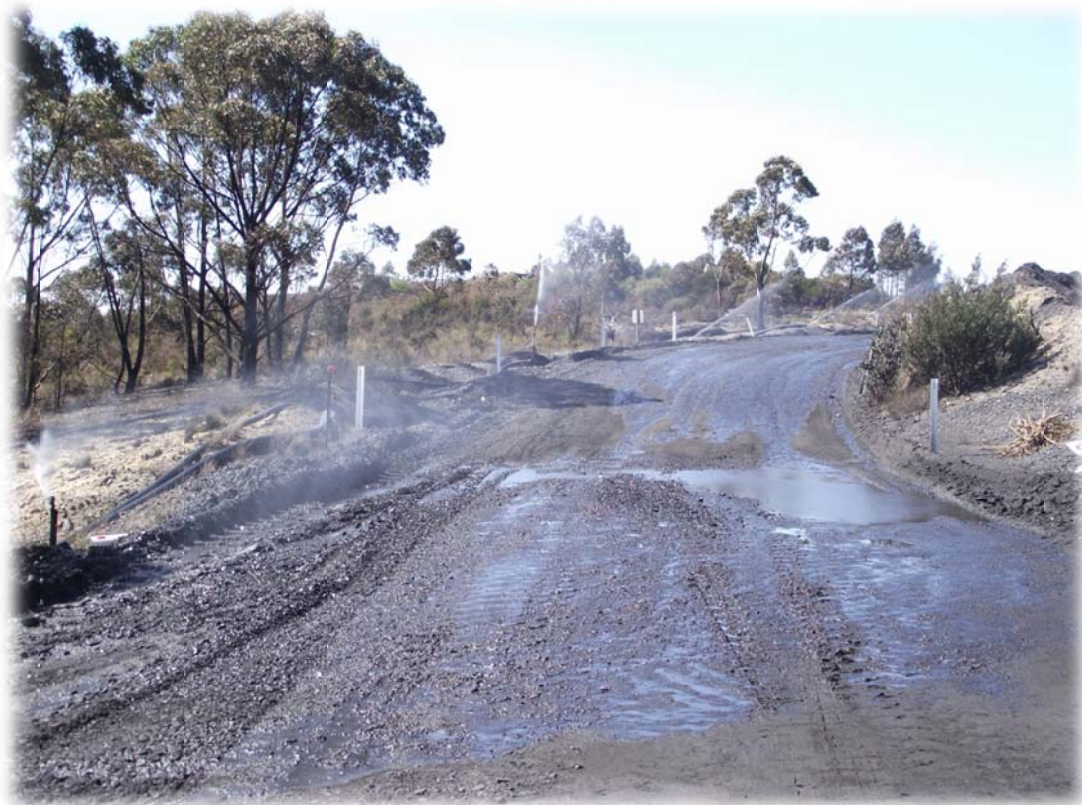
**Figure 10 REA Haul Road Sprinklers**

Dust generation around the CHPP and stockpile areas are managed using a water cart and/or fixed sprinklers (**Figure 10** and **Figure 11**). Throughout the reporting period, this control strategy has proved to be adequate to manage dust emissions.

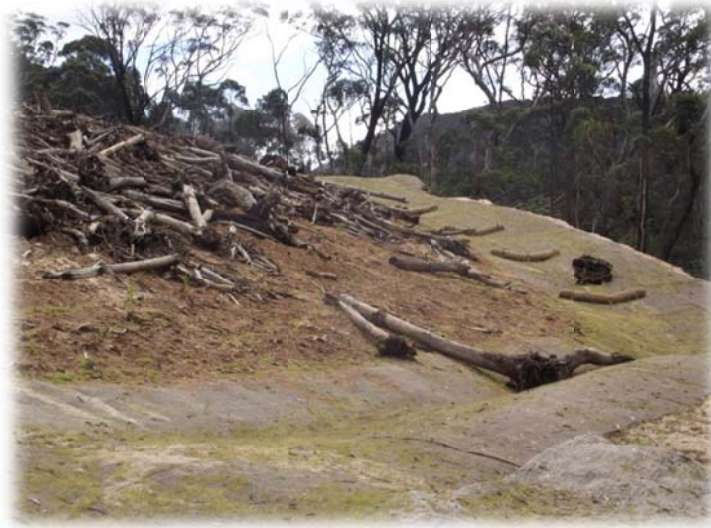
**Figure 50 REA IV Drainage Works completed in 2012**

Improved sediment and erosion control measures were installed in the newly constructed drainage channels for REA IV and in stream works completed in the Leachate Dam No. 2 drainage channel (**Figure 50** and **Figure 51**). The control measures included the installation of check dams, lining channels with jute mesh and using coir logs to reduce flow velocity.

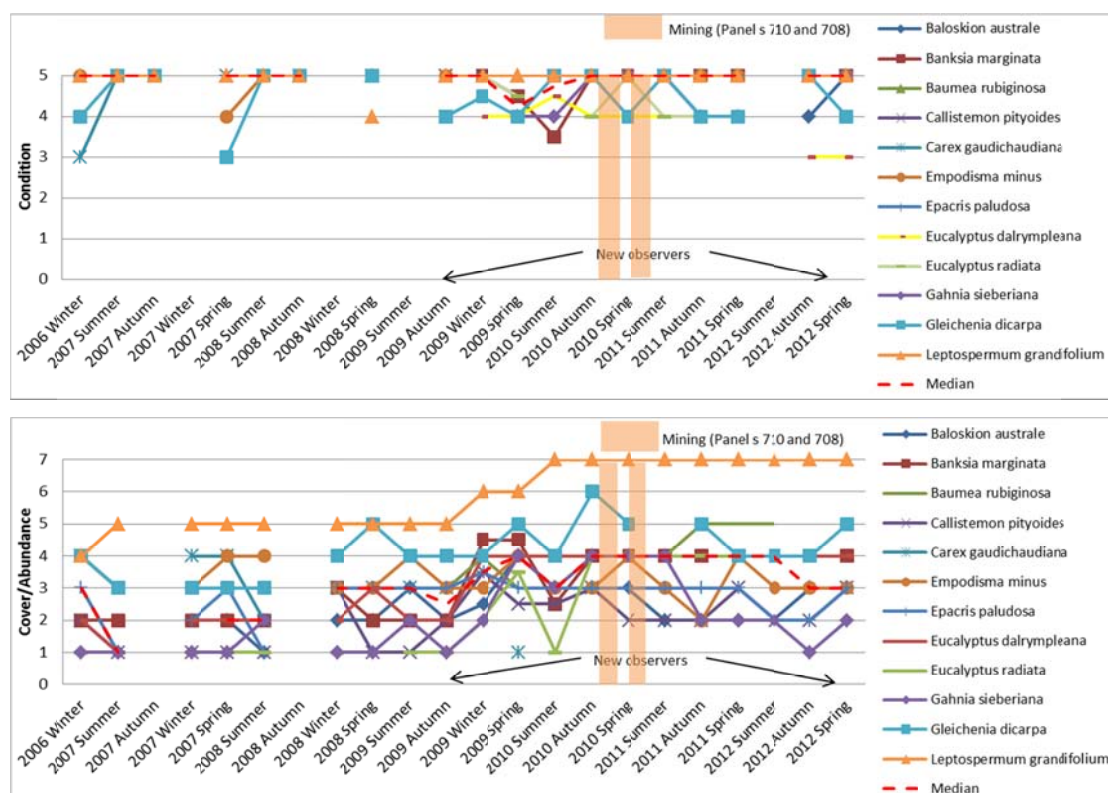
**Figure 64 Condition (a) and Cover/Abundance (b) of species at CLW03**

**Figure 63** and **Figure 64** below compare the condition of dominant species (using the condition scale) with scores recorded in previous monitoring and with time since undermining.

While the figures shown below are primarily being compared with time since undermining or the change in observers, care should be taken to also consider climate. Since 2005, all years, with the exception of 2007 and 2010 have shown below average rainfall anticipated for the Newnes Plateau. The data show that fluctuation in the condition and cover/abundance of species over time is common across sites. This may be due to a number of factors including:

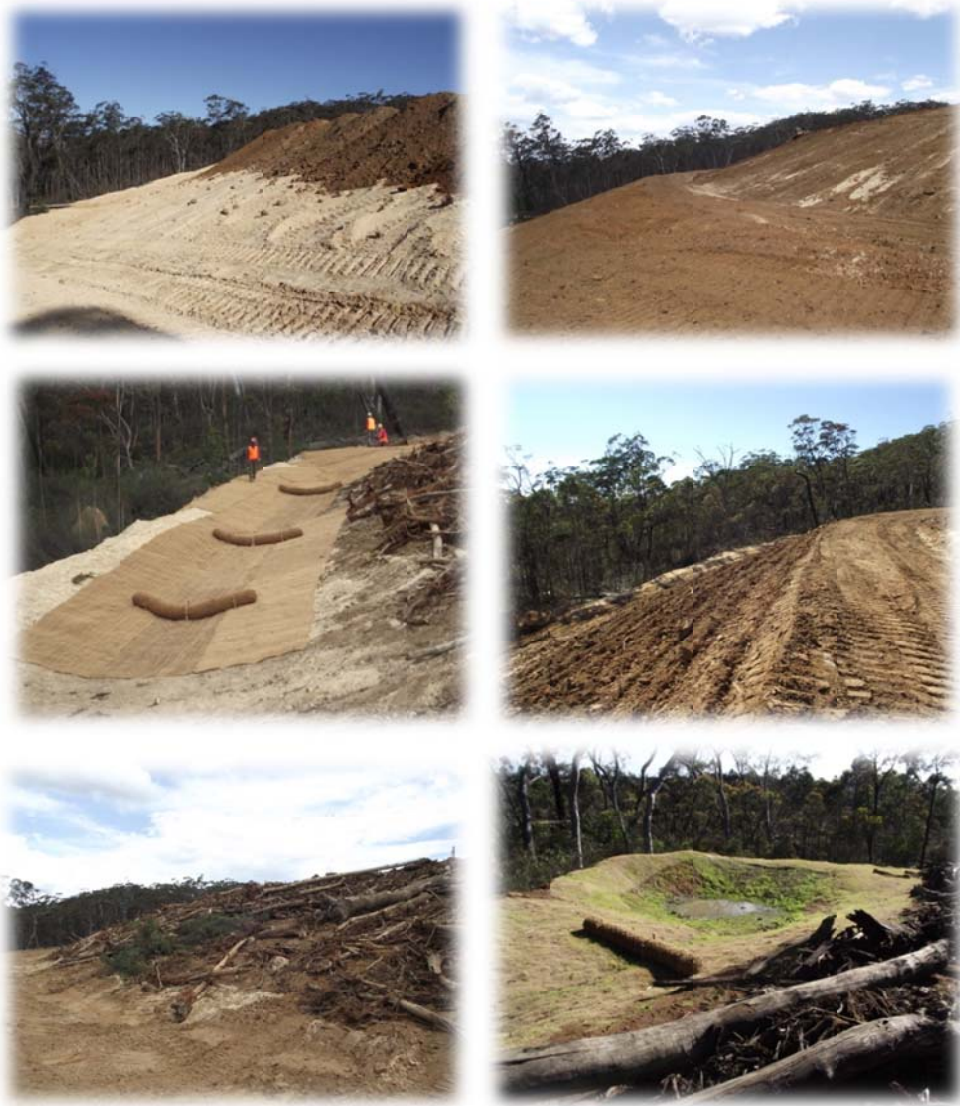
**Figure 88 Rehabilitation Progress of REA IV in 2012**

**Figure 88** below illustrates the rehabilitation progress and initial success. EFA will be employed to monitor the progress of rehabilitation and track against analogue sites to ensure the final meets the requirements set out in Clarence's Mine Closure and Rehabilitation Plan.

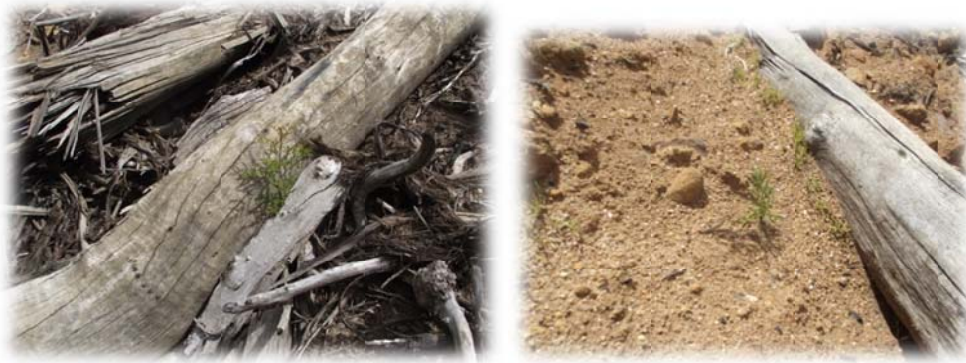
**Figure 89 Juvenile Endemic Shrub Species on the Rehabilitated Area**

Monitoring of the rehabilitated area has identified the following juvenile shrub species present on the rehabilitated batters in December 2012:

- *Acacia terminalis*
- *Hakea dactyloides*
- *Hakea salicifolia*
- *Entolasia marginate*

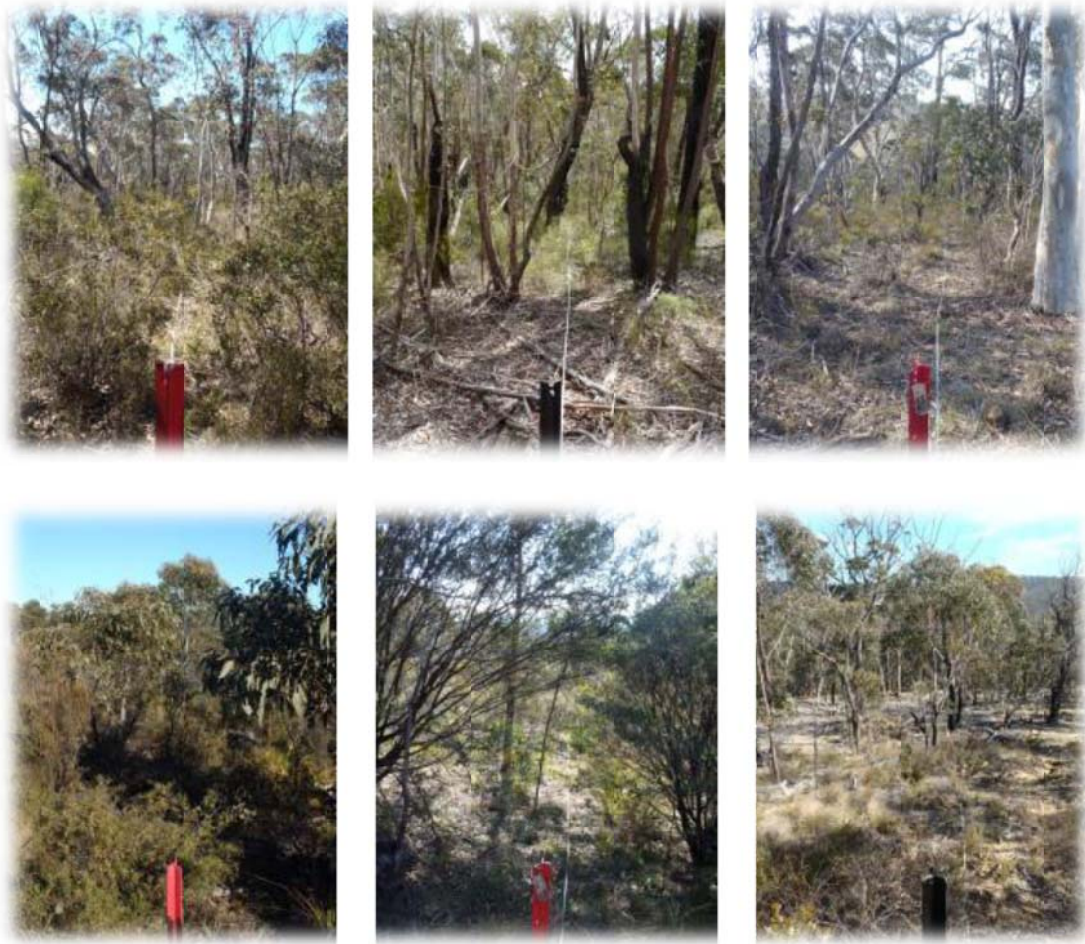
**Figure 90 Analogue and Rehabilitation Transects**

Six Study Transects were established in 2012 including 3 rehabilitation transects located on the previously rehabilitated REA I and REA II, and the partly rehabilitated REA III. Three analogue transects were established on undisturbed land surrounding the REA's.
