***Longwalls 900W and 910  
Integrated SMP/Extraction Plan  
2015 Annual Report***

**Angus Place Colliery**

**June 2017**

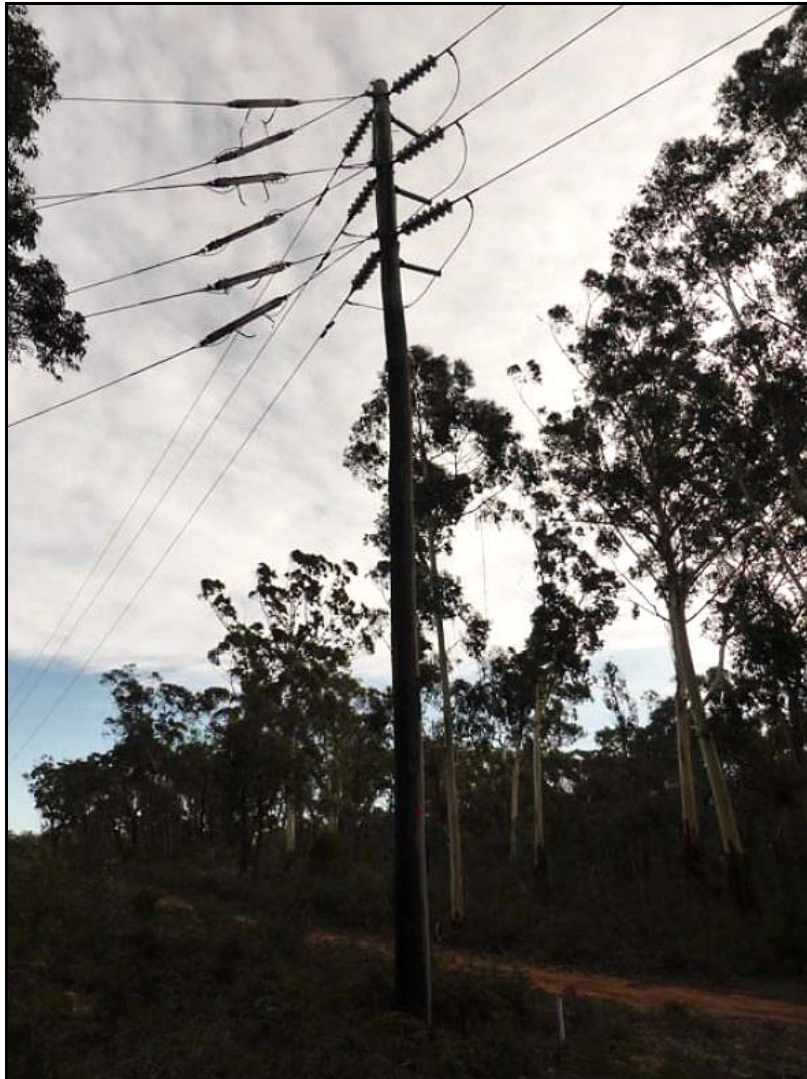
Photographic monitoring in the reporting period indicated there was no impact from mining observed.

**Figure 6. Power Pole #206 Facing North – 9 June 2015**

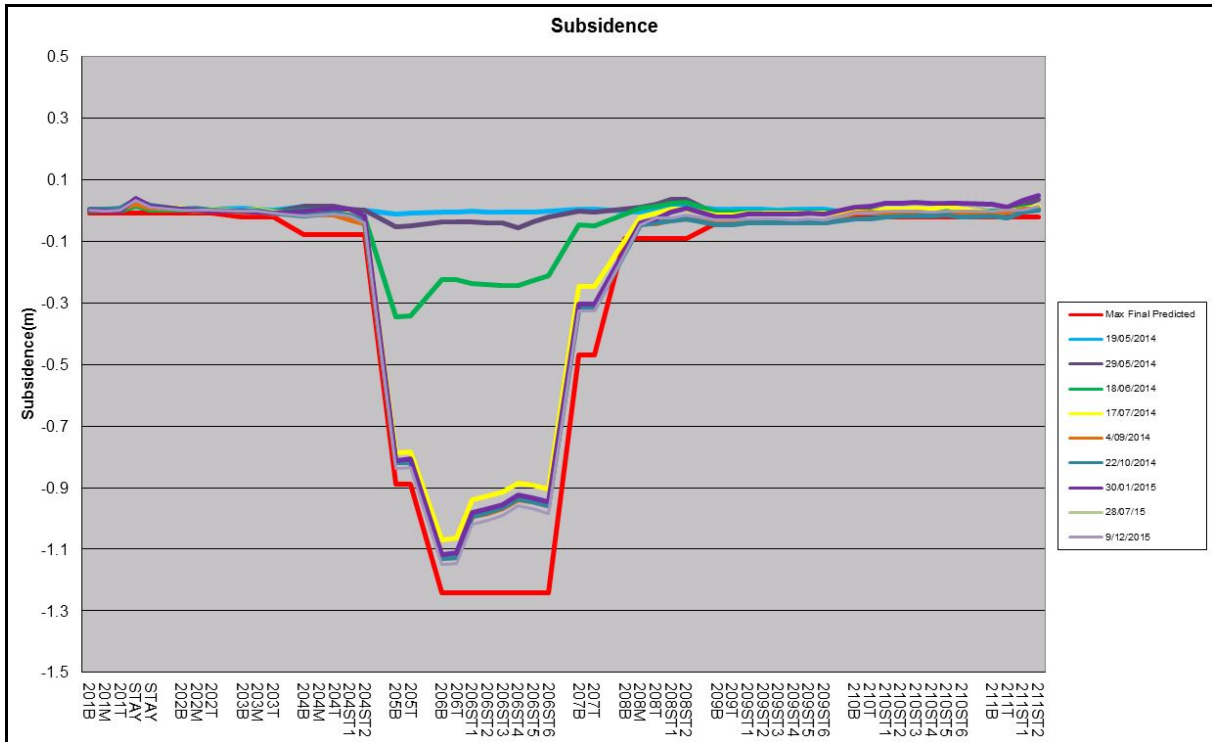
**Figure 7. Total Station Survey subsidence monitoring history**

Total Station Surveys were conducted on 28 July 2015 and 8 December 2015. The Total Station Survey of 28 July 2015 identified a maximum difference in subsidence over the previous survey of 30 January 2015 of 20mm at Stays 3 and 6 on Power Pole #206, shown in **Figure 6**. The December survey identified a maximum difference in subsidence over the previous survey of 28 July 2015 of 32mm at the top of Power Pole #208.

The Strain and Tilt values calculated for each survey were consistent with previous surveys where power poles had been undermined.

A summary of the Total Station Survey data is shown in **Figure 7**.

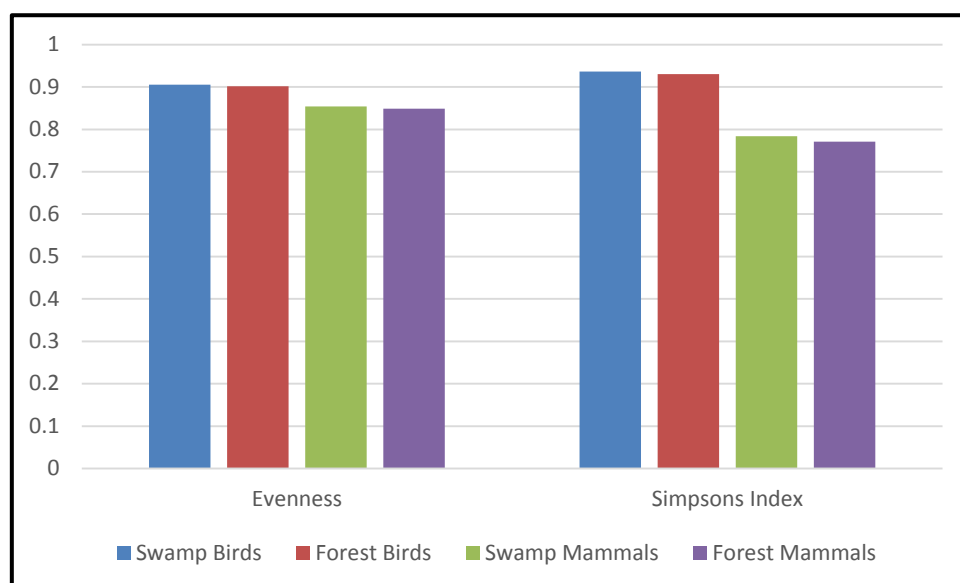
**Figure 11. Evenness and Simpsons Index of Biodiversity within the project area**

**Figure 11** shows the mean biodiversity values for the swamp and forest sites with the Project Area.

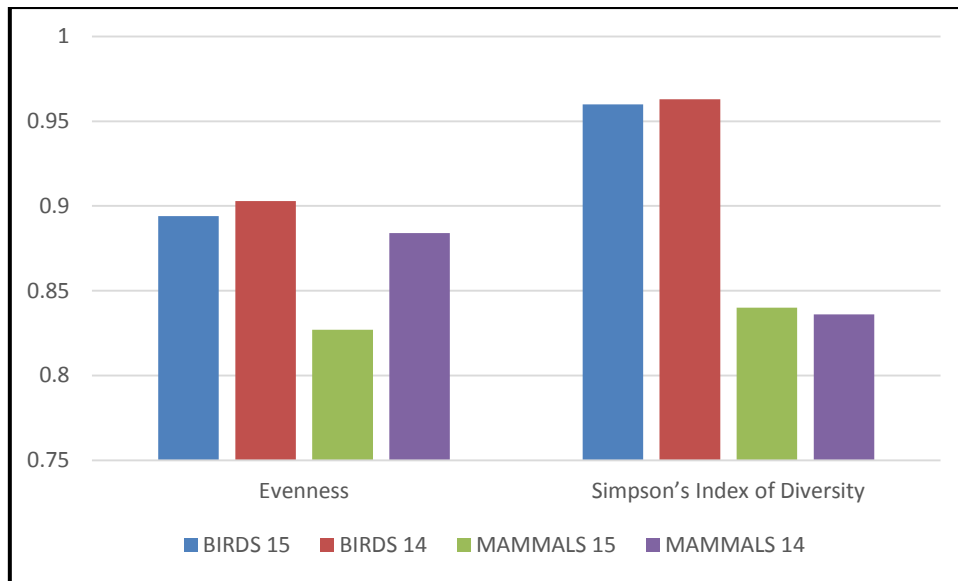
**Figure 12. Mean Biodiversity Indices within 930 980 Previous SMP Area and Area 900/910**

It is possible to compare the results from the Spring 2015 fauna monitoring surveys undertaken at Angus Place Colliery SMP Area with those obtained from area 900/910. A summary of the results is presented in **Table 5**. There are no significant differences between the habitat characteristics measured at area 900/910 and Angus Place Colliery SMP Area (Students t-test).

The results from the survey of the Angus Place Colliery 900/910 area in Spring 2015 show that the assemblages found are typical of that found throughout Newnes Plateau and are similar to that obtained in the remainder of Angus Place Colliery.
