Review of Environmental Factors

Subsidence Monitoring Line

Airly Mine, Capertee

Client Manager: Shaun Smith
Report Number: PR132971-2
Version / Date: Version 2 / August 2016

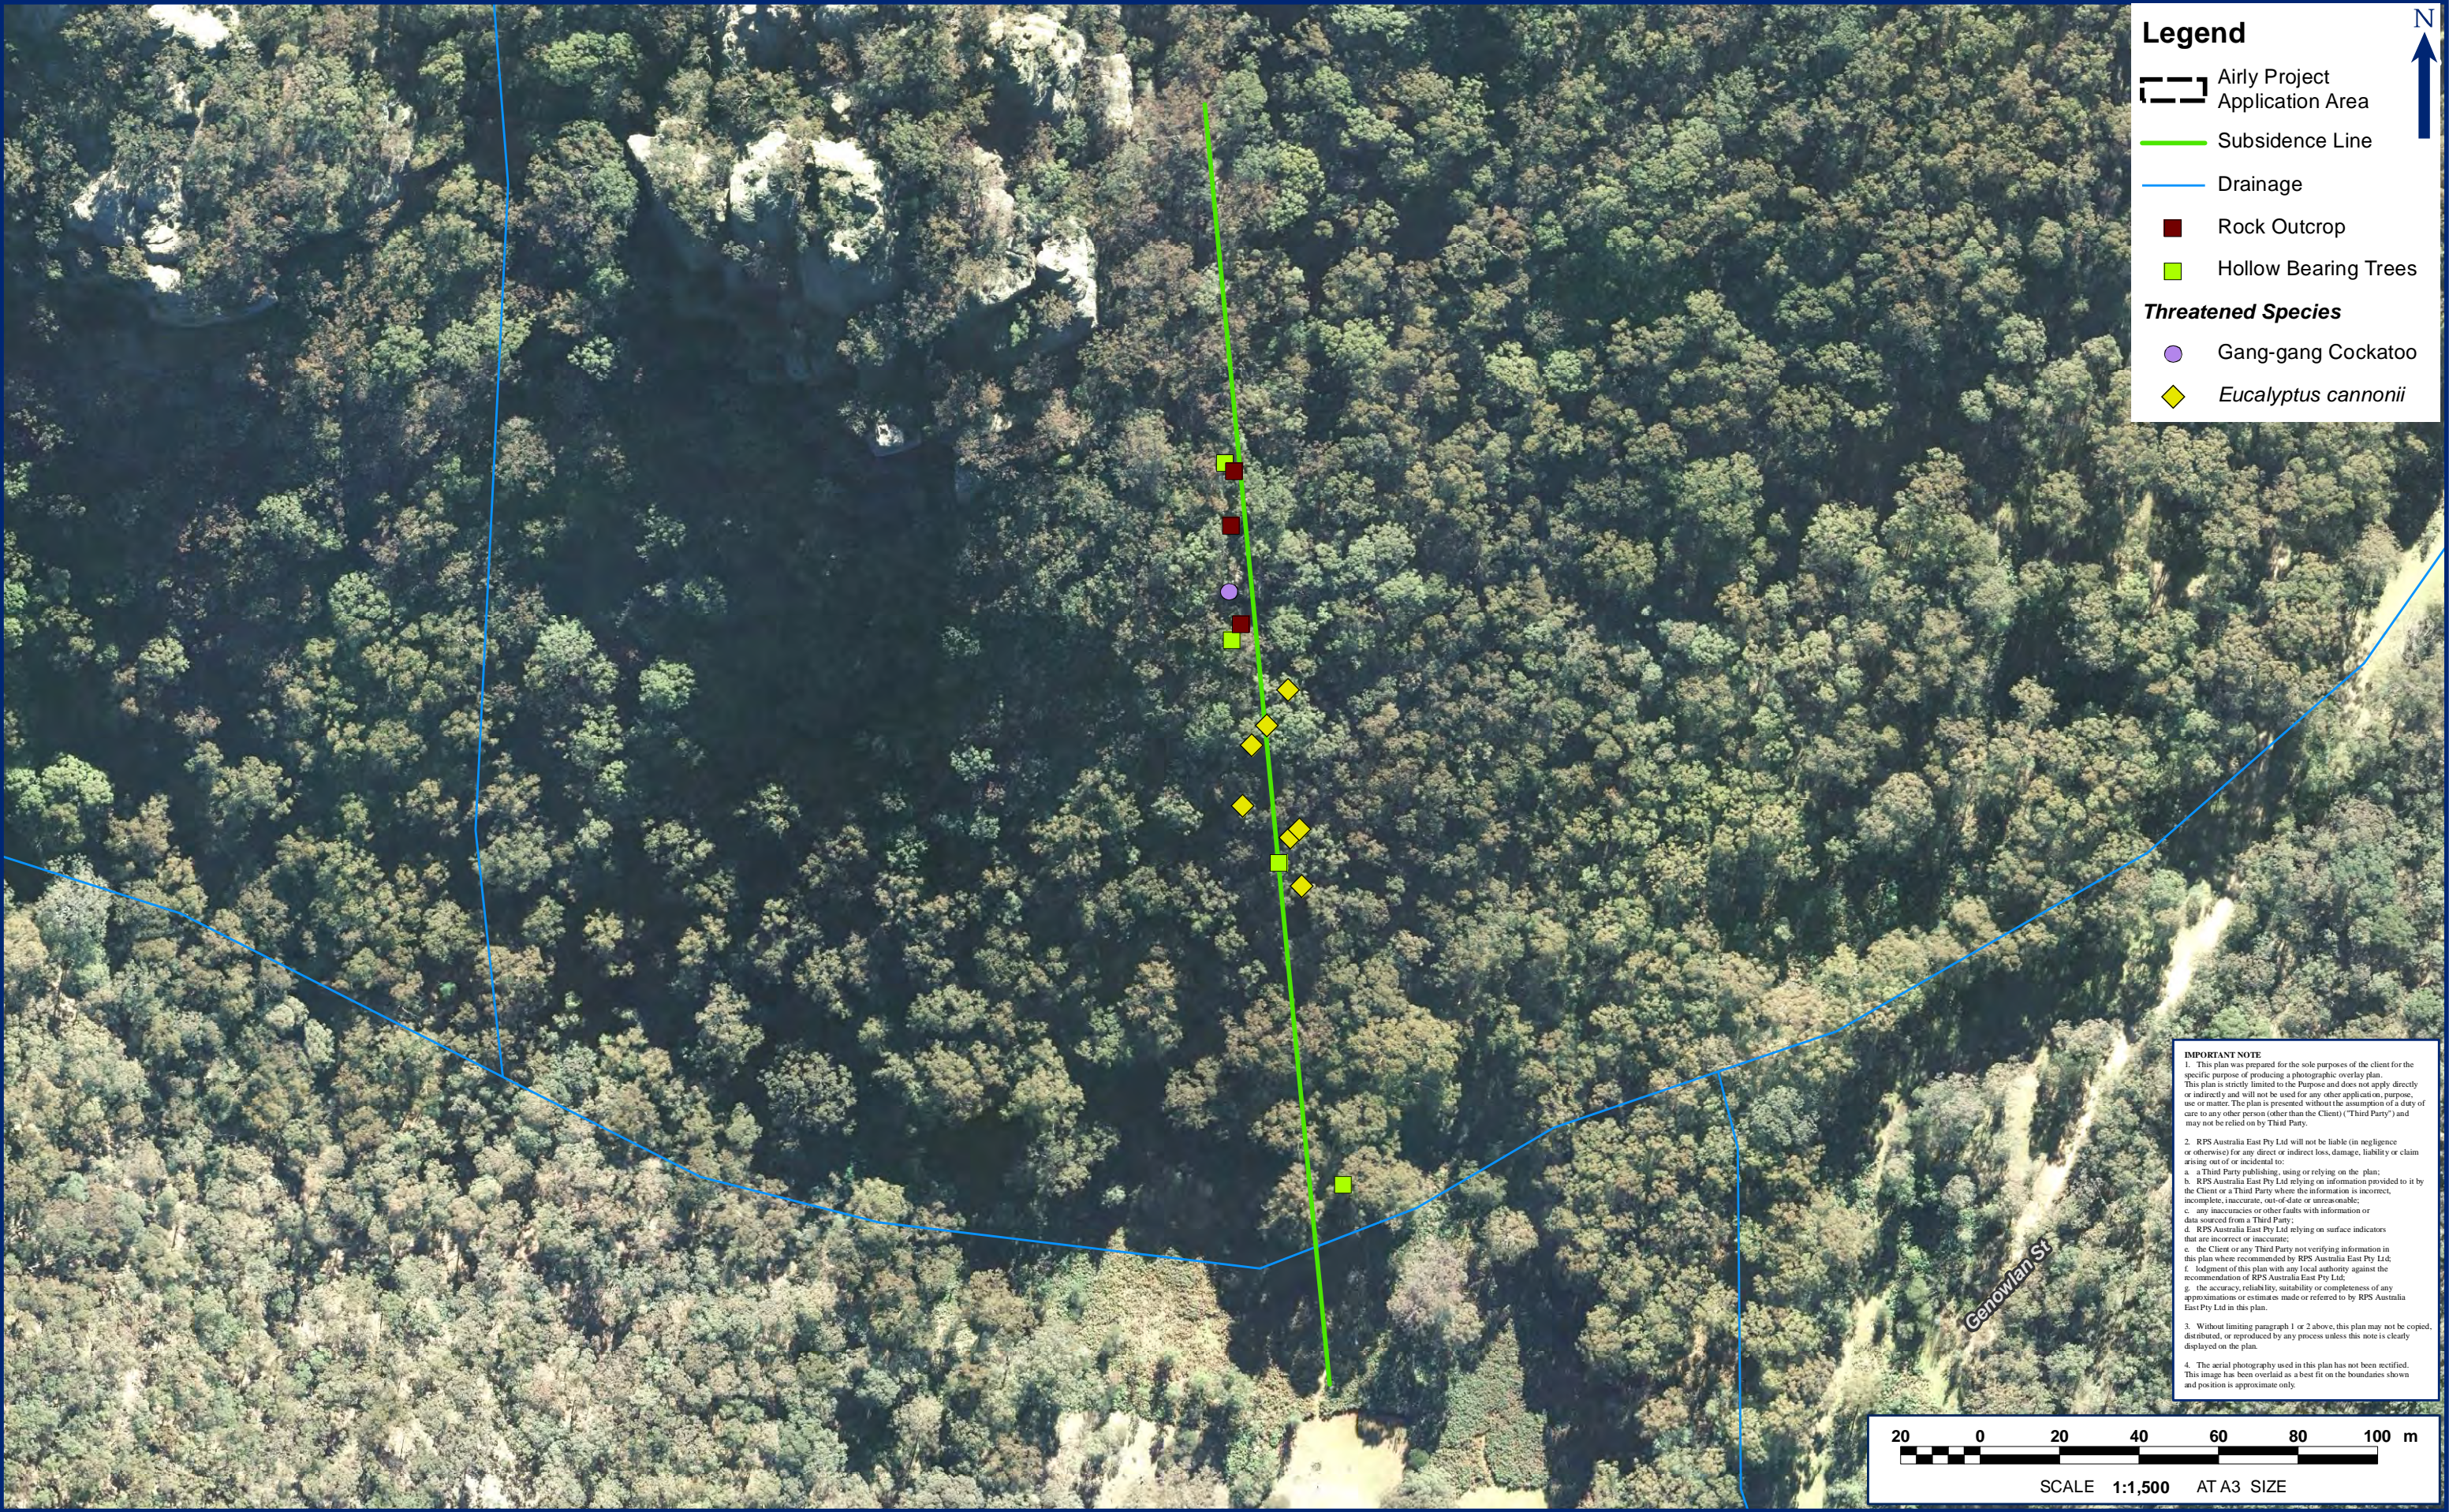
FIGURE 3: THREATENED FLORA, FAUNA AND HABITAT

The Project Area was found to contain an area of rocky pagodas which provides habitat for a range of fauna including the threatened Broad-headed Snake (*Hoplocephalus bungaroides*) and Brush-tailed Rock-wallaby (*Petrogale penicillata*).

The location of all threatened flora and fauna, and habitat features are displayed in **Figure 3**.

Two hollow-bearing trees and an area supporting rocky pagodas were discovered within a 10m buffer of the Project Area. Rock pagodas are susceptible to impacts created by subsidence that could ultimately result in cracking of rock, fissures or rock fall. RPS (2014) has assessed the predicted subsidence modelling for Airly, with no significant impacts considered to occur. Minor vegetation clearing proposed to occur within the Project Area will remove potential foraging habitat for local fauna. Subsequently, no significant impacts on fauna habitat are expected, due to the relatively minor actions of the proposed works.

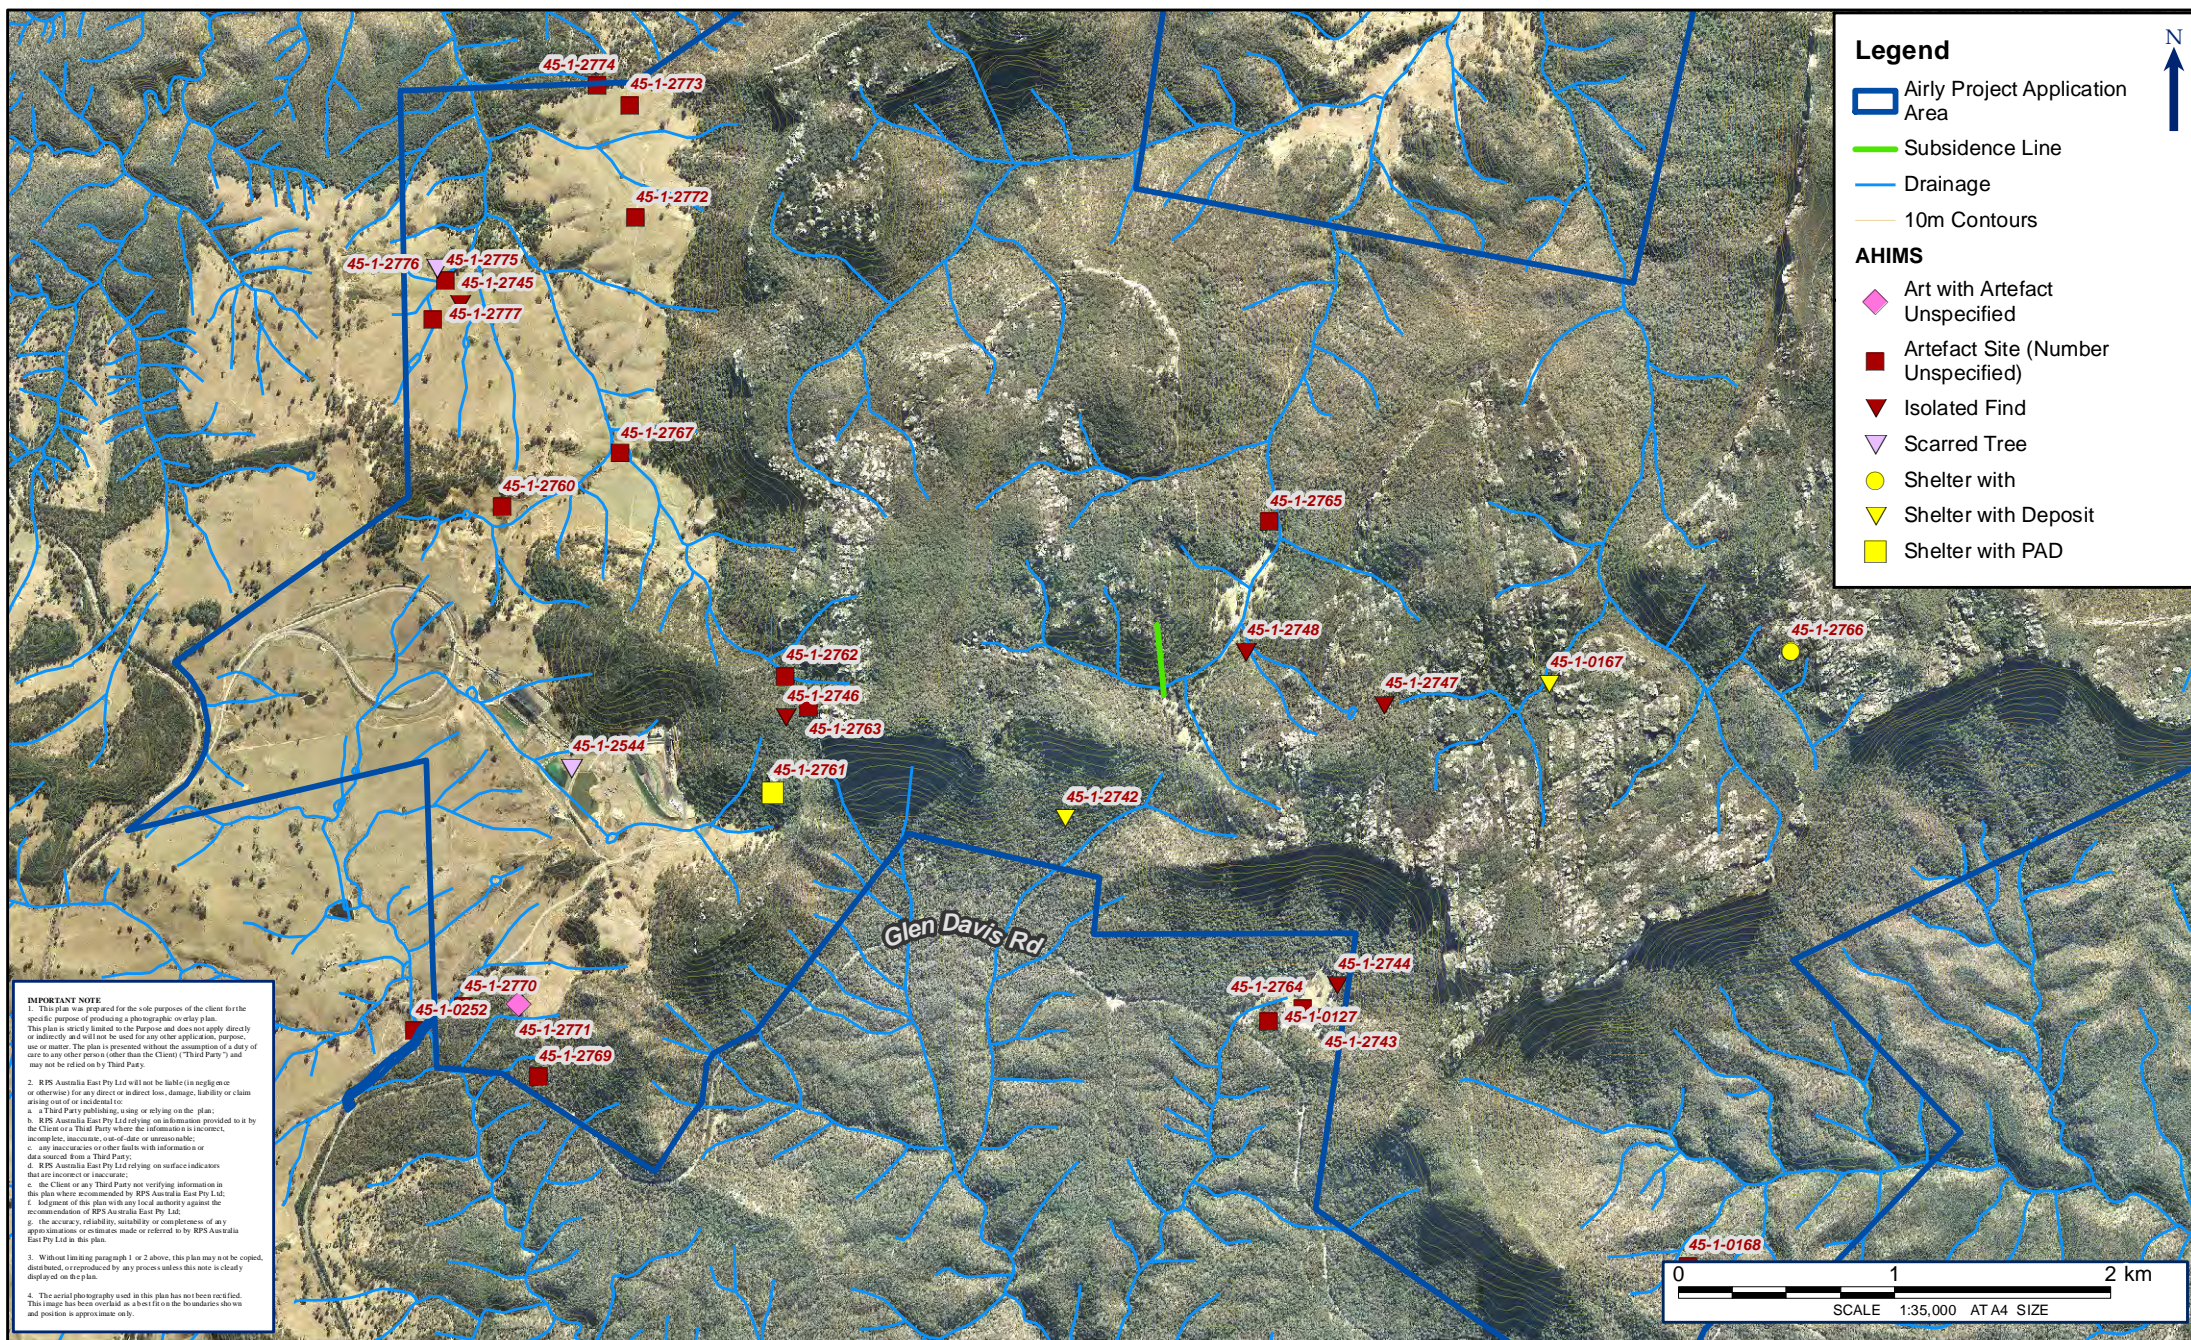
FIGURE 5: HERITAGE ITEMS

The northern half of the Project Area extends into the Airly, Torbane and Genowlan oil shale site which is listed on the Lithgow LEP (A144). This site contains extensive buildings associated with oil shale mining from 1893 until closing in 1918 (RPS 2013). No built structures lie within the Project Area, the nearest structure is located approximately 300 metres to the east and therefore unlikely to be directly impacted. Refer to **Figure 5** for the location of historic heritage items in relation to the proposed subsidence monitoring line.

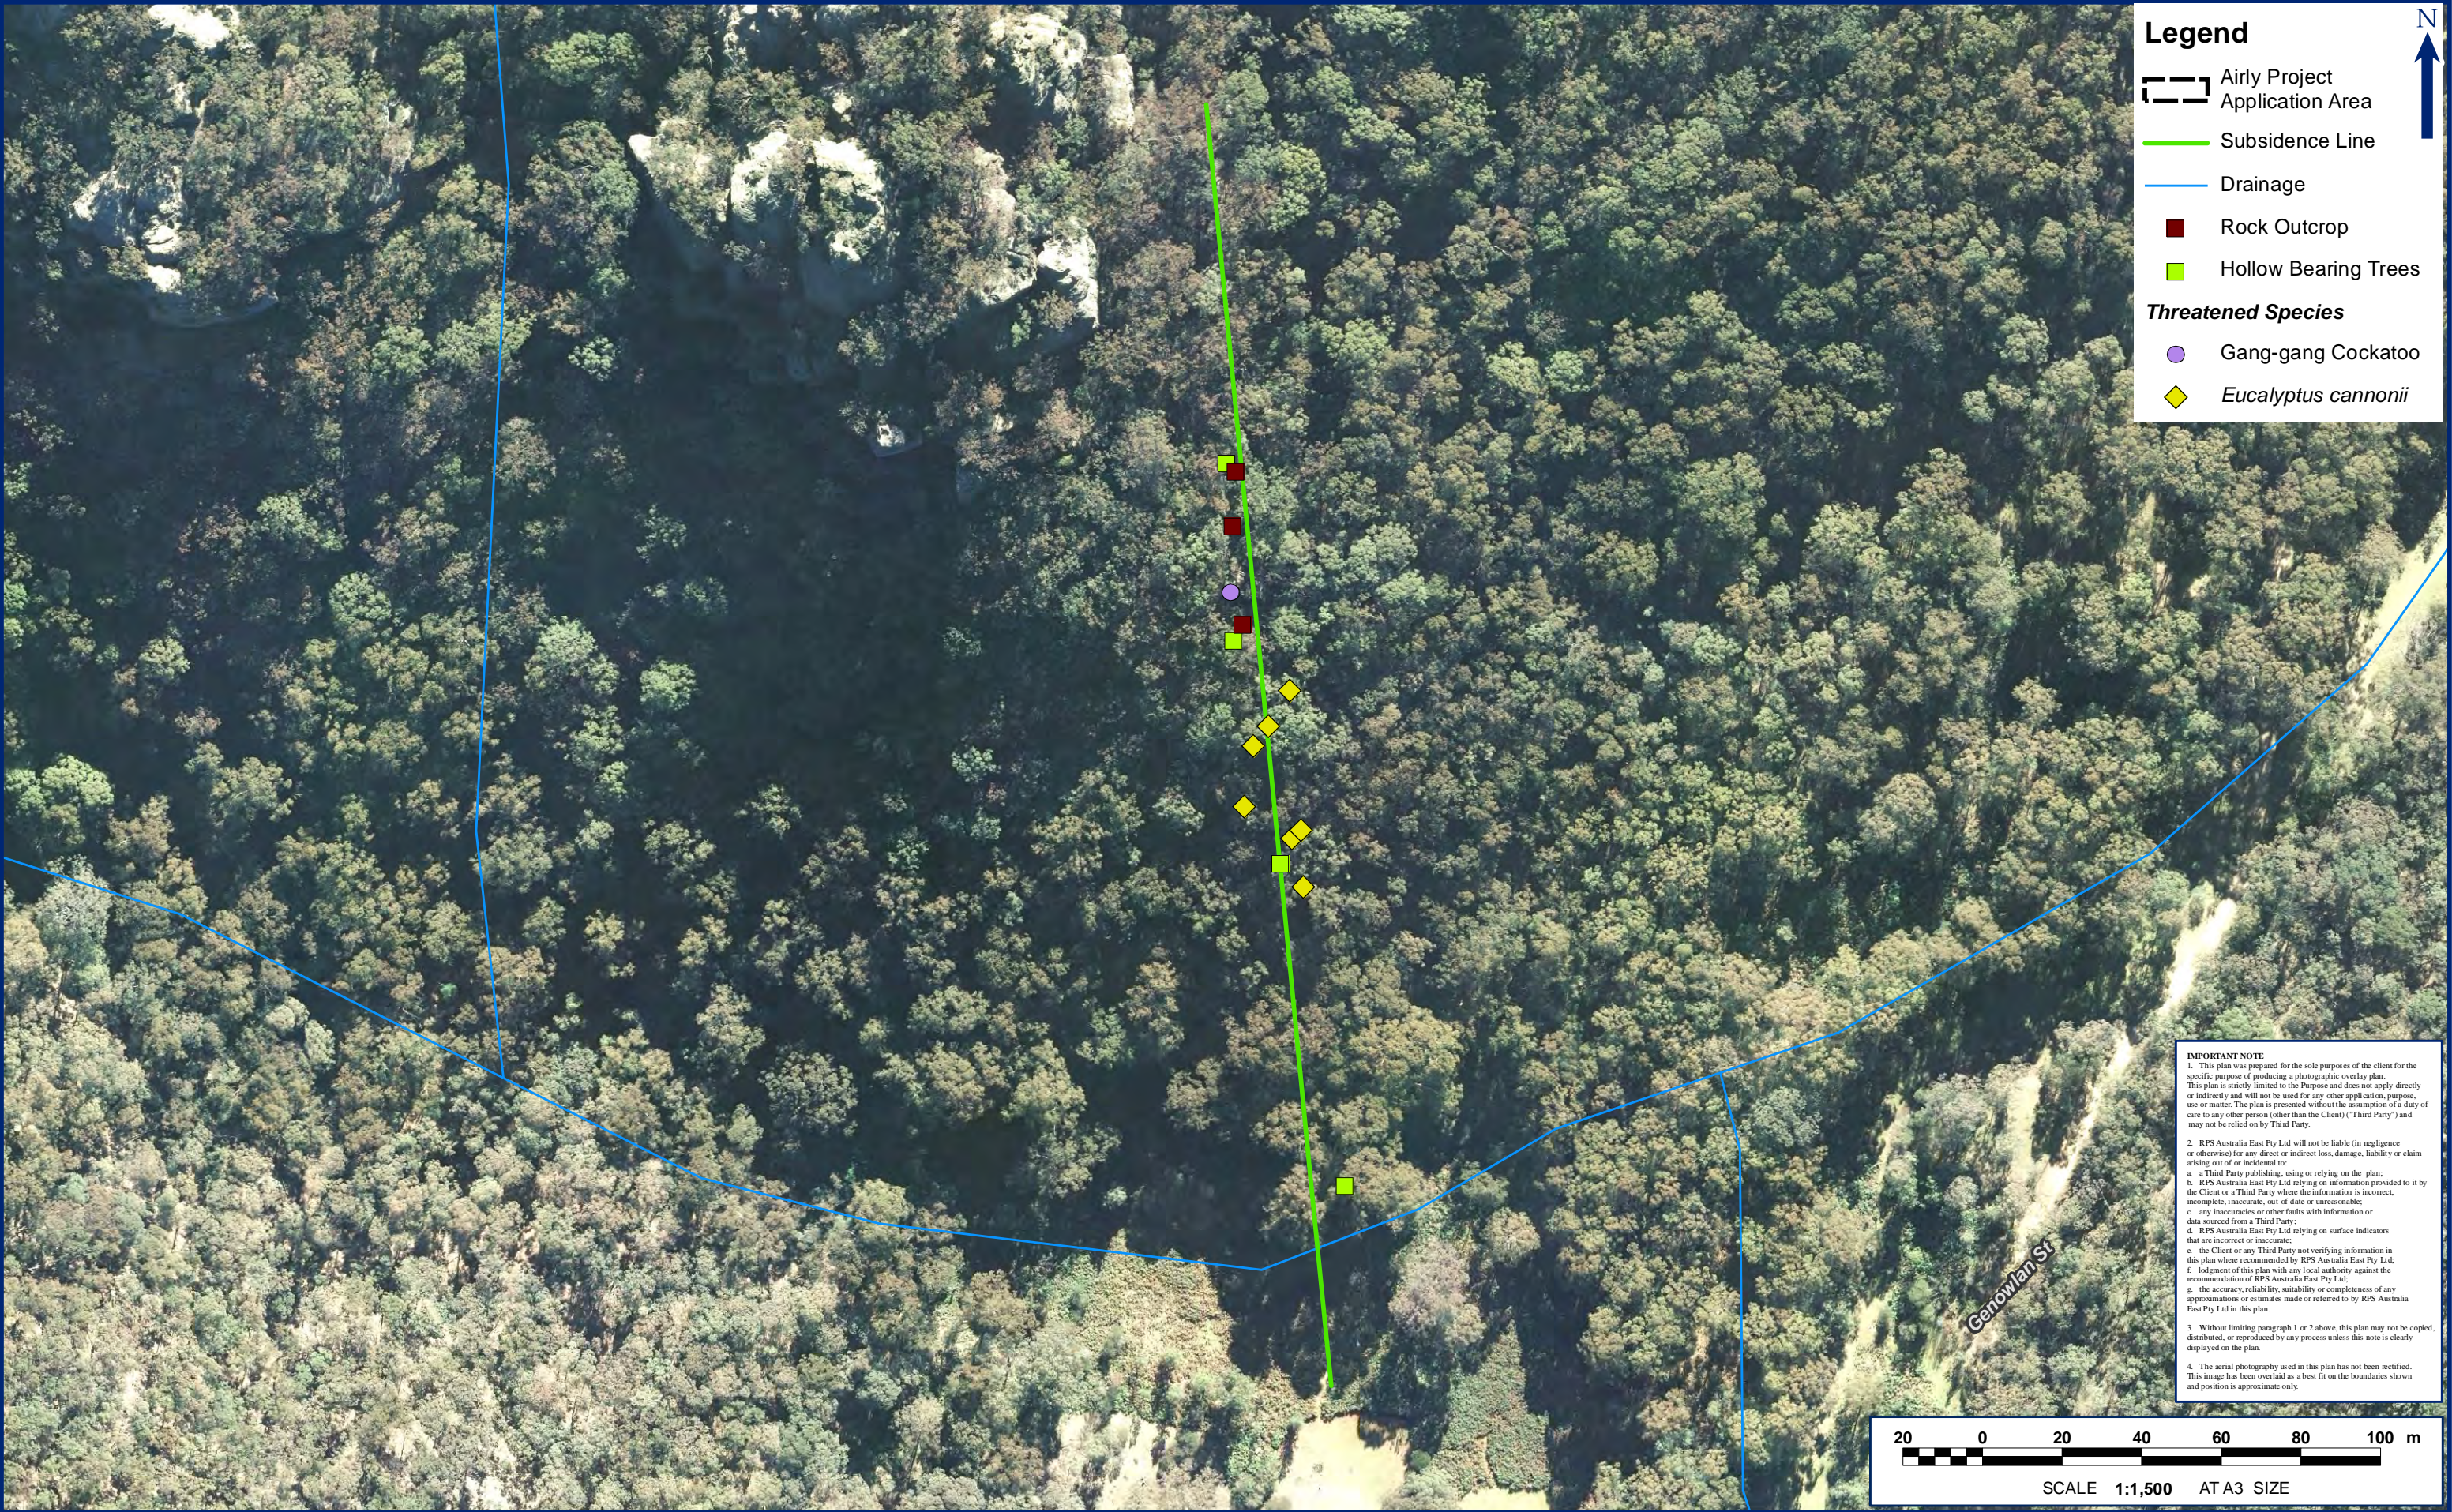
TITLE : **FIGURE 2 : THREATENED FLORA & FAUNA**

Seven individuals of the threatened plant *Eucalyptus cannonii* were identified along the subsidence monitoring line and within 10 m of the Project Area (refer to **Figure 2**).

Two hollow-bearing trees and an area supporting rocky pagodas were discovered within a 10m buffer of the Project Area. Rock pagodas are susceptible to impacts created by subsidence that could ultimately result in cracking of rock, fissures or rock fall. RPS (2014) has assessed the predicted subsidence modelling for Airly, with no significant impacts considered to occur. Minor vegetation clearing proposed to occur within the Project Area will remove potential foraging habitat for local fauna.

- Access to the subsidence line during installation and ongoing monitoring works should be restricted to established tracks where possible;
- No *Eucalyptus cannonii* are to be removed and should be clearly flagged and avoided;
- It is recommended that any felled trees and branches be retained within the immediate vicinity of the created monitoring line where possible to provide potential habitat for ground-dwelling fauna into the future;
- Hollow bearing trees should be avoided where possible. If hollow bearing trees are removed, nest boxes should be installed in surrounding habitat to compensate for the loss of hollows; and
- Disturbance to potential fauna habitat should be avoided, whilst removal of ground and shrub species during clearing works should be minimised wherever possible.

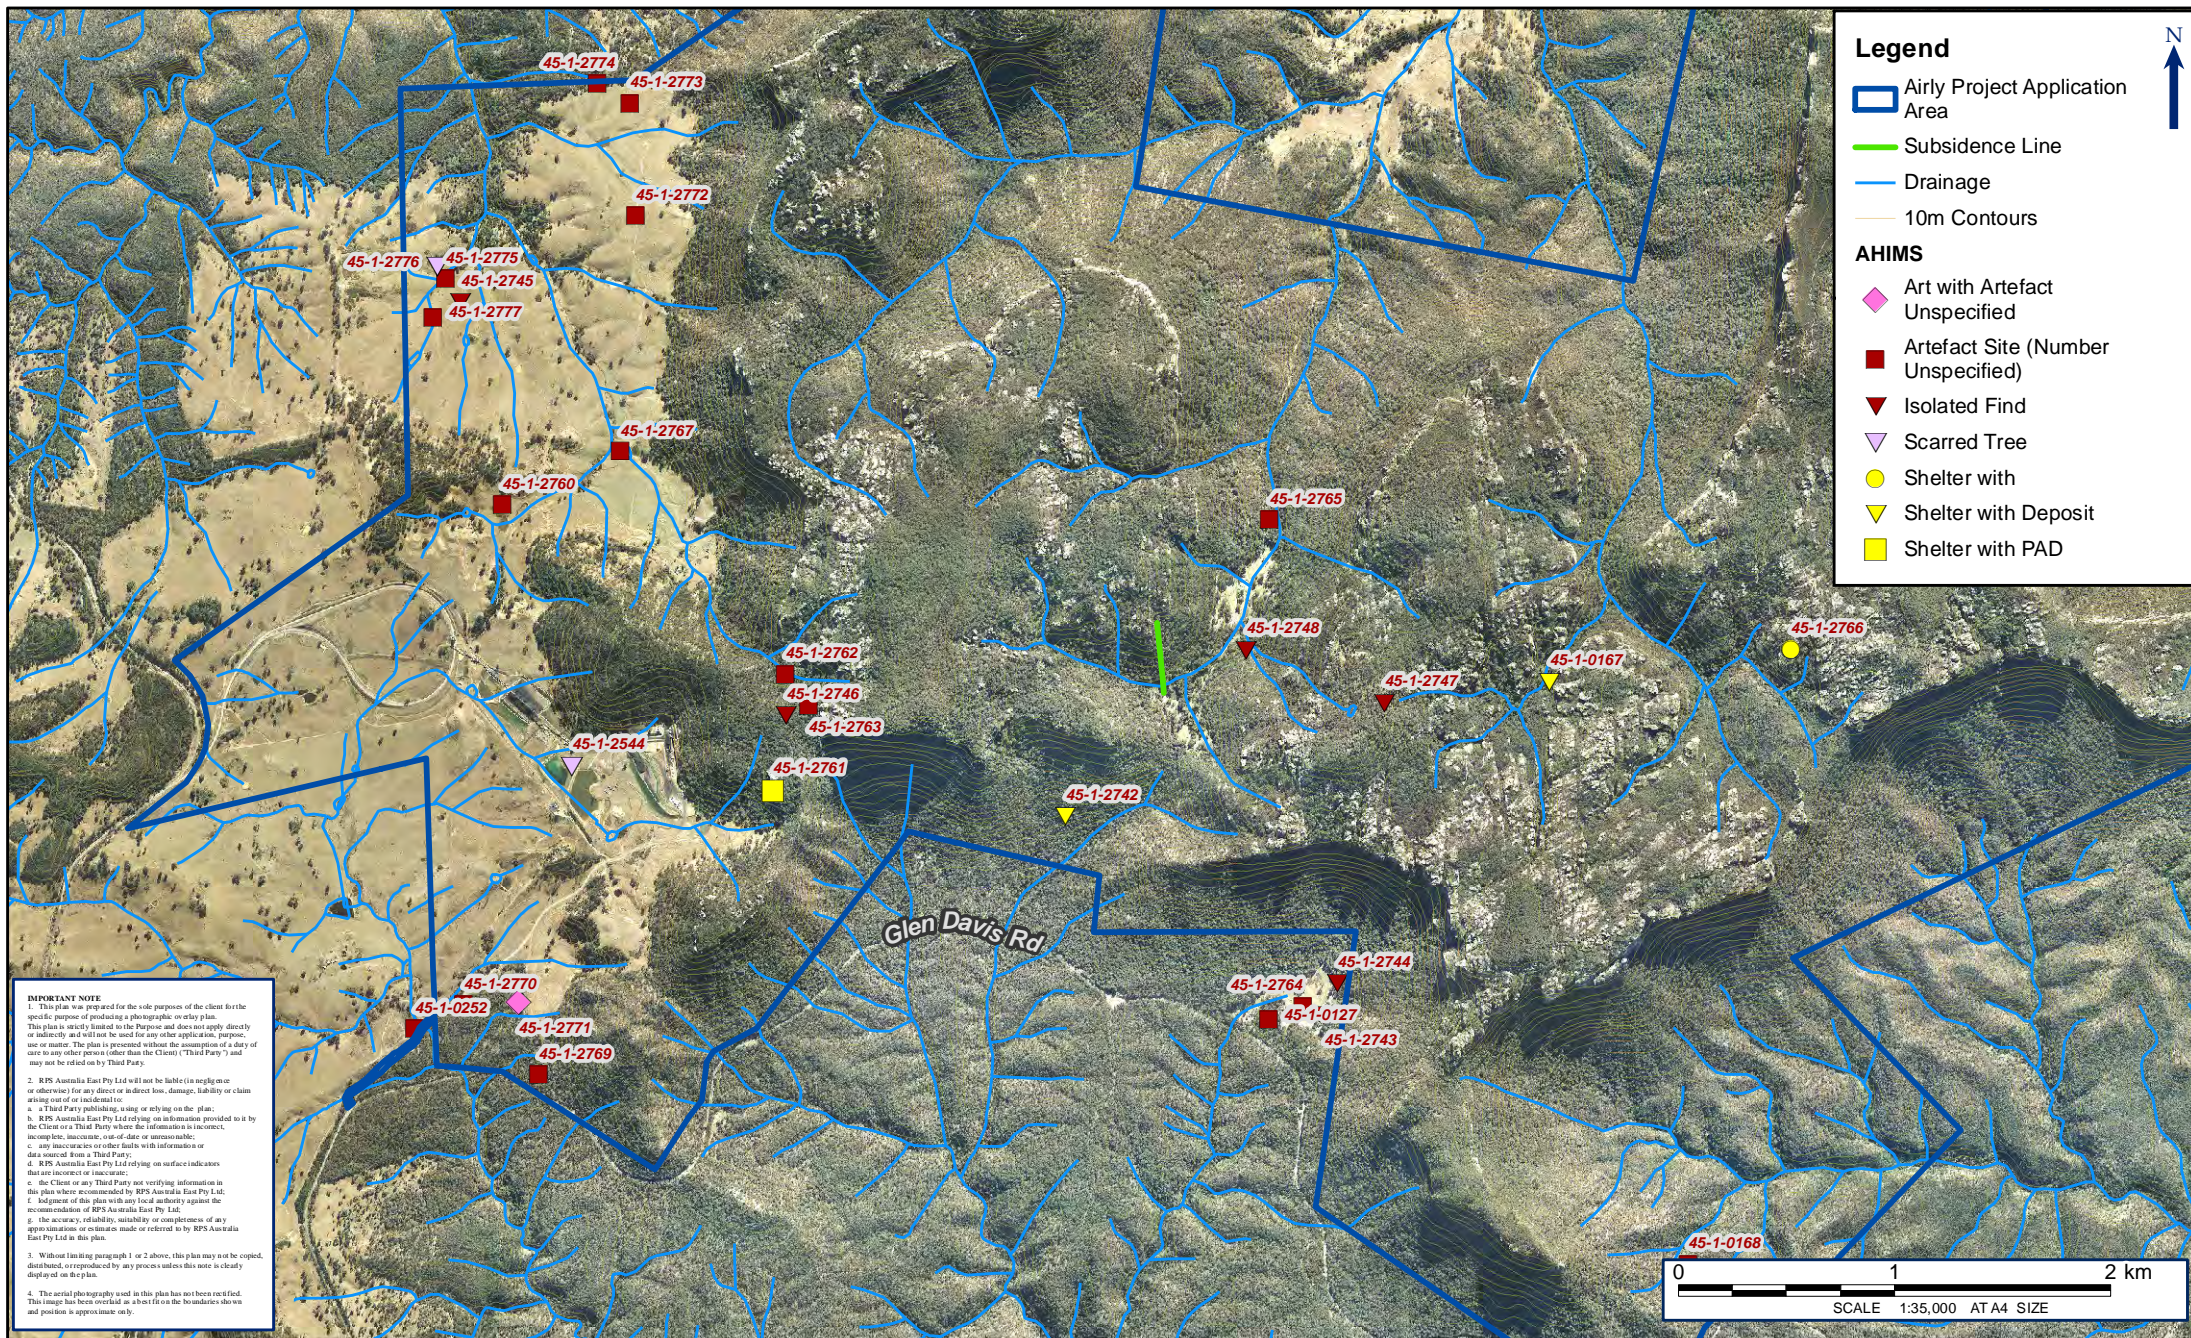
FIGURE 2: AHIMS

A search was undertaken of the Aboriginal Heritage Information Management System (AHIMS). The coordinates searched for the Project Area were GDA Zone 56, Eastings 220148 to 227469 and Northings 6329861 to 6338038 and revealed 29 previously recorded Aboriginal sites within these coordinates (0 and **Error! Reference source not found.**).

The search revealed that no Aboriginal objects or places were present in the Project Area. Summary of AHIMS sites within the searched coordinates can be found in Table 1.

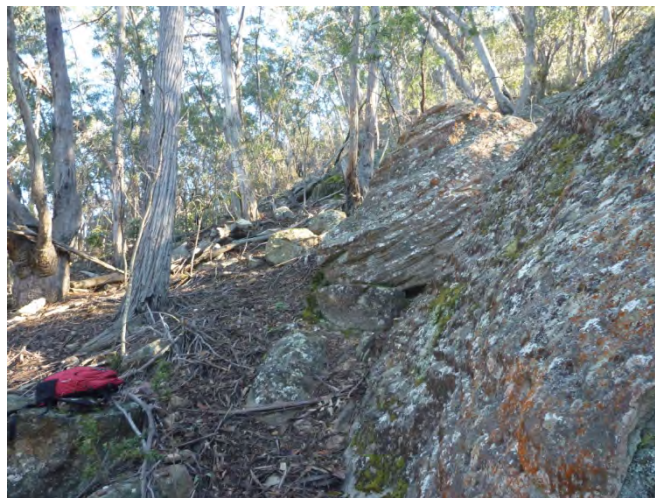
Plate 5 Sandstone outcrops

Approximately 100 metres into the Project Area large sandstone outcropping were observed (**Plate 5**). These continued throughout the remainder of the area until reaching the base of the cliff face (**Plate 6**). The entire Project Area is located on a spur associated with a large sandstone outcrop which runs in a north - south direction. Approximately 75 metres to the east of the Project Area a steep gully runs in a north-west to south-east axis and contained a small, steady stream of water (**Plate 7**). A buffer of ten metres either side of the subsidence line was given.
