CENTENNIAL COAL NEWSTAN COLLIERY ANNUAL REVIEW

March 2015

Name of Operation	Newstan Colliery
Name of Operator	Centennial Newstan Pty Ltd
Development Consent/ Project Approval #	DA 71_11_98 and SSD-5145
Mining Lease #	Consolidated Coal Leases 727, 746, 763 and 764.
	Mining Leases 1380, 1452, 1480, 1586, and 1587.
	Mining Purposes Leases 304, 305, 327, 328.
	Private Lands Lease 497.
Name of Holder of Mining Lease	Centennial Newstan Pty Ltd
Water License #	
Name of Holder of Water License	Centennial Newstan Pty Ltd
MOP/RMP Start Date	August 2015
MOP/RMP End Date	August 2018
Annual Review Start Date	January 2015
Annual Review End Date	December 2015

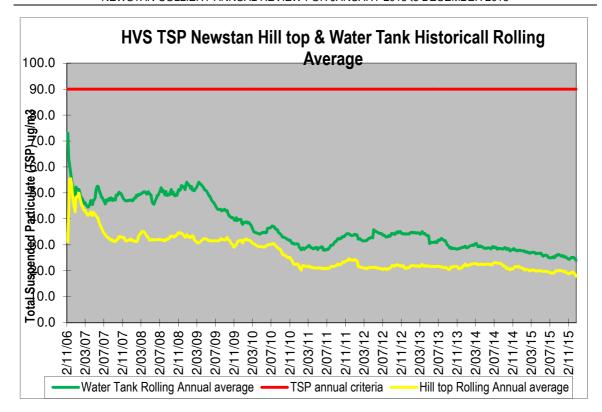
Figure 3: Newstan Rolling Annual Average and 24 hour results for High Volume Dust Sampling for PM10

Figure 3 displays the rolling annual average and 24 hour results for high volume dust sampling results for PM10, Figure 4 displays the Rolling Annual average and the 24 hour results for TSP at the Hill Top Location (HVS1) and Water Tank Location (HVS2).

The rolling annual average results for both locations were below the criteria for TSP of 90 μ g/m3 (annual average), and PM10 of 30 μ g/m3 (annual average), and the results were also below the PM10 24 hour limit of 50 μ g/m3 during the 2014 reporting period.

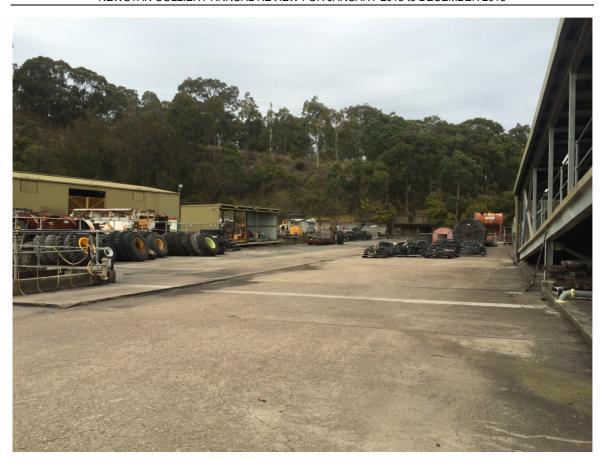
Figure 5: Prior to site auction and clean up.

In 2015 Newstan Colliery undertook a large site clean up and an auction to sell off redundant and scrap material from site which contributed to the increase in scrap metal and waste volume for the reporting period. Figure 5 and 6 below show an example of the before and after photos from the auction.

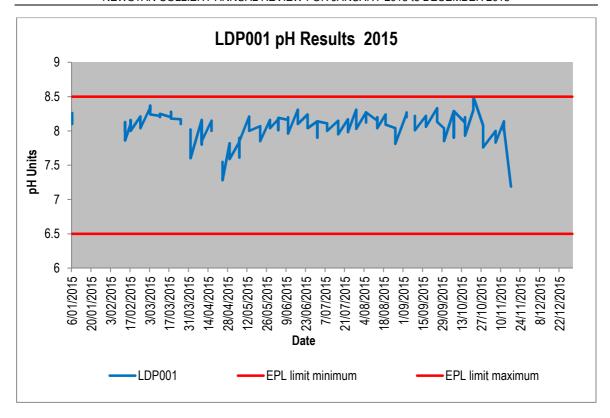
Figure 7: LDP001 pH Result 2015

Figures 6, 7, 8 and 9 show the pH, total suspended solids (TSS), oil & grease & conductivity for discharge waters through LDP001 in 2015. Note: If results are less then the limit of reporting, a value of 0 is put in for the development of the below graphs.

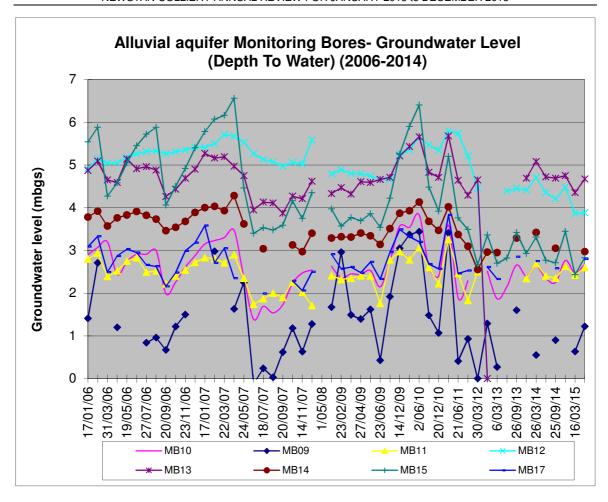
Figure 11: Alluvial aquifer monitoring bores – level trends (2006 – 2015)

Graphs of water level, pH and EC trends for the history of the bores are shown on Figures 11, 12 and 13 respectively.

The water levels indicate that the aquifer levels are higher then baseline and the average water levels over the historical monitoring period. The data indicates a slightly acidic to neutral pH generally in the range of 5.87 to 6.88 for 2015 for the alluvial groundwater, which is similar to baseline and historical data. The electrical conductivity (EC) has a wide range of 190-3935 μ S/cm. This large range may reflect the recharge source of the alluvial groundwater at the monitoring locations by either;

- direct surface infiltration from rainfall, giving relatively low EC readings; or
- upward leakage or lateral flow from the Permian sediments into the alluvium, giving higher EC readings.

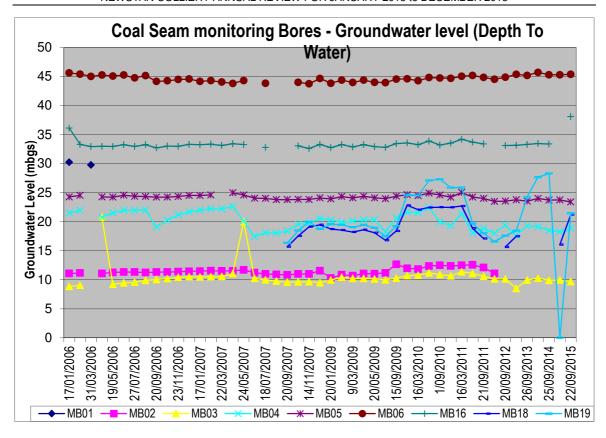
Figure 14: Coal Seam monitoring bores – level trends (2006 -2015)

Graphs of water level, pH and EC trends for the history of the bores are shown on Figures 14, 15, and 16 respectively.

The water levels within the Coal Seam bores are generally stable in 2015. The pH trends shown on Figure 14 indicate that groundwater from the coal seams were quiet variable, ranging from 4.91 to 7.71 during 2015. This could be a result of direct filtration into the shallower bores such as MB18.

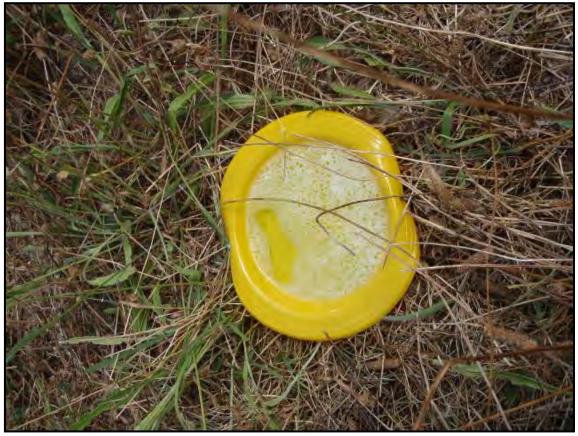
Flying invertebrates are attracted to the colour of yellow and as such were sampled using yellow pans (plastic plates with a diameter of 230 mm and a depth of 25 mm) containing a soap solution (Oliver *et al.*, 1999; Dahms, 1997) (refer to Plate 1). Each pan was pegged to the ground using two skewers, as to prevent disturbance by other mobile fauna in the area.

Each site had a transect consisting of three yellow pans set 5m apart, which were sampled on Wednesday and Friday mornings. A sieve was used to collect all insects, and as a result invertebrates <0.5 mm were not included in the sampling process. The filtered material was placed in sampling jars containing methylated spirits and labelled appropriately. All pans and sieves were inspected thoroughly after each filtering process and washed out to ensure all invertebrates were removed.

Plate 1 Yellow Invertebrate tray

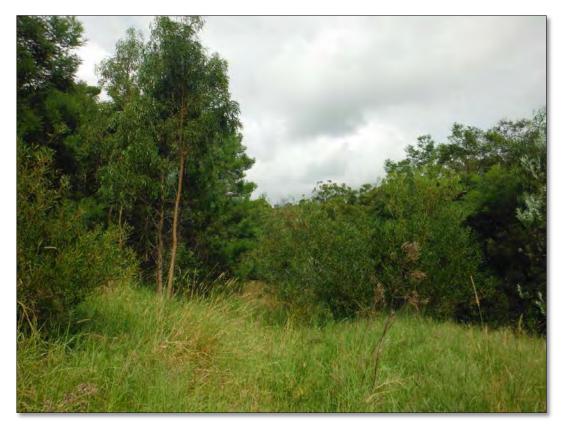
Rehabilitation Site A is situated in the mine rehabilitation area that has been subject to vegetation rehabilitation through direct seeding. It is the most western site of the three rehabilitation sites. Rehabilitation Site A is displayed in **Plate 3**.

Plate 3 Regenerating Acacias and non native grasses at Rehabilitation A

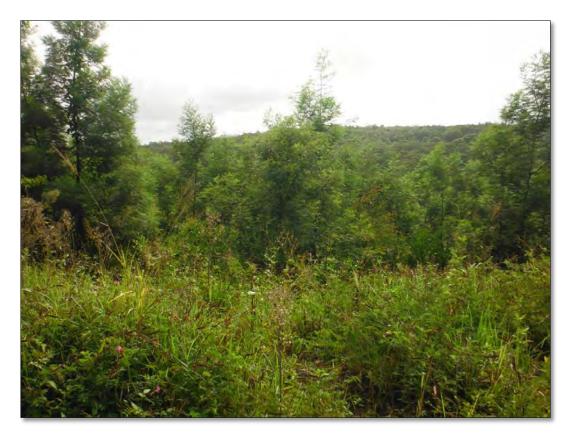
Rehabilitation Site B is situated in the mining rehabilitation area that has been subject to vegetation rehabilitation through direct seeding. It is situated between Rehabilitation Site A and Rehabilitation Site C. **Plate 4** displays Rehabilitation Site B.

Plate 4 Regenerating vegetation at Rehabilitation B

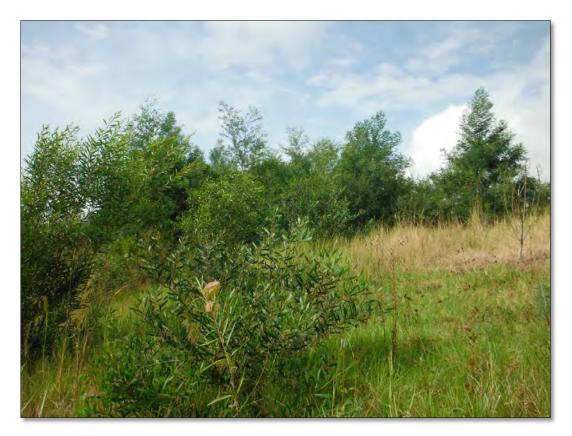
Rehabilitation Site C is situated in the mining rehabilitation area that has been subject to vegetation rehabilitation through direct seeding. It is situated to the east of Rehabilitation Site B. **Plate 5** displays Rehabilitation Site C.

Plate 5 Regenerating Vegetation at Rehabilitation C site

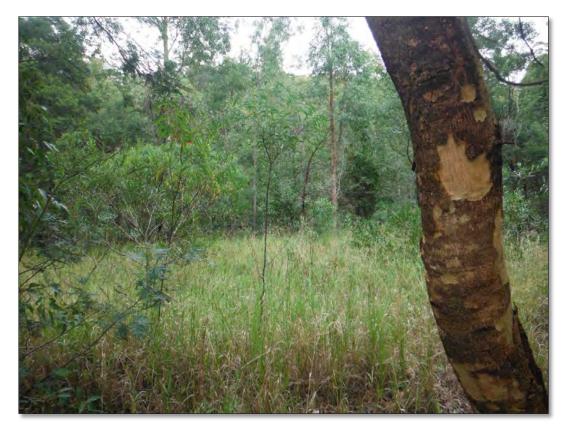
Analogue Site 1 is a more advanced rehabilitation area within the Newstan Colliery project area. It is situated within the western corner of the project application area boundary in close proximity to Miller Road. **Plate 6** displays Analogue Site 1.

Plate 6 Analogue Site 1 Vegetation

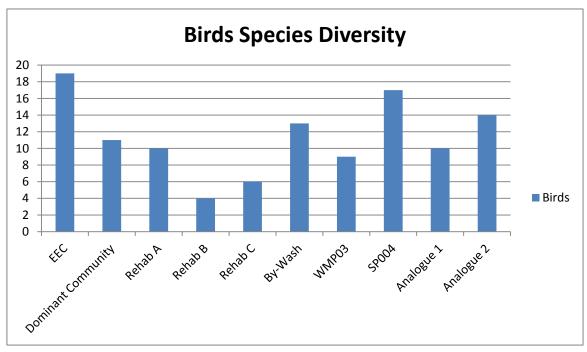
Figure 4 Bird Species Diversity in 2015

In total, 37 bird species were detected in the reference sites, while 25 birds species were detected in the rehabilitation sites. **Figure 4** demonstrates the differences in bird species diversity between all monitoring sites.
