***CENTENNIAL COAL
MYUNA COLLIERY
ANNUAL REVIEW
January 2021 to December 2021***

March 2022

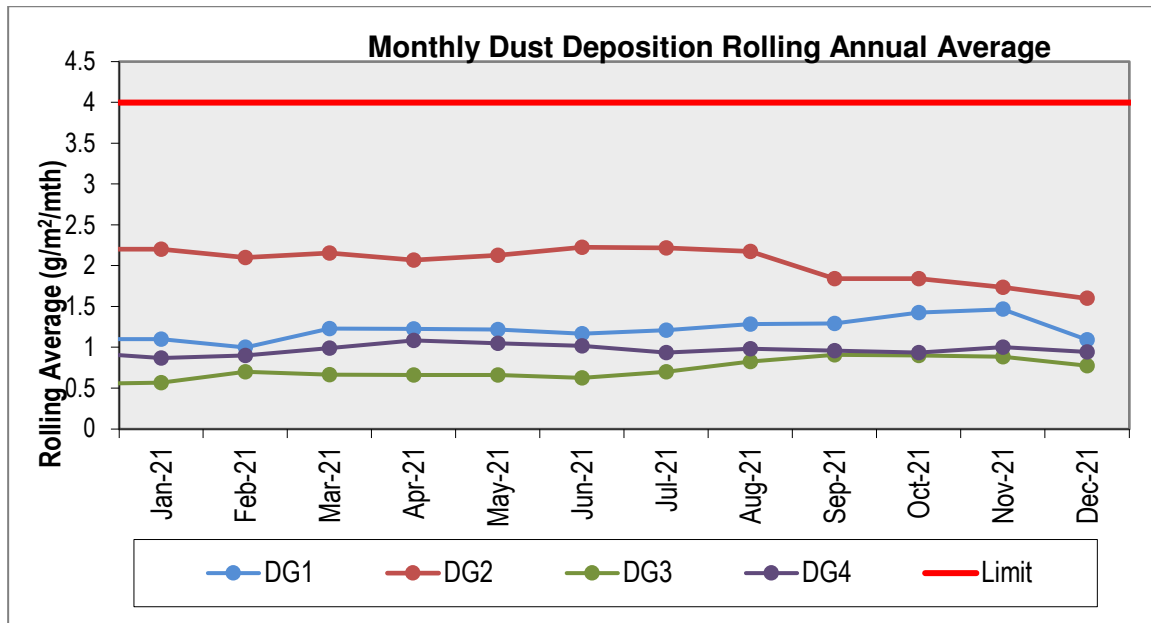
Figure 2. Dust Depositional Gauge – Rolling Annual Average

Figure 2 and Table 12 below show the depositional dust monitoring results of Myuna Colliery for 2021 in comparison to the long term results and EIS predictions. At all four dust gauges the annual averages were lower than long term averages and as a result the 2 g/m²/month max annual average increase limit was not exceeded.

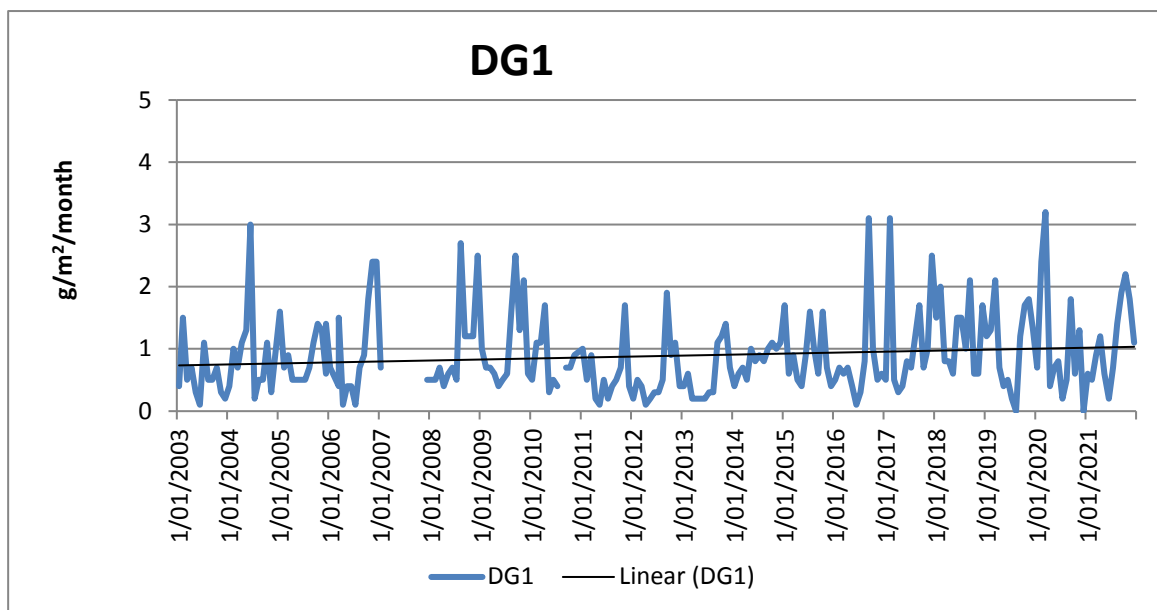
Figure 3. DG1 Trend Analysis Graph

Myuna Colliery has 18 years of dust monitoring data over the period from January 2003 to December 2021. Data for a 10 month period from February 2007 to November 2007 is not available. A trend analysis was undertaken using a linear trend line for the dust deposition monitoring from January 2003 to December 2021.

The 2021 annual average and long-term average for each dust gauge is provided in Table 12. The 2021 annual averages for all dust gauges are less than with the 17-year long term average. The long-term trend lines of DG 3 and 4 display a consistent trend for the monthly dust deposition while DG 1 and 2 display a slightly increasing trend.

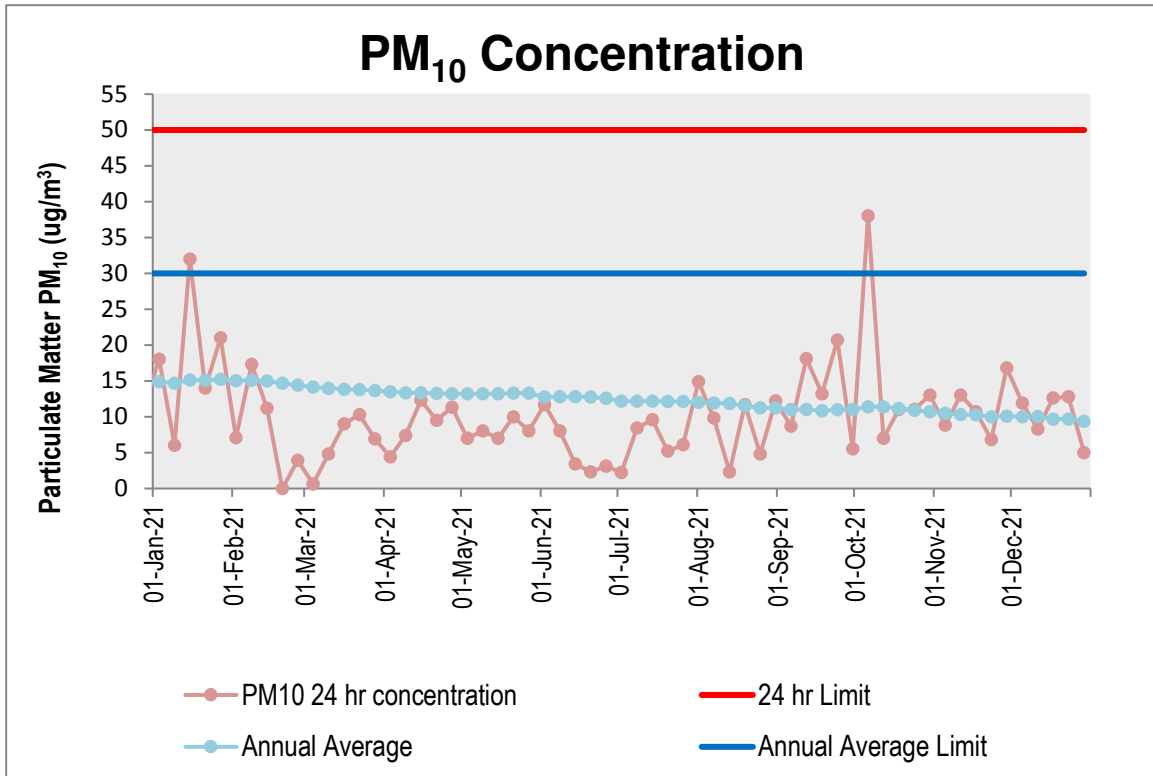
Figure 7. HVAS PM₁₀ Rolling Annual Average & 24 hr Results

The air quality monitoring data is assessed against the Project Approval. The annual average limit criterion for TSP is 90 µg/m³ and for PM10 is 30 µg/m³. The 24 hour limit criterion for PM10 is 50 µg/m³. There were no exceedances of the 24 hour limit criteria for PM10, or the annual average limit during the report period.

The maximum recorded 24 hour PM₁₀ concentration for the report period was 38 µg/m³ and the maximum recorded 24 hour TSP concentration for the report period was 74 µg/m³. Higher than average rainfall was observed during the 2021 reporting period.

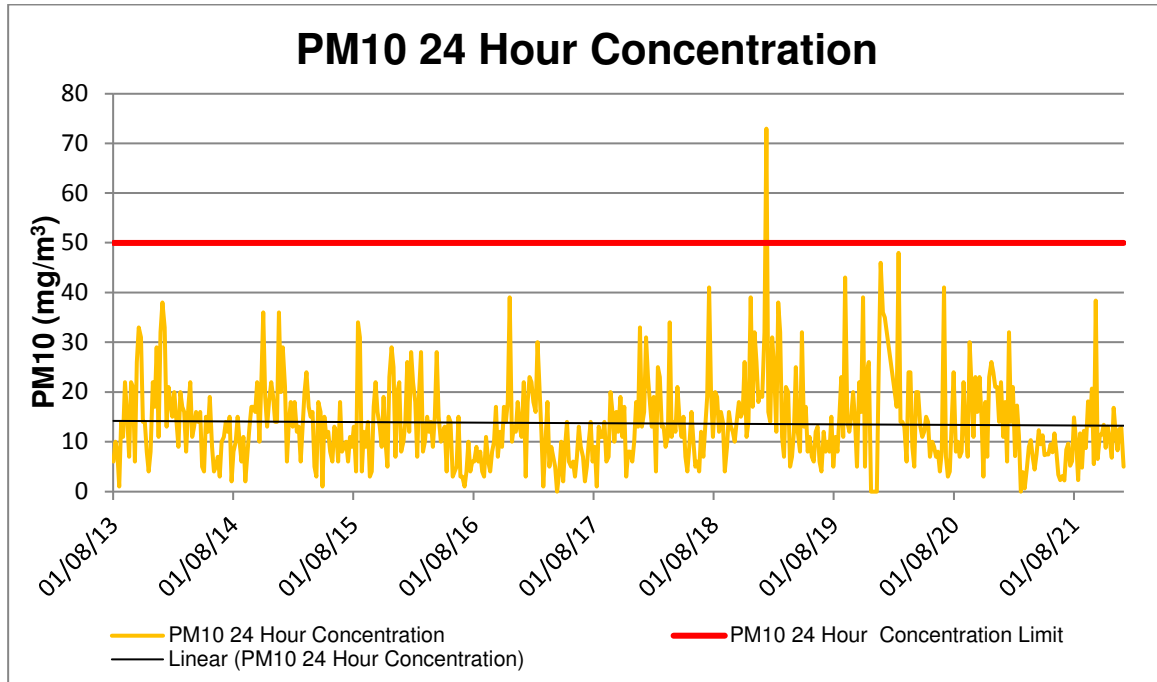
Figure 9. HVAS PM₁₀ Trend Analysis Graph

The trend analysis was undertaken using a linear trend line for the TSP and PM₁₀ monitoring data from August 2013 to December 2021. The trend lines indicate slightly increasing trends for the TSP and PM₁₀ over the long-term monitoring period.

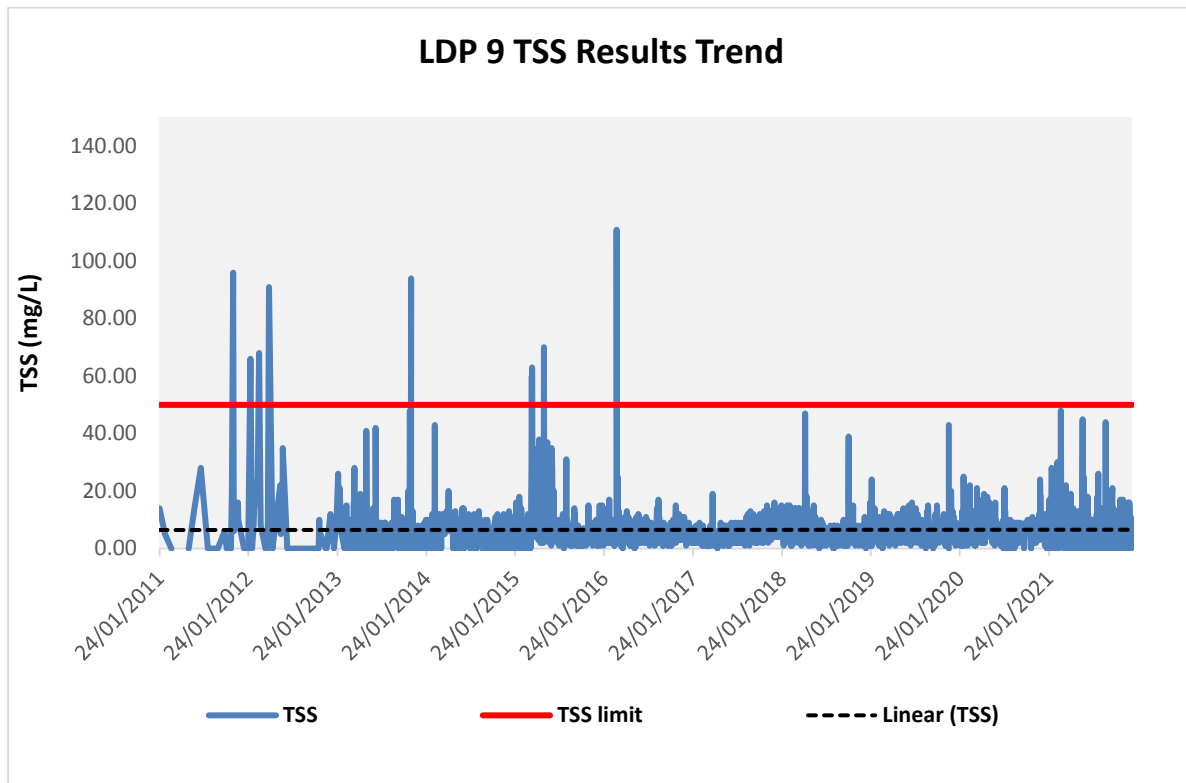
Figure 14. LDP 9 TSS Monitoring Results and Linear Trend Line

As shown in the figures below, linear trend lines were applied to the monitoring data from 2011 to December 2021 for pH, TSS and Oil & Grease. The trend lines displayed decreasing trends over the ten year period for TSS and Oil & Grease with pH tending to remain relatively constant.

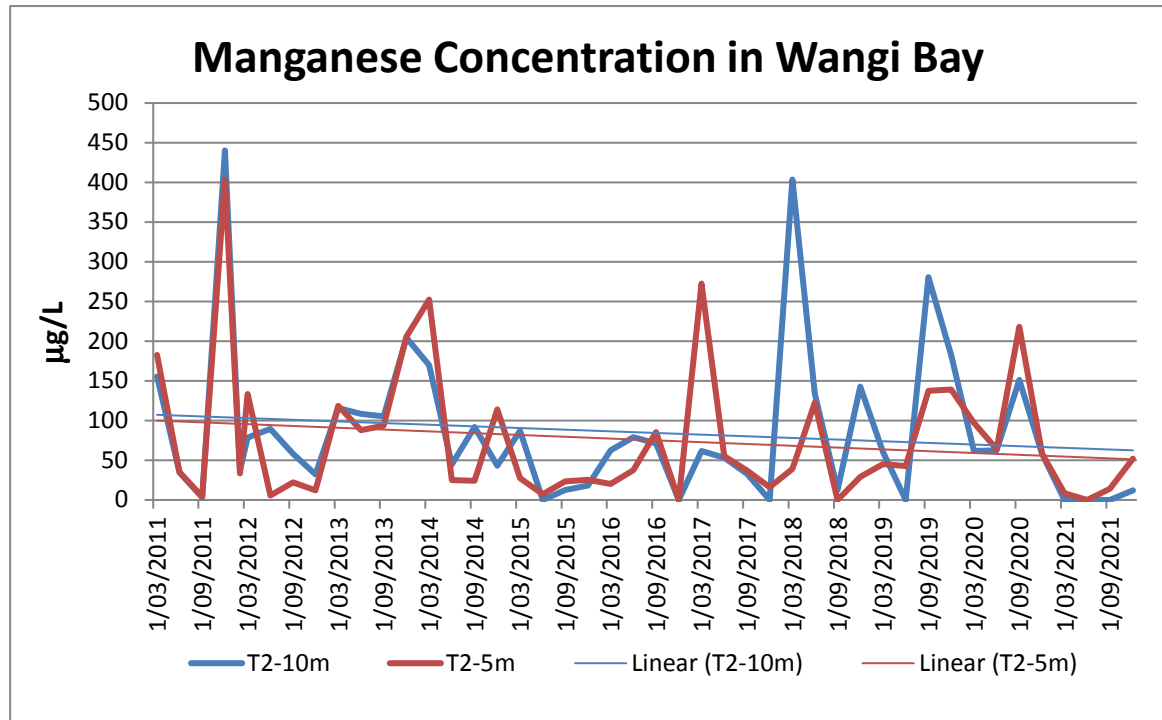
Figure 17. Manganese Monitoring Results and Linear Trend Line

The Manganese monitoring has been conducted over a period of ten years from 2011. Manganese concentrations recorded in Wangi Bay over the ten-year period of monitoring display a relatively constant trend at T2 10m and a downward trend at T2. 5m.

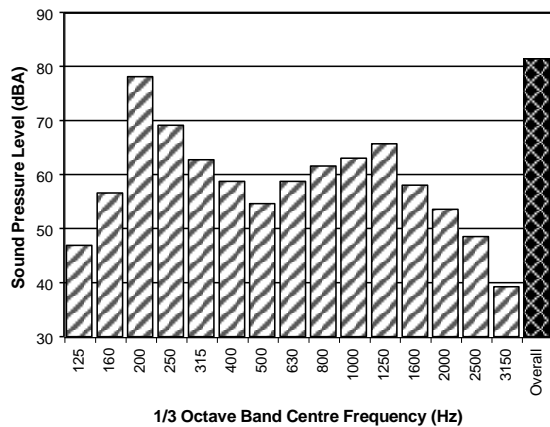
The following figure shows a 1/3 octave band frequency analysis where the noise is dominated by the 200 Hz band. Note that the indicated level of each individual band is less than the overall level, which is the logarithmic sum of the bands.

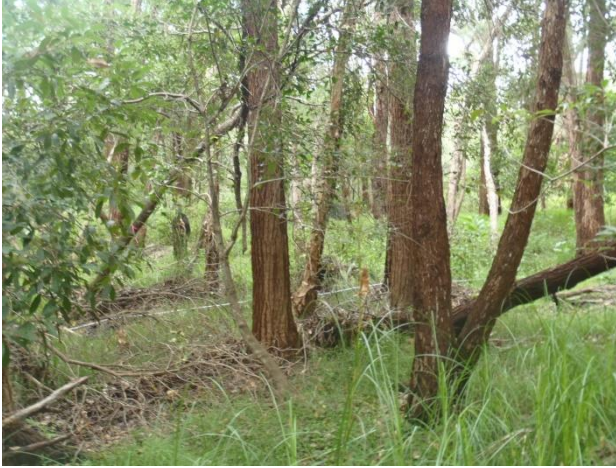
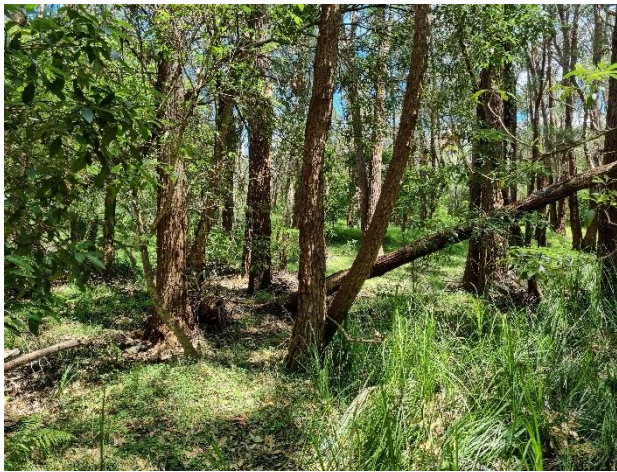
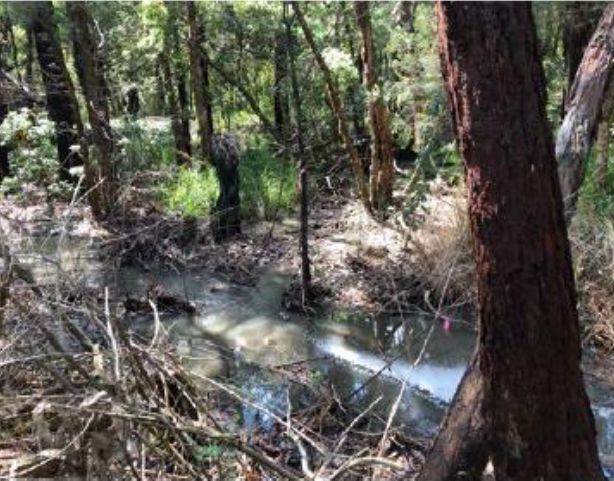
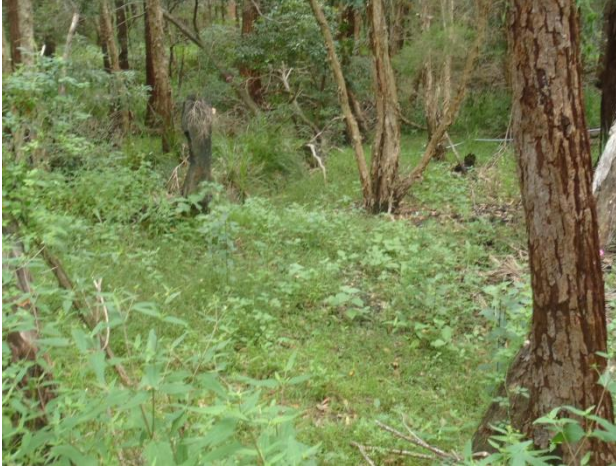
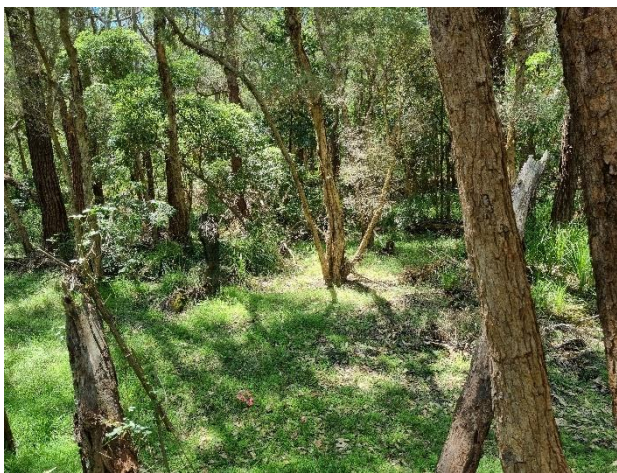
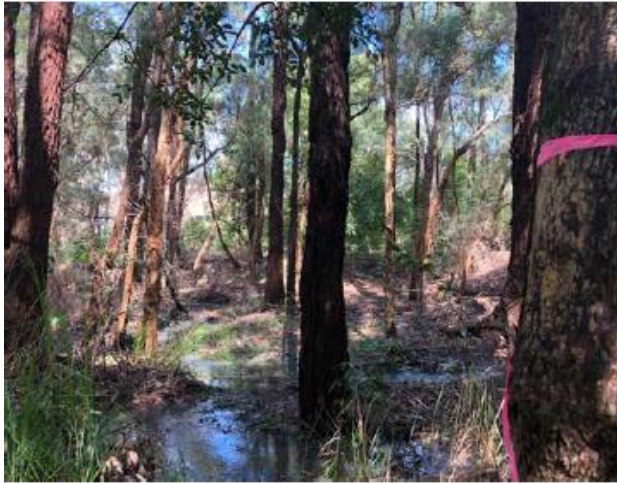
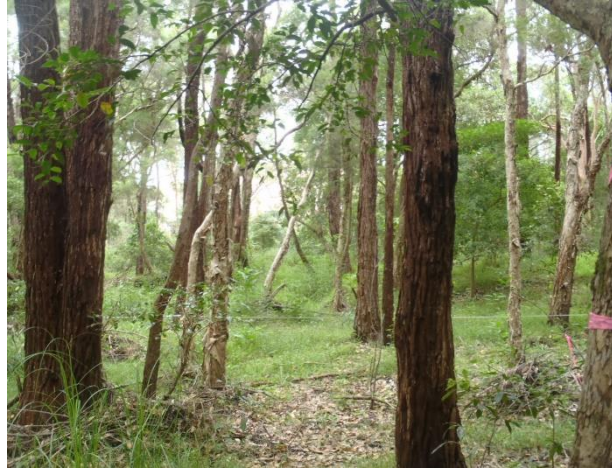
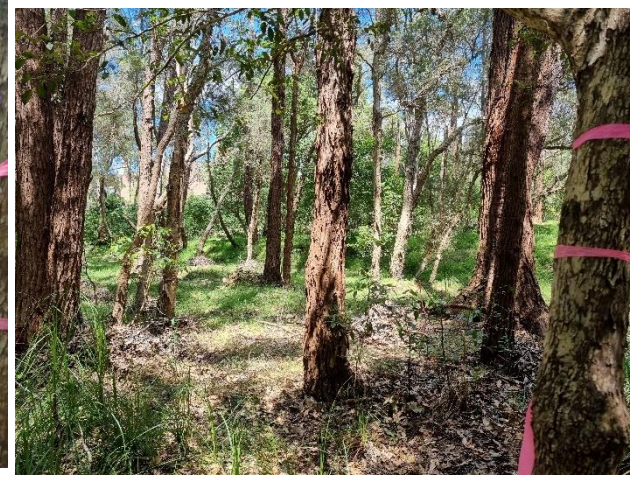
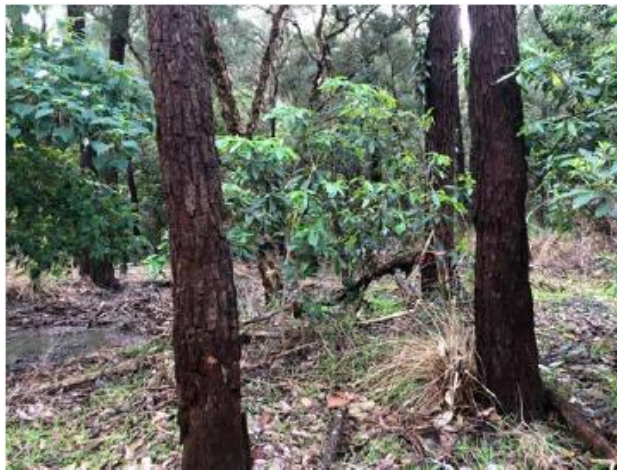
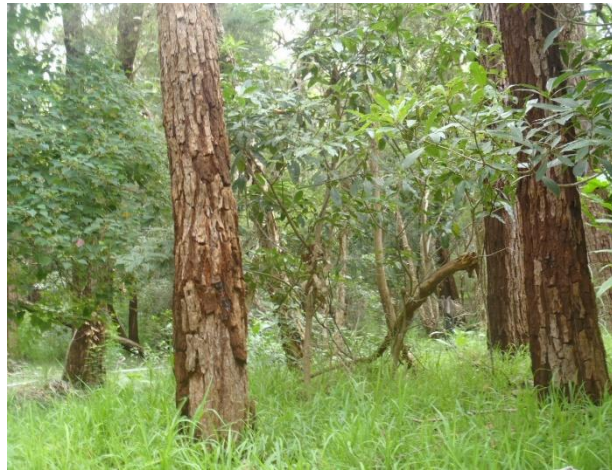
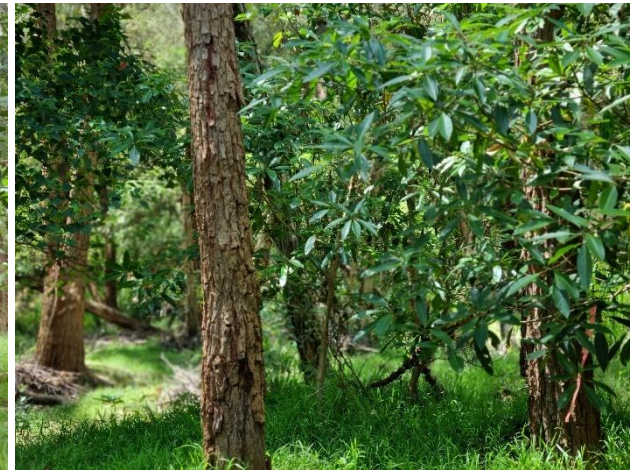
A comparison of images captured at the photo monitoring locations displays minimal variation in vegetation composition and structure, with any changes likely to be attributed to seasonal variations.
