***CENTENNIAL COAL***  
***Clarence Colliery***  
***ANNUAL REVIEW***

**April 2023**

## Annual Review Title Block

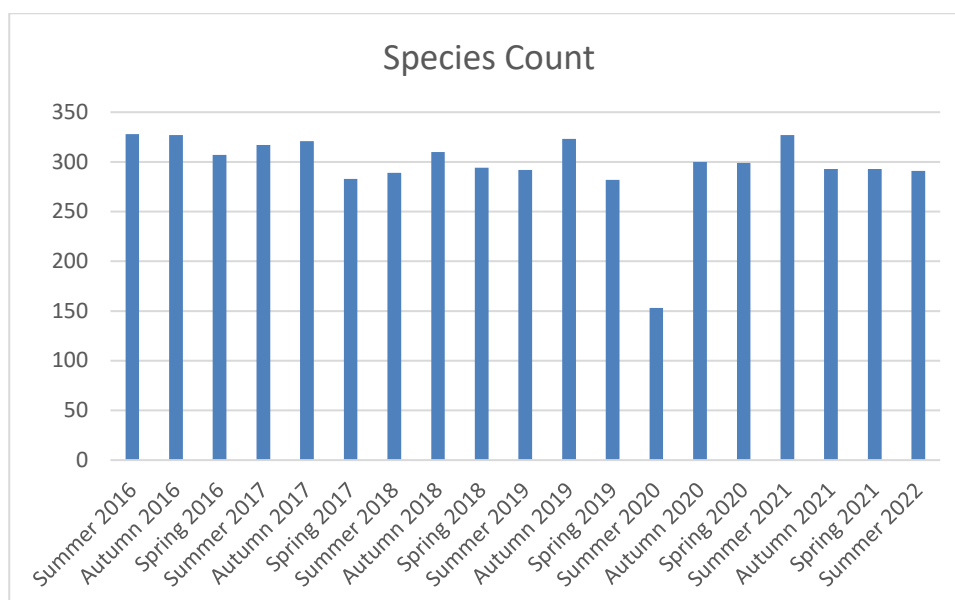
**Figure 1.** Seasonal Total Species Counts for 800 Area Monitoring Plots

Recent total species counts for the Clarence 800 sites are shown in Figure 1. Apart from the impact of the December 2019 bushfire, they indicate a seasonal response to rainfall conditions with higher numbers of ground layer and flowering plants detected during seasons following above average rainfall and lower numbers every spring. The Figure shows an initial post-fire decline, then an increase and subsequent decline.

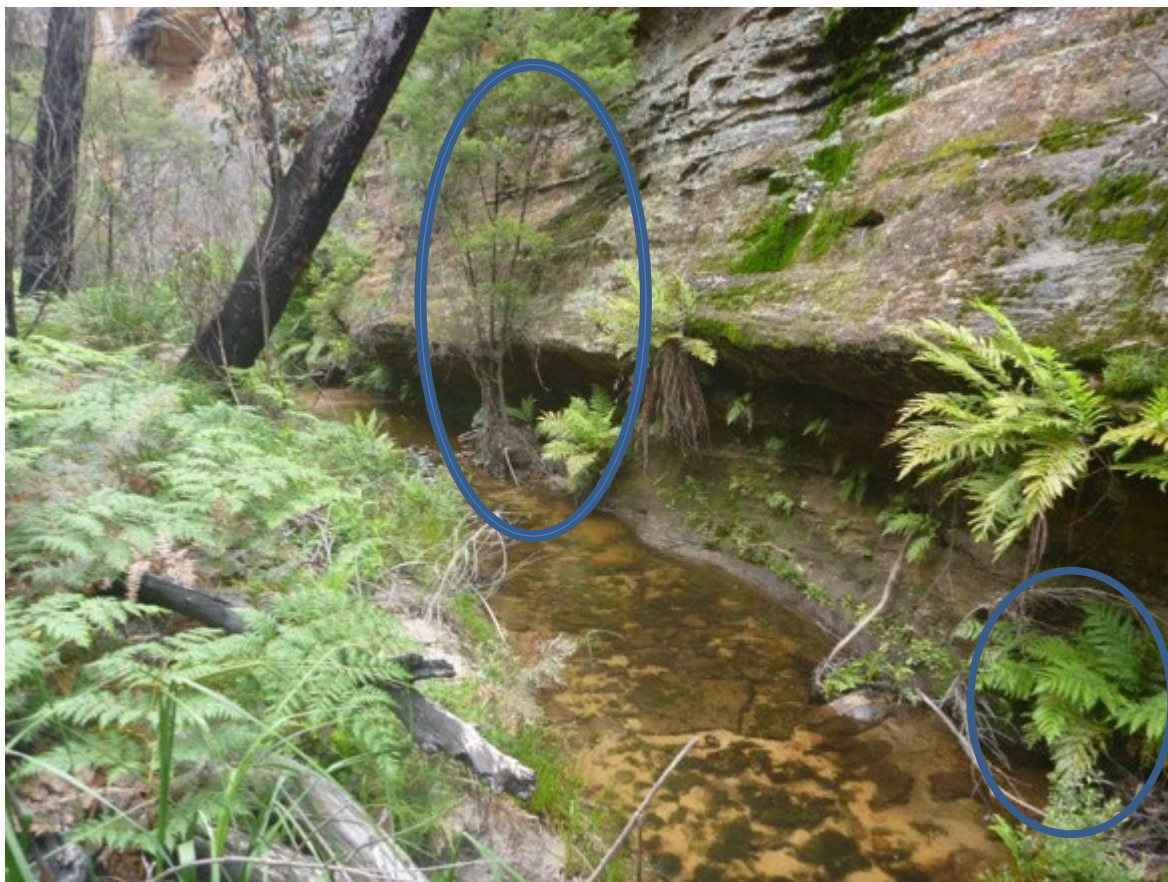
Plate 18: Looking upstream through gorge at BCDn2 in spring 2021. Note the tea tree and ferns (circled) that are missing from Plate 19 below.

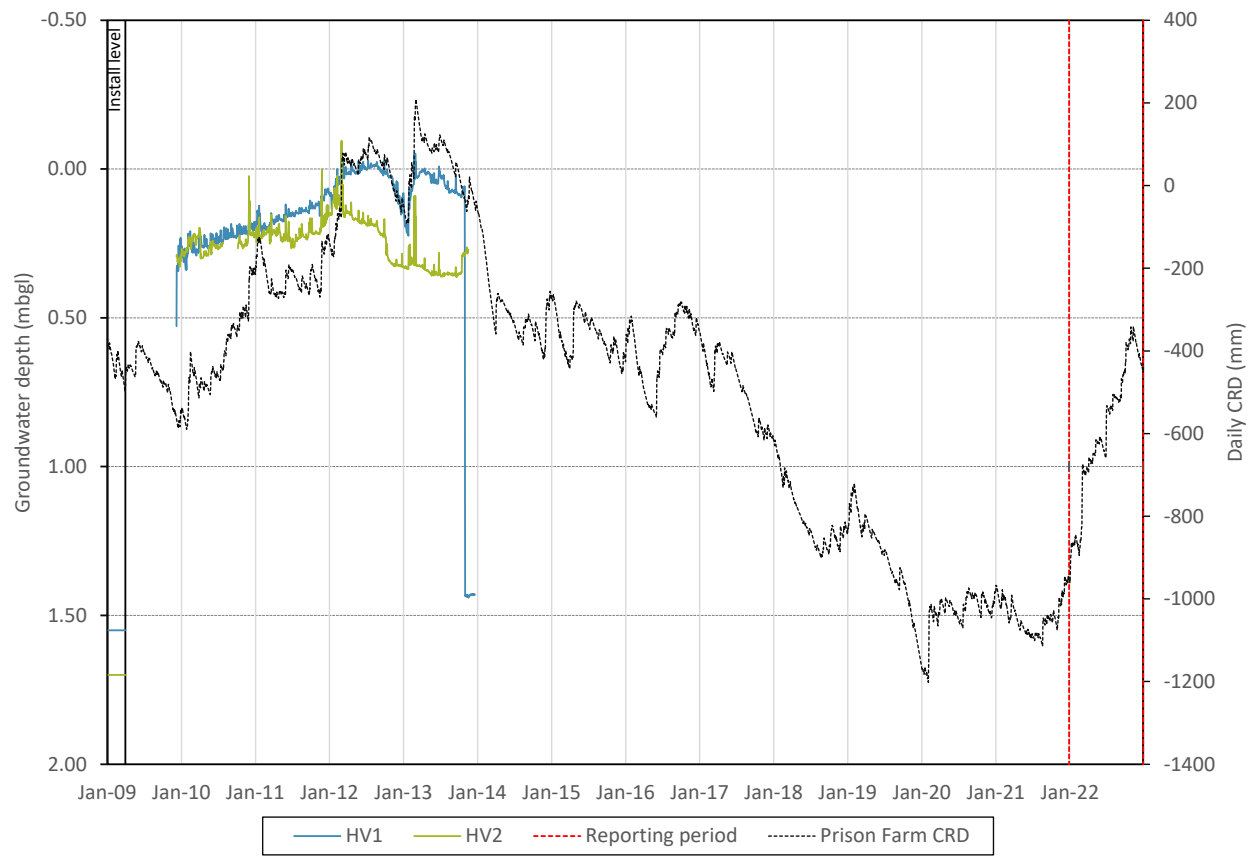
Figure 4.3 Happy Valley Swamp hydrograph

The hydrograph for Happy Valley Swamp is presented in Figure 4.3. Happy Valley Swamp was previously monitored by piezometers HV1 and HV2 until they were destroyed by bushfire in 2013 and have not been replaced.

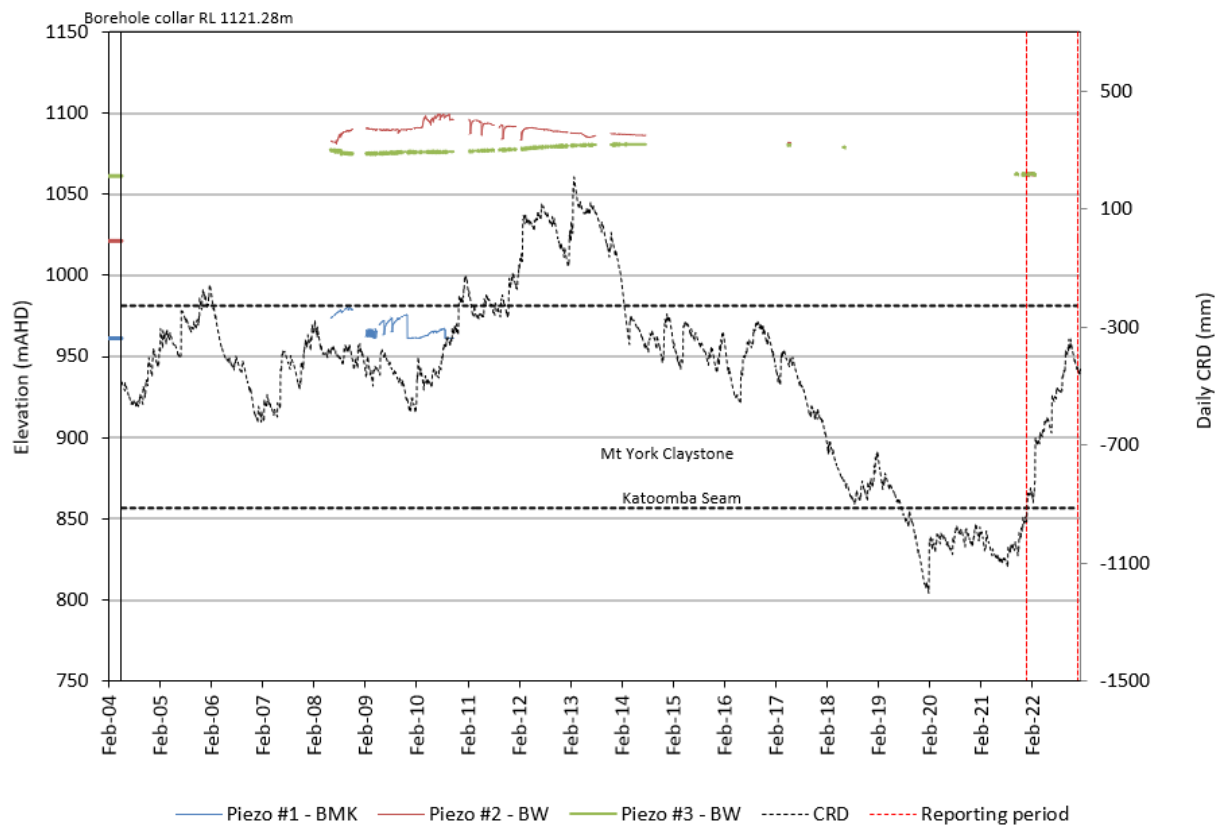
Figure 4.17 CLRP6 VWP hydrograph

The deepest Piezo #1 (160 m) was damaged by subsidence and failed in late-October 2010. Remaining Piezos are functional but logger issues after 2014 prevented the observation of reliable data. A new data logger was installed in mid-October 2021, but logger issues remain, and limited data was available throughout 2022. Piezo #1 remains unsaturated since being undermined.
