Centennial Coal

Annual Review

1st January – 31st December 2014

Airly Mine

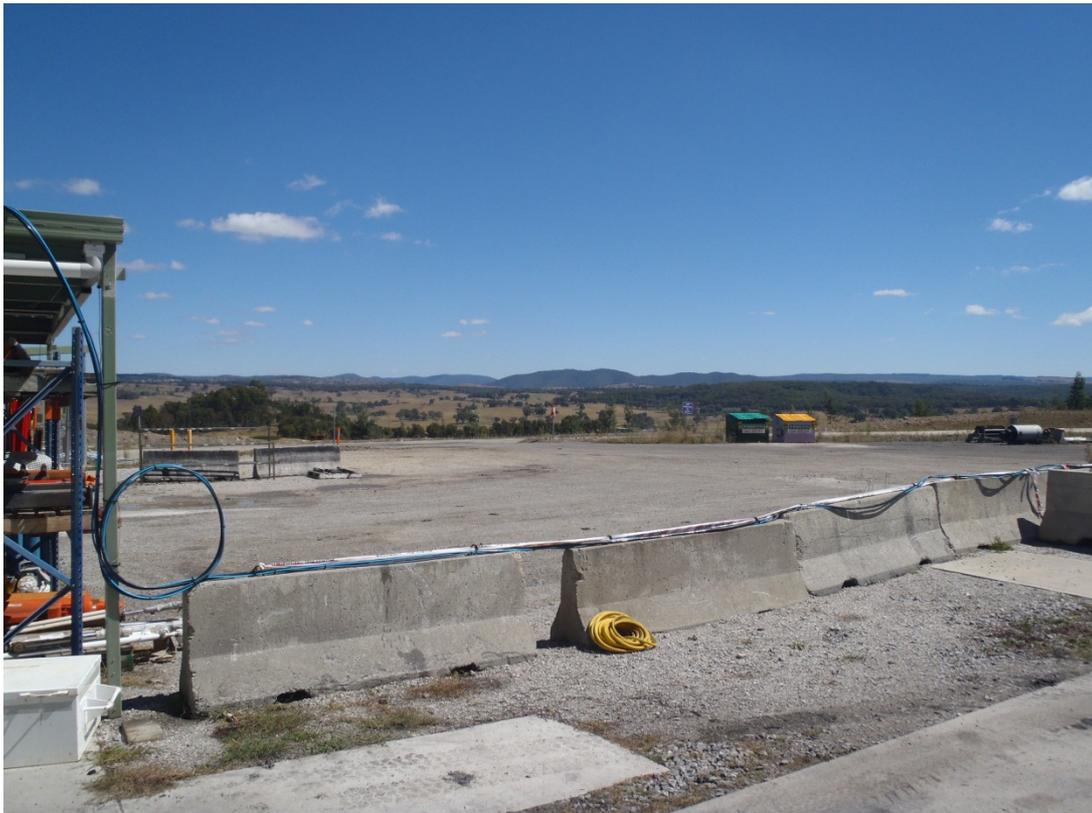
Plate 1 – Improved Access to the Stores Area

During 2014 some of the temporary office and bathhouse demountable buildings used during construction activity at the mine were disconnected from existing services and were relocated to a laydown area in proximity to the Coal Handling Plant. Roadbase material was transported to the mine and spread over the former site of the demountable buildings (**Plate 1**). The removal of these buildings has improved access to the Stores buildings at the mine.

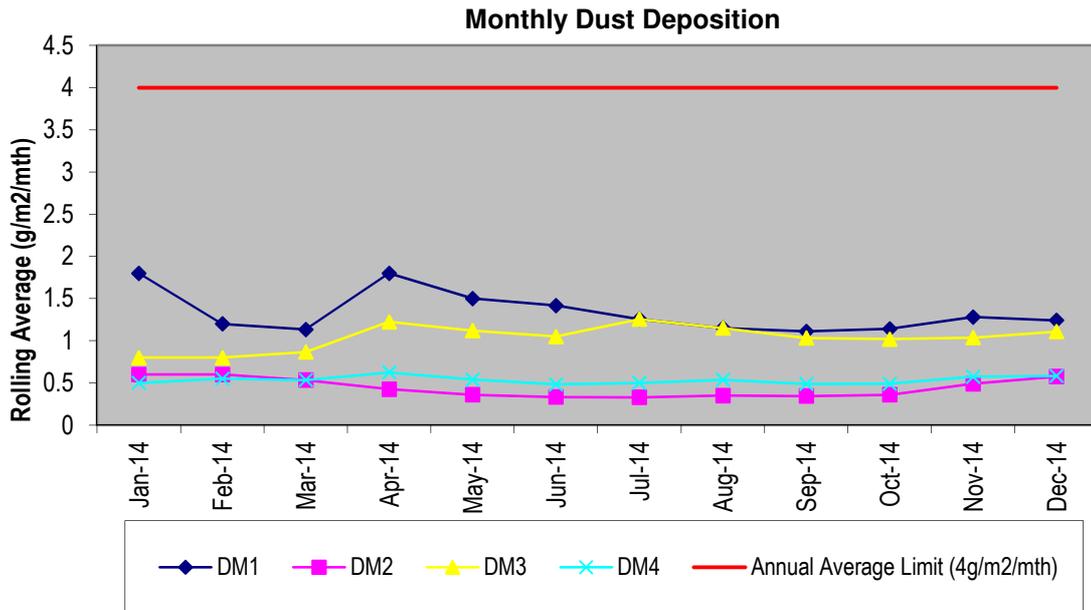
Figure 2: Monthly Dust Deposition Gauge Rolling Average

Monitoring data collected from the four dust monitoring stations are displayed in **Figure 2** below.

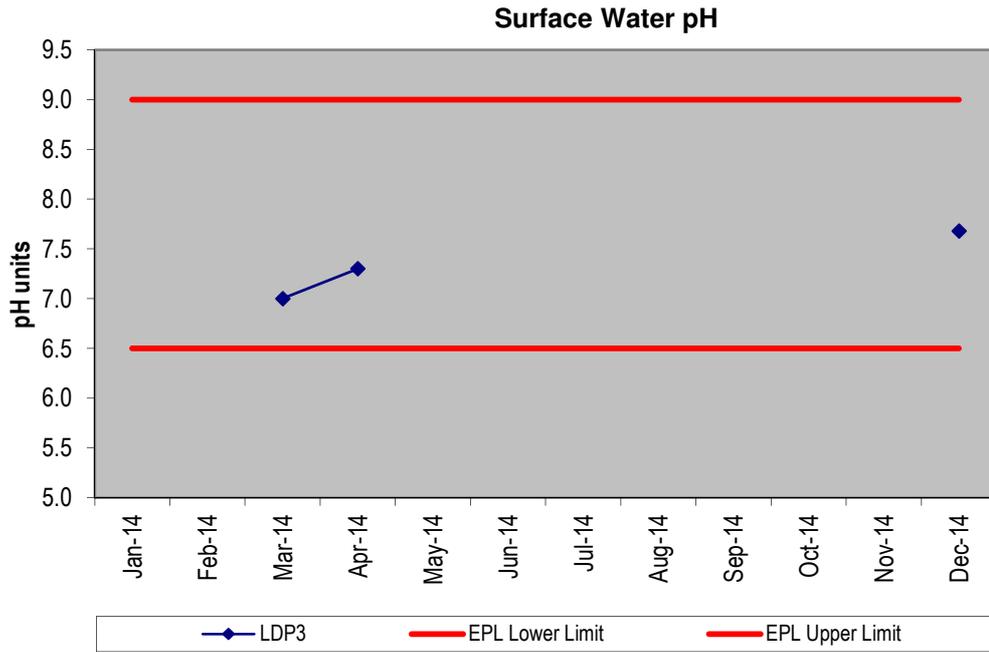
Figure 3: Monthly pH Results

pH monitoring data indicated that the pH results for the discharge of water at LDP3 on the 14th March, 4th April and 8th December 2014 were within the EPL 12374 limit 6.5 – 9.0 for pH.

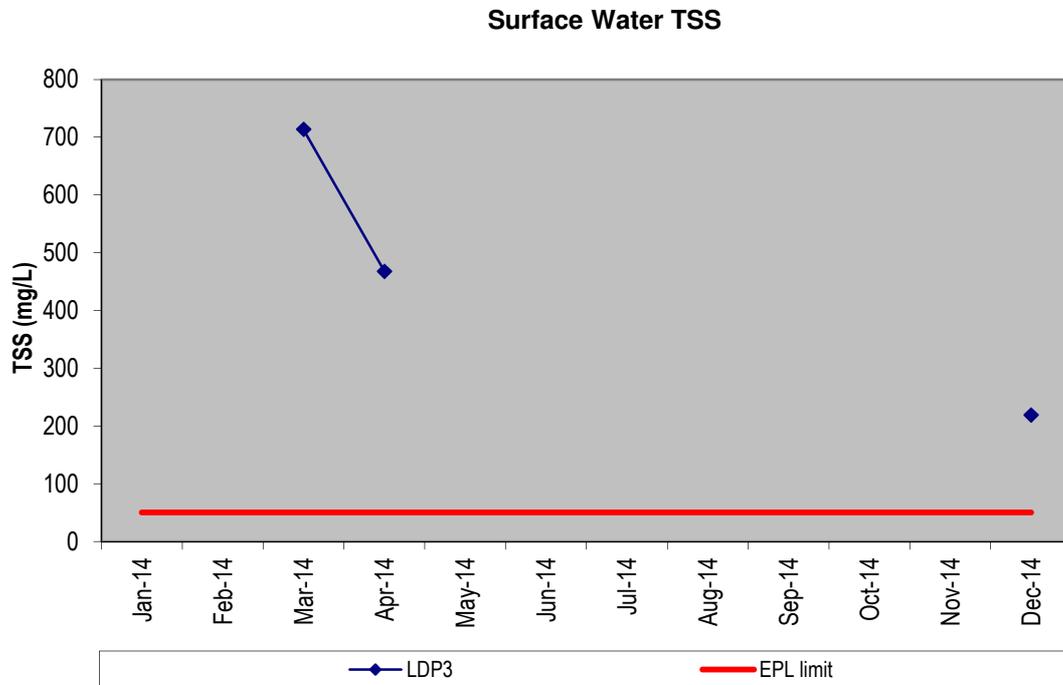
Figure 4: Monthly TSS Results

TSS monitoring data indicated that the TSS result for the discharge of water at LDP3 on the 14th March 2014 exceeded the EPL 12374 limit of 50 mg/L for TSS. The discharge of water followed a rainfall event during which approximately 25 mm of rain had fallen during an electrical storm. The electrical storm created power outages at the mine site and prevented safe access to the Train Loader Dam (LDP3). When it was safe to access to the Train Loader Dam a pump was used to transfer water to the 109 ML Dirty Water Dam.

TSS monitoring data indicated that the TSS result for the discharge of water at LDP3 on the 8th December 2014 was 219 mg/L. The discharge of water followed a rainfall event during which more than 50 mm of rain had fallen within five days prior to the discharge event. Condition L2.5 in EPL 12374 outlines that the limits specified under condition L2.4 (including TSS), do not apply at LDP1, LDP2 and LDP3 when the discharge of water occurs as a result of a rainfall event at the premises which exceeds 44 mm of rainfall over any consecutive 5 day period.

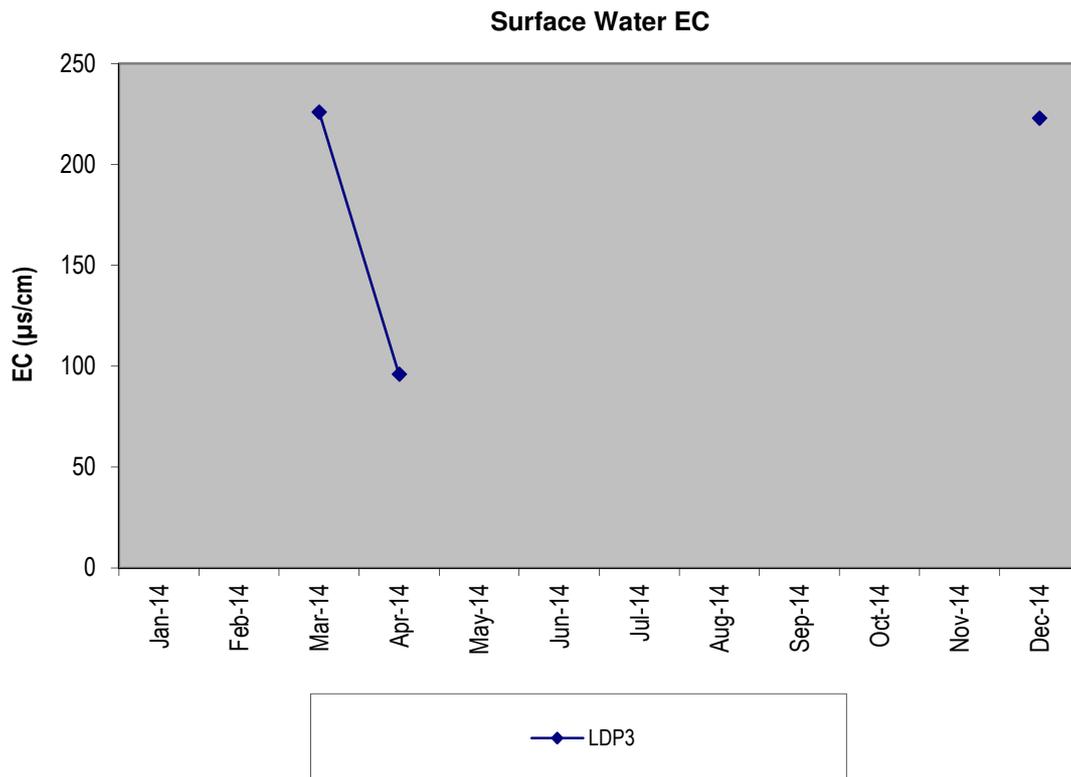
Figure 5: Monthly EC Results

EC monitoring data indicated that the EC result for the discharge of water at LDP3 on the 14th March 2014 was 226 µS/cm.

There is no limit prescribed for EC in EPL12374.

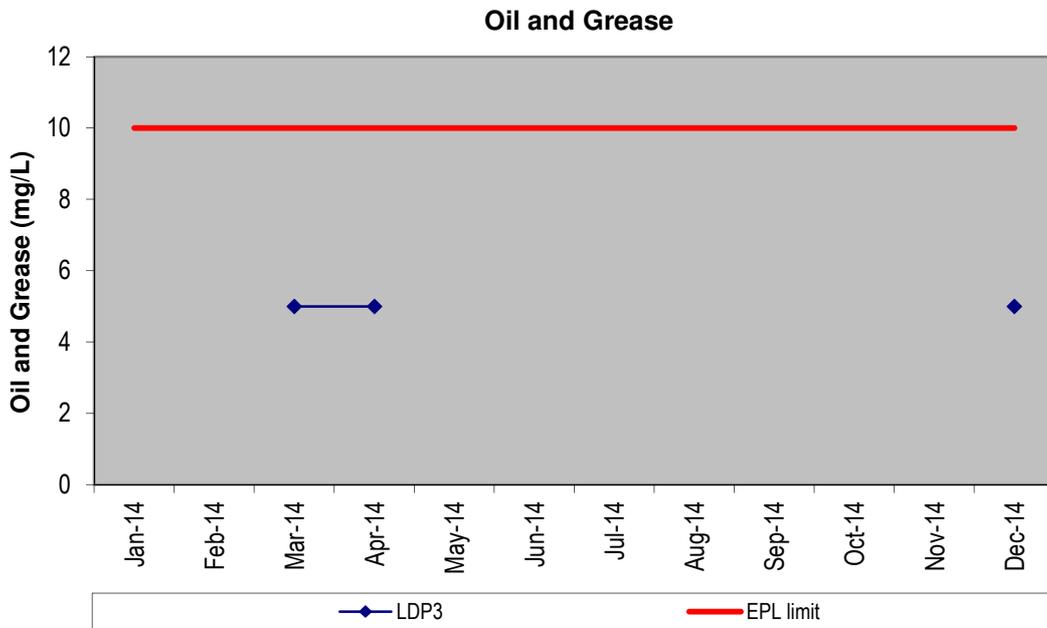
Figure 6: Monthly Oil and Grease Results

Oil and Grease monitoring data indicated that the Oil and Grease results for the discharge of water at LDP3 on the 14th March, 4th April and 8th December 2014 were within the EPL 12374 limit of 10 mg/L for Oil and Grease.

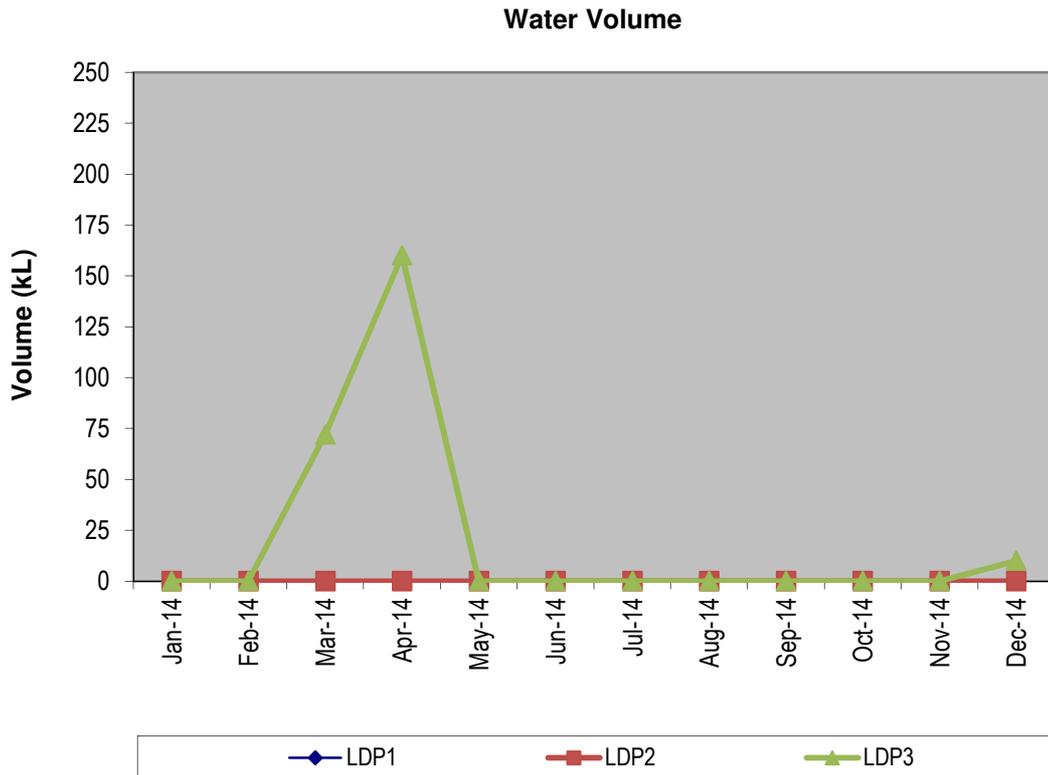
Figure 7: Monthly Water Volume Results

The volume of water discharged at LDP3 on the 14th March 2014 was estimated to be 72 kL.

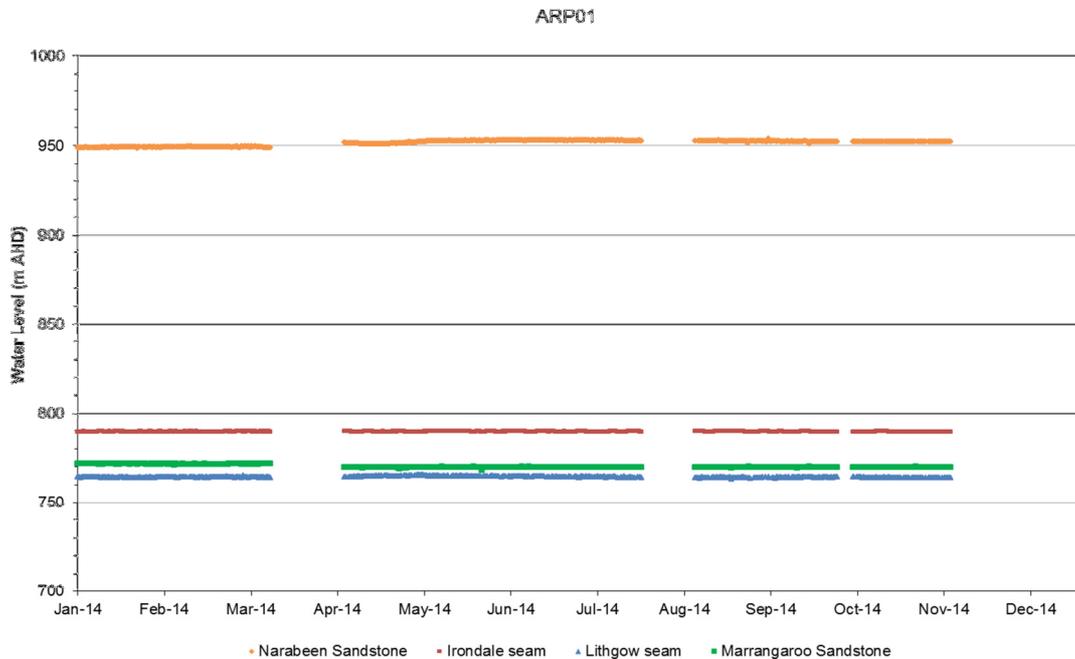
Figure 8: Borehole ARP01 Hydrograph

Piezometric pressure is generally low and stable at the existing VWP monitoring location ARP01, with little observable response to rainfall. The low piezometric pressure is considered to reflect the extensive groundwater seepage areas across the slopes of Mount Airly and Genowlan Mountain. Gaps in the datasets at borehole ARP01 were identified during 2014 due to data logger failure.

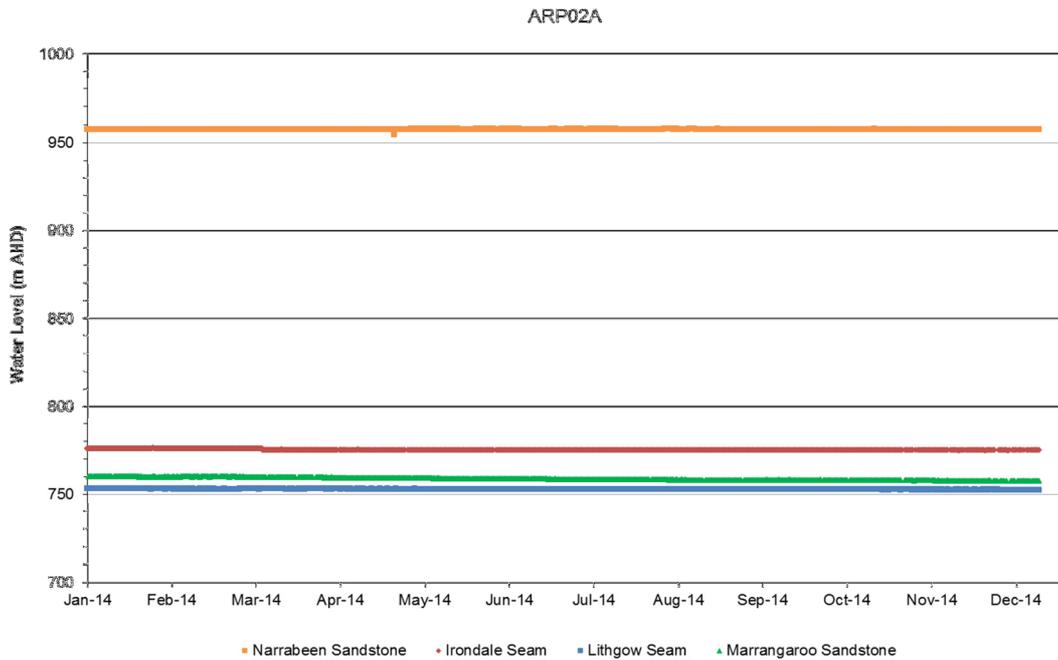
Figure 9: Borehole ARP02A Hydrograph

Piezometric pressure is generally low and stable at the existing VWP monitoring location ARP02, with little observable response to rainfall. The low piezometric pressure is considered to reflect the extensive groundwater seepage areas across the slopes of Mount Airly and Genowlan Mountain.

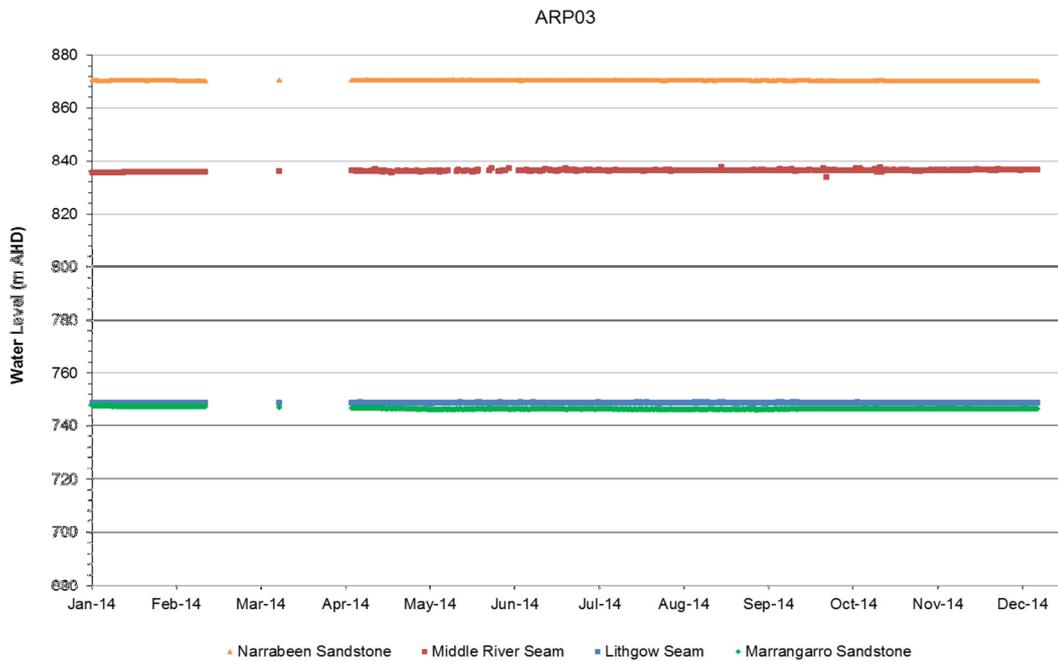
Figure 10: Borehole ARP03 Hydrograph

Piezometric pressure is generally low and stable at the existing VWP monitoring location ARP03, with little observable response to rainfall. The low piezometric pressure is considered to reflect the extensive groundwater seepage areas across the slopes of Mount Airly and Genowlan Mountain. Gaps in the datasets at borehole ARP03 were identified during 2014 due to data logger failure.

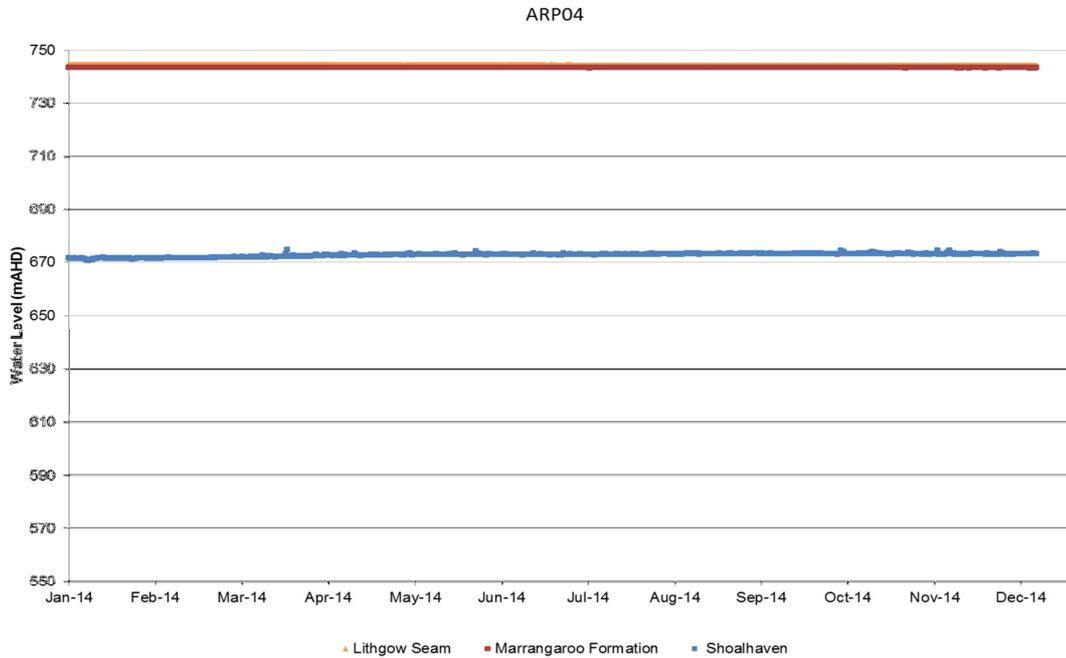
Figure 11: Borehole ARP04 Hydrograph

Piezometric pressure is generally low and stable at the existing VWP monitoring location ARP04, with little observable response to rainfall. The low piezometric pressure is considered to reflect the extensive groundwater seepage areas across the slopes of Mount Airly and Genowlan Mountain.

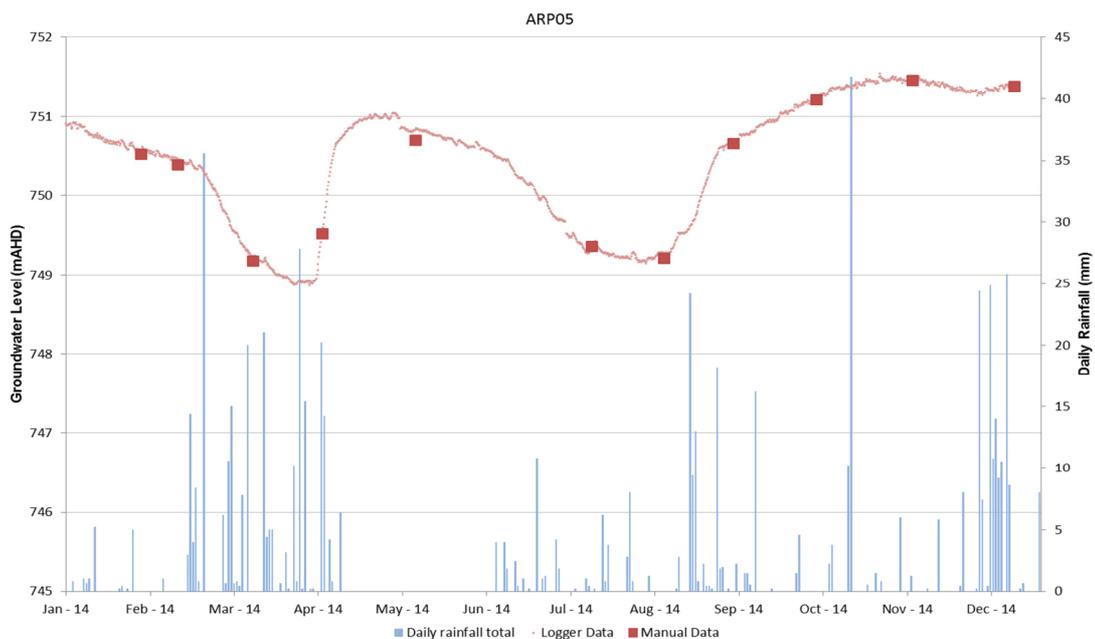
Figure 12: Borehole ARP05 Hydrograph

Groundwater at ARP05 showed some (often delayed) response to rainfall, indicating that aquifer transfer from Permian strata is also a source of recharge to the alluvium. Alluvial groundwater at site ARP05 is fresh and slightly acidic and is sodium-chloride/bicarbonate type water.

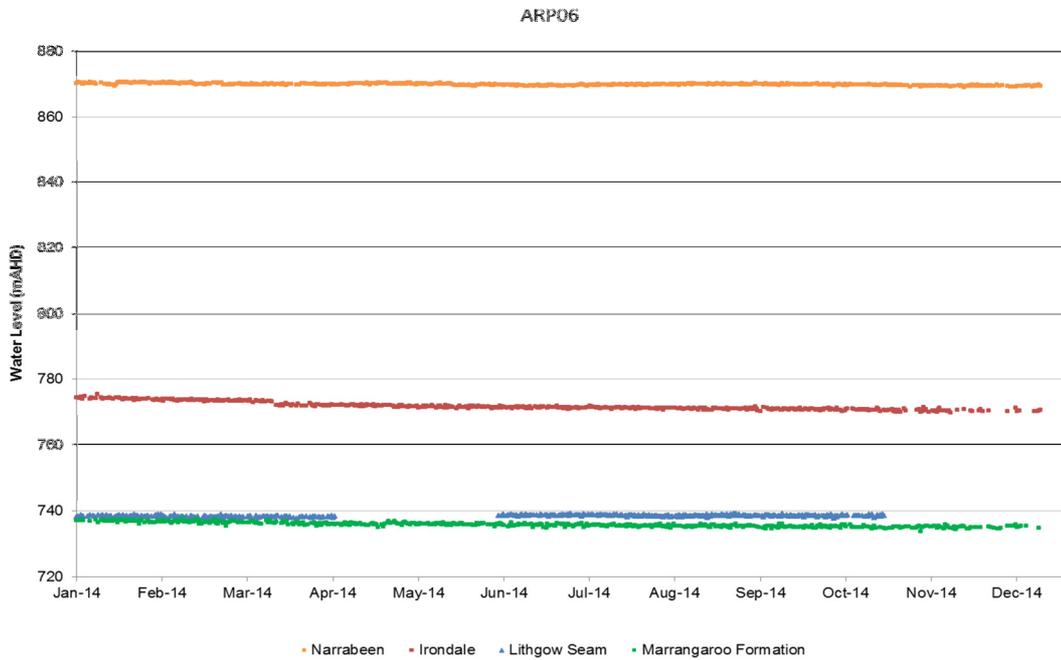
Figure 13: Borehole ARP06 Hydrograph

Piezometric pressure is generally low and stable at the existing VWP monitoring location ARP06, with little observable response to rainfall. The low piezometric pressure is considered to reflect the extensive groundwater seepage areas across the slopes of Mount Airly and Genowlan Mountain.

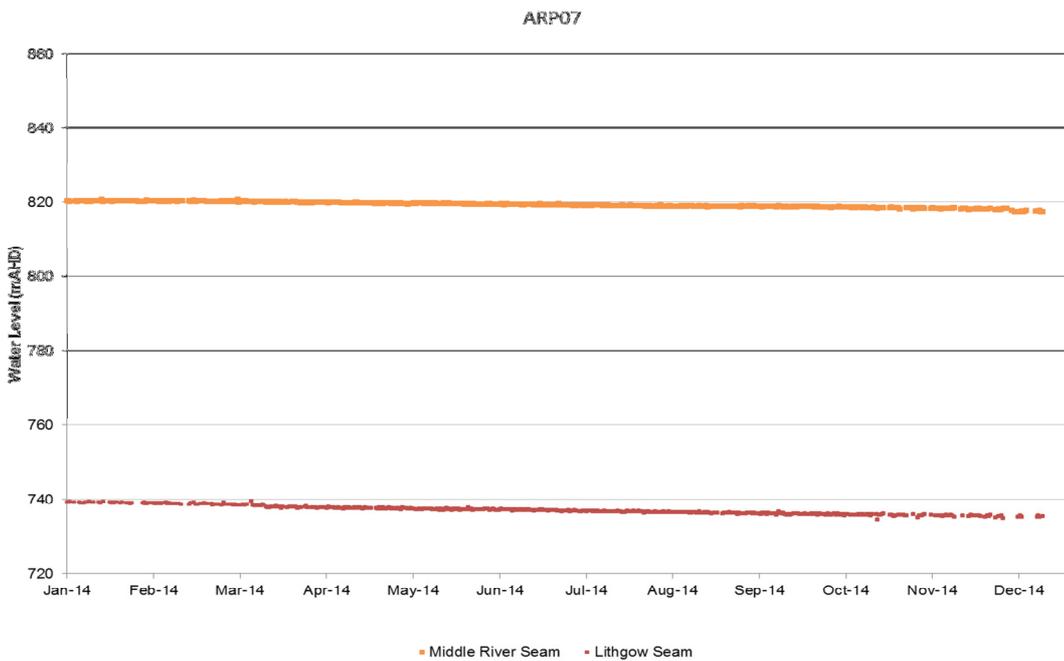
Figure 14: Borehole ARP07 Hydrograph

Piezometric pressure is generally low and stable at the existing VWP monitoring location ARP07, with little observable response to rainfall. The low piezometric pressure is considered to reflect the extensive groundwater seepage areas across the slopes of Mount Airly and Genowlan Mountain.

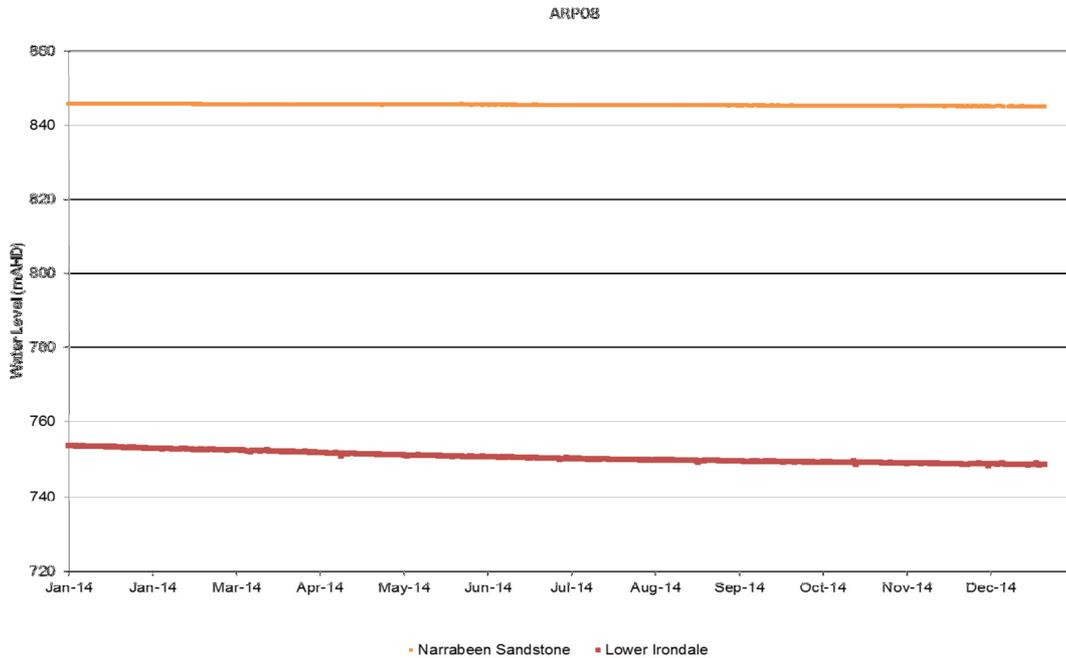
Figure 15: Borehole ARP08 Hydrograph

Piezometric pressure is generally low and stable at the existing VWP monitoring location ARP08, with little observable response to rainfall. The low piezometric pressure is considered to reflect the extensive groundwater seepage areas across the slopes of Mount Airly and Genowlan Mountain.

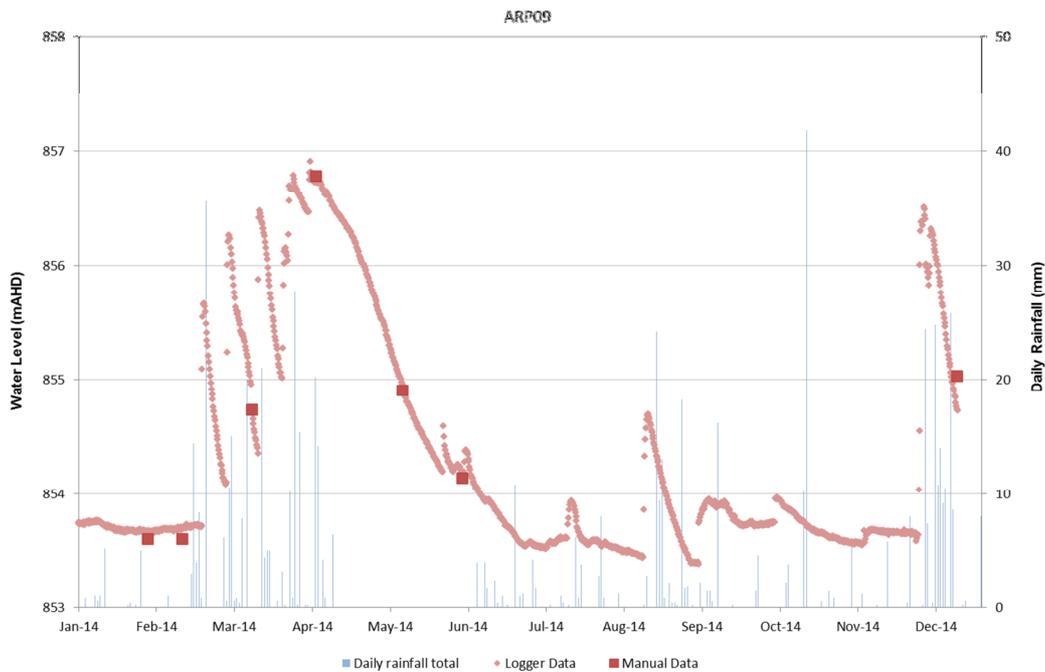
Figure 16: Borehole ARP09 Hydrograph

The standpipe within Genowlan Creek alluvium at ARP09 responded to periods of heavy rainfall in March, April and December 2014. For the remainder of 2014 the standpipe ARP09 was dry, with the exception of small temporary responses to rainfall. Based on the four samples collected in 2014, the alluvial groundwater at ARP09 is fresh and slightly acidic and is of sodium-chloride/bicarbonate type water.

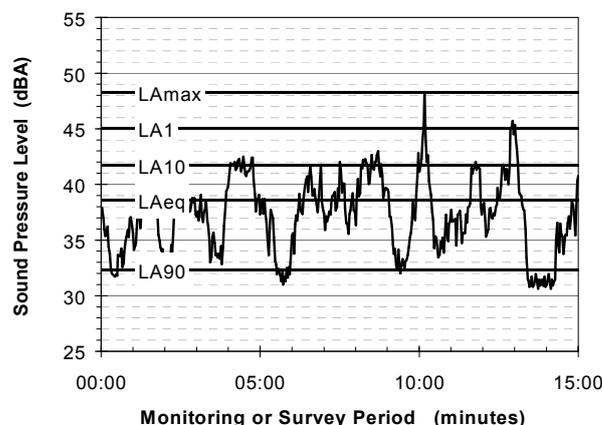
The following figure presents a hypothetical 15 minute noise survey, illustrating various common statistical indices of interest.

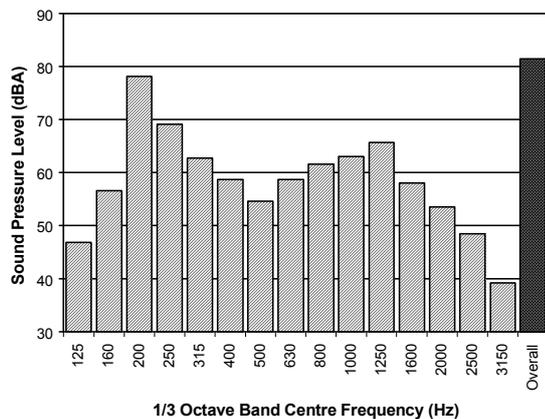
The following figure shows a 1/3 octave band frequency analysis where the noise is dominated by the 200 Hz band. Note that the indicated level of each individual band is less than the overall level, which is the logarithmic sum of the bands.

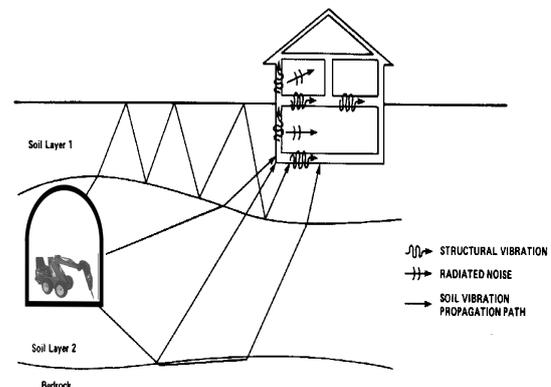
The following figure presents the various paths by which vibration and ground-borne noise may be transmitted between a source and receiver for construction activities occurring within a tunnel.
