**Centennial Coal**

# **SUPPLEMENTARY DATA**

***Application to Allow Longwall  
Mining Under Temperate Highland  
Peat Swamps on Sandstone on the  
Newnes Plateau***

**Springvale Colliery**

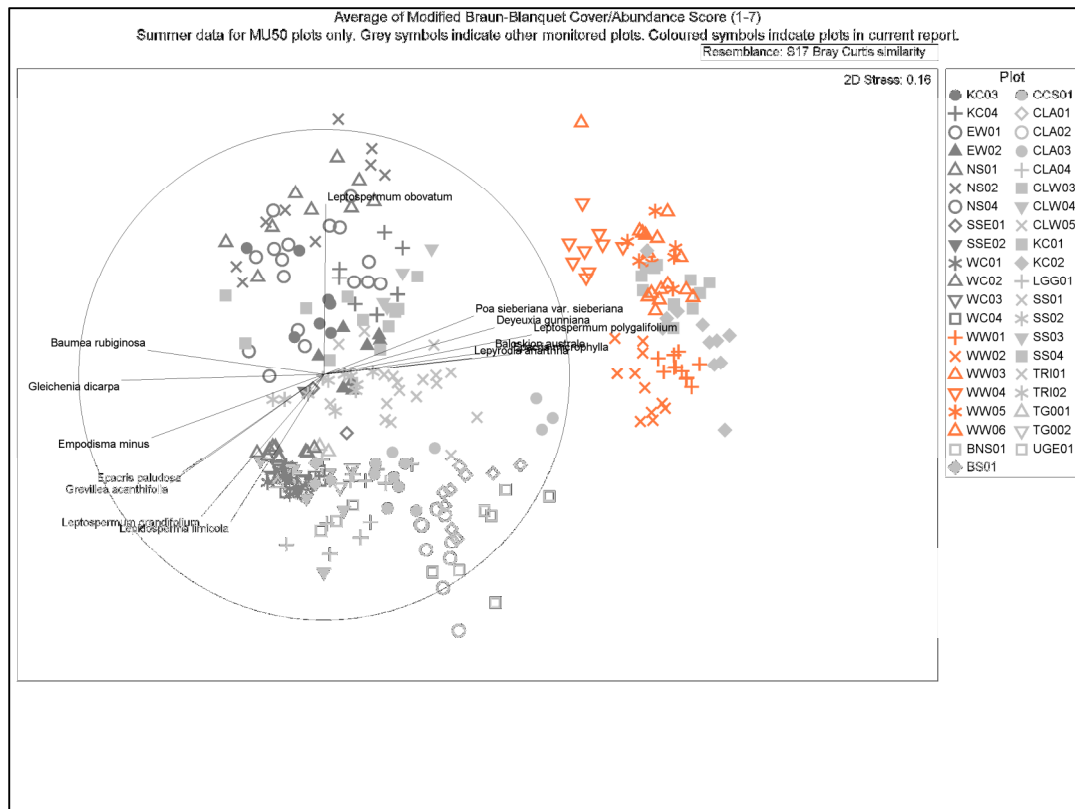
**Figure 4.13:** nMDS plot of all summer data for monitoring plots in West Wolgan swamp. Summer data for all other MU50 swamps provided for comparison.

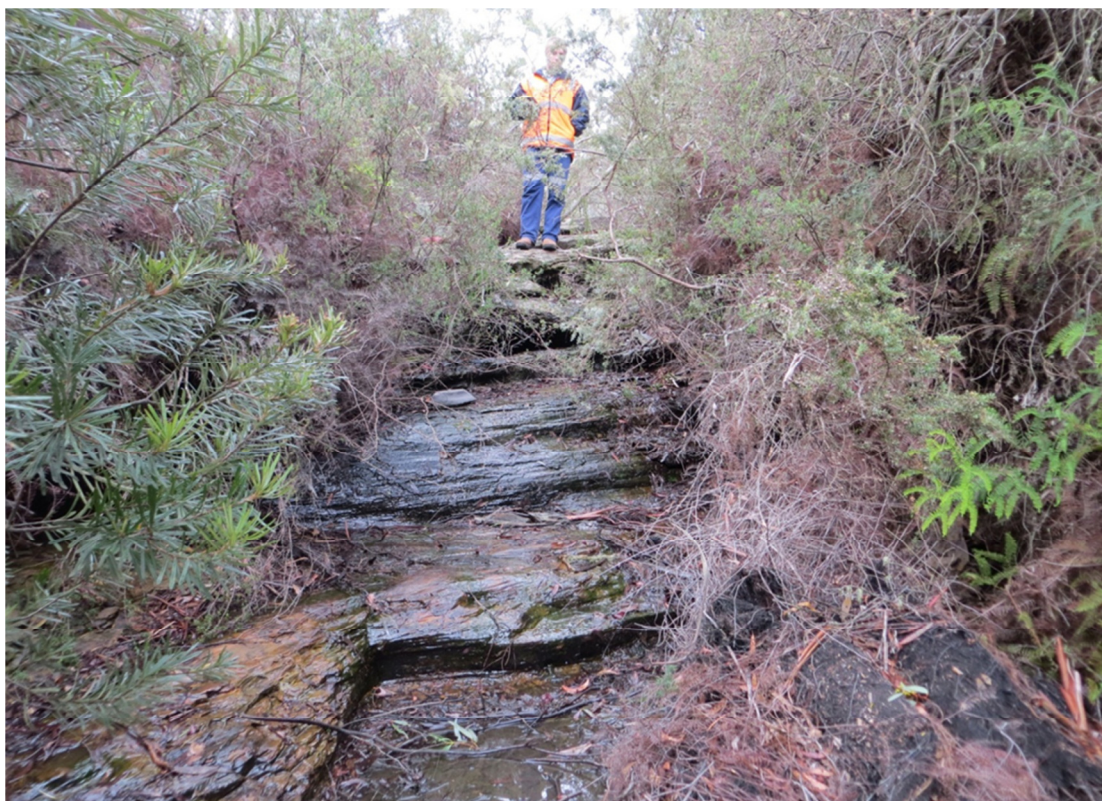
Figure 6.8 Spring Upstream of Kangaroo Creek Swamp – Unaffected by Longwall Mining

However, the perennial spring which is fed by the aquifer-aquitard systems within the Burralow Formation was unaffected by mining and the creek remained permanently wet below the spring. This, together with the presence of healthy hanging swamps along the valley walls surrounding Kangaroo Creek shrub swamp, indicates that the water supply from the spring and valley wall seepage has not been interrupted by longwall mining and that groundwater inputs to the swamp hydrological system remain intact. Figures 6.7 - 6.12 are photographs which illustrate the Burralow Formation aquifer / aquitard system have not been affected by longwall mining evidenced by the Spring, Waterhole and Hanging Swamps surrounding Kangaroo Creek Swamp. Kangaroo Creek Swamp was assessed by RPS (2013) as a *“High Quality Shrub Swamp in Good Condition.”* UQ (2013) reported that *“There is no trend of decreasing condition and the abundance of the condition monitored species is not declining”*

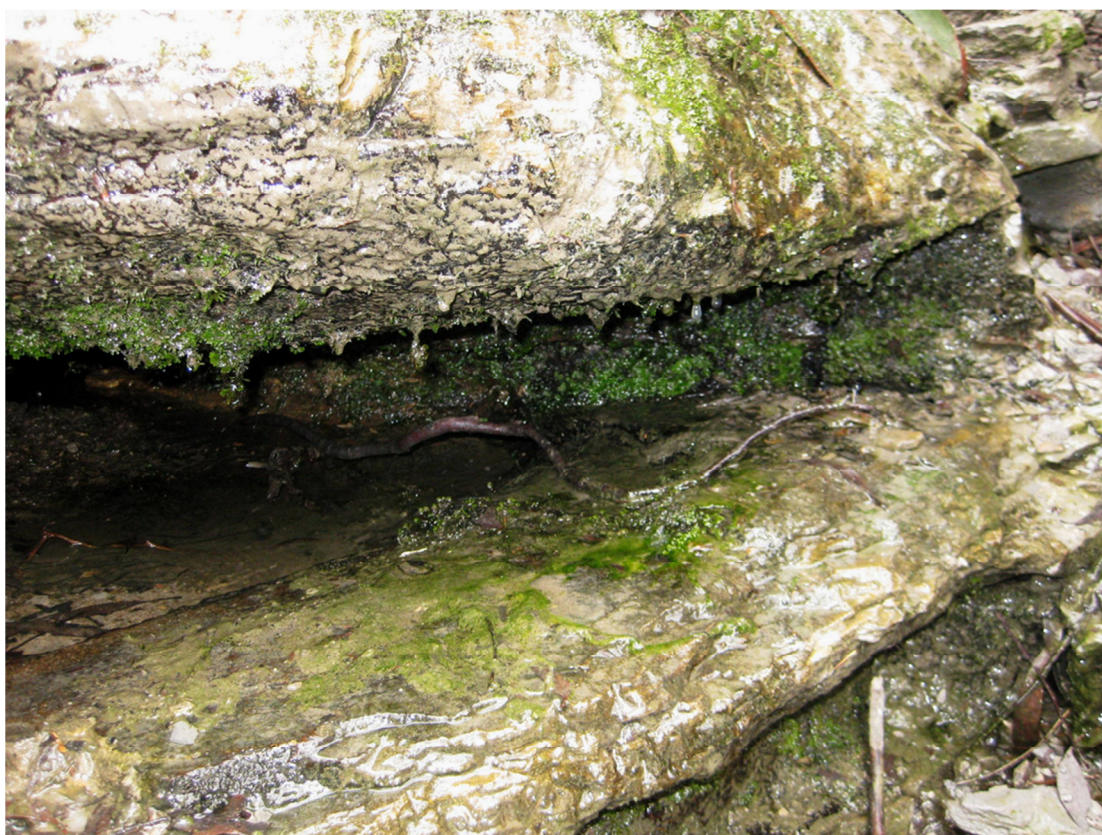
Figure 6.9 Detail of Spring Upstream of Kangaroo Creek Swamp – Unaffected by Longwall Mining

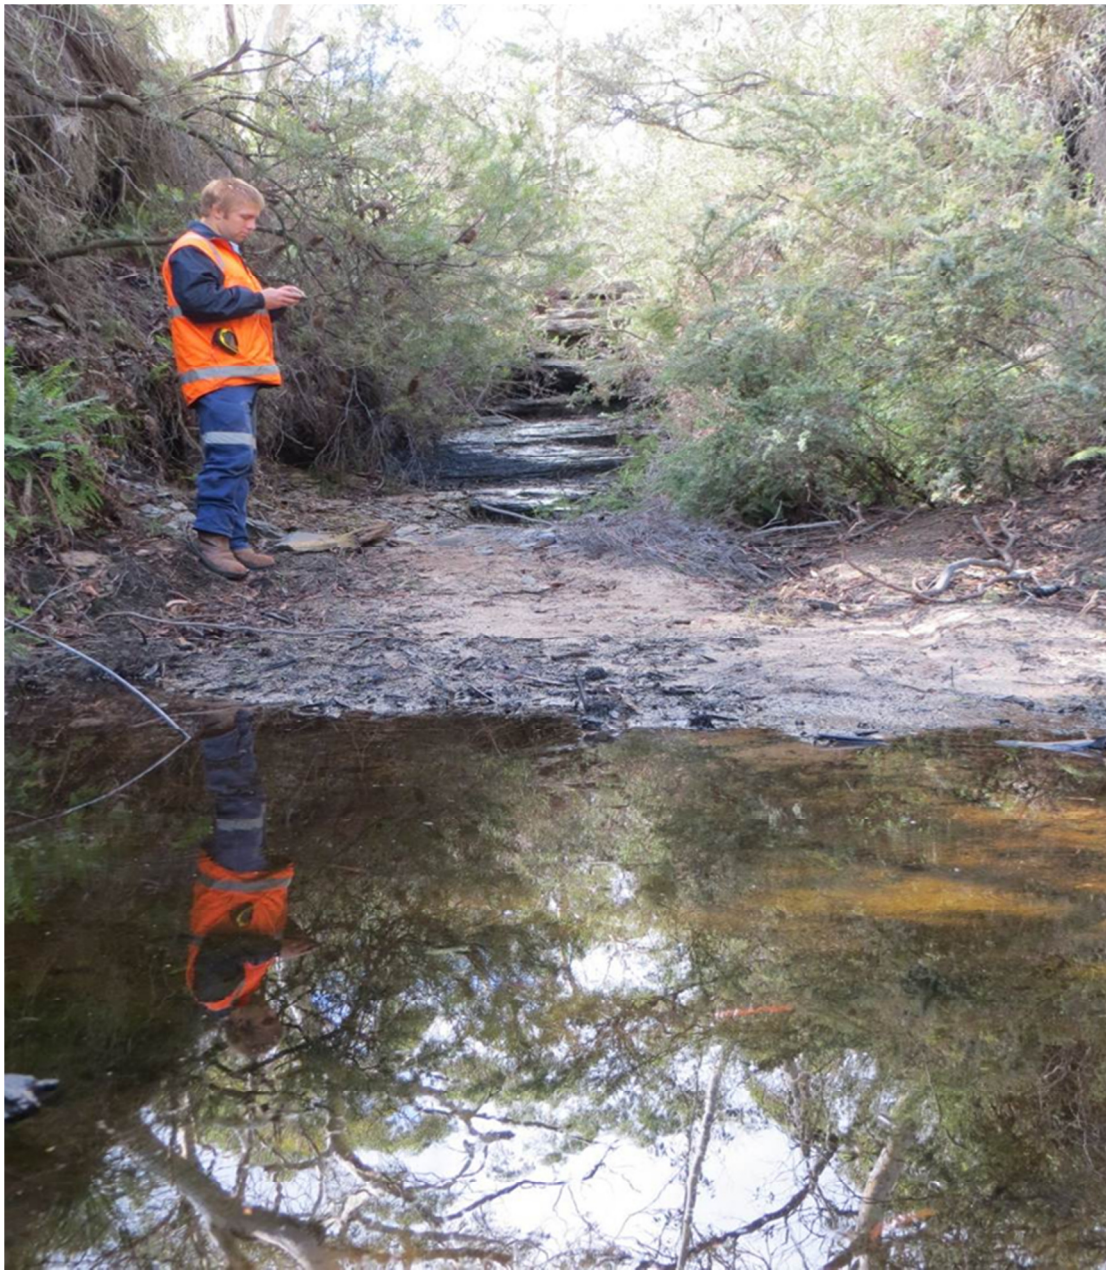
Figure 6.10 – Permanent Waterhole immediately upstream of Kangaroo Creek Swamp – looking upstream with Spring in the background

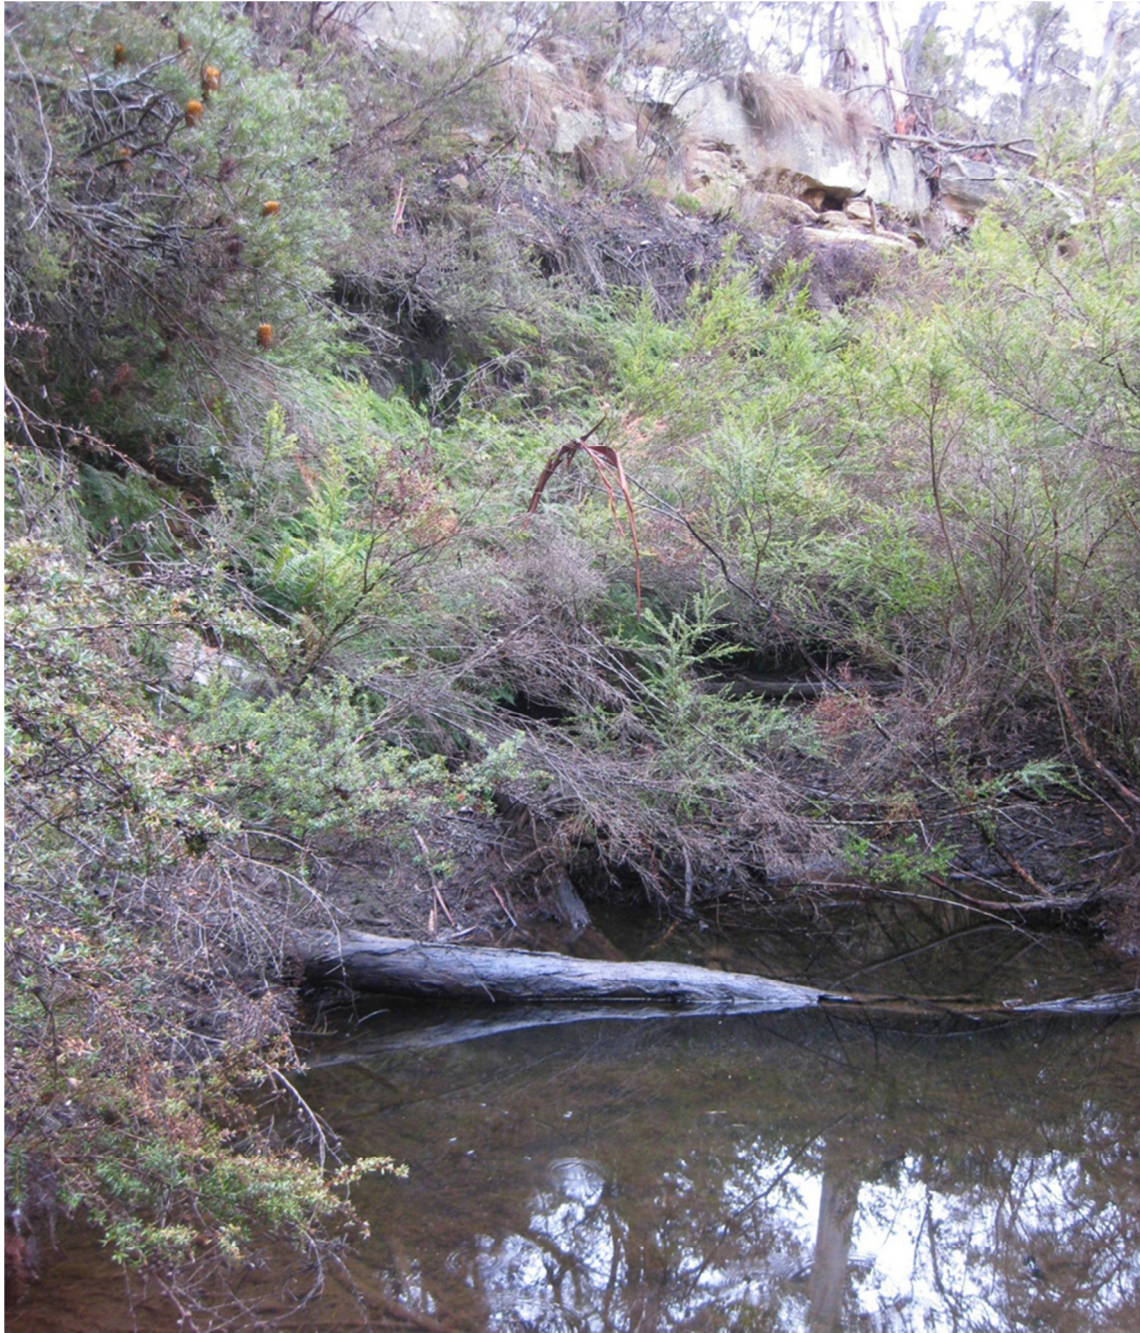
Figure 6.11 – Permanent waterhole immediately upstream of Kangaroo Creek Swamp looking downstream towards the swamp

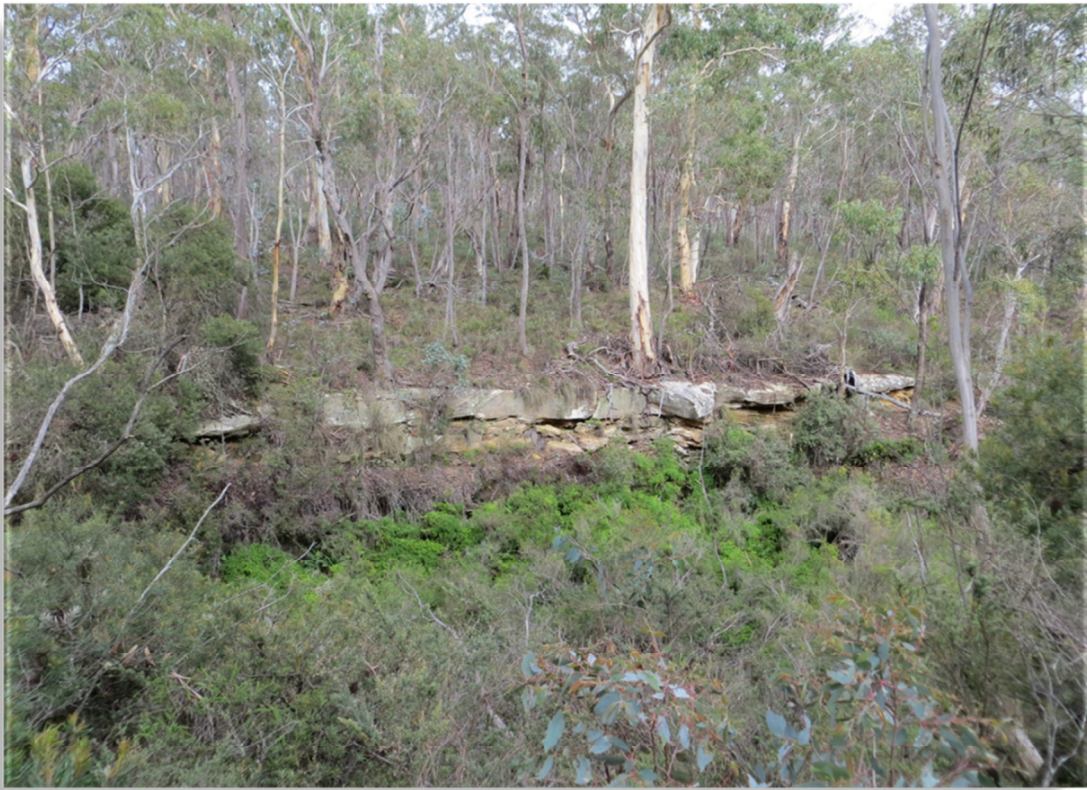
Figure 6.12 – Hanging Swamp in Western Valley Wall above Kangaroo Creek Swamp – unaffected by Longwall mining. The hanging swamp is evidence of ongoing valley wall seepage into Kangaroo Creek Swamp from the Burrallow Formation aquifer / aquitard system following longwall mining

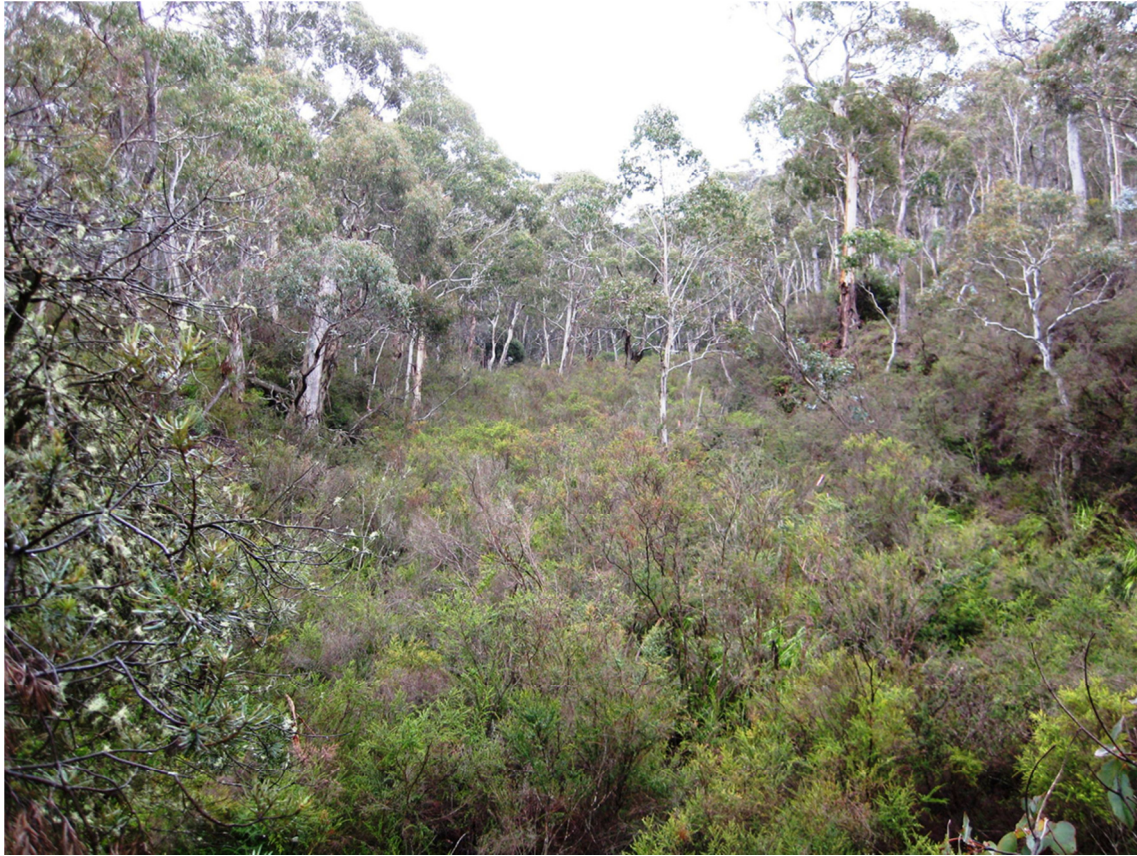
Figure 6.13 Photo of Kangaroo Creek Swamp – looking upstream from the Southern end of the swamp. UQ(2013) reported that “There is no trend of decreasing condition and the abundance of the condition monitored species is not declining”.

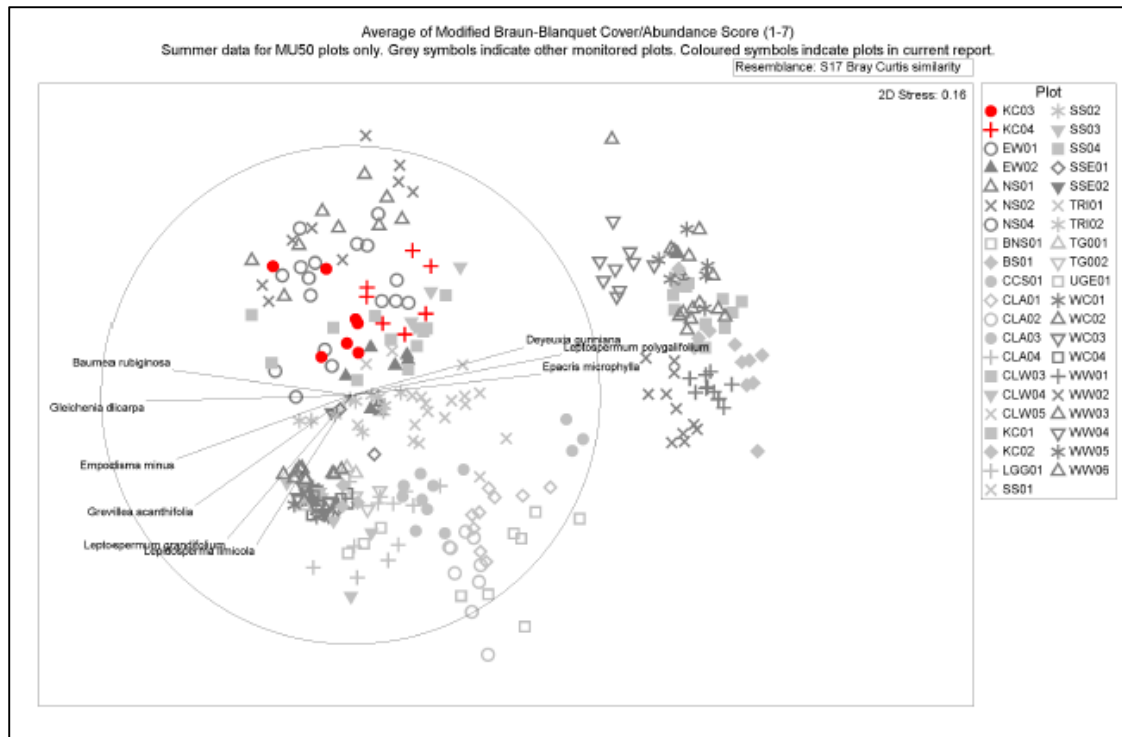
Figure 6.17 - 2D nMDS plot describing species composition of monitoring plots KC03-04 relative to all other MU50 monitoring plots for all summer monitoring conducted on the Newnes Plateau.
