***CENTENNIAL COAL  
MYUNA COLLIERY  
ANNUAL REVIEW***

***January 2022 to December 2022***

**March 2023**

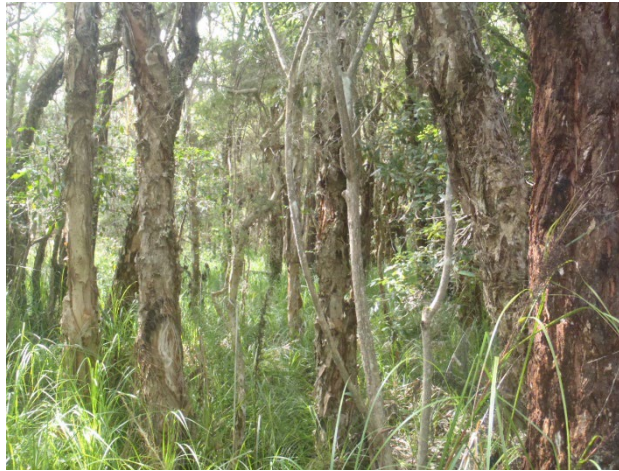
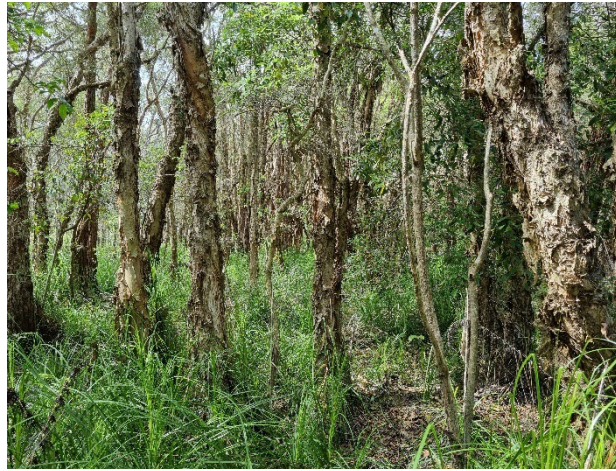
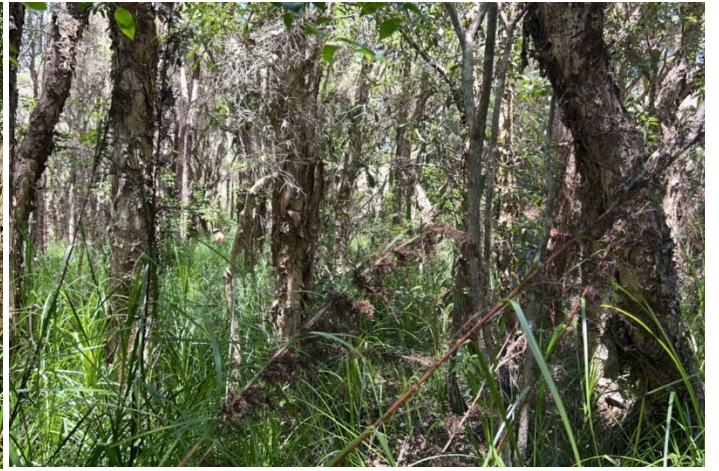
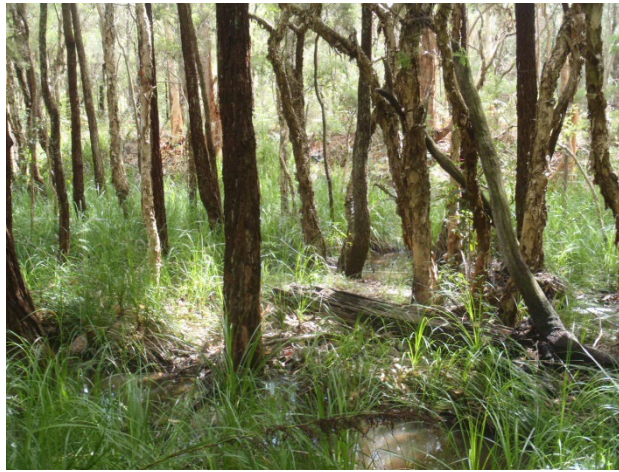
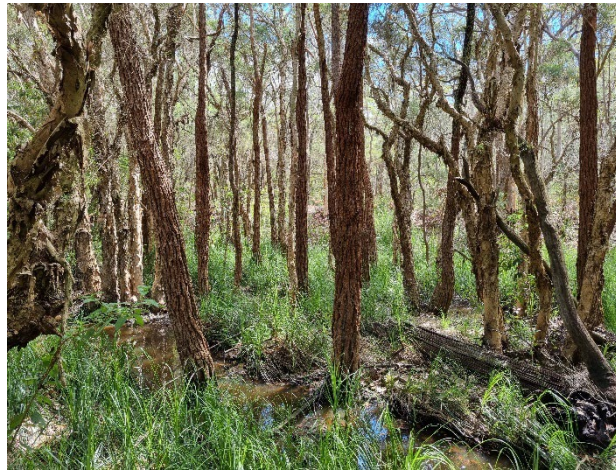
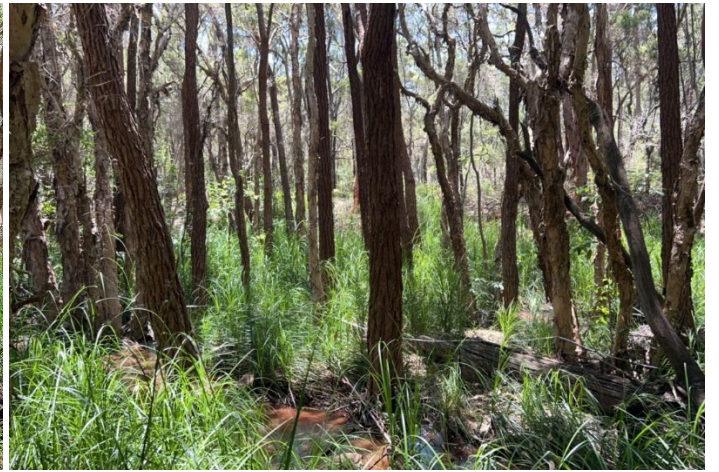
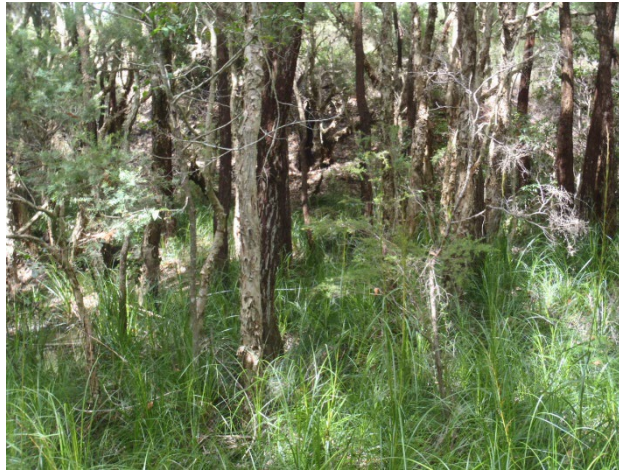
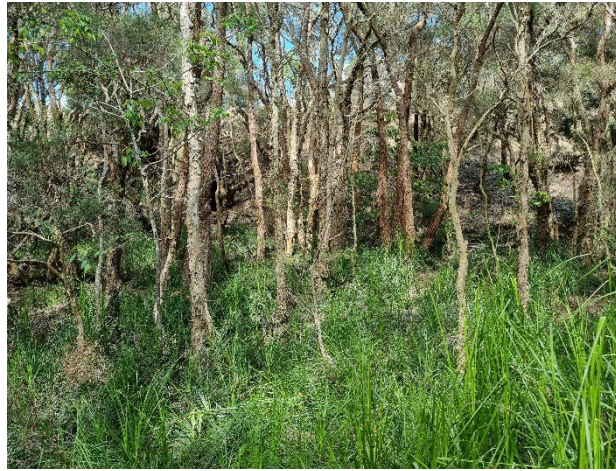
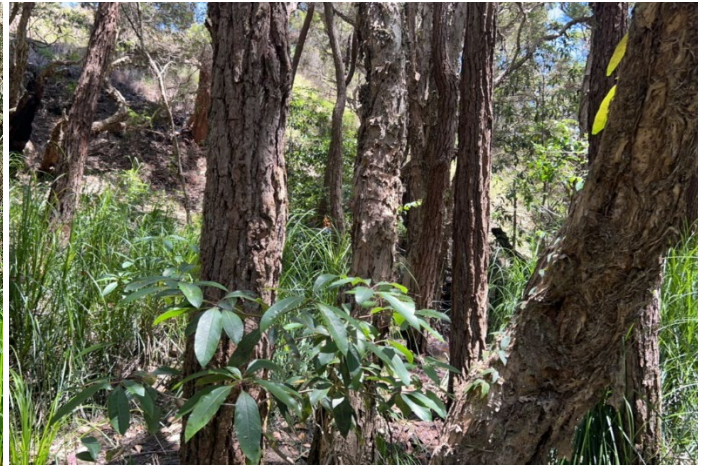
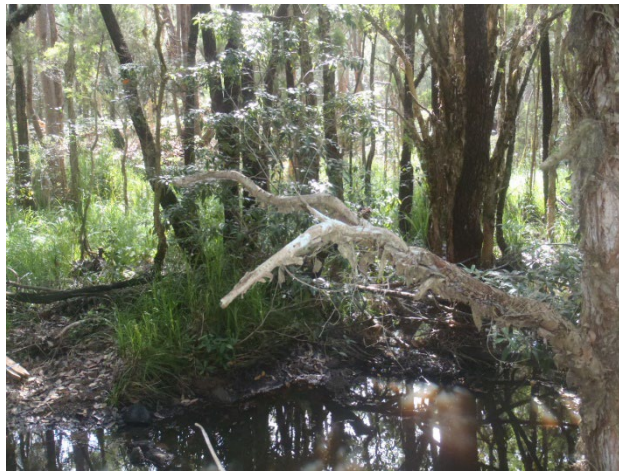
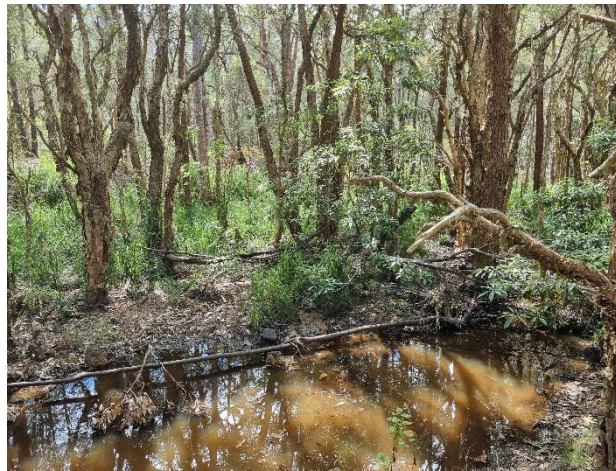
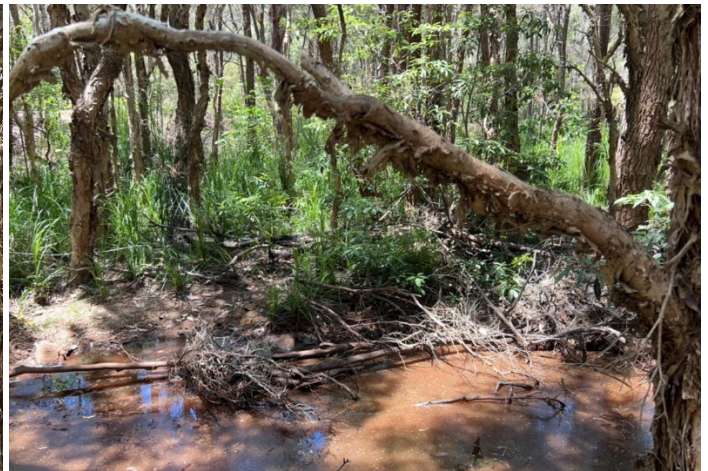
VMA 1 consists of two plots of high condition native vegetation (**Figure 4**). These plots are in locations which had historically experienced relatively high levels of water inundation due to rainfall events. This inundation appeared to be a low energy influx, with minimal deposition of vegetative debris and unconsolidated material. The following section reports on data collected from the 2022 monitoring event. There were no visual indicators of mining related activities or impacts (i.e., subsidence or ponding).

A comparison of images captured at the photo monitoring locations displays minimal variation in vegetation composition and structure, with any changes likely to be attributed to seasonal variations, or a change in camera positioning. Care will be taken in 2023 to ensure photos are lined up correctly.

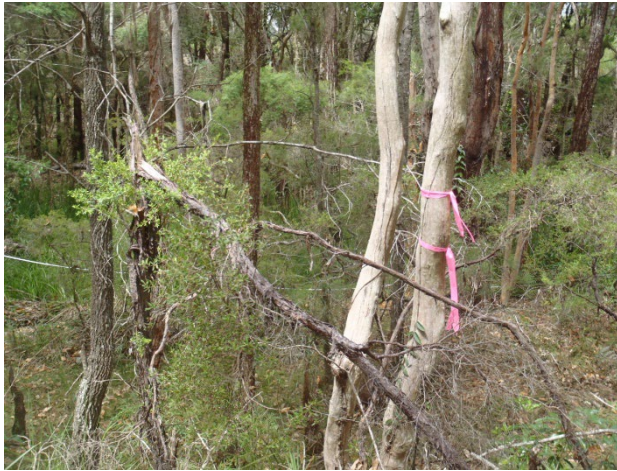
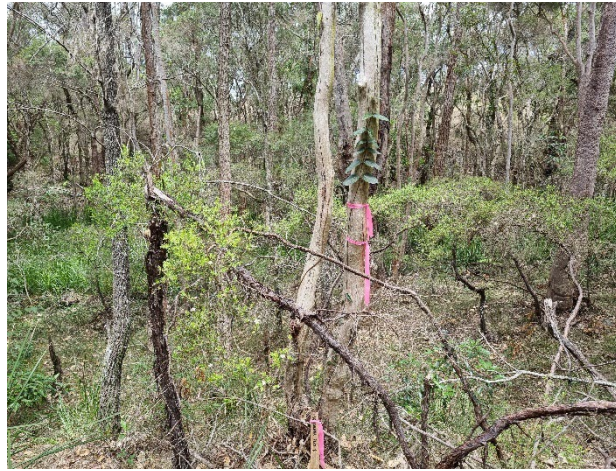
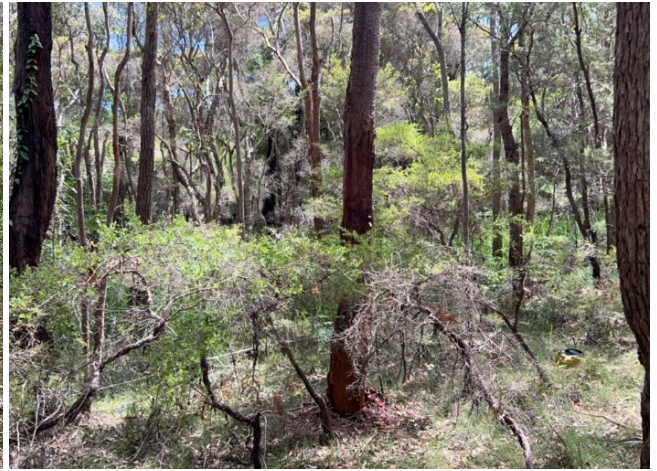
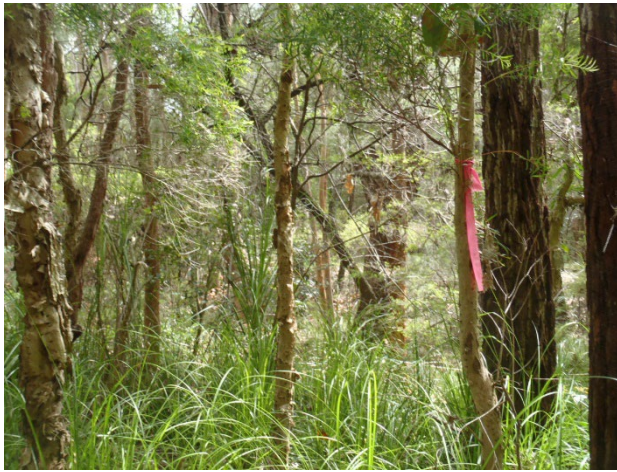
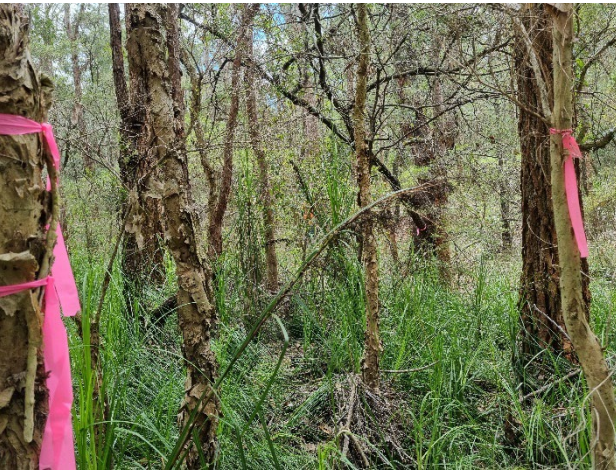
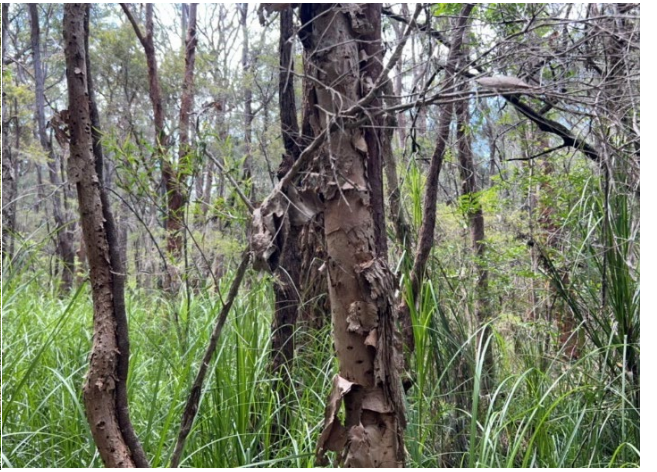
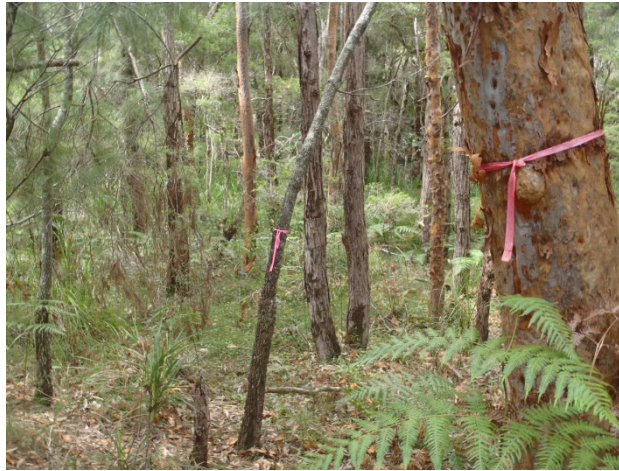
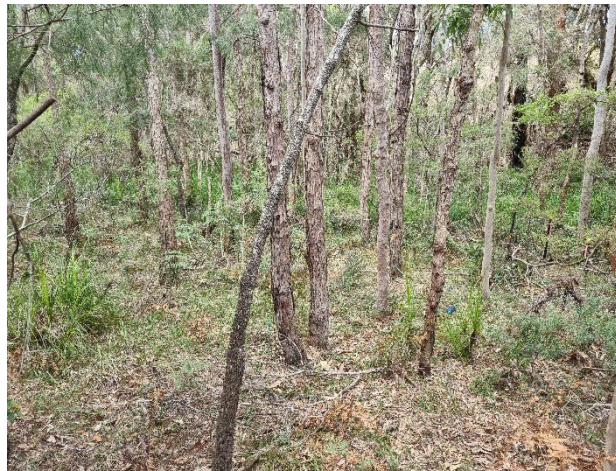
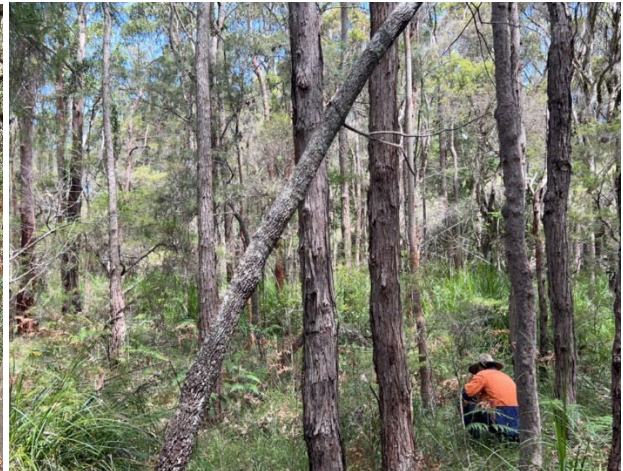
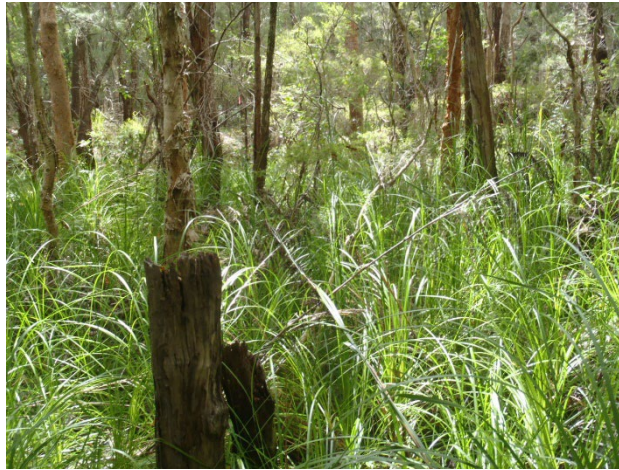
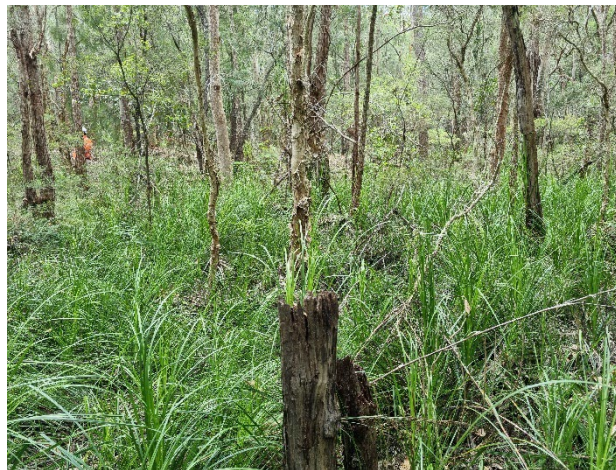
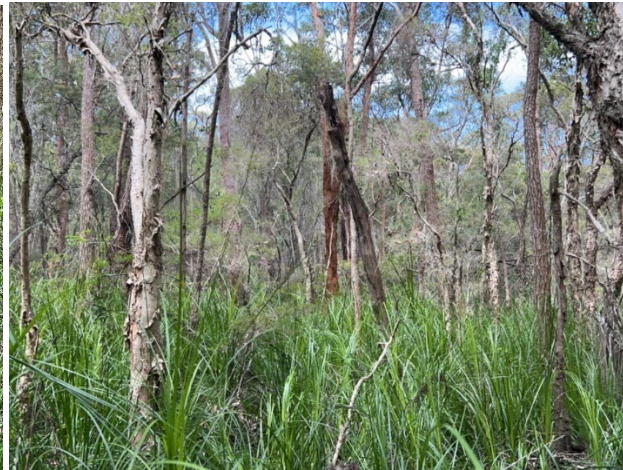
A comparison of images captured at the photo monitoring locations displays minimal variation in vegetation composition and structure, with any changes likely to be attributed to seasonal variations, or a change in camera positioning. Care will be taken in 2023 to ensure photos are lined up correctly.

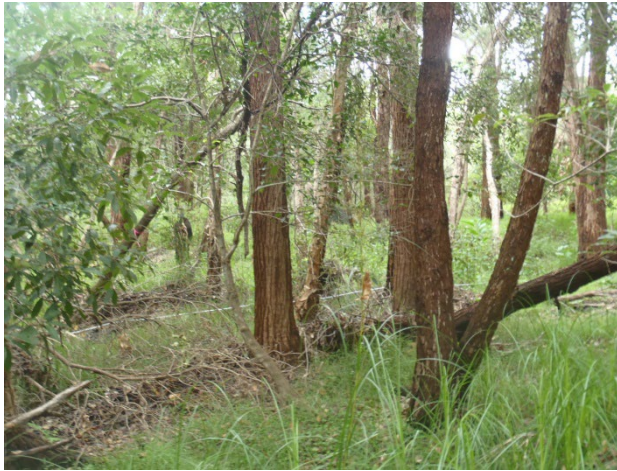
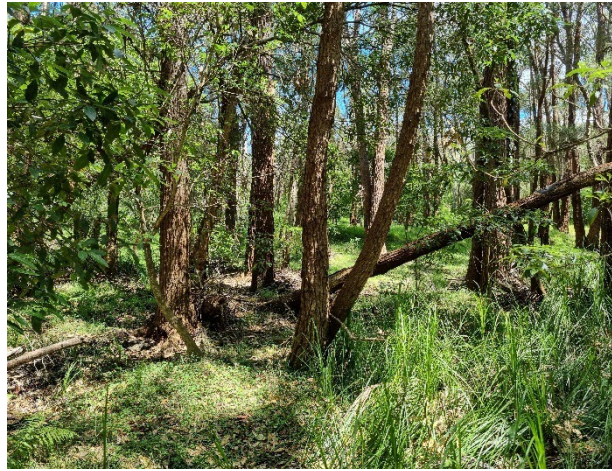
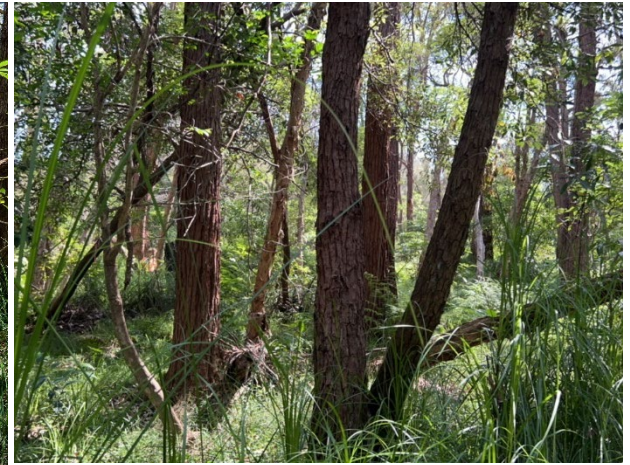
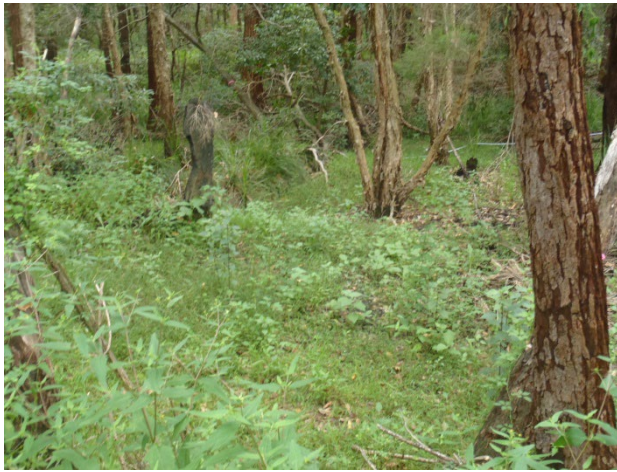
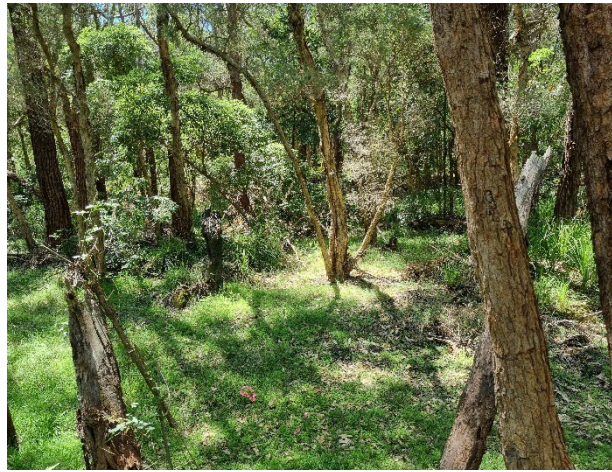
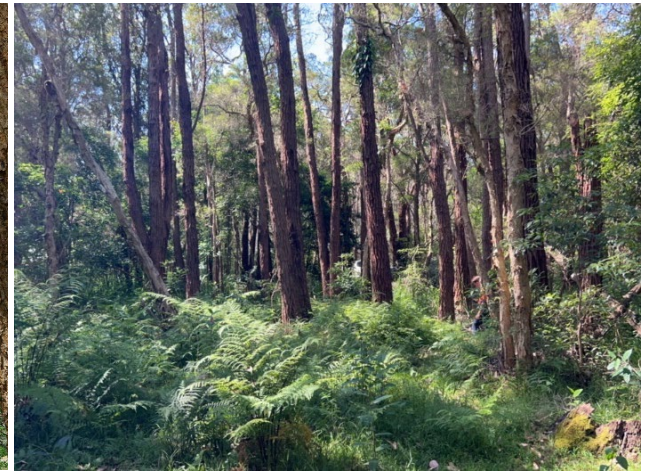
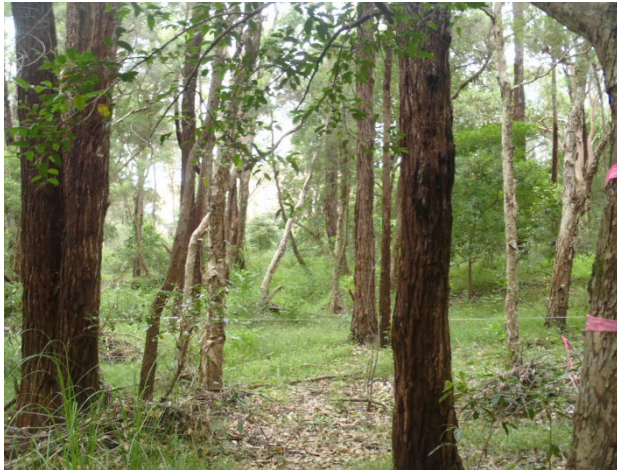
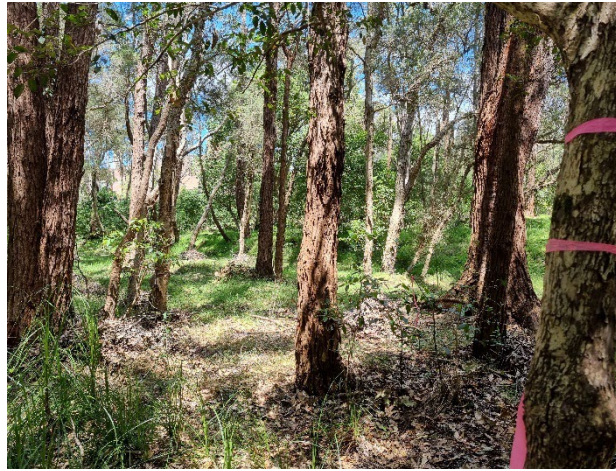
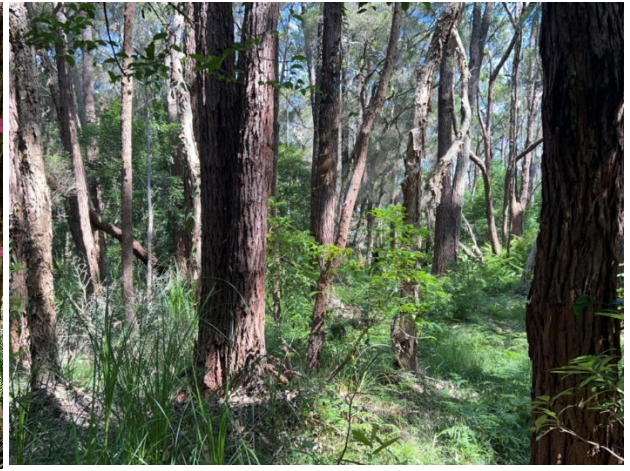
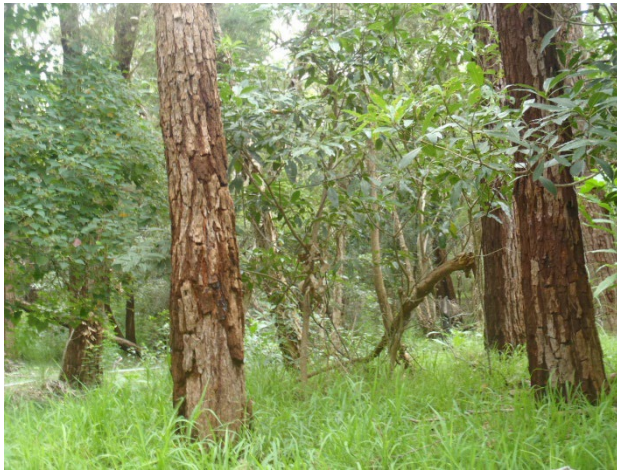
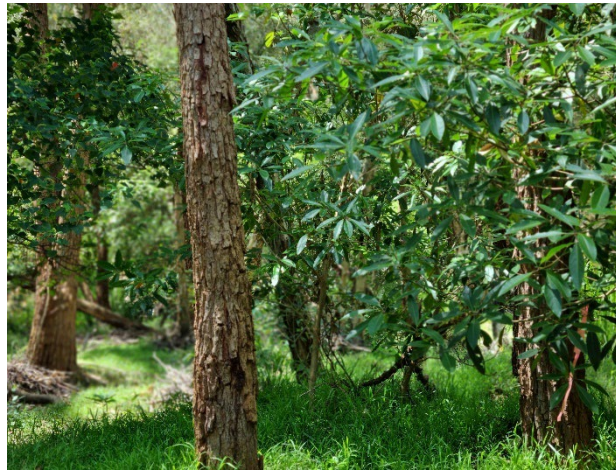
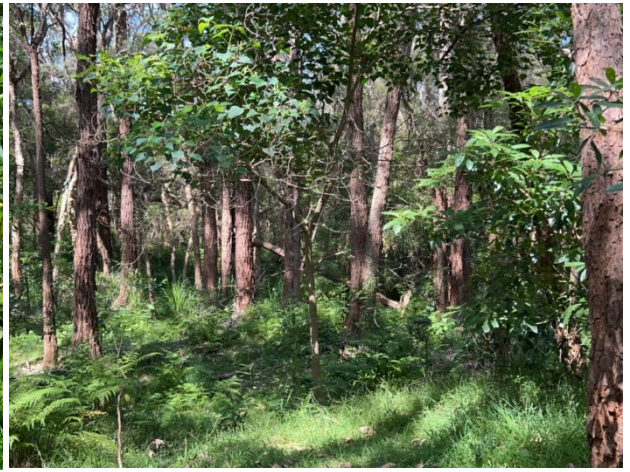
VMA 2 consisted of one plot (Plot 3) of medium condition vegetation (**Figure 4**). Plot 3 exhibited increased number of exotic species within and surrounding the plot. There were no visual indicators of mining related activities or impacts (i.e., subsidence or ponding).

A comparison of images captured at the photo monitoring locations displays minimal variation in vegetation composition and structure, with any changes likely to be attributed to seasonal variations.
