Clarence Colliery

Annual Environmental Management Report

2013

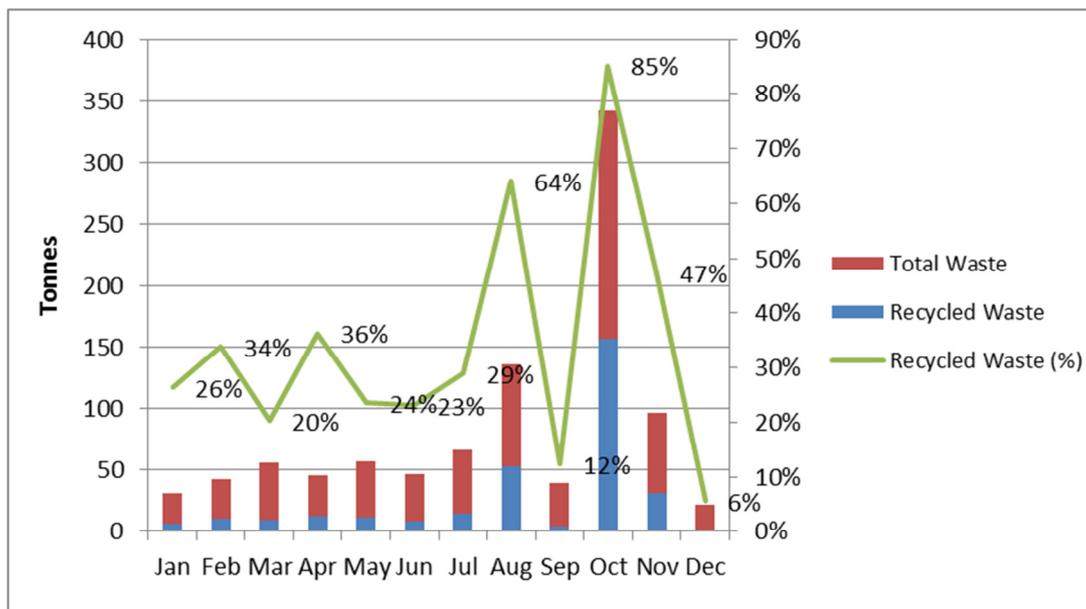
Figure 1. Total Waste and Recycling 2013

Waste targets will be reviewed and modified as required to assist in improving waste minimisation and management procedures. Total waste and percentage of material recycled during the reporting period is presented in **Figure 1**.

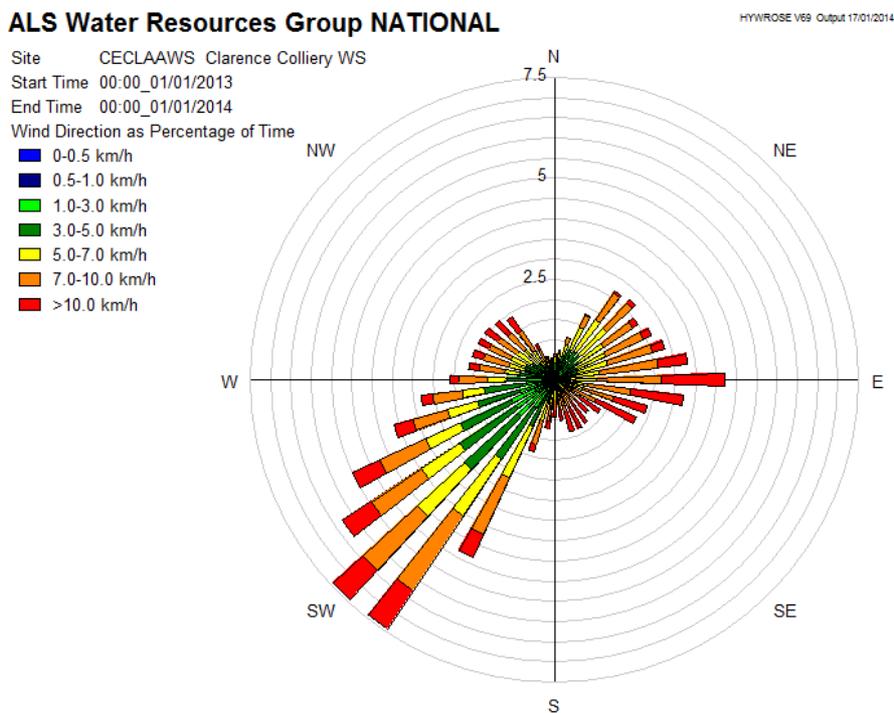
The wind direction during 2013 was predominantly south-westerly. Average wind speed was 6km/h. The maximum wind speed at Clarence was 19km/h in March. Wind speed data is presented in Figure 4.

Figure 4. Yearly Windrose Plot 2013

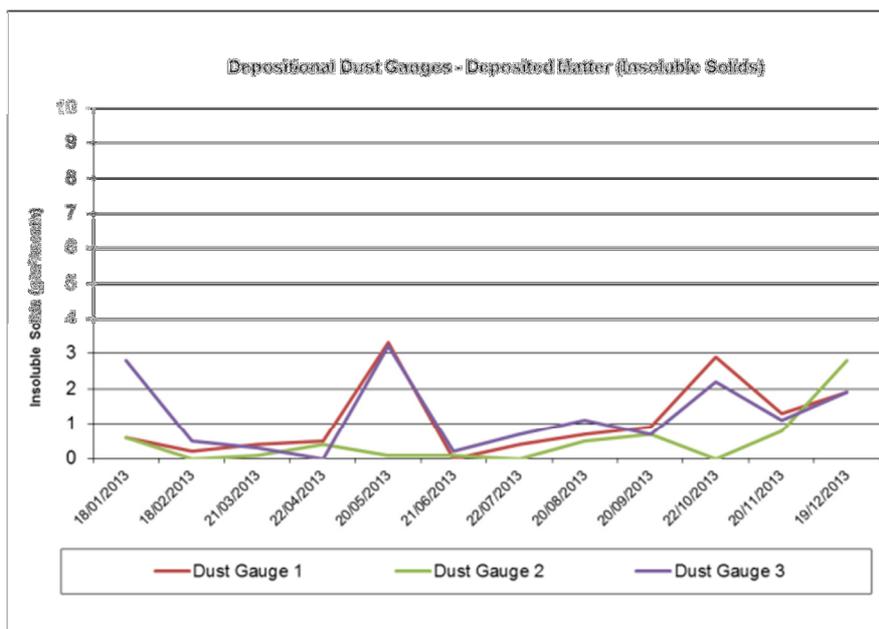
The annual average insoluble solids for 2013 was 1.2 g/m²/month at DG 1, 0.7 g/m²/month at DG 2 and 1.3 g/m²/month at DG 3. The results are all below the annual average air quality criteria of 4 g/m²/month. The location of the dust gauges are identified as dust monitoring sites (DM1, DM2 and DM3) on the Clarence Colliery Pit Top Monitoring Locations figure, located in the document titled Environmental Monitoring Program.

Figure 5. Depositional Dust Gauges 1, 2 and 3

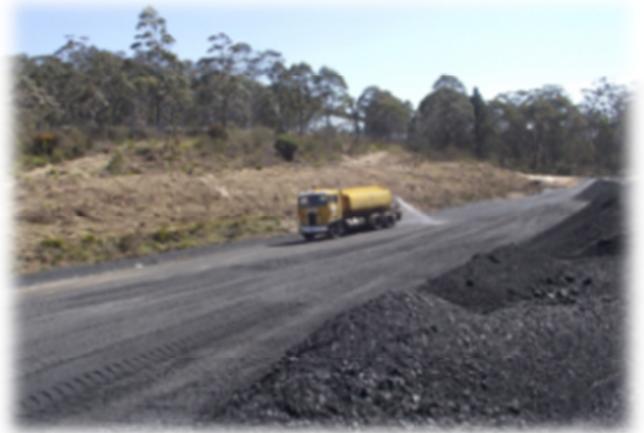
Figure 6. REA Haul Road Sprinklers and Water Cart in Use at REA IV

Dust generation from the Pit Top areas was considered a medium environmental risk, particularly during dry and windy days. A road sweeper from Lithgow City Council is utilised to sweep the pit top monthly reducing the volume of material potentially available to be mobilised to form airborne dust. All trucks transporting coal from Clarence Colliery are required to have covers.

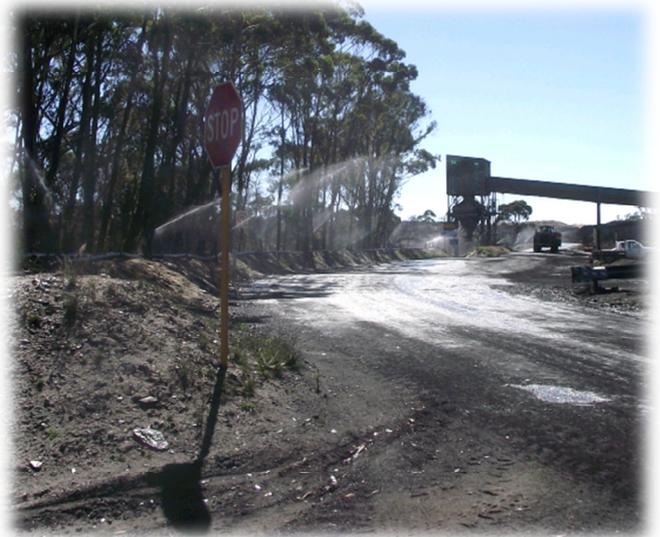
Figure 7. Upgraded Sprinkler System on Truck Access Road

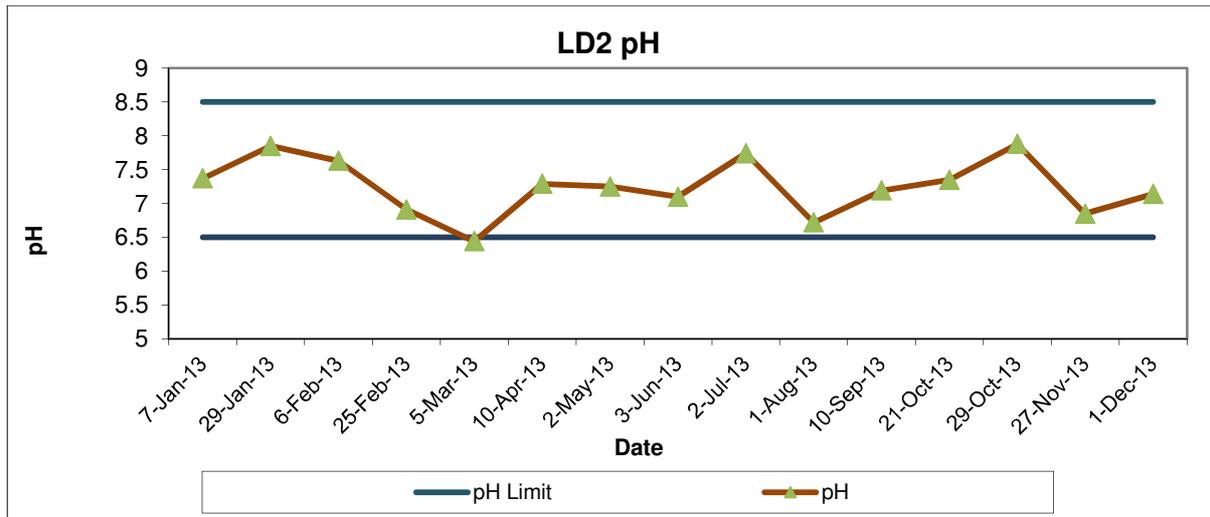
pH results at LD2 during the reporting period were generally within the 6.5 - 8.5 EPA licence limit except for one exceedence of 6.44 pH on 5 March 2013 (**Figure 12**). It is noted that the accuracy of a correctly calibrated pH probe used is plus/minus pH 0.07. Clarence Water treatment plant did not correctly adjust the pH on discharge. A sample was taken downstream at the Clarence Colliery Main Dam on the 5th of March 2013 to determine any environmental impact to downstream waters. The result of pH 6.67 was complaint with EPL 726 concentration limits and indicated no impact as a result of the discharge event. The pH control was reviewed and adjusted on discharge.

Figure 12. pH 2013 Monitoring Results for LD2

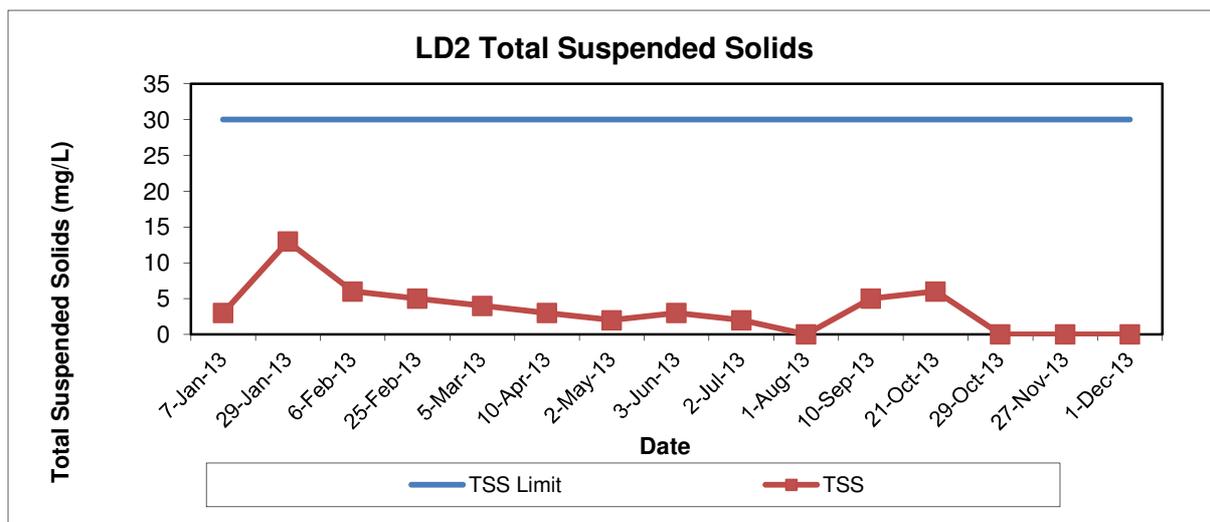
Total Suspended Solids (TSS) results for LD2 during the reporting period were below the 30 mg/L licence limit (Figure 13).

Figure 13. TSS 2013 Monitoring Results for LD2

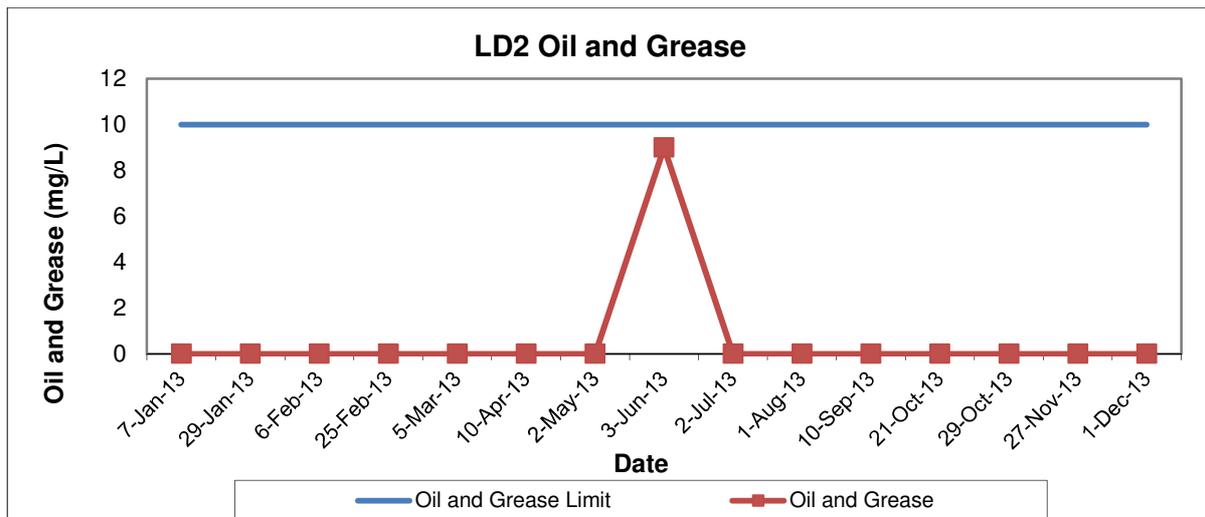
Oil and Grease results for discharged water sampled at LD2 during the reporting period were below the prescribed limit (10mg/L) in EPL 726 (Figure 14).

Figure 14. Oil and Grease 2013 Monitoring Results for LD2

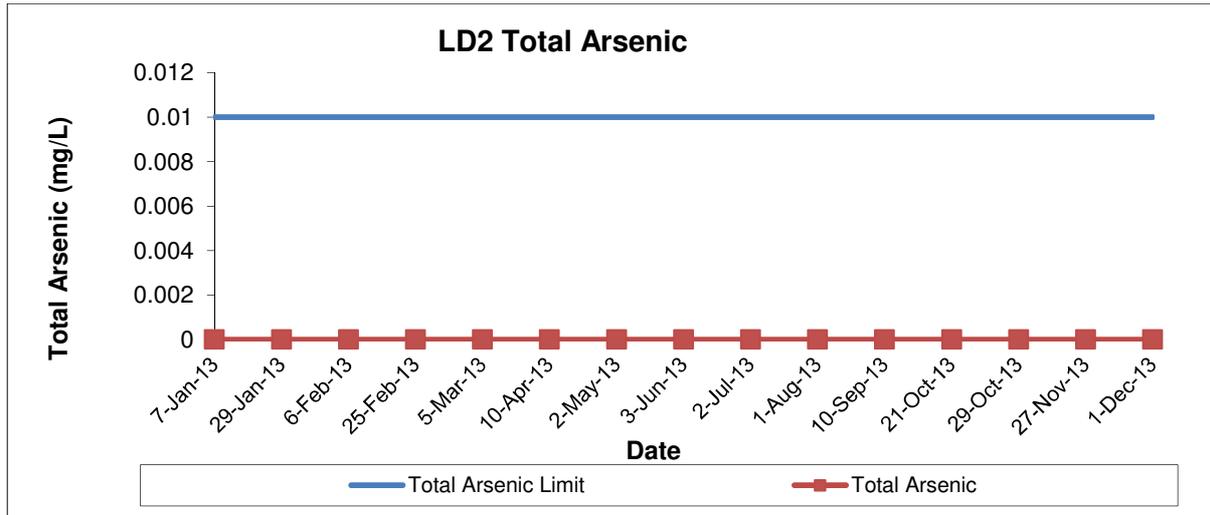
Total Arsenic results for discharged water sampled at LD2 during the reporting period were below the licence limit (0.01mg/L) and below the detection limit (0.001mg/L) on all occasions (Figure 16).

Figure 16. Total Arsenic 2013 Monitoring Results for LD2

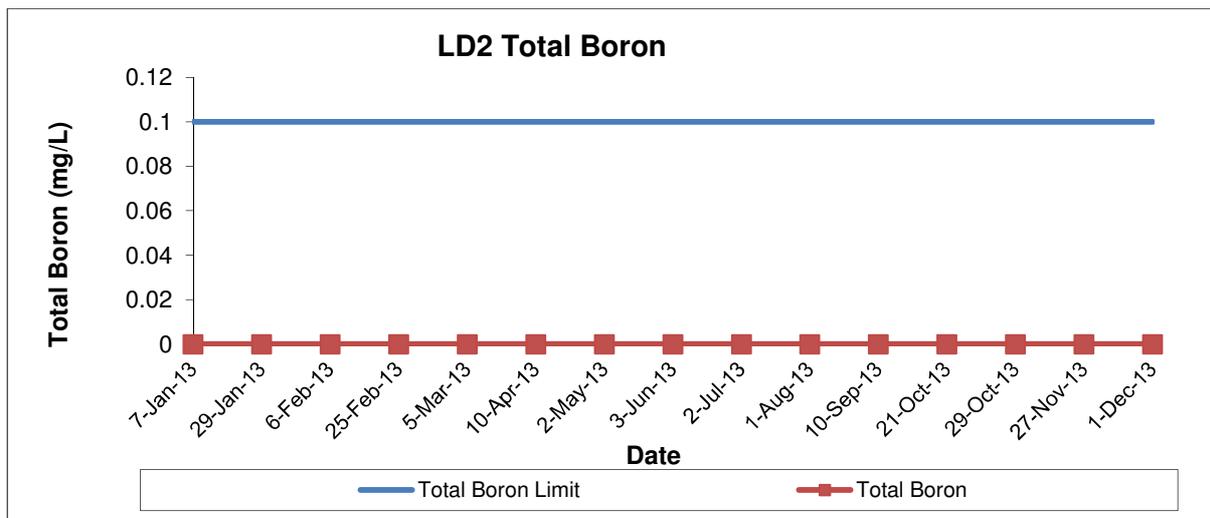
Total Boron results for discharged water sampled at LD2 during the reporting period were below the licence limit (0.1mg/L) and below the detection limit (0.05mg/L) on all occasions (Figure 17).

Figure 17. Total Boron 2013 Monitoring Results for LD2

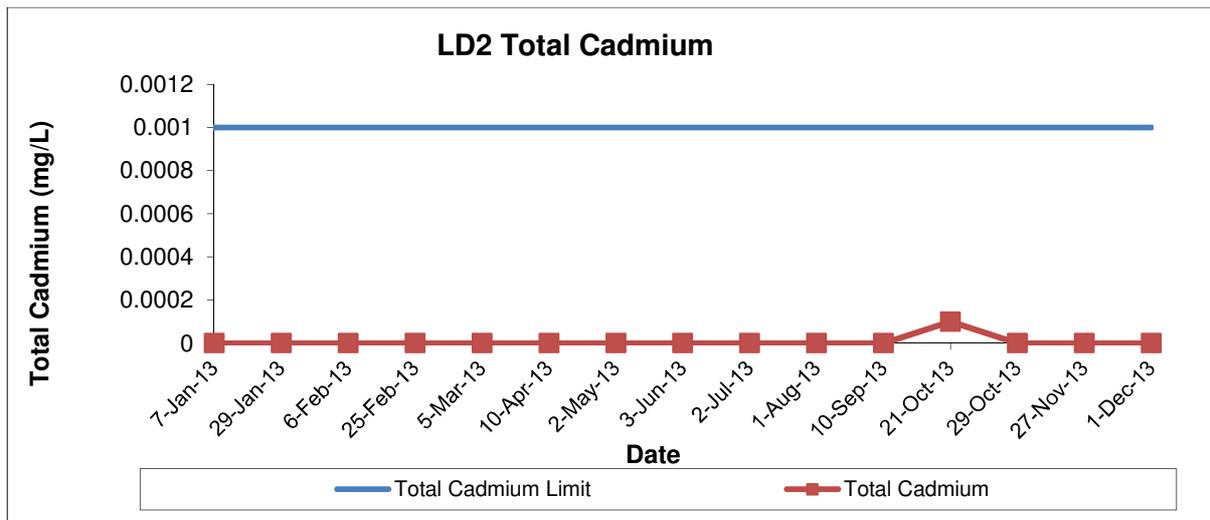
Total Cadmium results for discharged water sampled at LD2 during the reporting period were below the licence limit (0.001mg/L) on all occasions with the highest result being 0.0001mg/L on the 21 October 2013 (Figure 18).

Figure 18. Total Cadmium 2013 Monitoring Results for LD2

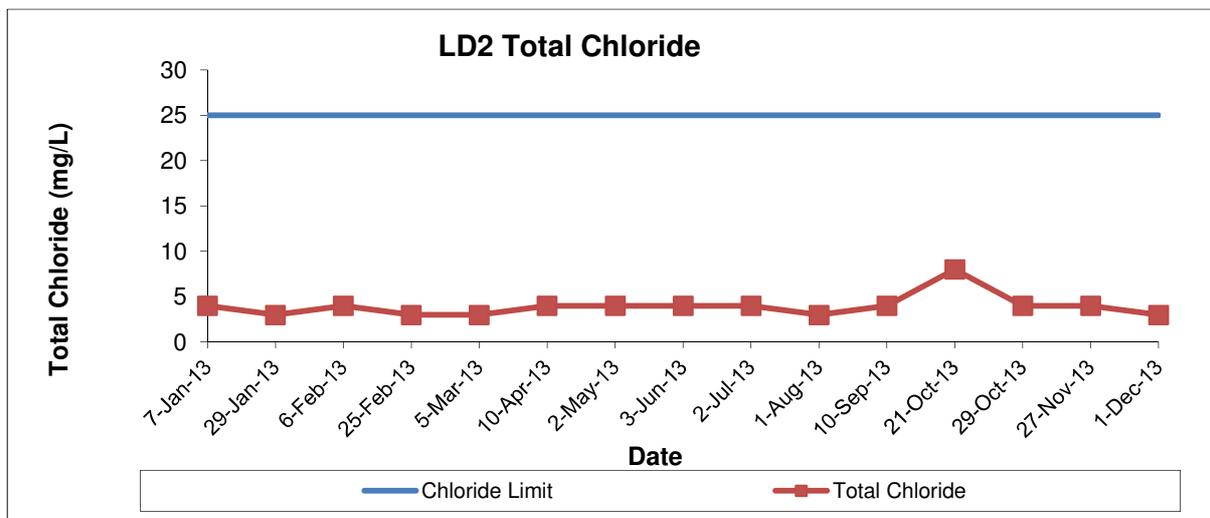
Total Chloride results for discharged water sampled at LD2 during the reporting period were below the licence limit (25mg/L) on all occasions with the highest result being 8 mg/L on 21 October 2013 (Figure 19).

Figure 19. Total Chloride 2013 Monitoring Results for LD2

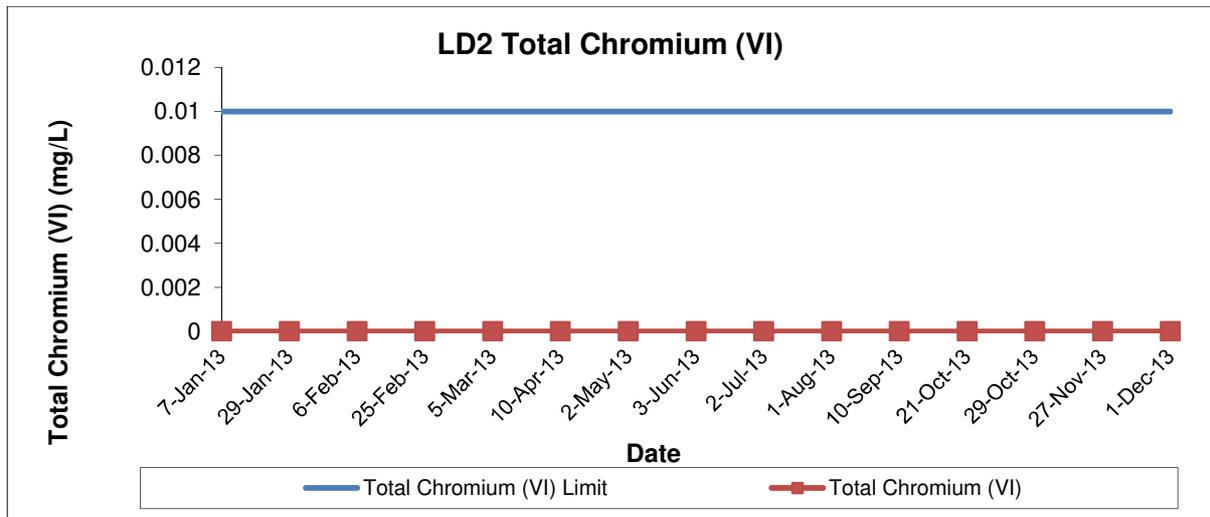
Total Chromium (hexavalent) also referred to as Total Chromium (VI), results for discharged water sampled at LD2 during the reporting period were below the licence limit (0.01mg/L) and below the detection limit (0.01mg/L) on all occasions (Figure 20).

Figure 20. Total Chromium (VI) 2013 Monitoring Results for LD2

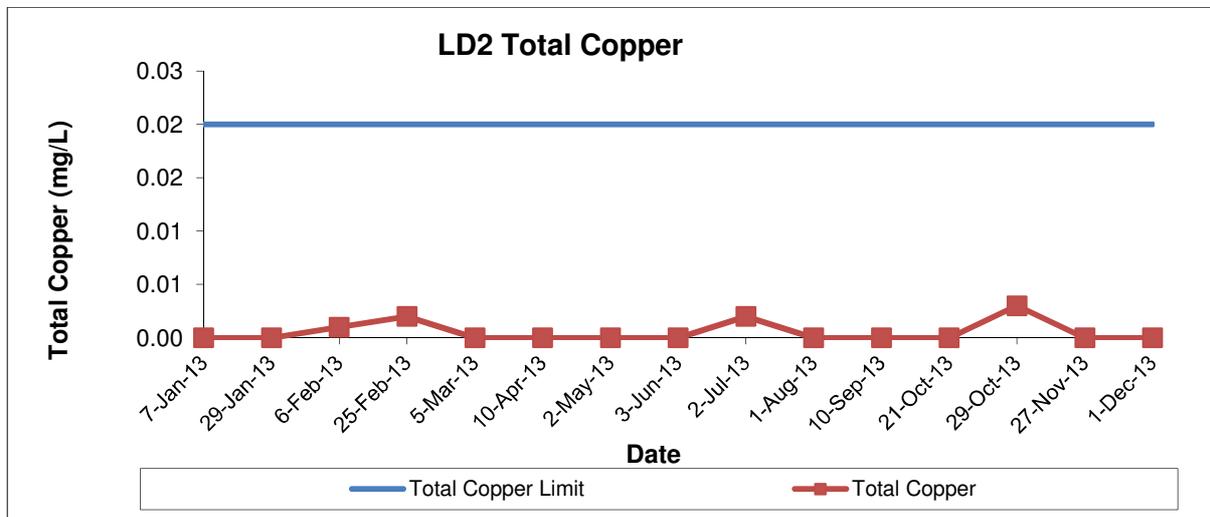
Total Copper results for discharged water sampled at LD2 during the reporting period were below the licence limit (0.02mg/L) on all occasions with the highest reading of 0.003mg/L recorded on 29 October 2013 (Figure 21).

Figure 21. Total Copper 2013 Monitoring Results for LD2

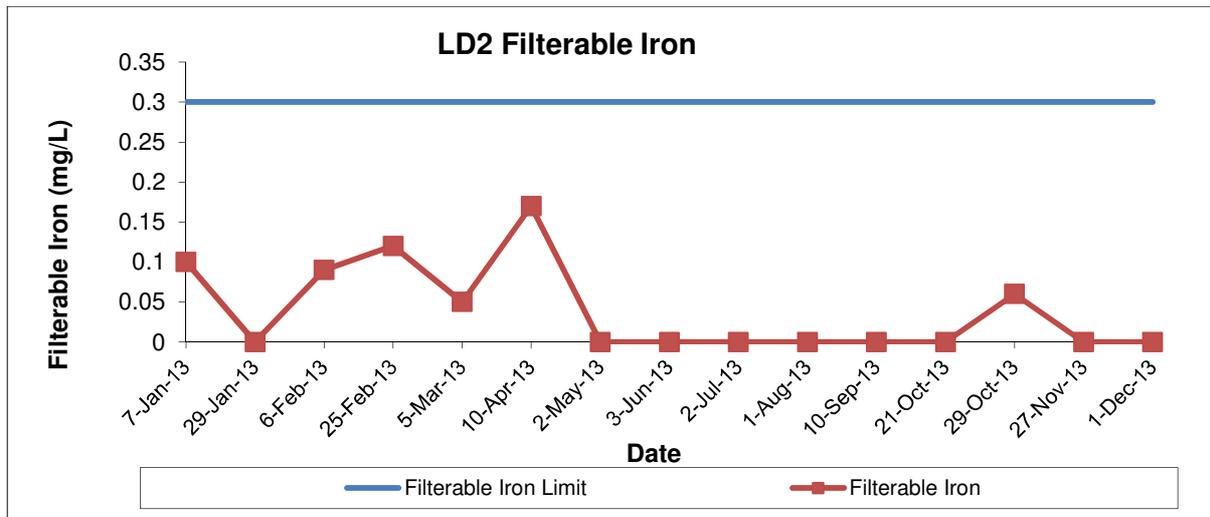
Filterable Iron results for discharged water sampled at LD2 during the reporting period were below the licence limit (0.3mg/L) on all occasions with the highest reading being 0.17 mg/L on 10 April 2013 (Figure 22).

Figure 22. Filterable Iron 2013 Monitoring Results for LD2

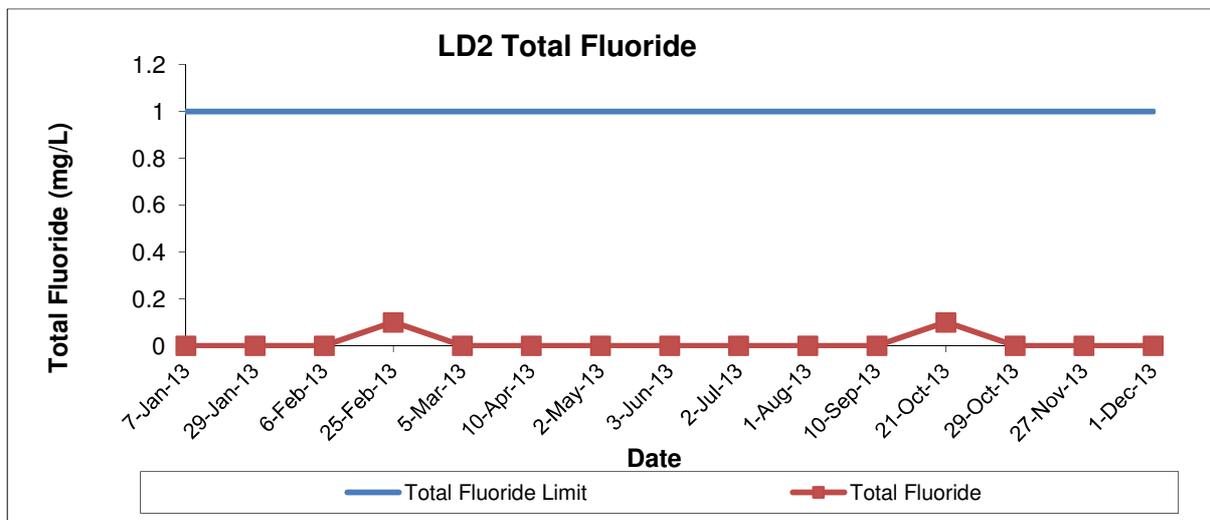
Total Fluoride results for discharged water sampled at LD2 during the reporting period were the below licence limit (1mg/L) on all occasions with the highest reading being 0.1 mg/L on 25 February and 21 October 2013 (Figure 23).

Figure 23. Total Fluoride 2013 Monitoring Results for LD2

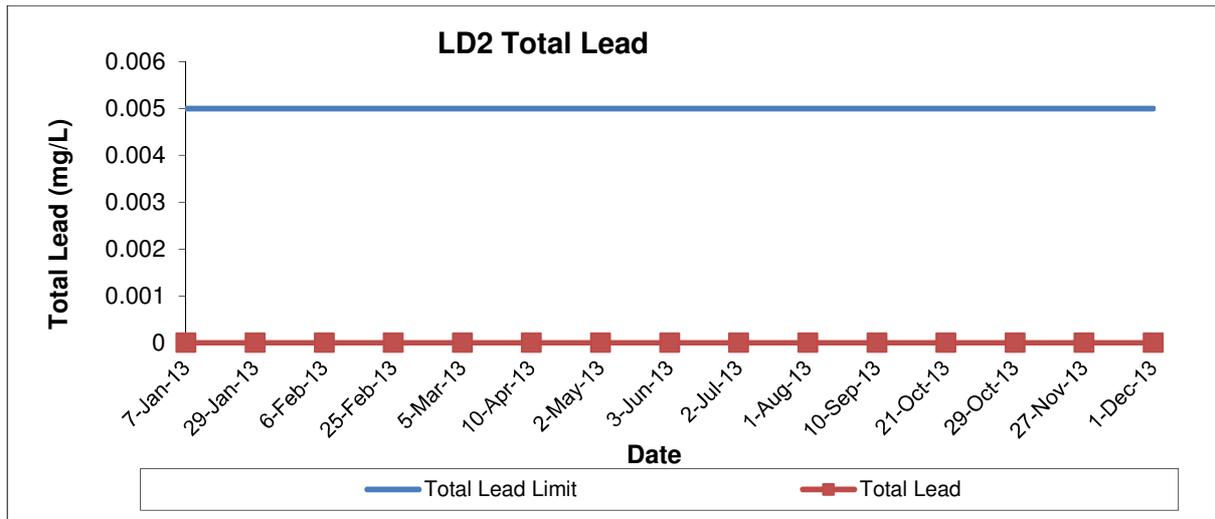
Total Lead results for discharged water sampled at LD2 during the reporting period were below the licence limit (0.005mg/L) and below the detection limit (<0.001mg/L) on all occasions (Figure 24).

Figure 24. Total Lead 2013 Monitoring Results for LD2

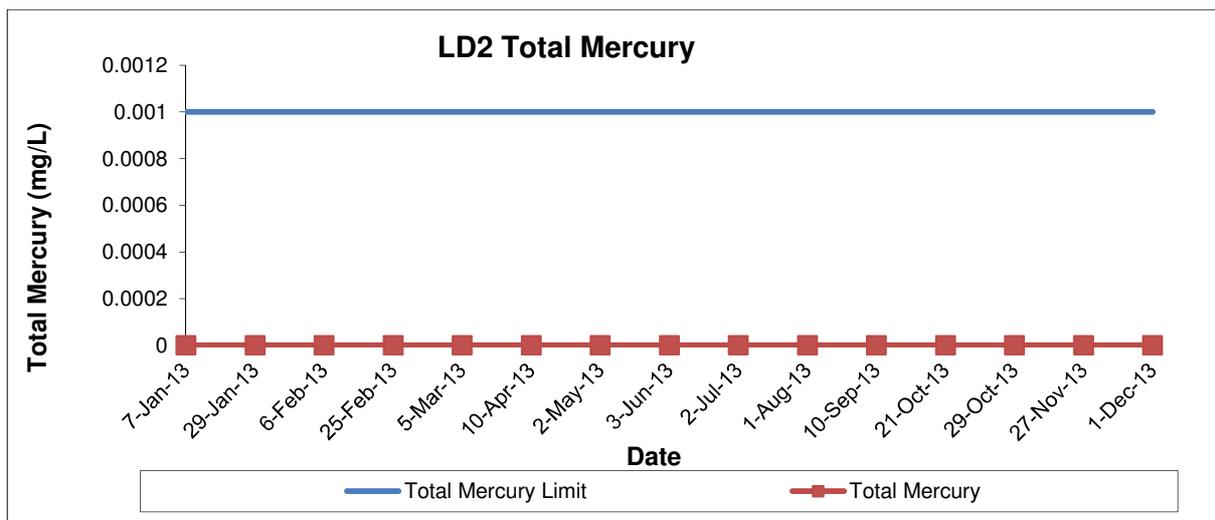
Total Mercury results for discharged water sampled at LD2 during the reporting period were below the licence limit (0.001mg/L) and below the detection limit (0.0001mg/L) on all occasions (**Figure 25**).

Figure 25. Total Mercury 2013 Monitoring Results for LD2

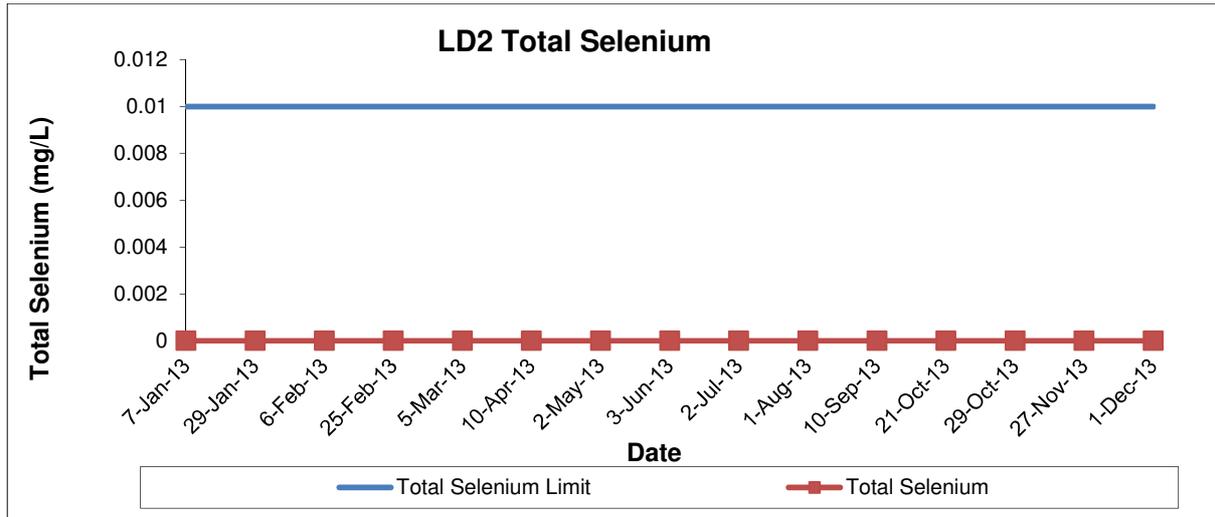
Total Selenium results for discharged water sampled at LD2 during the reporting period were below the licence limit (0.01mg/L) and below the detection limit (0.01mg/L) on all occasions (**Figure 26**).

Figure 26. Total Selenium 2013 Monitoring Results for LD2

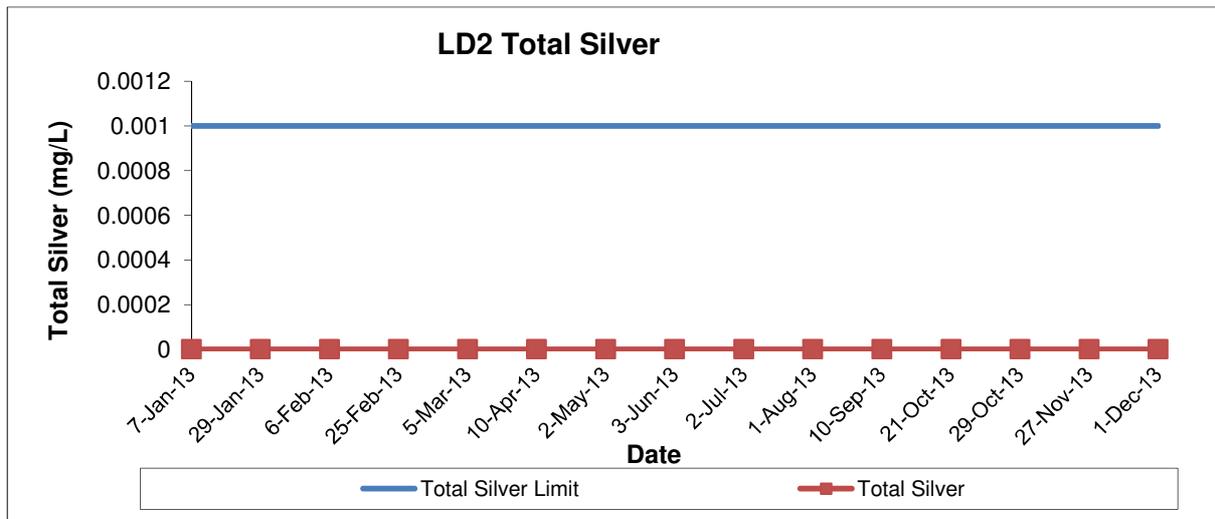
Total Silver results for discharged water sampled at LD2 during the reporting period were below the licence limit (0.001mg/L) and below the detection limit (0.001mg/L) on all occasions (Figure 27).

Figure 27. Total Silver 2013 Monitoring Results for LD2

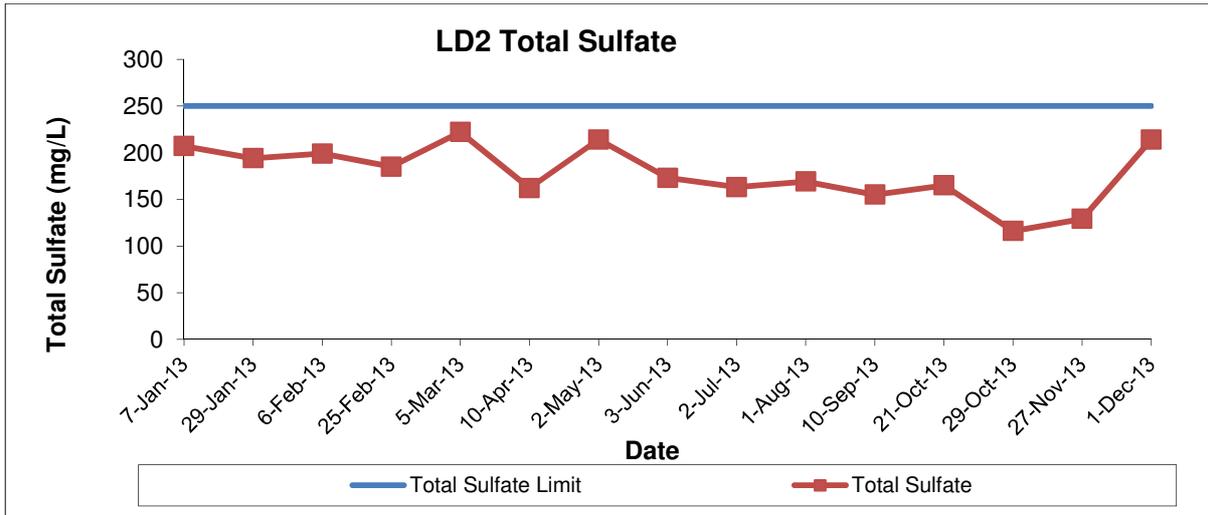
Total Sulfate results for discharged water sampled at LD2 during the reporting period were below the licence limit (250mg/L) on all occasions with the highest result being 222 mg/L on 5 March 2013 (Figure 28).

Figure 28. Total Sulfate 2013 Monitoring Results for LD2

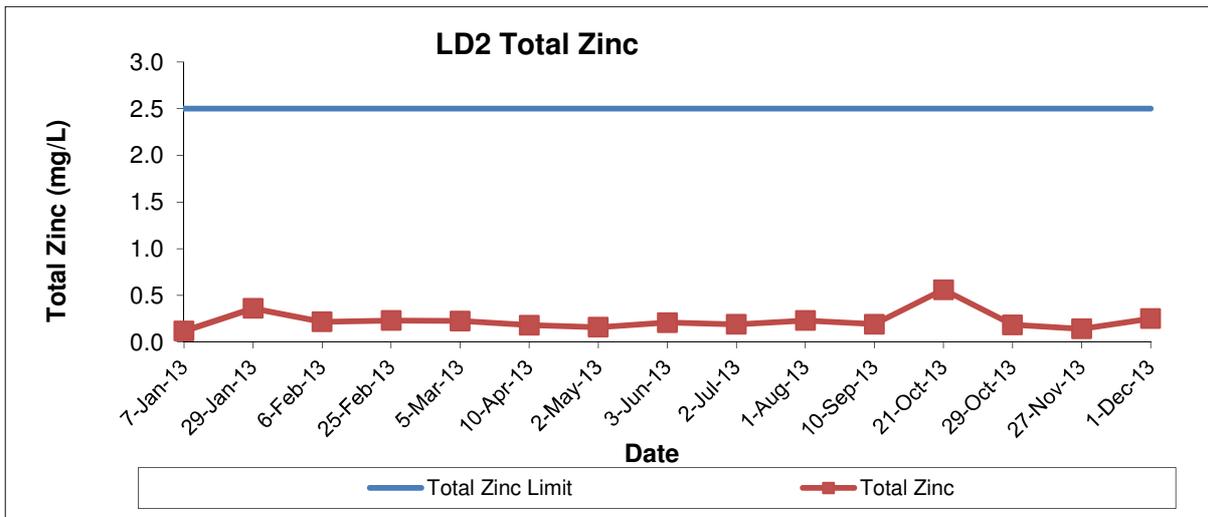
Total Zinc results for discharged water sampled at LD2 during the reporting period were below the licence limit (2.5mg/L) on all occasions with the highest result being 0.561 mg/L on 21 October 2013 (Figure 29).

Figure 29. Total Zinc 2013 Monitoring Results for LD2

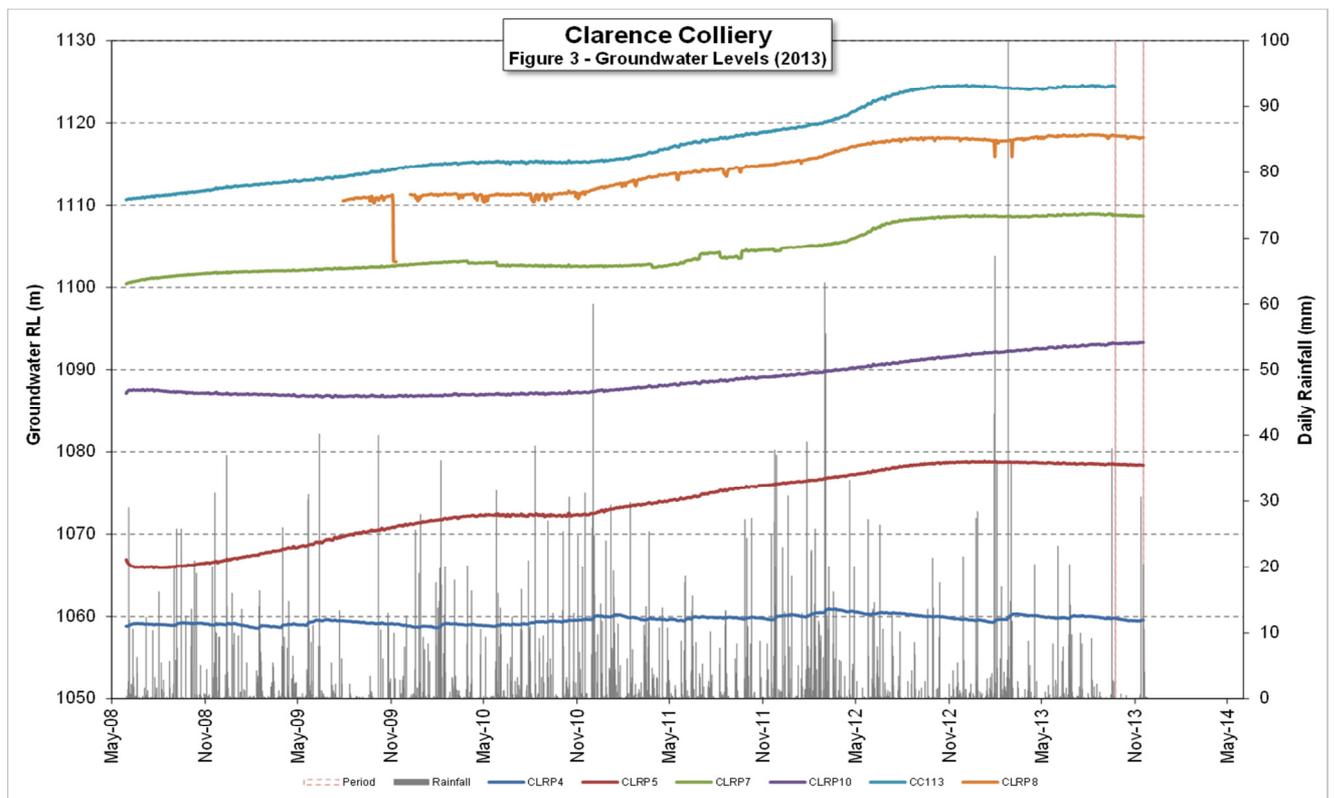
Groundwater levels in all of these holes stand generally at historically high levels in the data record extending back to 2008, related to the generally wetter conditions between late 2010 and early 2012. There is no evidence of any mining-related impacts on any of these piezometers, based on the continuing uniform responses of the piezometers.

Figure 30. CLRP4, CLRP5, CLRP6, CLRP7, CLRP8, CLRP10 and CC113 Piezometric Height

Monitoring results for piezometric height at CLRP4, CLRP5, CLRP6, CLRP7, CLRP8, CLRP10 and CC113 is presented in **Figure 30**.

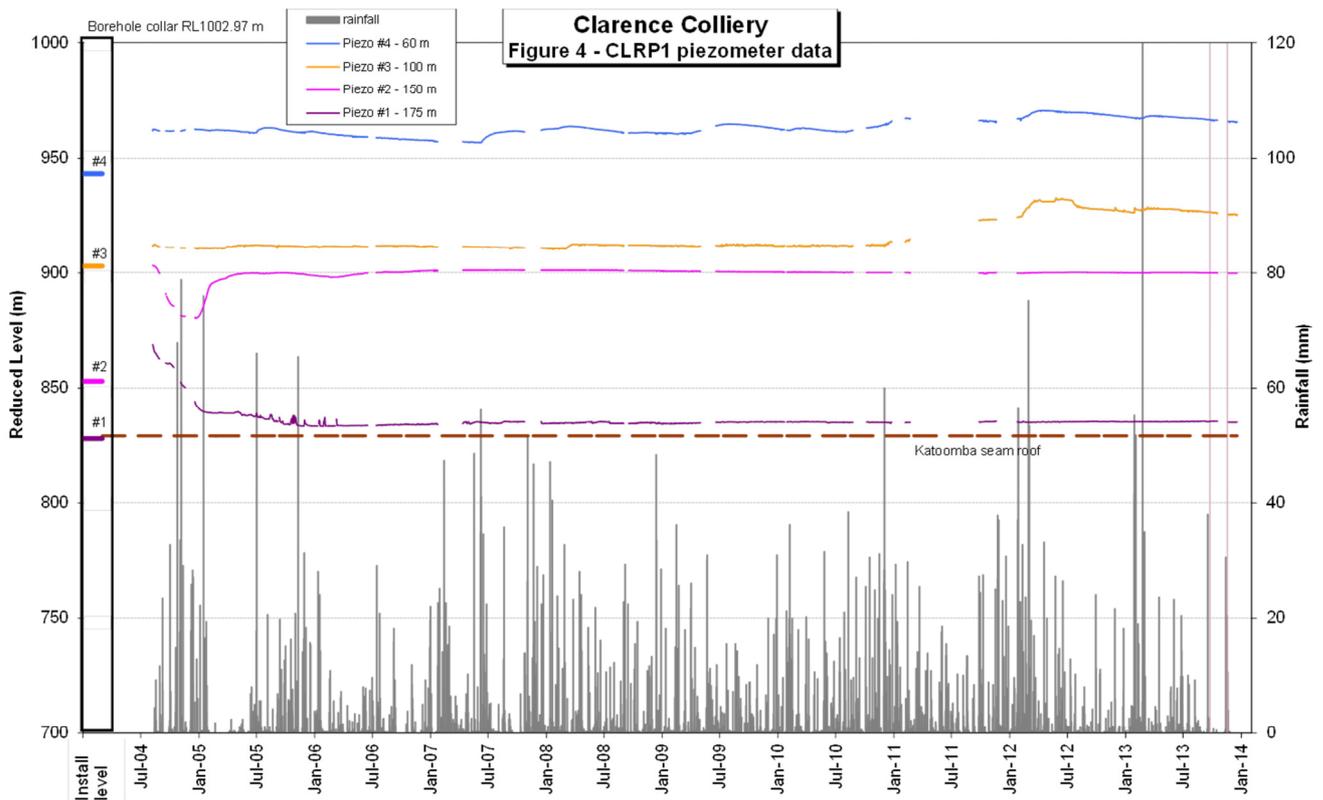
As noted previously, pillar removal was carried out in Panel 330 immediately to the north of this bore in late 2004. This resulted in a significant depressurisation of the Katoomba seam, as measured by piezometer 1. In December 2013, first workings in panel 803 were developed over 10km to the east. There was no evidence of any permanent mining-related impacts in the three piezometers higher up in the bore (including the two in the Banks Wall Sandstone), although piezometer 2 just above the roof of the seam did show partial depressurisation followed by near-complete recovery. Since that time there have been no further indications from the data recorded to the present of any mining-related impacts.

Figure 31. CLRP1 Piezometric Height

Monitoring results for piezometric height at CLRP1 is presented in **Figure 31**.

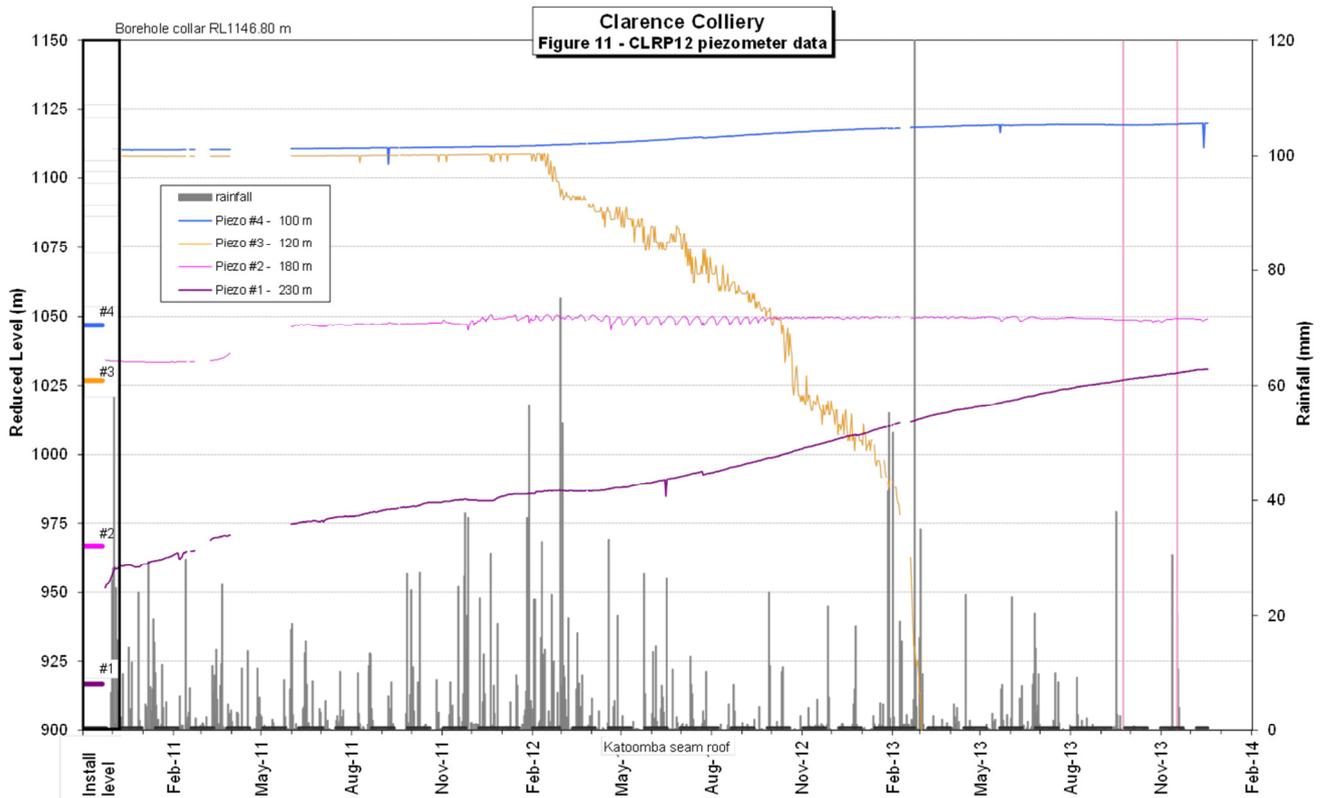
First workings and pillar extraction occurred in Panel 716 during July – August 2013, over 800 m to the east-southeast of CLRP12. Given the unreliable nature of most of the data, it is hard to identify any mining impact. However, pressure trends in the uppermost piezometer are unchanged, and it is clear that mining is having no impact on the near-surface unconfined aquifer. Monitoring results for Piezometric height at CLRP12 is presented in **Figure 38**.

Figure 38. CLRP12 Piezometric Height

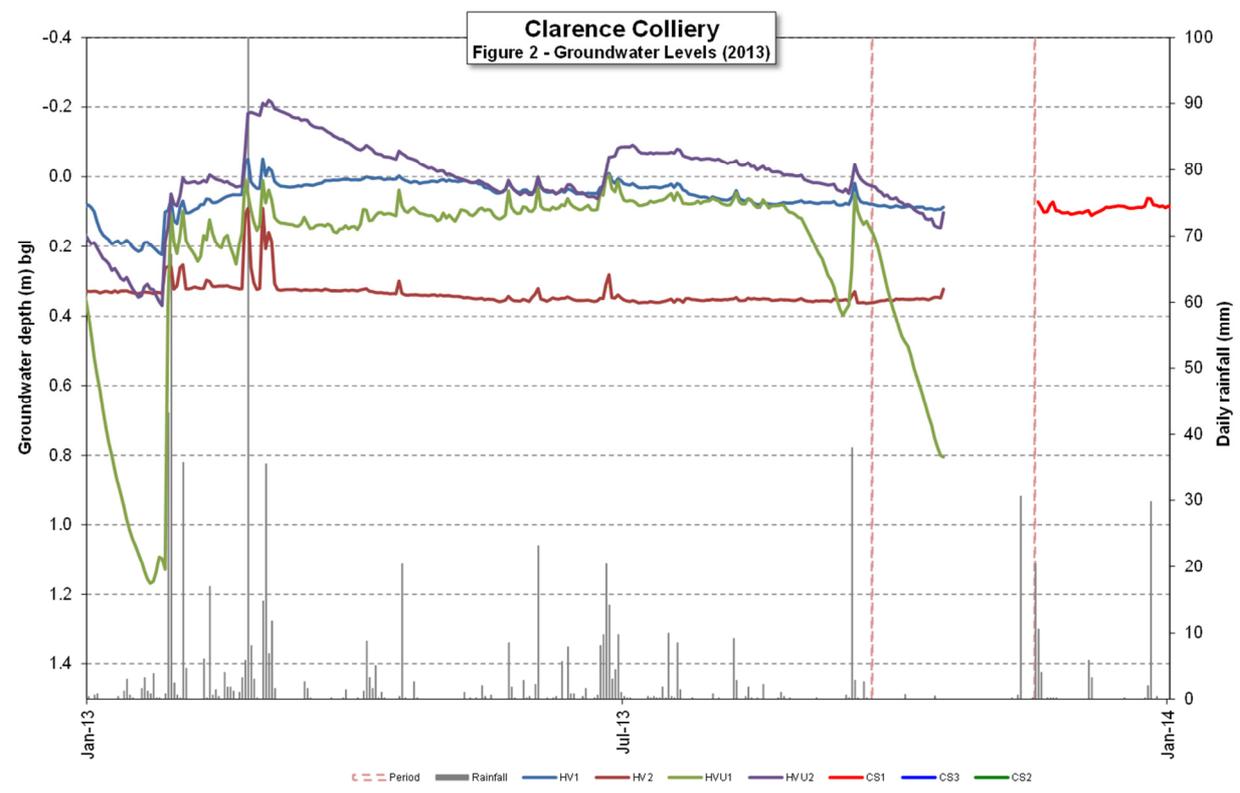
There is no evidence from the data of any impact on the groundwater levels in the swamp that could be attributed to the mining. Continuing monitoring shows groundwater level behaviour that is typical for these swamps in areas that have not been undermined. Changes in the measured groundwater levels appear to be due solely to prevailing weather conditions.

Figure 42. HV1, HV2, HVU1 and HVU2 Piezometric Height

Monitoring results for piezometric height at HV1, HV2, HVU1 and HVU2 is presented in **Figure 42**.

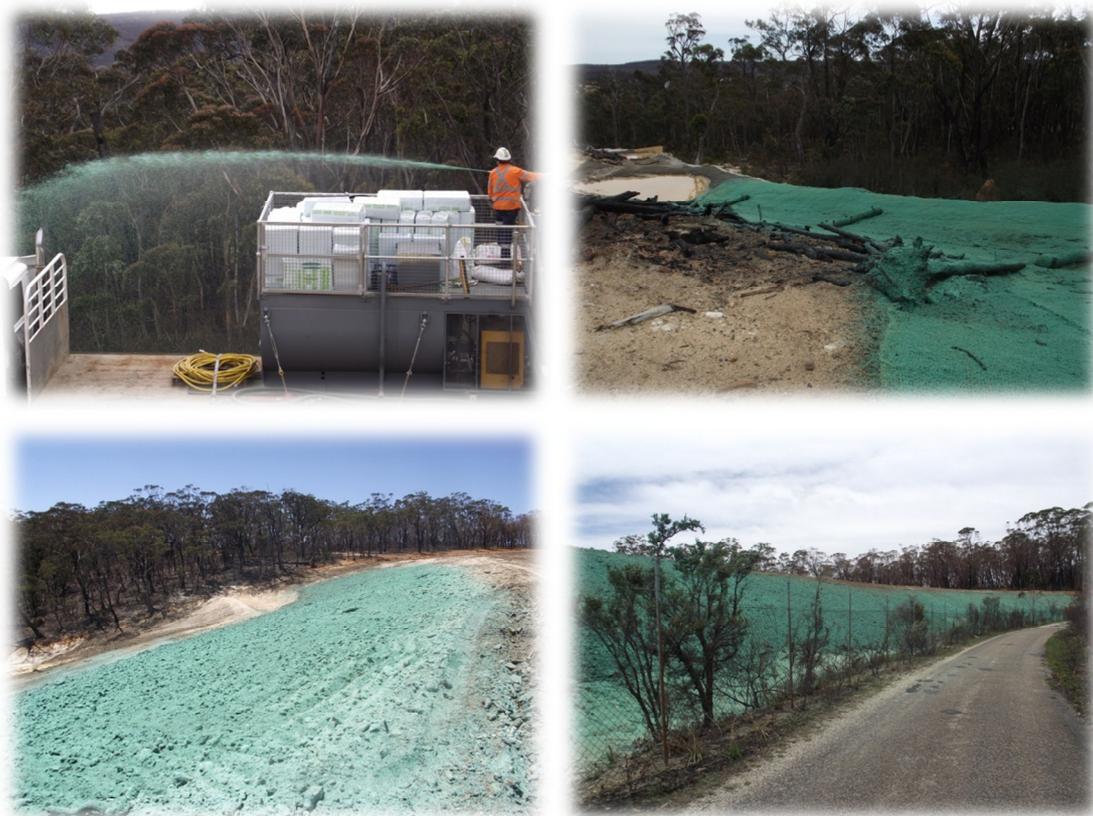
Figure 52. Rehabilitation Progress and Seed Spraying of REA IV in 2013

vegetation Subsoil was applied at 0.5m in depth and covered with 100mm of topsoil. Upstream sediment controls were installed in the rehabilitated areas in the form of sediment dams (add and refer to photo) and lined run-off control drains installed. The area was seeded by spray application of a sterile cover crop, native seed collected from site, fertiliser and a binding agent (**Figure 52**). EFA will be employed to monitor the progress of rehabilitation and track against analogue sites to ensure the final meets the requirements set out in Clarence's Mine Closure and Rehabilitation Plan.

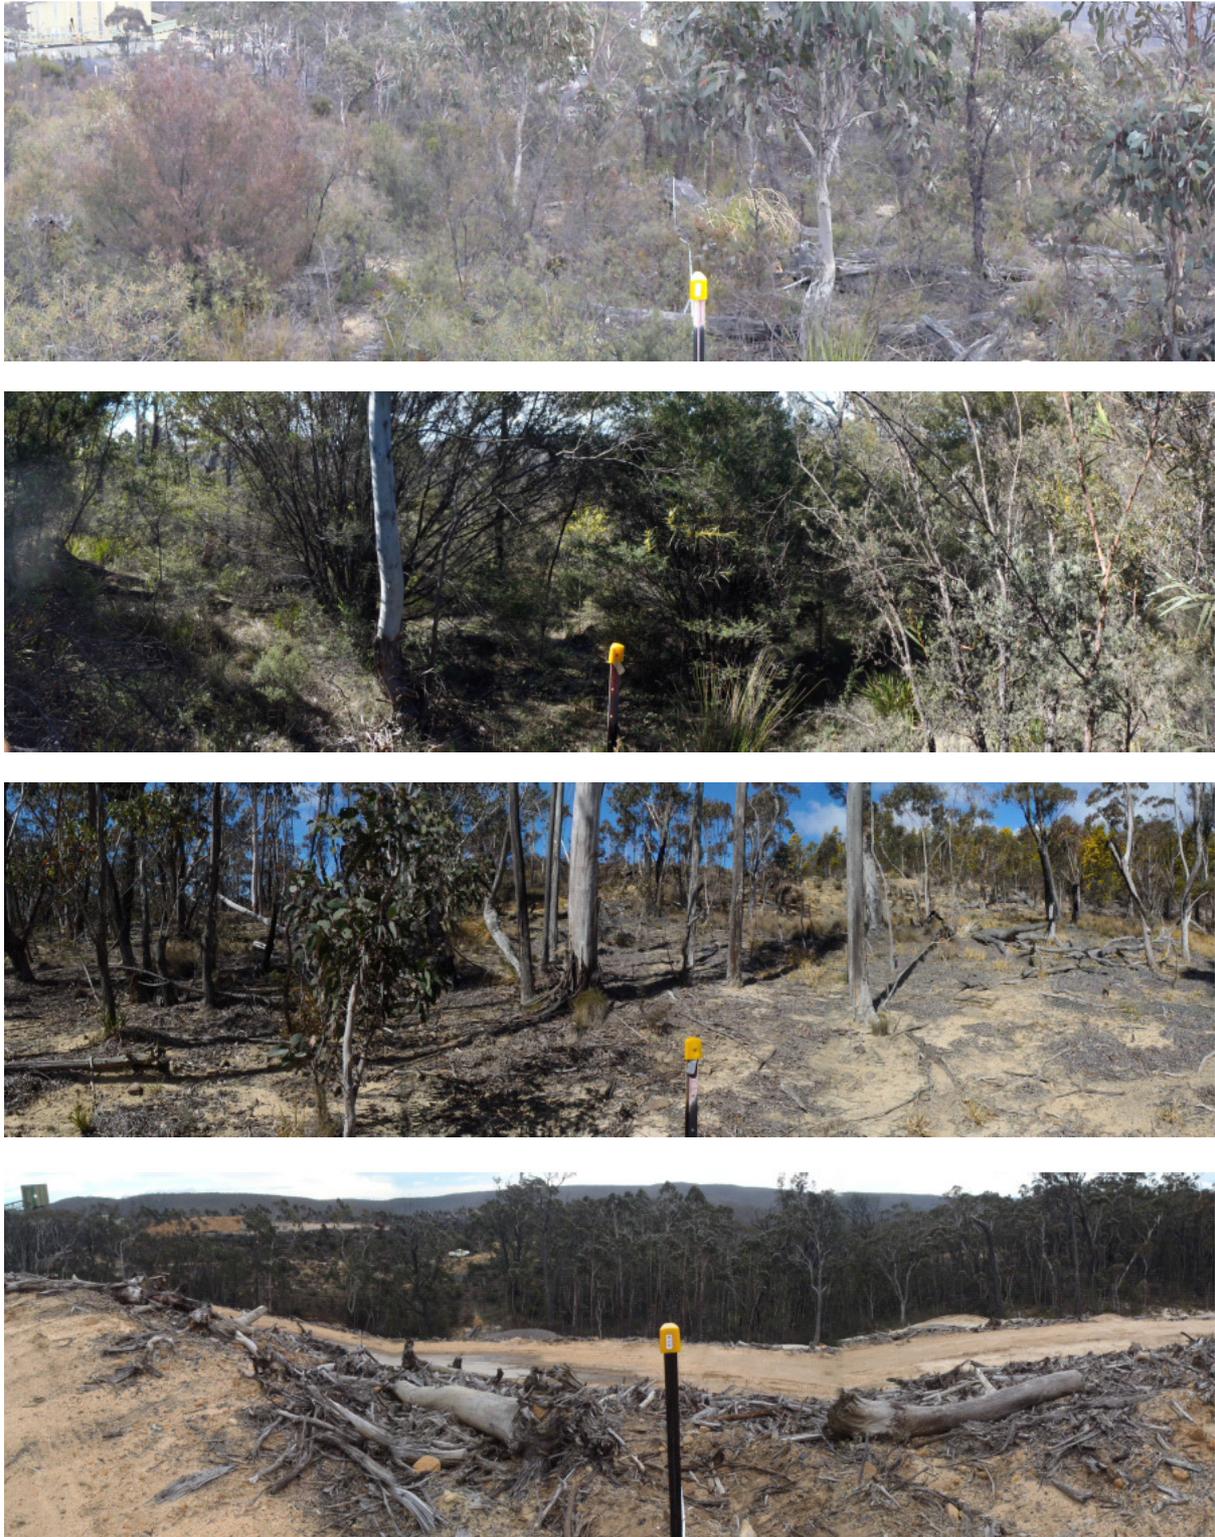
Figure 53. Rehabilitation Transects - REA I, II, III and IV

The monitoring program currently includes seven transects, comprising four transects in rehabilitated areas and three analogue transects (**Table 27, Figure 53 and Figure 54**).

Transect	Type	Location	Rehabilitation Works Completion
Transect 1	Rehabilitation	REA I	2002
Transect 2	Rehabilitation	REA II	1996
Transect 3	Rehabilitation	REA III	2002
Transect 4	Analogue	South-east of Transect 2	NA
Transect 5	Analogue	Directly downslope of Transect 3	NA
Transect 6	Analogue	North-west of Transect 3	NA
New Transect (2013)	Rehabilitation	REA IV	2012
