Charbon Coal Environmental Monitoring Data

November 2018

This report summarises environmental monitoring results for Charbon Colliery for the period of November 2018.

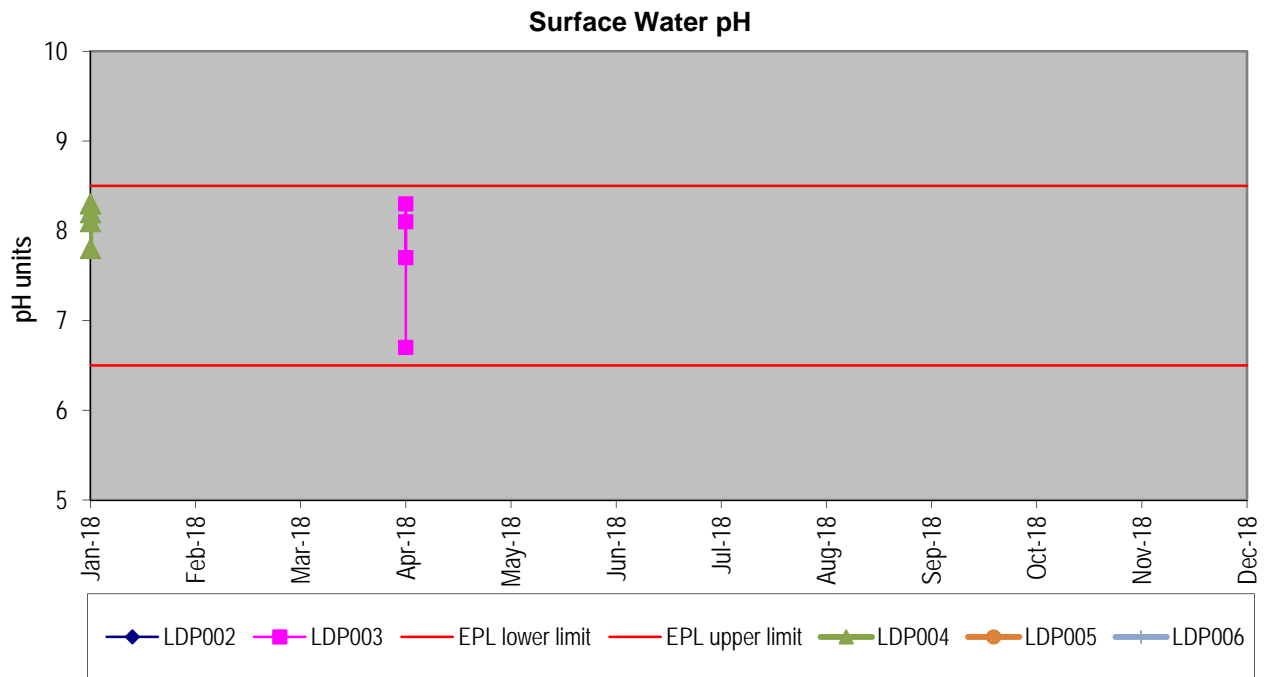
Figure 1 – Surface Water pH Results

Figures 1 - 5 below show a summary of the surface water monitoring results from January to December 2018 for LDP002, LDP003, LDP004, LDP005 and LDP006.

There were no discharges of water from licensed discharge points during the reporting period.

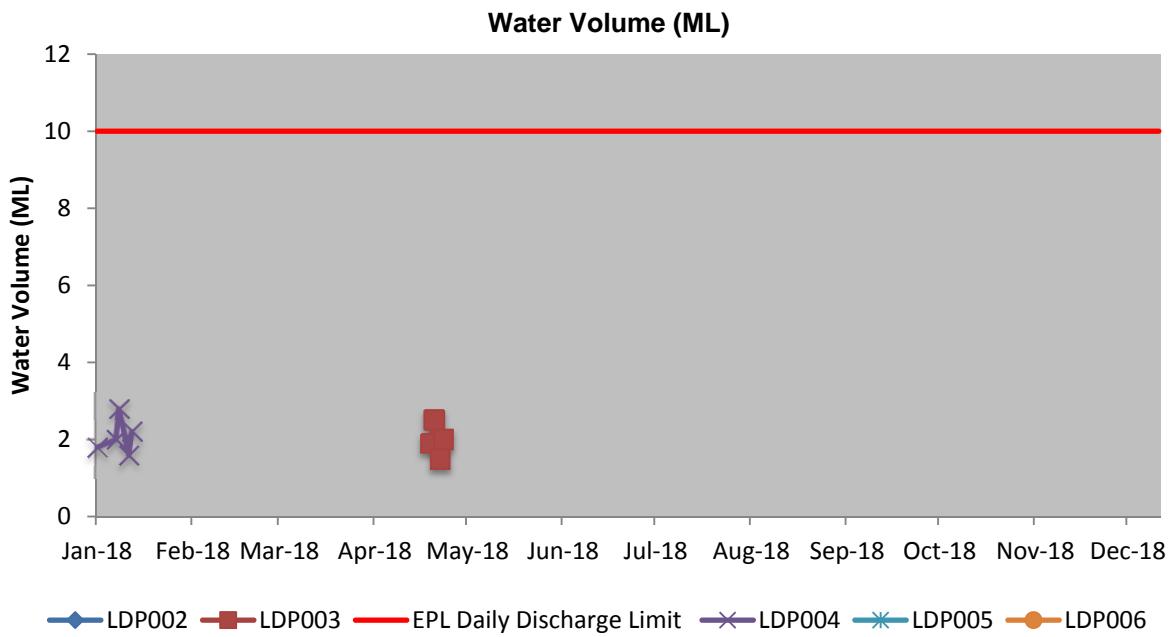
Figure 6 – Discharged Water Volume (ML) 2018

The volume of water discharged off site is measured through licensed discharge points (LDPs). EPL 528 sets limits on the maximum volume of water to be discharged for a given period. There were no discharges of water from licensed discharge points during the reporting period.

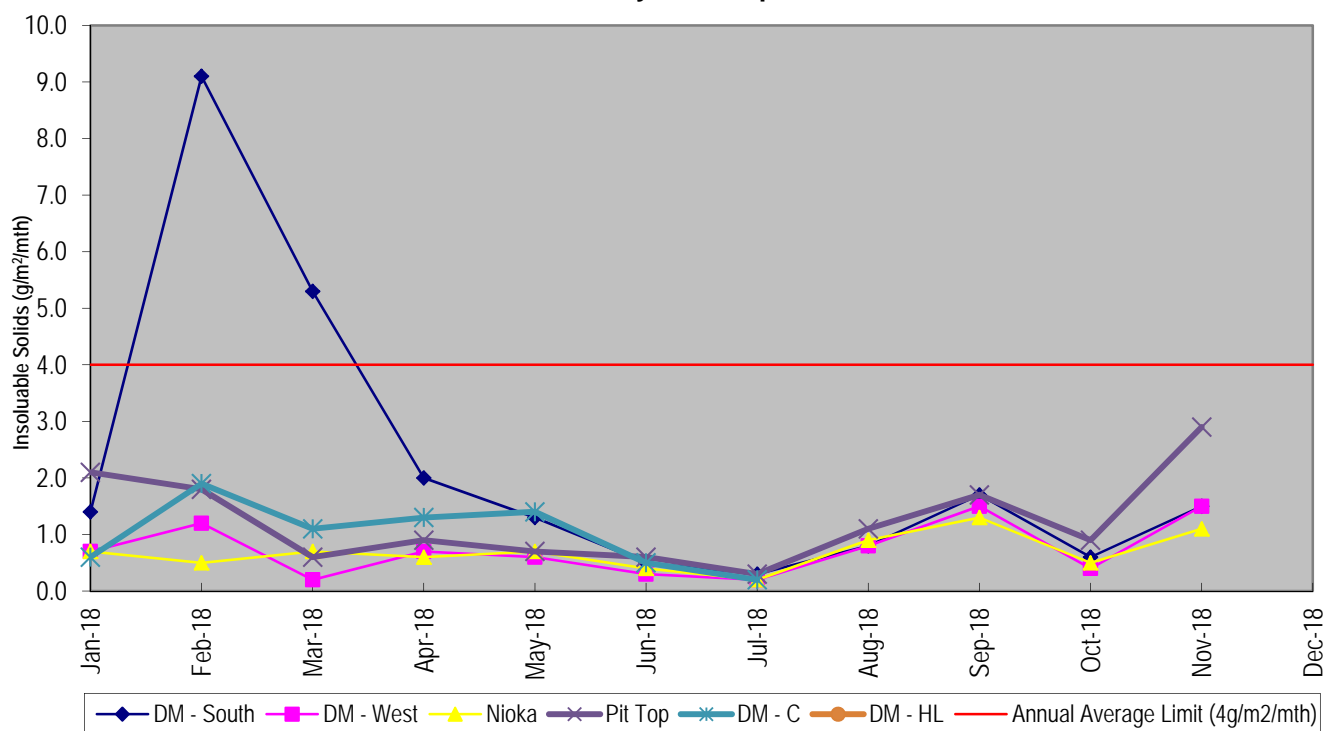
Figure 7 – Monthly Depositional Dust 2018

Depositional dust (g/m²/mth) results (insoluble solids) for the reporting period are shown in Table 3. Monthly depositional dust (g/m²/mth) results for January to December 2018 are shown graphically in Figure 7.

Depositional dust gauge (DDG) monitoring data indicated that dust deposition results for November 2018 ranged from 1.1 g/m²/mth to 2.9 g/m²/mth. EPL 528 does not include a license limit for depositional dust; however, a maximum total deposited dust level of 4 g/m²/mth and a maximum increase in deposited dust level (2 g/m²/mth) is set by conditions included in Charbon's Project Approval. The depositional dust levels complied with the limits prescribed in the Project Approval during the reporting period.

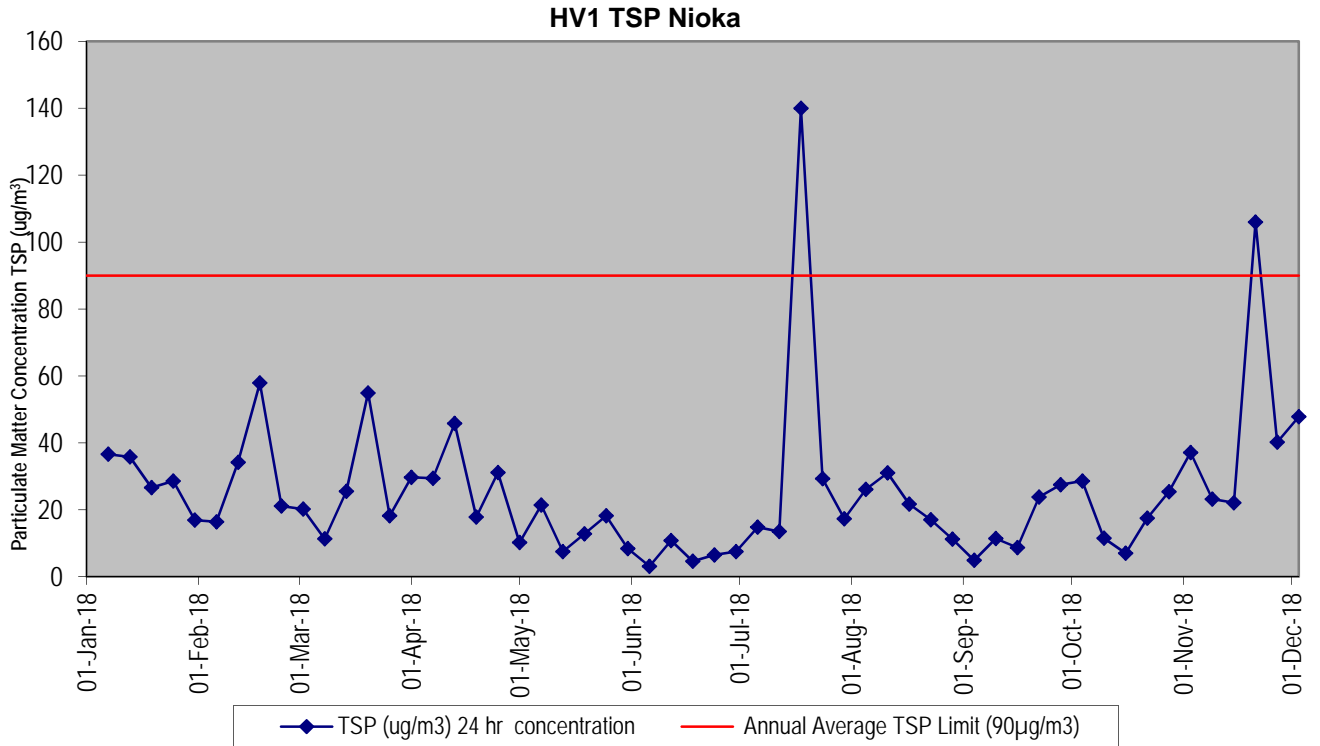
Figure 8 – HVAS TSP Nioka

High volume air samplers monitored Particulate Matter (PM) concentrations (less than 10 micrometres in size) and Total Suspended Particulates (TSP) during the reporting period. A summary of monitoring results is provided in Table 4 and Table 5 and shown graphically in Figure 8 and Figure 9, below.

In accordance with Condition 19 of Schedule 3 in Project Approval 08_0211, TSP have an annual average limit of 90 µg/m³, whilst particulate matter less than PM₁₀ have a 24 hour limit of 50 µg/m³ and an annual average limit of 30 µg/m³. Although a result of 106 µg/m³ for TSP was recorded on the 21st November 2018, the annual average TSP level of 25.6 µg/m³ remained below the annual average limit for TSP during the reporting period. However, whilst a result of 73.8 µg/m³ for PM₁₀ was recorded on the 21st November 2018 and the annual average PM₁₀ level of 15.2 µg/m³ remained below the annual average limit for PM₁₀ during the reporting period, the result did exceed the 24 hour limit of 50 µg/m³ for PM₁₀. The monitoring result for the 21st November 2018 was recorded on a day when a regional dust event was reported in the media.

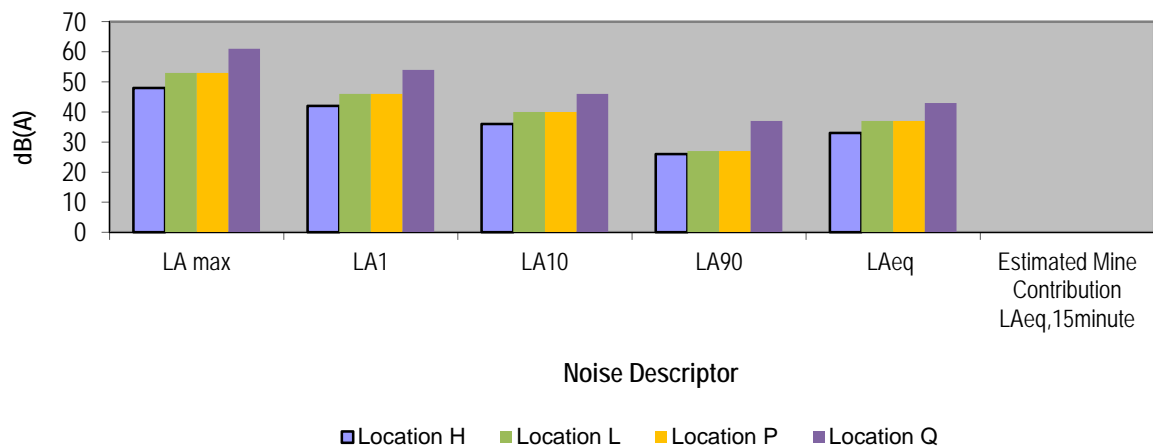
Figure 10 – August Day Noise Monitoring

The noise monitoring comprises of operator attended monitoring in 15 minute intervals coinciding with day, evening and night periods. Statistical indices recorded include L_{Amax}, L_{A1}, L_{A10}, L_{A90} and L_{Aeq}. The results of noise monitoring conducted on the 23rd of August 2018 can be seen in Tables 6, 7 and 8 and shown graphically in Figures 10, 11 and 12 below. All locations at all times were compliant with the conditions in the Project Approval. The location of the focus receptors is provided in Figure 14 in Appendix 1.

Day Noise Monitoring, Charbon Colliery, 23/08/2018

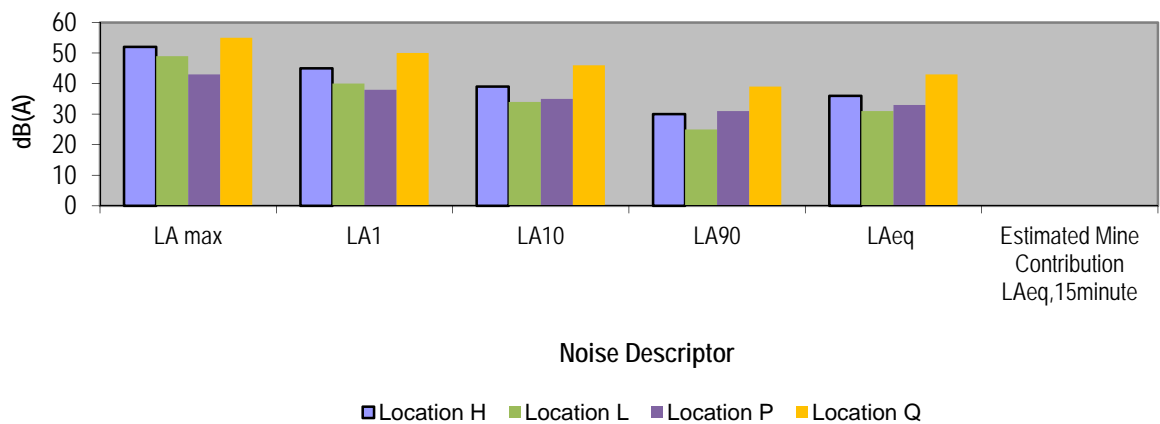
Figure 11 – August Evening Noise Monitoring

Evening Noise Monitoring, Charbon Colliery, 23/08/2018

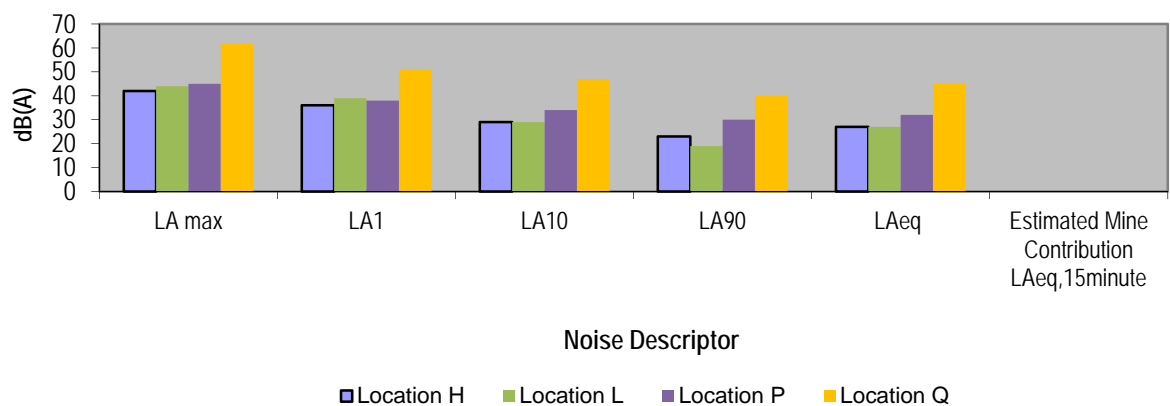
Figure 12 – August Night Noise Monitoring

Night Noise Monitoring, Charbon Colliery, 23/08/2018

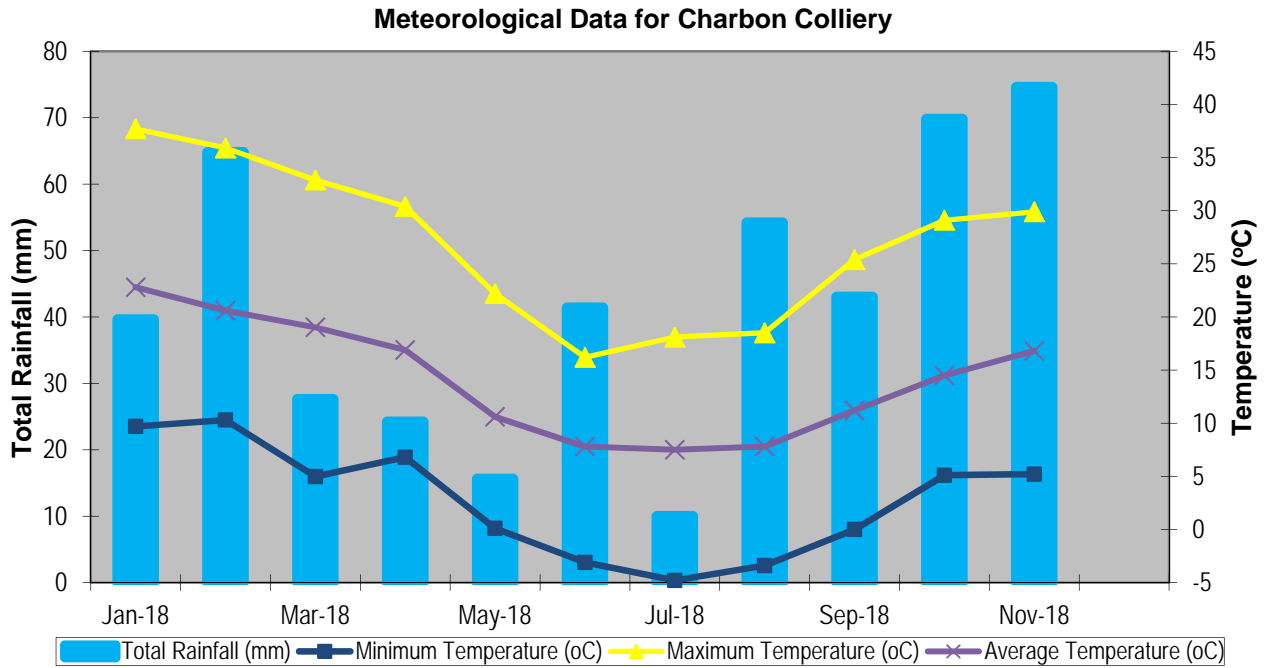
Figure 13 – Charbon Colliery Meteorological Data

A summary of temperature and rainfall data recorded at the on-site meteorological monitoring station during the reporting period is shown in Table 10 below, and graphically in Figure 13.
