Springvale Coal Services and Lamberts Gully Open Cut

2011 ANNUAL ENVIRONMENTAL MANAGEMENT REPORT

January 2011 – December 2011

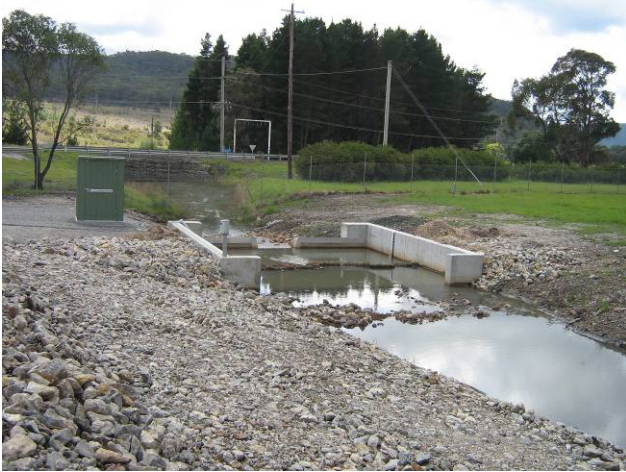
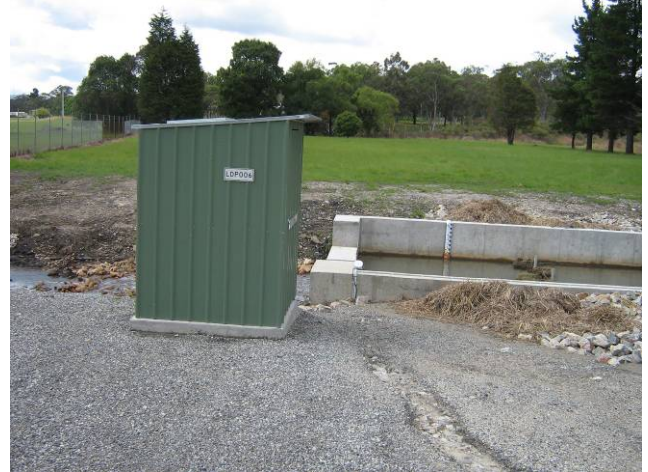
Photo 2 and 3: LDP006 was upgraded LDP006

An upgrade was completed to the LDP006 weir during the reporting period. The upgrade included the construction of a new concrete weir, gabion mattress and installation of a new flow monitoring system. **Photo 2 and 3** illustrates upgrade to LDP006.

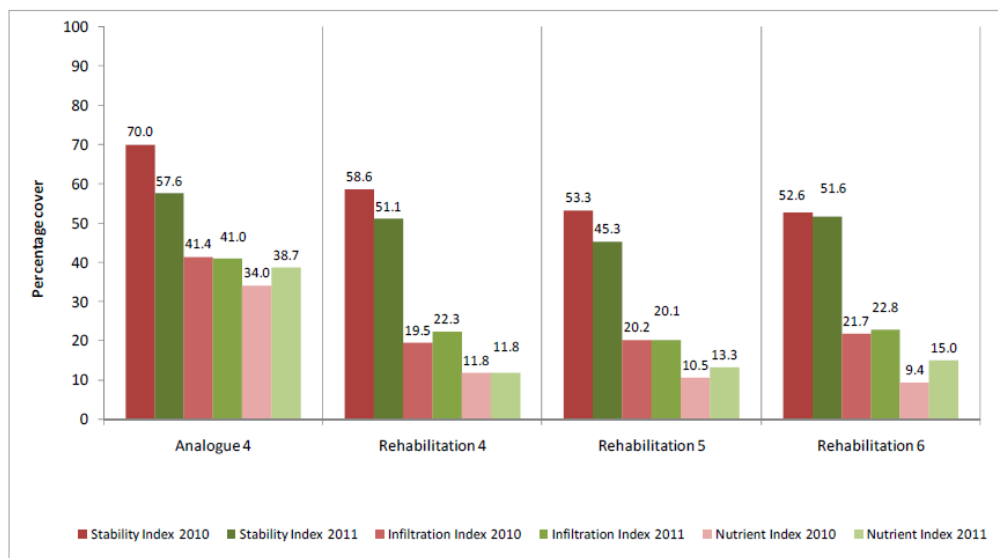
Figure 1: LFA: Soil Surface Condition Assessment – Lamberts Gully

The landscape organization index value recorded in 2011 is consistent with that recorded in 2010 for Analogue 4. The ground surface consisted of approximately 70% leaf litter, whilst the remaining 30% was made up of small clumps of grass and vegetative debris such as sticks and branches. The high amount of vegetative material and absence of bare ground also contributes to the relatively consistent stability, infiltration and nutrient index values at this transect over the past two years.

Landscape organization index values recorded over the past two years are consistently low for rehabilitation transects 4, 5 and 6. The low values achieved suggest that the distribution of ground cover and other deposited material is irregular and fails to adequately capture resources such as water and nutrients in a sustainable fashion. In 2011 the percentage of bare ground present was 93%, 71% and 88% at rehabilitation transect 4, 5 and 6 respectively. All sites contained at a maximum <10% leaf litter and <15% grass over the past two years.

Stability, Infiltration and Nutrient Index values for each rehabilitation transect 4, 5 and 6 in 2011 are comparable to values recorded in 2010.

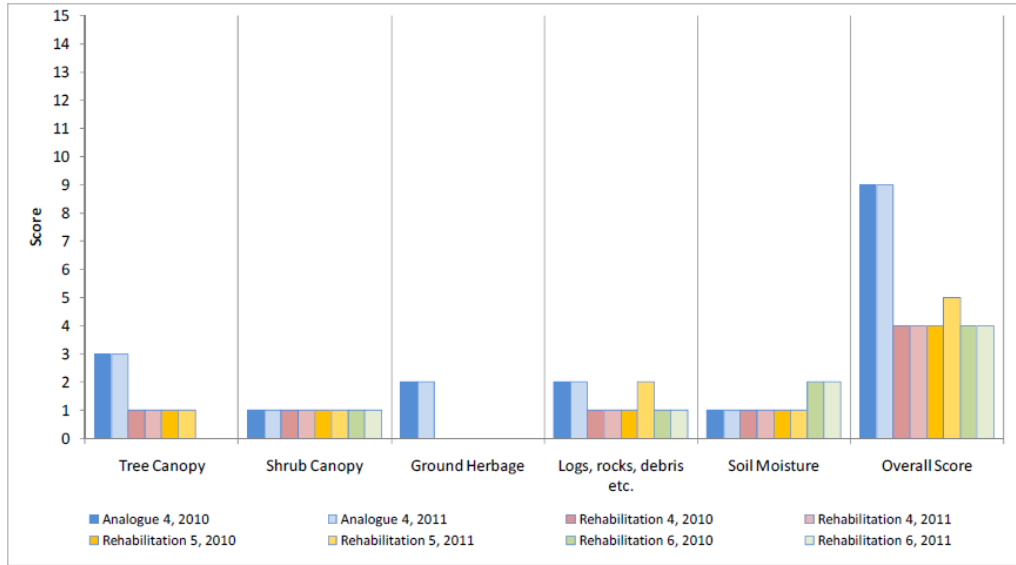
Figure 2: Habitat Complexity Score – Lamberts Gully

Habitat complexity scores were consistent across the 2010 and 2011 reporting periods. The presence of feral animals remains an influence of disturbance at Analogue 4 (scats observed in 2011).

Habitat complexity scores were consistent across the 2010 and 2011 reporting periods. The increase in deposited material such as logs and branches observed at rehabilitation transect 5 resulted in a slight increase in 2011.

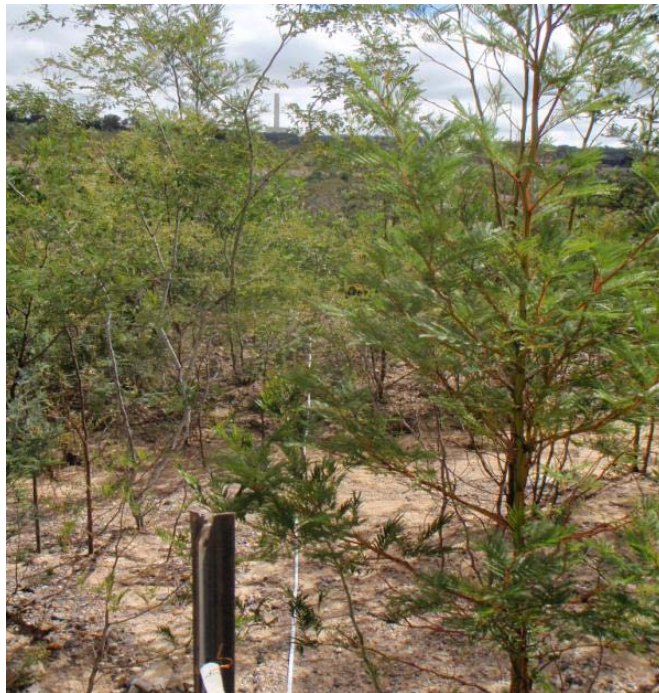
Photo 4: Rehabilitation Monitoring Location at Lamberts Gully

Permanent transects and associated photo reference sites were established in areas of post-mining rehabilitation and correspondingly in adjacent undisturbed areas to provide analogue/reference sites. The analogue sites are selected to represent as close as possible the slope, aspect and proposed vegetation characteristics of the revegetation areas. The analogue sites also provide data on the long-term goal for the revegetation area. 2010 was the first year of the EFA monitoring program.
