Centennial Coal

***Application to Allow Longwall
Mining Under Temperate Highland
Peat Swamps on Sandstone on the
Newnes Plateau***

Springvale Colliery

Information Request Regarding Application to Allow Longwall Mining Under Temperate Highland Peat Swamps on Sandstone on the Newnes Plateau (EPBC Approval 2011/5949)

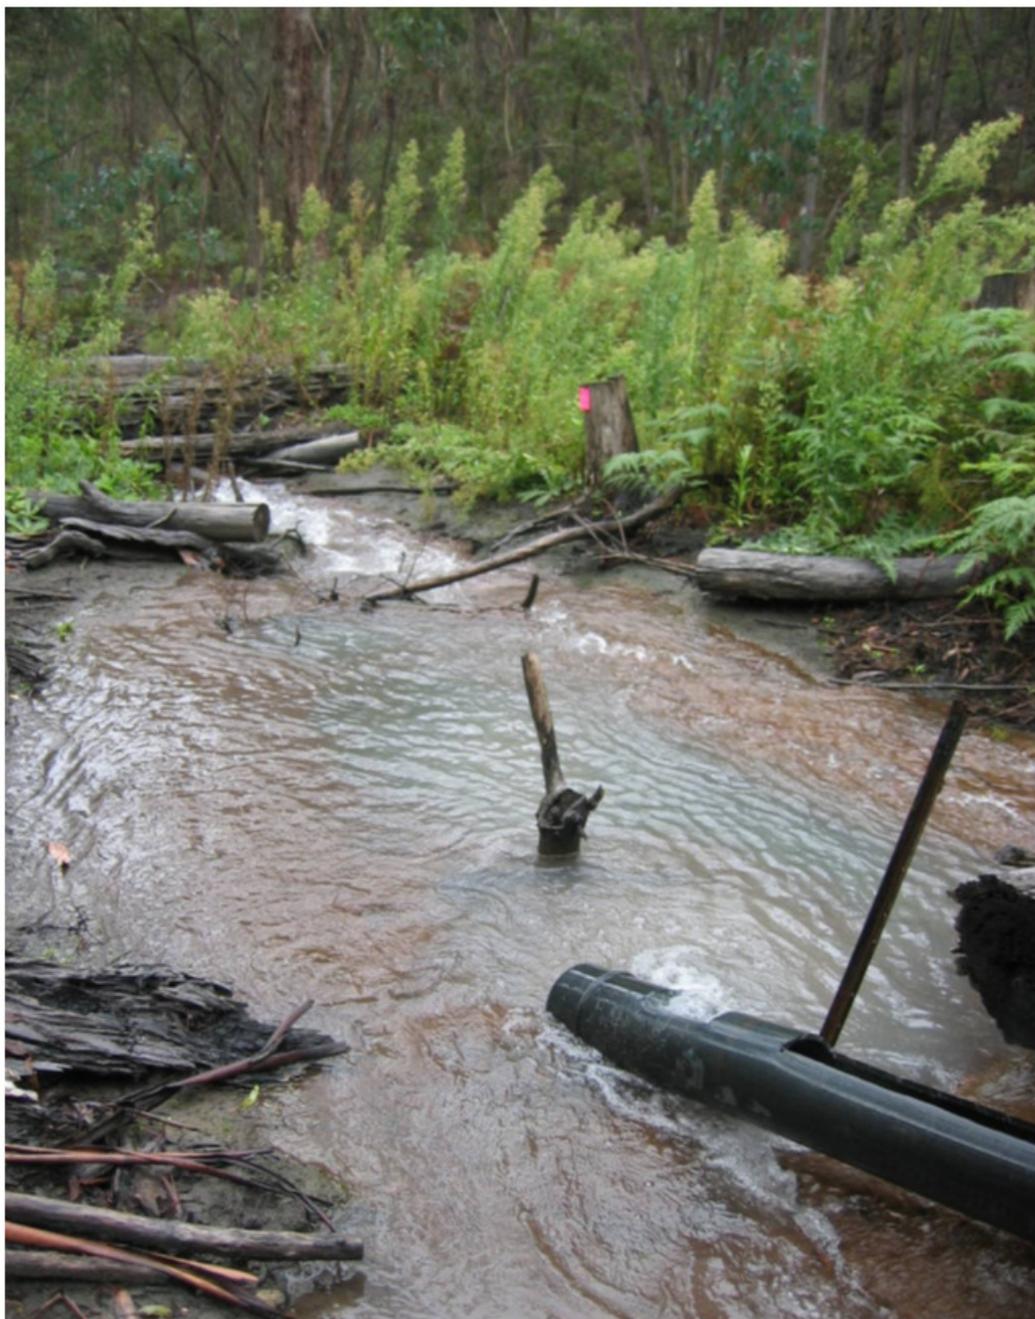
Figure 1.4 - LDP004 water discharge flow downstream 20 April 2009

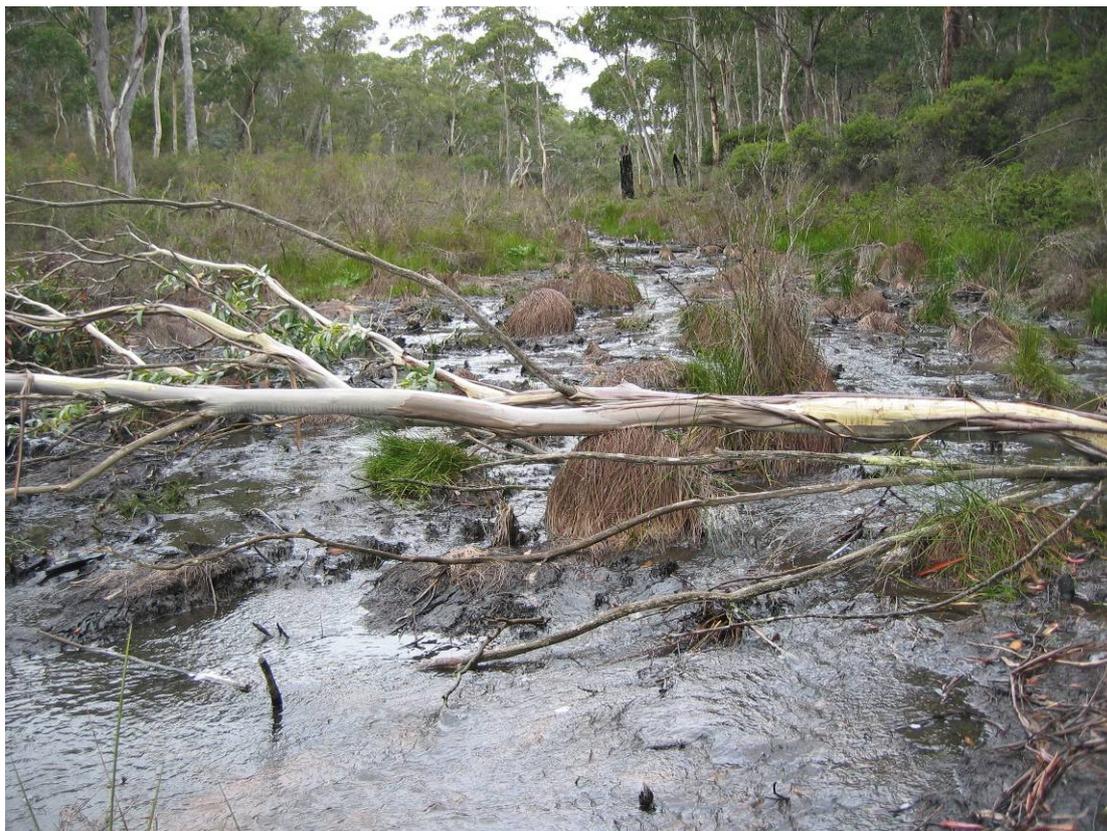
Figure 1.5-Location 10 Upstream of Southern Slumping Site During Mine Water Discharge 20/04/2009

This assessment was in terms of the upstream (Southern) slump area. As shown in Figure 1.11, there was no observed loss of surface water flows (mine water discharge) at this site with flows from upstream pooling of water at the slump location and continuing to flow downstream from the slump location with no apparent water loss.

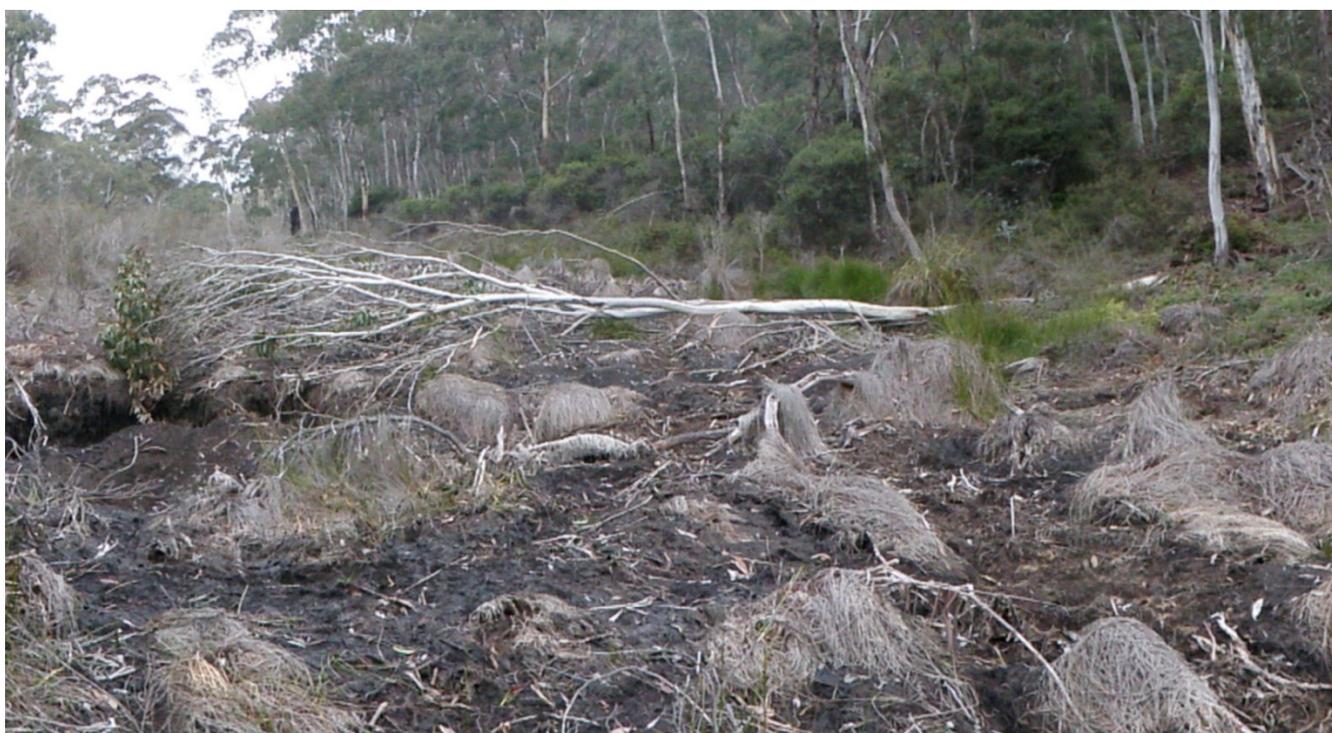
Figure 1.6 - Location 10 Upstream of Southern Slumping Site No Mine Water Discharge 17/06/2009

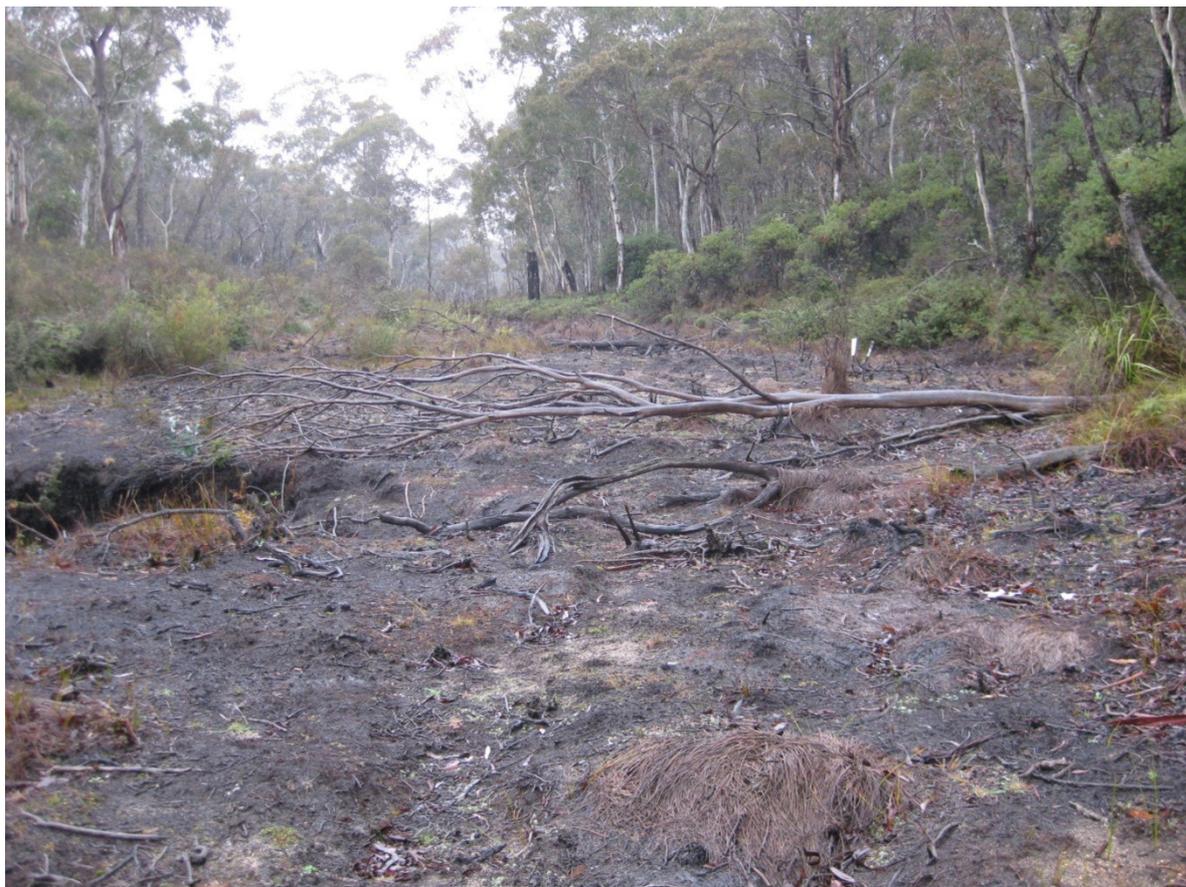
Figure 1.7 - Location 10 Upstream of Southern Slumping Site at 28/06/2013

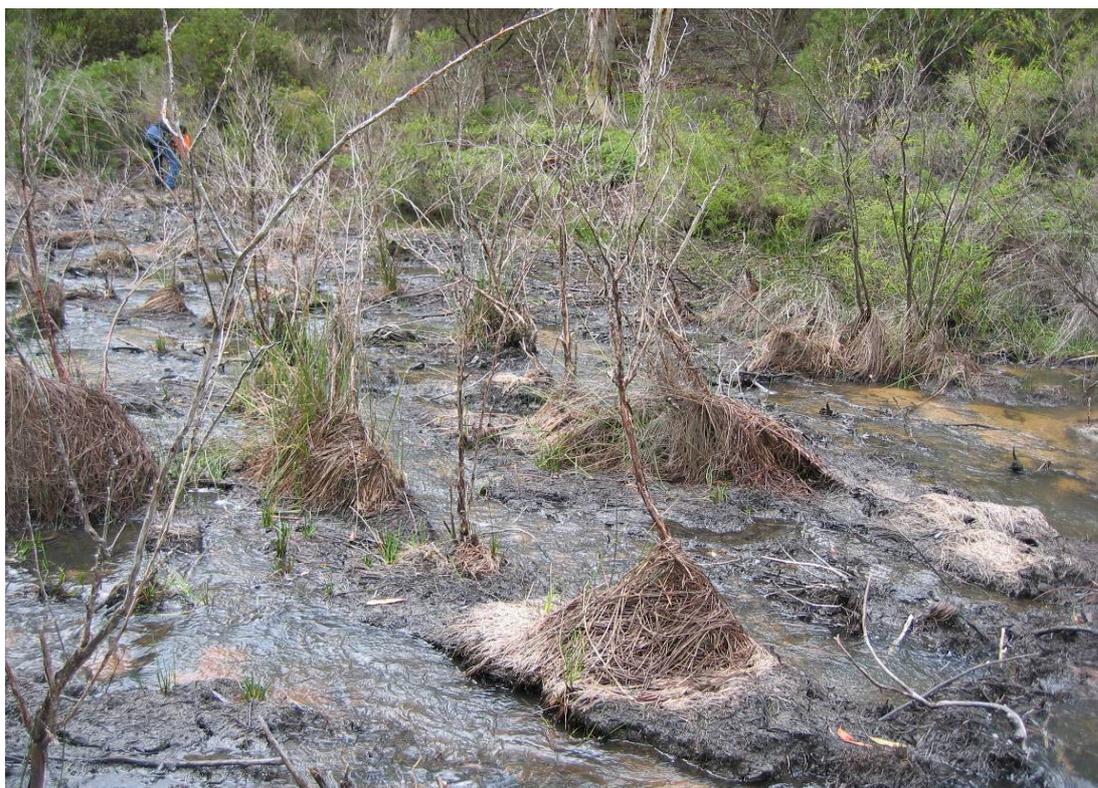
Figure 1.8 - East Wolgan Swamp at Location 1 on 20 April 2009 (during mine water discharge)

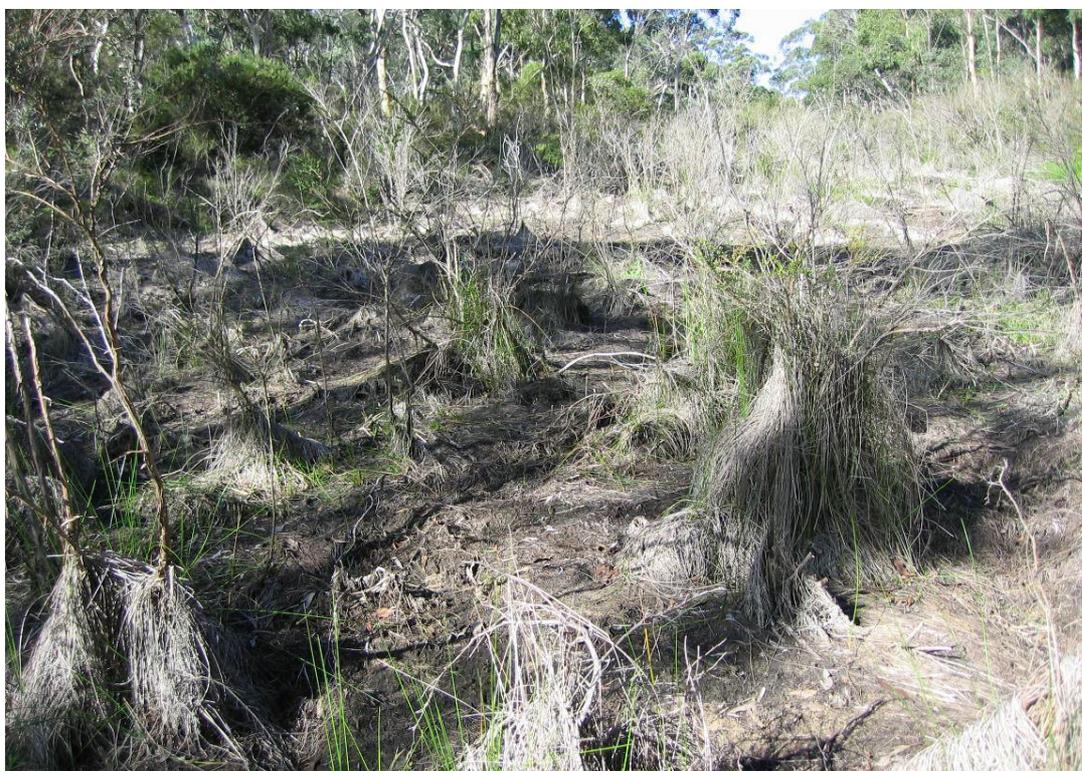
Figure 1.9 - East Wolgan Swamp at Location 1 on 17 June 2009 (no mine water discharge).

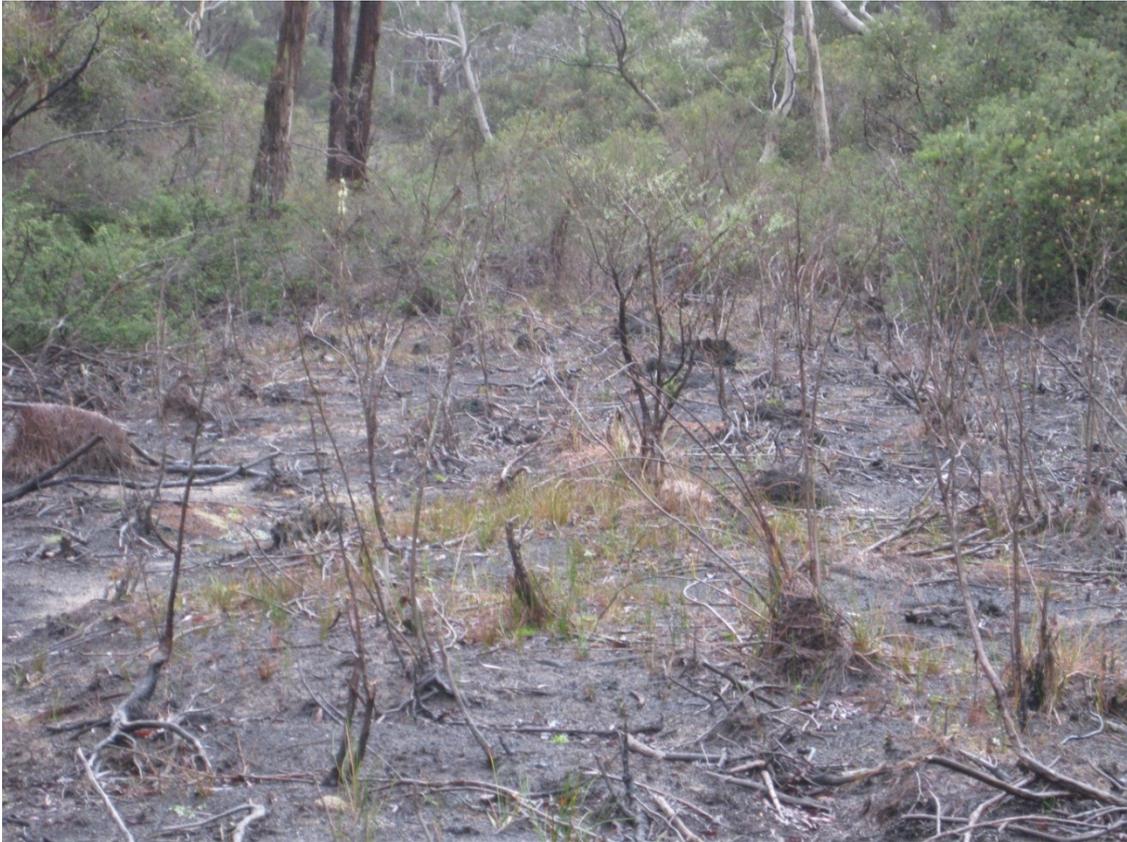
Figure 1.10 - East Wolgan Swamp at Location 1 on 28 June 2013 Upstream of Northern Slumping / Cavity Location Note: Vegetation Impacts

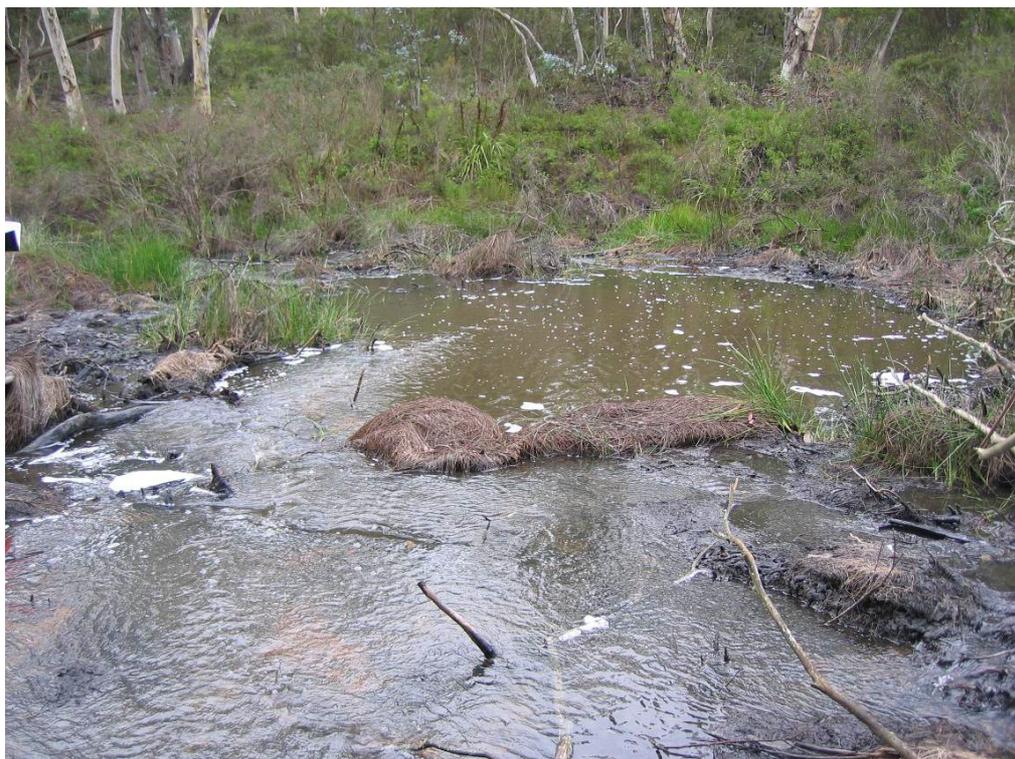
Figure 1.11 - Location 16 Southern Slumping Site During Mine Water Discharge on 20 April 2009
(No Obvious Water Loss - Upstream Flow Similar to Downstream Flow)

Figures 1.11 to 1.13 are photos taken at the Southern slumping location, showing the area during mine water discharge, soon after cessation of mine water discharge and at 28 June 2013 (three years post mine water discharges). Figure 1.11 shows inflow of water from upstream, pooling of water at the slump location and downstream flow of water from the slump location (with no apparent water loss). Figures 1.12 and 1.13 show the Southern slumping location following cessation of mine water flows and three years after cessation of mine water discharge. Minor erosional infilling is evident at the site, with very limited vegetation regrowth.

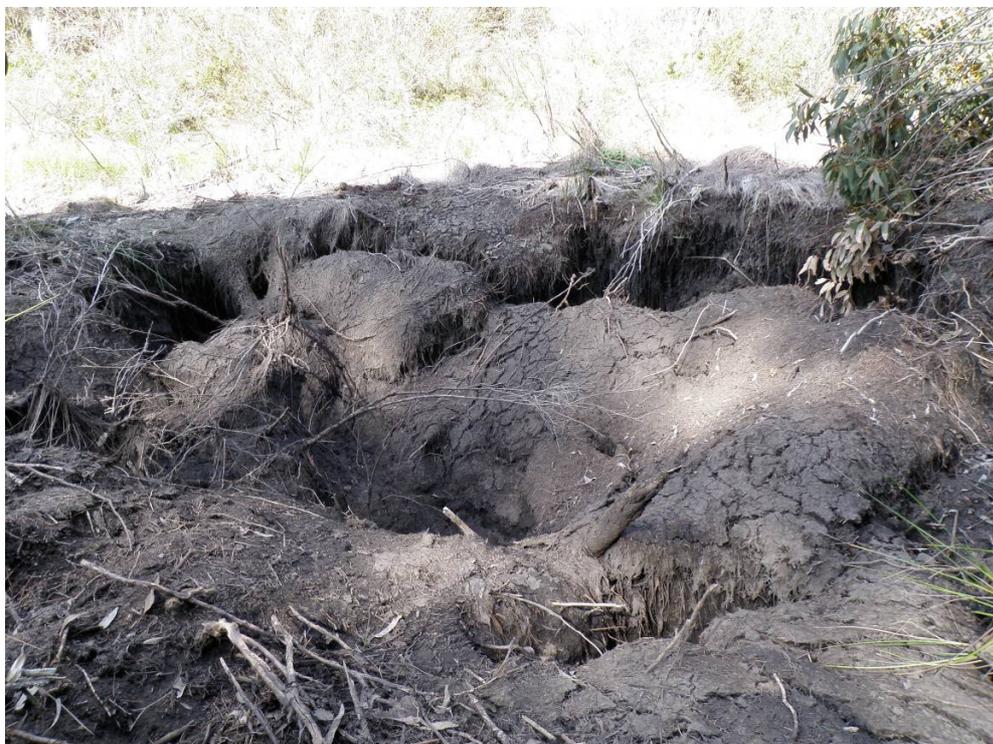
Figure 1.12 - Location 16 Southern Slumping Site - No Mine Water Discharge on 1 May 2009

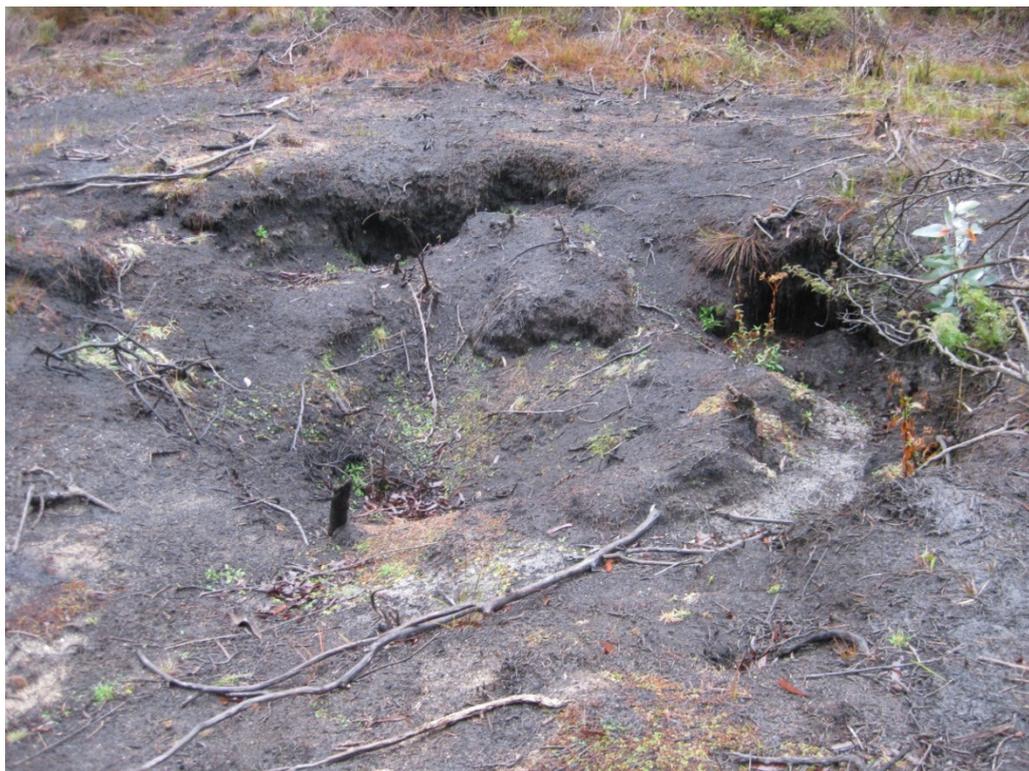
Figure 1.13 - Location 16 Southern Slumping Site - No Mine Water Discharge on 28 June 2013

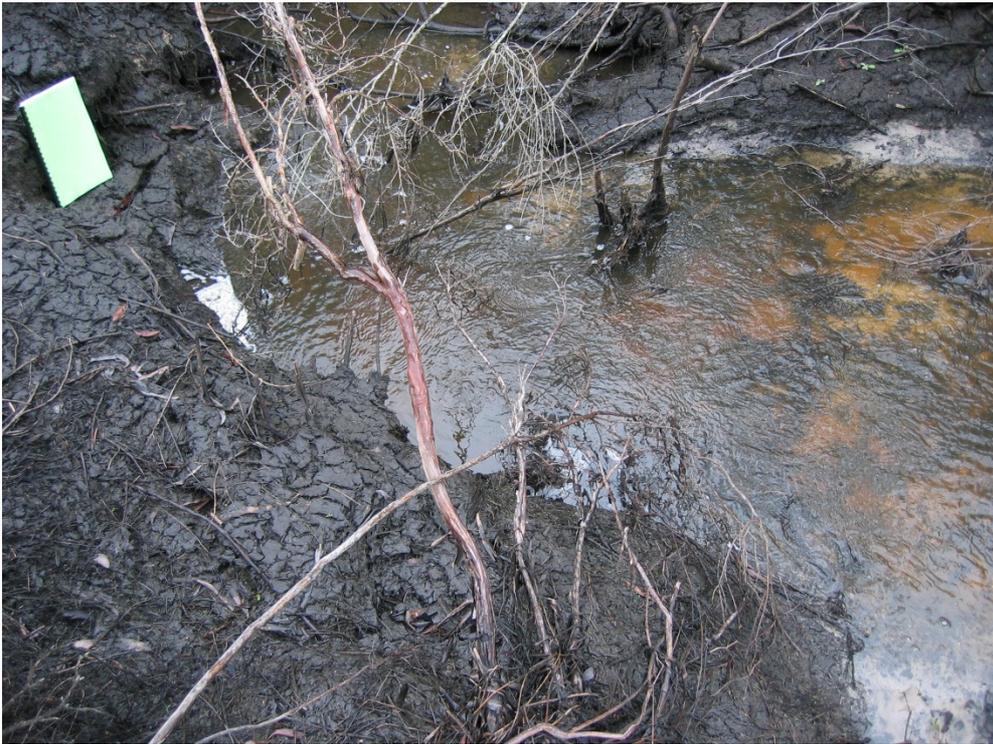
Figure 1.14 - Location 7-9 Northern Slumping and Cavity Site - During Mine Water Discharge on 20 April 2009 (Complete Water Loss -No Downstream Flow)

discharge and at 28 June 2013 (three years post mine water discharges). Figure 1.14 shows the area during mine water discharge, with complete water loss into the cavity and no downstream flow. Figure 1.15 shows the hole in the peat where water loss occurred (note limited area of hole). Figures 1.16 and 1.17 show the Northern slumping and cavity location following cessation of mine water flows and three years after cessation of mine water discharge. A significant erosional headcut is present in the swamp peat to the South of the original slumping location, which has progressed approximately five metres upstream in the period since the slumping was identified in 2009. Limited vegetation regrowth is evident. Rehabilitation of this site is required to prevent further erosion of the swamp peat.

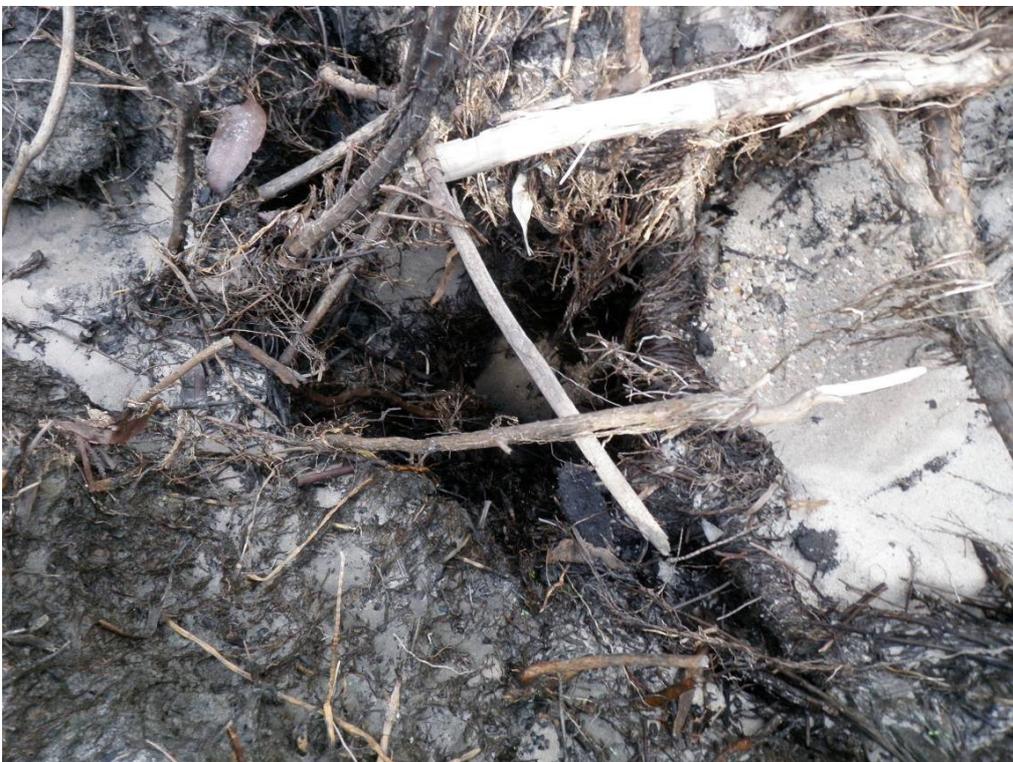
Figure 1.15 - Location 7-9 Northern Slumping and Cavity Site - No Mine Water Discharge on 1 May 2009 – Hole Where Water Loss Occurred

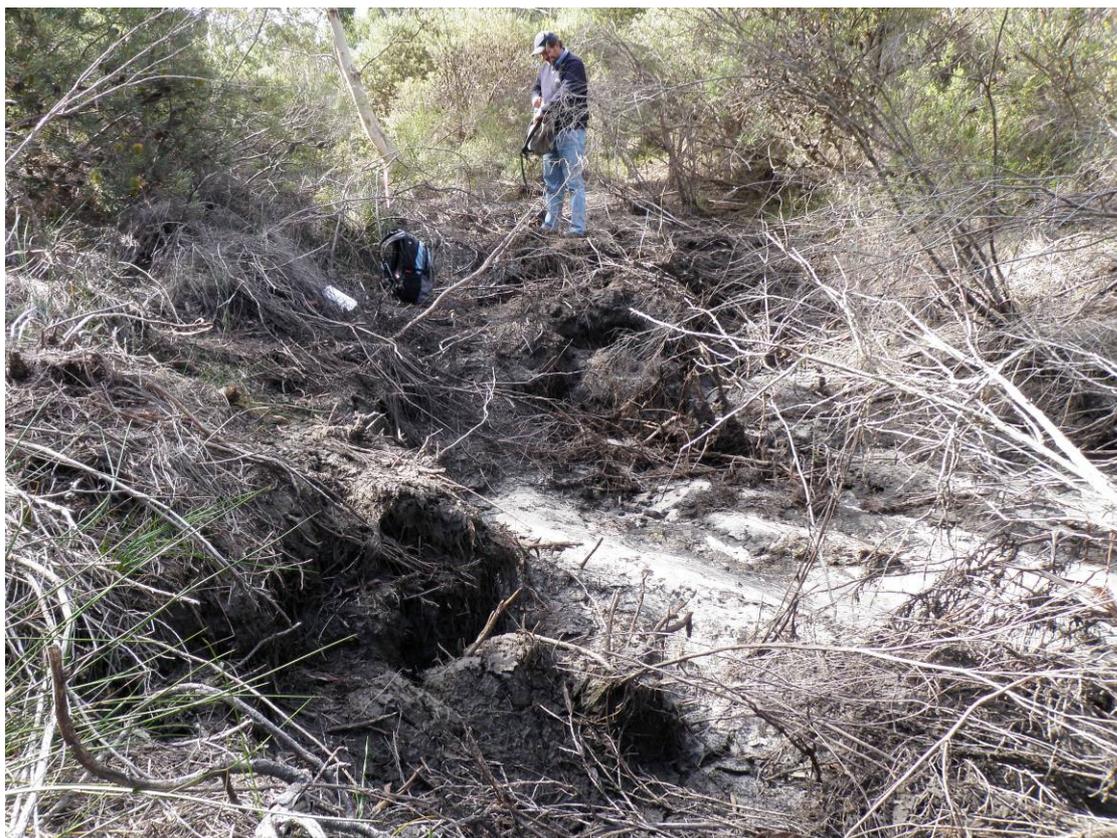
Figure 1.16 - Location 7-9 Northern Slumping Site - No Mine Water Discharge on 1 May 2009

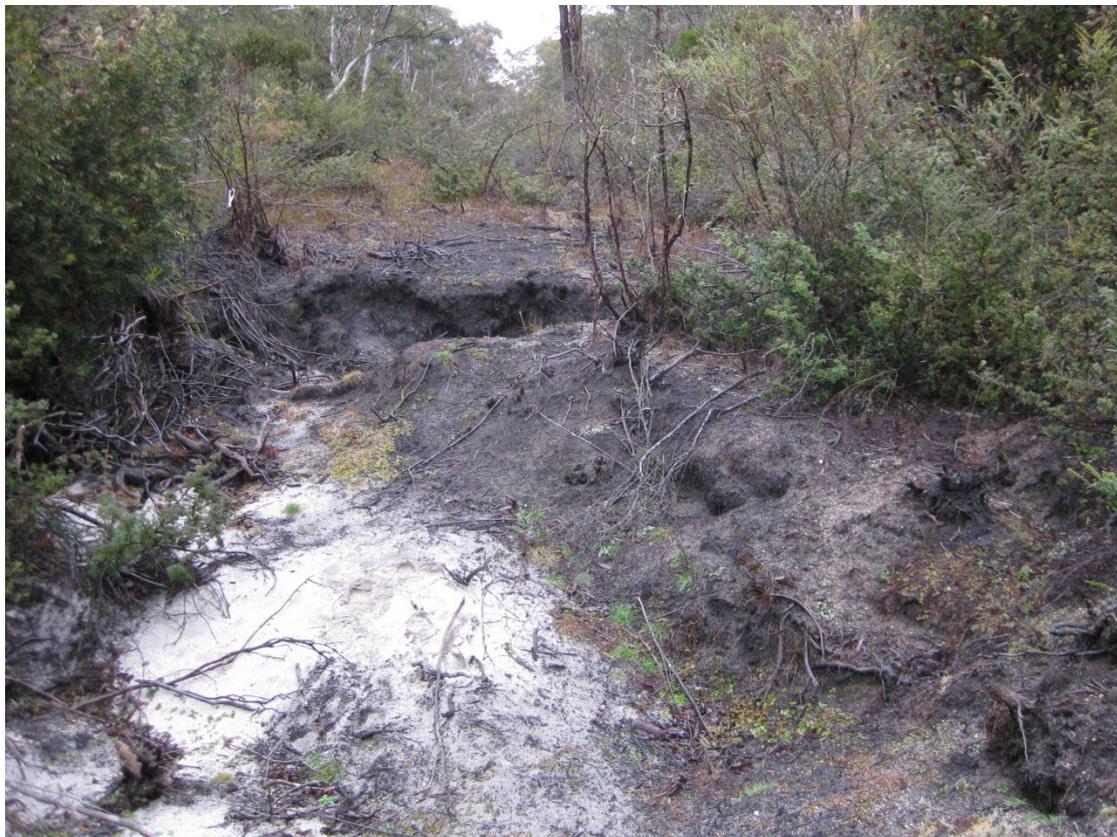
Figure 1.17 – Location 7-9 Northern Slumping Site on 28 June 2013 – note vegetation impacts

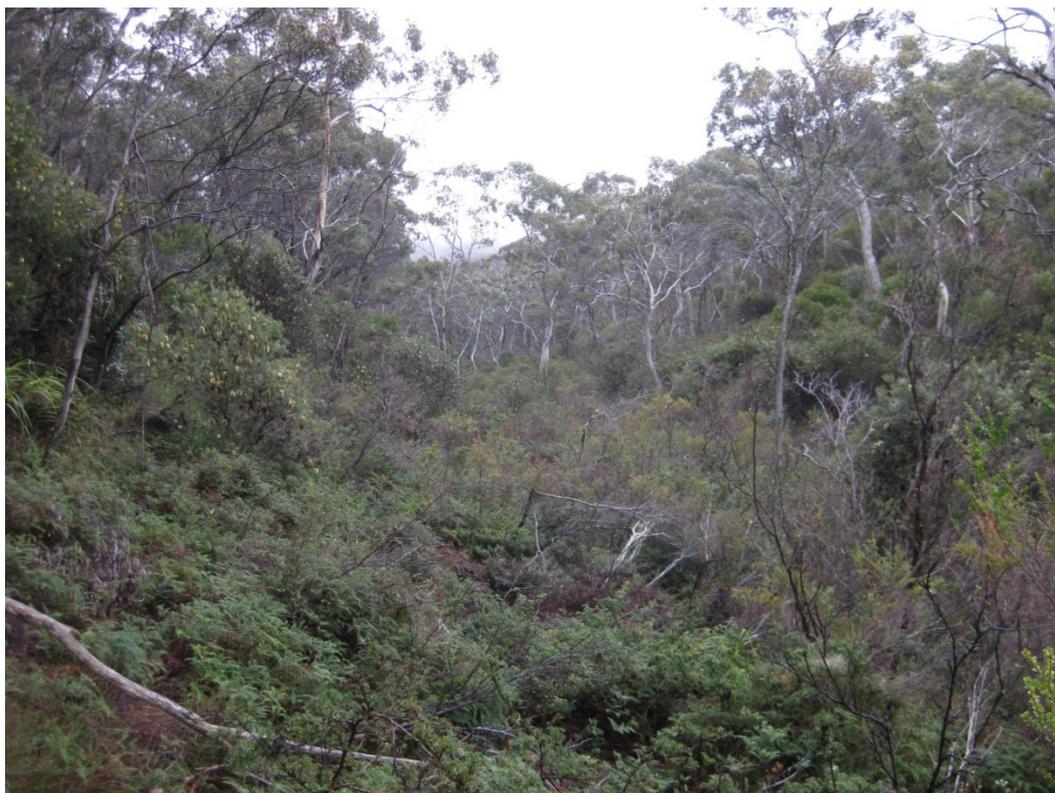
Figure 1.18 and 1.19 are photos taken immediately to the North (upstream) of the cavity location on 28 June 2013 (three years after mine water discharge). Figure 1.18 shows healthy swamp vegetation downstream of cavity. The swamp narrows downstream due to topography (swamp lies within a narrower, steeper valley downstream). The condition of the swamp vegetation downstream of the cavity is important in the context of discussions regarding swamp hydrology i.e. the good condition of the vegetation is indicative that there has been an ongoing supply of water to the swamp downstream of the cavity. This will be discussed in more detail later.

Figure 1.18 - Location 7-9 Northern Slumping Site Looking Downstream (North) on 28 June 2013 – Note that there is **No Apparent Effect of Cavity on Downstream Vegetation**

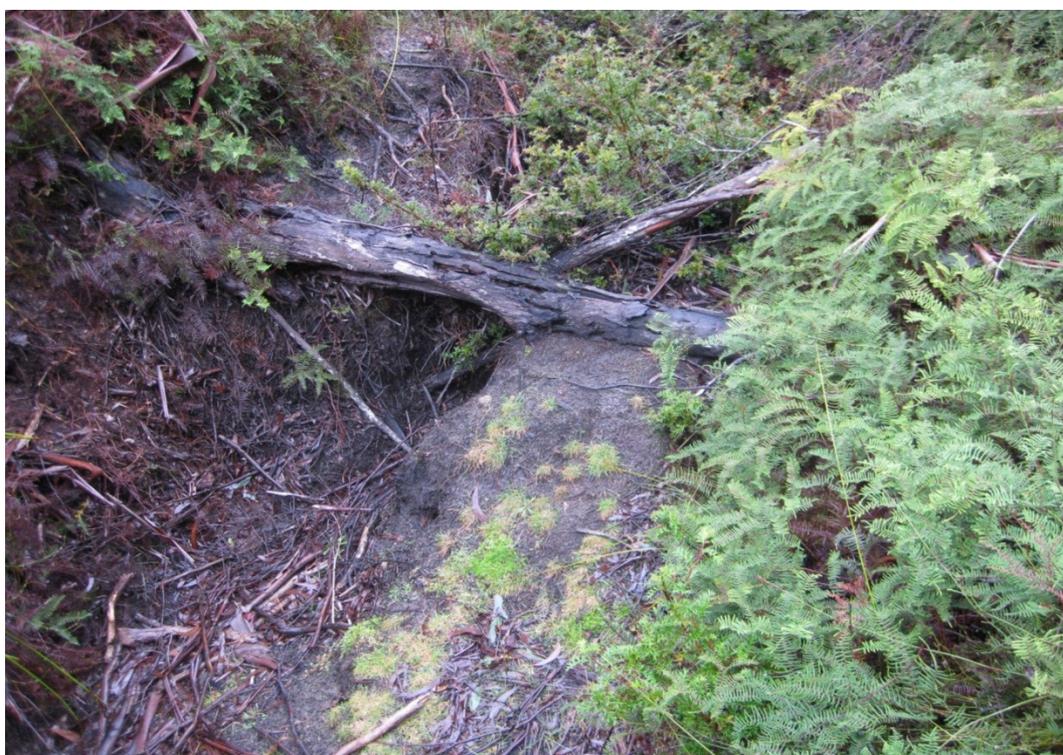
Figure 1.19 Location 7 Northern Slumping Site Looking Downstream (North) on 28 June 2013 - note erosion channel in peat downstream of cavity (concentrated flow path for mine water discharge)

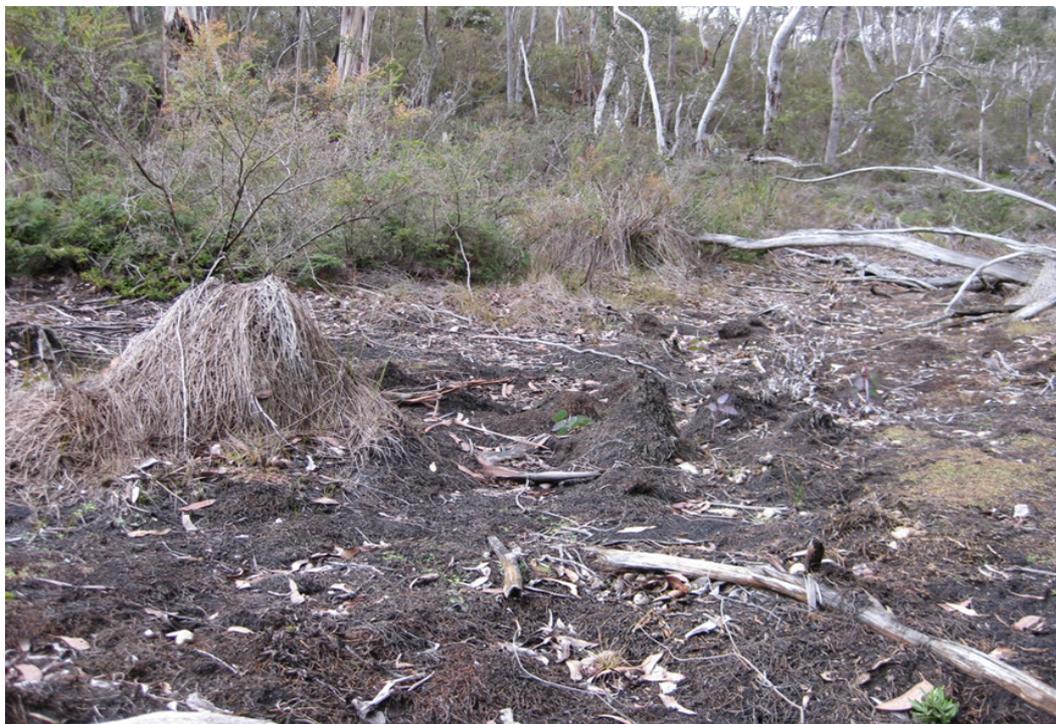
Figure 1.20 East Wolgan Swamp in Area Affected by Mine Water Discharge. Note surface erosion and remnants of topsoil secured from erosion by (dead) root biomass (hummocky surface)

Figures 1.20 to 1.24 were taken in areas of East Wolgan Swamp affected by mine water discharge. These photos show the following trends:

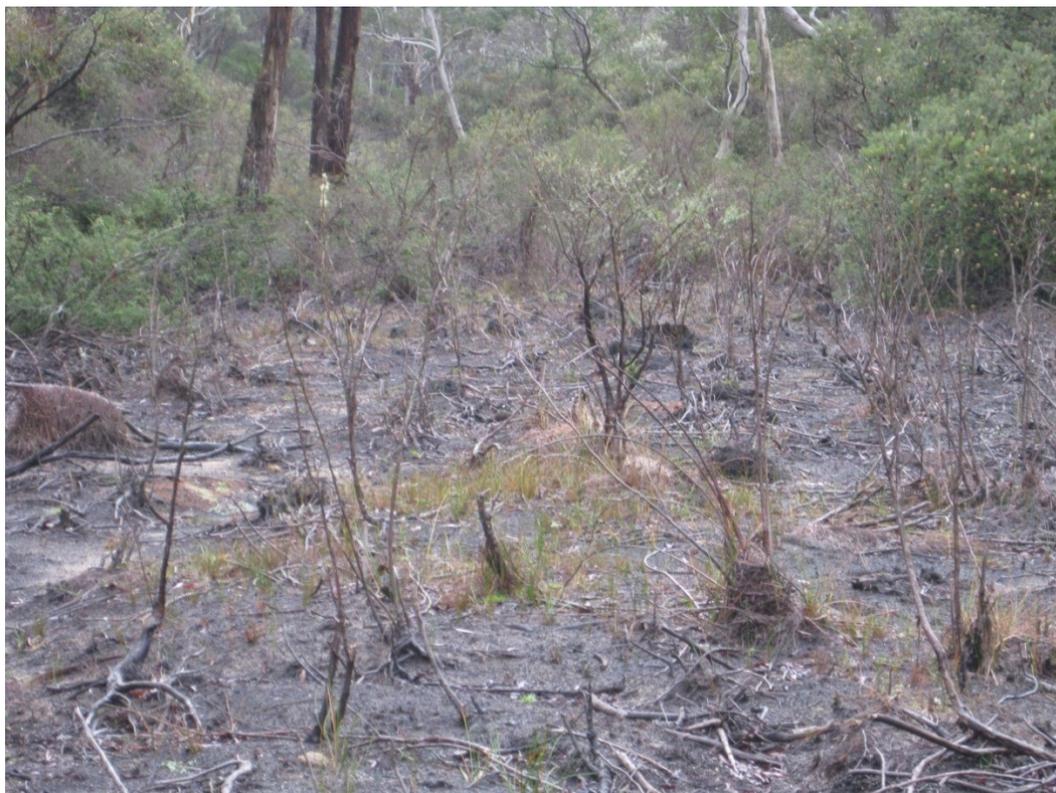
Figure 1.22 - East Wolgan Swamp in Area Affected by Mine Water Discharge – Note Limited Regrowth of Sedges Outside of Erosion Channels

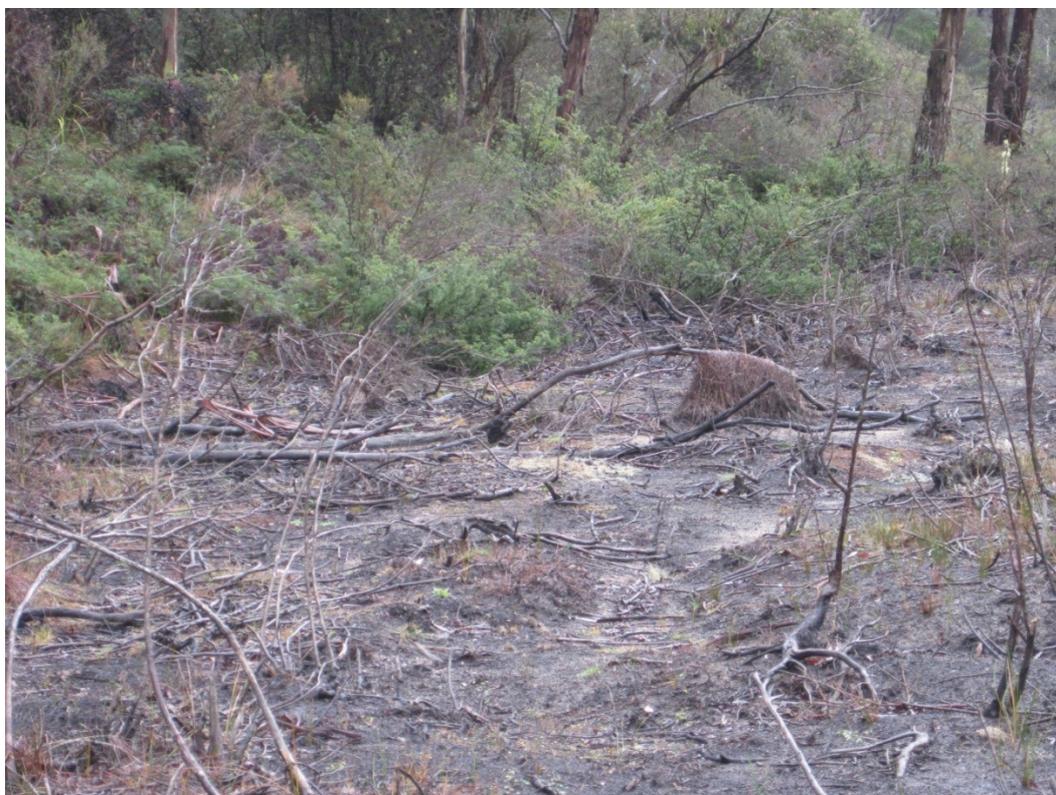
Figure 1.23 - East Wolgan Swamp Between Slumping Locations – Note Erosion Channels and Sediment Deposition Caused by Mine Water Discharge

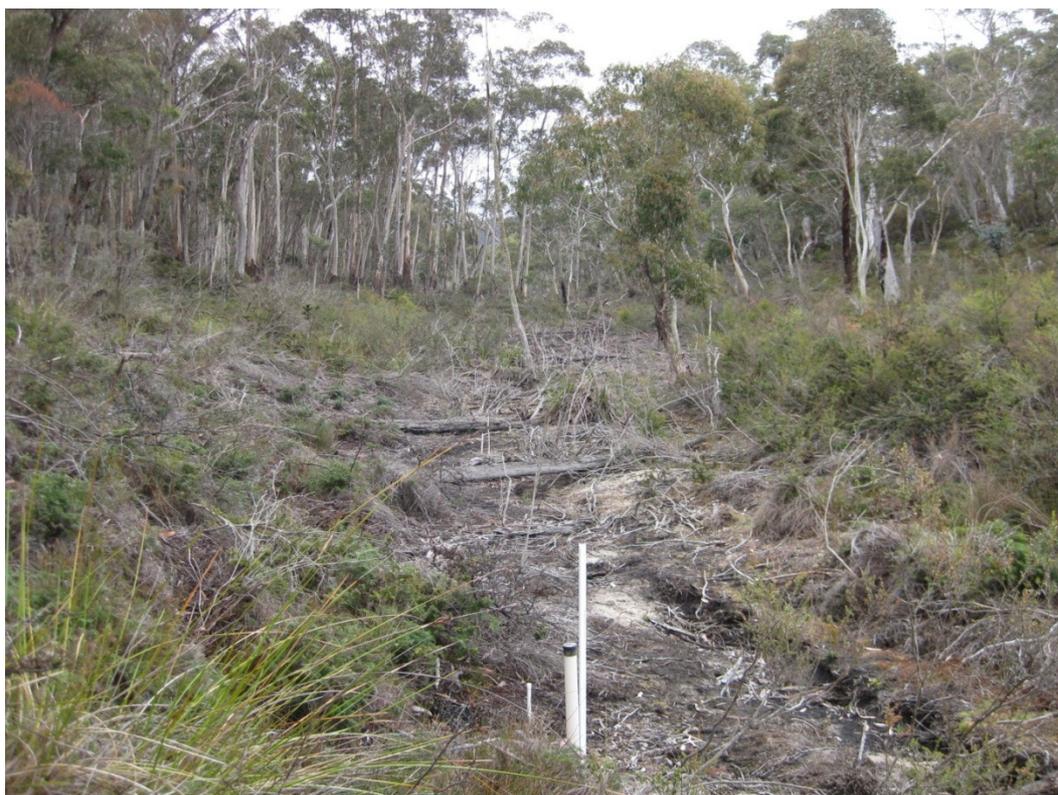
Figure 1.24 Photo of East Wolgan Swamp at WE2 Piezometer location showing vegetation damage along flow path of mine water discharge – not evident outside of flow path

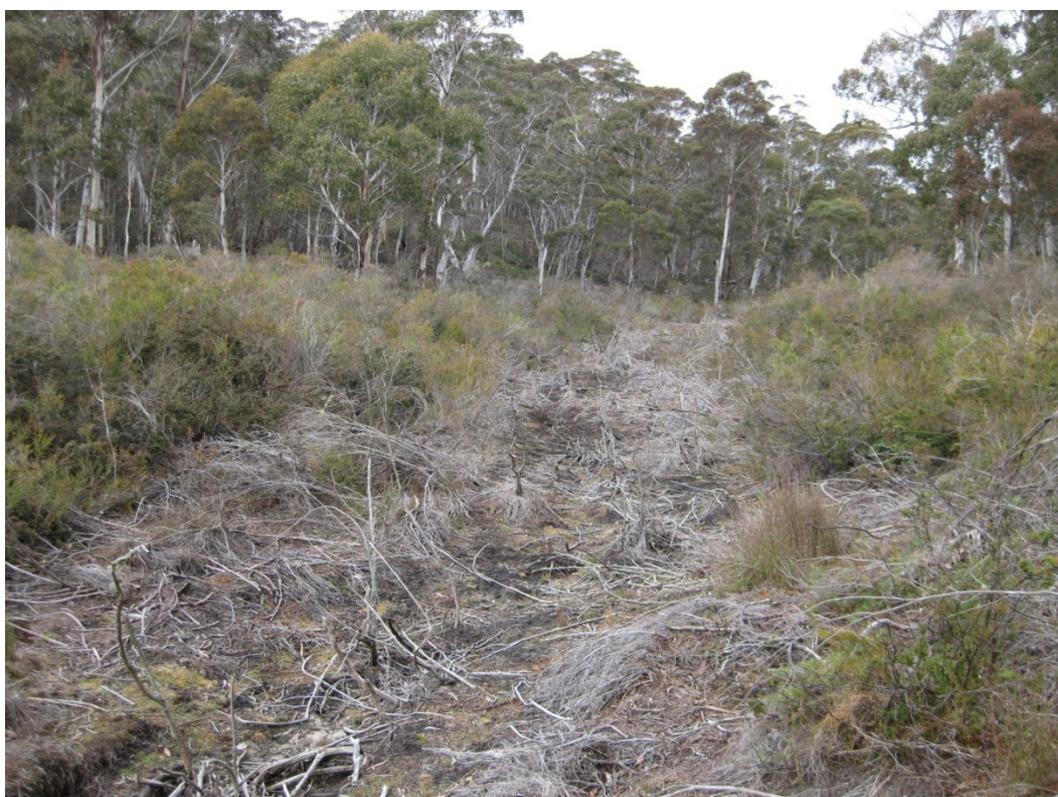
Figure 1.25 Photo of East Wolgan Swamp downstream of WE2 Piezometer location showing vegetation damage along flow path of mine water discharge – not evident outside of flow path.

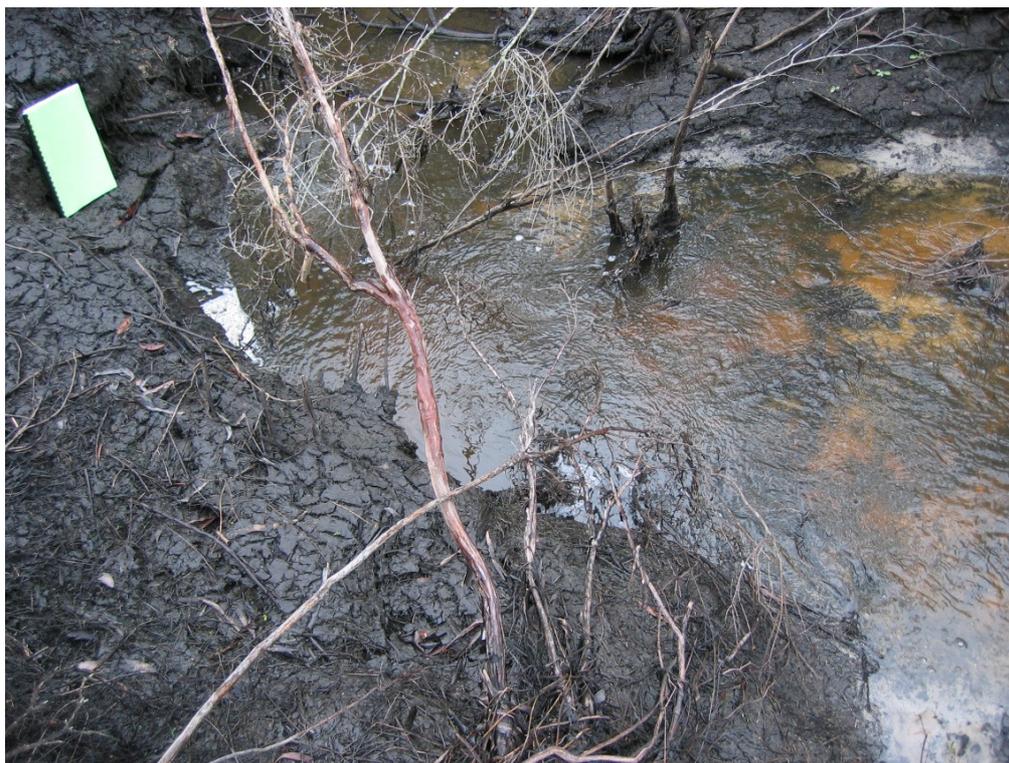
Figure 1.57 Cavity Site During Mine Water Discharge on 20 April 2009 (Complete Water Loss - No Downstream Flow)

Figure 1.57 shows the cavity site during mine water discharge on 20 April 2009. At this time there was complete water loss into the cavity, with no downstream flow.

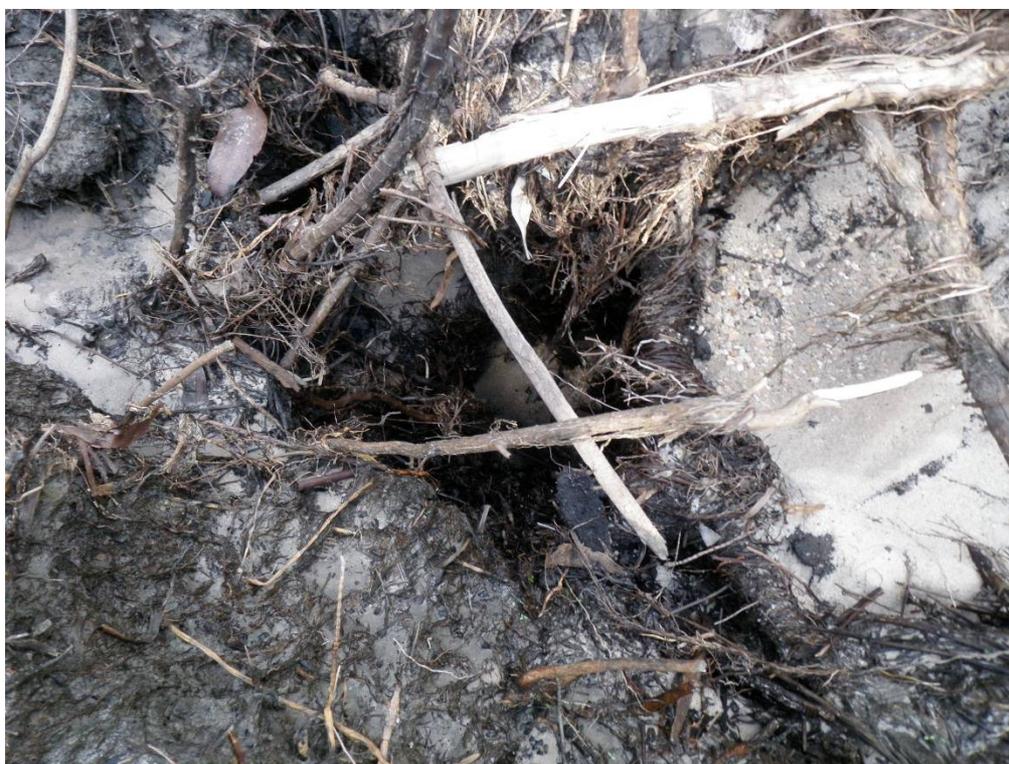
Figure 1.58 Cavity Site - No Mine Water Discharge on 1 May 2009 – Hole Where Water Loss Occurred

Figure 1.58 shows the cavity site with no mine water discharge on 1 May 2009, showing the hole in the peat where water loss occurred.

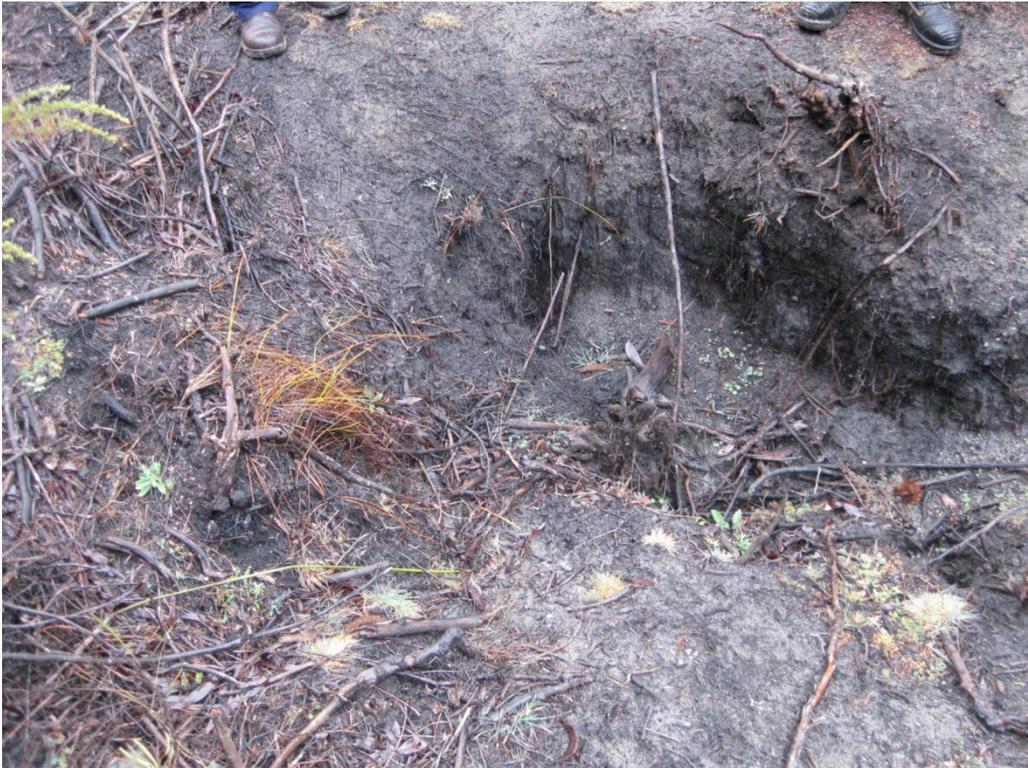
Figure 1.59 Cavity Site – 28 June 2013 – Infilling of Hole Where Water Loss Occurred Through Natural Processes

Figure 1.59 shows the cavity site on 28 June 2013 showing the infilling of the hole where water loss occurred through natural processes.
