Centennial Coal

***Application to Allow Longwall
Mining Under Temperate Highland
Peat Swamps on Sandstone on the
Newnes Plateau***

Springvale Colliery

Information Request Regarding Application to Allow Longwall Mining Under Temperate Highland Peat Swamps on Sandstone on the Newnes Plateau (EPBC Approval 2011/5949)

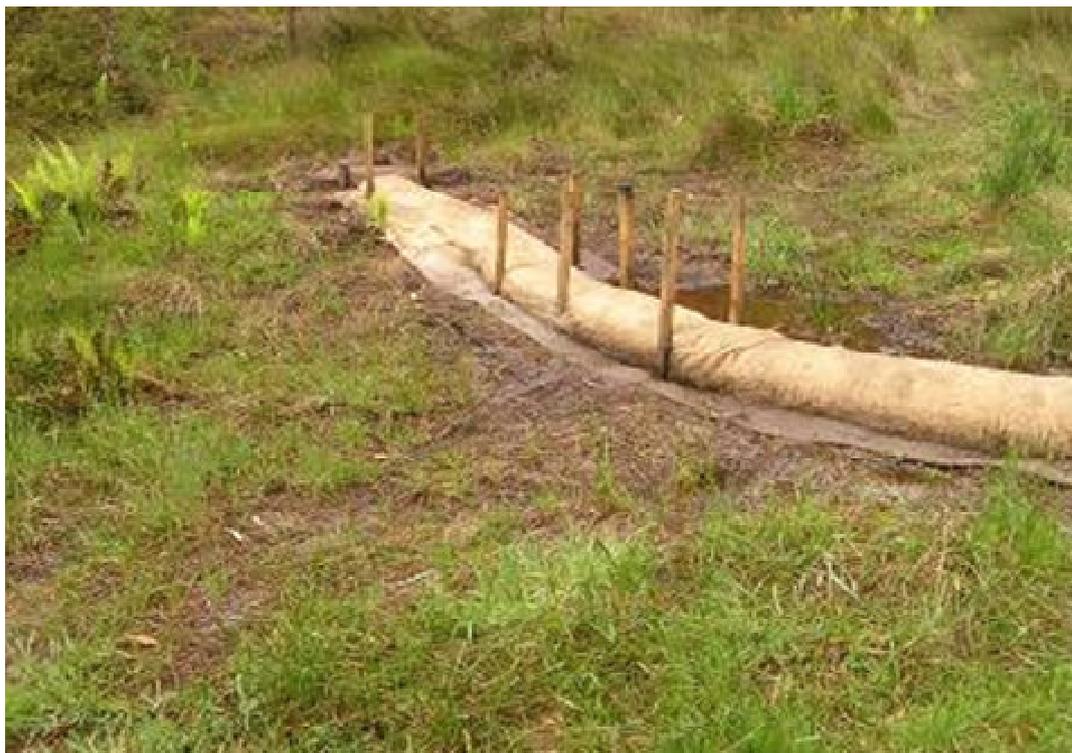
Figure 1.61 – Photo of Braeside Swamp at time of Remediation works using similar techniques to those proposed for channelized areas in East Wolgan Swamp

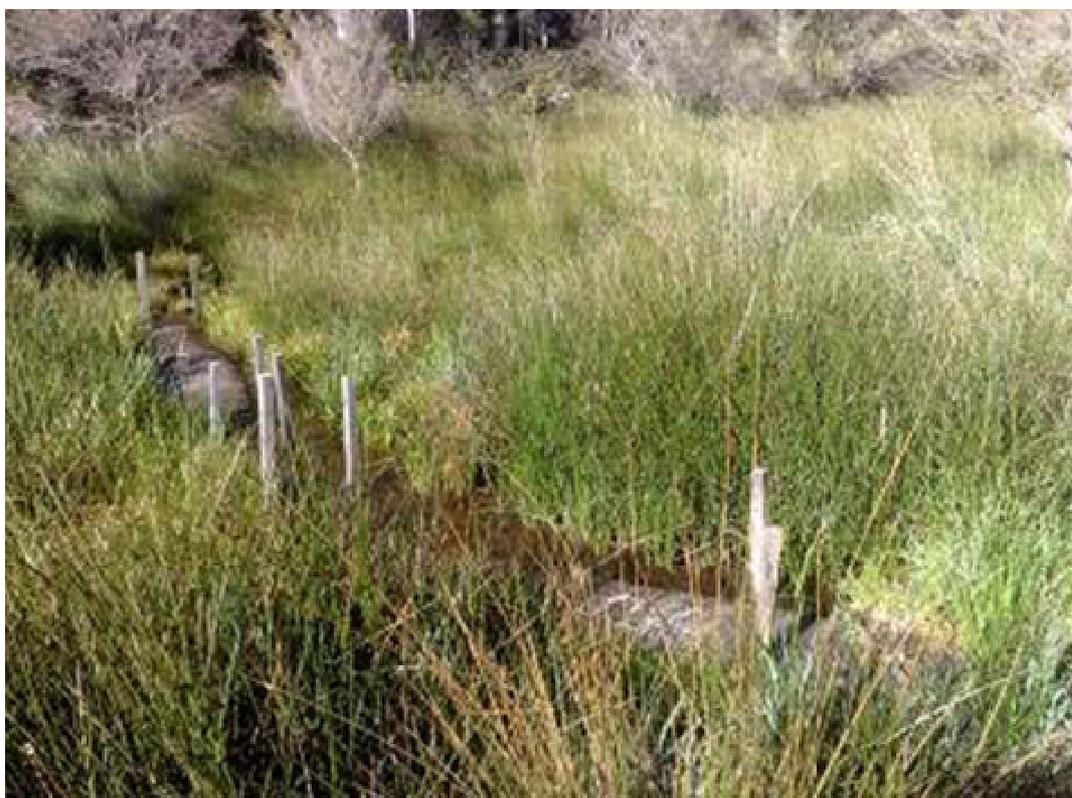
Figure 1.62 – Photo of Braeside Swamp approximately 12 months after remediation works using similar techniques to those proposed for channelized areas in East Wolgan Swamp

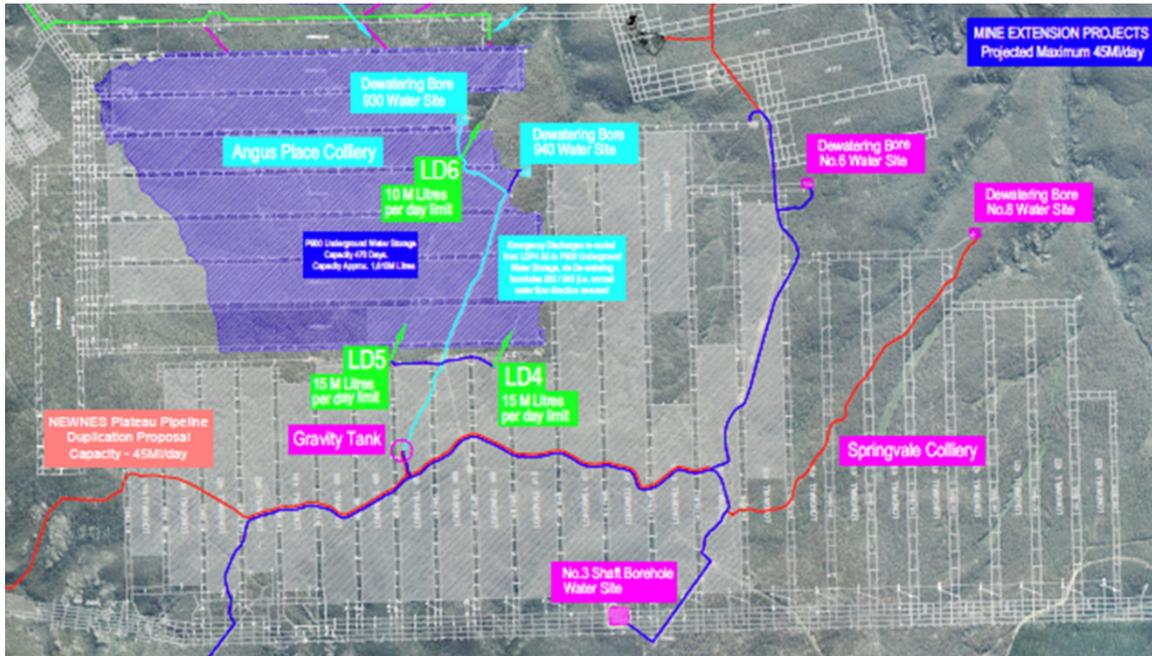
Figure 1.66 – Image of Springvale and Angus Place Mine Water Management System on the Newnes Plateau

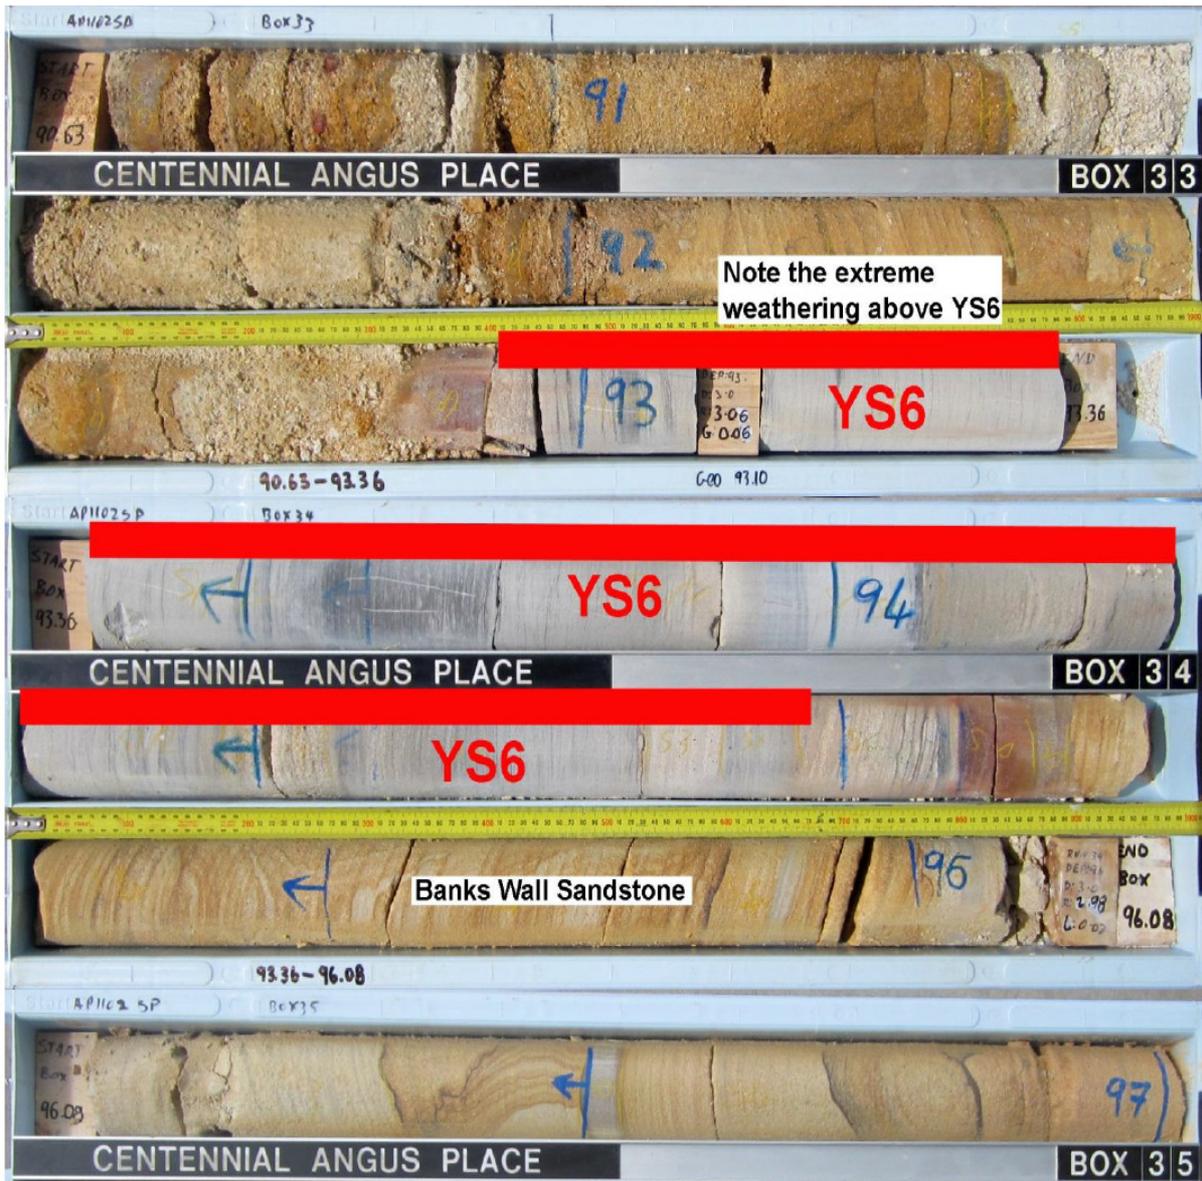
Figure 1.68 - Photo of a core drilled from the Buralow Formation on the Newnes Plateau showing medium- to coarse-grained sandstones interbedded with frequent sequences of fine-grained, clay-rich sandstones, siltstones, shales and claystones. These latter fine-grained units can be several metres in thickness and their presence differentiates the Buralow Formation from the underlying Banks Wall Sandstone.

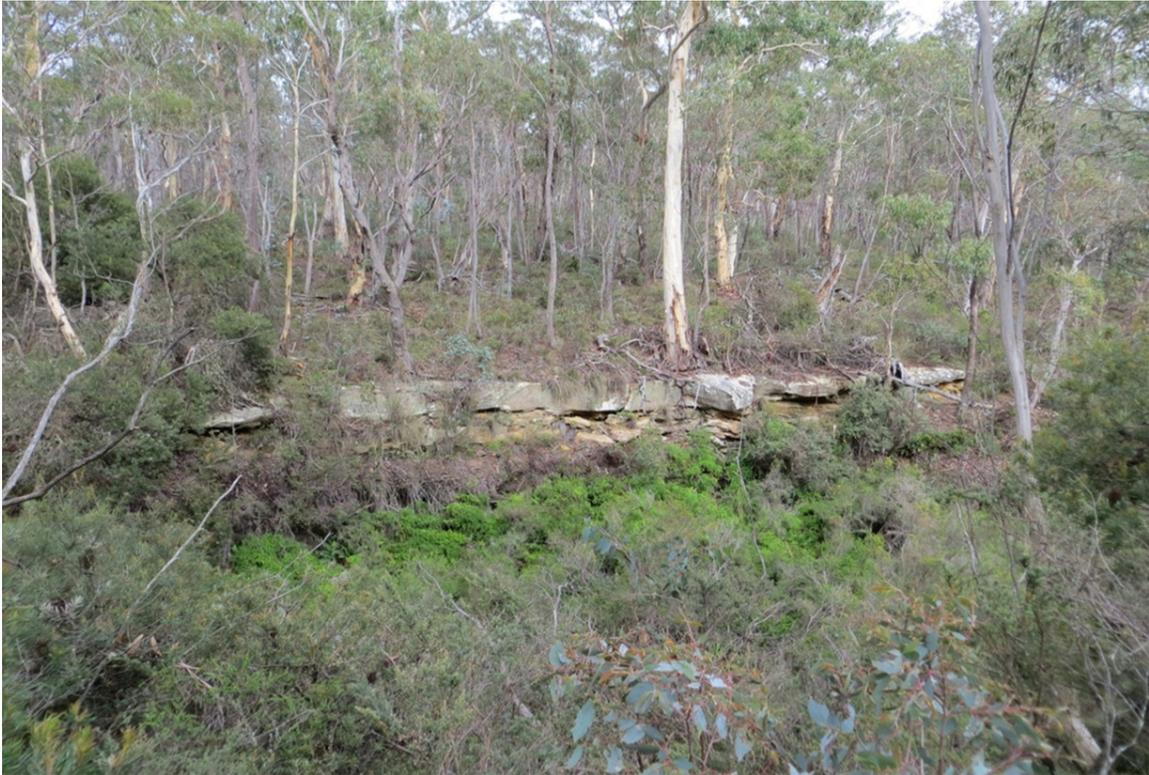
Figure 1.77 – Unmapped Hanging Swamp on the Western Side of Kangaroo Creek Swamp – illustrating valley seepage mechanism continuing post-longwall mining

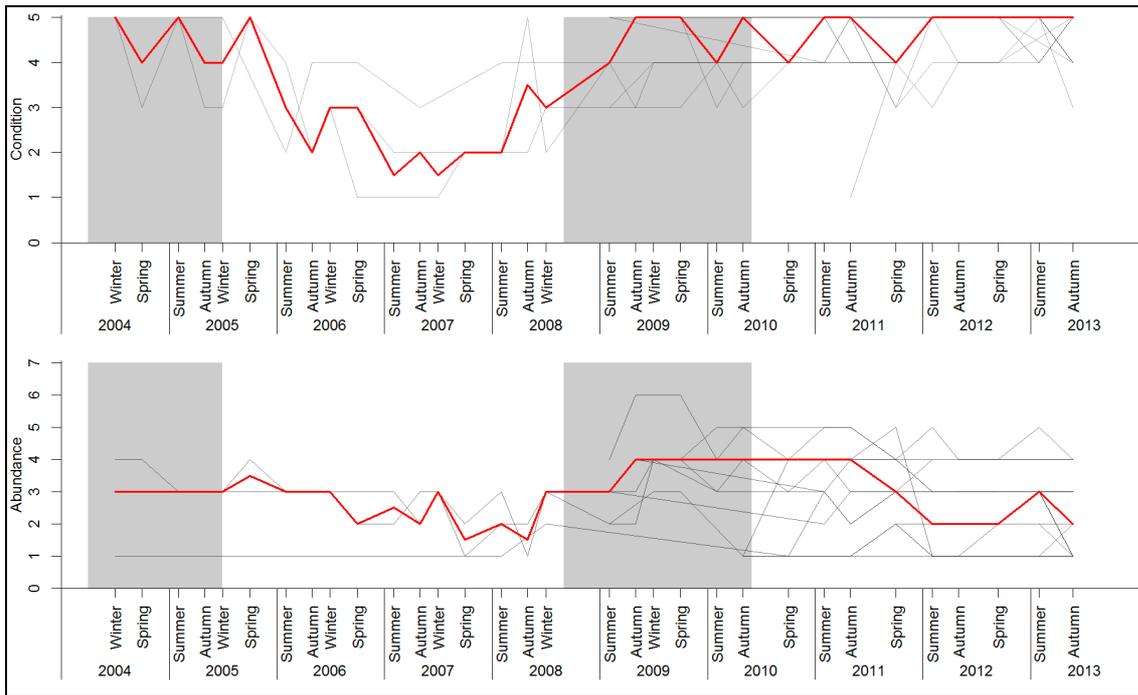
Figure 1.86: Median condition and abundance for Narrow Swamp 2 flora monitoring plot.
