CENTENNIAL COAL AIRLY MINE ANNUAL REVIEW

March 2017 (Reporting Period: Jan – Dec 2016)

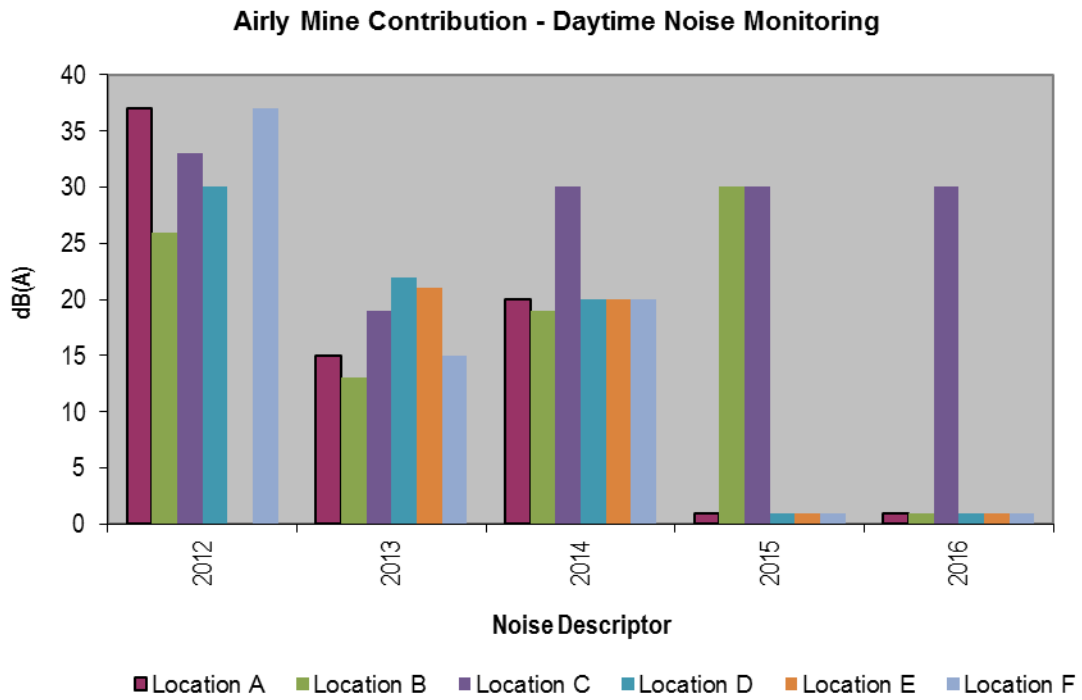
Figure 6.1.1: Airly Mine – Historic Daytime Noise Monitoring Results.

Historic monitoring of the Airly Mine's estimated noise contribution ($L_{Aeq,15min}$) is shown in figures 6.1.1, 6.1.2 and 6.1.3.

The above graphs shows the years succeeding 2012, have recorded lower noise monitoring results. It is difficult to draw further trends in noise monitoring data at Airly Mine due to a number of results being inaudible and detectible results being recorded at their maximum potential. For example, a recording of <30dB is graphically represented as 30dB when the actual results might be half of that recording. What is clear from the historic trends is Airly Mine is a low noise generating site. For the last 4 years have maintained compliance with the adopted criteria and for the past 2 years have recorded inaudible results at the nearest residential receiver.

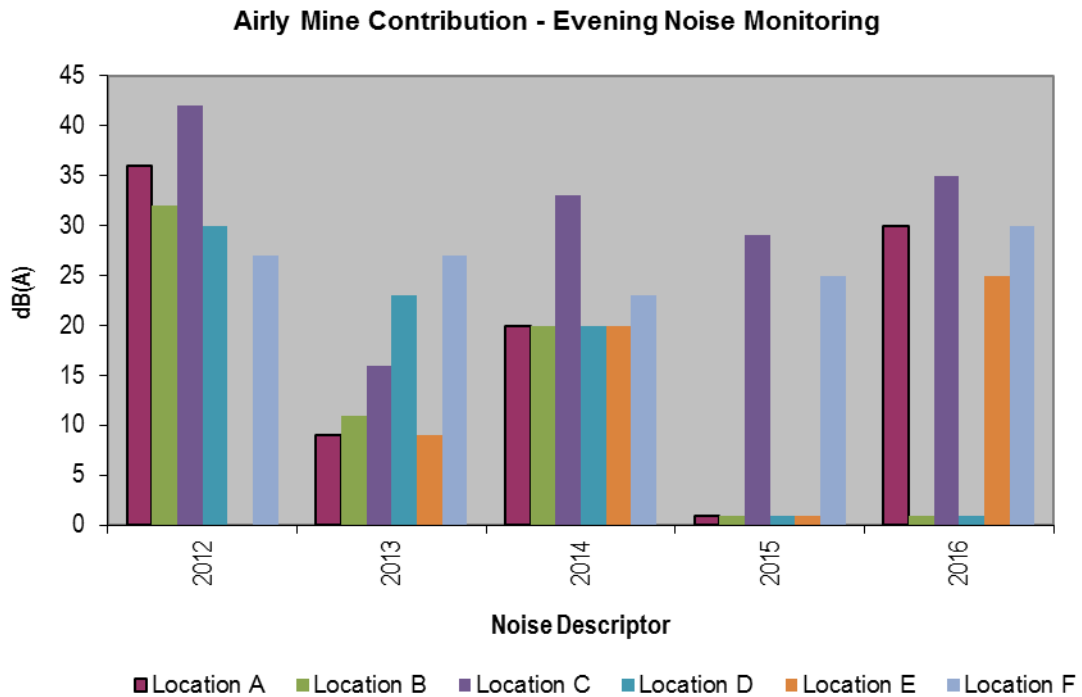
Figure 6.1.2: Airly Mine – Historic Evening Noise Monitoring Results.

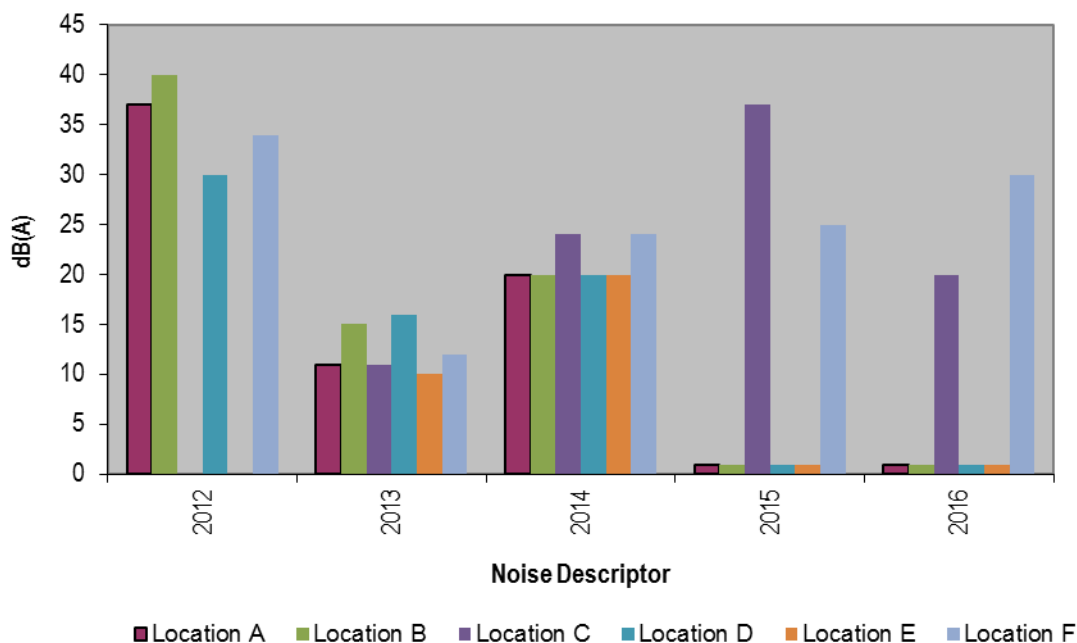
Figure 6.1.3: Airly Mine – Historic Night Noise Monitoring Results.

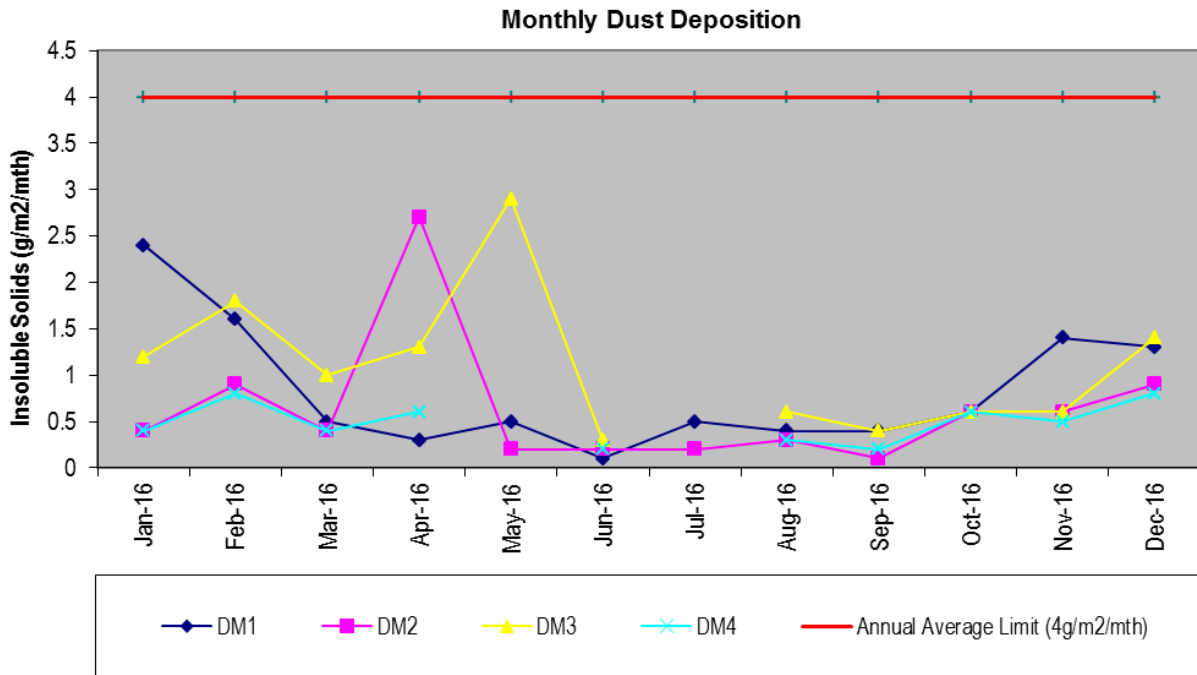
Figure 6.2.1: Airly Mine – 2016 Depositional Dust Monitoring Results

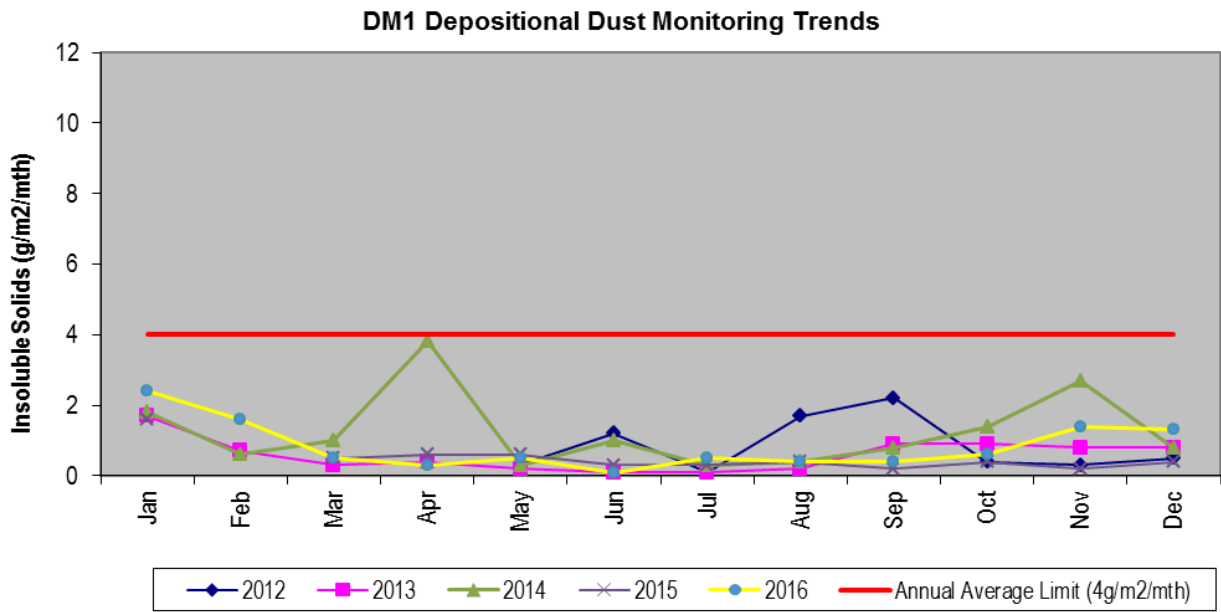
Figure 6.2.2: Airly Mine – Historic Trends in Depositional Dust – DM1

Historic trends in depositional dust data is graphically represented below in figures 6.2.2, 6.2.3, 6.2.3 and 6.2.4. There are no identifiable trends in historic data. All historic depositional dust monitoring results from 2012 to 2016 have been compliant with the annual average limit of 4g/m²/mth.

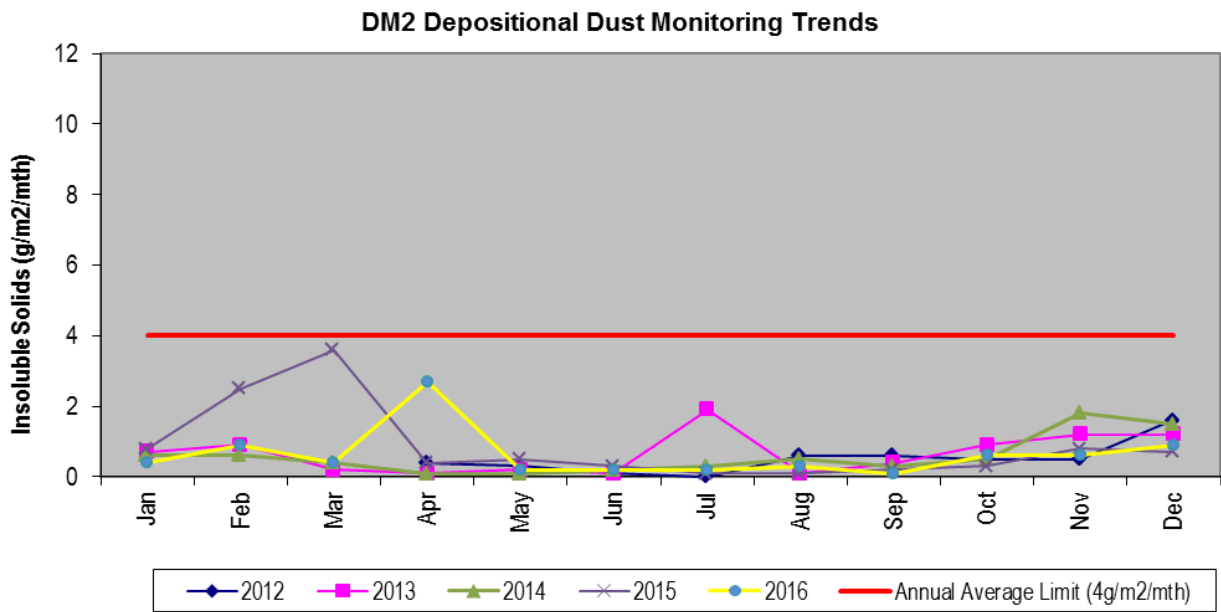
Figure 6.2.3: Airly Mine – Historic Trends in Depositional Dust – DM2

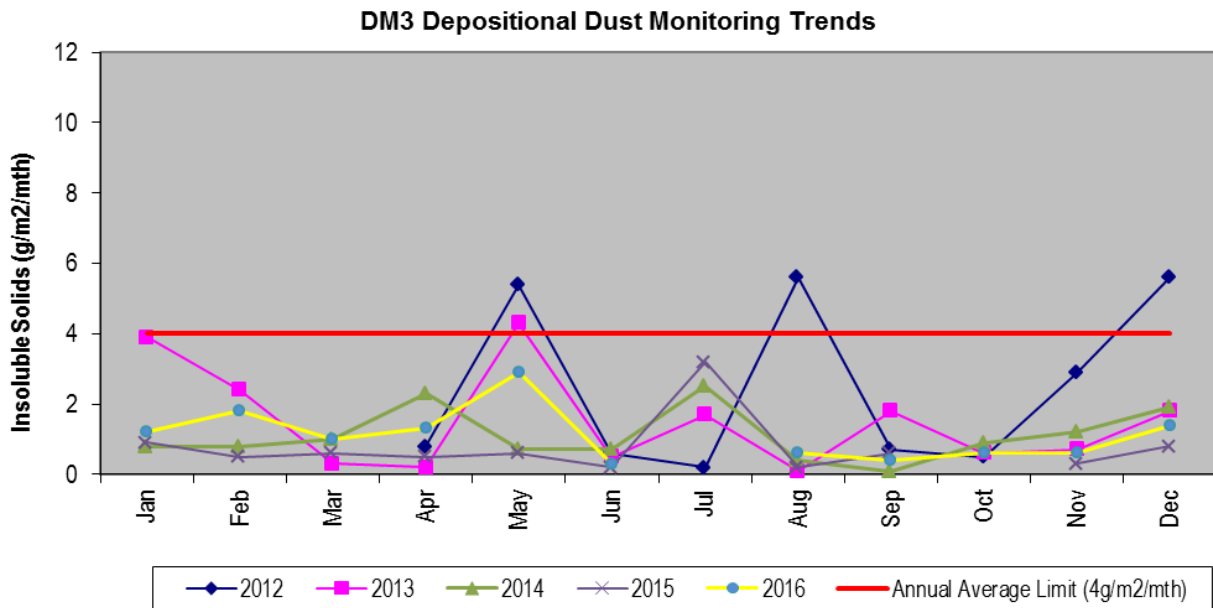
Figure 6.2.4: Airly Mine – Historic Trends in Depositional Dust – DM3

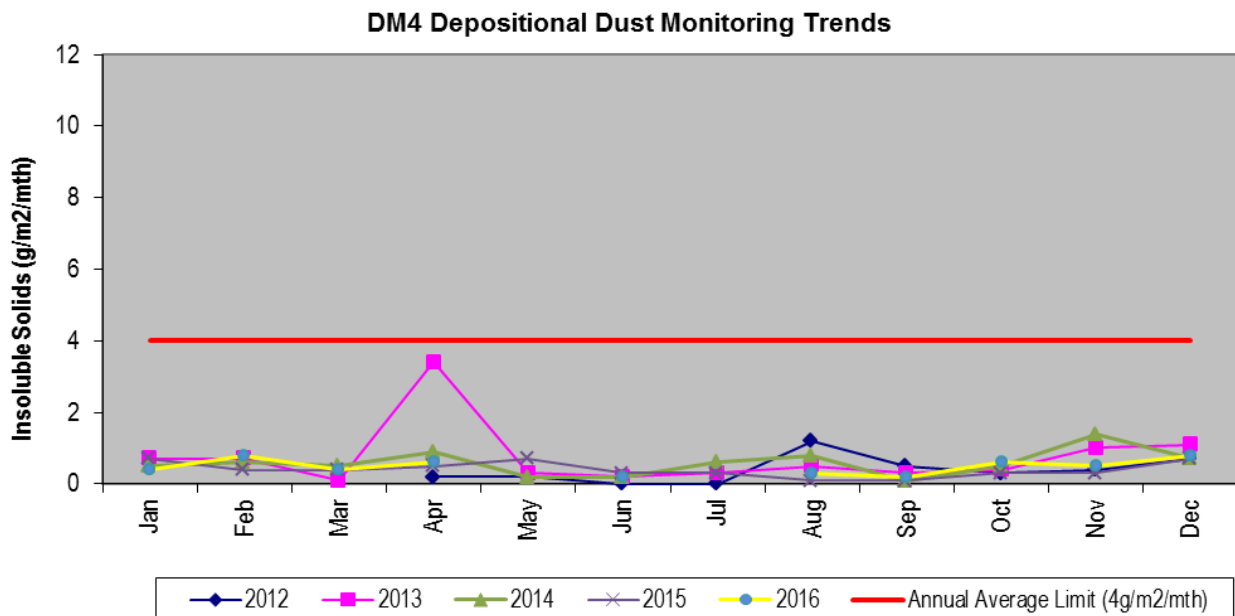
Figure 6.2.4: Airly Mine – Historic Trends in Depositional Dust – DM4

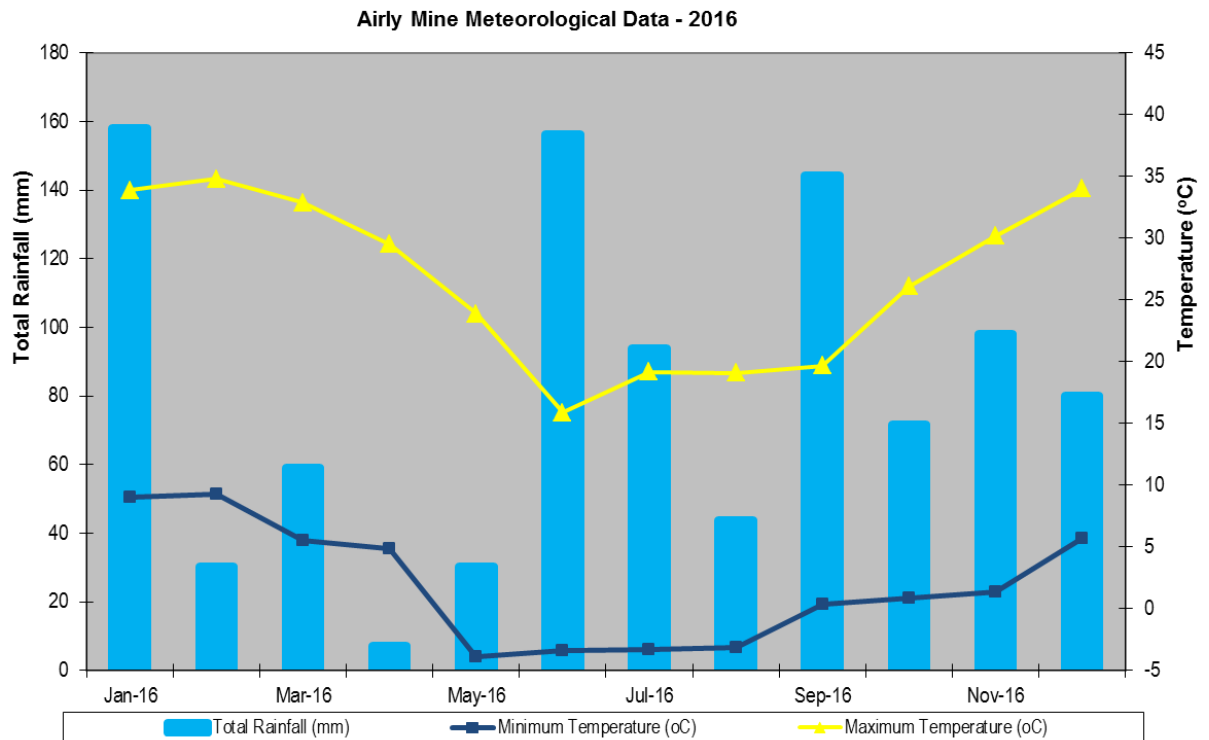
Figure 7.2.1 Airly Mine 2016 Meteorological Data

Airly Mine has a site-based meteorological station which was established in April 2010. Rainfall and temperature data for 2016 is shown in Figure 7.2.1 below.

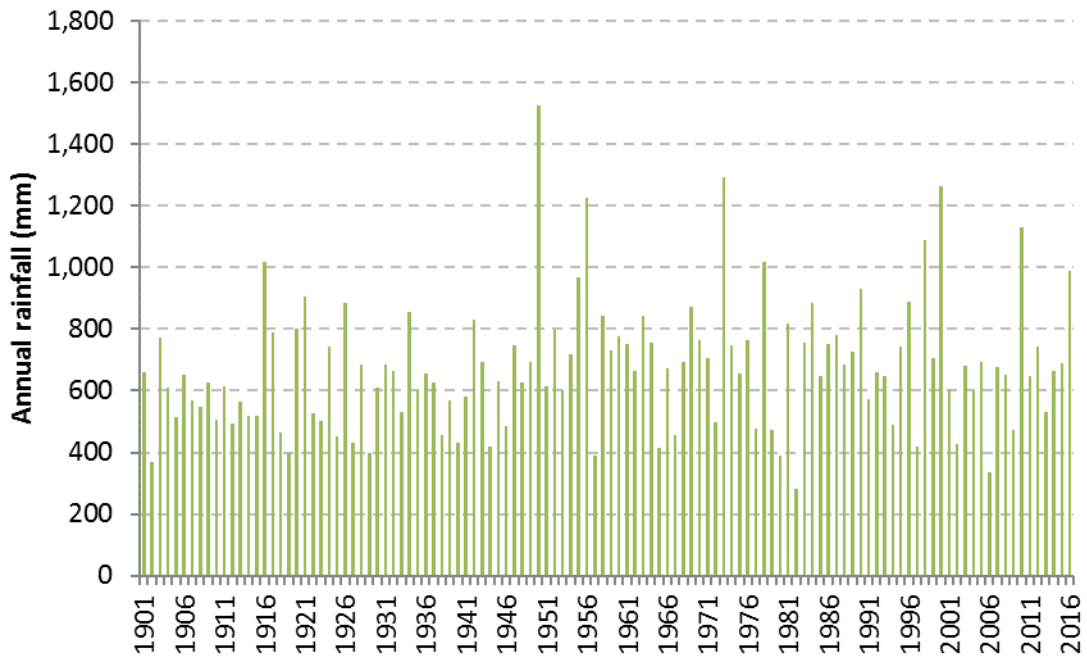
Figure 7.2.2 Annual rainfall recorded at Illford (Warrangunyah) Weather Station

Historic and trended rainfall data has been obtained from the BOM Ilford (Warrangunyah) weather station, which is located approximately 29km north-west of Airly Mine. The period of rainfall data extends from January 1901 to December 2016 and is summarised as annual totals in Figure 7.2.2.

- Minimum annual rainfall – 277mm (1982)
- Average annual rainfall – 675mm
- Maximum annual rainfall – 1,513mm (1950)

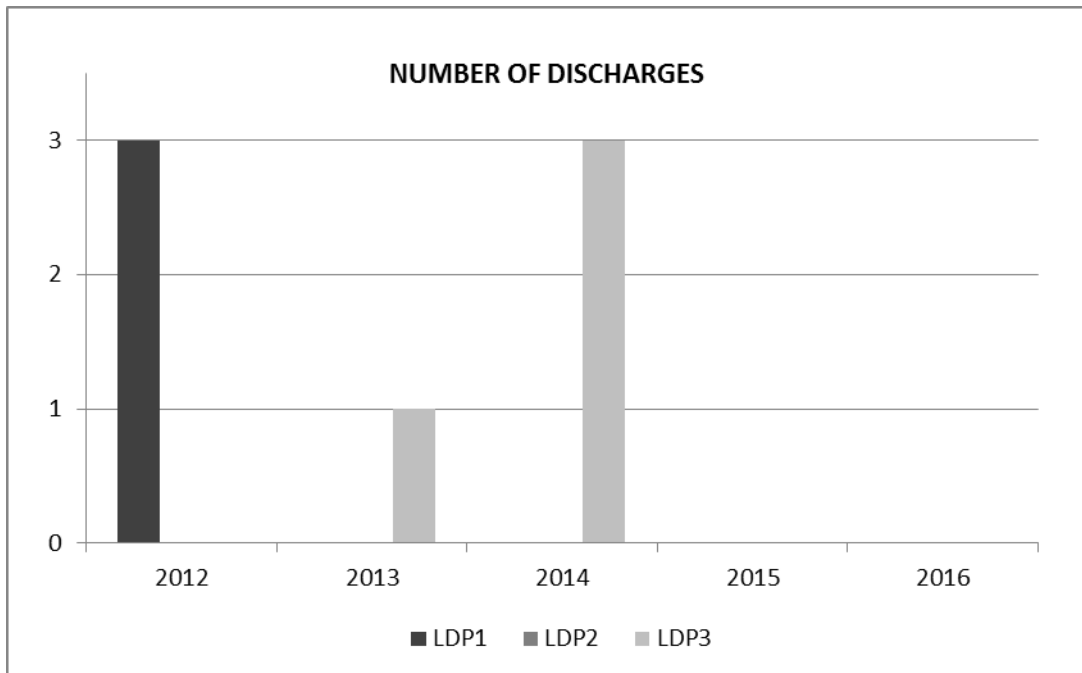
Figure 7.3.1 Airly Mine – Historic Discharges

Historic water discharges from Airly Mine have been summarised in Figure 7.3.1, there has been three (3) discharges from LDP1 and four (4) discharges from LDP3 from 2012 to 2014. Corresponding water discharge volumes can be seen within Figure 7.3.2. There were no discharges from any licenced discharge point during the 2015 or 2016 reporting period.

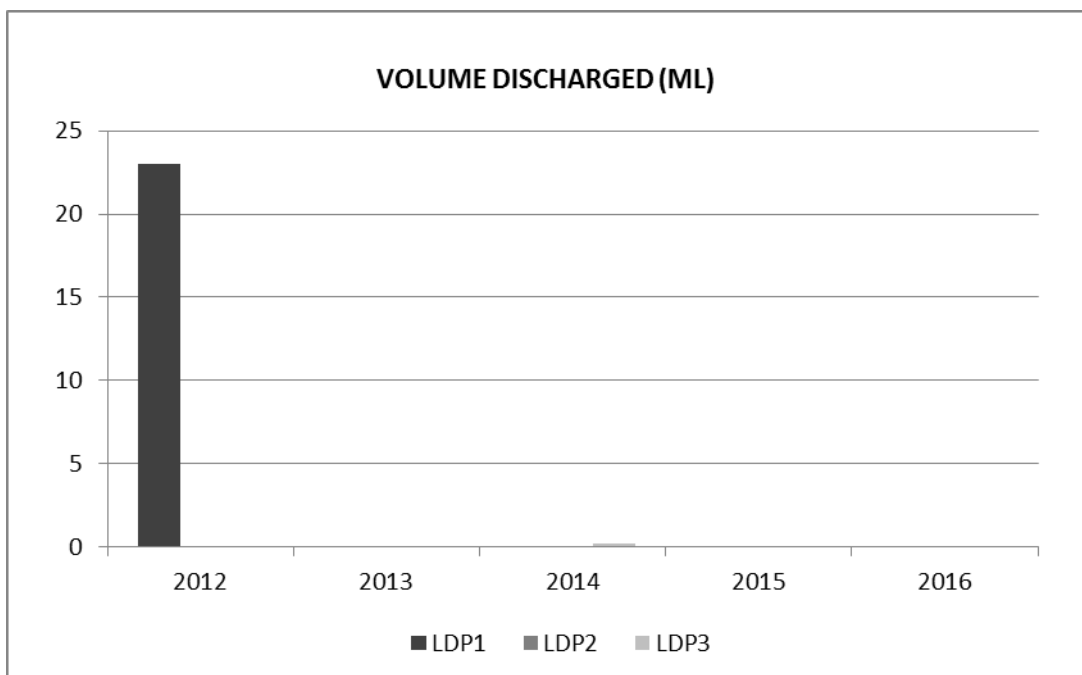
Figure 7.3.2 Airly Mine – Historic Discharges – Volume (ML)

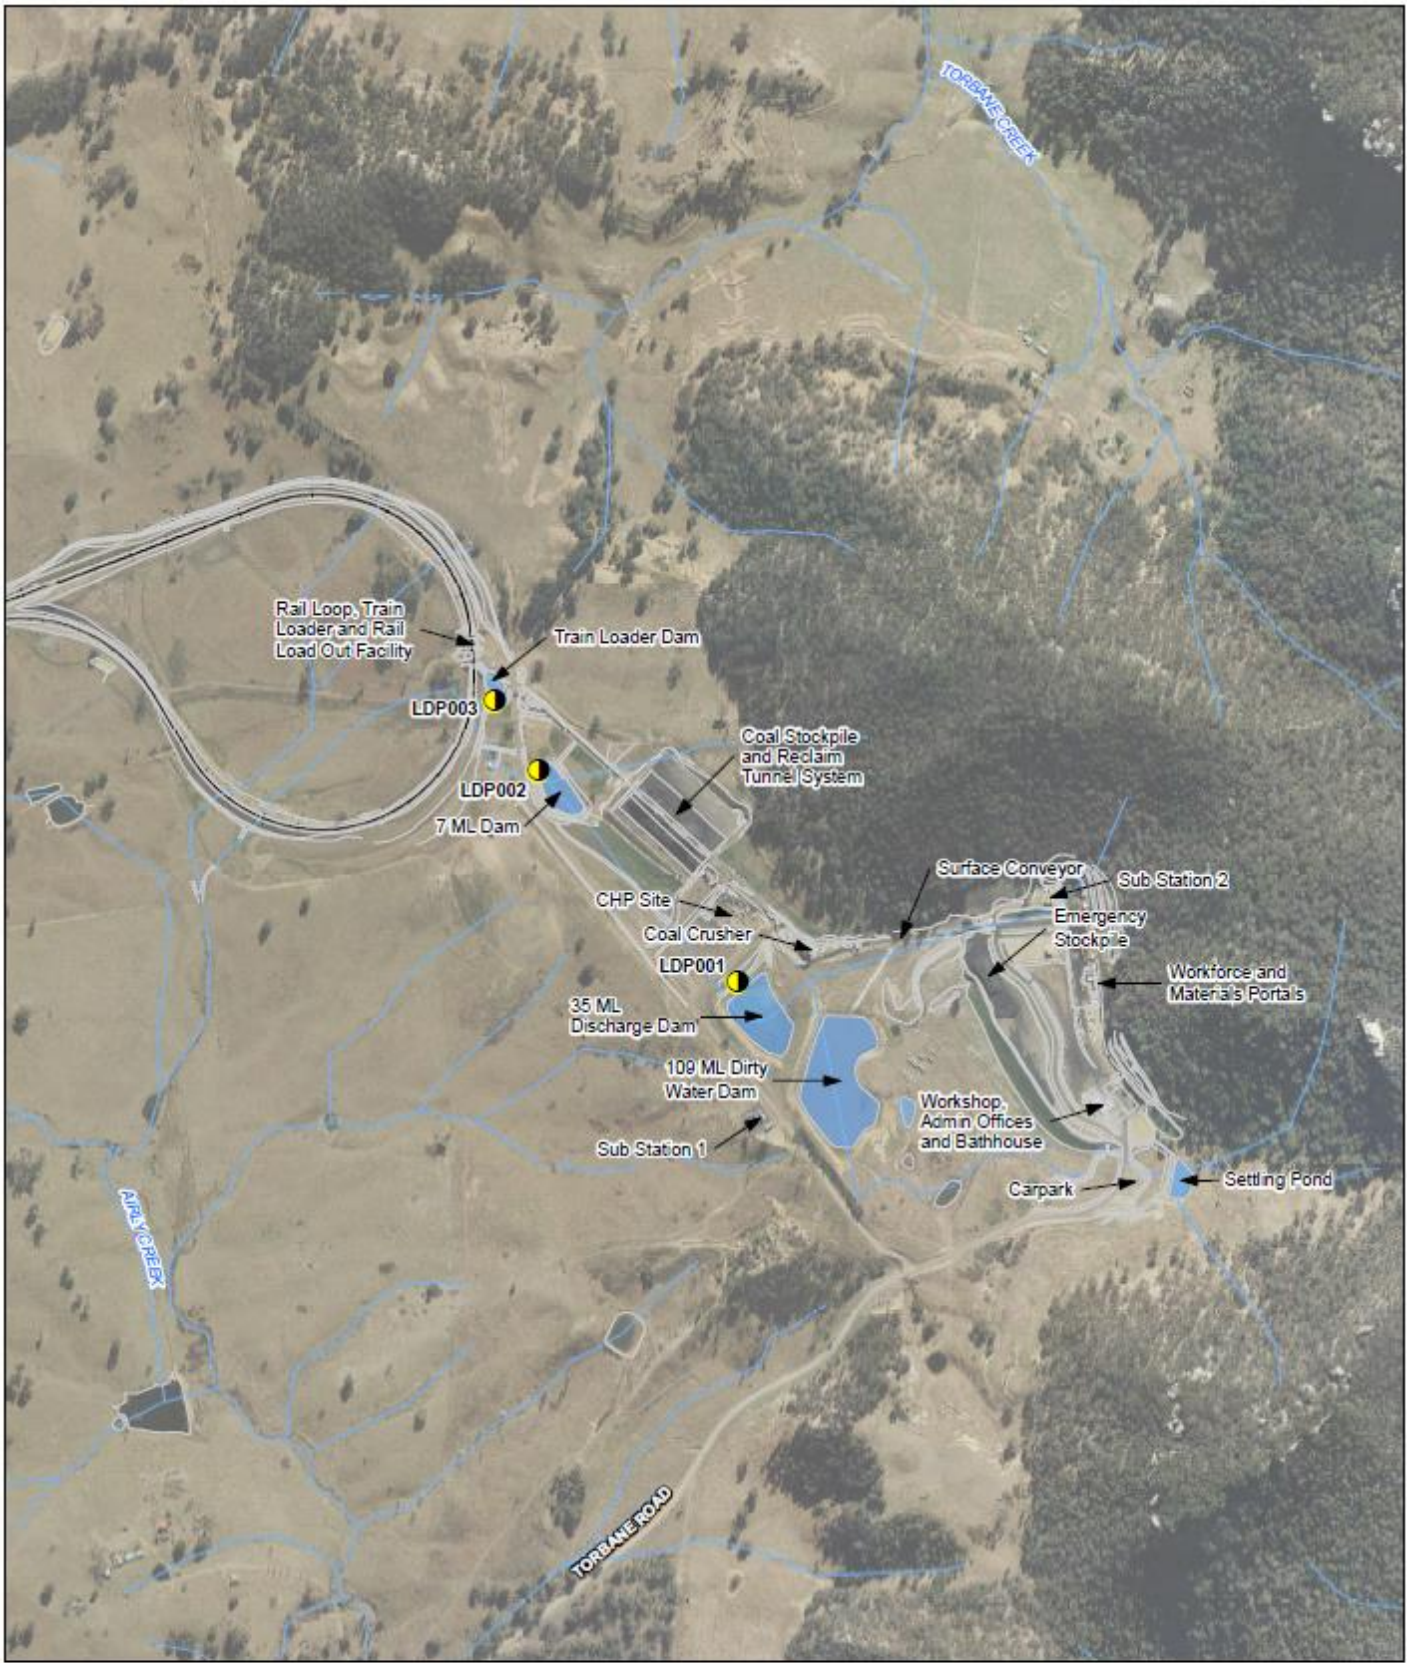
Figure 7.3.3 Airly Mine Surface Features & Water Management Structures

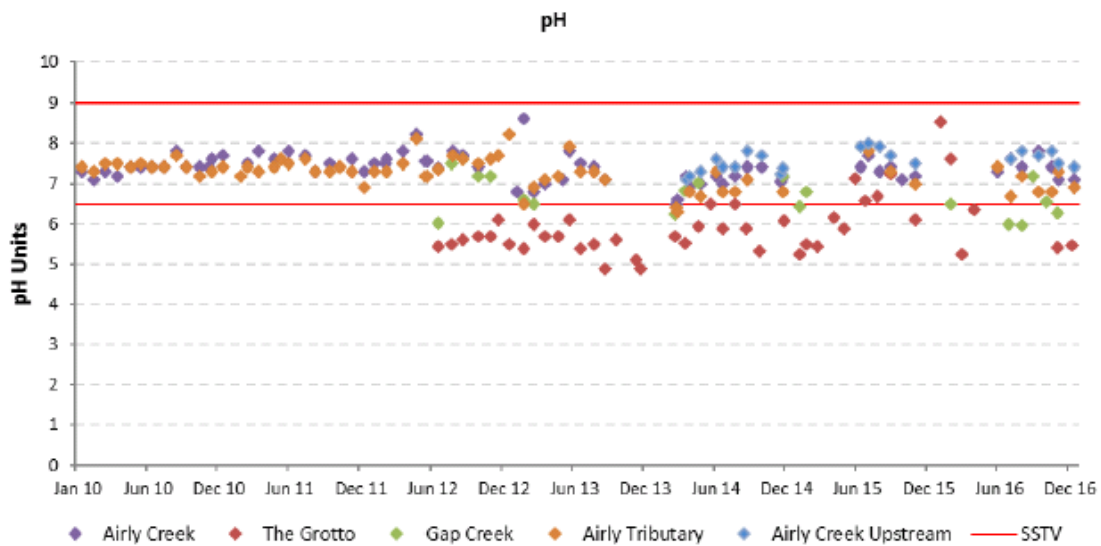
Figure 7.5.1: Airly Mine – Surface Water – pH

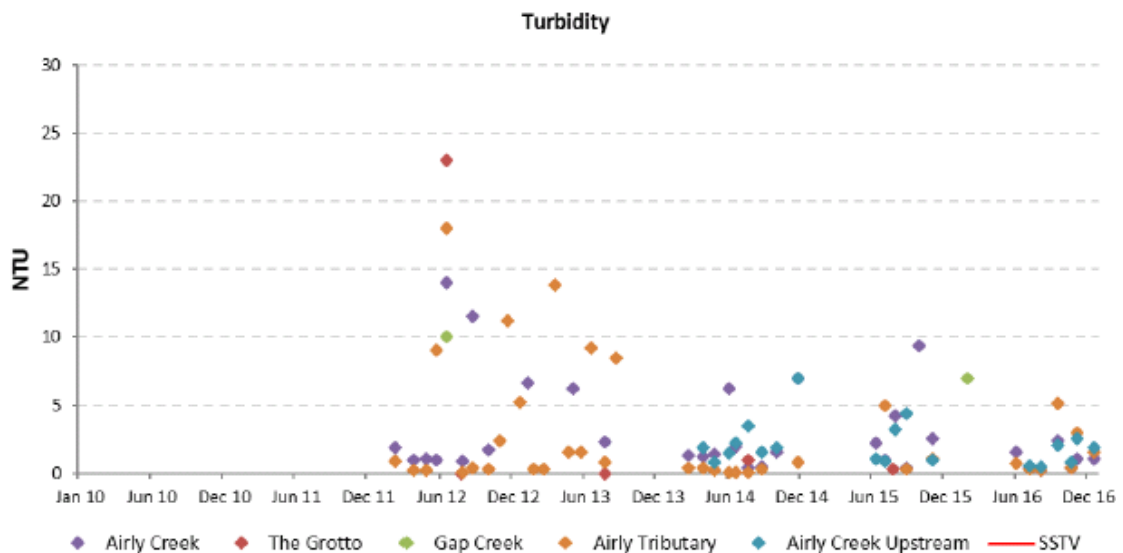
Figure 7.5.4: Airly Mine – Surface Water – Turbidity

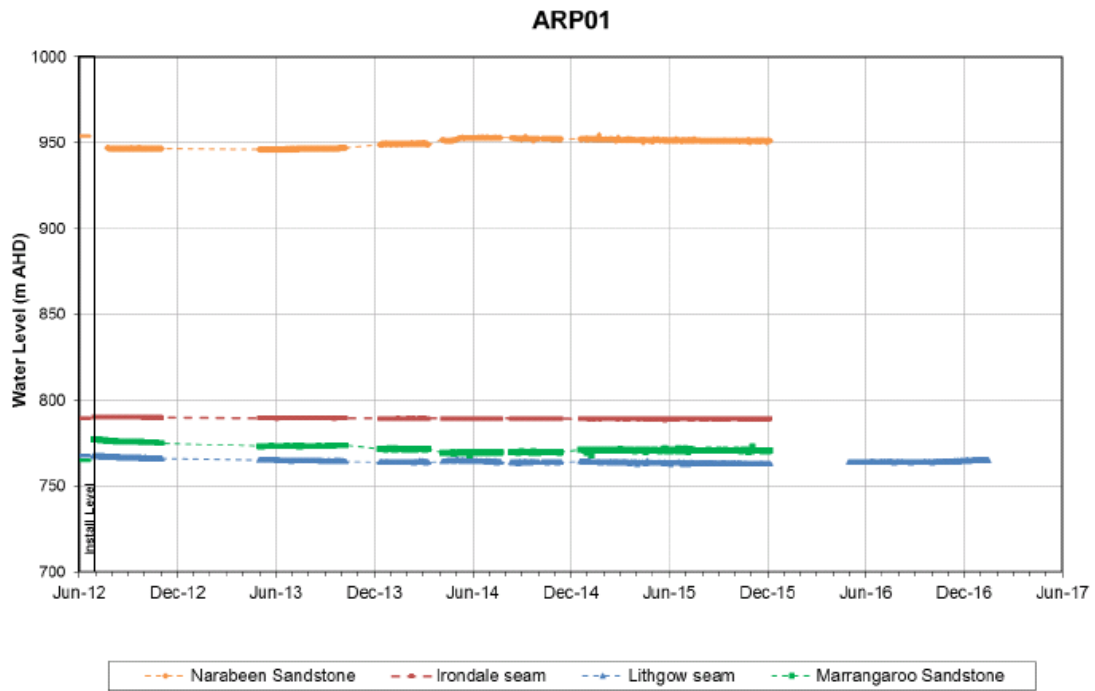
Figure 7.8.1: ARP01

Trended piezometric head data recorded from 2012 to 2016 for locations ARP01, ARP02A, ARP03A, ARP04, ARP06, ARP07 and ARP08 are shown below.

Pressures reported in 2016 are generally similar to those reported between 2013 and 2015 (and reported in the EIS). Minor decreasing trends were observed in 2014 and 2015 in the middle river stream at ARP07, in the Irondale Seam at ARP08 and in the Marrangaroo Sandstone at ARP02A. These minor decreasing trends continued in 2016. There was a minor decreasing trend in pressures at ARP07 in the Lithgow Seam during 2014 and 2015. This trend ceased in 2016 with pressures very stable in the Lithgow Seam at ARP07.

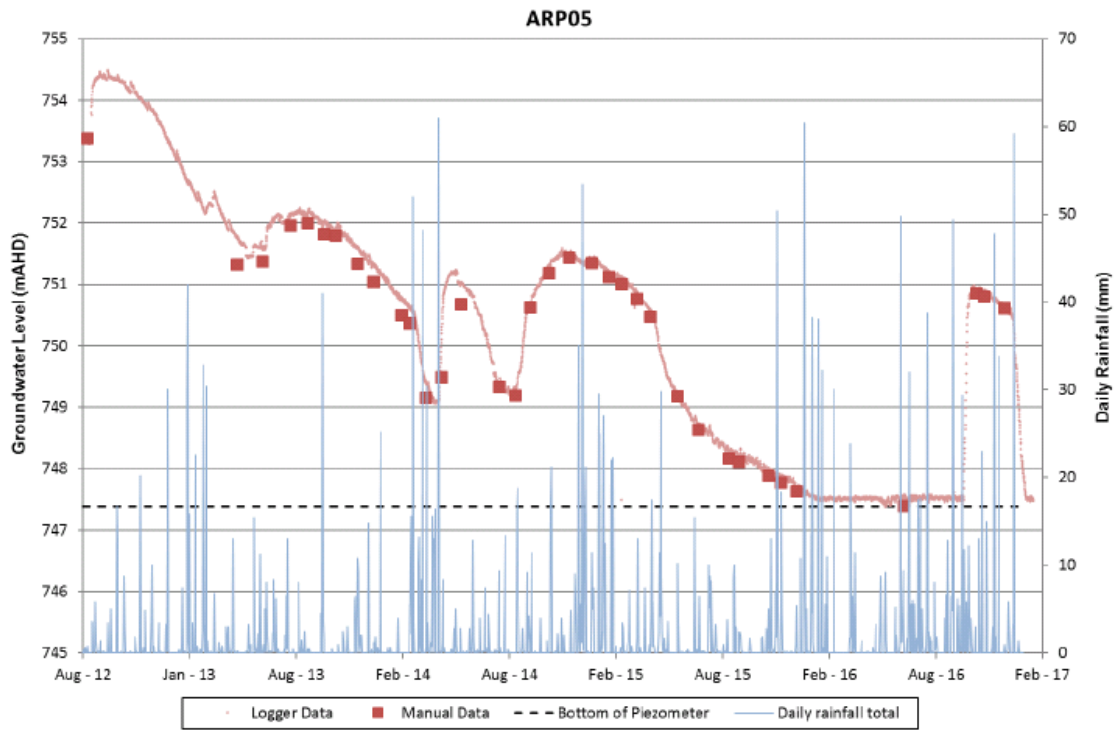
Figure 7.9.1: ARP05 – Rainfall Comparison

Hydrographs for alluvial groundwater at ARP05 and ARP09 are shown below.

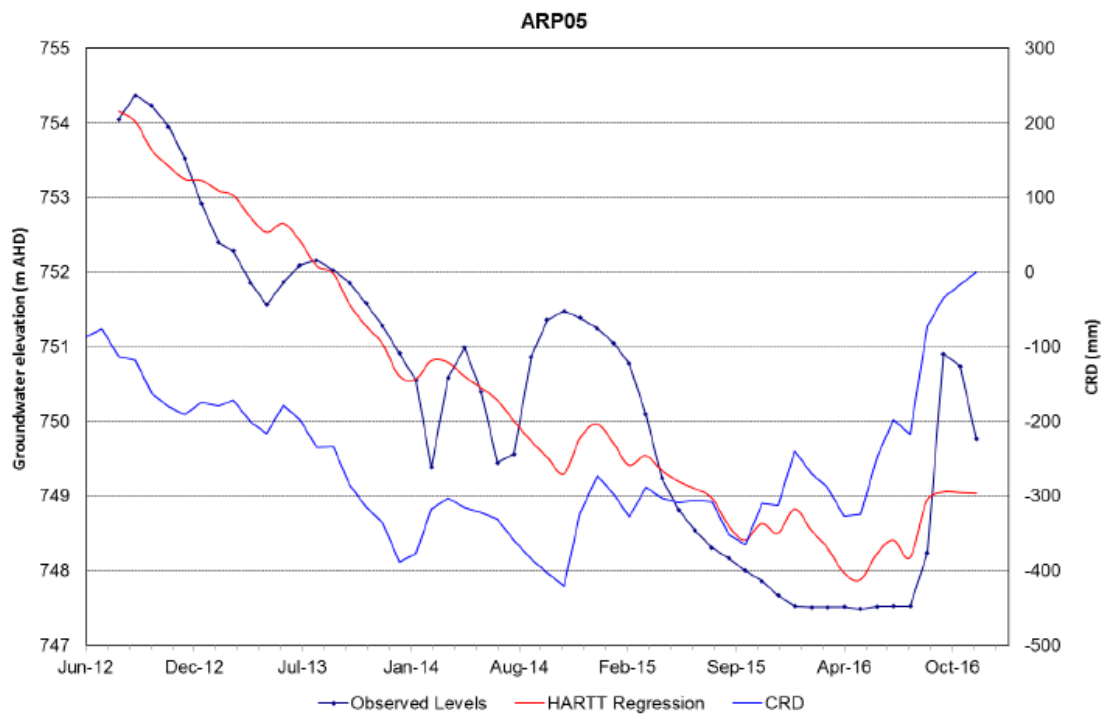
Figure 7.9.2: ARP05 – HARTT Regression

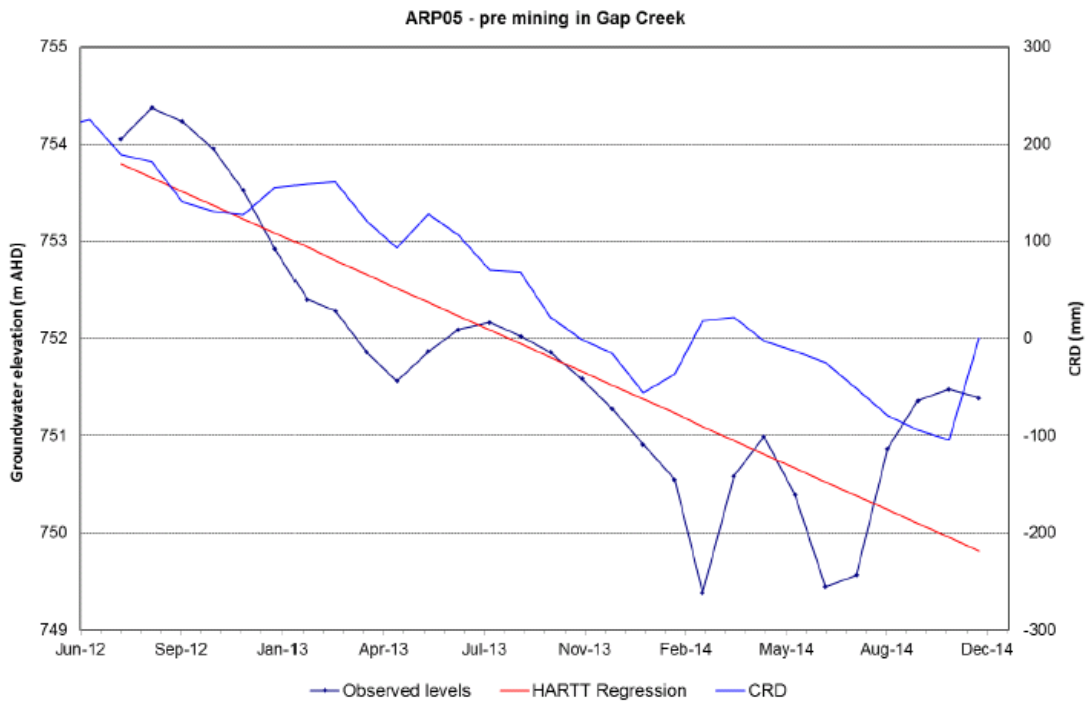
Figure 7.9.3: ARP05 – Pre-mining HARTT Regression

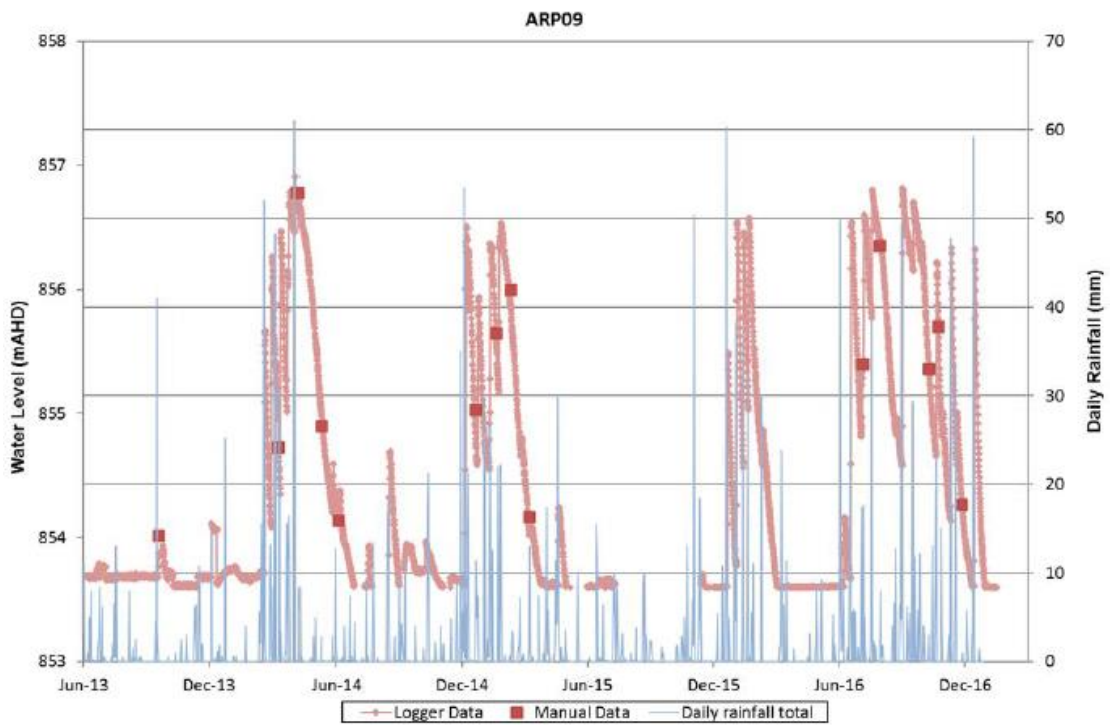
Figure 7.9.1: ARP09 – Rainfall Comparison

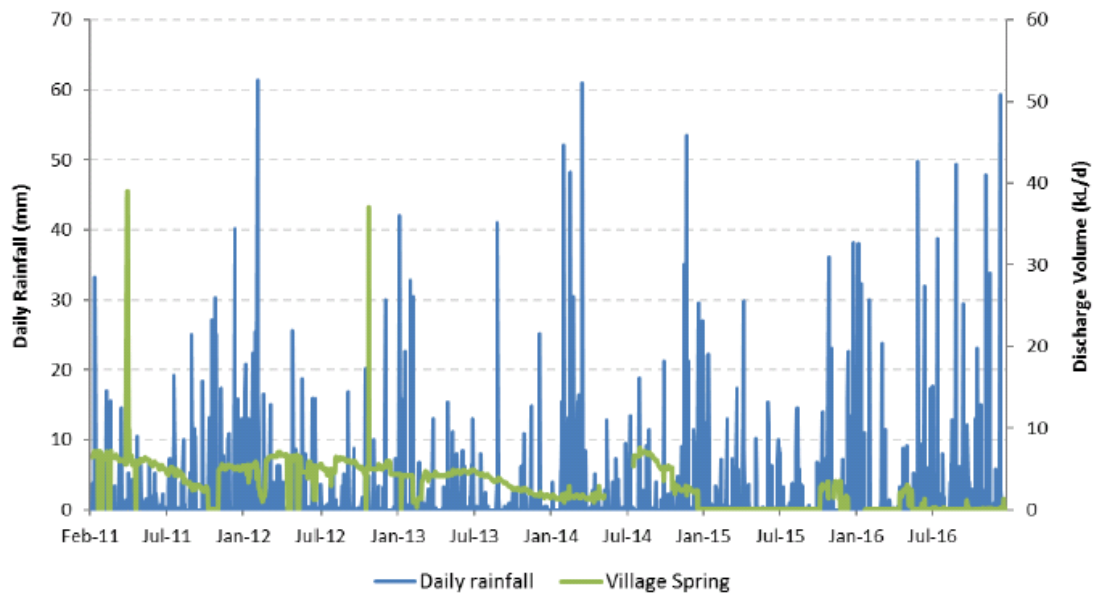
Figure 7.10.1: Village Spring – Seepage Rate

The rate of seepage of groundwater from the Permian strata at Village Spring has been monitored since February 2011 and was monitored throughout 2016. The Village Spring groundwater seepage rate was not available from 1 January 2016 to 30 January 2016. A plot of the daily groundwater seepage rate at Village Spring is shown in Figure 7.10.1. Flow rate gauging indicated that there was no seepage from Village Spring throughout much of 2016.

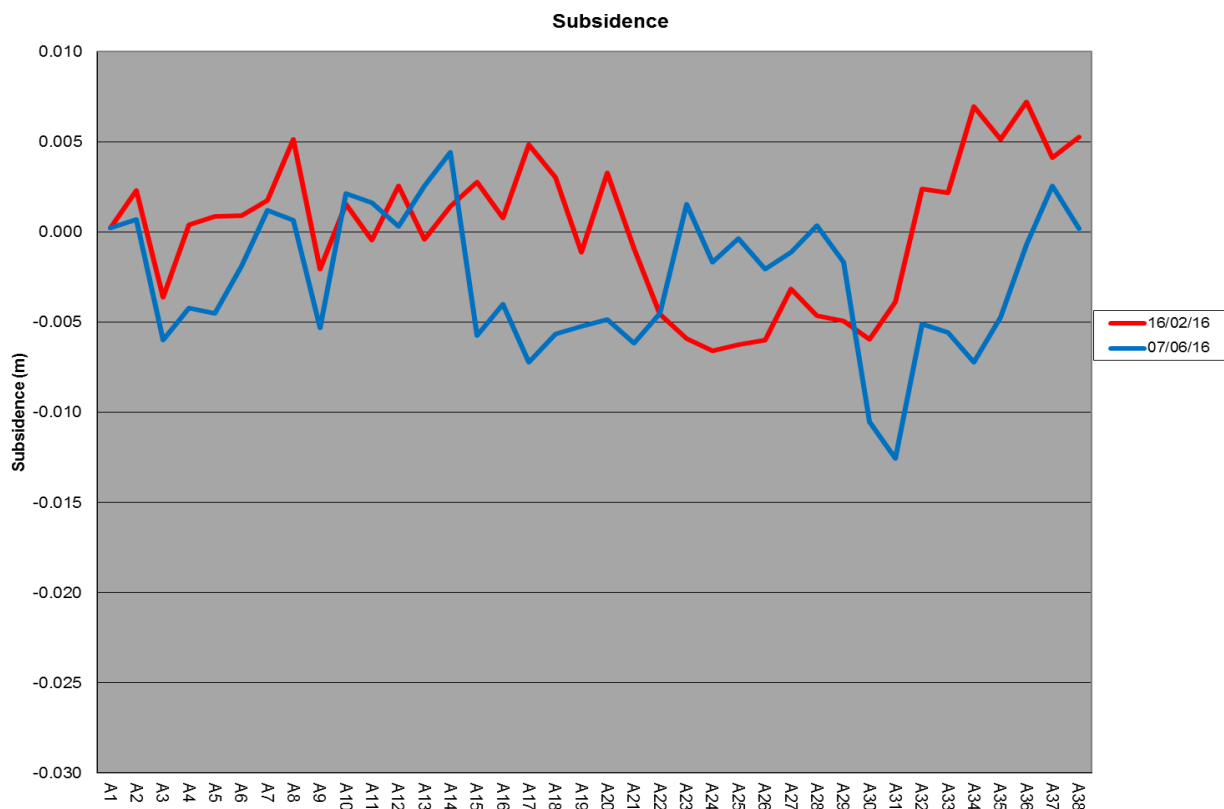
Figure 9.2 Airly Mine Subsidence Results Above 200 Panel

1. The area monitored over 200 panel is a on a ridge (Figure 9.3). The subsidence predictions assume a worst case scenario of a level ground surface placing an even loading an all pillars. The ridge situation over 200 panel has lower DOC on either side resulting in greater stiffness of the adjacent pillars to those under the ridge. This allows load shedding from the deeper pillars to those less stressed by overburden loading nearby.
2. The very low levels of subsidence are potentially impacted by natural ground movements. Subsidence is typically considered to be insignificant below values of 20mm due to these effects. This is tempered somewhat by the results showing a trend of subsidence in the deeper areas as expected.
3. Instrument error can be as much as 3mm. At low levels of subsidence such as these, instrument error becomes a consideration in the overall measurements.

Much of what is being measured in the 200 panel subsidence line is in fact “noise” as mentioned above. General subsidence trends indicate the splitting and quartering system is performing well within predicted outcomes.
