St John the Evangelist Church, Wallerawang

Statement of Heritage Impact

Client Manager: Darrell Rigby
Report Number: PR117929-1
Version / Date: Final April 2014

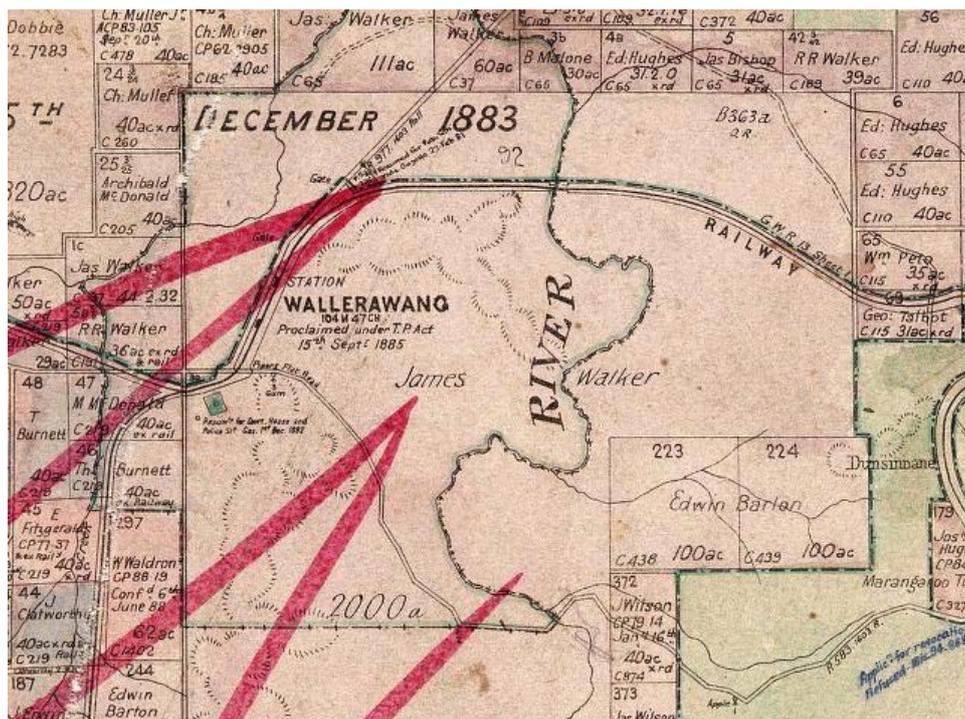
Figure 2: Detail from Lidsdale Parish Map of 1892 showing James Walker's holding at Wallerawang (Courtesy Department of Lands)

Darwin’s description paints a common picture of large farming establishments of the time. The owner did not always live on the property; it was mainly housed by servants. Conditions were rough with the sole purpose of the property being to raise and graze stock for market. A monument commemorating Darwin’s visit now stands on Barton Avenue, near Lake Wallace, at Wallerawang (see **Figure 2**).

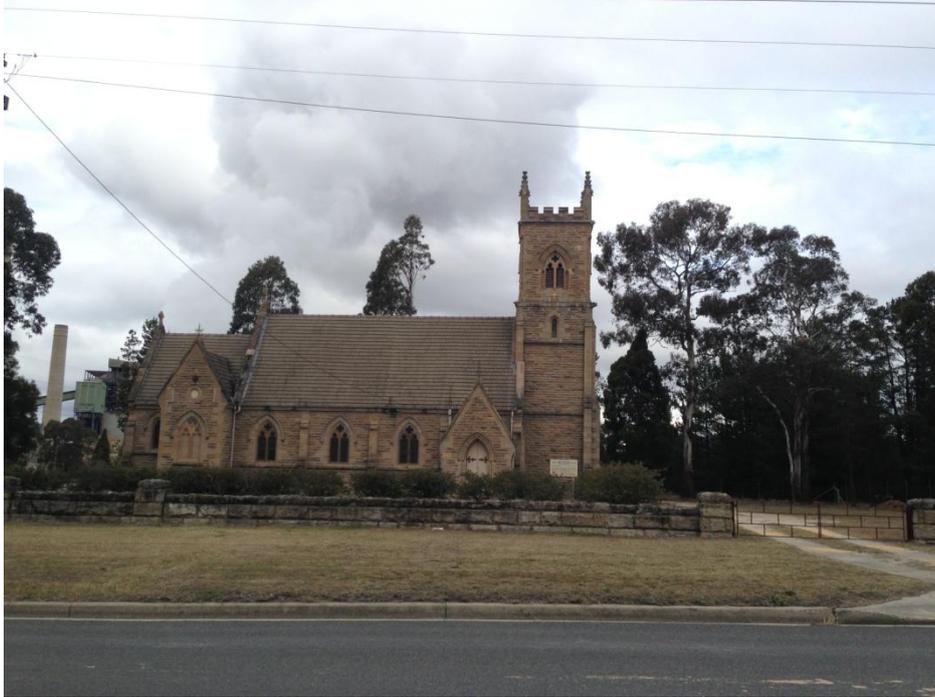
Plate 1: St John the Evangelist, Wallerawang, looking south. Part of Wallerawang Power Station can be seen at far left.

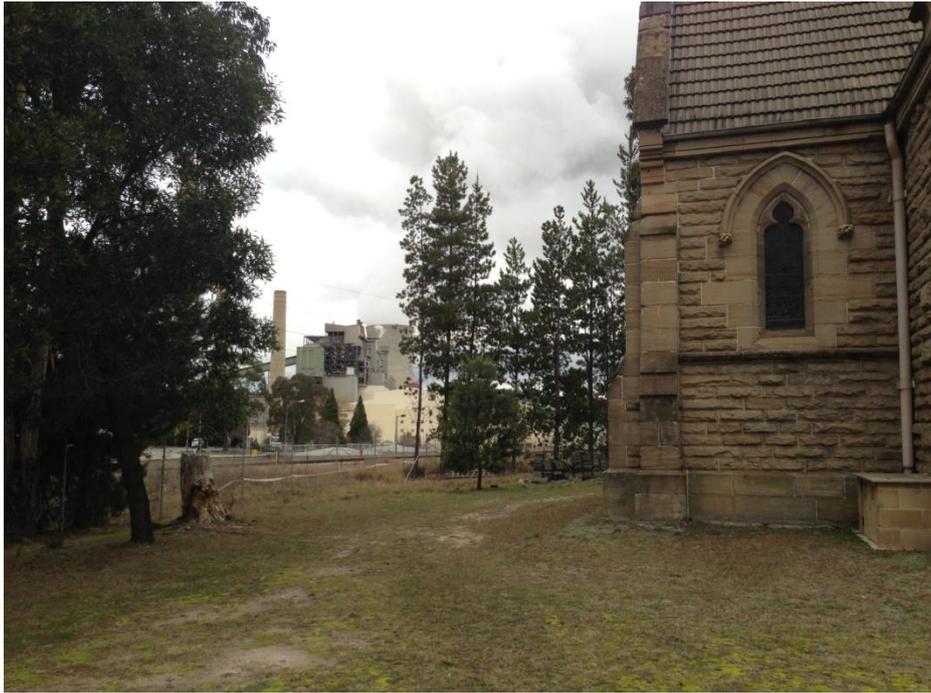
Plate 3: Eastern end of St Johns with Wallerawang Power Station in background.

It is not expected that the construction of the new facilities will have significant additional visual impact on the rural setting of St John's Church. Whilst there may be some impact on the northerly aspect of the church, particularly the new stock pile and conveyor, as noted in the earlier Visual Assessment (RPS, 2012), existing facilities from Lidsdale Siding are already visible from this aspect and despite the Church's prominence at the entrance to the town from the Castlereagh Highway, it is largely already overshadowed by the cooling towers of the adjacent Wallerawang power station (**Plate 3**).

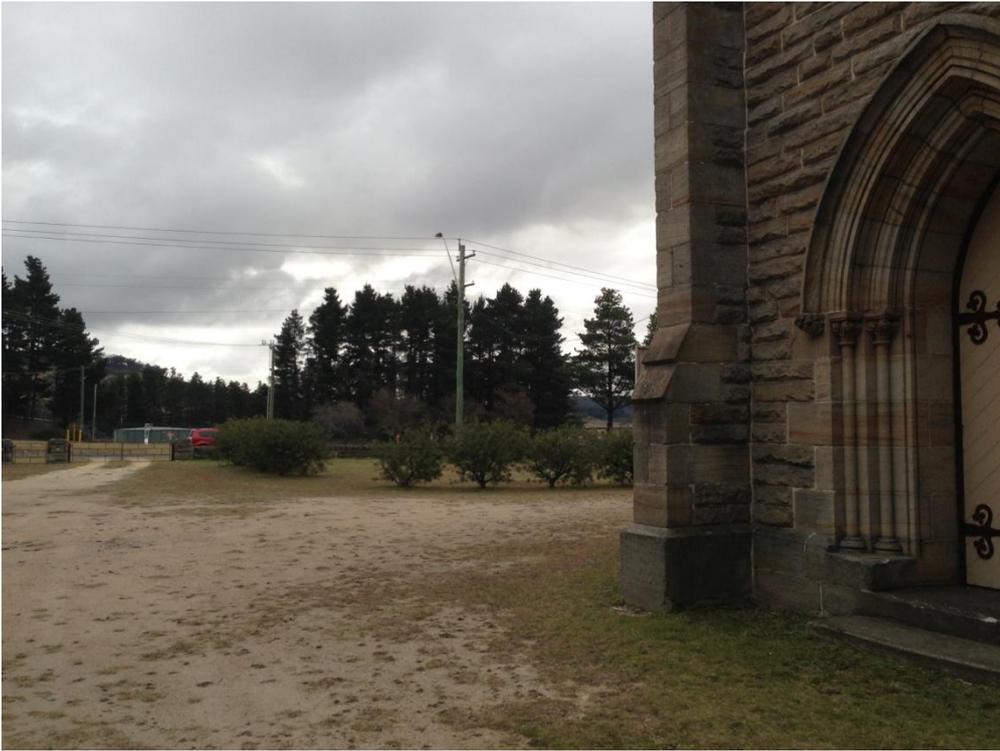
Plate 5: Western doorway of St Johns (at right) looking north across the road towards Lidsdale Siding facility

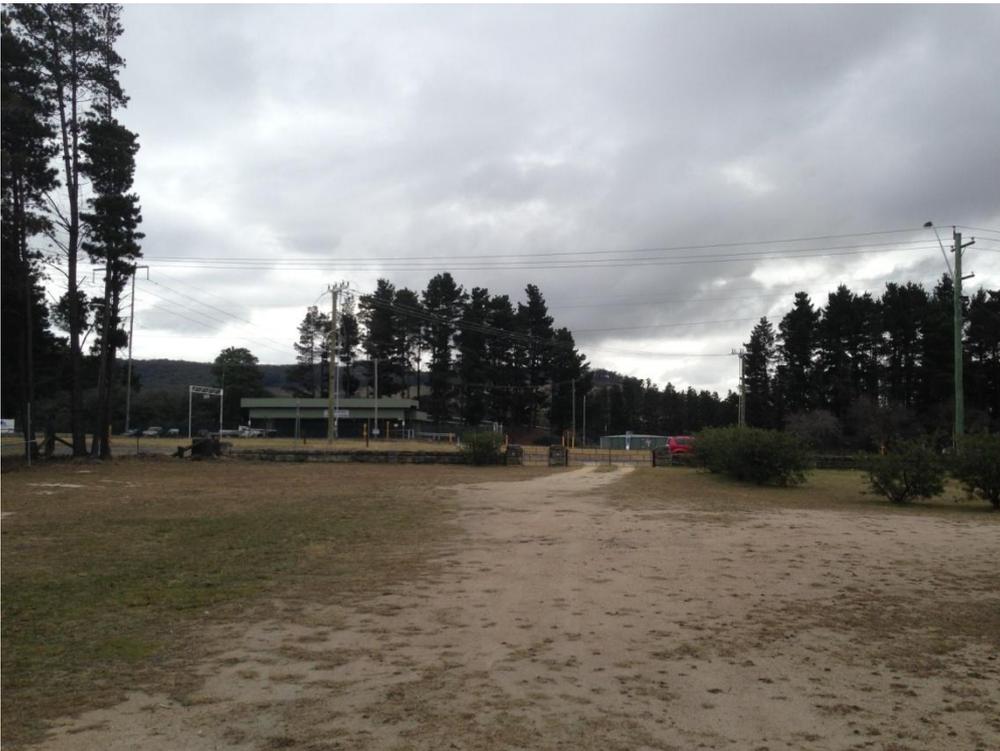
Plate 6: Lidsdale Siding facility viewed from St John's, looking north.
