# ARCHAEOLOGY ASSESSMENT

**Archaeology Assessment  
For  
Proposed Powerline  
At  
Airly Coal Mine  
Near Capertee, NSW**

Job No: 25401  
Date: June 2009

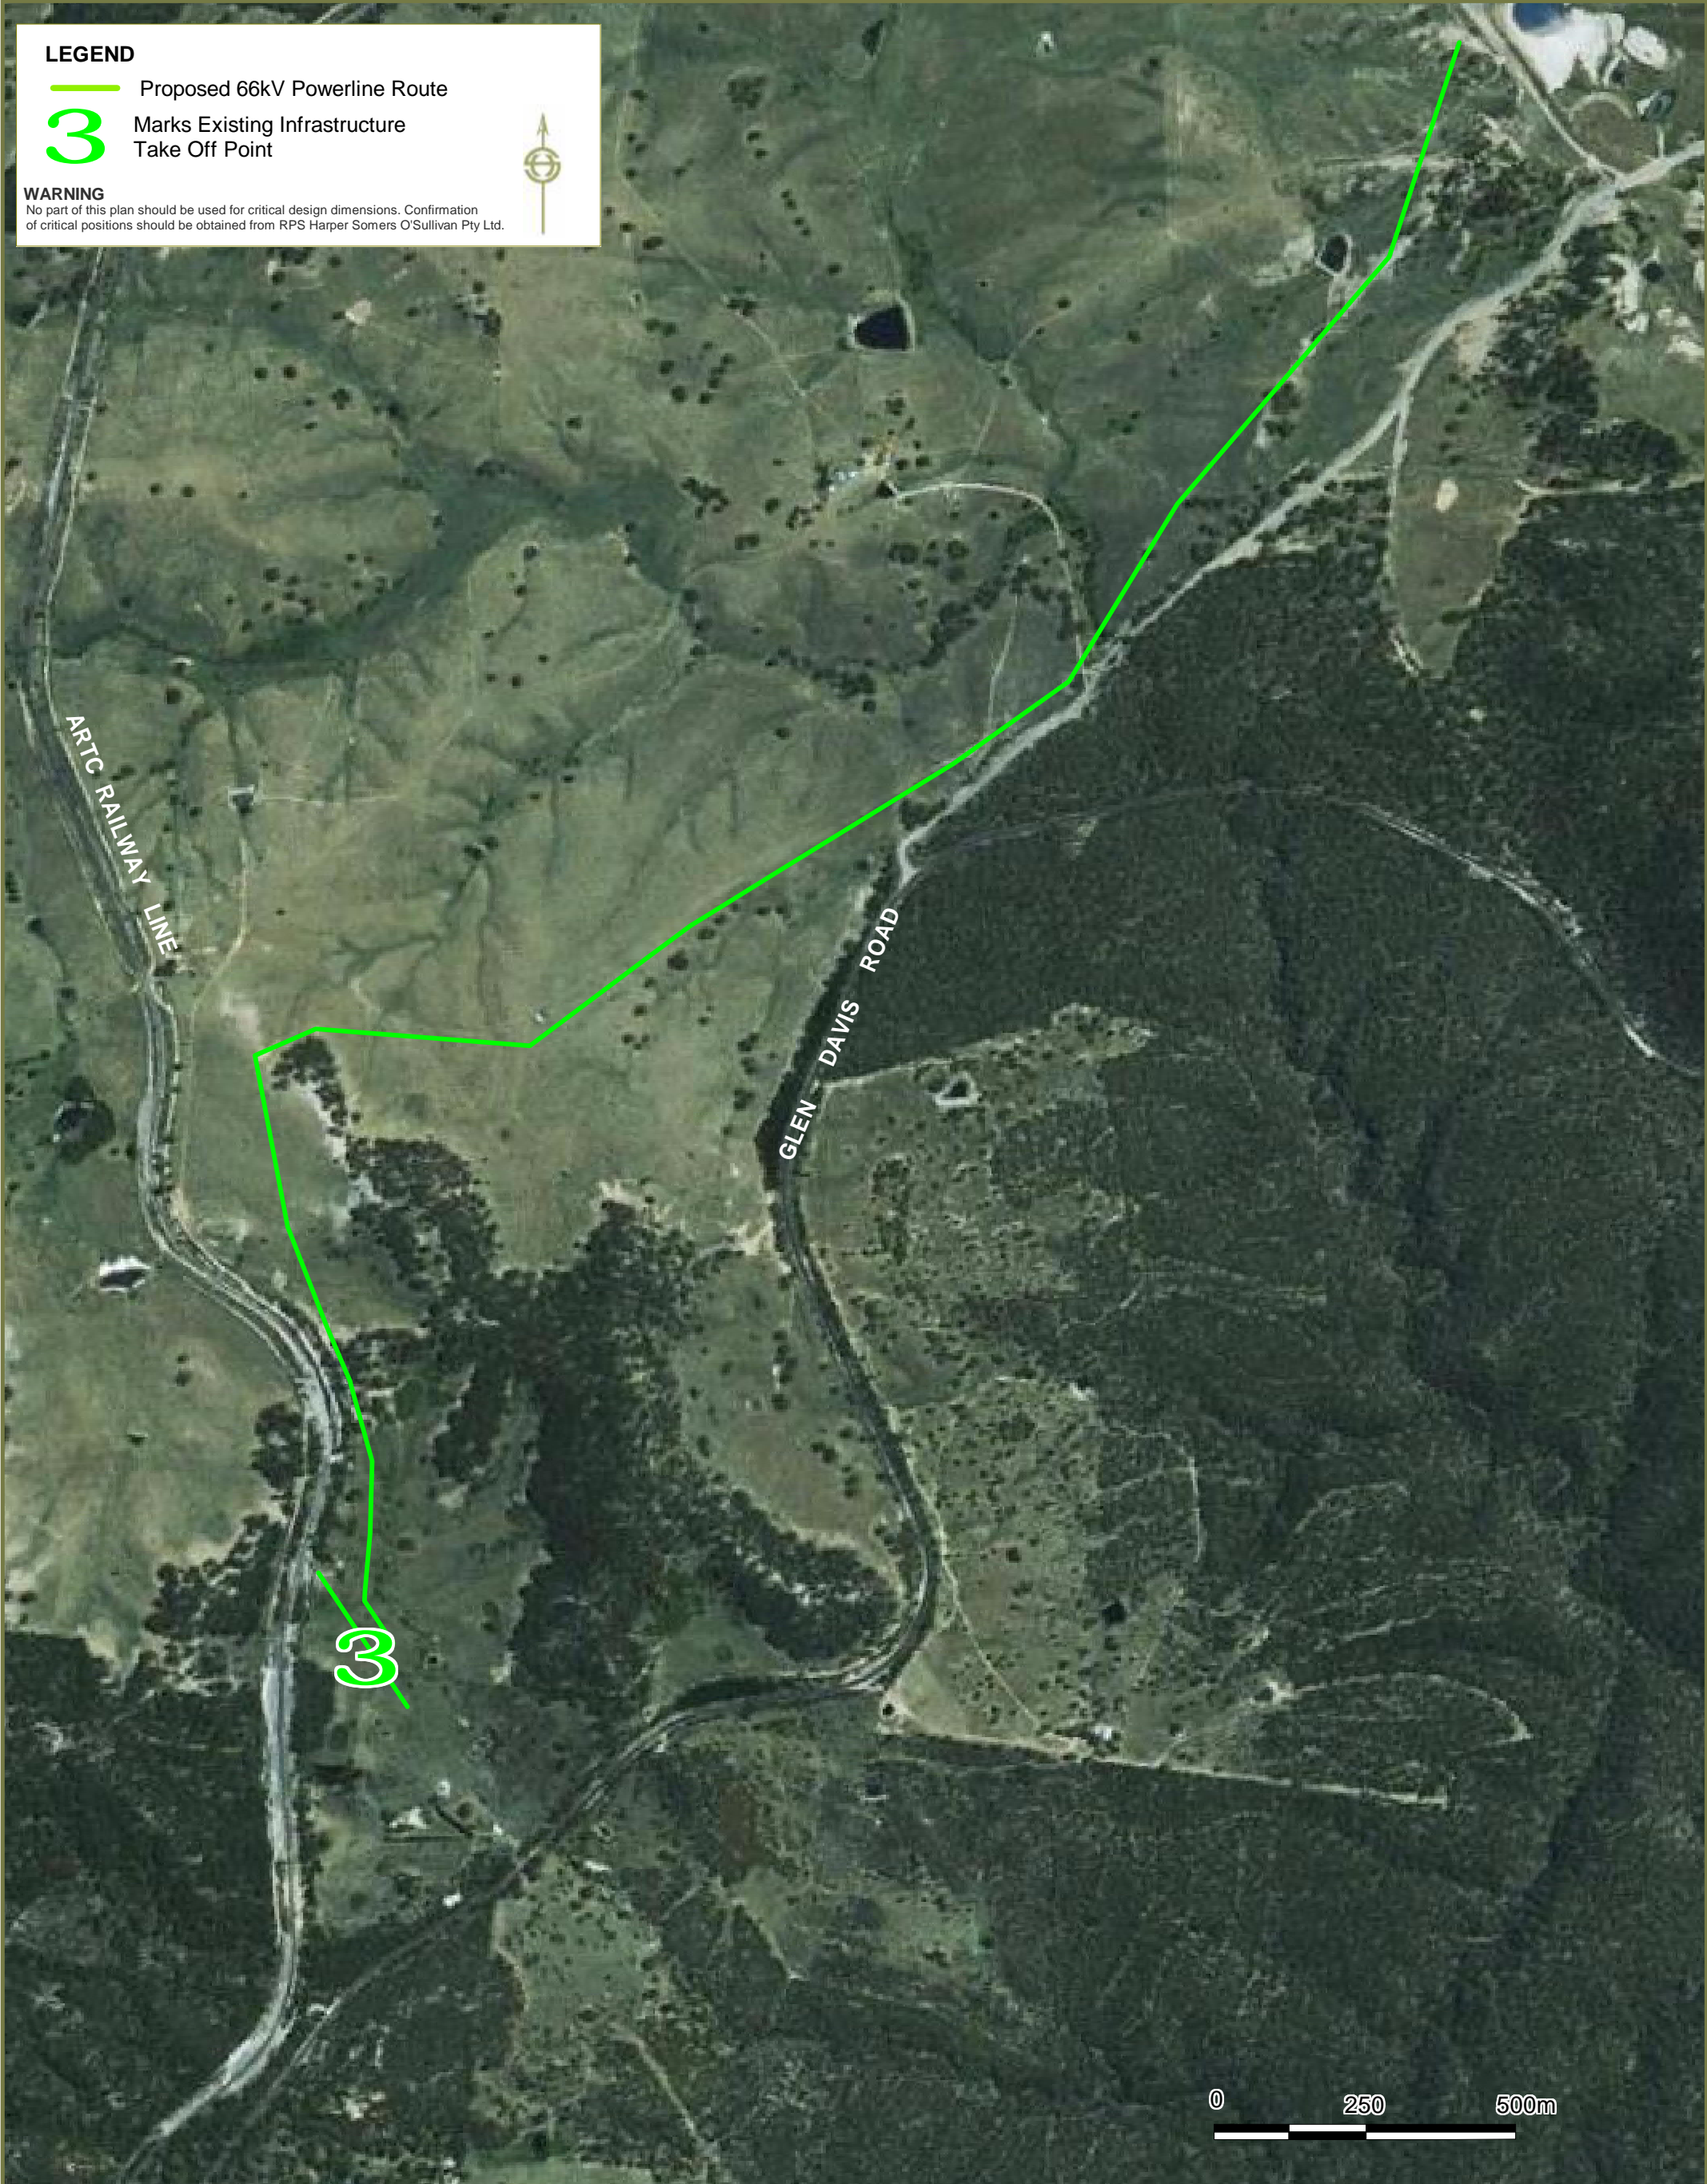
<p><b>TITLE:</b> Figure 1-2 Proposed 66kV Powerline Route AIRLY PROJECT</p> <p><b>CLIENT:</b> Centennial Coal Pty Ltd</p> <p><b>PLANNING SURVEYING ECOLOGY</b></p>

The proposed powerline will commence from the Integral Energy take-off point (Figure 1-2) and continue in a north-east direction towards Airly. The proposed powerline route will be owned and maintained by Centennial and will include the following:

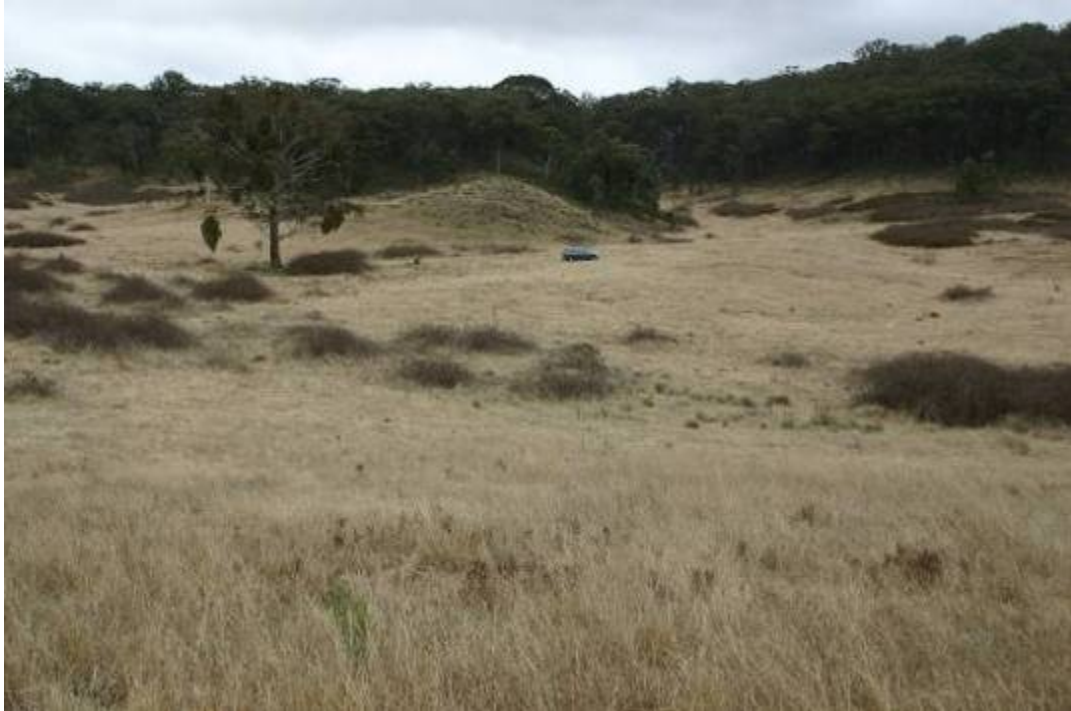
**Plate 1: Photo of Powerline Take off Position**

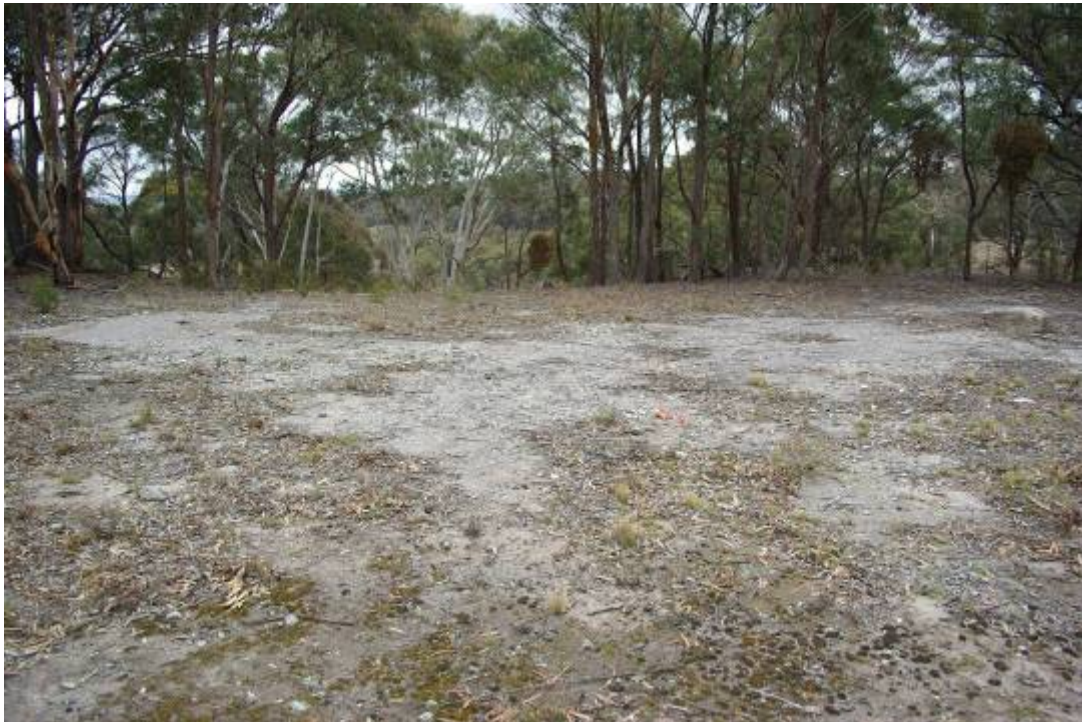
Strewn along the saddle is a scatter of quartz artefacts (Plate 2). The artefacts were predominantly located on the western side of the saddle in a cleared area. This area has been partially disturbed by farming activities and includes access tracks, vegetation clearing, fencing and grazing. The quartz raw material is of a much better quality than the local quartz material observed along the ridge to the south. The quartz had been knapped by free hand percussion rather than the usual bipolar technique used for quartz (Plates 3&4).

**Plate 2: Quartz Artefact Scatter. Scatter is approximately 25m<sup>2</sup> in area.**

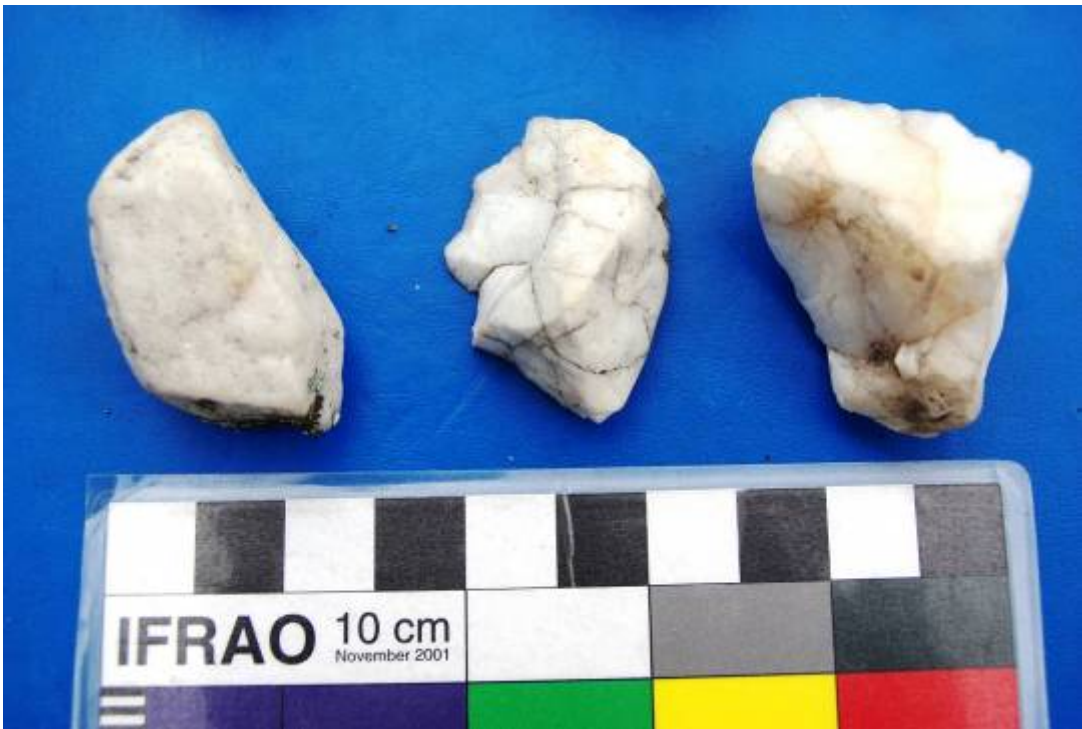
Plate 3: Quartz Artefacts

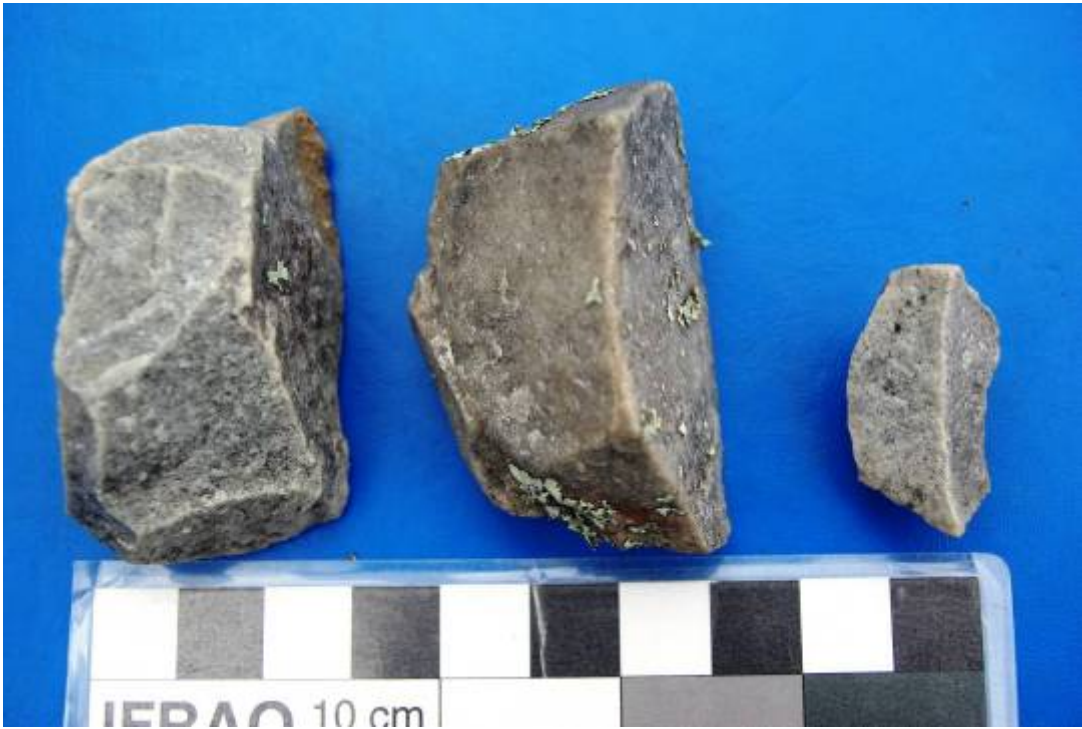
Plate 4: Quartzite artefacts
