Consent Conditions Extract - Mandalong

Mandalong Compliance Audit Of Consent Conditions

Mandalong - Groundwater Monitoring Review 2013 (G1455J)

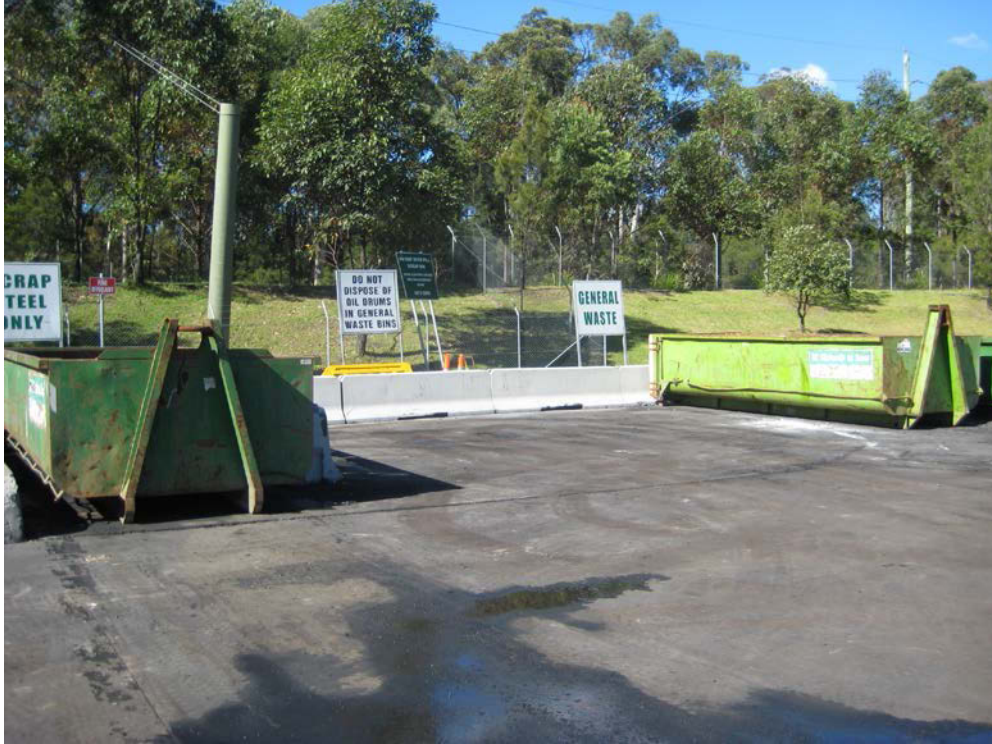
Plate One: New Waste Bunker installed at the Mandalong Mine in 2013

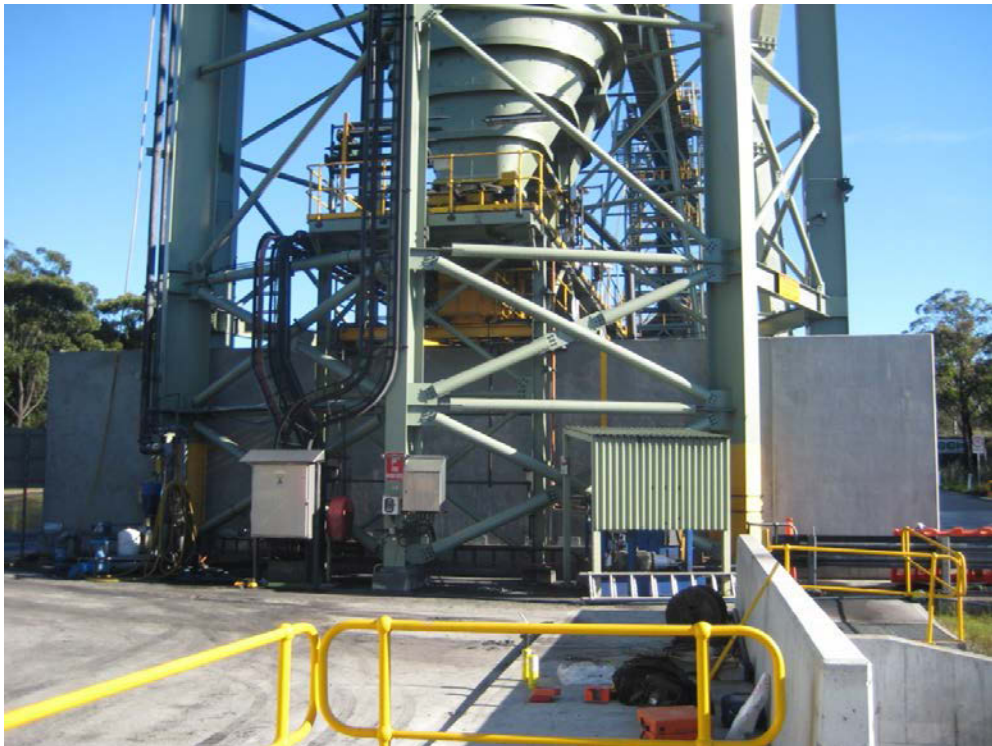
Plate Two: Cooranbong Export Bin Sound Wall installed in May 2013.

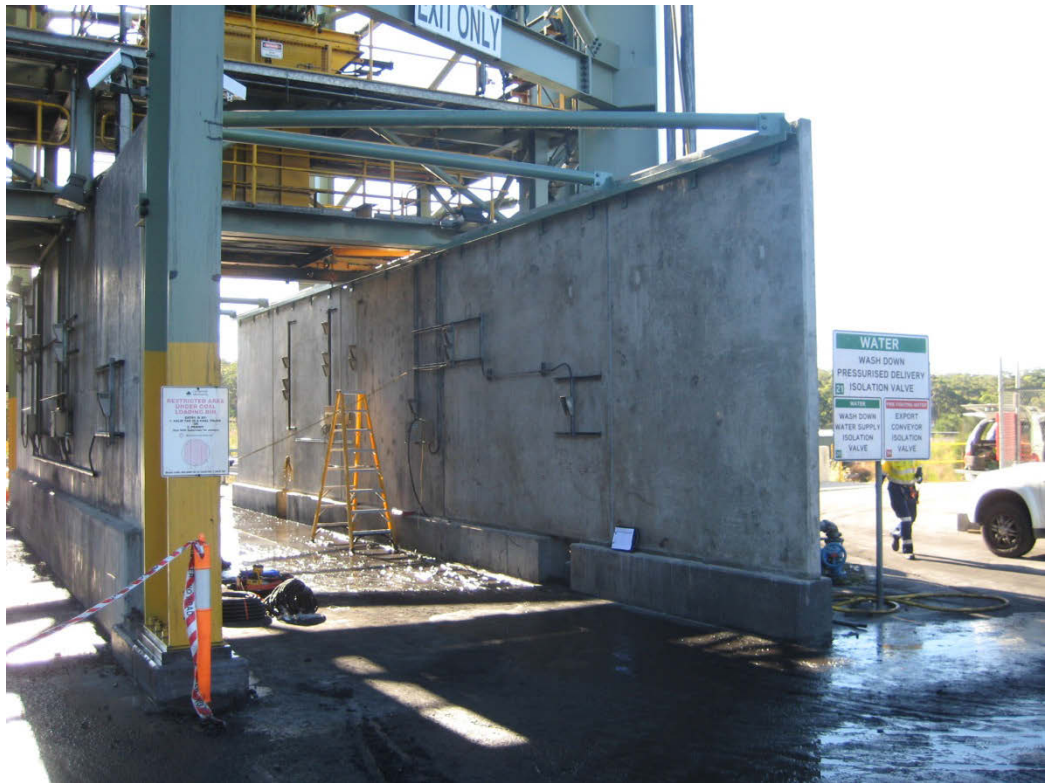
Plate Three: Cooranbong Export Bin Sound Wall installed in May 2013.

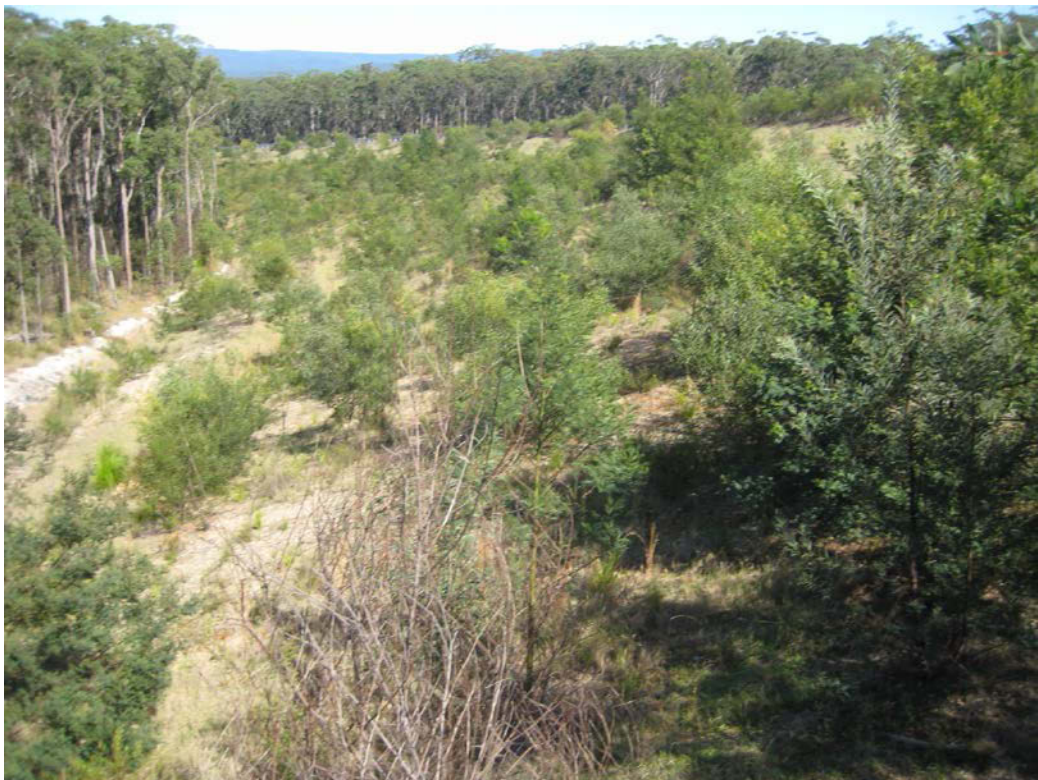
Plate Four: Mandalong Haul Road Rehabilitation October 2013.

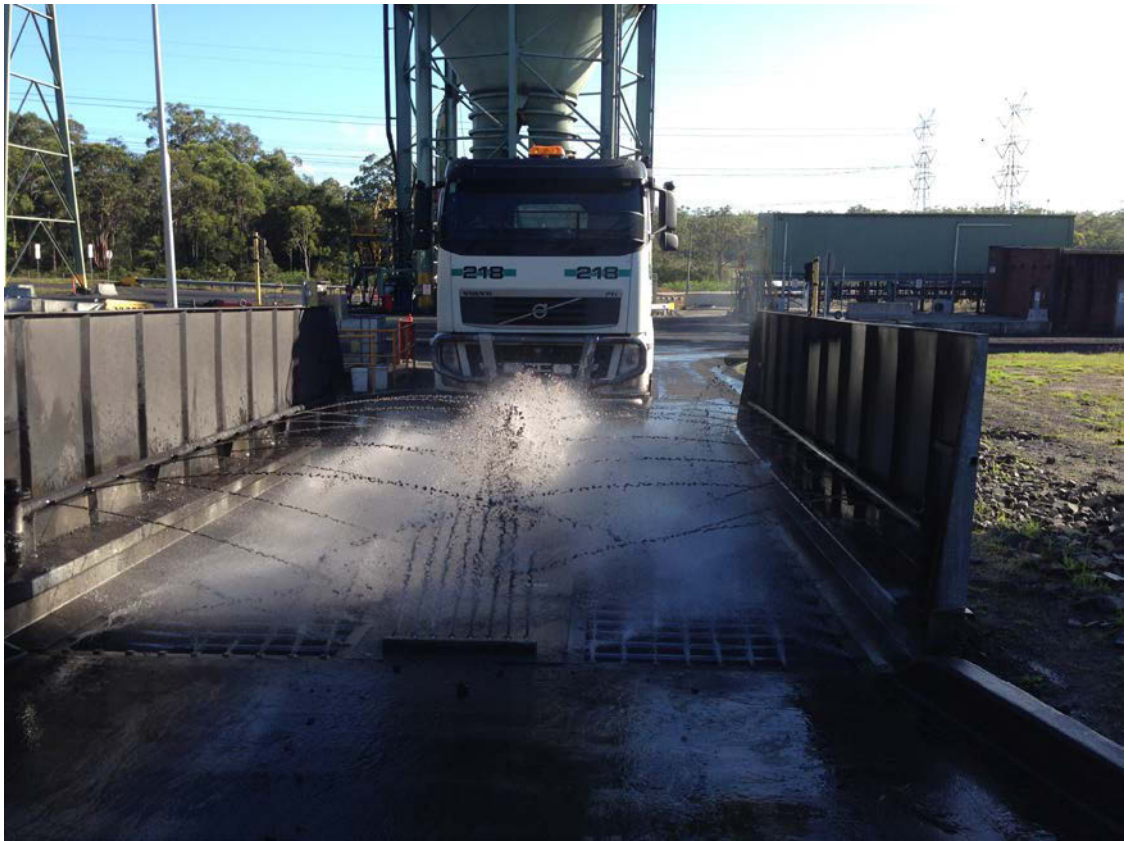
Plate Five: Cooranbong Truck Wheel Wash installed in October 2013.

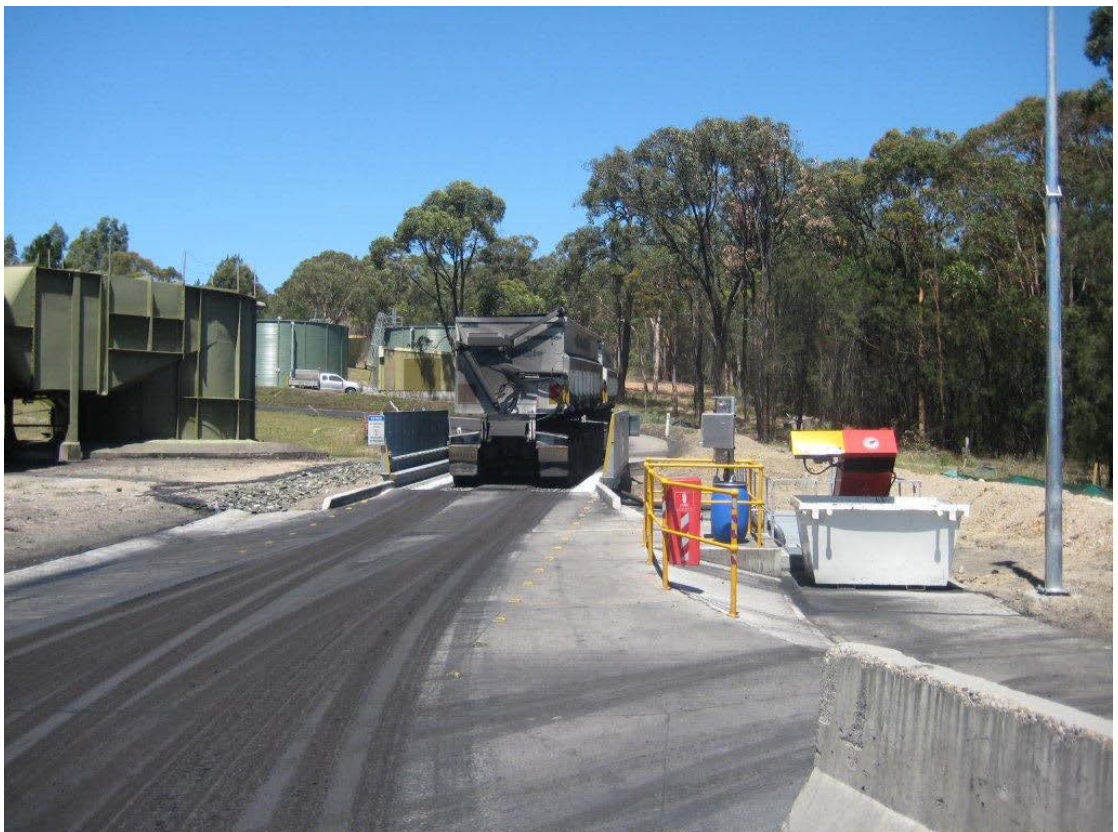
Plate Six: Cooranbong Truck Wheel Wash installed in October 2013.

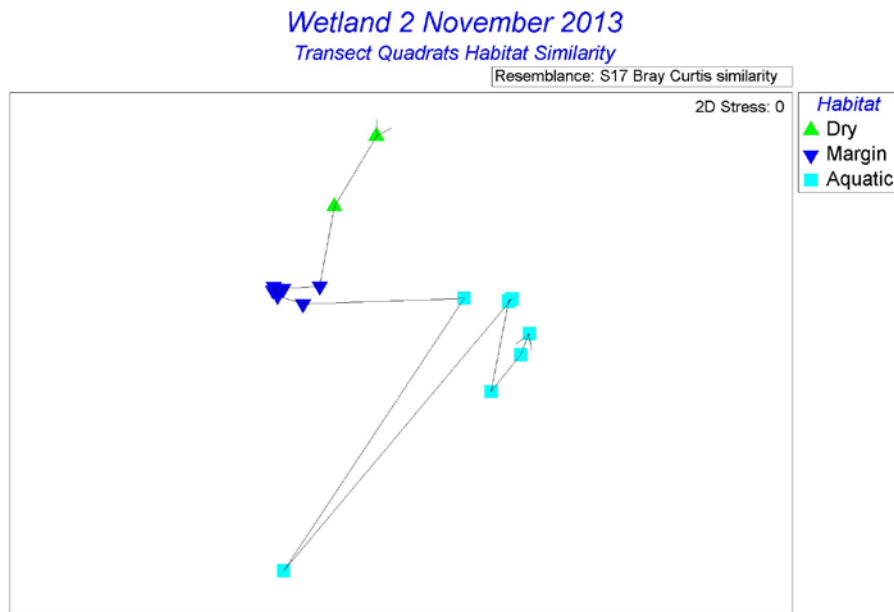
A two metre mesh fence around Wetland 2 will keep out feral deer and other herbivores. Fencing around Wetlands 4 and 5 is normal stock fencing that is proving ineffective against deer. Evidence is now accumulating pointing to a consistent reduction in diversity across all wetlands since monitoring commenced and the cause is tentatively suggested to be increased herbivory by both domestic and feral animals.

This wetland (**Figure 9**) was again full of water. However, other than for two quadrats at the start of the aquatic habitat, there were no water plants present. As reported previously, feral deer were recorded grazing in this wetland and are likely to have contributed to the loss of aquatic vegetation. This wetland was fenced from domestic stock but the tenant on the property reports having seen many deer inside the fence.

Figure 9 MDS showing Wetland 2 transect quadrats grouped according to habitat type

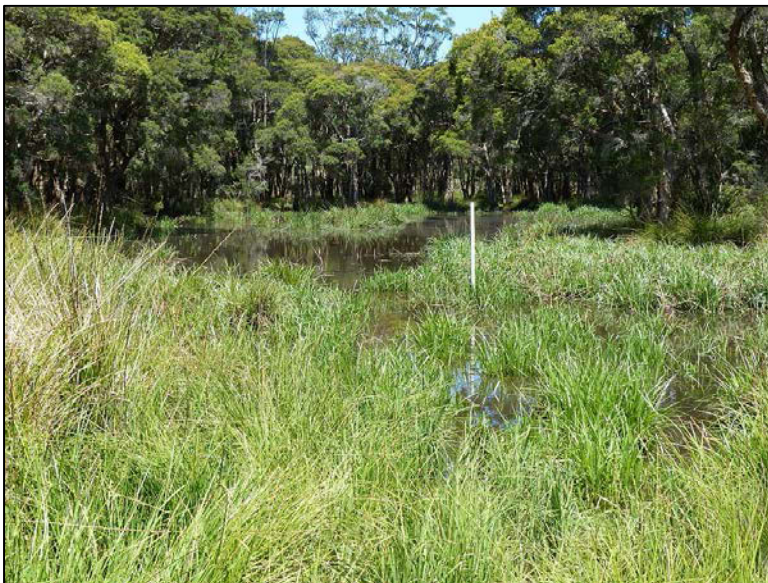
This wetland was full of water and **Figure 13** shows a sharp distinction between margin and aquatic habitat. As previously, there was no longer any dry habitat present. The Aquatic habitat was dominated by dense *Cyperus exaltatus*.

Figure 14 Wetland 6 aquatic habitat dominated by grazed *Cyperus exaltatus*

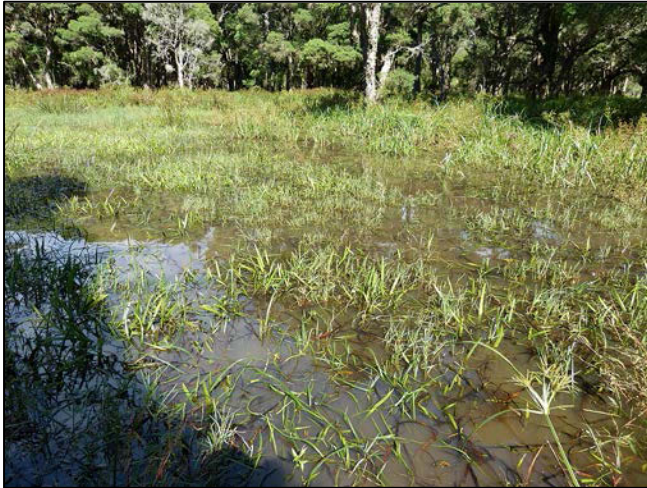
The dense patch of the threatened *Maundia triglochinoidea* reported in November 2012 (**Figure 15**) was substantially reduced in April 2013 (**Figure 16**) and further reduced in November 2013 (**Figure 17**). It is not known what causes this change but the abundance of this species has also reduced since April 2009 in wetlands 1, 2 and 4.

Figure 16 Wetland 6 Maundia triglochinooides patch April 2013

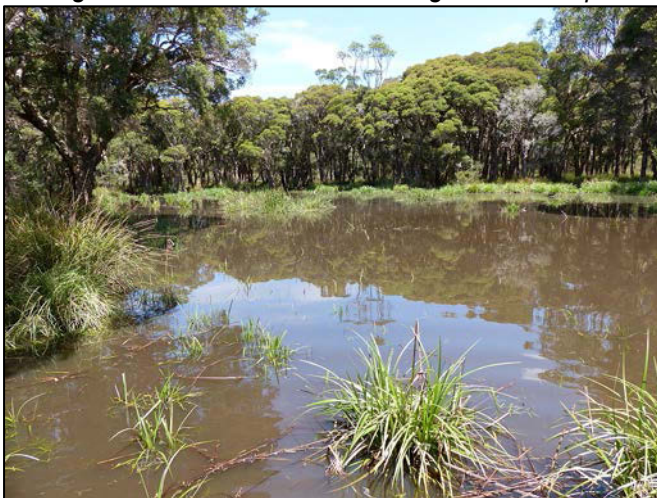
Figure 17 Wetland 6 Maundia triglochinooides patch November 2013

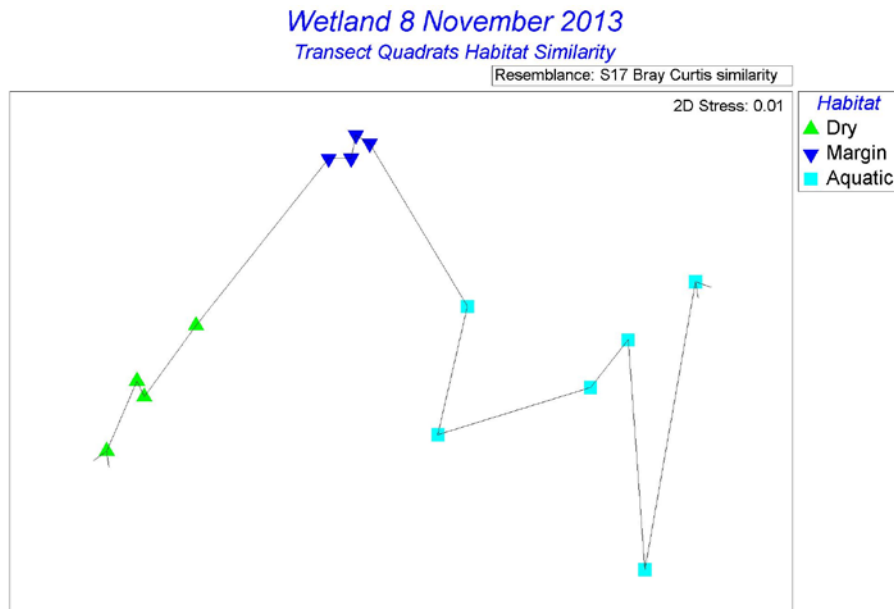
This wetland was again full of water and **Figure 18** shows the distinct habitat transitions. While there was no evidence of any change in this wetland that could be attributed to subsidence, it is apparent that water has ponded immediately to the south.

Figure 18 MDS showing Wetland 8 transect quadrats grouped according to habitat type

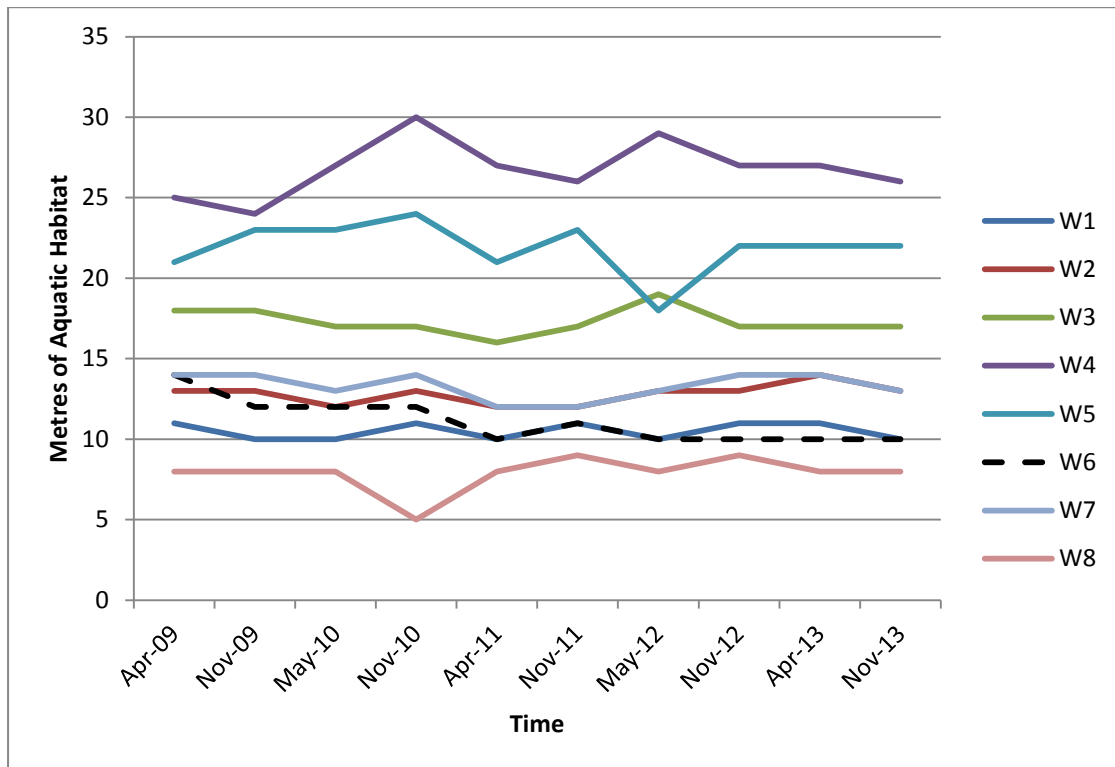
Figure 20 shows the metres of aquatic habitat in each transect over time. Previously regression analysis showed that in Wetland 6 aquatic habitat had been significantly reduced as margin habitat had extended. However, the extent has remained the same over the last four sampling periods including November 2013. For all other wetlands the variation has not been significant.

Figure 20 Metres of Aquatic habitat in each wetland transect over time

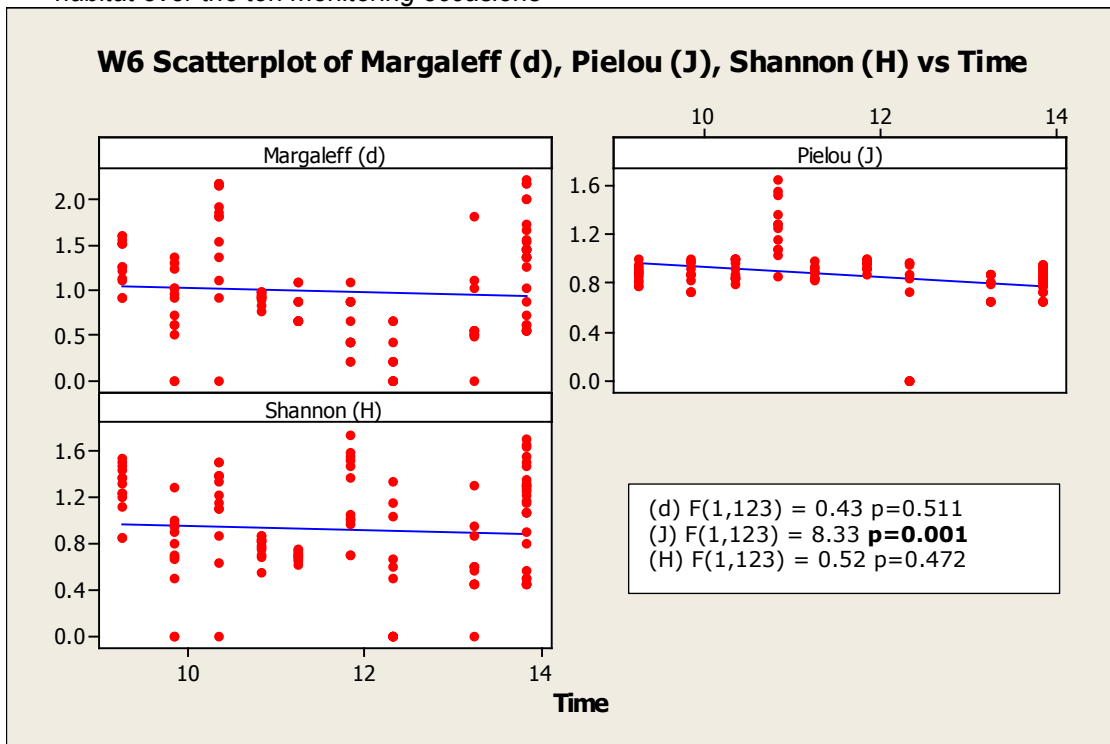
Wetland 6 is located over the pillars between longwalls 11 and 12 that were subsided in September 2011 and April 2012 respectively. Subsidence monitoring indicates that the land has tilted to the north west and this appears to have been expressed by the original dry habitat vegetation being replaced by margin habitat species due to increased inundation.

Figure 24 Wetland 6 plots showing the trend of the three diversity indices for aquatic habitat over the ten monitoring occasions

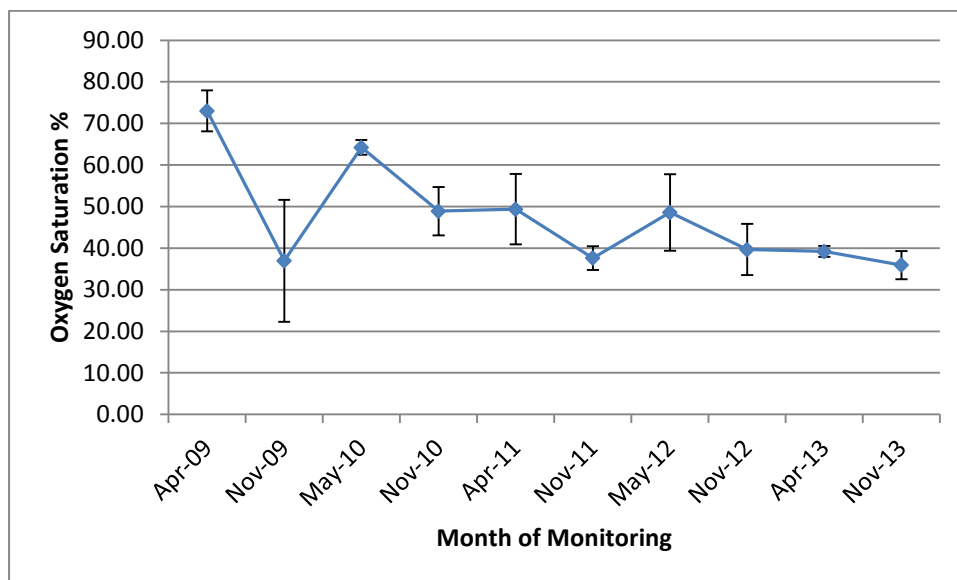
Previous analyses have shown a general downward trend in oxygen saturation for individual wetlands, although not all trends were statistically significant. **Figure 32** shows the combined trend for all wetlands for the ten monitoring occasions.

Figure 32 Oxygen saturation levels over time for each wetland (bars are standard error)

Simple linear regression shows a significant downward trend with $F_{(1, 68)} = 11.37$, $p = 0.001$.
