# MAIN TAILINGS DAM ANNUAL TYPE 2 INSPECTION, NEWSTAN COAL MINE

## CENTENNIAL COAL

OUR REF: 2122823B-GEO-REP-17088 REVA\_FINAL.DOCX

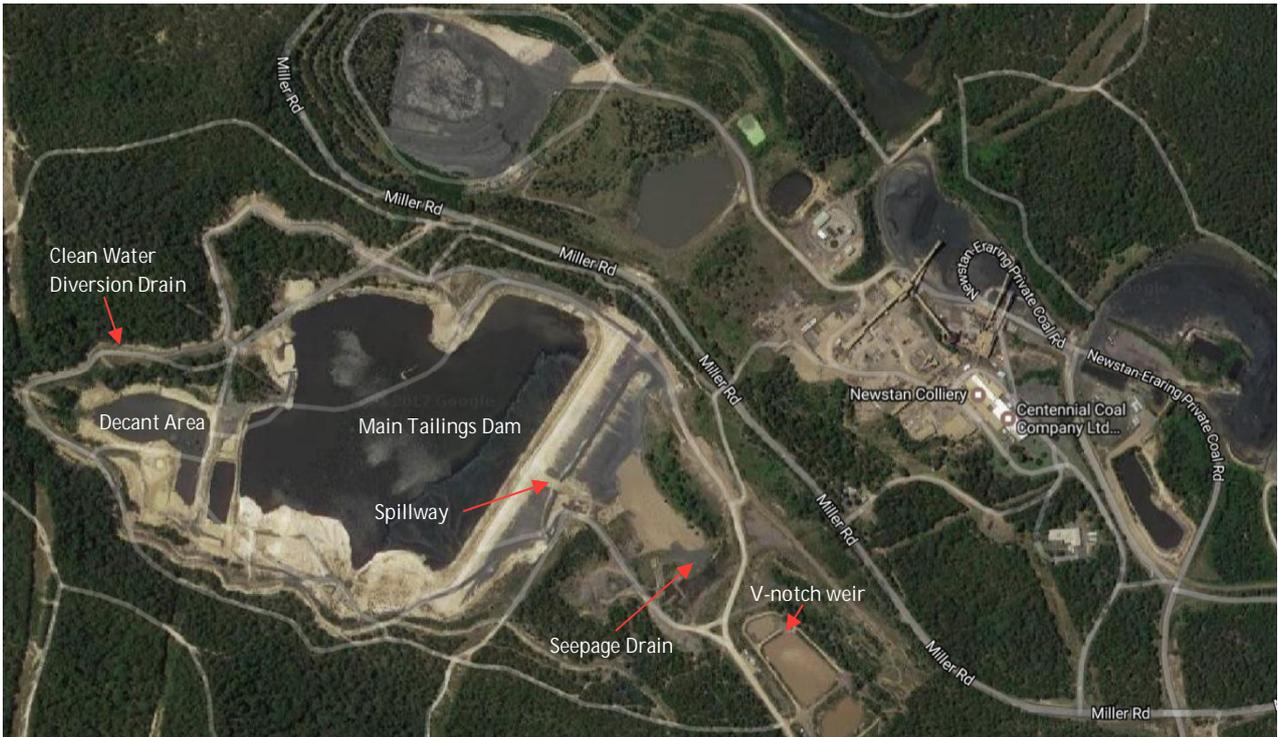
Figure 1.1 Main Tailings Dam Location (Google Maps)

The Main Tailings Dam is in the Southern Reject Emplacement Area (SREA) at Newstan Colliery. The dam is on the southern side of Miller Road opposite the existing Newstan Colliery pit top facilities. The location of the dam within the mine site is shown on Figure 1.1 below.

This is an interim emergency spillway until the final embankment height is reached. The spillway has been completely lined with rock rip rap and the invert level was at RL 42 m at the time of the inspection. The location of the spillway is shown on Figure 1.1

A small decant dam is located at the western end of the tailings dam. The decant dam is formed by a rock wall which acts as a filter screen for the supernatant that accumulates on the dam surface. The supernatant filters through the rock screen and is removed via a borehole into the underground workings in the Fassifern Seam, or is pumped to other surface water storage facilities at the site. The location of the decant dam is shown in Figure 1.1.

The flow in the drain is checked during routine inspections and sediment is cleaned out as required. The flow from the drain is measured by visual inspection and a v-notch weir located at the Seepage Dam which is immediately downstream of the Main Tailings Dam. Any increases in observed flow over the v- notch weir are noted during routine inspections. The location of the seepage collector drain and v-notch weir is shown on Figure 1.1.
