Ivanhoe North

Centennial Coal

Annual Environmental Management Report

2013

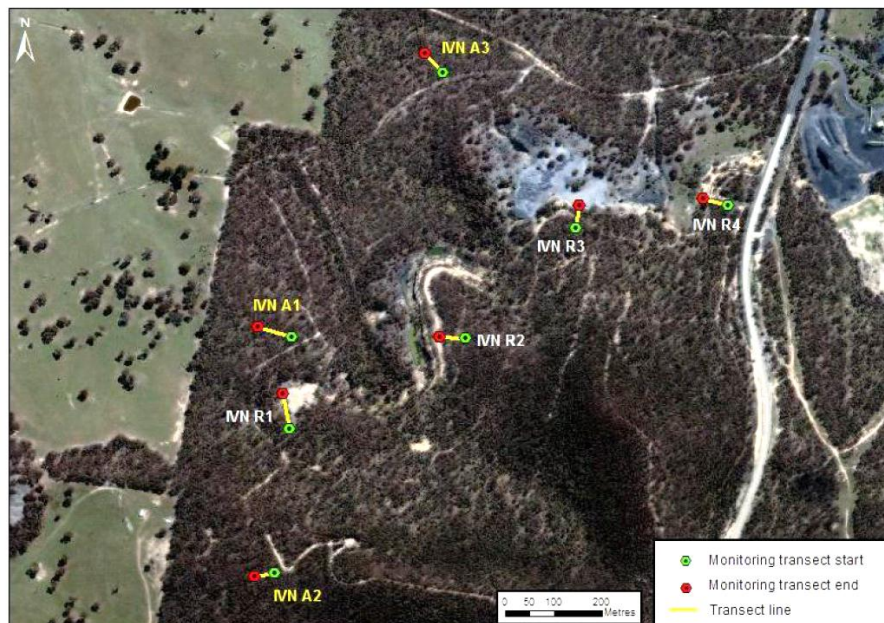
Figure 7. Monitoring Transect Locations at Ivanhoe North Colliery

- IVN R1 (established in 2011): located mid slope in a relatively flat area of the rehabilitated landform;
- IVN R2 (established in 2013): located on the upper slope of the rehabilitated landform;
- IVN R3 (established in 2013): located on the upper slope of the rehabilitated landform; and
- IVN R4 (established in 2013): located on the upper slope of the rehabilitated landform (**Table 12 and Figure 7**).

Despite the increase observed in 2012, the LOI at IVN R1 dropped back to a very low value of 0.02, which reflects the unsuccessful establishment of perennial ground cover at this site. In contrast to the other rehabilitation transects, IVN R1 is established in a flatter area lacking the trough and bank structure promoting the retention of resources and the gradual establishment of ground cover.

Overall, the landscape organisation at all rehabilitation sites poorly compare with that observed in analogue sites (where LOIs are comprised within 0.66-0.81). In the case of IVN R2, IVN R3 and IVN R4 this performance is explained by the young age of rehabilitation, and the LOIs at these sites are expected to increase in the coming years as the troughs trap resources and promoting the establishment of ground cover in larger areas. However, the situation appears different for IVN R1 where monitoring over the last three years indicates that ground cover is failing to establish (still >90% of bare ground recorded in 2013).
