CENTENNIAL COAL CLARENCE COLLIERY ANNUAL REVIEW

January 2018 to December 2018

March 2019

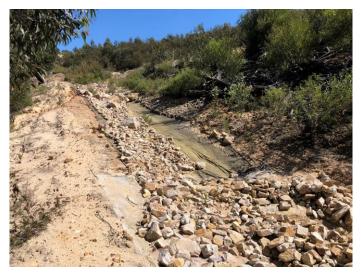
No.	Photo	Observation description	Action required
1	Photo 1	Erosion – low severity erosion in drainage structures at REA IV, evidenced through rocks being washed down and exposing the geotextile fabric.	 Implement regular visual inspections of the drains (particularly following significant rainfall events) to ensure structure integrity and stability are maintained.
2	Photo 2	Erosion – severe gullying within the diversion drain at REA IV, with gully channel near 1 metre deep at its most severe.	• Repair the diversion drain structure.
3	Photo 3	Erosion – failed outside batter of diversion drain at REA IV, with sediments actively washing into adjacent natural bushland.	• Repair the diversion drain structure.
4	Photo 4	Erosion – localised area of moderately severe and frequent gullying within REA III. The erosion has exposed large amounts of carbonaceous material to the surface, and the capping depth was observed as inadequate (<20cm).	• Given its location on the perimeter of the REA, consider re-working the area when rehabilitation works in the adjacent area are undertaken, including the reconstruction of a cap of sufficient depth.

Photo 1 Low severity erosion in rock drain structure (REA IV)

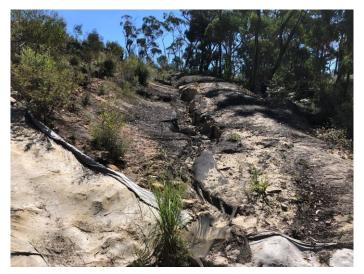
Photo 2 Severe gully erosion channel within diversion drain (REA IV)

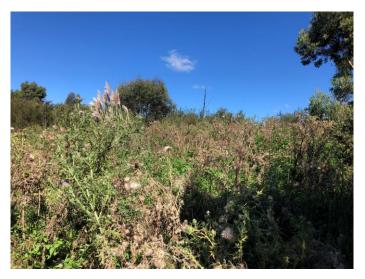
5	Photo 5	Weed incursion – severe weed infestation along the length of the installed irrigation pipe within REA I, dominated by including Thistles, Blackberry Nightshade and Pampas Grass. Weed growth likely promoted by nutrient rich water.	 Remove the weed infestation through chemical control, targeting Pampas Grass as the highest priority. The use of the irrigation system must be suspended during and following herbicide applications to prevent chemical drift and leaching.
6	Photo 6	Weed incursion – Pampas Grass (isolated plant or small cluster of plants). Recorded in all REAs.	• Control the species as per the mechanisms suggested in Table II of this report.
7	N/A	Weed incursion – Blackberry (isolated plant) (REA II).	 Control the species as per the mechanism suggested in Table II of this report.
8	Photo 7	Weed incursion – St John's Wort rapidly establishing in contour bank trough in REA IV.	• Control the species as per the mechanisms suggested in Table 11 of this report.

Photo 5 Severe weed infestation along irrigation pipeline (REA I)

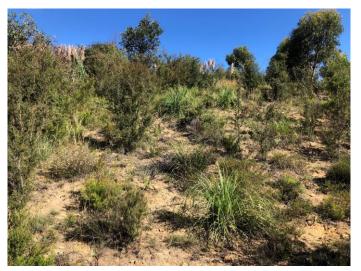
Photo 6 Pampas Grass incursion (REA I)

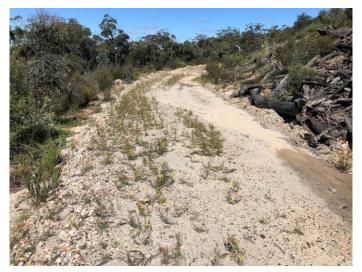
Photo 7 St John's Wort incursion (REA IV)

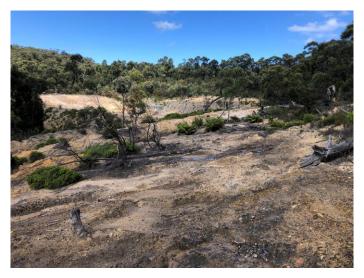
9	N/A	Weed incursion – Paterson's Curse (isolated plants on top of REA IV landform).	• Control the species as per the mechanisms suggested in Table 11 of this report.
10	Photo 8	Vegetation establishment – several areas across REA III showed overall poor vegetative performance, typically with high levels of exposed bare ground and limited shrub/tree establishment. In some locations tubestock plantings were previously established but did not survived.	 Consider further soil investigations / testing to determine growing media suitability in the area (including assessments of capping depth). Ameliorate substrate as required to remedy any identified deficiencies. Generally, these areas would greatly benefit from the incorporation /spread of organic matter onto the soil surface Following soil enhancements, revegetate areas using a combination of direct seeding and/or planting methods.
11	Photo 9	Community structure and composition – in all REAs some localised areas were noted where excellent establishment and growth of mid storey shrubs was achieved (particularly acacias or Tea	 Undertake supplementary infill plantings of tubestock using endemic eucalypt species. In areas of very dense and thick mid-storey, plantings may need to be preceded by selective

Photo 8 Example of area with poor vegetation establishment performance (REA III)

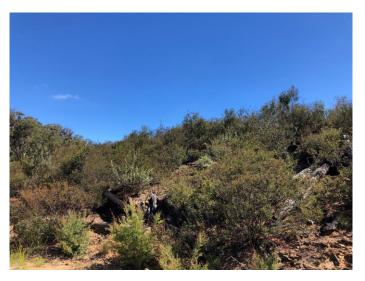
Photo 9 Example of area showing good shrub establishment but lacking canopy eucalypt species (REA IV)

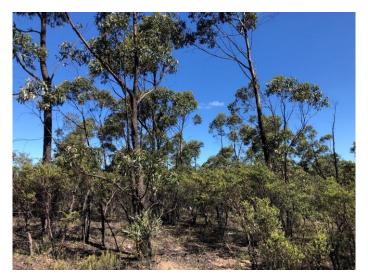
No.	Photo	Observation description	Action required
		Trees, and sometimes occurring at very high densities), but canopy eucalypts densities were inadequate (sparse to lacking).	thinning of the shrub layer (through cut and lay or mulching in situ).
12	Photo 10	Community structure and composition – localised area within REA II showing excellent shrub and tree establishment and growth, but generally very poor species diversity (Silver-top Ash only in the canopy layer and Tea-trees very largely dominant in the mid-layer).	• Consider improving community composition and species diversity in the mid and upper layers through localised patch plantings of shrubs and supplementary tubestock plantings of eucalypts.
13	Photo II	Good performance – areas within REA I, II and IV showing good establishment of woodland communities, typically with a diversity and densities of native shrubs and trees and good vegetation growth. In REA IV the ground cover remained sparse but should rapidly increase as litter is returned to the surface.	 Nil action required. Continue the implementation of the monitoring program to demonstrate ongoing progress of vegetation community

Photo 10 Area with good shrub and tree establishment and growth but poor species diversity (REA II)

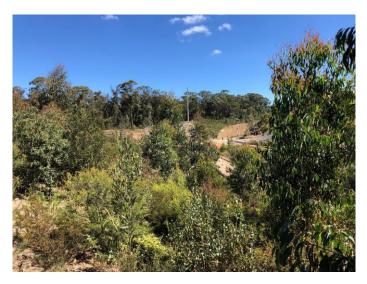
Photo 11 Excellent woodland vegetation establishment in young rehabilitation area (REA IV)

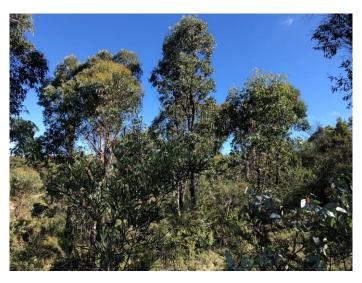
14	Photo 12	Good performance – well established woodland rehabilitation in REA I, II and III showing excellent performance, typically with a high diversity of native shrubs and trees, good vegetation growth and high structural complexity.	• Nil action required.

Photo 12 Excellent mature woodland rehabilitation with good structural complexity (REA II)
