Longwalls 900W and 910 Rehabilitation Management Plan

Angus Place Colliery

April 2014

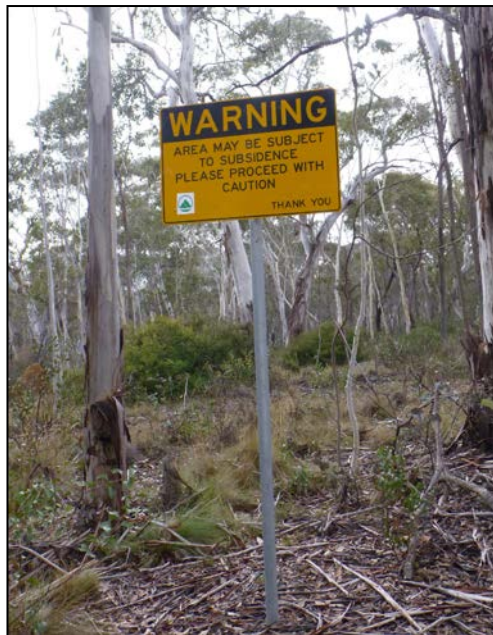
Plate 1. Warning Sign at Angus Place

- Visual inspections of access tracks will be undertaken prior to, during and post secondary extraction of longwalls within the Project Area. Inspections will include photo monitoring;
- In response to observed impacts, Angus Place will erect warning signs (see **Plate 1**) or danger tape in the immediate area if the cracking is considered to be a public safety risk; and
- If rehabilitation works for surface cracks are required these will be undertaken in accordance with the methodology specified in **Section 8.5** and in consultation with FCNSW.
