Angus Place

Longwalls 900W and 910 Built Features Management Plan

Angus Place Colliery

November 2013

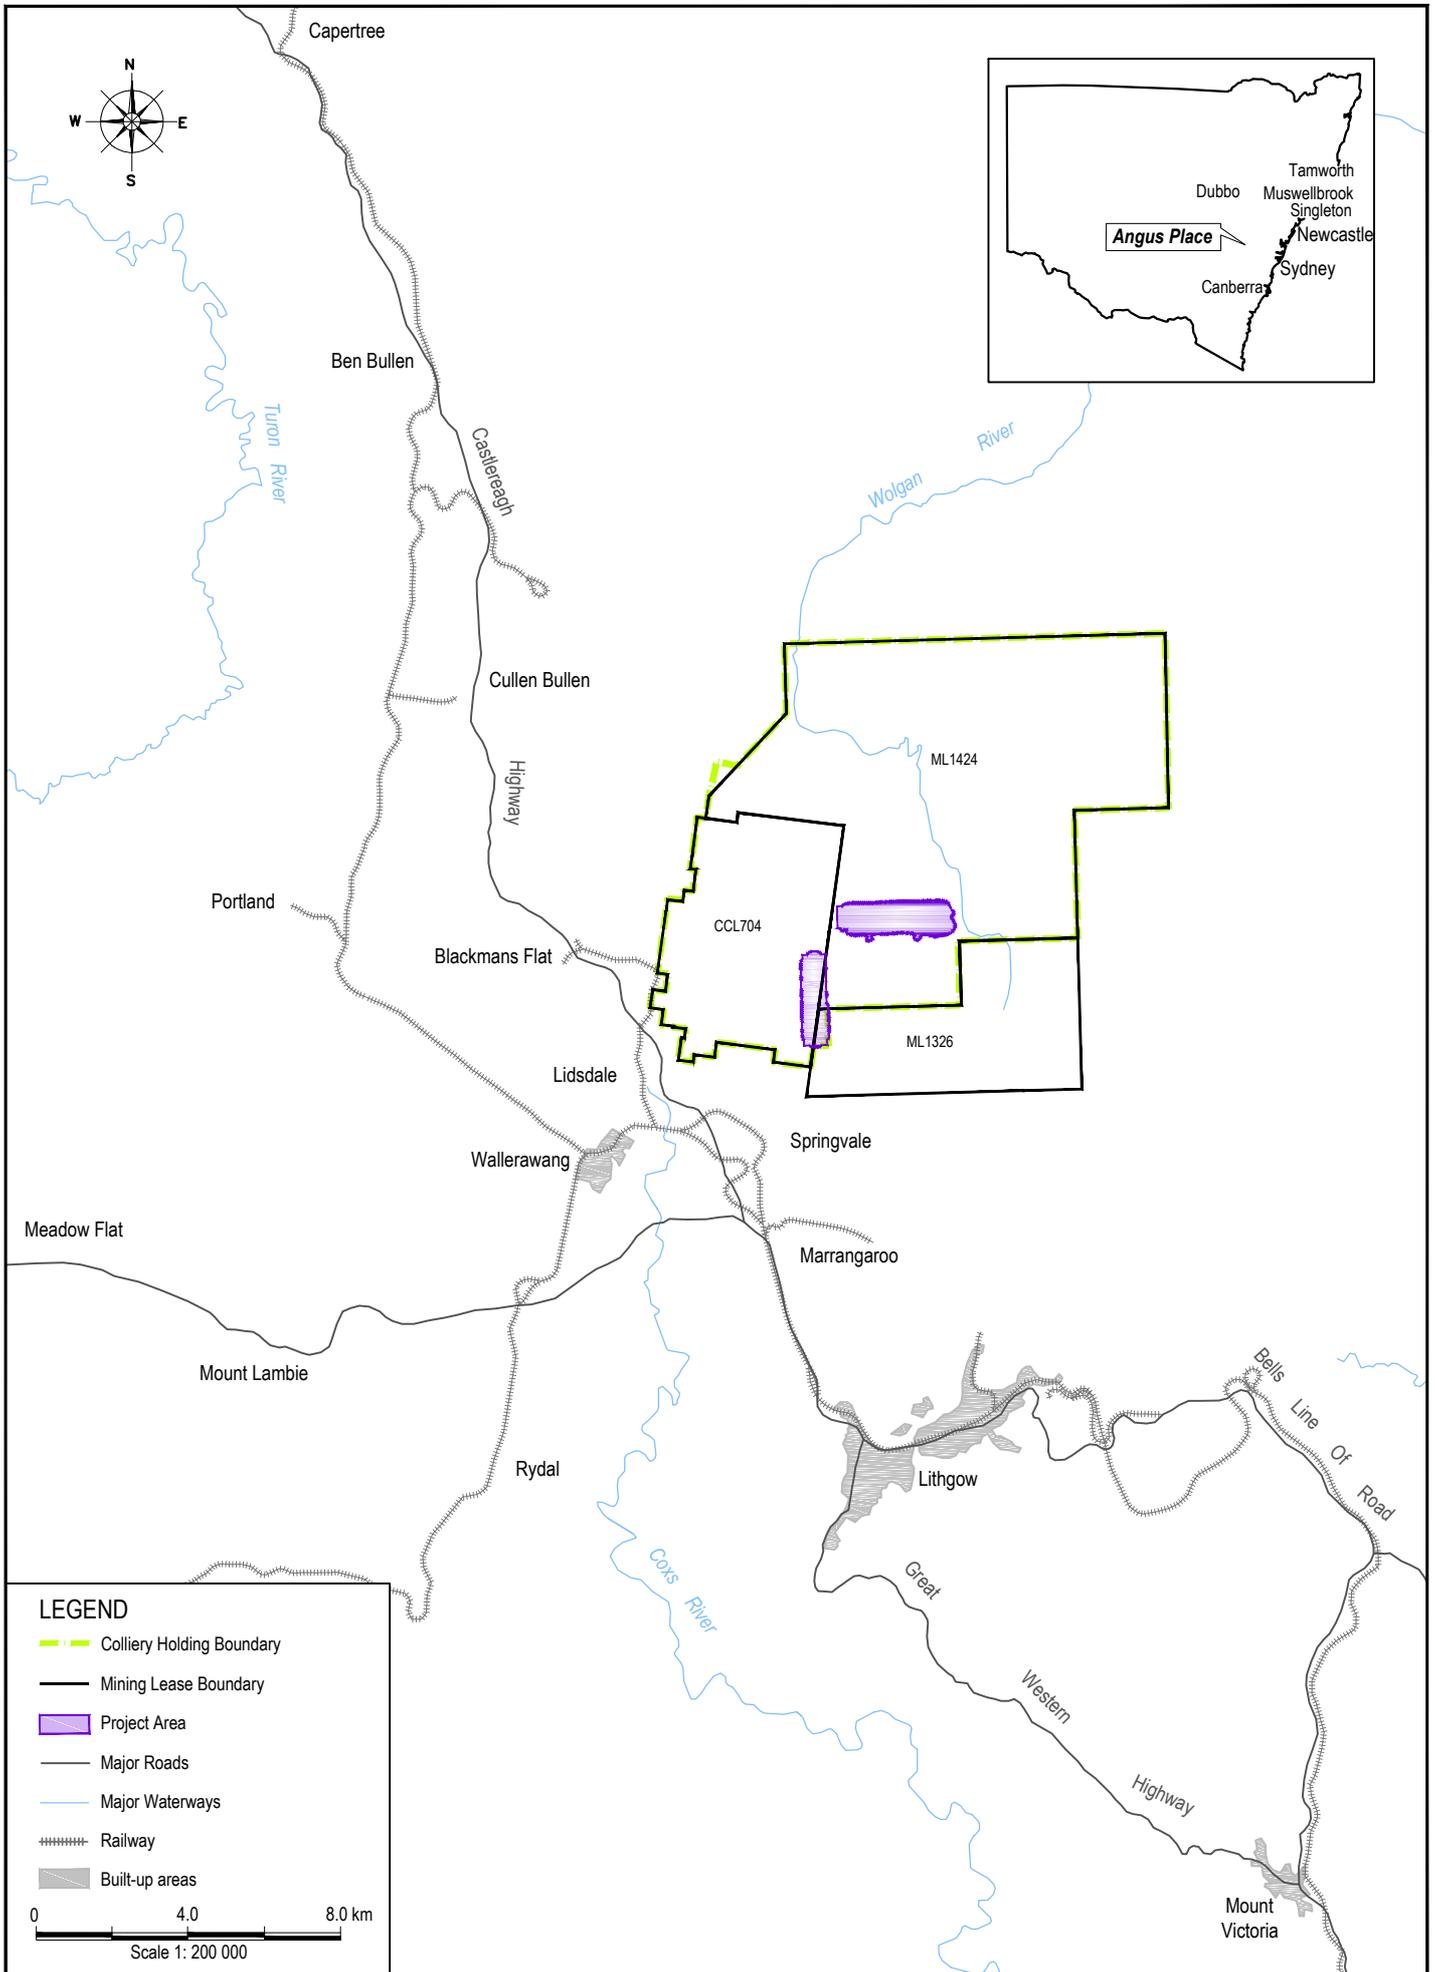
Angus Place Colliery (Angus Place) is an underground coal mining operation located approximately five kilometres north of the village of Lidsdale, eight kilometres northeast of the township of Wallerawang and approximately 15 kilometres northwest of the city of Lithgow in the Blue Mountains region of NSW. It is bordered by Springvale Colliery to the south, Ivanhoe Colliery to the northwest and Wolgan Valley and Newnes Plateau to the north and east respectively. The regional locality of Angus Place is shown on **Figure 1**.

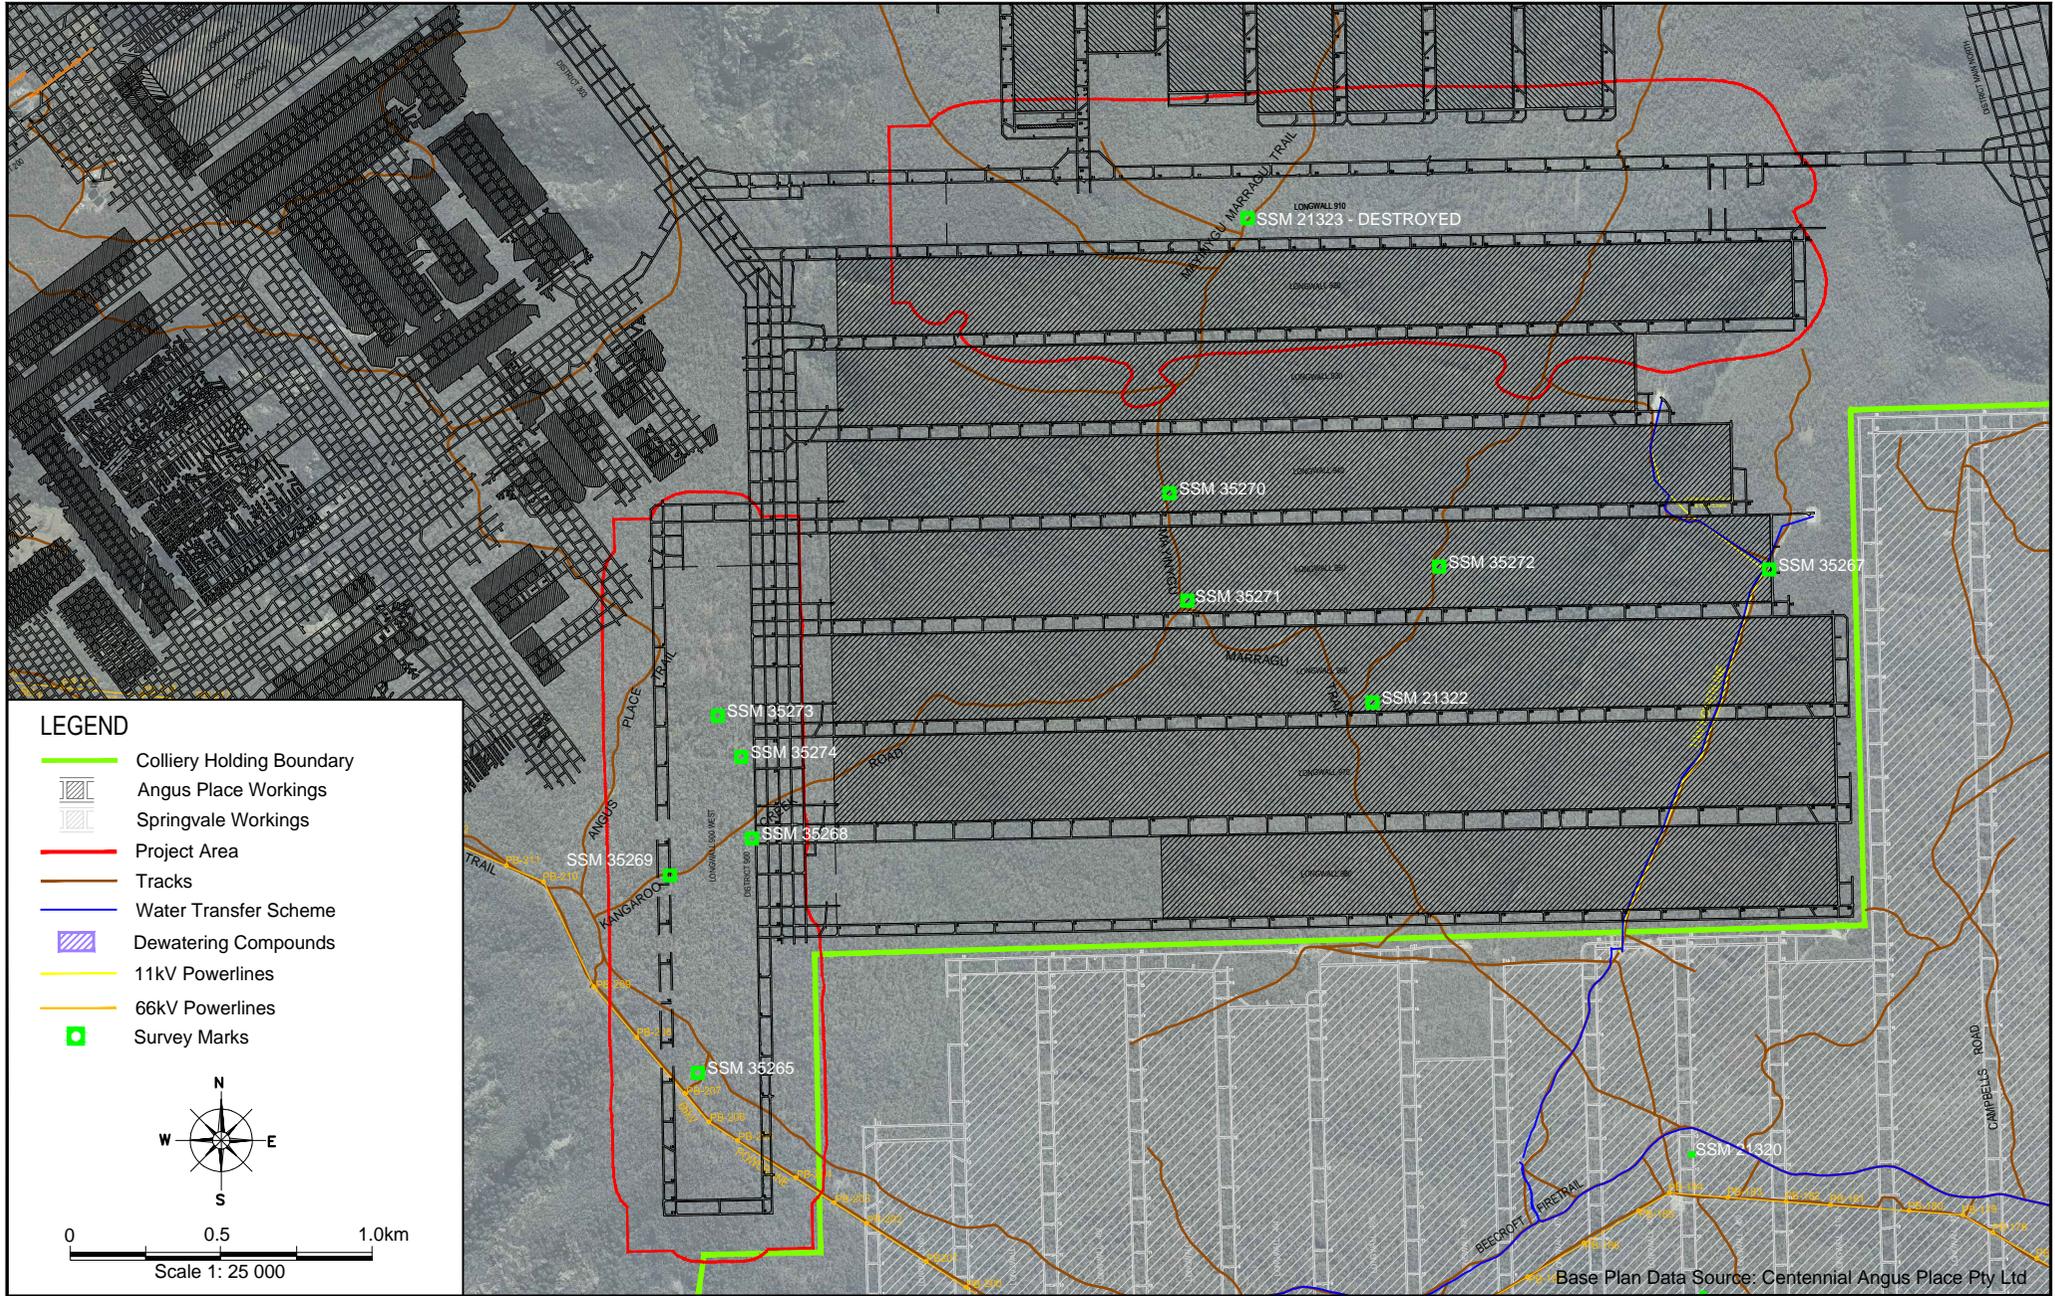
This Built Features Management Plan applies to the forest access tracks (including Kangaroos Creek Road, Beecroft Fire Trail and Mayinygu Marragu Trail), state survey marks and the Endeavour Energy owned 66kV powerline located within the Longwalls 900W and 910 area (herein referred to as the Project Area). In accordance with the requirements of the *Guidelines for Applications for Subsidence Management Approvals* (2003), published by the NSW Department of Mineral Resources (now the NSW Department of Trade and Investment, Regional Infrastructure and Services – Division of Resources and Energy (DTIRIS)), this Project Area has been calculated by combining the areas bound by the following limits (see **Figure 2**):

- A 26.5° angle of draw line from the limit of proposed extraction; and
- The predicted limit of vertical subsidence, taken as the 20mm subsidence contour resulting from the extraction of the Longwalls 900W and 910.

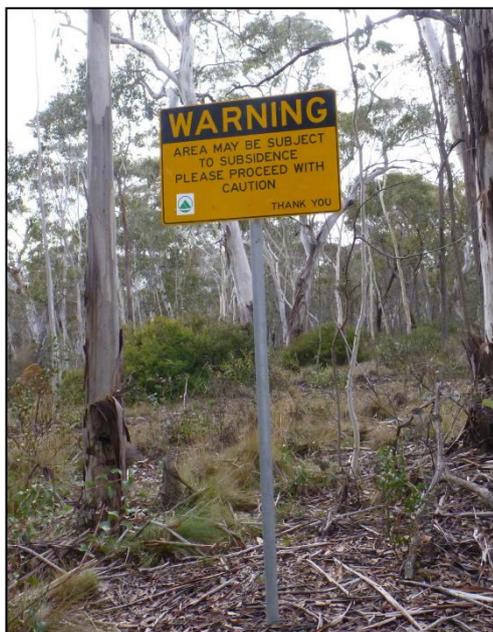
Plate 1. Warning Sign at Angus Place

- Visual inspections of access tracks will be undertaken prior to, during and post secondary extraction of longwalls within the Project Area (see **Section 9.2**). Inspections will include photo monitoring;
- In response to observed impacts, Angus Place will erect warning signs (see **Plate 1**) or danger tape in the immediate area if the cracking is considered to be a public safety risk; and
- If rehabilitation of surface cracks are required these will be undertaken in accordance with the methodology specified in the approved *Mining Operations Plan* (GSS Environmental, 2013), in consultation with FCNSW.
