Annual Environmental Management Report

Myuna Colliery

January 2014 to December 2014

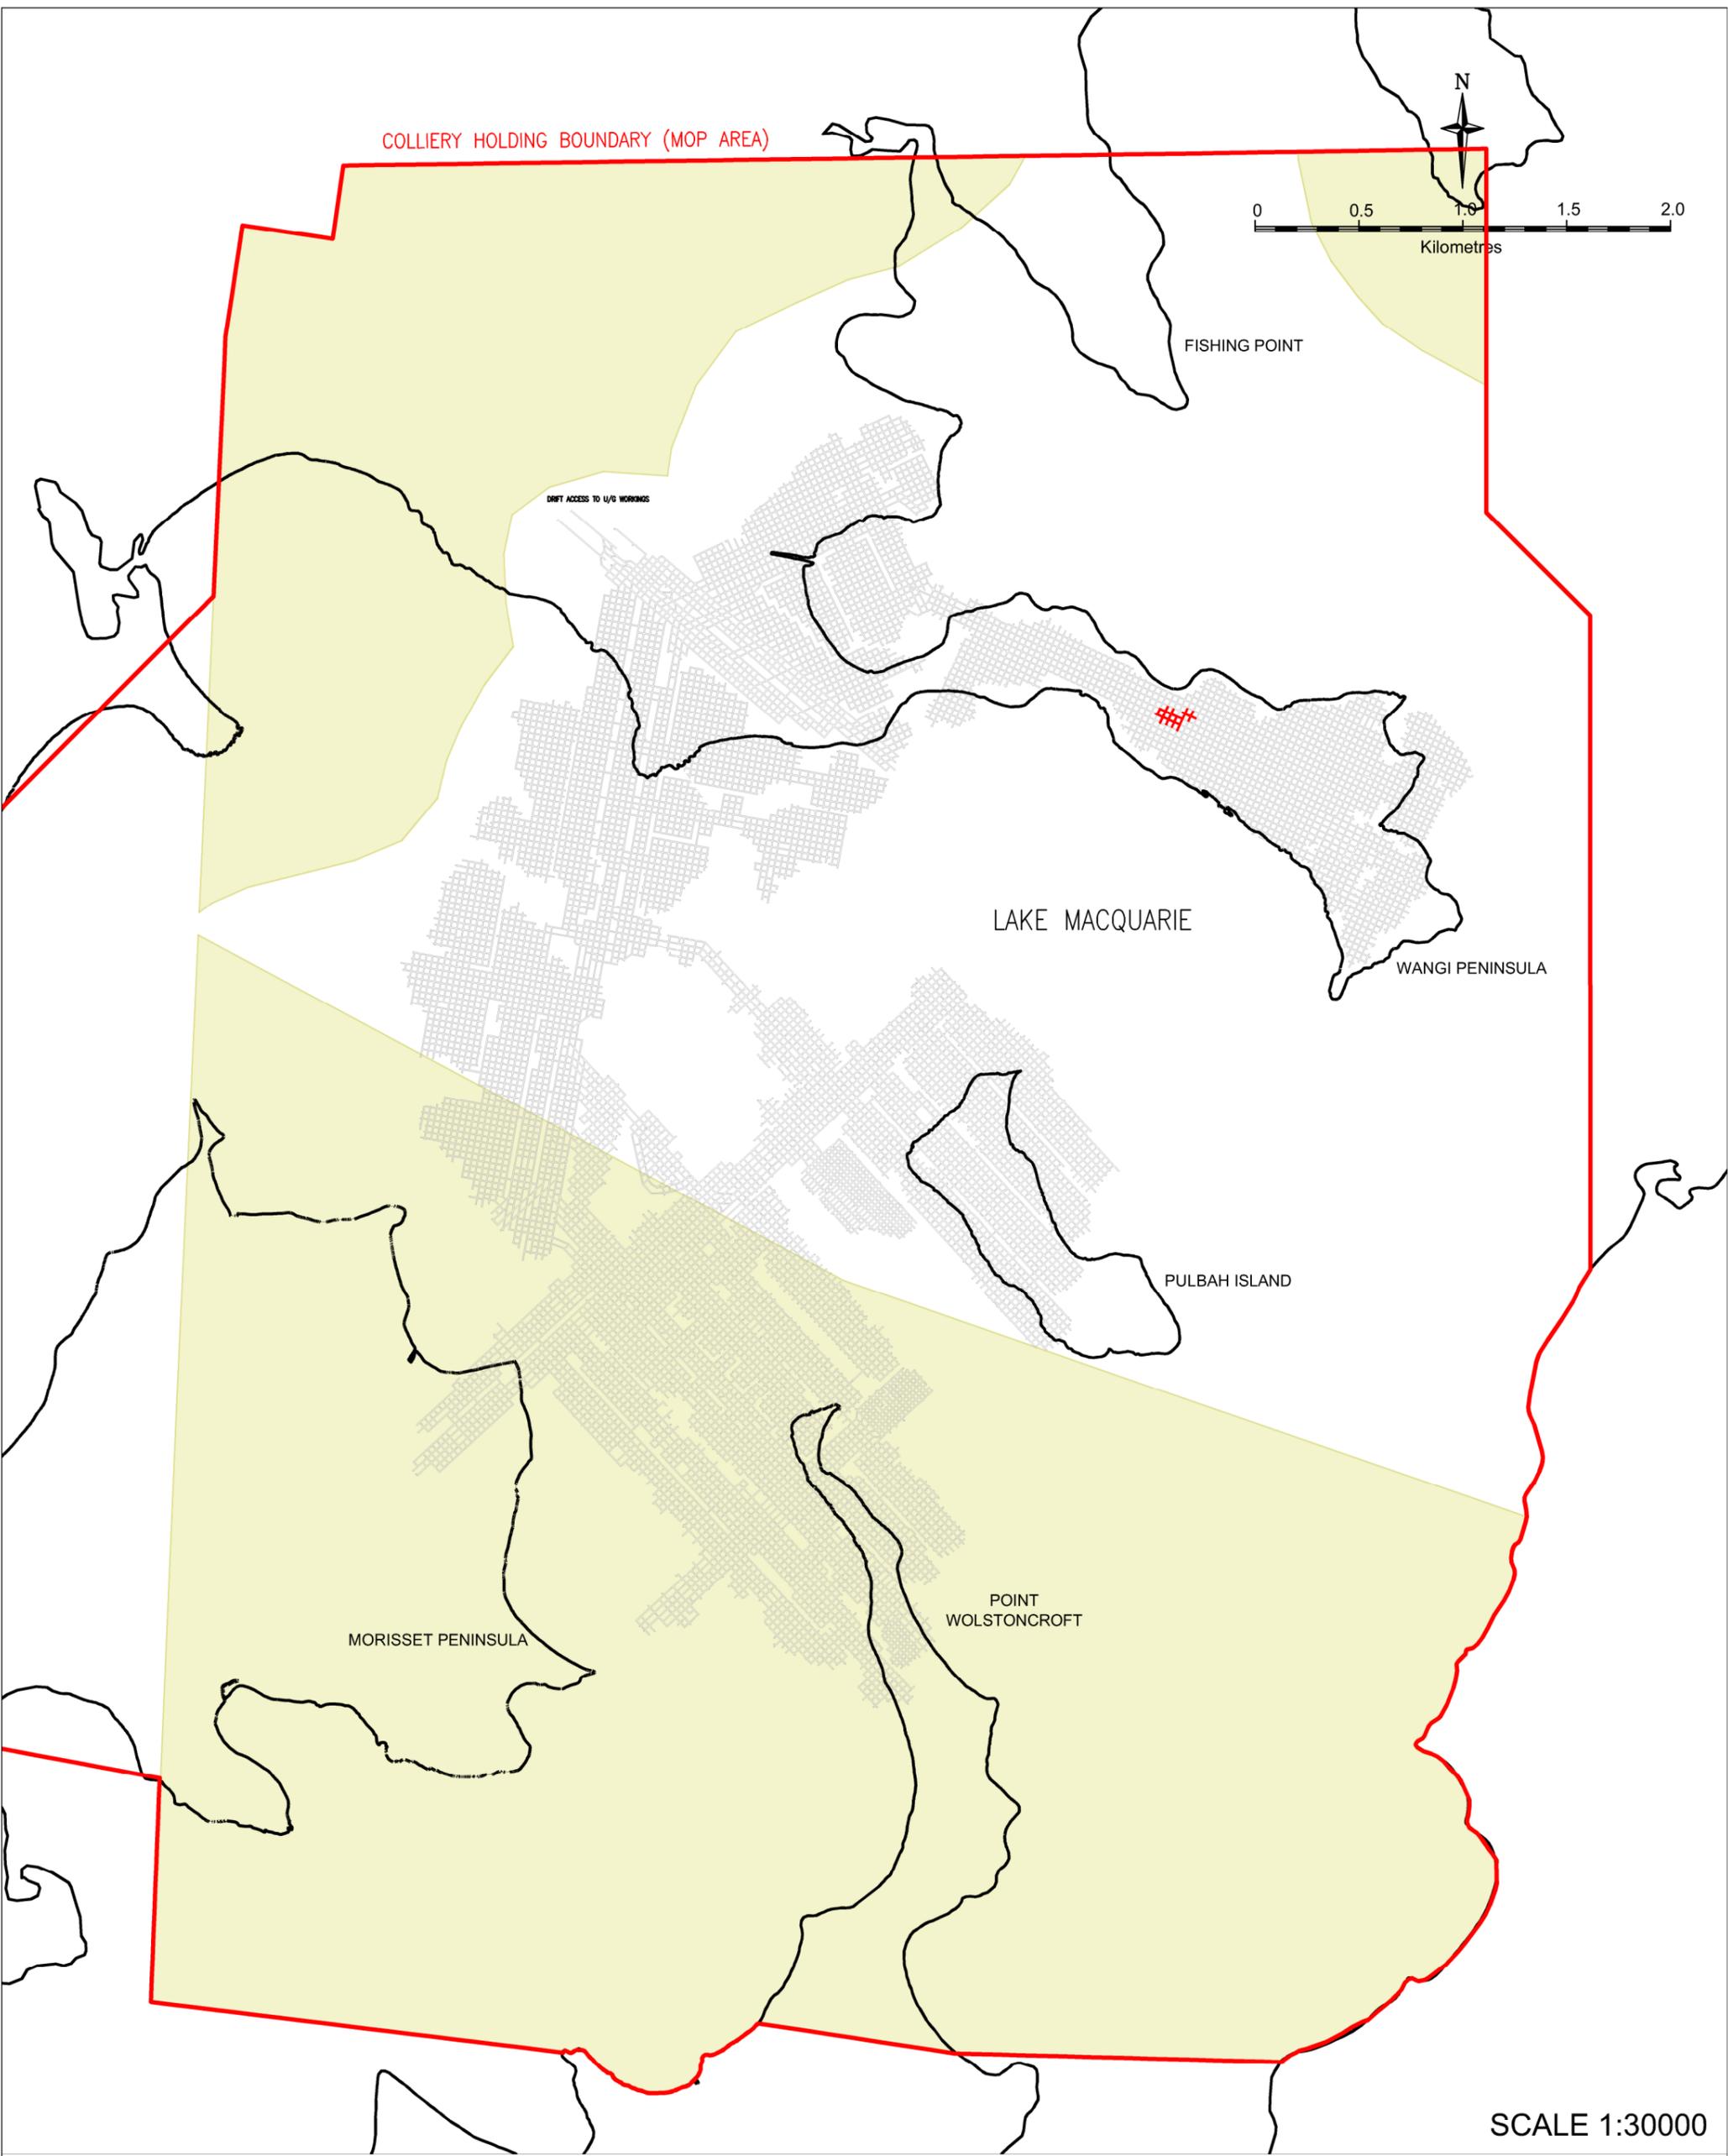
WALLARAH SEAM WORKINGS

- PART 3A PROJECT APPLICATION AREA
- EXISTING MINE WORKINGS
- WORKINGS FOR PERIOD 01 JAN 2014 TO 31 DEC. 2014

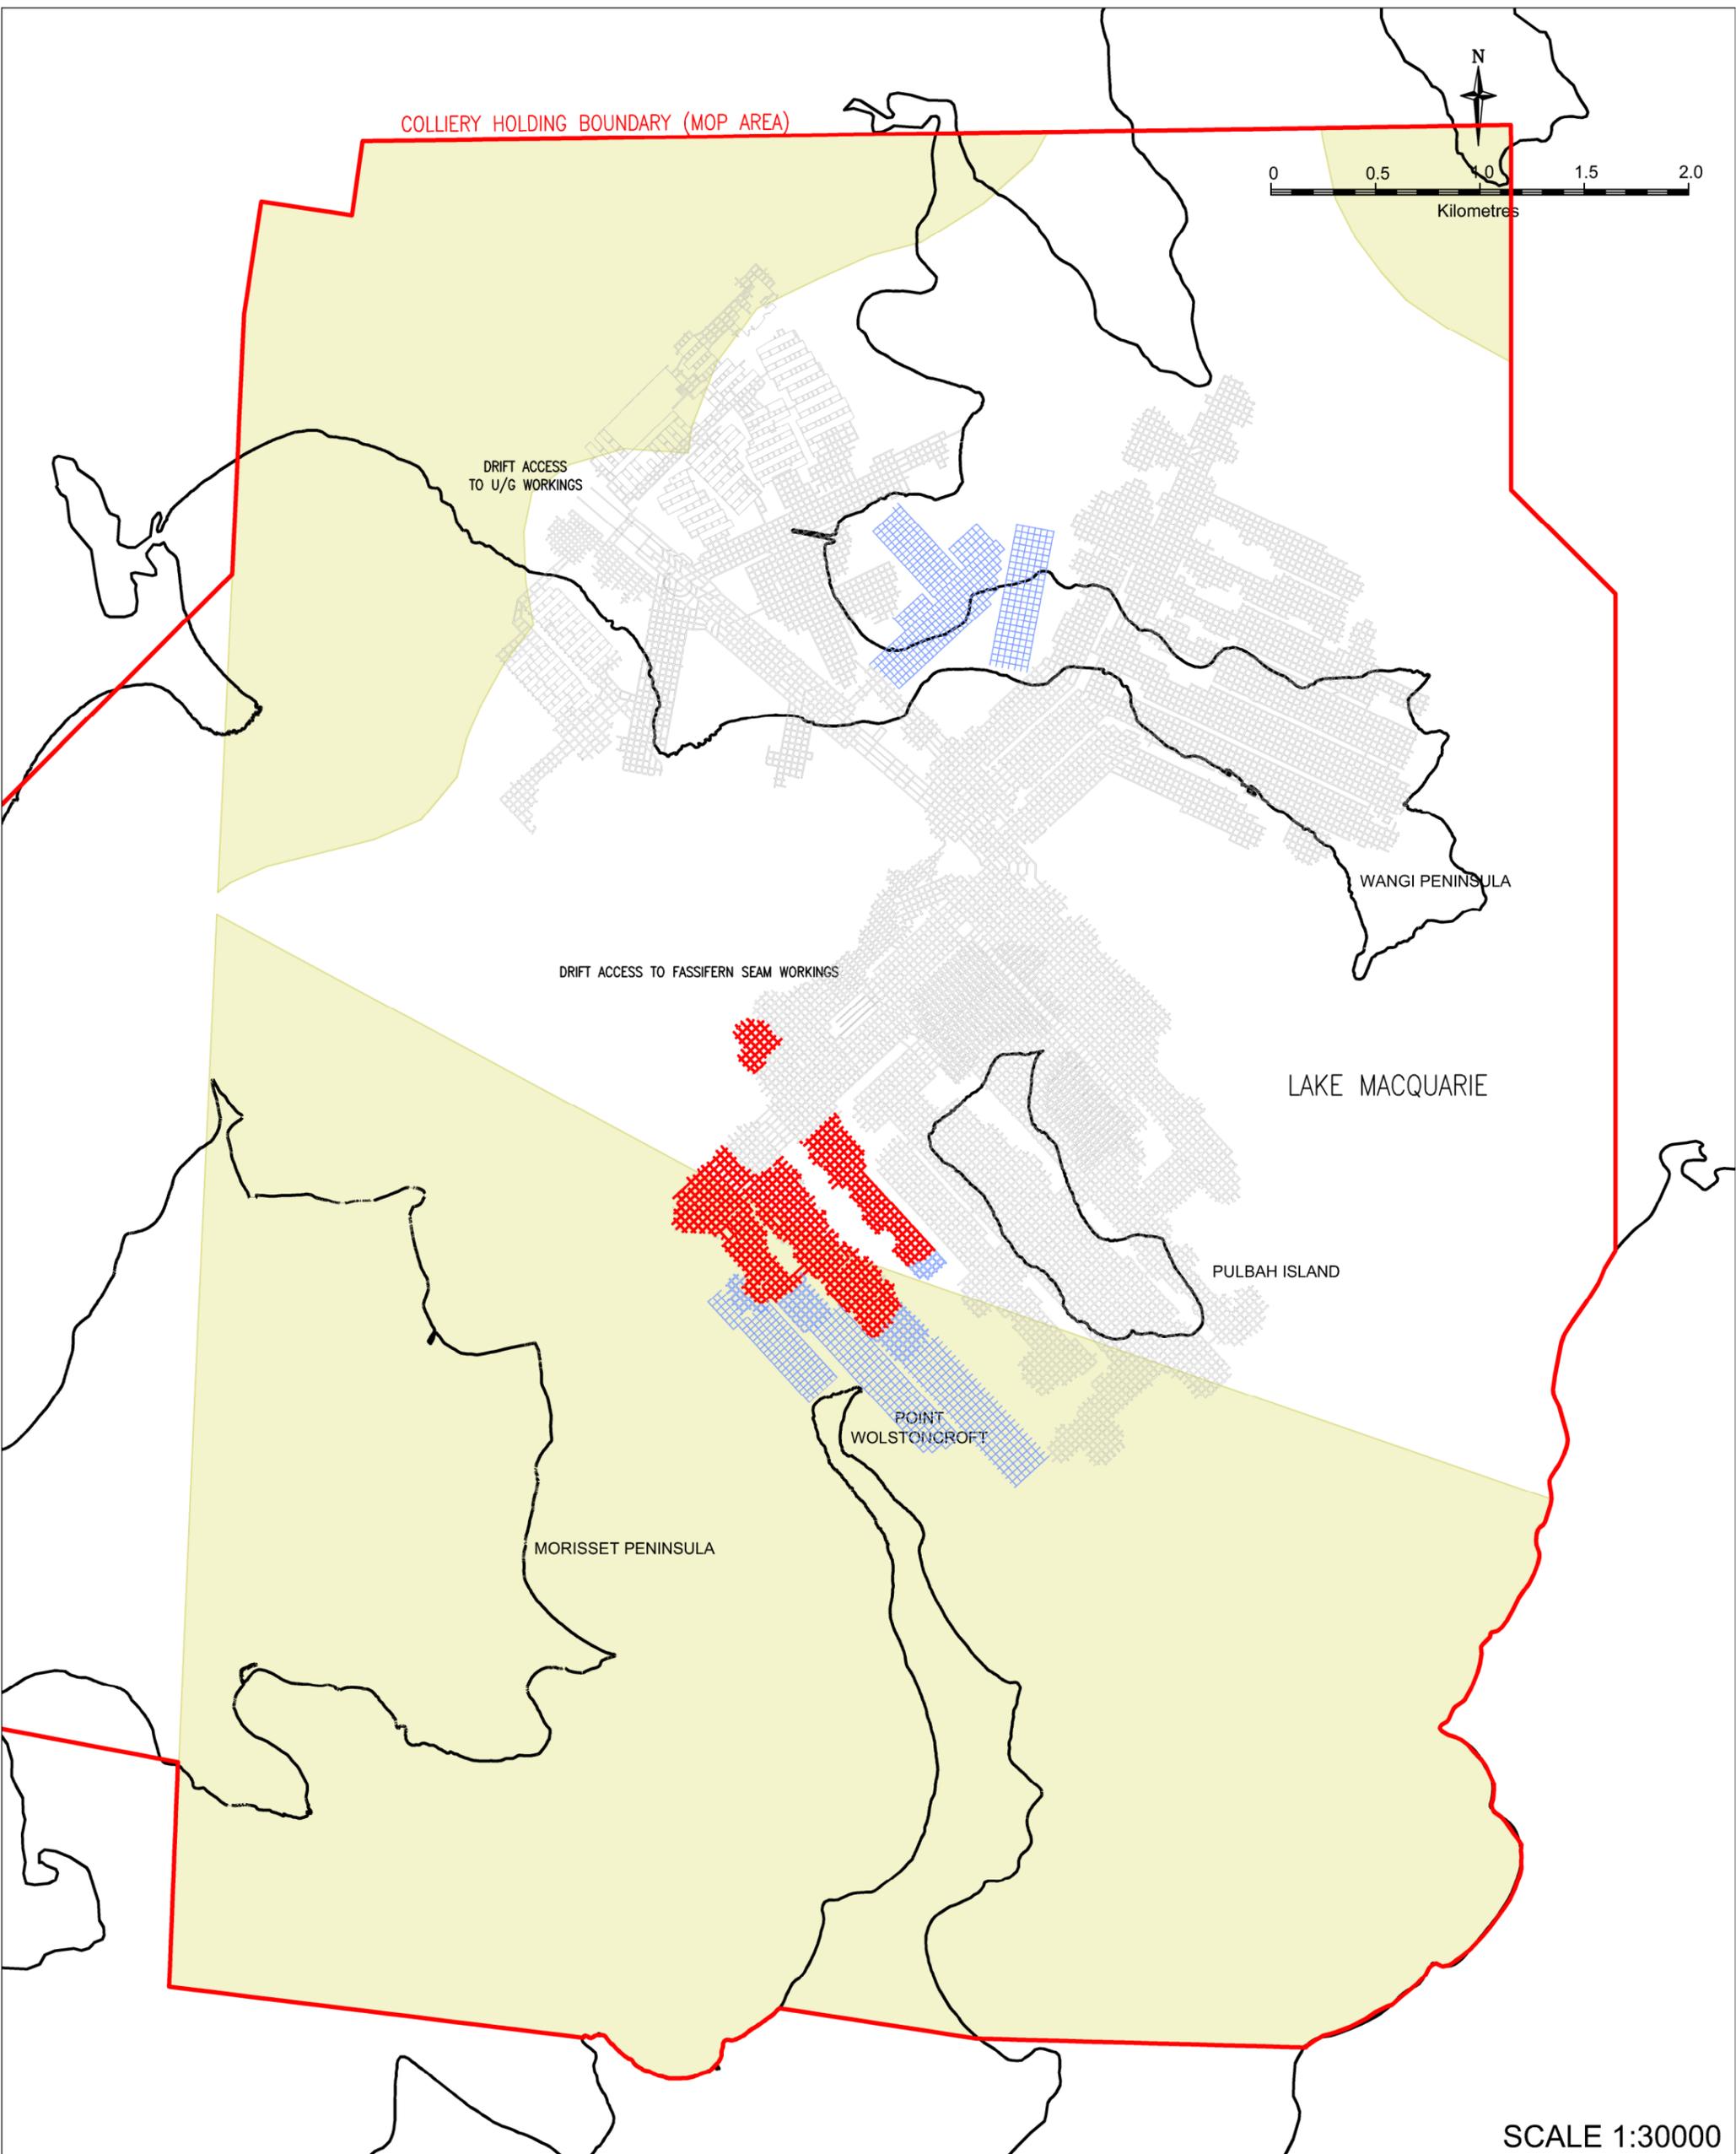
GREAT NORTHERN SEAM WORKINGS

- PART 3A PROJECT APPLICATION AREA
- EXISTING MINE WORKINGS
- WORKINGS FOR PERIOD 01 JAN 2014 TO 31 DEC. 2014
- WORKINGS (PROPOSED) FOR PERIOD 01 JAN 2015 TO 31 DEC. 2015

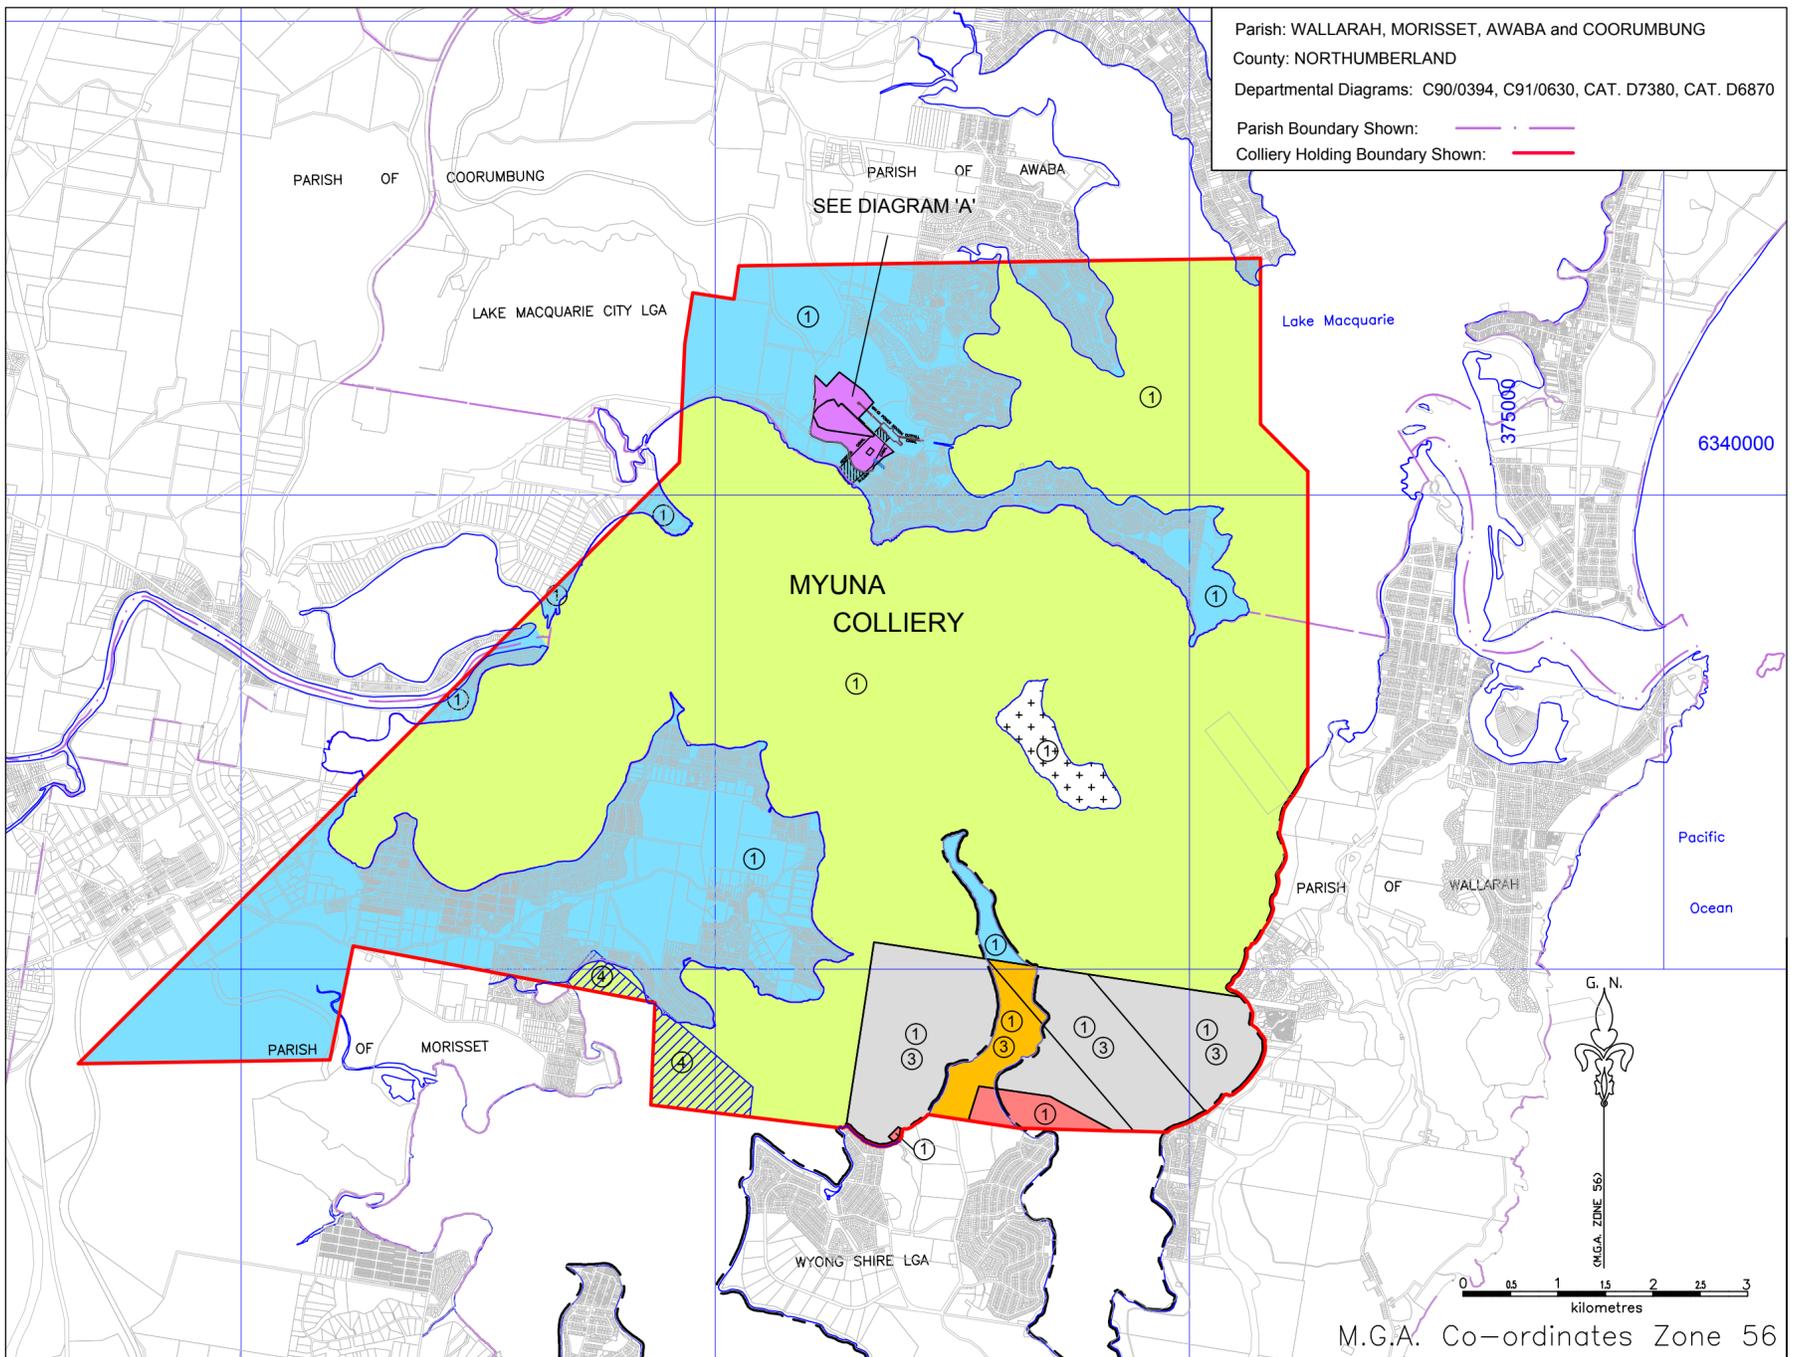
DIAGRAM 'A'

SURFACE / DEPTH RESTRICTION
