***ANNUAL ENVIRONMENTAL  
MANAGEMENT REPORT 2012***

**Centennial Mandalong Mine**

**For the period 1 January 2012 to  
31 December 2012**

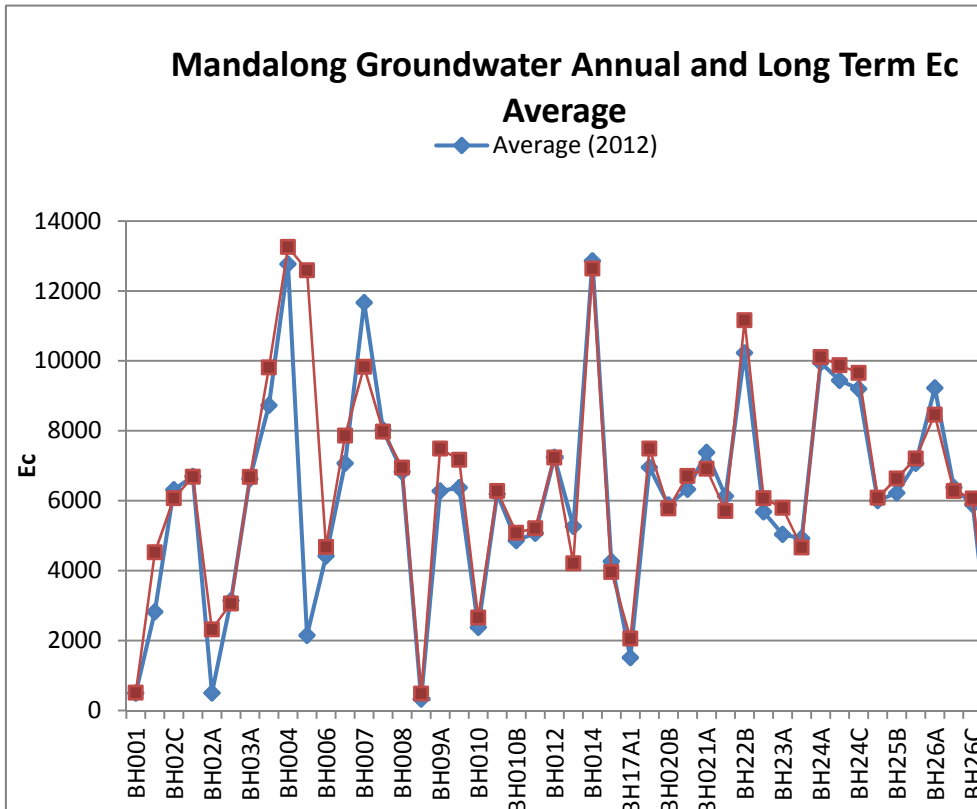
Figure 2: Long-term Average (LTA) and Annual Average Groundwater EC

The groundwater monitoring results are summarised in **Table 11** and **Figure 1**, **Figure 2** & **Figure 3**. The individual borehole results are provided in **Appendix 5**. Hydrographs of the groundwater levels and Electrical Conductivity (EC) are included in the AGE report (2013) provided in **Appendix 5**.

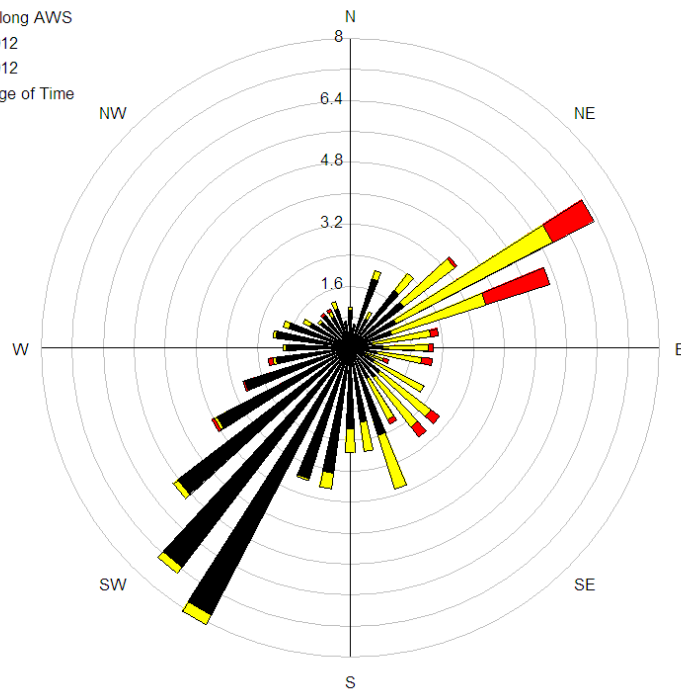
**Figure 4: Average Daily Wind Direction Recorded for Summer 2012**

Wind speed data is shown in **Table 16**. Wind speed and direction are shown graphically in, **Figure 4**, **Figure 5**, **Figure 6** and **Figure 7**.

**Figure 4** indicates that the wind is predominantly from the north east and south west direction for the summer period in 2012.

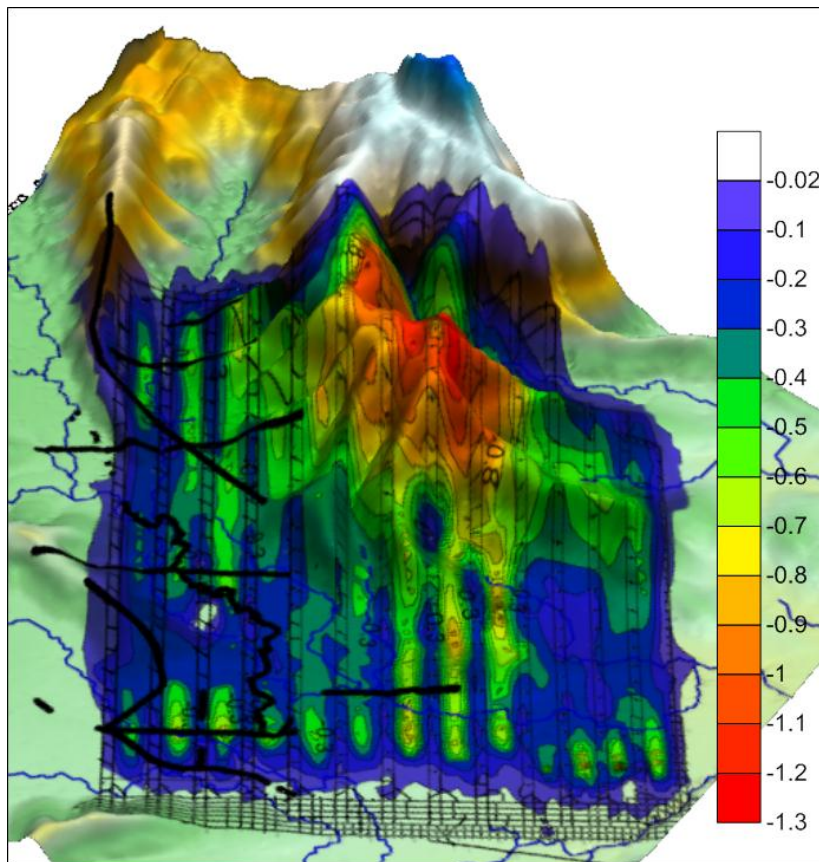
Figure 13: Visualisation of Subsidence to LW13 Projected onto the Topography

**Figure 11** presents a visualisation of the vertical subsidence over the whole area based on interpolation of survey data from 54km of subsidence lines over the mining area. **Figure 12** shows the subsidence visualisation overlayed on the topography and includes the subsidence lines monitored for during the extraction of Longwall 13. This figure illustrates the association of the greatest subsidence with the most elevated topography which provides the greater depth of cover.

shown in **Figure 13** indicates, subsidence on the floodplain, where the majority of pasture areas are found, ranges from up to 0.60 m. There is little evidence that these relatively low levels of subsidence have impacted on pasture condition, as further discussed below.
