Centennial Coal

***CENTENNIAL MANDALONG PTY
LTD
Mandalong Mine
ANNUAL REVIEW***

March 2019

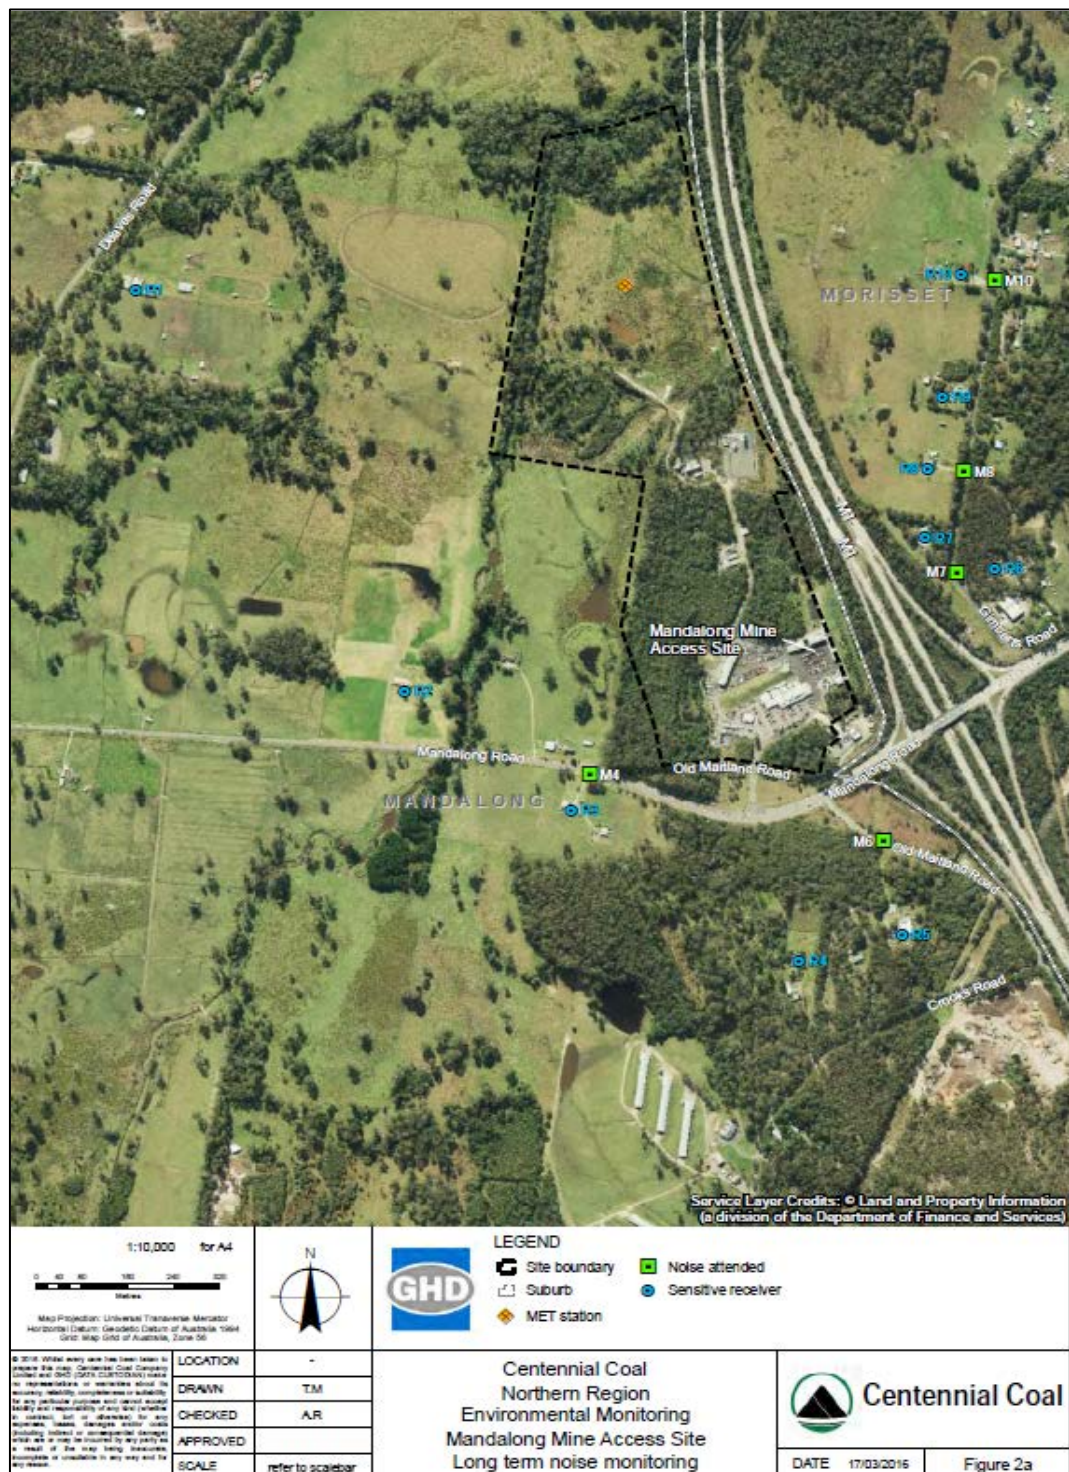
Figure 2: Mandalong Mine Noise Monitoring Locations

Annual noise monitoring was conducted to assess operational noise levels compared to the noise limits specified by SSD-5144, SSD-5145 and EPL 365 in accordance with the requirements of the Northern Region Noise Management Plan. The Mandalong Mine Noise Monitoring Program requires Centennial Mandalong to survey noise from the operation annually at the Mandalong Mine and the Cooranbong Entry Site (shown in **Figure 2** and **Figure 3**), and quarterly at the Mandalong South Surface Site (**Figure 4**).

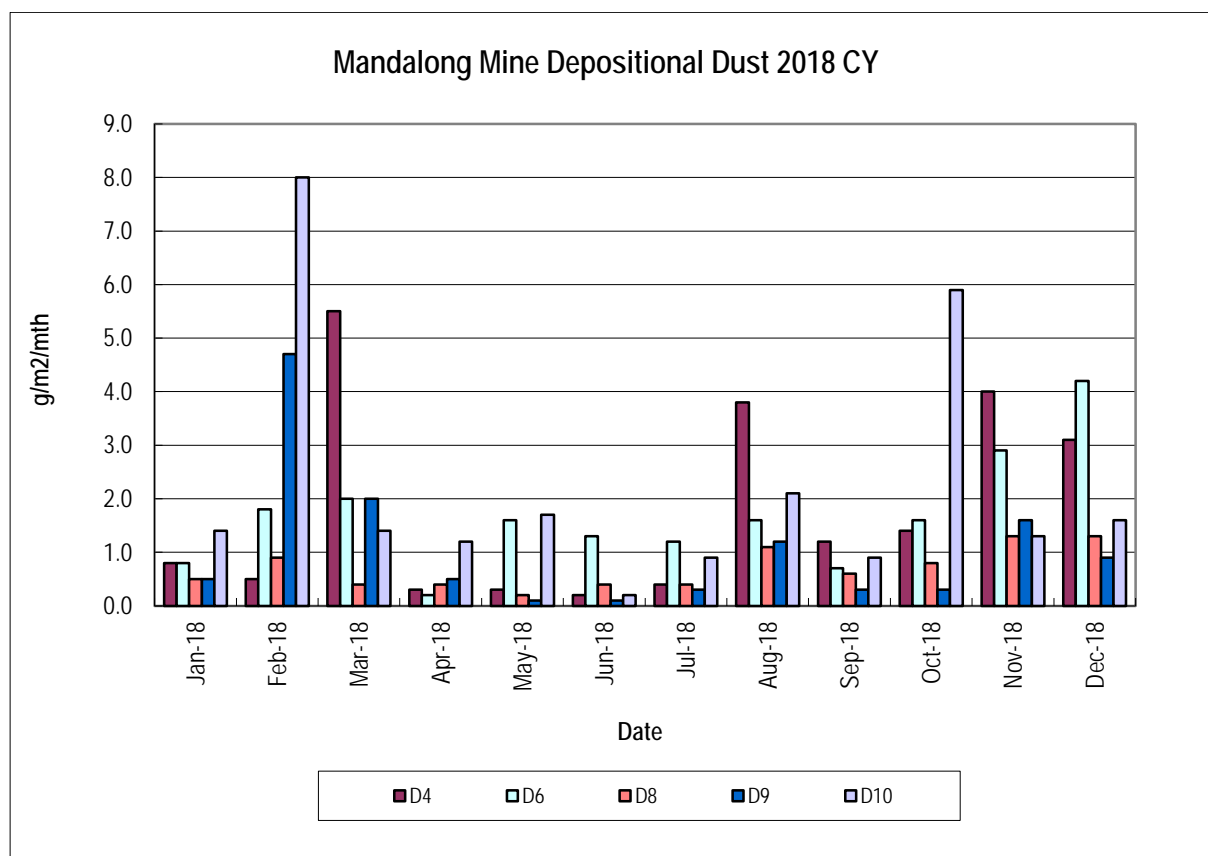
Insoluble Solids (Combustible Matter + Ash) g/m ² /month			
	DG6	DG8	DG9	DG10
Long Term Average	1.3	0.7	1.1	1.6
Average 2018 (Reporting Period)	1.7	0.7	1.0	2.2
Pre-Construction Average	0.8	0.8	0.9	*
EPA Dust Deposition Goal	4.0	4.0	4.0	4.0

Figure 5: Depositional Dust Results Surrounding Mandalong Mine for 2018

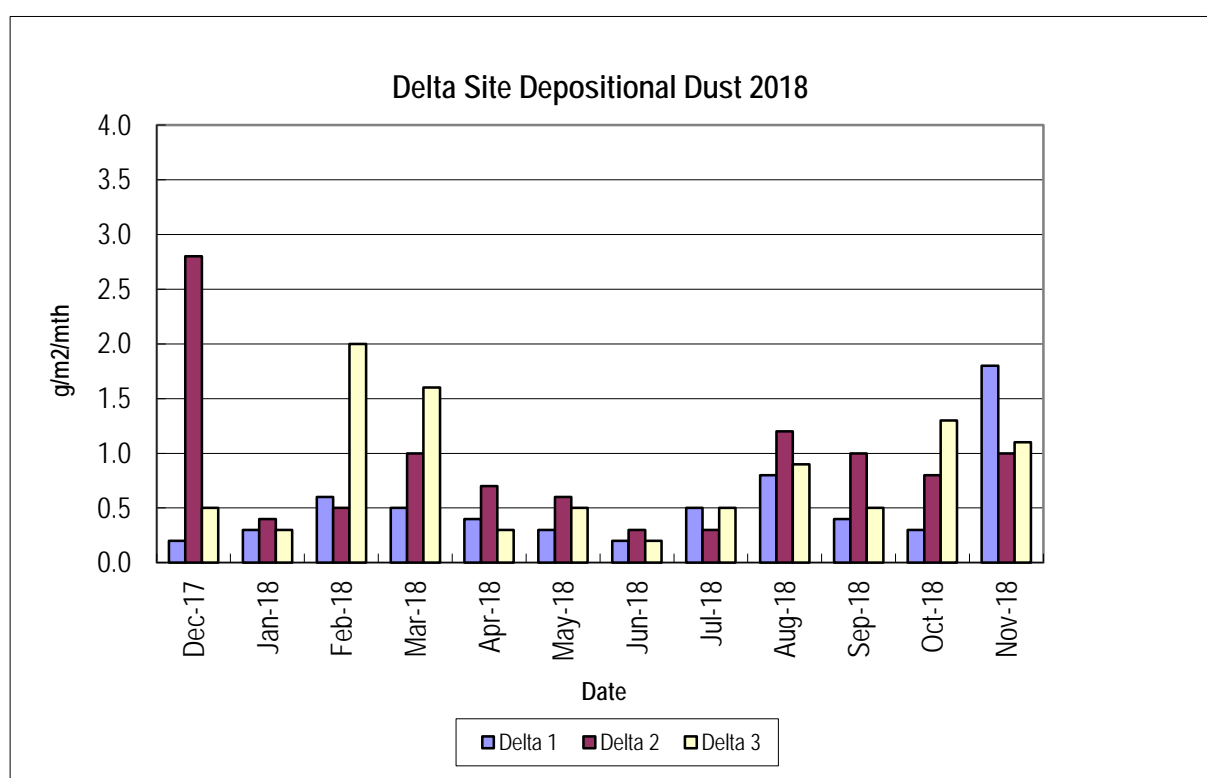
Insoluble Solids (Combustible Matter + Ash) g/m ² /month		
	DG1	DG2	DG3
Long Term Average	0.6	0.7	0.7
Average 2018 (Reporting Period)	0.5	0.9	0.8
EPA Dust Deposition Goal	4.0	4.0	4.0

Figure 6: 2018 Depositional Dust Results for Delta Entry Site

Depositional dust monitoring results are provided in **Table 14**. The monthly dust monitoring data for the Delta Entry Site for 2018 is included in **Figure 6**.

Average annual depositional dust results for dust gauges DG1, DG2 and DG3 are relatively low. The highest average depositional dust rate for the period was 0.9 g/m²/month for DG2. All results are well below the EPA air quality goal of 4 g/m²/month and are provided in **Table 14** and **Figure 6**.

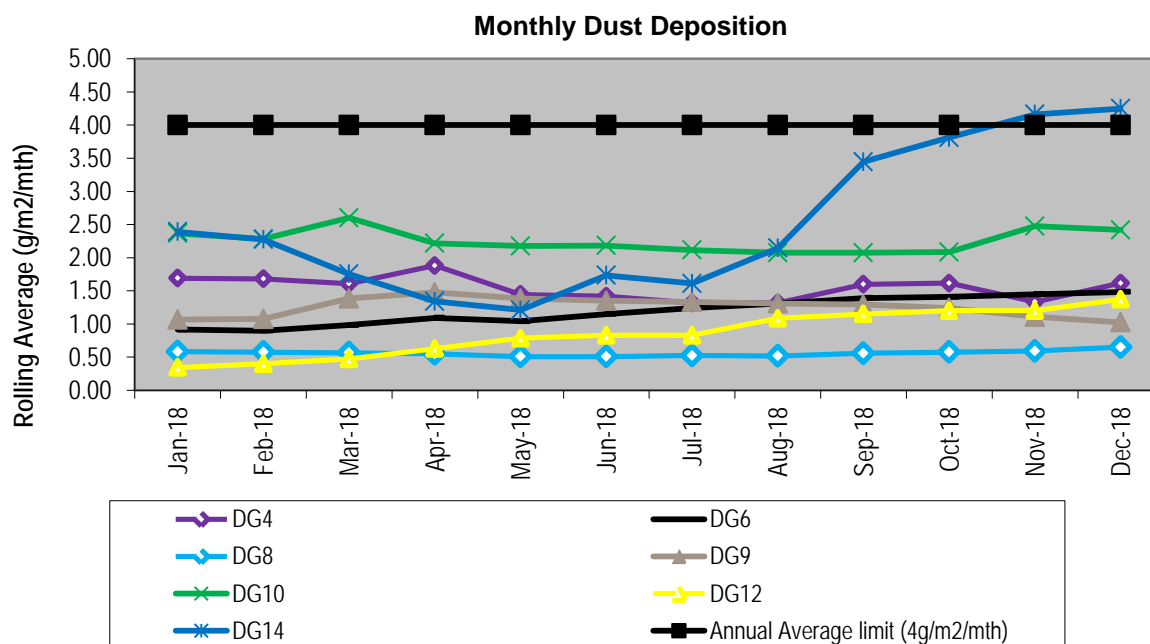
Figure 7: Monthly Rolling Annual Average Dust Deposition for 2018.

All dust gauges except DG12 during November and December recorded results below the EPA air quality goal of annual dust deposition of 4 g/m²/month (**Figure 7**). The results for DG14 in April and May were excluded due to a bird building a nest within the dust gauge funnel. The results for DG14 during November and December have been impacted by the contamination as a result of a bird continually attempting to build a nest in the monitoring equipment.

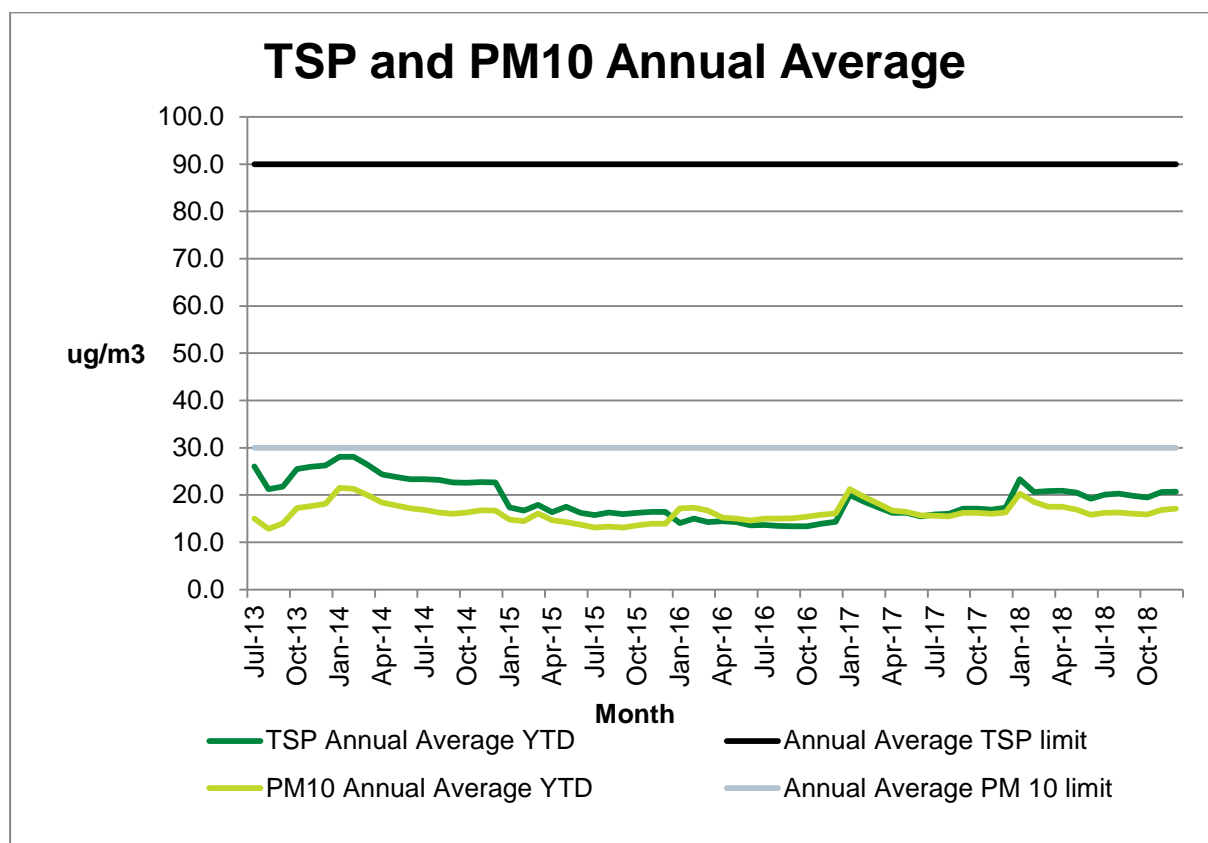
Figure 8: TSP and PM10 2018 Annual Rolling Average

TSP and PM10 monitoring results are shown in **Figure 8**. The results are presented as an annual average for the monitoring period (July 2013 to December 2018). TSP and PM10 monitoring results to date since installation in June 2013 are in accordance with the predictions from the air quality impact assessment for the Cooranbong Distribution Project EA (GSS Environmental, 2012). TSP and PM10 monitoring results to date since October 2015 are in accordance with the predictions from the air quality impact assessment for the Northern Coal Logistics Project EIS (SLR, 2014).

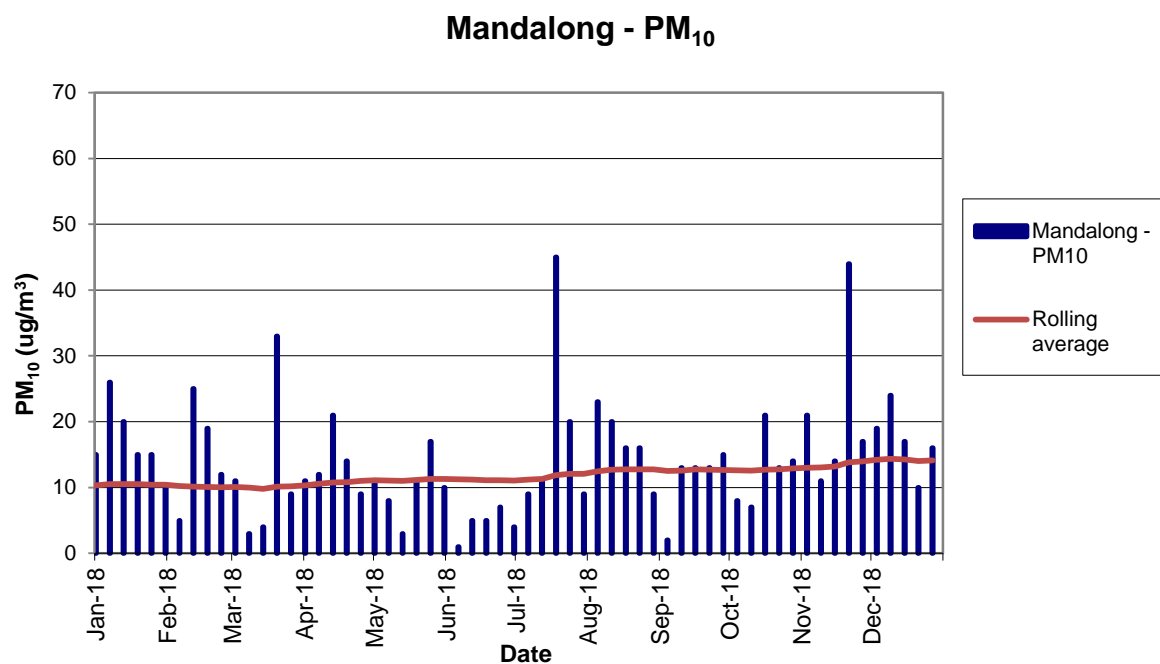
Figure 9: MMAS PM10 Monitoring Results

Results from the 2018 HVAS sampling during 2018 recorded a PM₁₀ rolling annual average of 14.1 ug/m³ and PM_{2.5} ug/m³ with a rolling annual average of 6.4 ug/m³. Refer to **Figure 11** for the 2018 monthly PM₁₀ results and **Figure 12** for the monthly 2018 PM_{2.5} results.

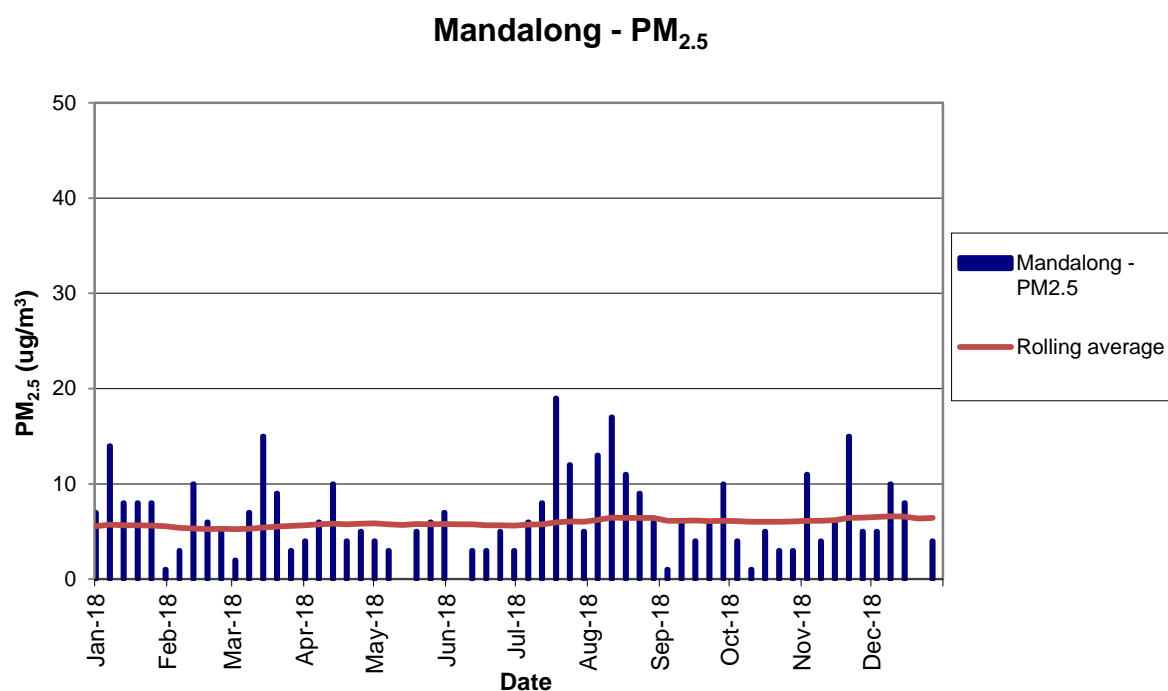
Figure 10: MMAS PM2.5 Monitoring Results

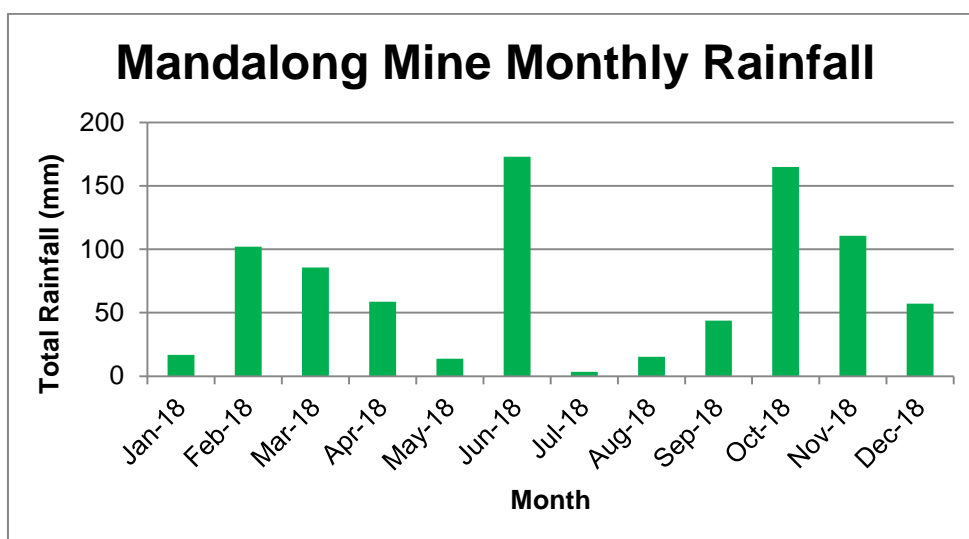
Figure 16: Mandalong Annual Rainfall

The total monthly rainfall data is shown below in **Table 22** and in **Figure 16**.

A total of 845.3 mm of rainfall was recorded at the Mandalong Mine site during the reporting period. The total annual rainfall for 2018 was lower than the annual average rainfall (1,124 mm) recorded at the Cooranbong Station (BOM station number 61012) from 1889 to 2016. The wettest monthly period in 2018 was June recording 173.1 mm.

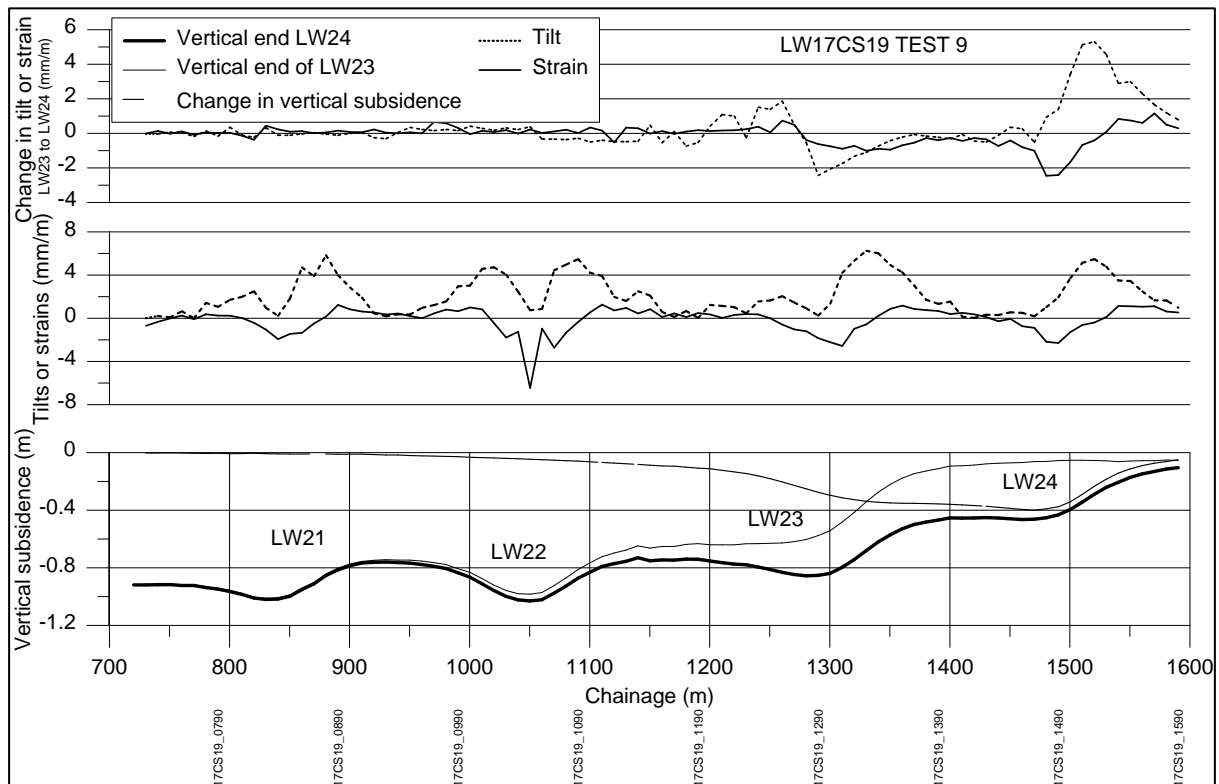
Figure 18: Subsidence Parameters measured along Crossline 19 (Tobins Rd)

Table 26 to **Table 29** show the maximum predicted and measured subsidence values on crosslines located over Longwalls 22 to 24A, while **Figure 18** and **Figure 19** graph the subsidence parameters measured along Crossline 19 and Crossline 8.

Crossline 19 is located along Tobins Road, that is positioned and near the commencement end of the longwall panels up to Longwall 24 and shown on **Figure 17**. The measured subsidence data is graphed in **Figure 18**. The subsidence associated over the longwall panels is dominated by the deformation of the coal pillar system, with lesser amounts of sag over the panels. Maximum vertical subsidence was consistent with the predicted values. Tilts and strains were within the anticipated ranges.

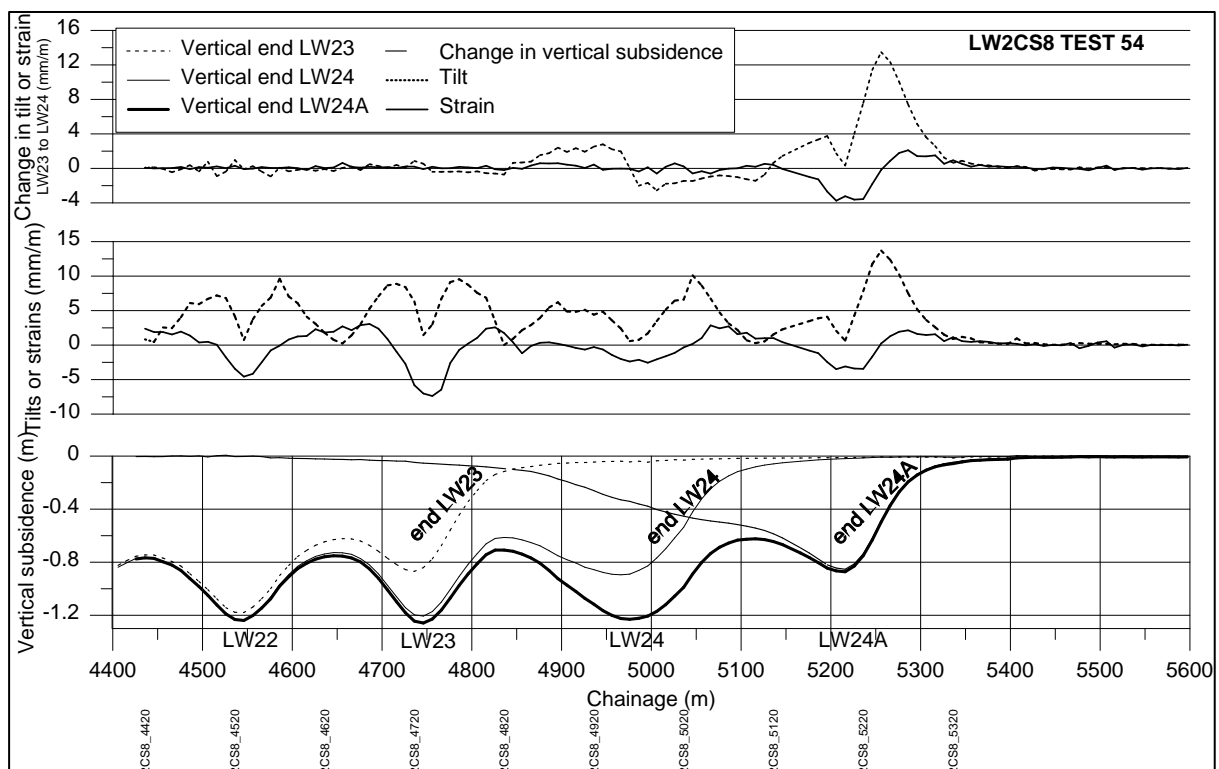
Figure 19: Subsidence parameters measured along Crossline 8 Mandalong Rd

Crossline 8 is located along Mandalong Road that traverses the floodplain. **Figure 19** shows the pattern of vertical subsidence has been similar over the last four longwall panels. Pillar compression is between 0.6m to 0.8m, while the sag is 0.5m. Measured vertical subsidence over Longwalls 22 to 24A has been greater than the predicted values and most likely due to geological variations in conglomerate beam thickness as a result of limited borehole data obtained to the south-east of Mandalong Road.

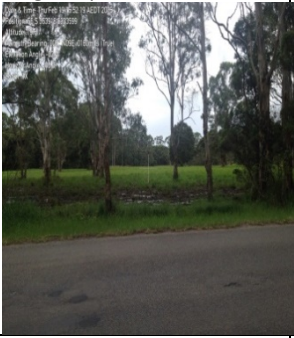
Location	Description	Remediation	Remediation Comments	Ponding Predicted	Subsidence Completed	Status	Property Ref. Lot & DP
Longwall 11 (P11)	Mixed paperbark woodland in an already periodically inundated area. Contains threatened <i>Melaleuca biconvexa</i> paperbarks. Ponding has extended an existing wetland.	Remain as freshwater wetland	To remain as a freshwater wetland.	Yes	Yes	Completed	Ref. 44 9/800491
Longwall 13 (P13)	Open grassland and Redgum Rough-barked Apple Forest	Minor increase in low lying area. No permanent ponding.	Existing ponding has been moved towards centre of longwall panel.

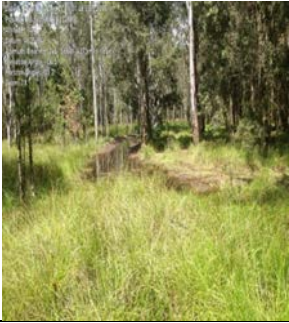
Location	Description	Remediation	Remediation Comments	Ponding Predicted	Subsidence Completed	Status	Property Ref. Lot & DP
Longwall 16 (P16)	Redgum Rough-barked Apple Forest and Coastal Foothill Spotted Gum-Ironbark Forest.	Increase in existing ponded area remediated to pre-mining condition. Minimal impact on flora	Constructed open drain and connected to nearby water course to return existing ponding to pre-mining levels. Quarterly ecology monitoring program completed.

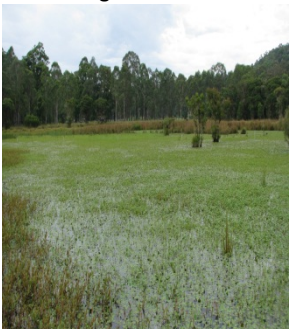
Yes	Yes	Completed	Ref.33 861/83516 0
Longwall 17 (P17)	Freshwater Wetland Complex EEC and Redgum Rough-barked Apple Forest EEC	No remediation required.	Marginal increase in extent and depth of wetland as predicted. No predicted long-term impact on wetland. Wetland 4 & 5 in Wetland Management Plan – property sole and monitoring finished

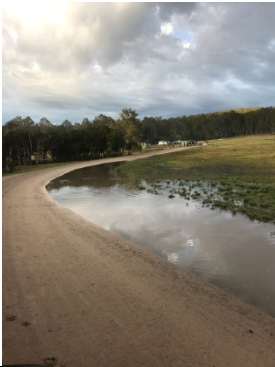
No	Yes	Completed	Ref. 212 3/3039
Longwall 24 (P24)	Observation Point 'K' Trotting track	Installation of additional drainage lines and resurface affected section of track. Final design completed following LW24A subsidence.	Increased ponding on recently upgraded trotting track.

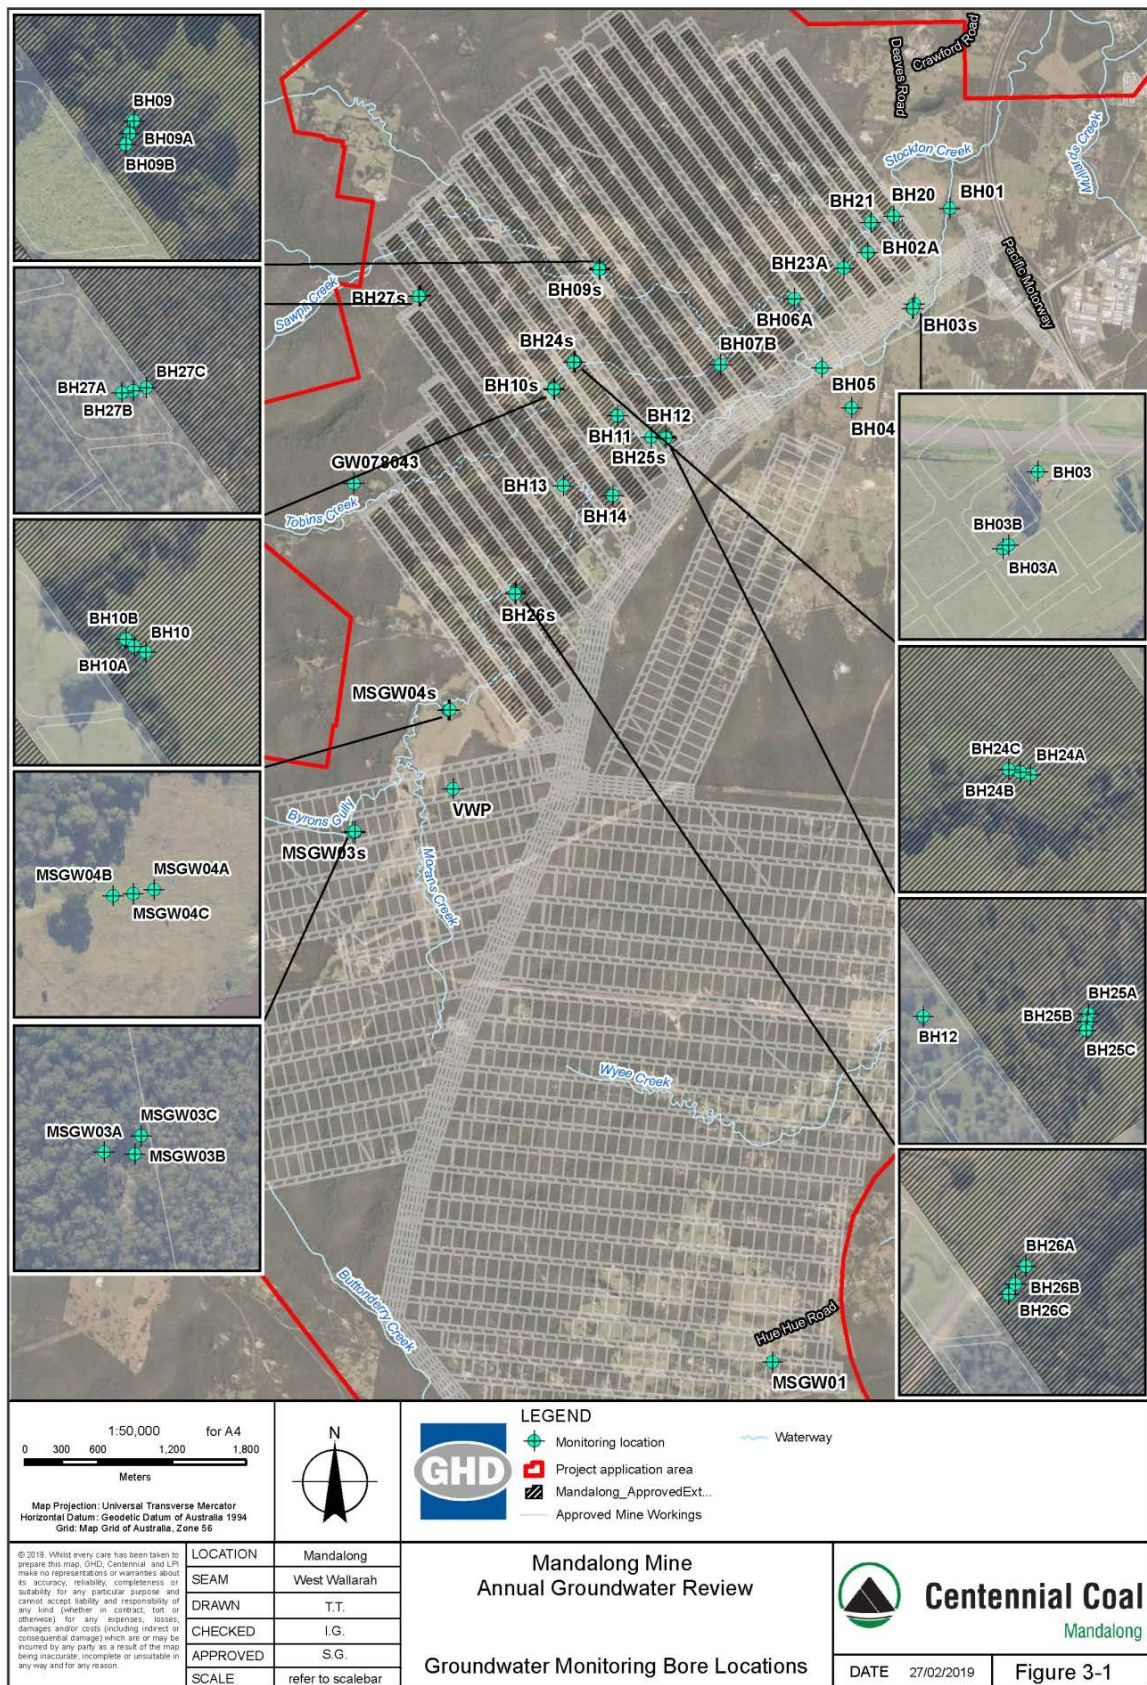
Figure 21: Mandalong Mine Groundwater Monitoring Locations.

Source: (GHD, 2019c)

The network consists of standpipe monitoring bores installed in alluvial and fractured rock groundwater sources. Locations were monitored monthly for groundwater level and limited water quality parameters (electrical conductivity and pH).

Details of the groundwater monitoring bores in the current groundwater monitoring program are summarised in **Table 43**. The location of the groundwater monitoring bores is shown in **Figure 21**.
