***ANNUAL ENVIRONMENTAL
MANAGEMENT REPORT 2014***

Centennial Mandalong Mine

**For the period 1 January 2014 to
31 December 2014**

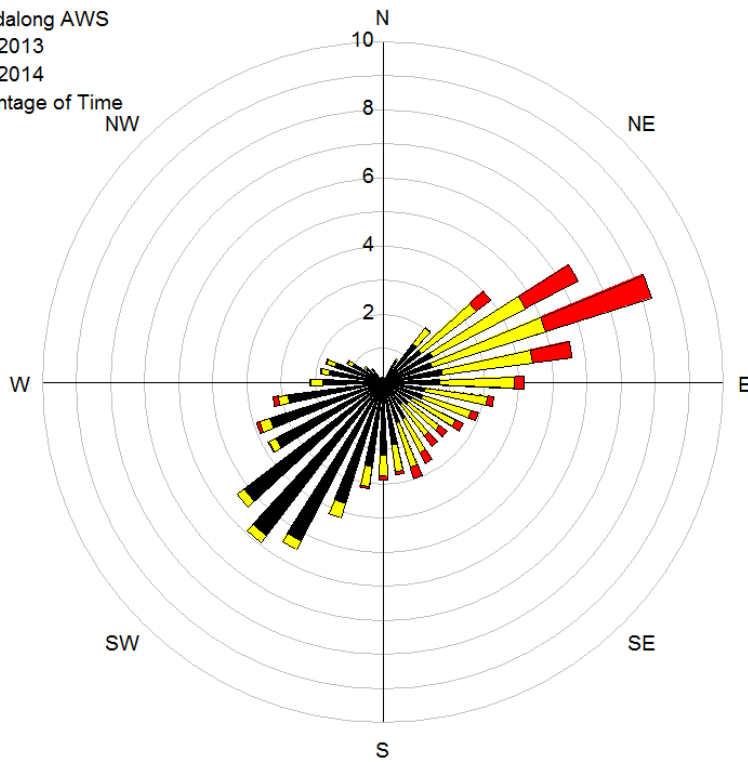
Figure 8: Average Daily Wind Direction Recorded for Summer 2014

Site 411601 Mandalong AWS
 Start Time 00:00_01/12/2013
 End Time 00:00_01/03/2014
 Wind Direction as Percentage of Time
 ■ 0-2.0 m/s
 ■ 2.0-4.0 m/s
 ■ 4.0-8.0 m/s
 ■ >8.0 m/s

Wind speed data is shown in **Table 17**. Wind speed and direction are shown graphically in **Figure 8**, **Figure 9**, **Figure 10** and **Figure 11**.

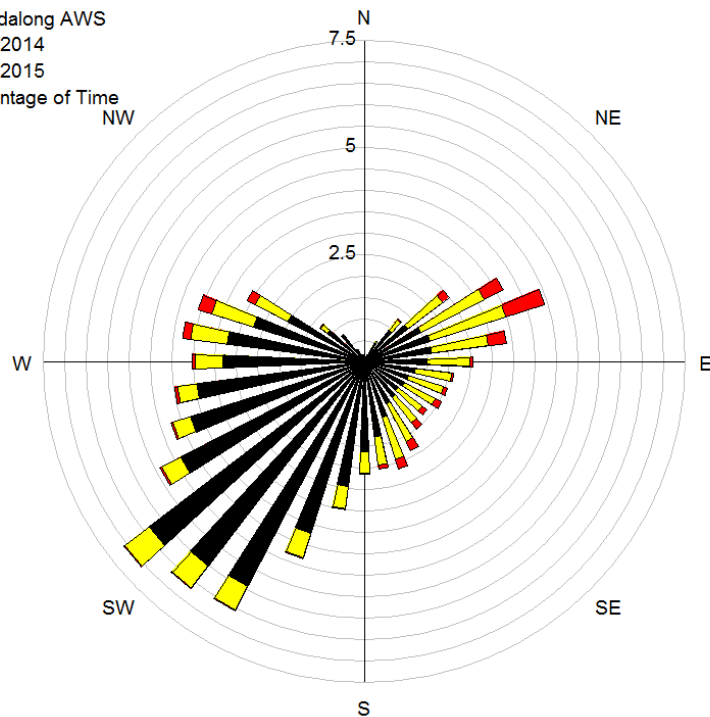
Figure 11: Annual Percentage of Wind Direction for the Period of 2014

Site 411601 Mandalong AWS
 Start Time 00:00_01/01/2014
 End Time 00:00_01/01/2015
 Wind Direction as Percentage of Time
 0-2.0 m/s
 2.0-4.0 m/s
 4.0-8.0 m/s
 >8.0 m/s

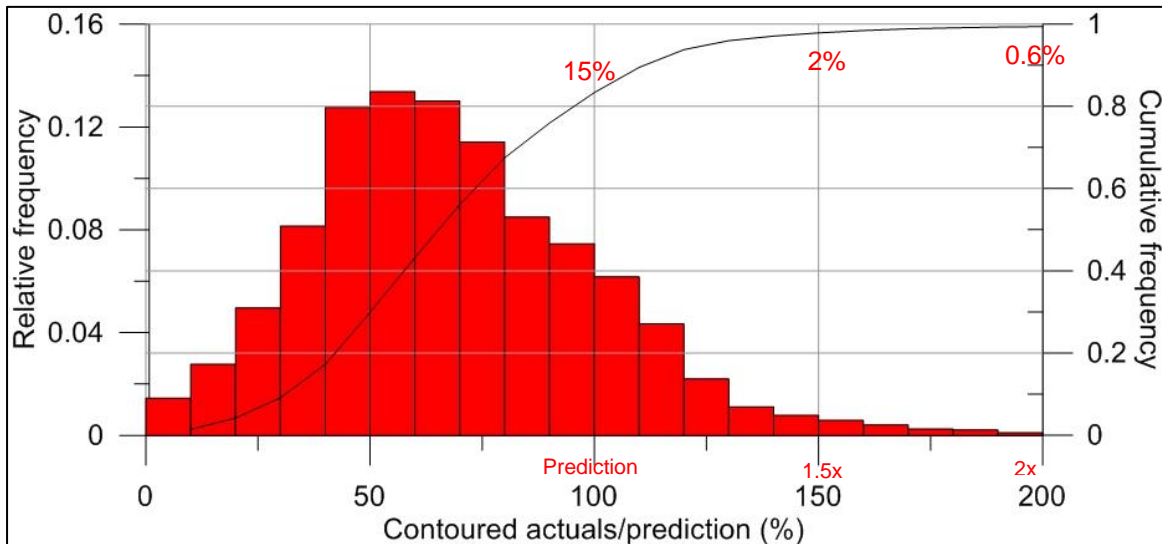
Figure 19: Relative and Cumulative Frequency Graph of Measured and Predicted Vertical Movements

Using **Figure 19** it can be seen the majority of the actual subsidence measurements are below prediction, while 15% of the database measurements were greater than predicted. Only 2% of measurements have exceeded the prediction by 1.5 times (150%) and 0.6% of measurements exceeded the predictions by two times (200%). These high percentage exceedances occur at low levels of vertical movement.
