***ANNUAL ENVIRONMENTAL
MANAGEMENT REPORT 2013***

Centennial Mandalong Mine

**For the period 1 January 2013 to
31 December 2013**

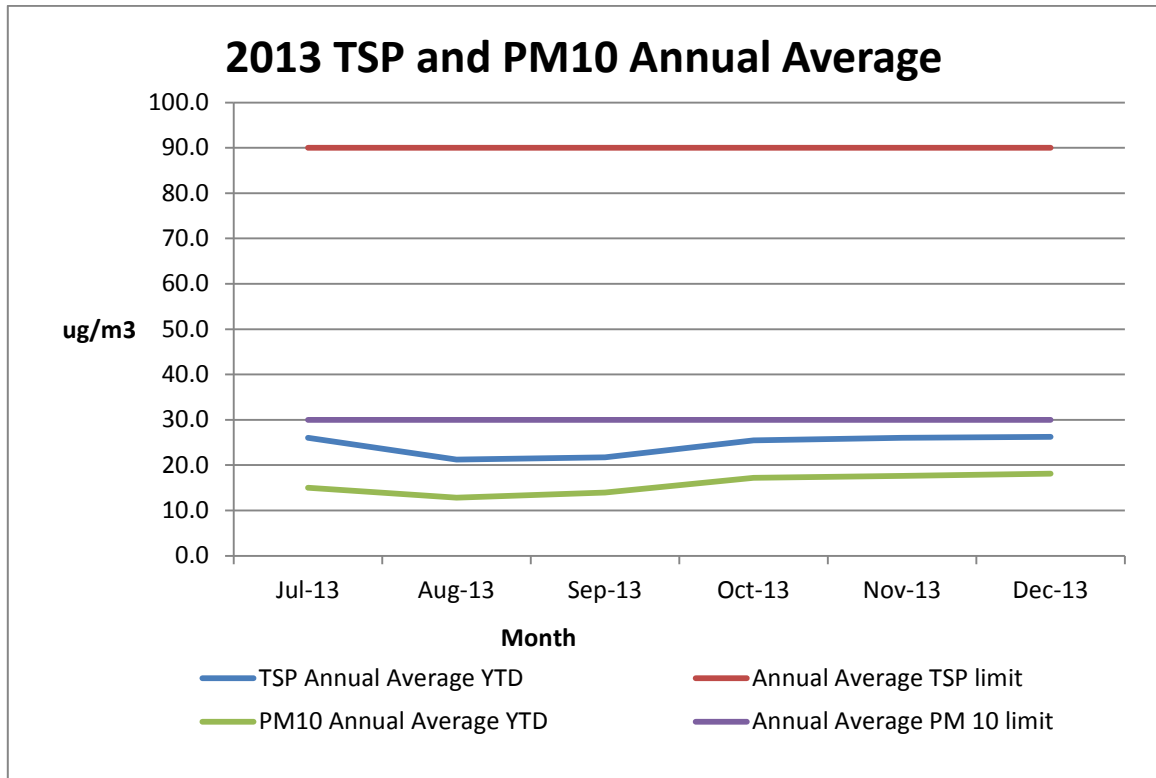
The monitoring of particulate matter was conducted from the 1st July 2013. Particulate matter monitoring results are shown in **Figure 1**. The results are presented as annual average for year to date during the report period (July 2013 to December 2013).

Figure 1: TSP and PM10 Annual Average Year to Date

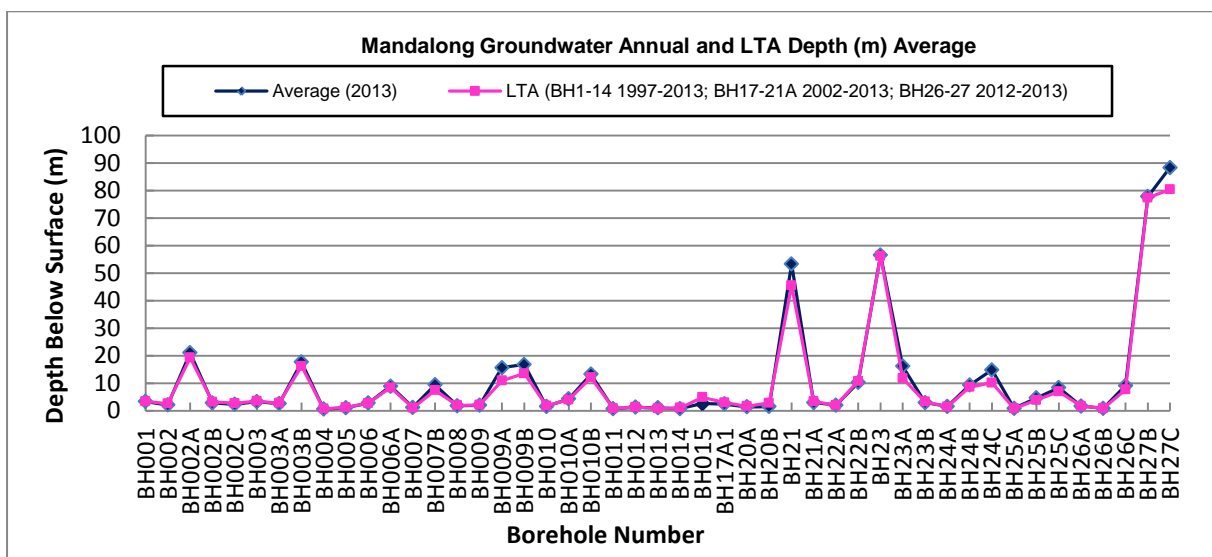
Figure 4: Long-term Average (LTA) and Annual Average Groundwater Borehole Depth (m)

The recorded depth is relative to the ground surface. The deepest water is found at BH27C averaging 88.4 m during the report period. The shallowest groundwater is found at BH004, which averaged 0.67m for the reporting period. **Figure 4** shows the annual average and long-term average depths are very similar with only minor variations for most boreholes.

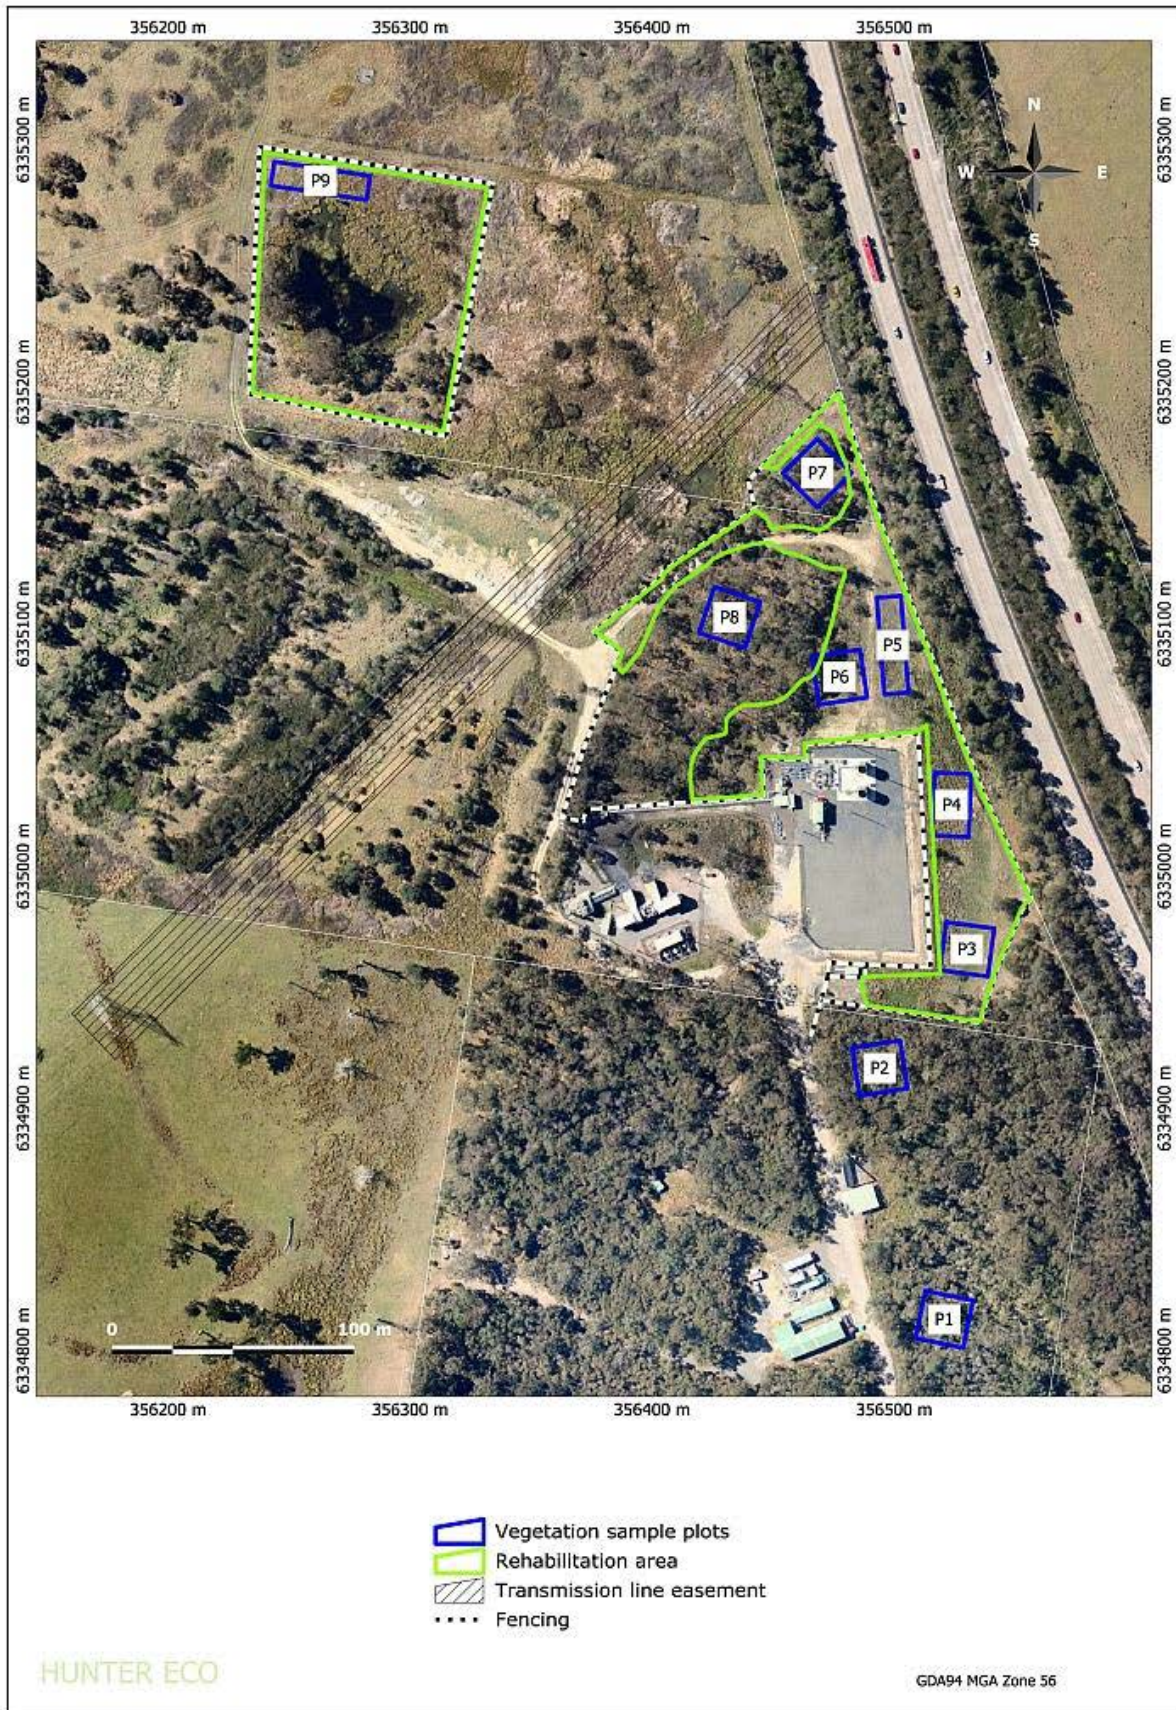
Figure 10: Location of Floristic Sample Plots

All plots were permanently established with star pickets at each corner in 2012, and floristic data were collected on 21 and 25 October 2013 (**Source** (Hunter Eco, 2013d) Figure 10).

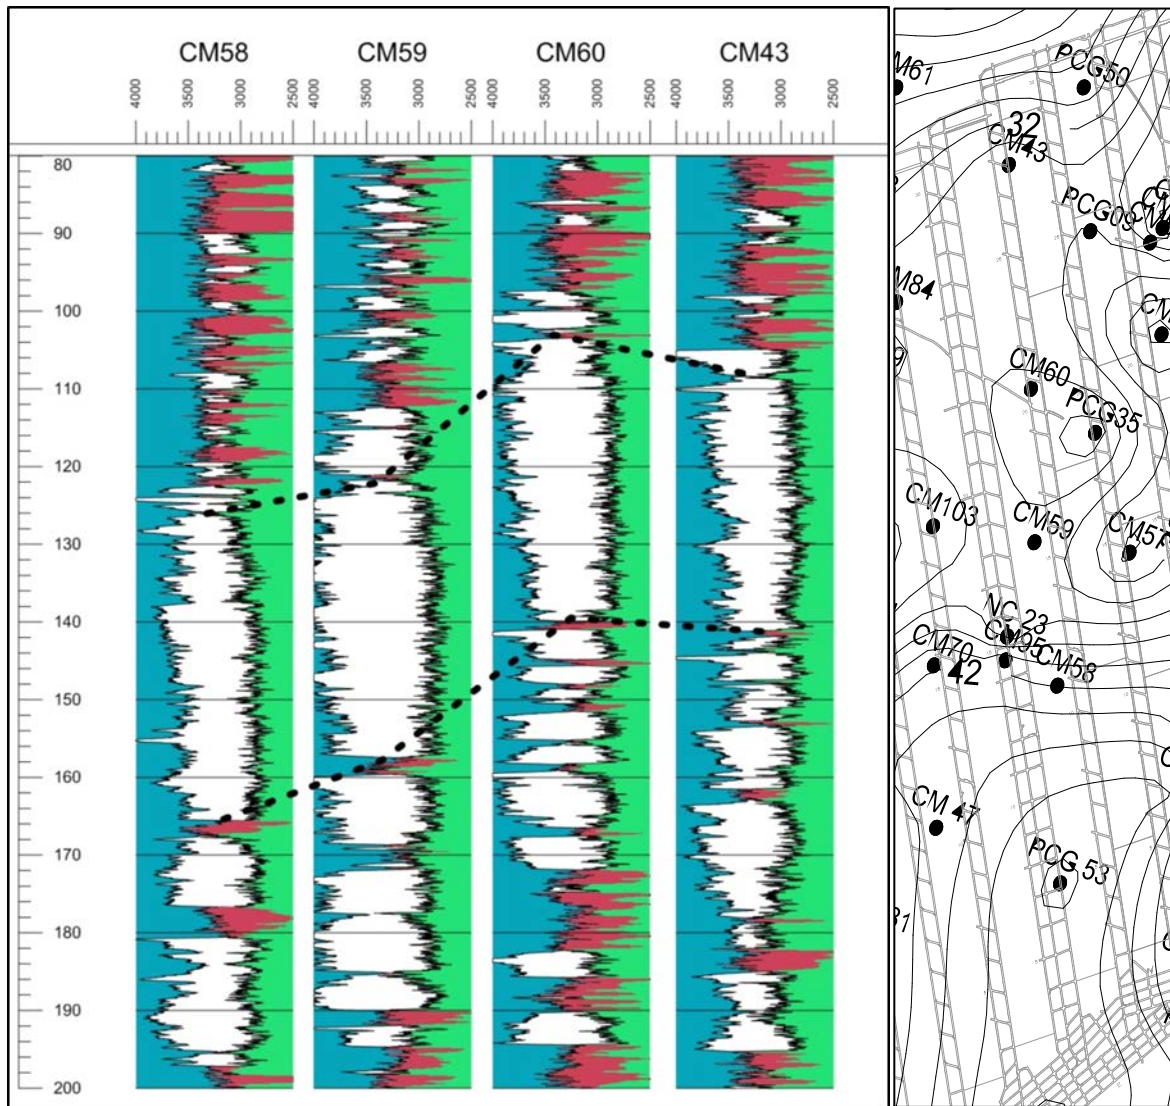
Figure 15: Geophysical Logs showing Conglomerate Beam Thickness along LW14

The subsidence results above Longwall 14 were generally within anticipated levels, with maximum vertical subsidence over the majority of the panel typically ranging between 0.25m and 0.35m, consistent with less variation in the depth of cover and conglomerate beam 35m to 40m thick as shown in **Figure 15**.

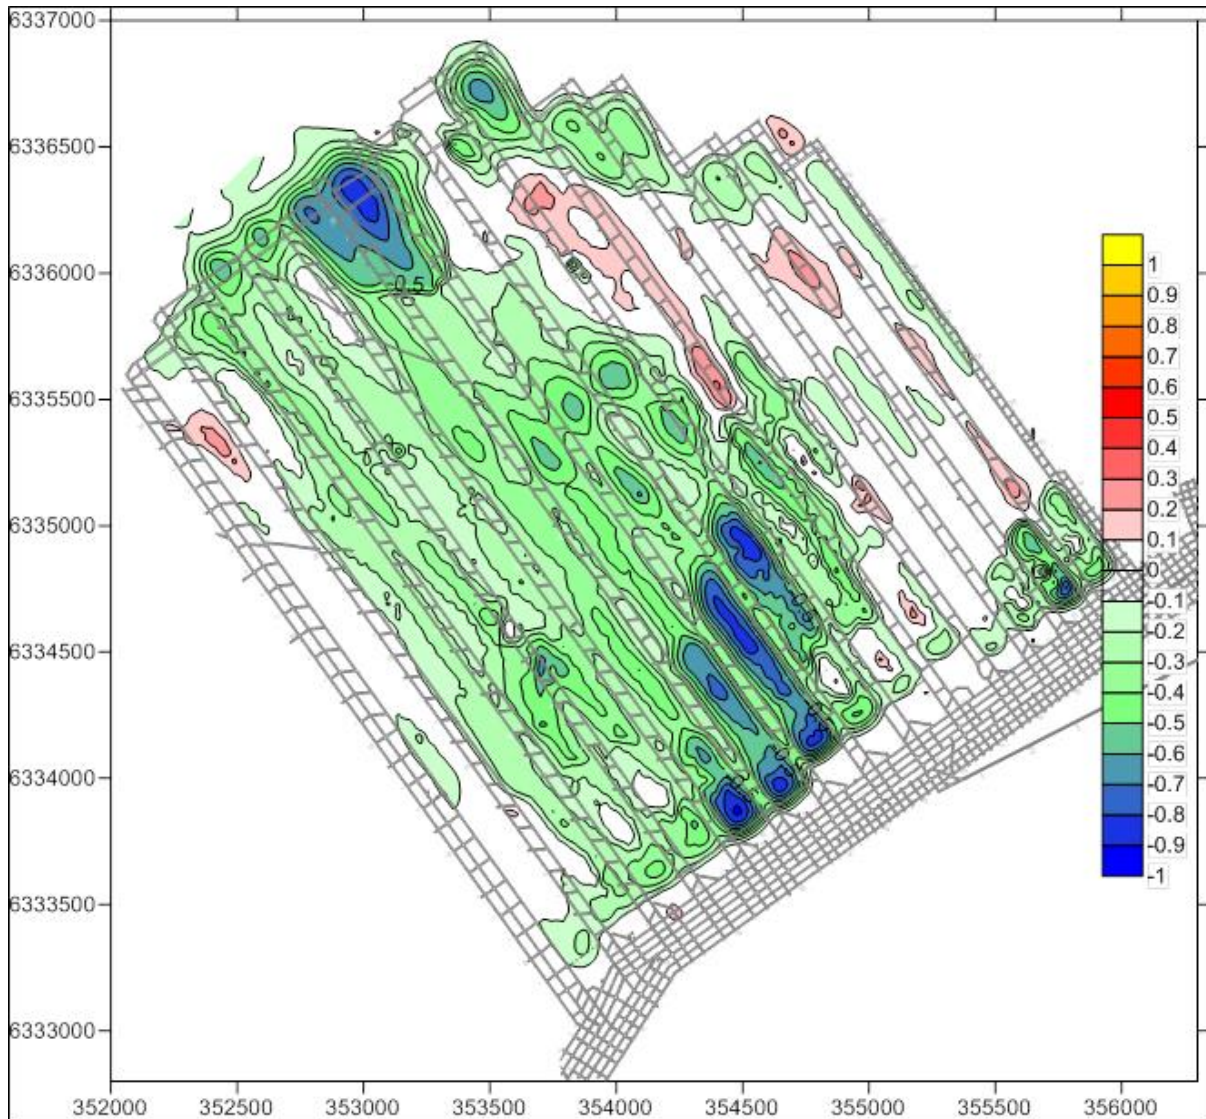
Figure 15 below, shows the difference between actual and predicted subsidence, where green shading is where actual subsidence is less than predicted and red shading is where actual subsidence greater than predicted. Apart from the slight increase in subsidence at the commencement of the panel (0.53m), maximum subsidence was within the predicted range.

Figure 16: Difference between Predicted and Actual Subsidence

Vertical subsidence levels on Longwalls 13 to 15 are generally within predicted maximums. The distribution of subsidence above Longwalls 13 to 15, shown in **Figure 16** indicates subsidence on the floodplain, where the majority of pasture areas are found, ranges up to 0.60 m. There is little evidence that these relatively low levels of subsidence have impacted on pasture condition, as further discussed below.

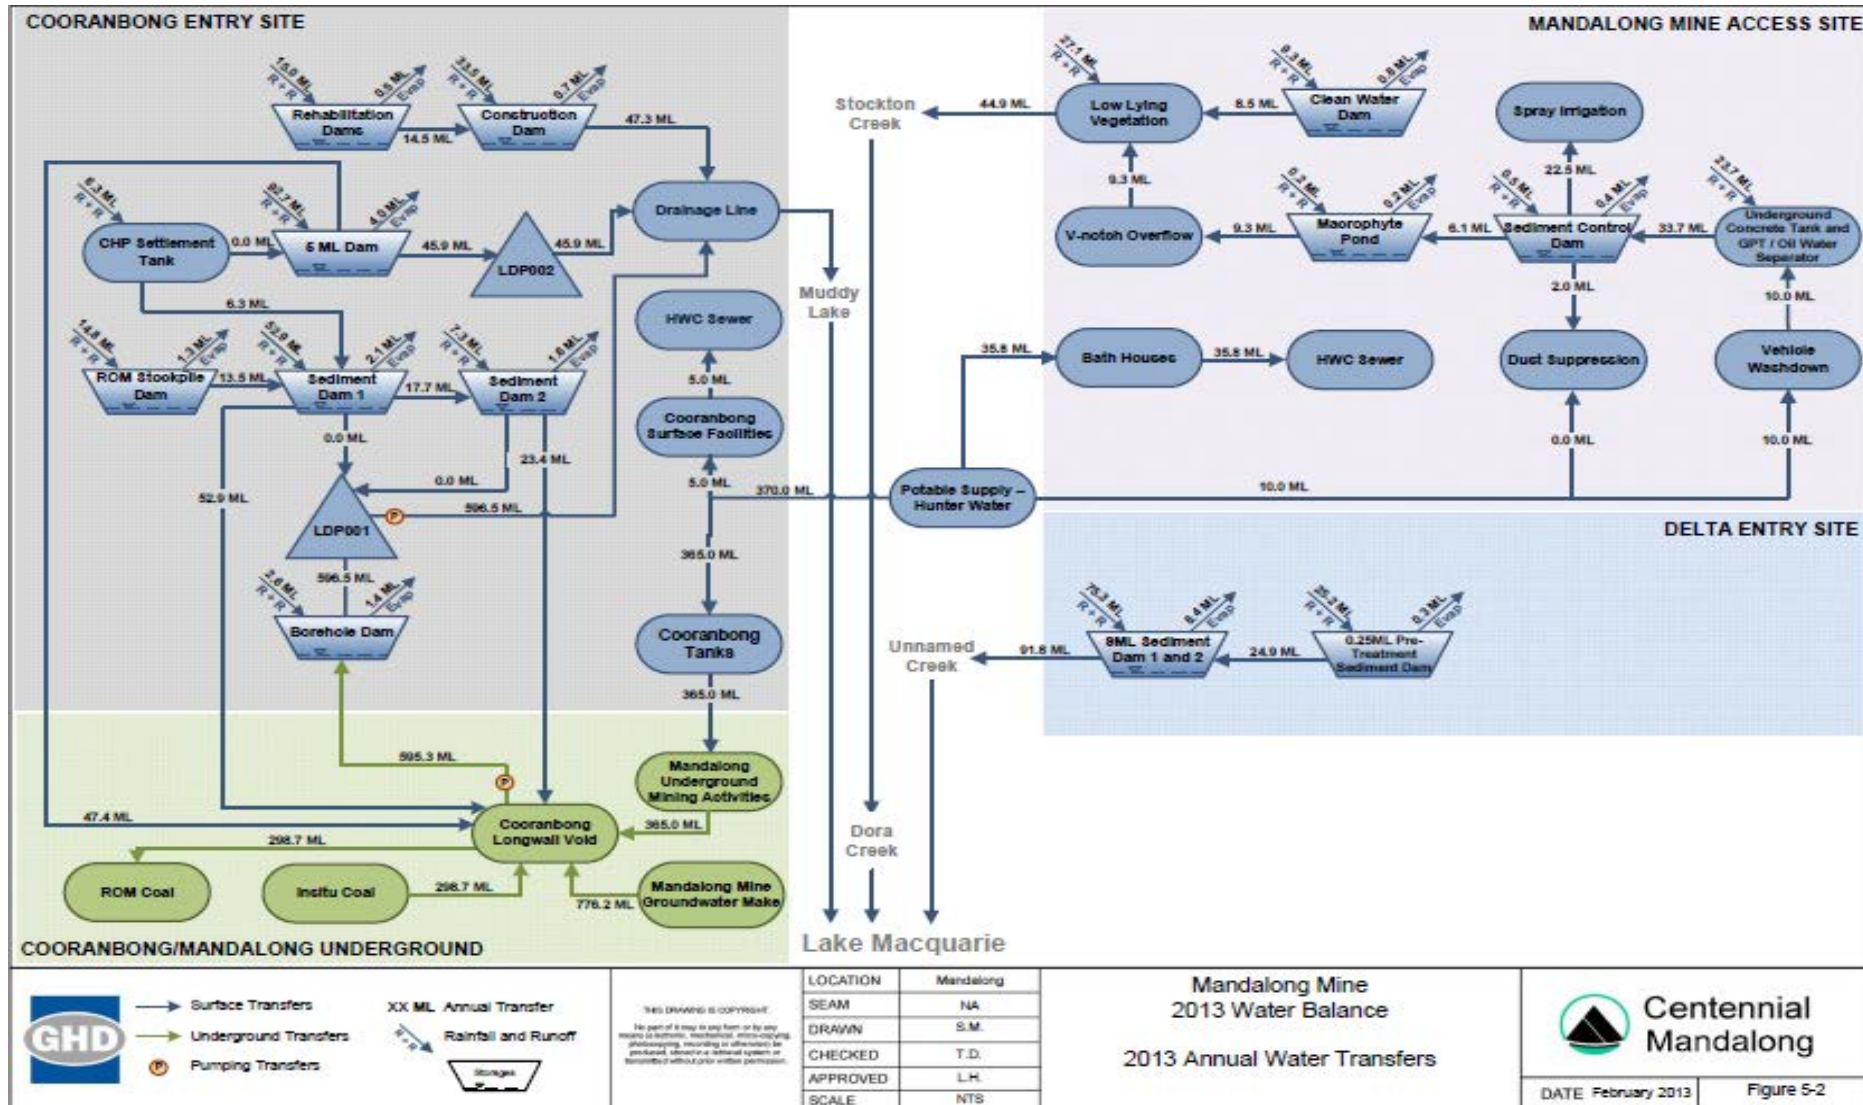
Figure 18: GHD Water Balance Model 2013

The 2013 water balance diagram (GHD, 2014) for Mandalong Mine is shown in **Figure 15**. The water balance for 2013 is presented in **Table 31**. The primary inputs for the water budget are potable water, groundwater, and surface run off as described below. The primary outputs from the water budget are discharged water, water loss in product coal and water to sewer.

Figure 18 this consisted of 44.9 ML from the Mandalong Mine Sediment Control Dam. A total of 689.7 ML was discharged from the Cooranbong Services Site, with 596.5 ML from LDP001, 45.9 ML from LDP002 (5 ML dam) and 47.3 ML from the construction dam (clean water dam). 91.8 ML of surface water run off water was discharged from Delta Entry Site dams.

The majority of discharged water from the sites is generated from surface water run-off as, shown in **Figure 18**. The exception being LDP001 at the Cooranbong Services Site. It is estimated 123.7 ML was pumped from the Cooranbong Settlement Dams to the underground to provide sufficient surface water storage during rainfall events.
