# Independent Environmental Audit (IEA) Myuna Colliery

for Centennial Myuna Pty Ltd

Myuna Colliery, 14 Summerhill Drive, Wangi Wangi NSW 2283

Report Title	Independent Environmental Audit 2016 Myuna Colliery
Client	Centennial Myuna Pty Limited 14 Summerhill Drive, Wangi Wangi, NSW 2283
Report Reference	MCW_Environmental_10022_Myuna_IEA_Final_2016Rev1
Status	Final
Issue Date	31 October 2016

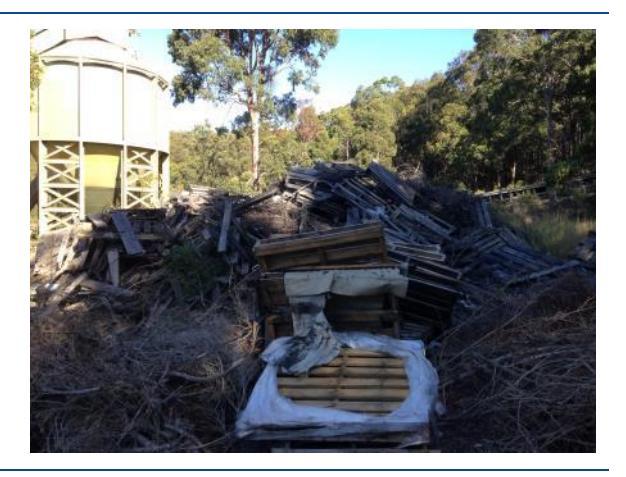
5-5. A pile of wooden pallets was observed during the site inspection. Site management reported they were in the process of sorting the pallets for disposal.

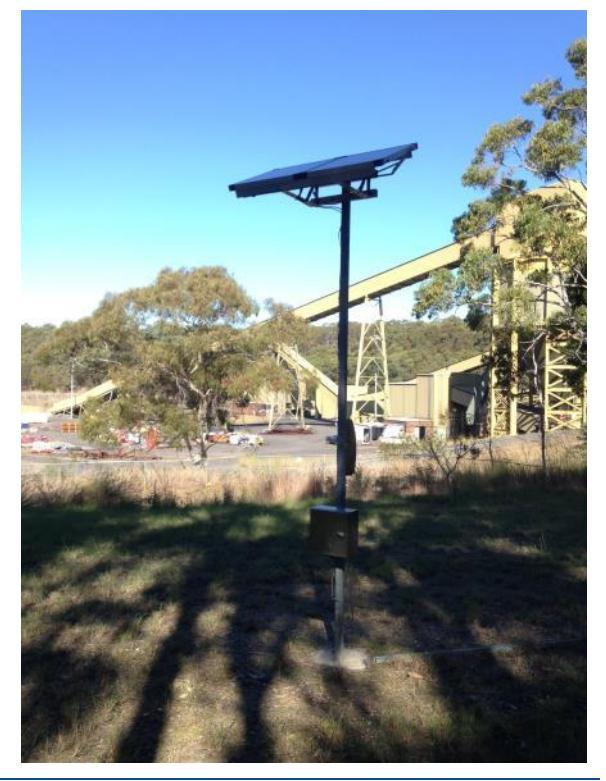
5-6. A permanent real-time noise logger was installed to the north of the site during the audit period.
